**Barn 1 Conversion**

**Four Winds**

## **Visual Structural Inspection and Report**

**Project No. 7106**

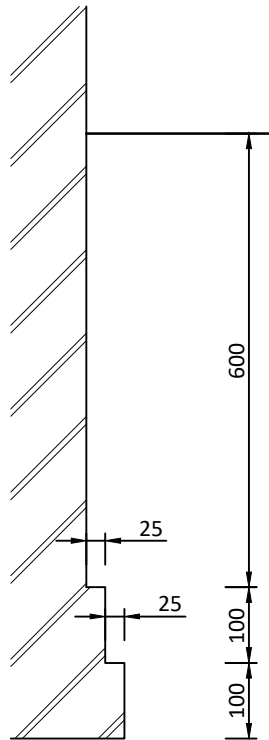
**TH1**

Dark brown silty/clay  
(medium firm)

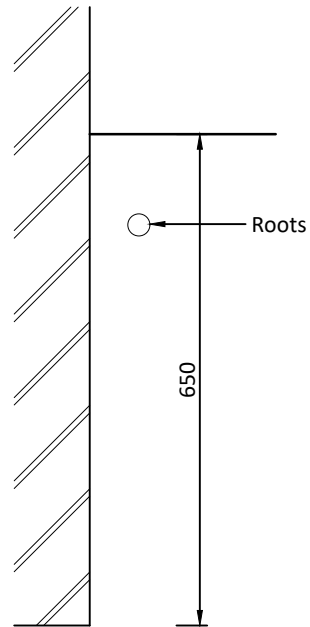
**TH2**

Dark brown silty/clay  
(medium firm)

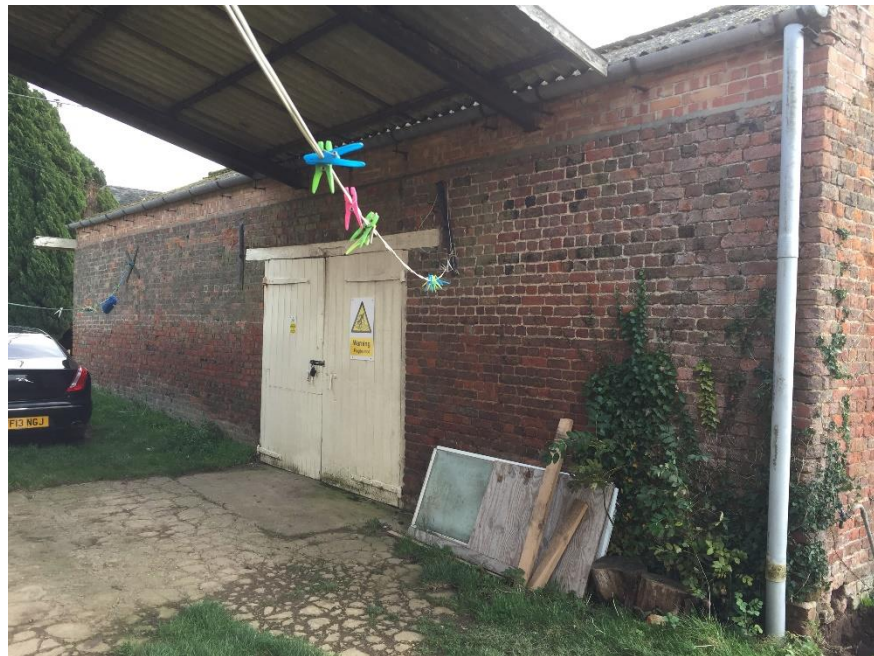
**Photograph 1**

#### **North Elevation – Photograph 1**

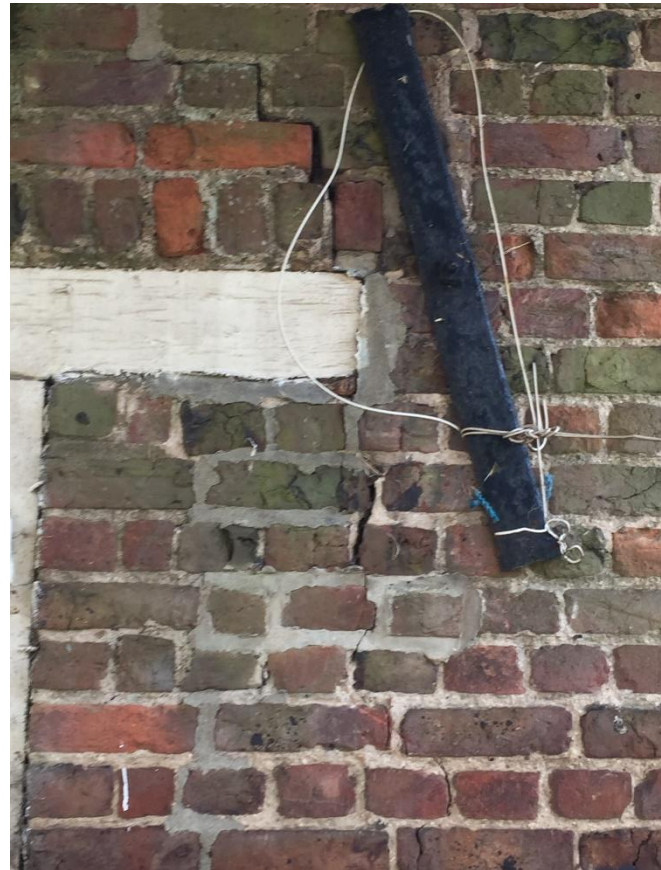
**Photograph 2**

- 4.01     We noted cracking within the brickwork up to 10mm in width to the side of the external door and timber lintel. **Photograph 2.**
- 4.02     Above the door, the brickwork displayed an outward rotation and bulging.
- 4.03     Vertical cracking up to 5mm in width was noted to towards the western gable close to the uPVC downpipe.
- 4.04     The later addition of high-level brickwork at eaves level displayed undulations and bulging and is set back from the brickwork below.

- 6.02 All severe diagonal stepped cracking noted should be repaired with a “Helibar” or similar crack stitching technique to strengthen.
- 6.03 In areas, the timber and masonry has suffered from damp and moisture due to inadequate roof drainage. As part of the proposed conversion, new gutters will be installed and these need to discharge into sewers or soakaways positioned a minimum 5.0m away from the structure, in accordance with the Building Regulations.

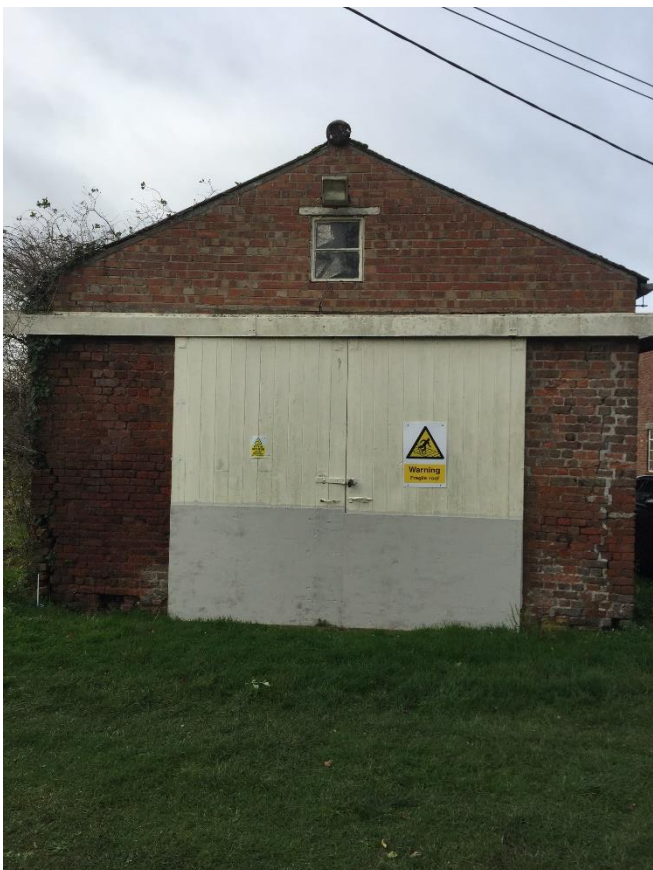
**Photograph 3**

#### **East Elevation – Photograph 3**

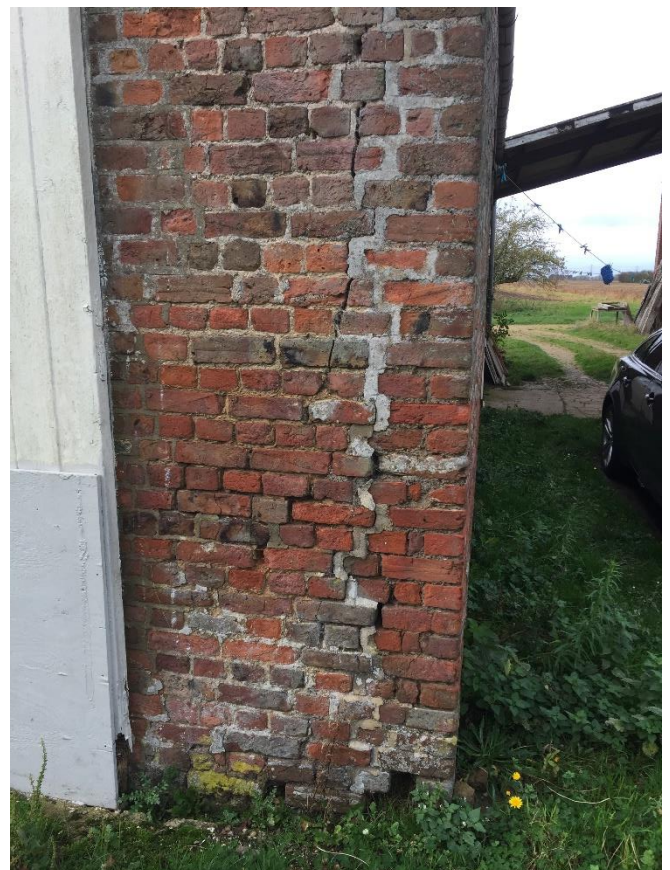
**Photograph 4**

- 4.05     We noted vertical cracking between 5-10mm in width and missing bricks at low level to the northern corner. **Photograph 4.**
- 4.06     Above the door opening to the underside of the window, we noted a vertical crack up to 5mm in width within the later constructed brickwork. **Photograph 5.**
- 4.07     We noted loose brickwork and missing bricks at low level to the southern corner.
- 4.08     Cracking up to 10mm in width was evident from the side of the lintel bearing up to eaves level. **Photograph 6.**
- 4.09     General erosion of mortar joints was common throughout this elevation.

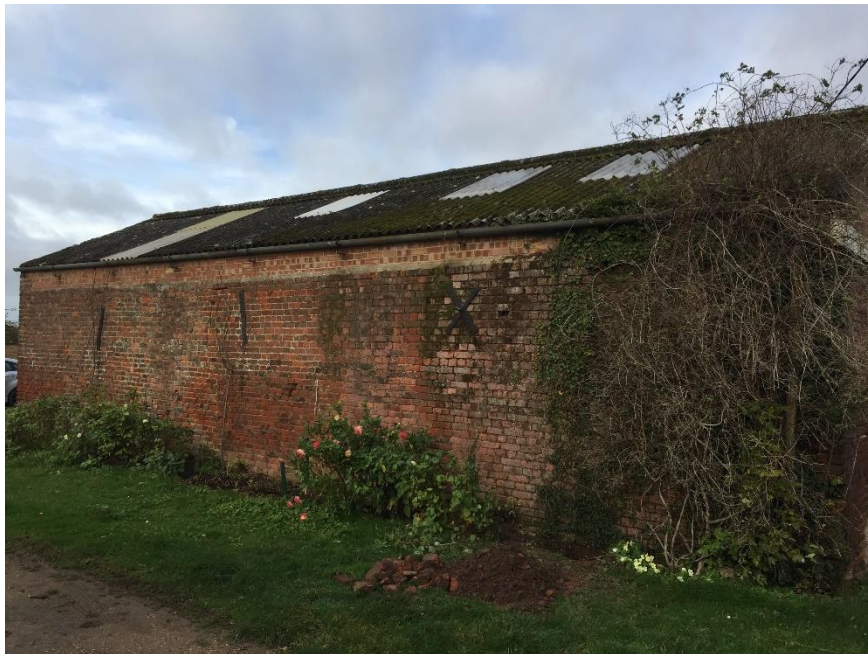
**Photograph 7**

#### **South Elevation – Photograph 7**

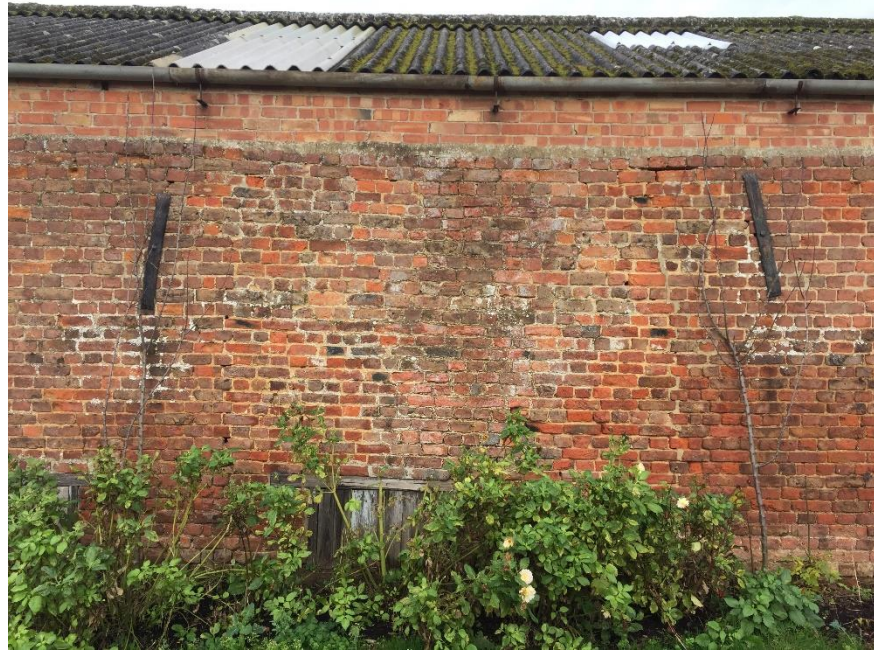
**Photograph 8**

- 4.10 The brickwork was found to be unlevel along the bed coursing and an outward bulge was evident at mid-height. **Photograph 8.**
- 4.11 Low level openings are boarded up and above the western opening a full height vertical crack up to 20mm in width was evident. **Photograph 9.**
- 4.12 Loose and eroded brickwork was noted to the western corner at low level. **Photograph 10.**
- 4.13 Isolated areas of the brickwork faces have spalled, and mortar joints were eroded.

- 6.07 The cause of the undulations and movement with the brickwork to the south elevation is unknown. It may be necessary that some localised underpinning is required, and that the low-level openings are further investigated. The movement does appear to be historic.

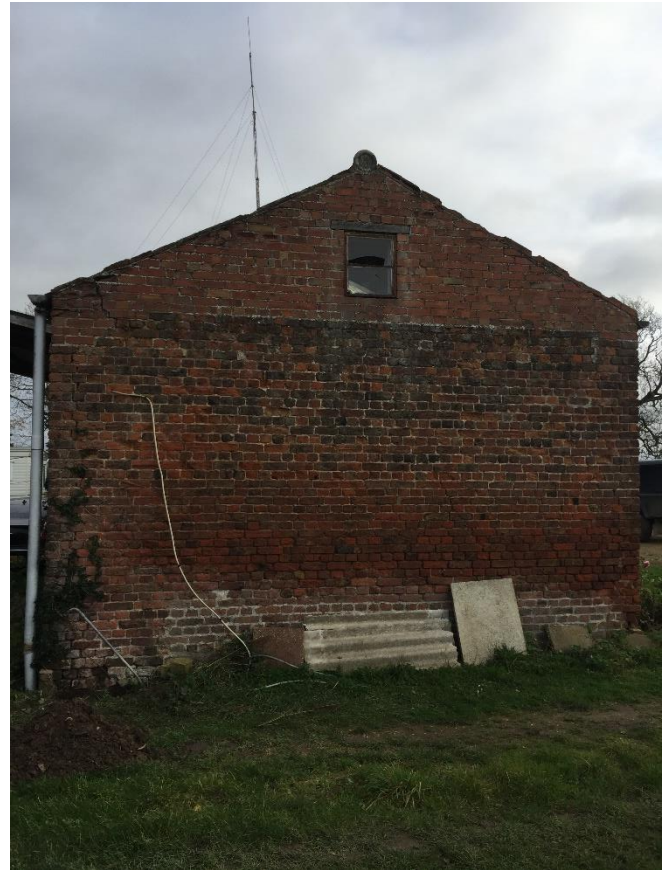
**Photograph 11**

#### **West Elevation - Photograph 11.**

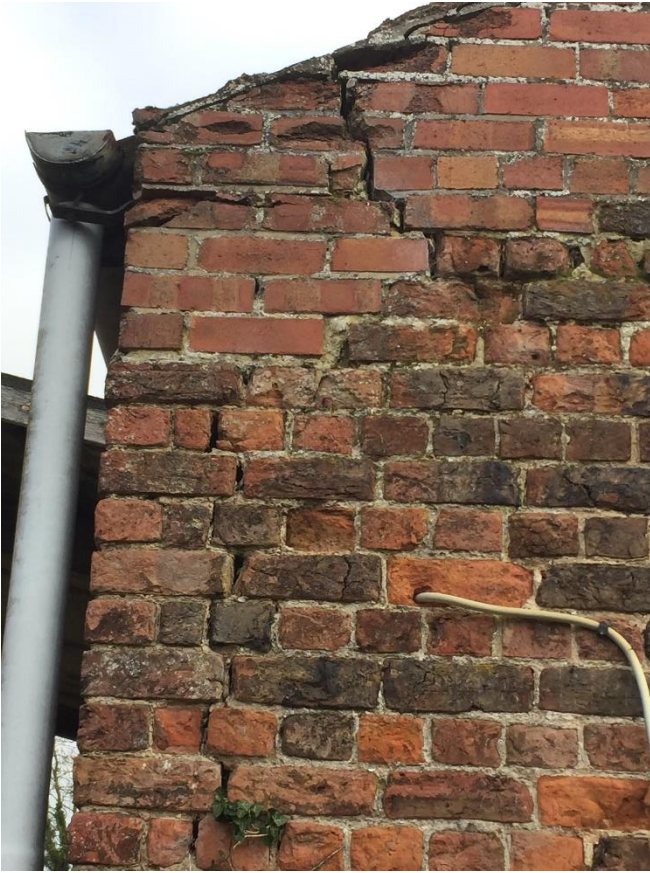
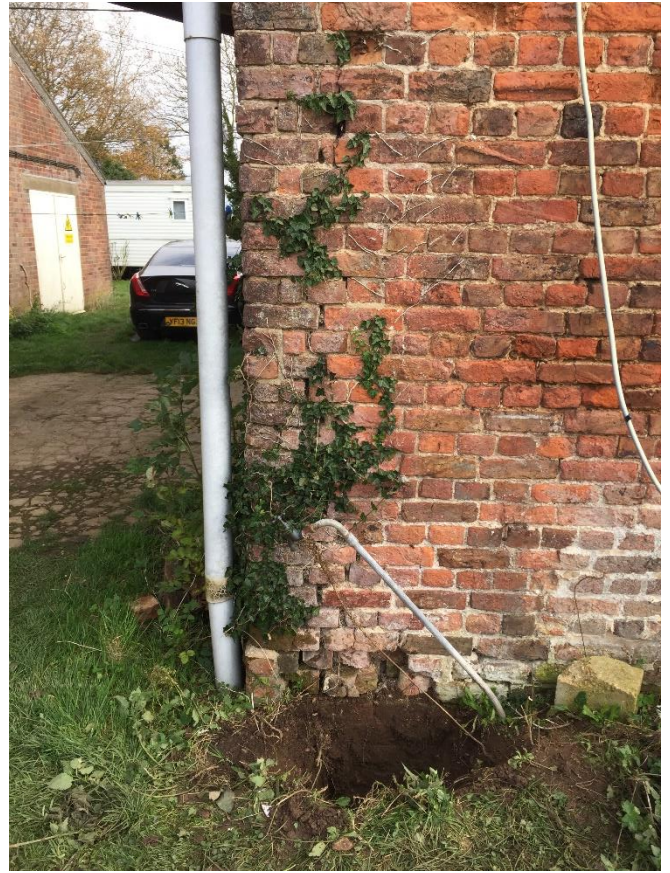
- 4.14 Similar to the east elevation, the gable wall has been later constructed in brickwork.
- 4.15 We noted vertical cracking up to 10mm in width to the northern corner; loose brickwork was evident at eaves and low level. **Photographs 12 & 13.**
- 4.16 Isolated areas of the brickwork faces have spalled, and mortar joints were eroded.

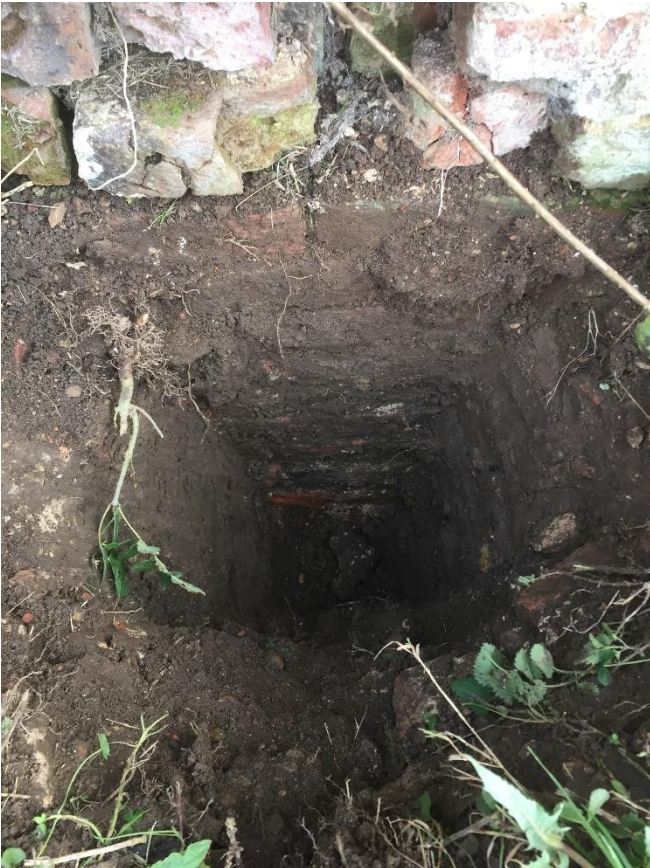
**Photograph 14 – Trial Hole 3**

#### **Trial Holes - Photographs 14 & 15**

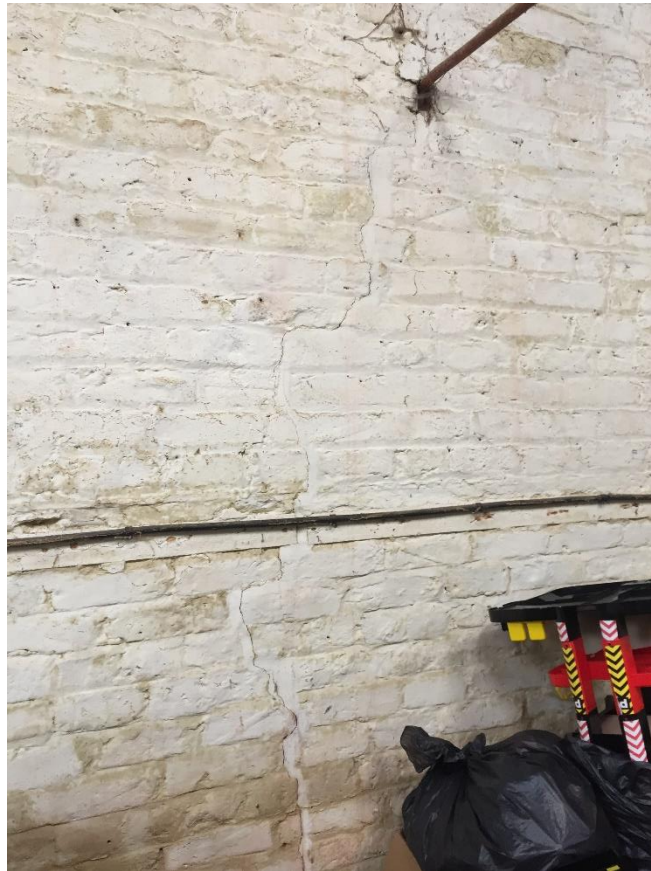
**Photograph 16**

- 5.01 The roof structure is formed with steel trusses and purlins built into the gable ends. A steel tie rod and timber tie beam were noted between the eaves of the original brickwork.
- 5.02 We noted a vertical crack within the original brickwork to the north elevation below the tie bar. **Photograph 16.**
- 5.03 We noted a vertical crack within the original brickwork to the west elevation. **Photograph 17.**
- 5.04 A series of timber beams formed the lintel over the large door opening to the east elevation. **Photograph 18.**
