**Barn 2 Conversion**

**Four Winds**

## **Visual Structural Inspection and Report**

**Project No. 7106**

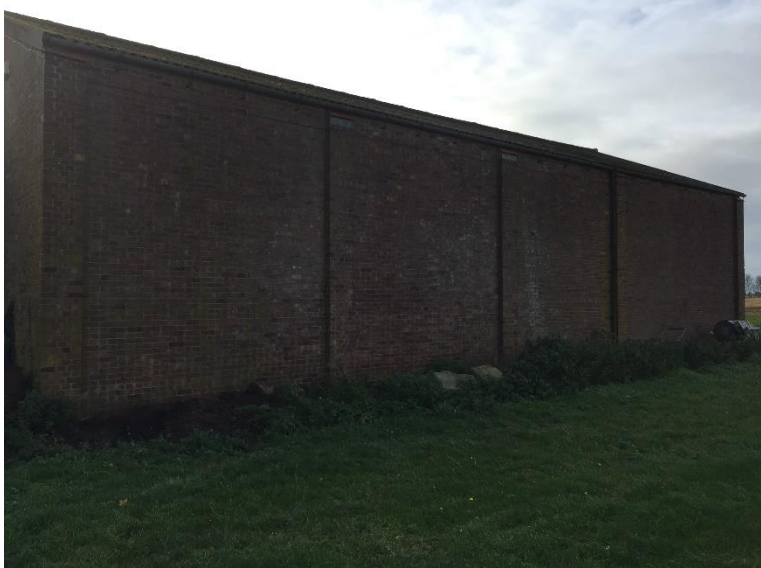
**Photograph 1**

#### **North Elevation – Photograph 1**

- 4.01 We noted cracking in the bed joint of the brickwork at eaves level to the central section of the elevation.
- 4.02 External brick piers projected out from the external wall.

- 6.04 In areas noted in this report, the horizontal cracking to the bed joints of the brickwork should be repointed. Holding down straps may require to be installed if the cause is found to be due to an issue with the effect of wind uplift. If steel tie corrosion is found to be the cause, then the ties are to be locally removed and replaced. Further on site investigations by a Contractor are advised.

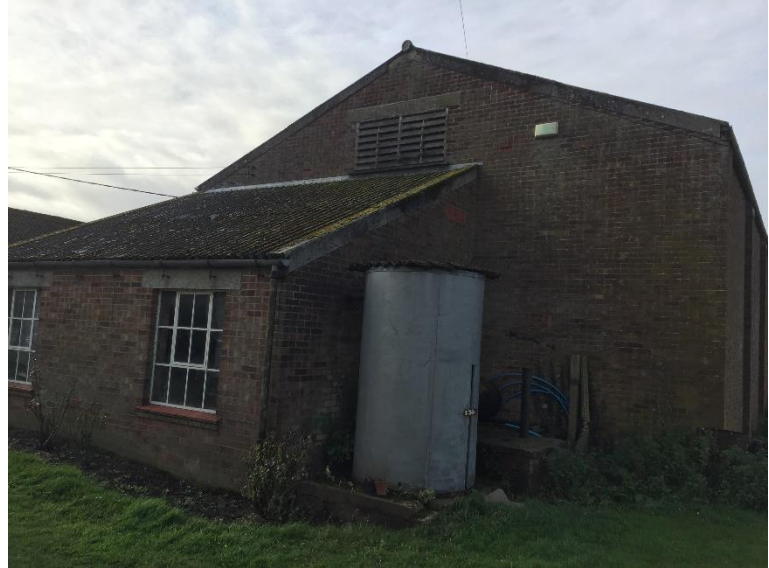
**Photograph 2**

#### **East Elevation – Photograph 2**

- 4.03 A single storey lean to structure adjoined part of the main two storey gable end.

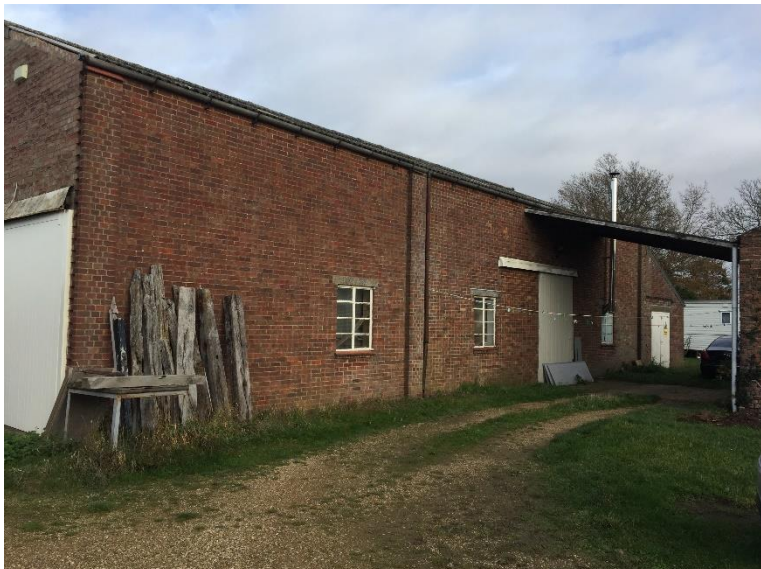
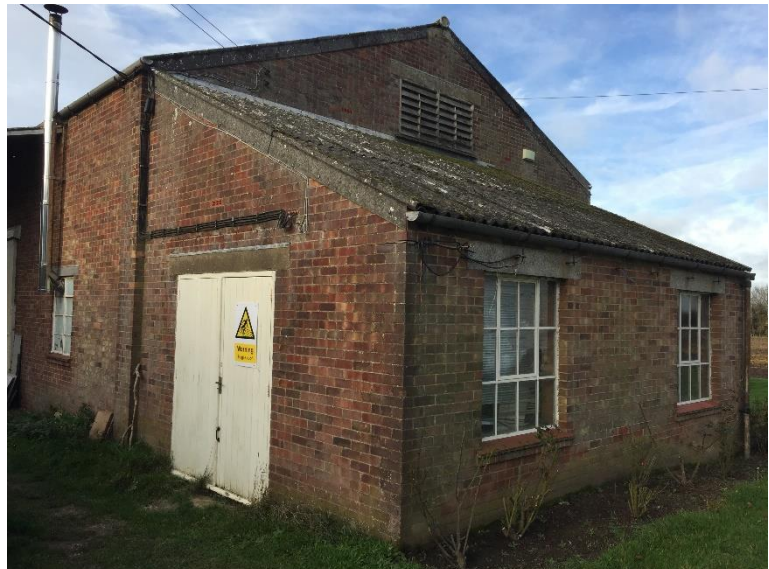
#### **South Elevation - Photographs 3 & 4**

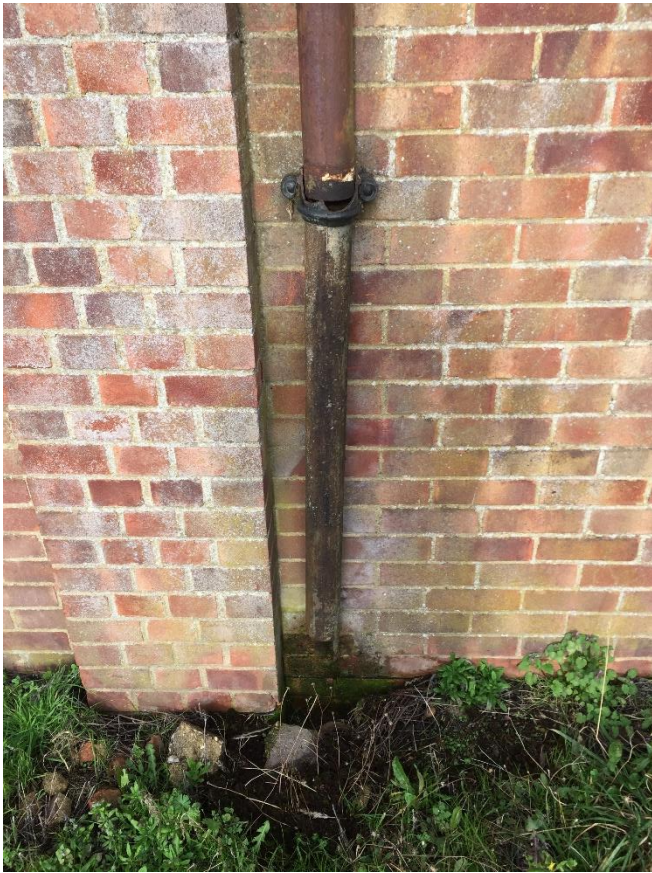
**Photograph 5**

- 4.04 We noted that the cast iron downpipe was broken and damaged, resulting in the damp staining of the brickwork at low level. **Photograph 5.**
- 4.05 Exposed reinforcement was evident to the lintel above the window. **Photograph 6.**
- 4.06 Horizontal cracking along the bed joint of brickwork was noted above the door to the single storey lean to section. **Photograph 7.**
- 4.07 We noted vertical and stepped cracking between 1-2mm in width above the window and to the side of the external brick pier.

- 6.05 The broken downpipe noted to the south elevation will need to be repaired.
- 6.06 We recommend that all timber, if retained, be surveyed by a specialist for decay and infestation and treated or replaced as advised in their report.

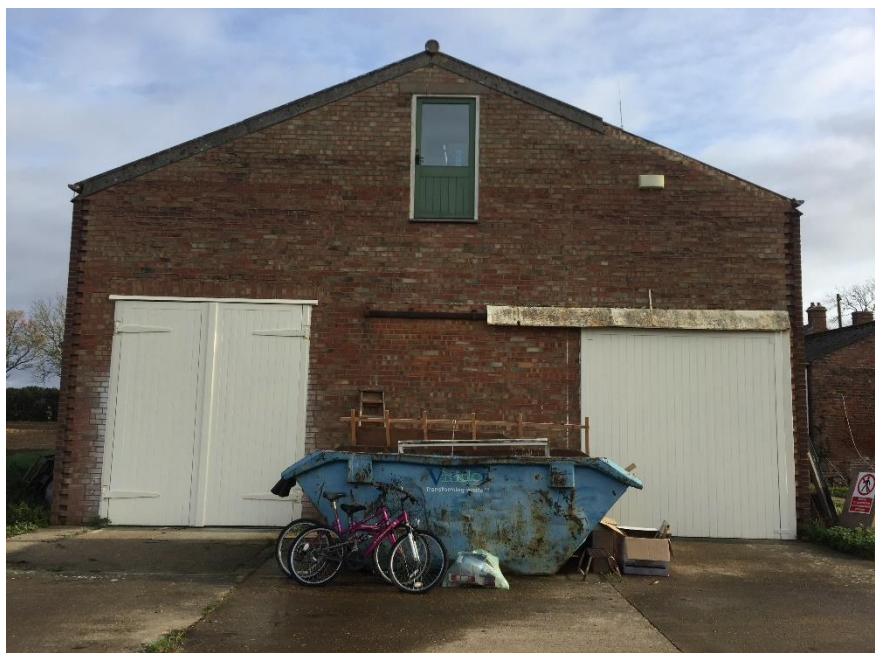
**Photograph 8**

#### **West Elevation – Photograph 8**

- 4.08 Above the large door openings, areas of the brickwork faces have spalled, and mortar joints were eroded.

- 6.01 We recommend that all spalled and eroded brickwork be repaired and repointed as part of the proposed conversion works to maintain integrity and weatherproofing.

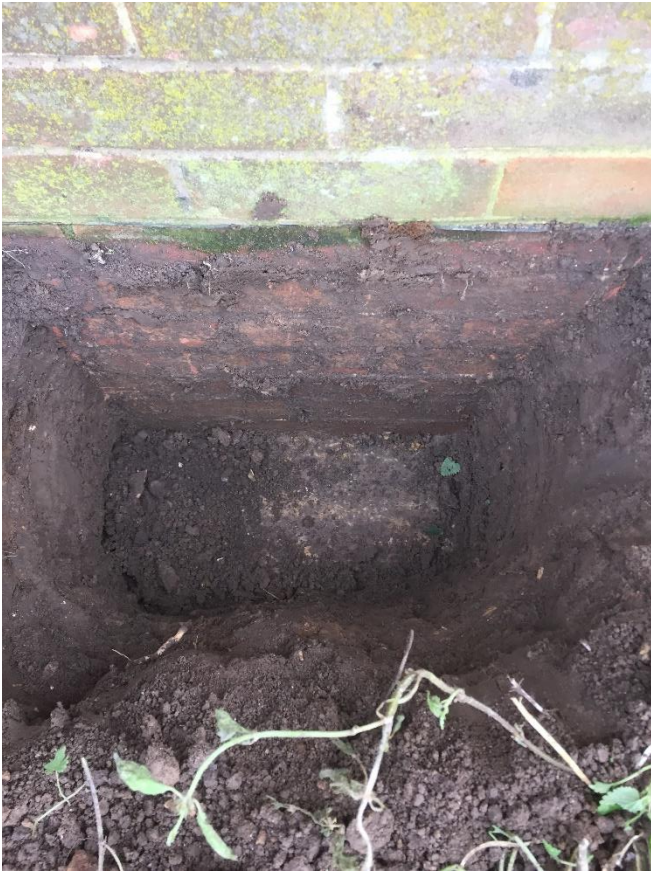
**Photograph 9 – Trial Hole 5**

#### **Trial Holes - Photographs 9 & 10**

- 4.09 Refer to location plan and sketches in Appendix 2.

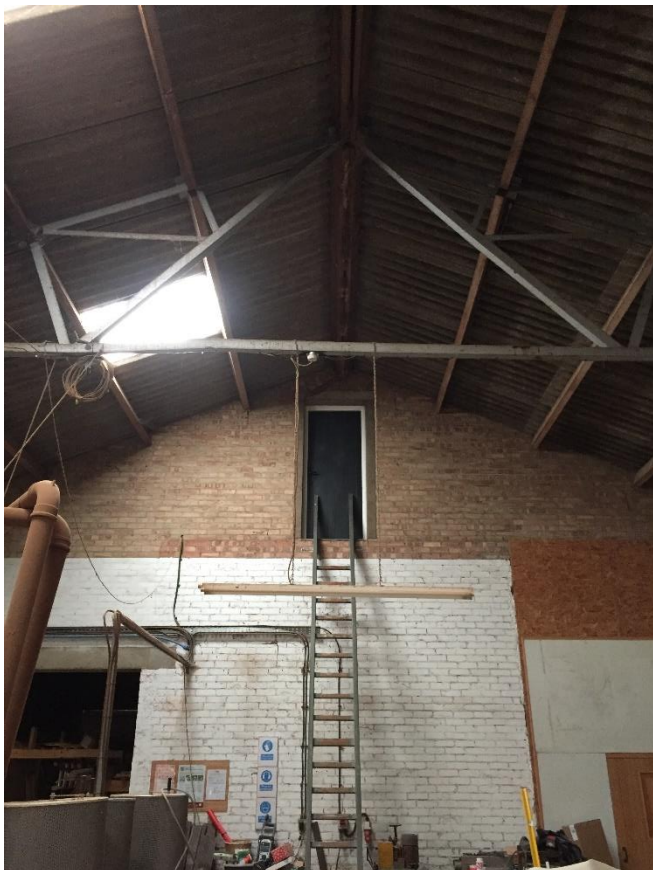
**Photograph 11**

- 5.01 The main two storey roof structure is formed with steel trusses and purlins built into the gable ends. **Photograph 11.**
- 5.02 A blockwork leaf is constructed to the northern and eastern walls.
- 5.03 Internal brick piers projected in from the southern external wall.
- 5.04 A concrete downstand beam supported the brickwork forming the internal party wall. **Photograph 12.**
- 5.05 The single storey lean to roof structure constructed to the east elevation is formed with steel RSJ purlins and underdrawn with boarding.
