# ASBESTOS REFURBISHMENT SURVEY REPORT

Within Specified Areas of  
FOUR WINDS  
TYDD LOW ROAD  
LONG SUTTON  
PE12 9AR

L-02010

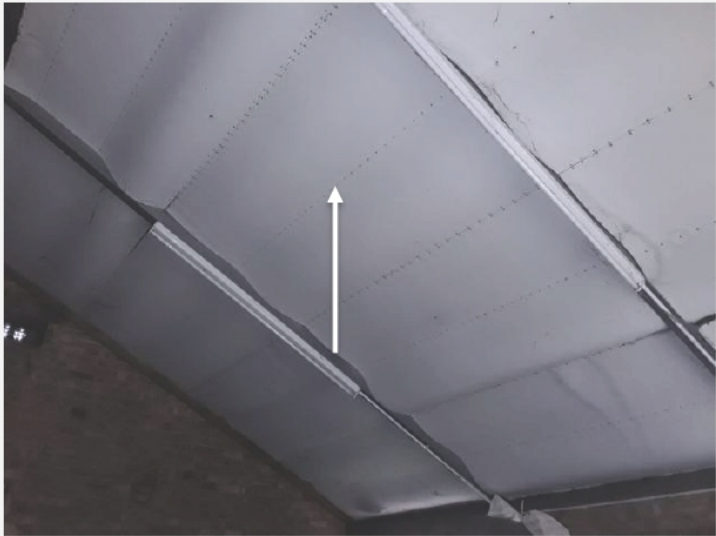
| SURVEY DATA SHEET | | | |
|---|---|---|---|
| Photo No. | 1 | Location | Barn 1, 0.01 Store |

| SURVEY DATA SHEET | | | |
|---|---|---|---|
| Floor | Ground | Product Description | Fibreboard ceiling panels |
| Product Type | Fibreboard | | |
| Asbestos Type | No Asbestos Detected | | |

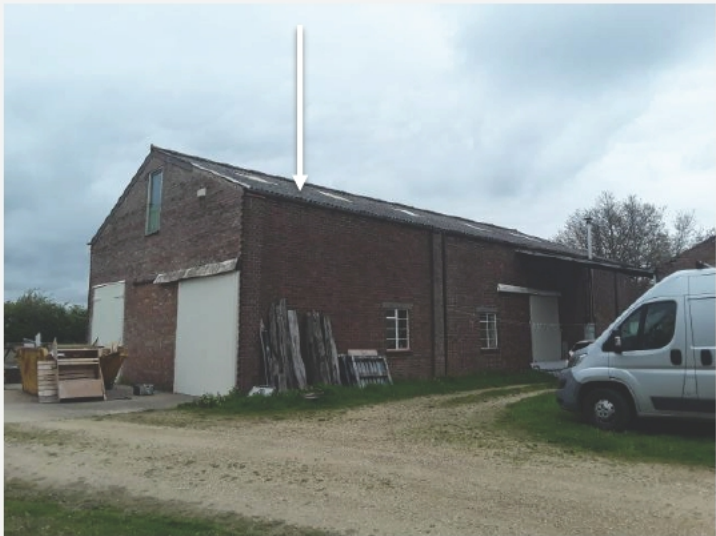
| Barn 1 | | | | | | | | |
|---|---|---|---|---|---|---|---|---|
| External | Cement Sheet | L-02010/08<br>Cement roof sheets (to barn, lean-to & tank) | Unsealed | 280 m <sup>2</sup> | Low | Chrysotile | 4 (VERY LOW) | Remove if due to be disturbed |

| SURVEY DATA SHEET | | | |
|---|---|---|---|
| Floor | External | Product Description | Cement roof sheets<br>(to barn, lean-to and tank) |
| Product Type | Cement Sheet | | |
| Asbestos Type | Chrysotile | | |
| Extent of Damage | Low | | |

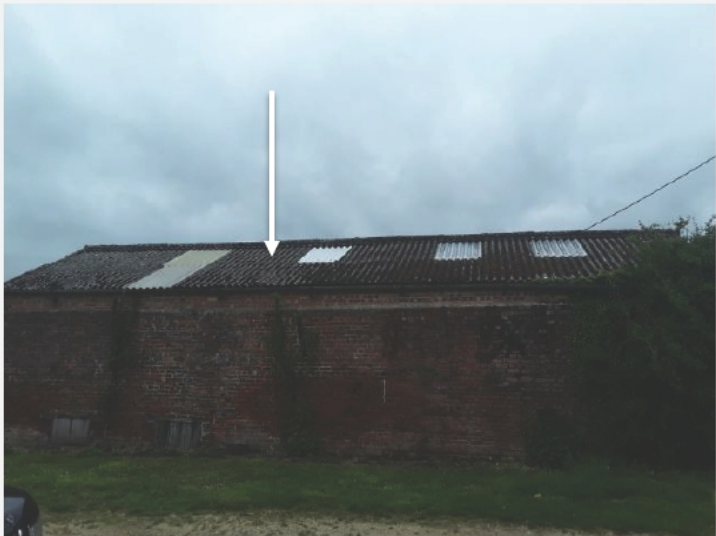
| Barn 2 | | | | | | | | |
|---|---|---|---|---|---|---|---|---|
| External | Cement Sheet | L-02010/09<br>Cement roof sheets | Unsealed | 100 m <sup>2</sup> | Low | Chrysotile | 4 (VERY LOW) | Remove if due to be disturbed |

| SURVEY DATA SHEET | | | |
|---|---|---|---|
| Floor | External | Product Description | Cement roof sheets |
| Product Type | Cement Sheet | | |
| Asbestos Type | Chrysotile | | |
| Extent of Damage | Low | | |

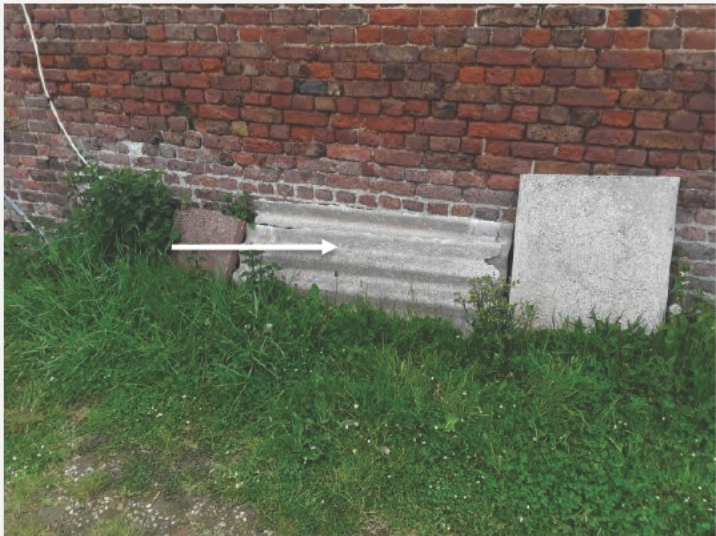
| Four Winds | | | | | | | | |
|---|---|---|---|---|---|---|---|---|
| External of whole site | Cement Debris | L-02010/15<br>Cement debris to floor to various areas | Unsealed | NQ | High | Chrysotile | 6 (LOW) | Remove |

| SURVEY DATA SHEET | | | |
|---|---|---|---|
| Floor | External | Product Description | Cement debris to floor to various areas |
| Product Type | Cement Debris | | |
| Asbestos Type | Chrysotile | | |
| Extent of Damage | High | | |

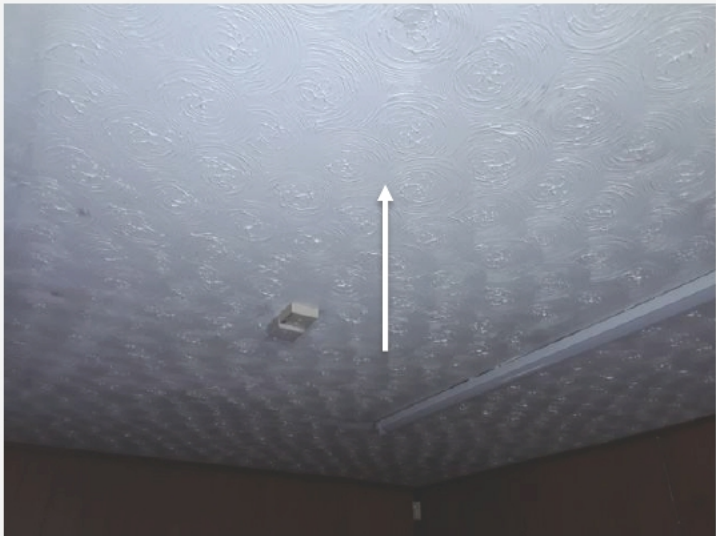
| Main house | | | | | | | | |
|---|---|---|---|---|---|---|---|---|
| 0.09 Office | Textured Coating | L-02010/02 Textured coating to ceiling | Sealed | 19 m <sup>2</sup> | Low | Chrysotile | 4 (VERY LOW) | Remove if due to be disturbed |

| SURVEY DATA SHEET | | | |
|---|---|---|---|
| Floor | Ground | Product Description | Textured coating to ceiling |
| Product Type | Textured Coating | | |
| Asbestos Type | Chrysotile | | |
| Extent of Damage | Low | | |

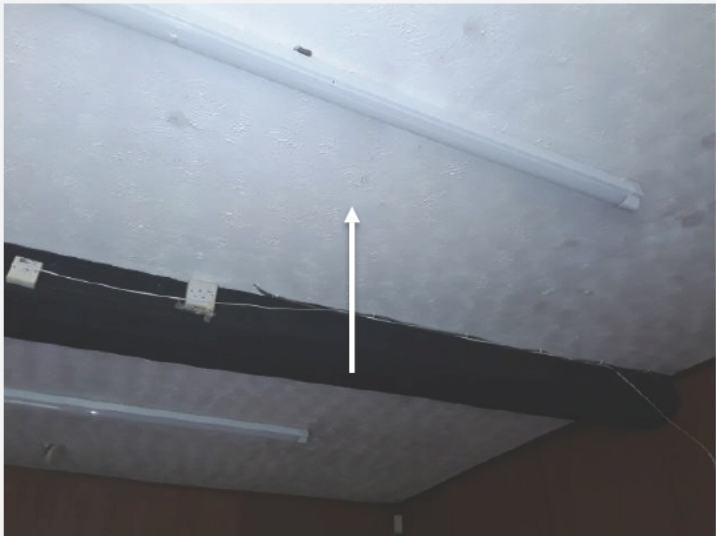
| Main house | | | | | | | | |
|---|---|---|---|---|---|---|---|---|
| 0.10 Office | Textured Coating | As L-02010/02 Textured coating to ceiling | Sealed | 22 m <sup>2</sup> | Low | Chrysotile | 4 (VERY LOW) | Remove if due to be disturbed |

| SURVEY DATA SHEET | | | |
|---|---|---|---|
| Floor | Ground | Product Description | Textured coating to ceiling |
| Product Type | Textured Coating | | |
| Asbestos Type | Chrysotile | | |
| Extent of Damage | Low | | |

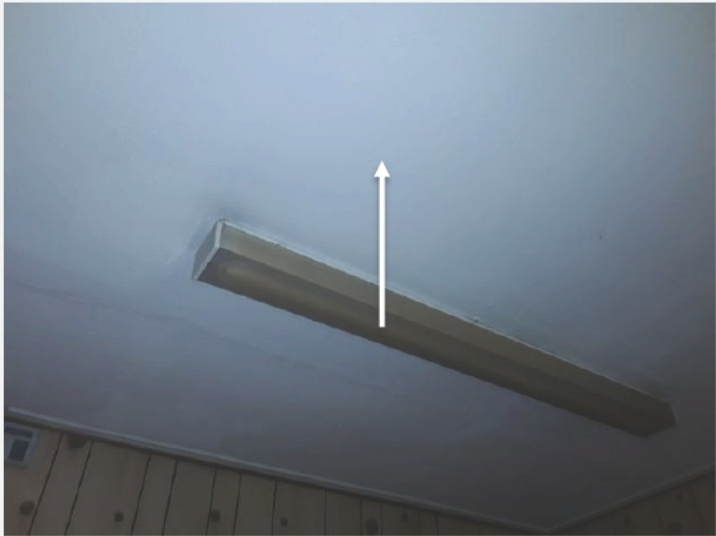
| SURVEY DATA SHEET | | | |
|---|---|---|---|
| Photo No. | 7 | Location | Main House, 0.11 Kitchen |

| SURVEY DATA SHEET | | | |
|---|---|---|---|
| Floor | Ground | Product Description | Textured coating to ceiling |
| Asbestos Type | No Asbestos Detected | | |

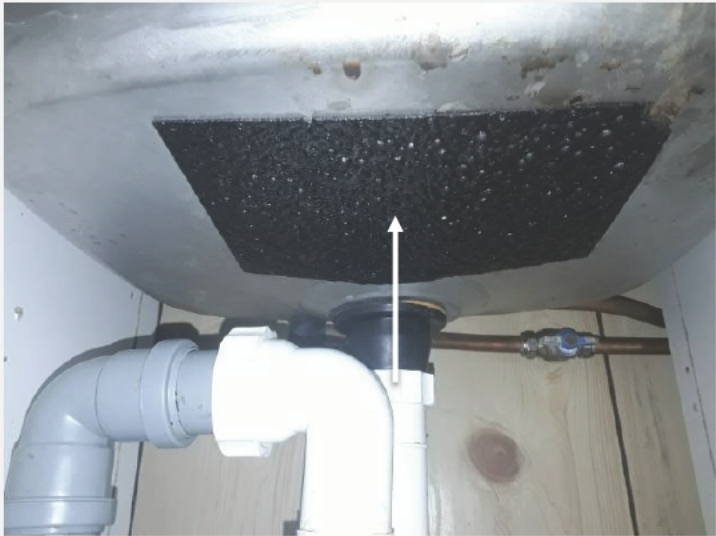
| SURVEY DATA SHEET | | | |
|---|---|---|---|
| Photo No. | 8 | Location | Main House, 0.11 Kitchen |

| SURVEY DATA SHEET | | | |
|---|---|---|---|
| Floor | Ground | Product Description | Bitumen sink pad |
| Asbestos Type | No Asbestos Detected | | |

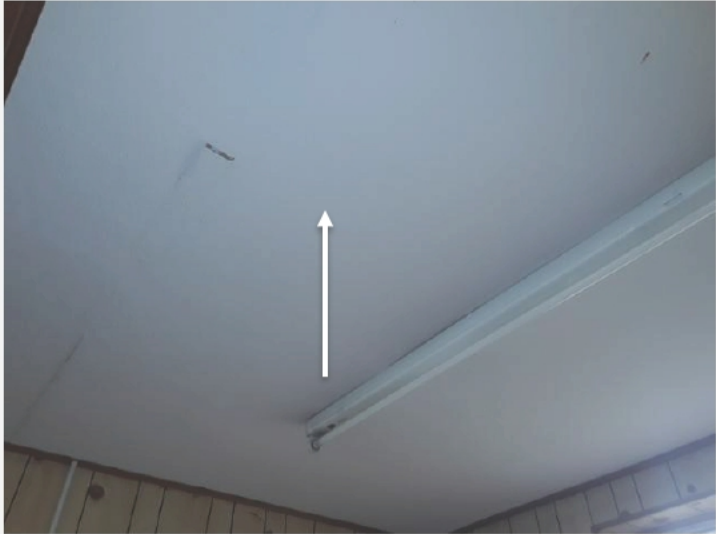
| SURVEY DATA SHEET | | | |
|---|---|---|---|
| Photo No. | 9 | Location | Main House, 0.12 Store |

| SURVEY DATA SHEET | | | |
|---|---|---|---|
| Floor | Ground | Product Description | Textured coating to ceiling |
| Asbestos Type | No Asbestos Detected | | |

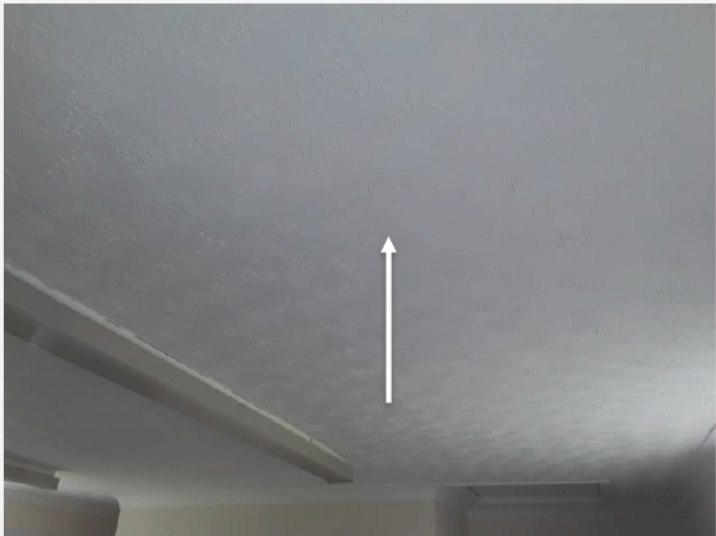
| Main house | | | | | | | | |
|---|---|---|---|---|---|---|---|---|
| 1.05 Office | Textured Coating | L-02010/05 Textured coating to ceiling | Sealed | 24 m <sup>2</sup> | Low | Chrysotile | 4 (VERY LOW) | Remove if due to be disturbed |

| SURVEY DATA SHEET | | | |
|---|---|---|---|
| Floor | 1st | Product Description | Textured coating to ceiling |
| Product Type | Textured Coating | | |
| Asbestos Type | Chrysotile | | |
| Extent of Damage | Low | | |

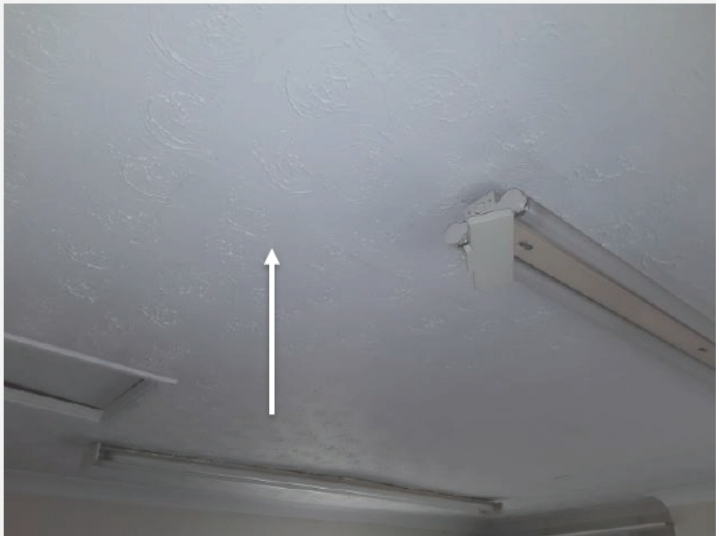
| Main house | | | | | | | | |
|---|---|---|---|---|---|---|---|---|
| 1.06 Office | Textured Coating | As L-02010/05 Textured coating to ceiling | Sealed | 21 m <sup>2</sup> | Low | Chrysotile | 4 (VERY LOW) | Remove if due to be disturbed |

| SURVEY DATA SHEET | | | |
|---|---|---|---|
| Floor | 1st | Product Description | Textured coating to ceiling |
| Product Type | Textured Coating | | |
| Asbestos Type | Chrysotile | | |
| Extent of Damage | Low | | |

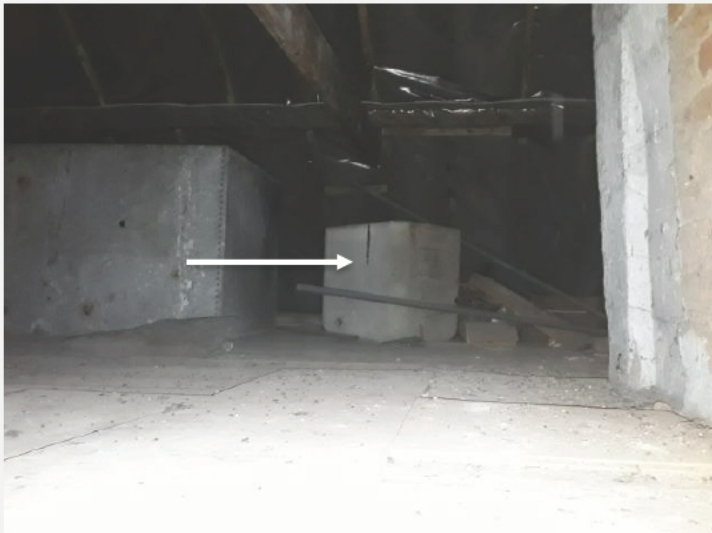
| Main house | | | | | | | | |
|---|---|---|---|---|---|---|---|---|
| V.01 Roof void | Cement Product | L-02010/06 Cement water tank | Unsealed | 1 no | Low | Chrysotile | 4 (VERY LOW) | Remove if due to be disturbed |

| SURVEY DATA SHEET | | | |
|---|---|---|---|
| Floor | Void | Product Description | Cement water tank |
| Product Type | Cement Product | | |
| Asbestos Type | Chrysotile | | |
| Extent of Damage | Low | | |

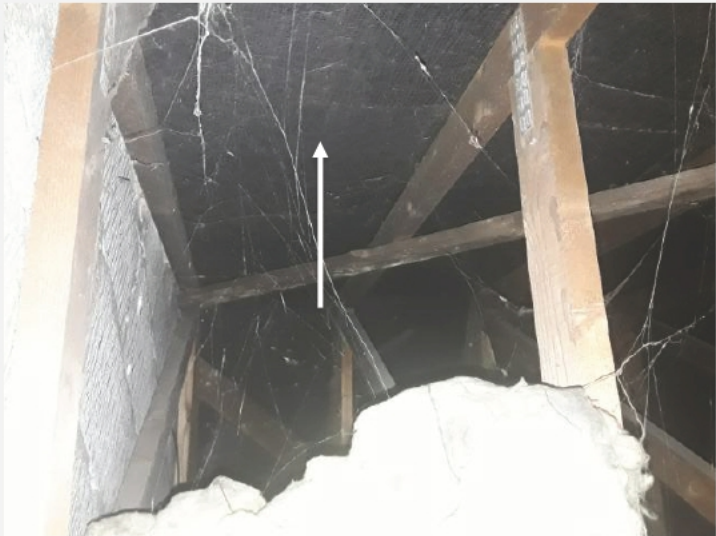
| SURVEY DATA SHEET | | | |
|---|---|---|---|
| Photo No. | 13 | Location | Main House, V.02 Roof void |

| SURVEY DATA SHEET | | | |
|---|---|---|---|
| Floor | Void | Product Description | Bitumen felt lining underside of roof |
| Asbestos Type | No Asbestos Detected | | |

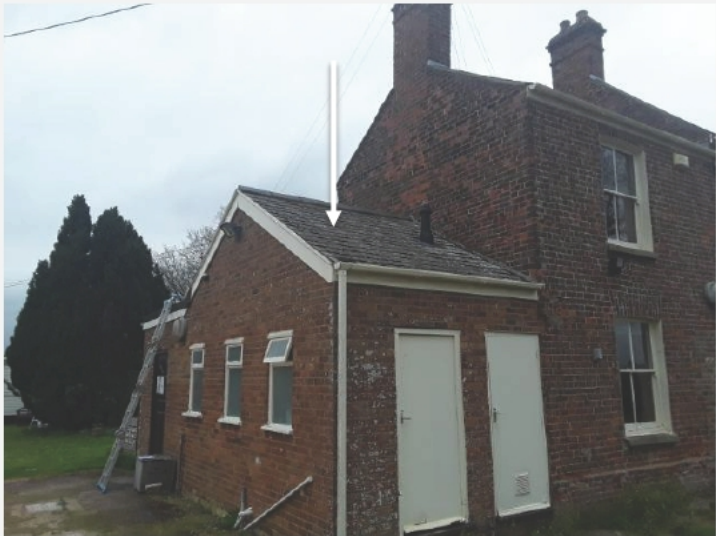
| Main house | | | | | | | | |
|---|---|---|---|---|---|---|---|---|
| External | Cement Product | L-02010/10 Cement roof tiles | Unsealed | 25 m <sup>2</sup> | Low | Chrysotile | 4 (VERY LOW) | Remove if due to be disturbed |

| SURVEY DATA SHEET | | | |
|---|---|---|---|
| Floor | External | Product Description | Cement roof tiles |
| Product Type | Cement Product | | |
| Asbestos Type | Chrysotile | | |
| Extent of Damage | Low | | |

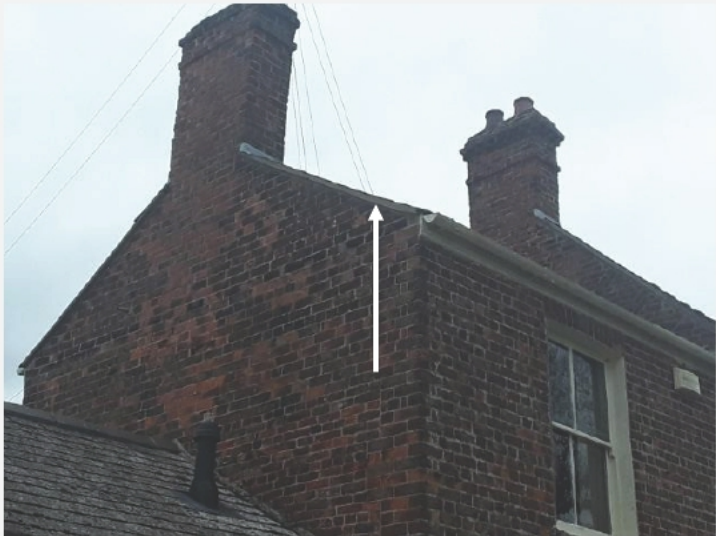
| Main house | | | | | | | | |
|---|---|---|---|---|---|---|---|---|
| External | Cement Product | L-02010/11 Cement undercloaking | Unsealed | 20 lin m | Low | Chrysotile | 4 (VERY LOW) | Remove if due to be disturbed |

| SURVEY DATA SHEET | | | |
|---|---|---|---|
| Floor | External | Product Description | Cement undercloaking |
| Product Type | Cement Product | | |
| Asbestos Type | Chrysotile | | |
| Extent of Damage | Low | | |

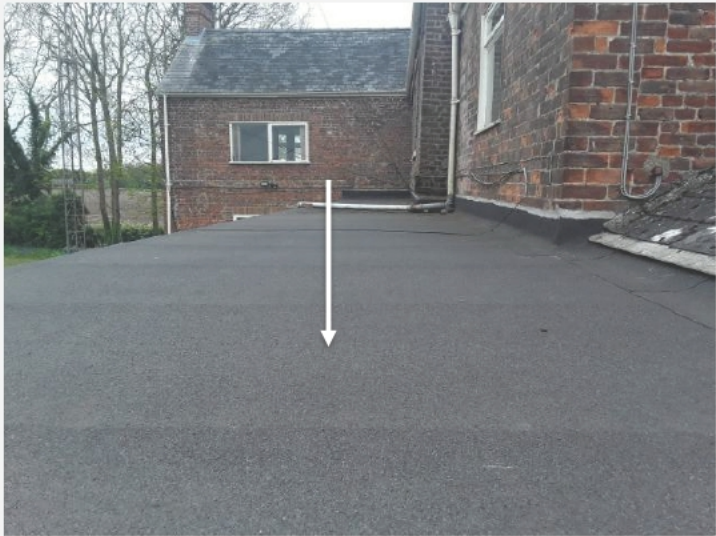
| SURVEY DATA SHEET | | | |
|---|---|---|---|
| Photo No. | 16 | Location | External of Main House |

| SURVEY DATA SHEET | | | |
|---|---|---|---|
| Floor | External | Product Description | Bitumen roof felt |
| Asbestos Type | No Asbestos Detected | | |

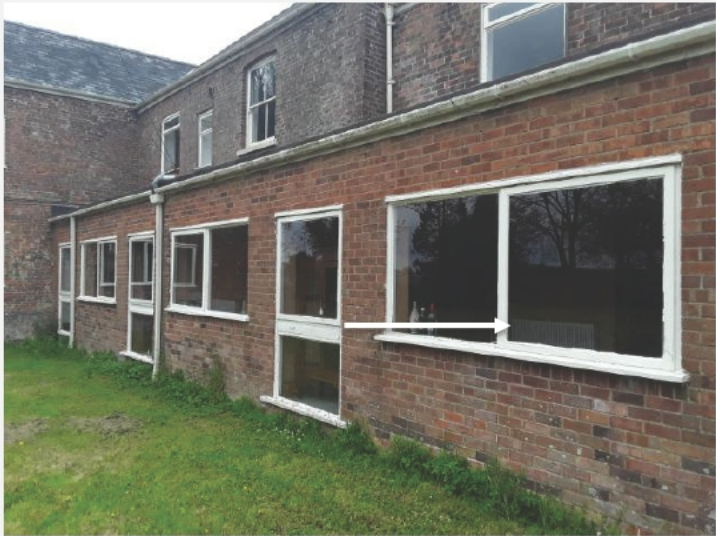
| SURVEY DATA SHEET | | | |
|---|---|---|---|
| Photo No. | 17 | Location | External of Main House |

| SURVEY DATA SHEET | | | |
|---|---|---|---|
| Floor | External | Product Description | Putty to windows |
| Asbestos Type | No Asbestos Detected | | |

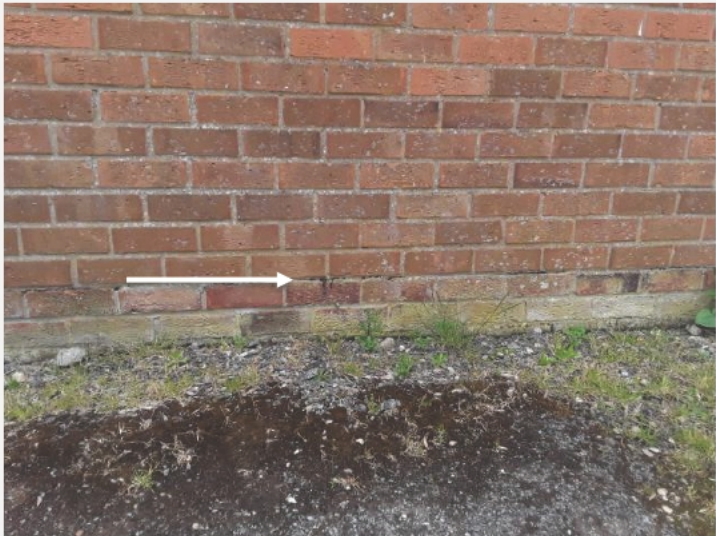
| SURVEY DATA SHEET | | | |
|---|---|---|---|
| Photo No. | 18 | Location | External of Main House |

| SURVEY DATA SHEET | | | |
|---|---|---|---|
| Floor | External | Product Description | Damp proof course to walls |
| Asbestos Type | No Asbestos Detected | | |
