## STRUCTURAL APPRAISAL REPORT

**Barn Adj Adderley House,  
London Road,  
Long Sutton,  
Spalding,  
Lincolnshire.**

| <b>Reference:-</b> | JC/20/06/5466 | <b>Issued:-</b> Aug 2020 |

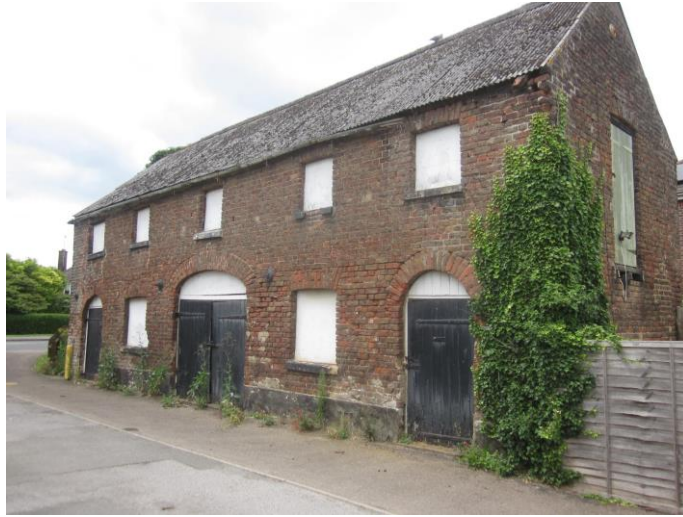
**Photograph # 1**  
(Front Facing Elevation)

- Minor fractures to masonry panels throughout.
- Settlement of masonry panel (adjacent London Road) – distorted masonry and significant cracking over left hand door opening and window above.
- Minor Cracking and distortion of arches over openings.
- Slight movement of masonry units below door threshold.
- Localised areas of displaced units.
- Localised areas of previous hard cement repointing.
- Evidence of defective guttering.
- Wall ties and pattress plates present at first floor level.
- Ivy growth present in parts.

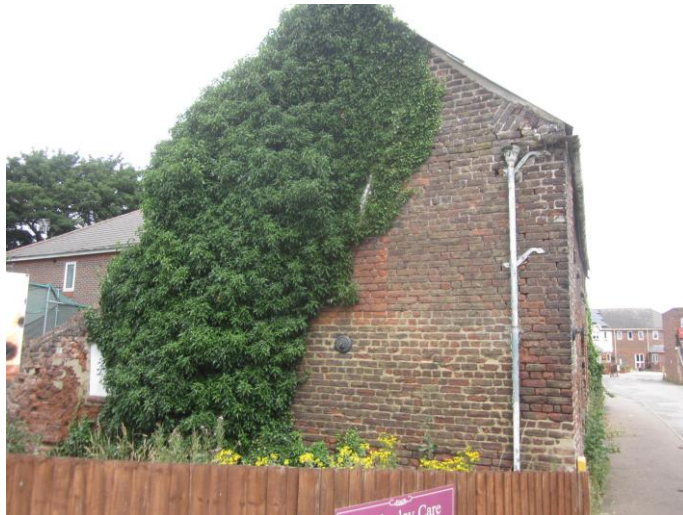
**Photograph # 2**  
(Gable Elevation – Facing London Road)

- Ivy growth prevented inspection of the majority of the left hand side of the elevation.
- No major fractures to masonry panels but the gable has suffered settlement.
- Minor Cracking and open mortar joints adjacent rainwater hopper.
- Perished / defaced units at lower level.
- Evidence of former pockets presumably to support timber steps (now removed).
- Localised areas of previous hard cement repointing at lower levels – possible previous part re-build / repair of lower panel.
- Pattress plates at centreline of gable.

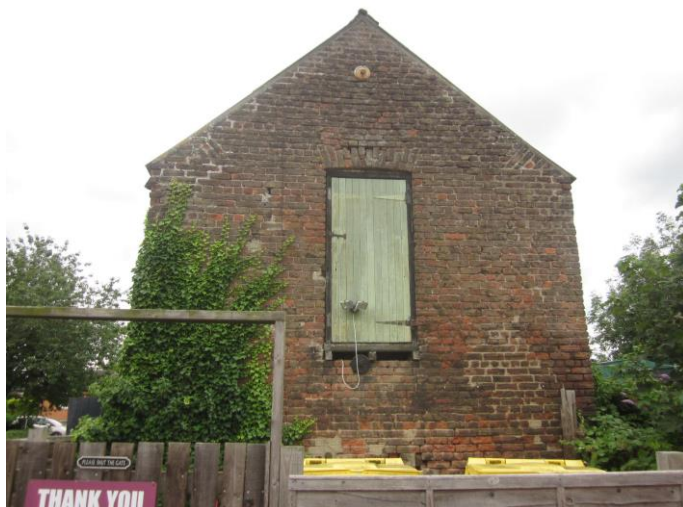
**Photograph # 3**  
(Gable Elevation – Facing Residential Home)

- No major fractures to masonry panels.
- Minor Cracking and displaced units over arch of centrally located opening (Serves first floor).
- Perished / defaced units at lower level.
- Evidence of former pockets presumably to support timber steps (now removed).
- Localised areas of previous hard cement repointing close to eaves and mid panel.
- Pattress plates at centreline of gable.
- Ivy growth present in parts.

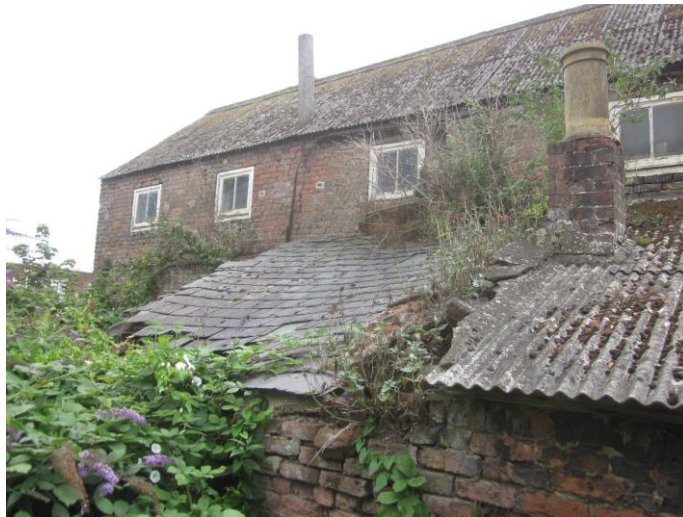
**Photograph # 4**  
(Part Rear Elevation / Single Storey Roof)

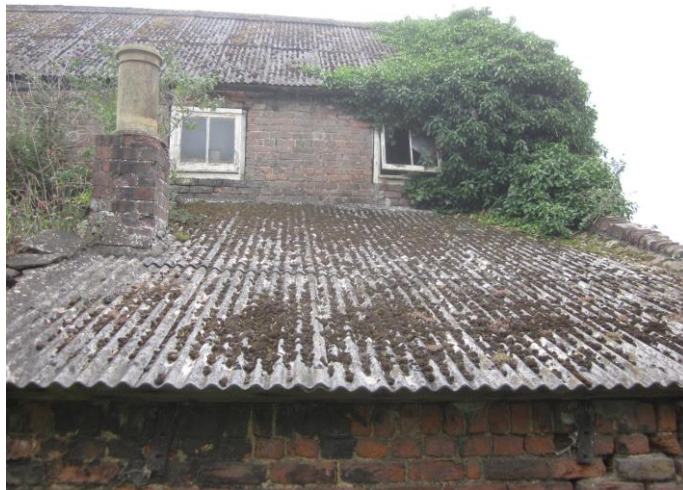
**Photograph # 5**  
(Part Rear Elevation / Single Storey Roof)

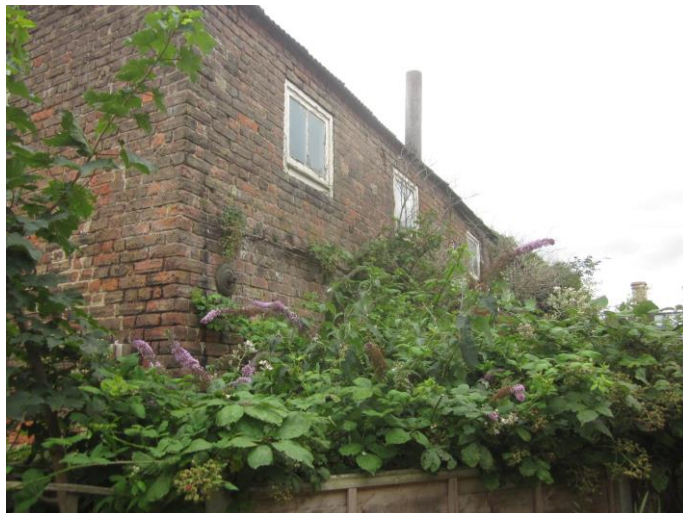
**Photograph # 6**  
(Part Rear Elevation)

- Only partial inspection possible due to access and abutting single storey element.
- Settlement of masonry panel (adjacent London Road).
- Minor Cracking and distortion of arches over openings.
- Slight movement of masonry units below door threshold.
- Vertical cracks noted at panel mid span.
- Localised areas of previous hard cement repointing.
- Evidence of defective guttering.
- Ivy growth present in parts.
- Single storey element partially collapsed.

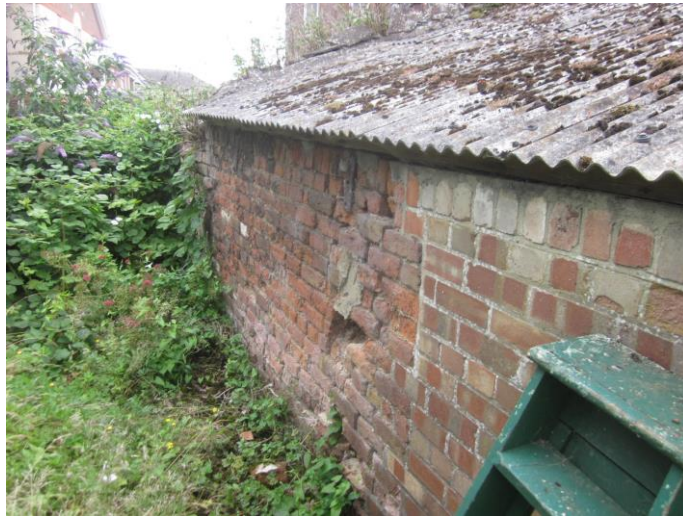
- 5.6 The structural fabric forming the single storey, lean-to element located to the rear of the main barn is considered to be extremely fragile. The key elements of this part of the structure including roof and walls have suffered significant material fatigue. The roof structure has partially collapsed which has resulted in lateral movement of the supporting masonry walls. The overall structural stability of this element of the building appears to have been compromised and as such it is currently deemed to be unstable.

**Photograph # 7**  
(Single Storey Rear Projection)

We therefore recommend that consideration is made to record the existing fabric of this part of the building to enable the careful demolition and construction of a replacement element, should local planning regulations provide this opportunity. The progression of any proposals for demolition and construction of a replacement dwelling should be done only following liaison with, and guidance from, the Local Authority Planning Department.

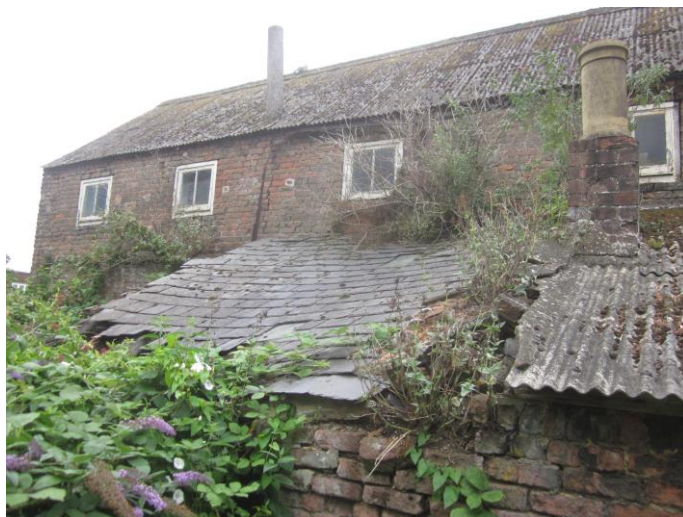
**Photograph # 8**  
(Single Storey Rear Projection)

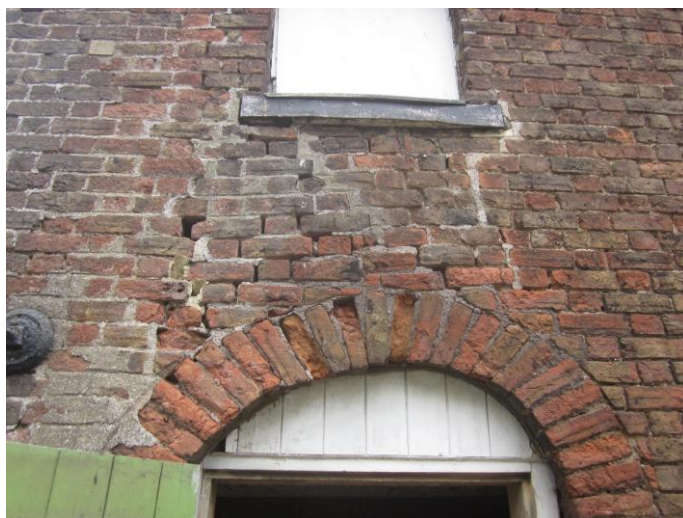
**Photograph # 9**  
(Typical Distorted Arch / Masonry over Arch)

- 6.2.5 Any defective masonry arches, timber lintels and arch backing timbers should be replaced throughout. The beams over the larger openings should be replaced. Any timber wall plates that are present within the walls should be removed and replaced with remedial brickwork infill.

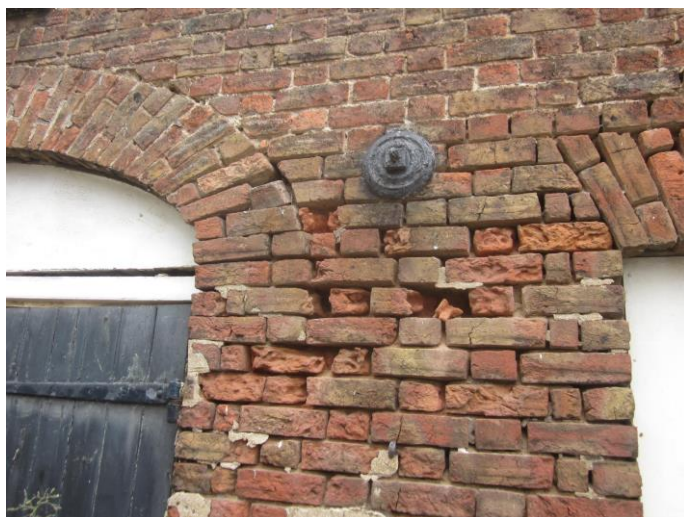
**Photograph # 10**  
(Typical Perished Masonry Arch / Pattress Plate)

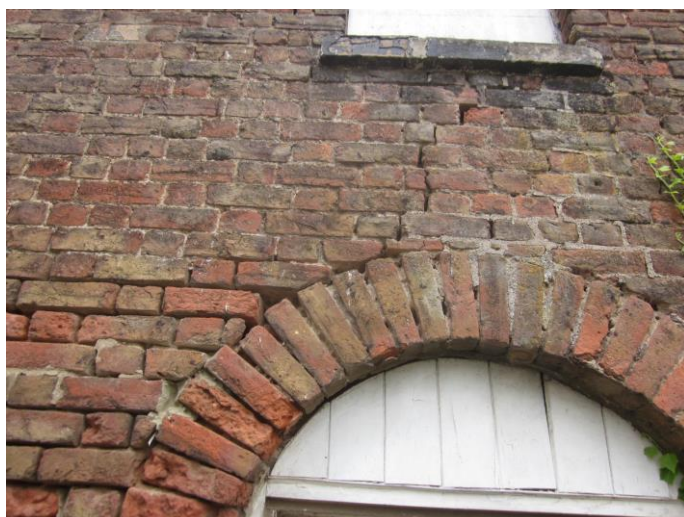
**Photograph # 11**  
(Typical Distorted Arch / Masonry over Arch)

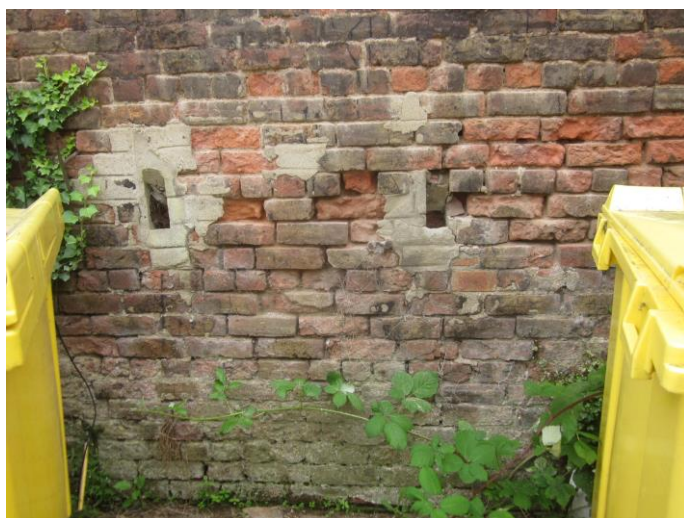
**Photograph # 12**  
(Pockets in Gable Wall)

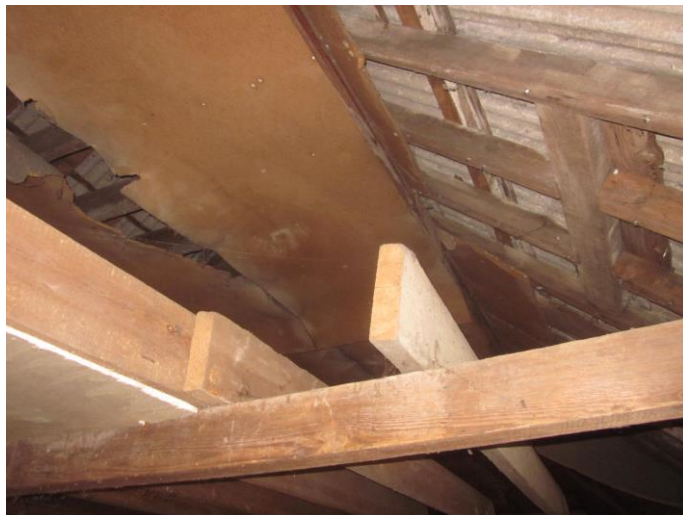
**Photograph # 14**  
(Typical Roof)

- Lightweight corrugated roof finish in reasonable condition – no missing elements noted.
- Roof Structure only partially inspected due to access, but consists of raised tie trusses, rafters and purlins - no missing elements noted.
- Slight undulation of ridge line.
- Remainder of ivy growth present over parts over Rear / Gable.
- Defective guttering / downpipes throughout.
- Slight rotation of wall-plate noted at eaves – minor cracking to eaves brickwork with possible slight outward thrust of wall at front / rear elevation eaves.
- Part collapse of single storey lean-to roof supporting slate roof finish.

Attempting to strengthen existing roof elements is possible, however a replacement roof would reduce the degree of stresses on the existing supporting walls and may prove to be the most practicable and cost-effective solution. We therefore recommend that consideration is made for a replacement roof structure as part of any conversion scheme.

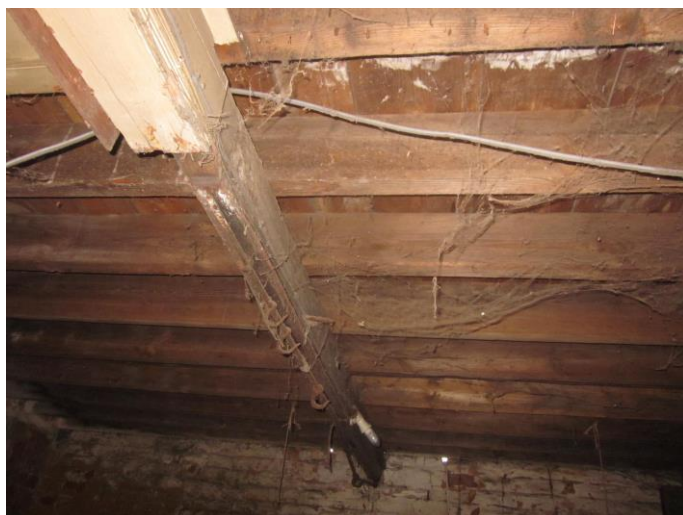
- First floor joists are relatively slender.
- Timber support beams Unregularised, deflecting and overstressed.
- Various elements of the floor have been subjected to continued wetting and decay appears to be prevalent.
- Floorboards covered with general debris – inspection limited.

**Photograph # 19**  
(Underside of First Floor – Undersized Beams)

The first floor joists are relatively slender and are supported in parts by timber beams that appear to be overstressed. Various elements of the floor have been subjected to continued wetting and decay appears to be prevalent. Attempting to strengthen existing floor elements is possible, however a replacement floor would reduce the degree of stresses on the existing supporting walls and may prove to be the most practicable and cost-effective solution. We therefore recommend that consideration is made for a replacement floor structure as part of any conversion scheme. Support for the floor can be gained from a new inner leaf wall system that is recommended in item 6.2.9 of this report.

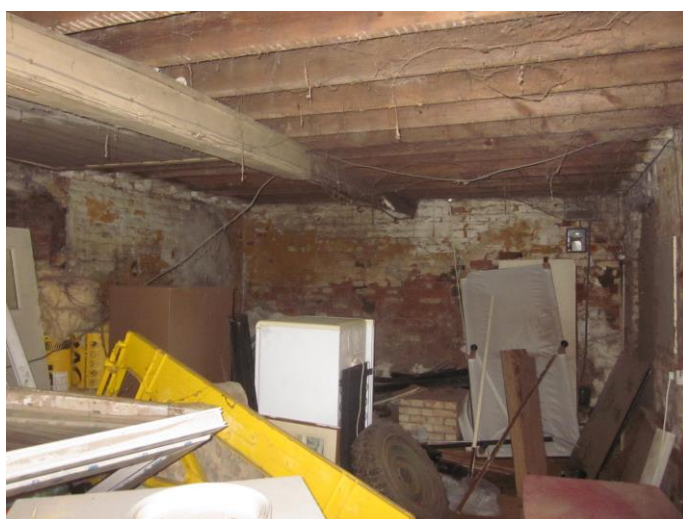
**Photograph # 20**  
(Underside of First Floor – Overspanned Beams)

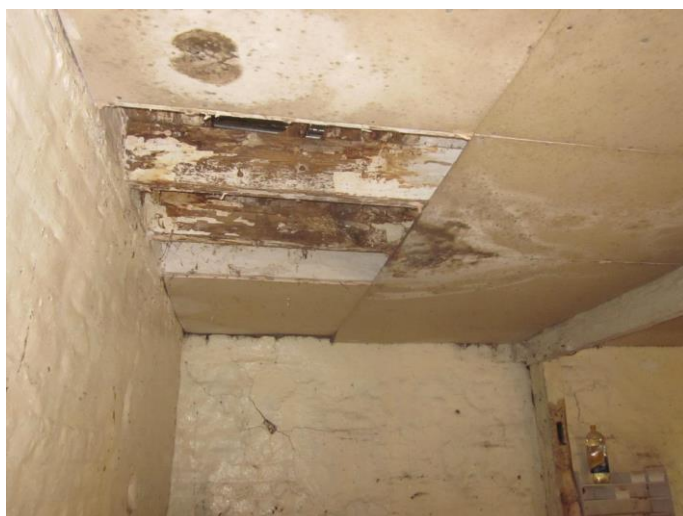
**Photograph # 21**  
(Underside of First Floor – Water penetration / decay)

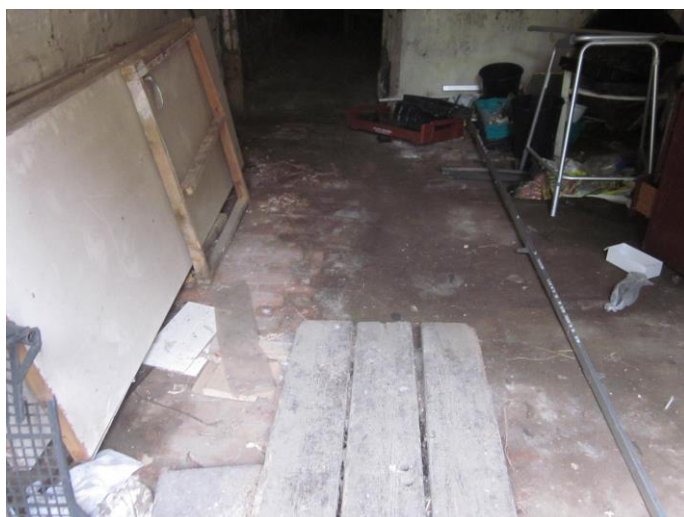
**Photograph # 23**  
(Typical Ground Floor / Tiles)

- No floor slab present – tiles present presumably over earth – undulations felt and noted.
- Floor covered with various stored material throughout – inspection limited.

- 6.4.1 No ground floor slab is present. A new floor slab is required throughout and therefore allowance should be made for the installation of a new ground bearing, concrete ground floor slab to typical architects' specification, incorporating suitable damp-proof systems, insulation and screeds as required. If the floor slab is to be utilised as providing support for the new inner leaf wall (as recommended in item 6.2.9 of this report) then it should be engineer designed as a reinforced concrete flat slab to ensure that it can safely accommodate and distribute the loadings applied.
- 6.4.2 We do not recommend that the floor slab levels are raised substantially higher than existing ground levels, as the process of raising the floor levels will undoubtedly place an increase in stress and outward force upon the lower levels of the wall panels.
