**BUILDING SPECIFICATION, DETAILED WORKS  
AND PHOTOGRAPHIC RECORD**

**BARN CONVERSION AT LUTTON HOUSE  
1 LOWGATE, LUTTON**

**Job Ref: 4081  
February 2011**

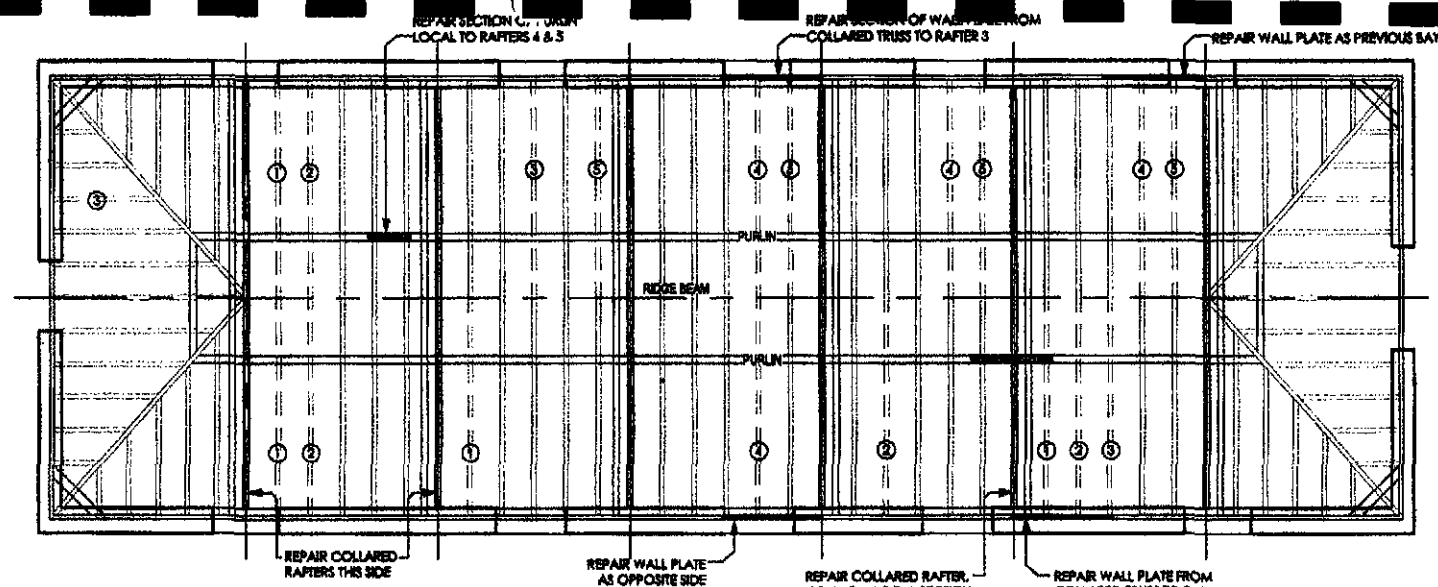
**FIRST FLOOR PLAN (roof timbers considered)**

NOTE: Numbered & noted timbers require repair

- Existing joists and rafters to be exposed by removal of all roof and first floor boarding. As detailed on South Lines Consulting approved survey drawing number 10-0231-01 dated October 2010, timbers where damaged due to "wet-rot" to be removed. Any further damaged timbers to be inspected by the Structural Engineer and reported to South Holland District Council.

All floor joists to be checked by the Structural Engineer for damage, wet-rot, insect attack etc. Joists to be replaced as detailed on approved survey drawing number 10-0231-01 dated October 2010.

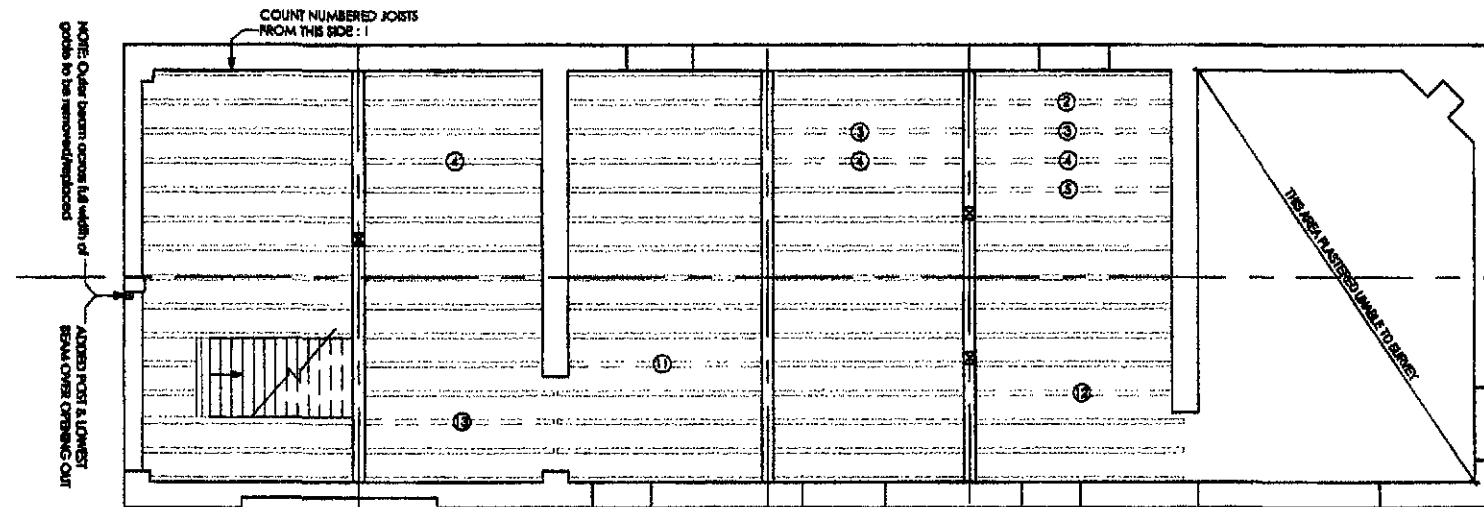
**GROUND FLOOR PLAN (Ceiling timbers & opening at stair end considered)**

NOTE: Numbered & noted timbers require repair

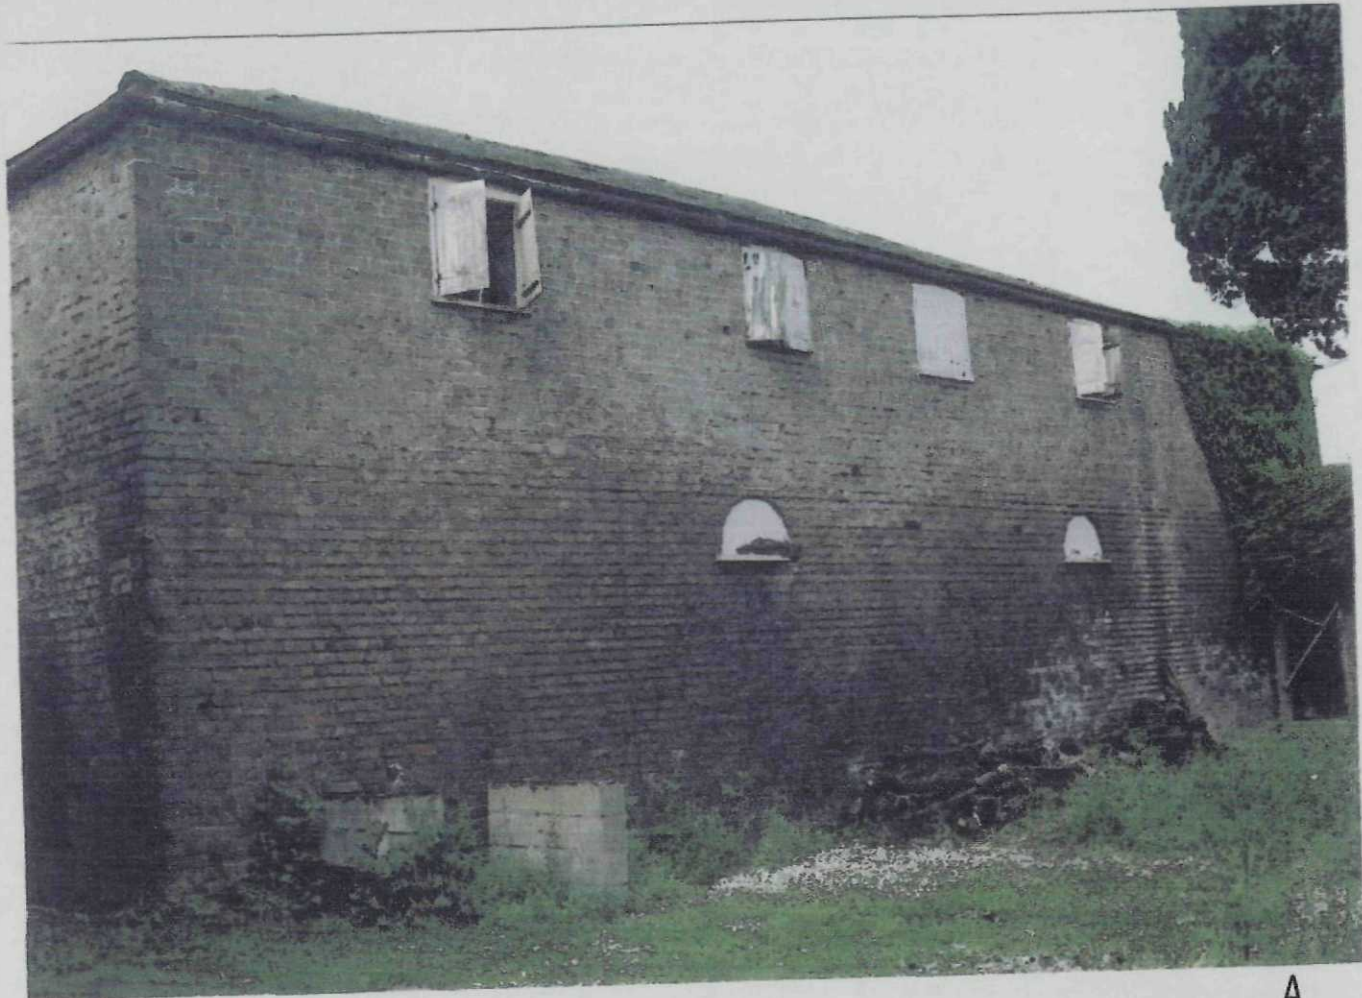
| A | Current Northeast elevation |

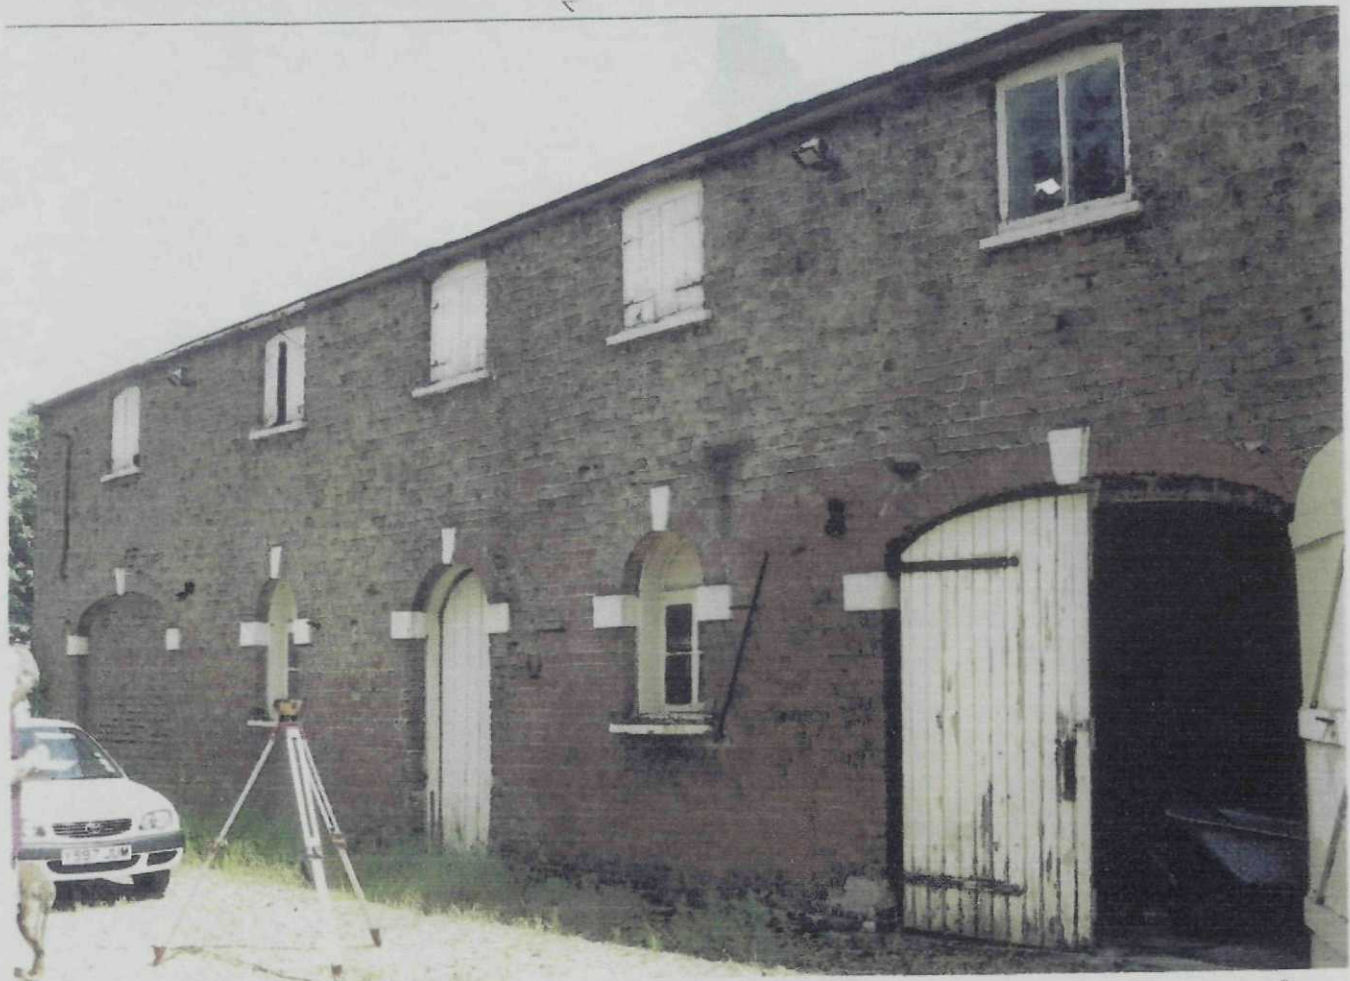
| B | Current Southwest elevation |

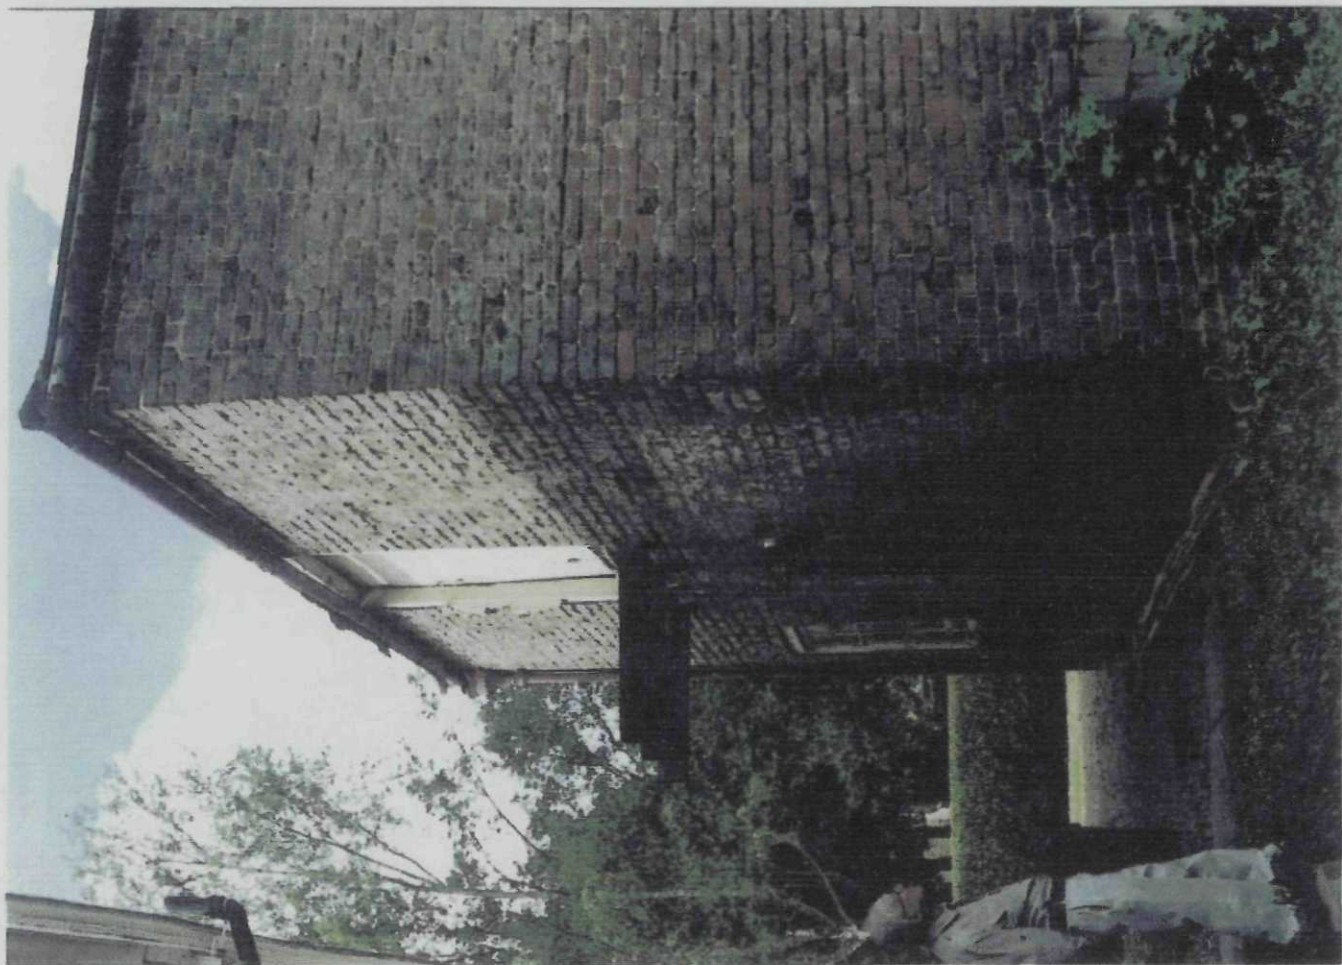
| C | Current Southeast elevation |

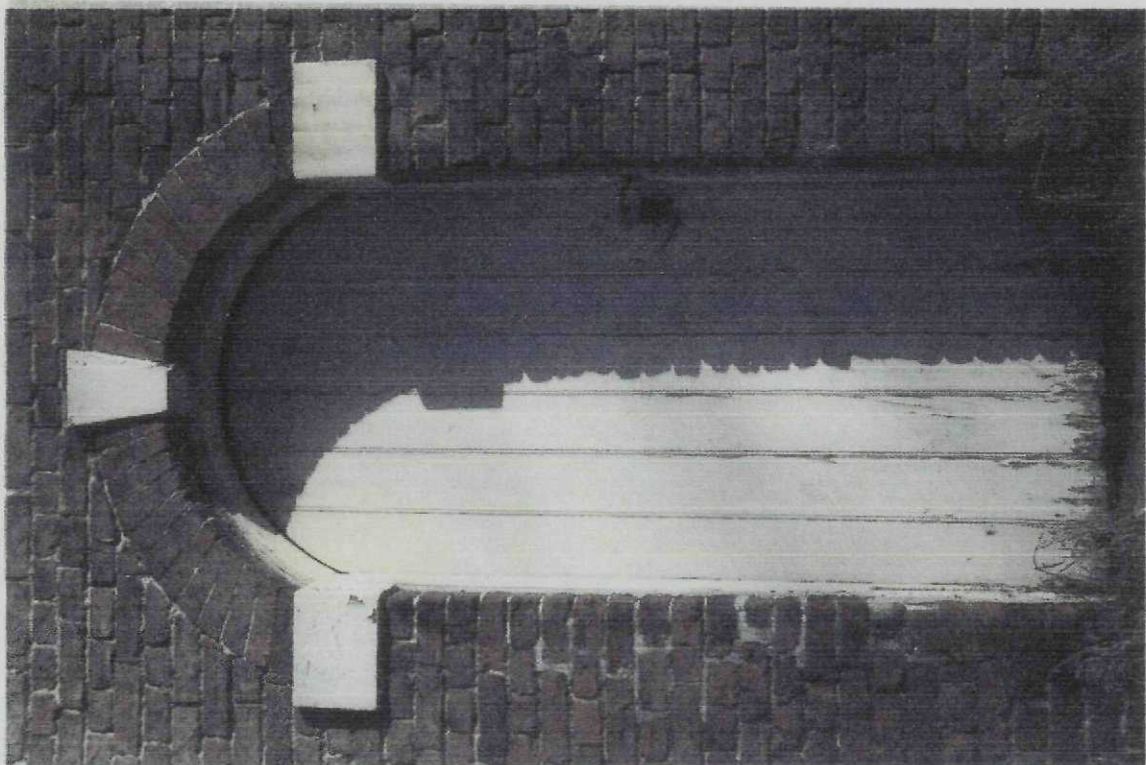
| H | Door D1. Paint to be removed from keystone and stone arch base. Plank door to be refurbished, new timber stop added to extended timber frame. Lipping to door edges added behind face and new vertical planks added to internal. See drawing 4081-108. |

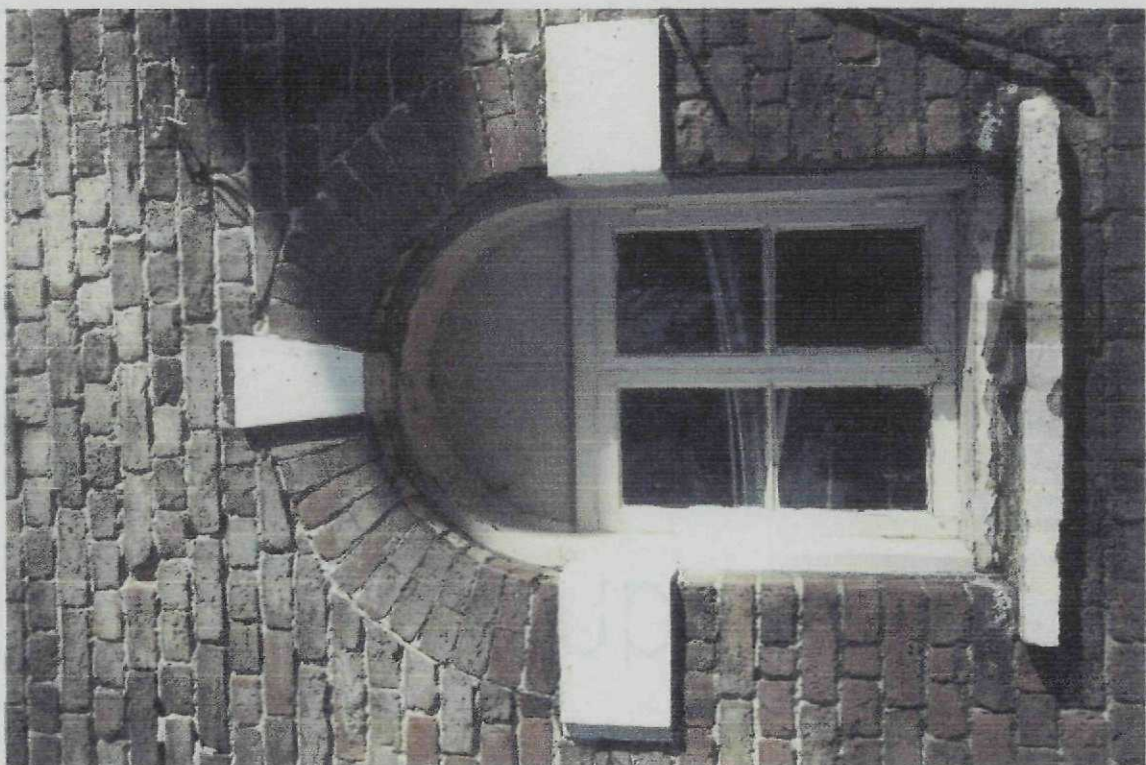
| G | Window W2 and W3. Paint to be removed from keystone, stone arch base and cill. New window with glazed half-round top panel proposed. Extended from timber frame to be retained and window located behind. See drawing 4081-103. |

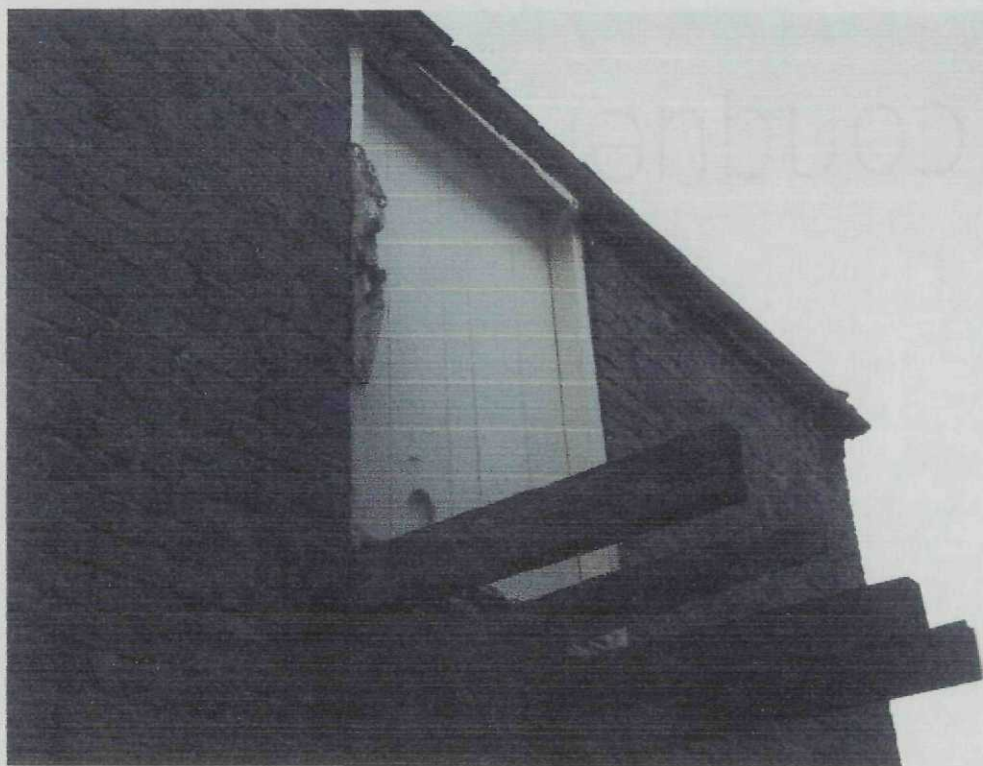
0

| O | First floor door D12 to Southeast elevation, with cantilevered timber landing structure. Window to be installed into existing opening and existing door refurbished and re-used as external shutter. |

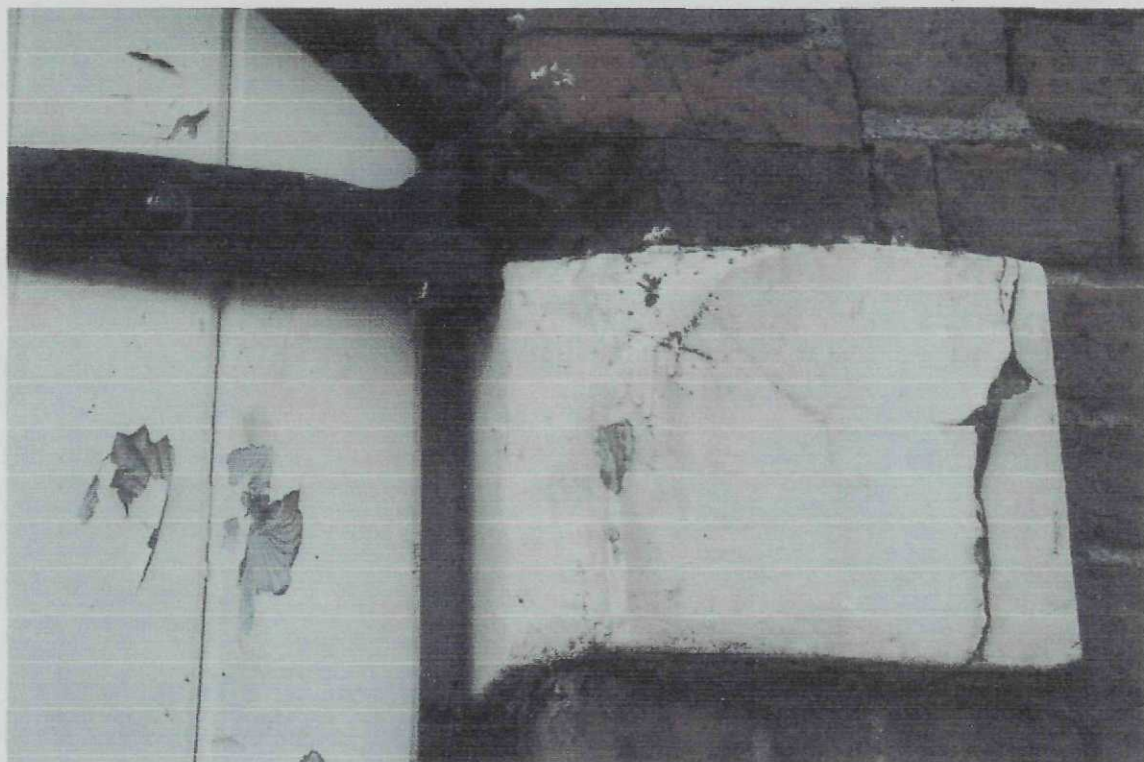
| Q | Stone base to arch over garage door D1. Paint to be cleaned off surface. |

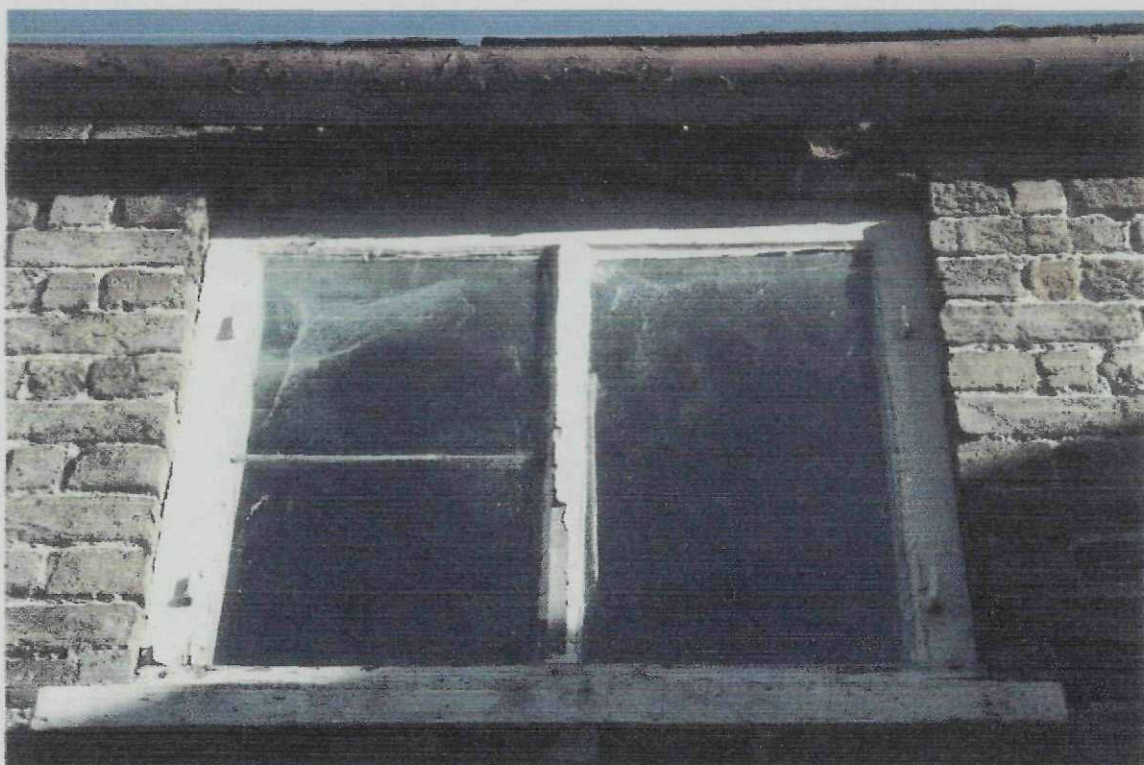
| R | Window and either concrete or stone cill. New timber window and external shutter to exactly match adjacent. |

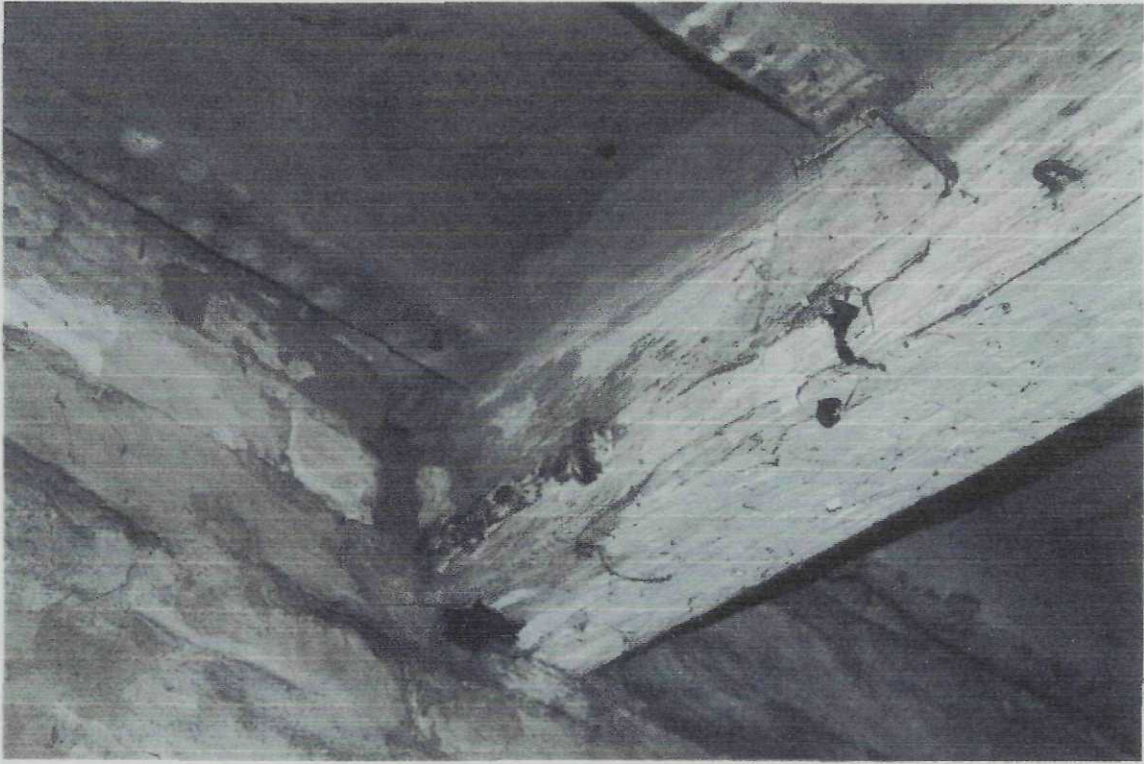
| S | Ground floor timber beam within proposed office supported on external brick wall and securing metal bracket. Beam to be cleaned, rust removed from bracket and be exposed to underside of ceiling. Walls and ceiling to be insulated and lined with plasterboard. |

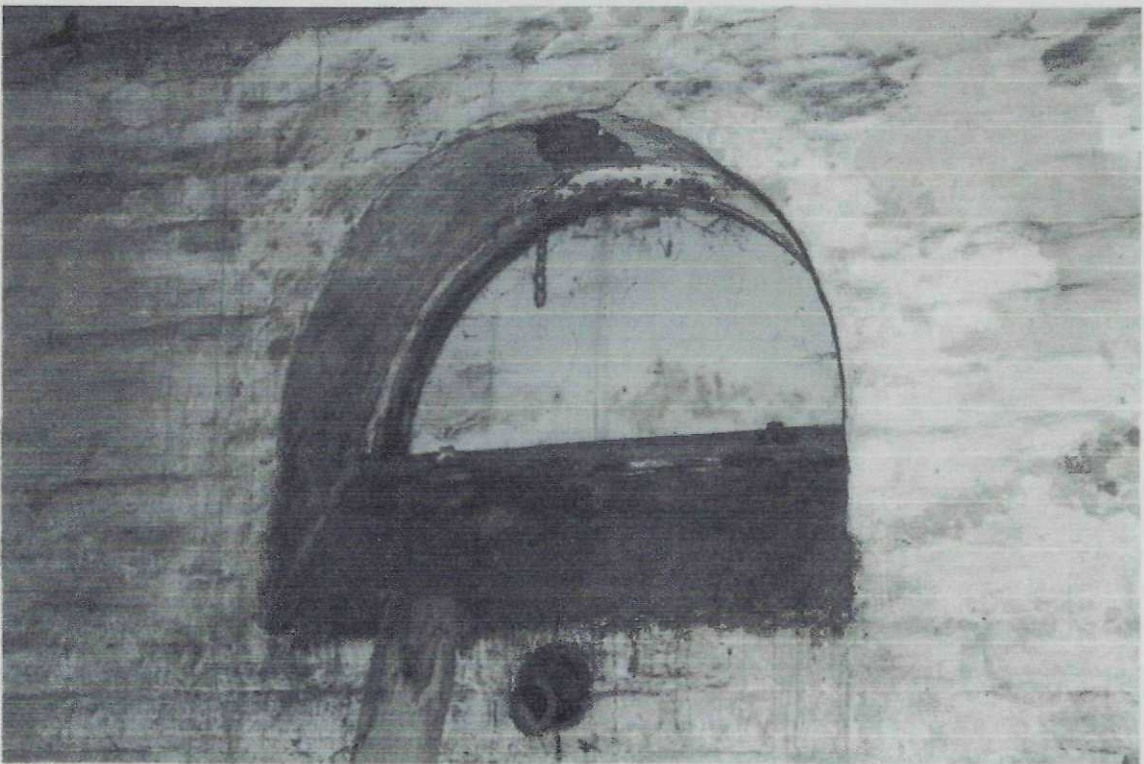
| T | External wall opening W6 and W7. Plywood and frame to be removed and new timber window installed. Sloping cill retained as feature. |

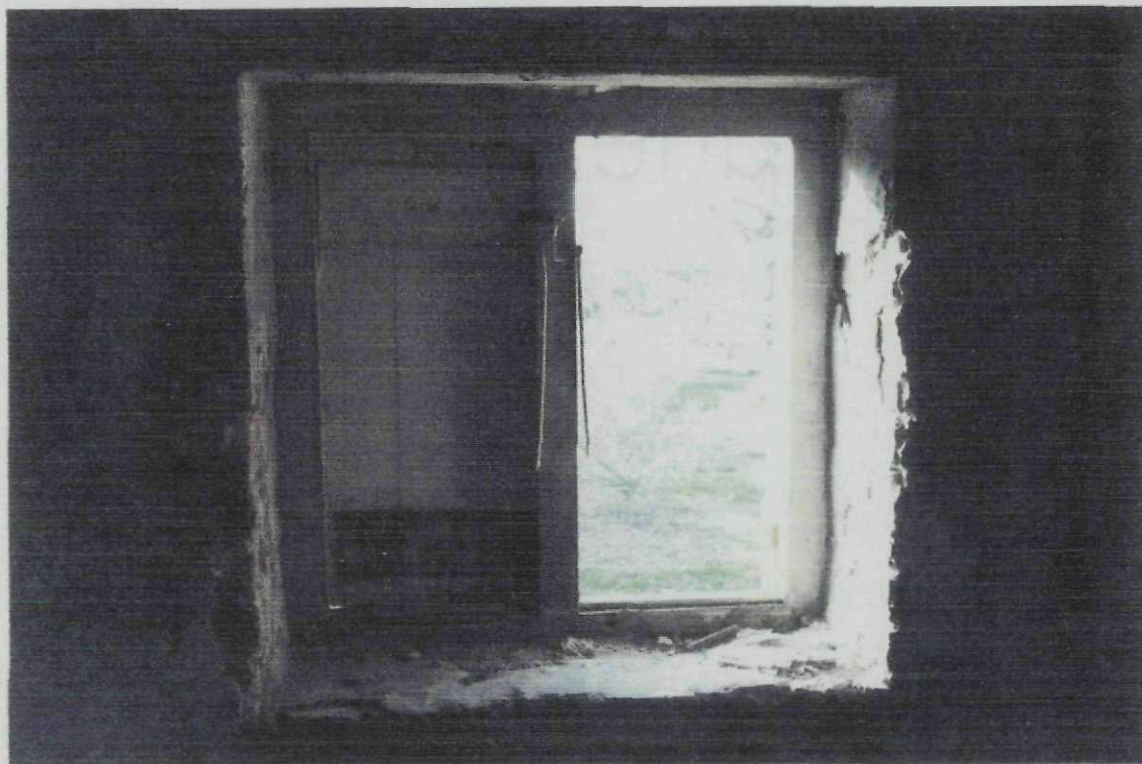
| U | Internal view of first floor opening with shutter. New window installed and shutters refurbished. |

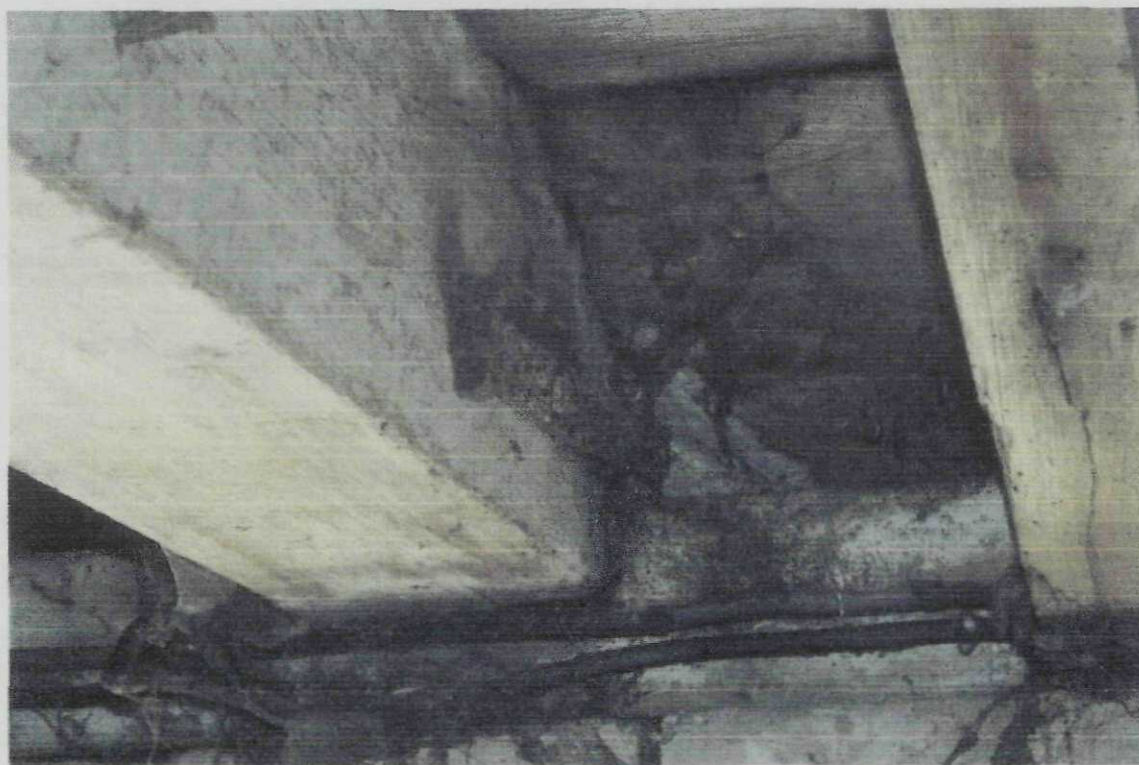
| V | First floor beam cut over timber wallplate. Redundant cables and roof boarding to be removed. |

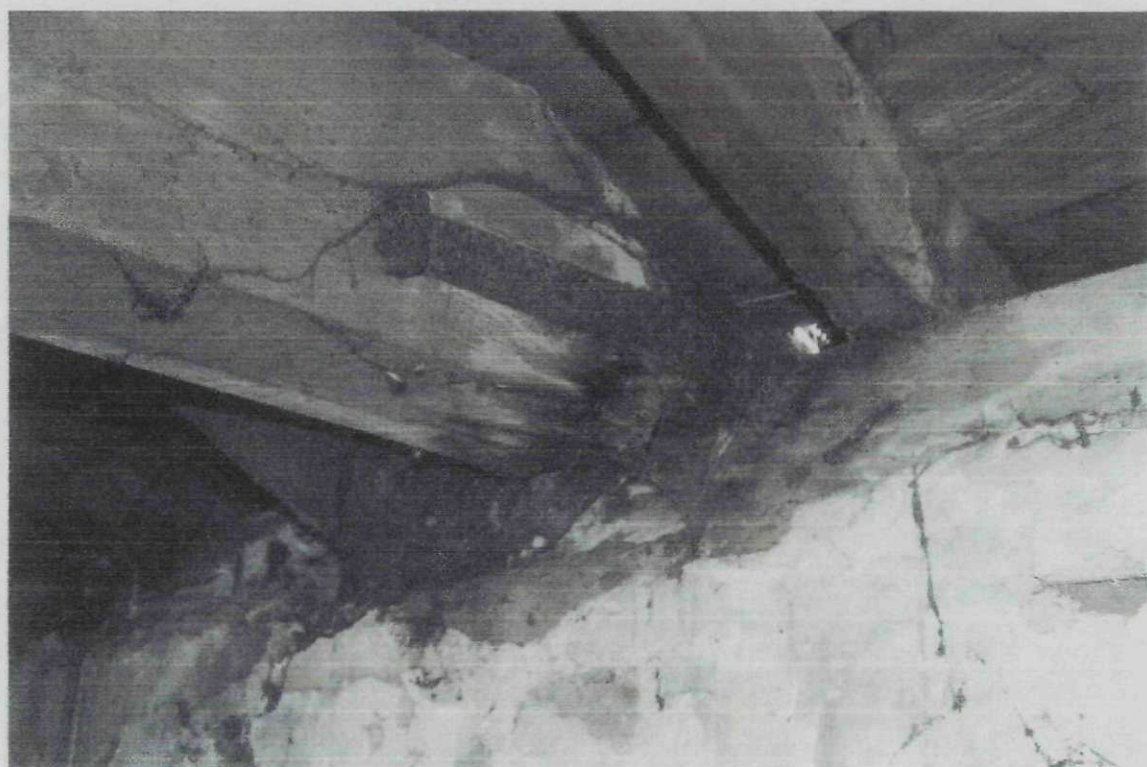
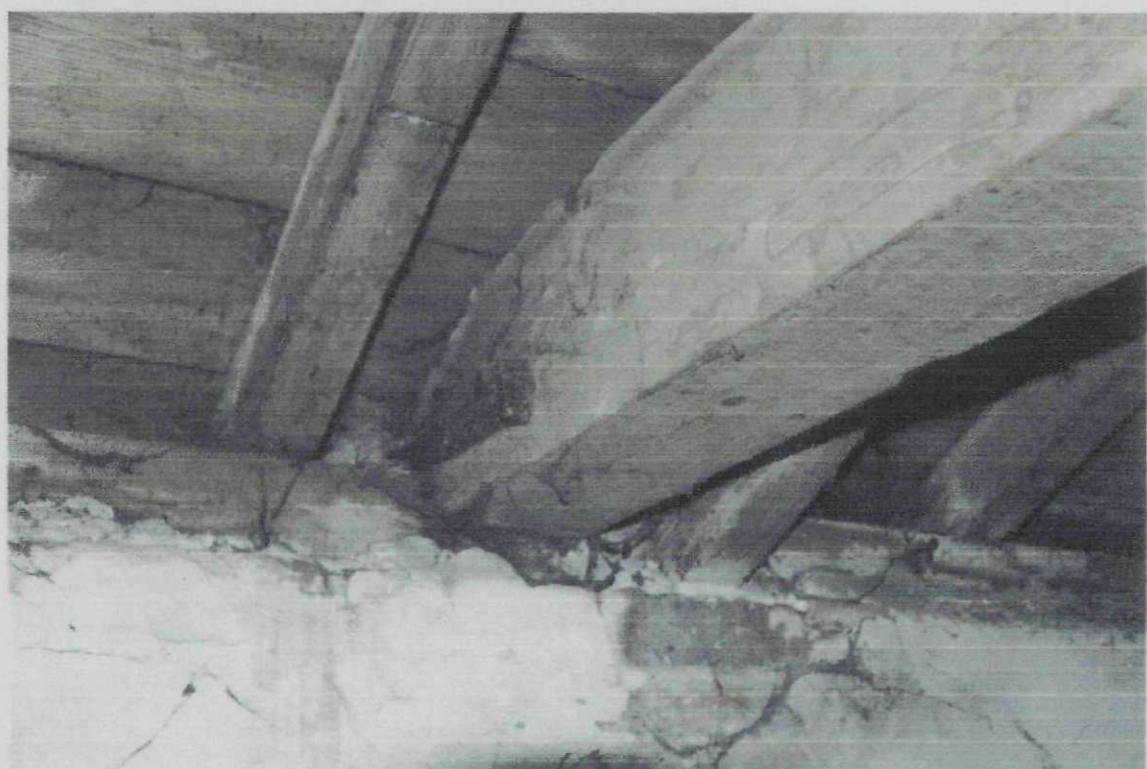
| W and X | First floor beam, roof rafters and wallplate. Beam secured to wallplate with metal bracket. |

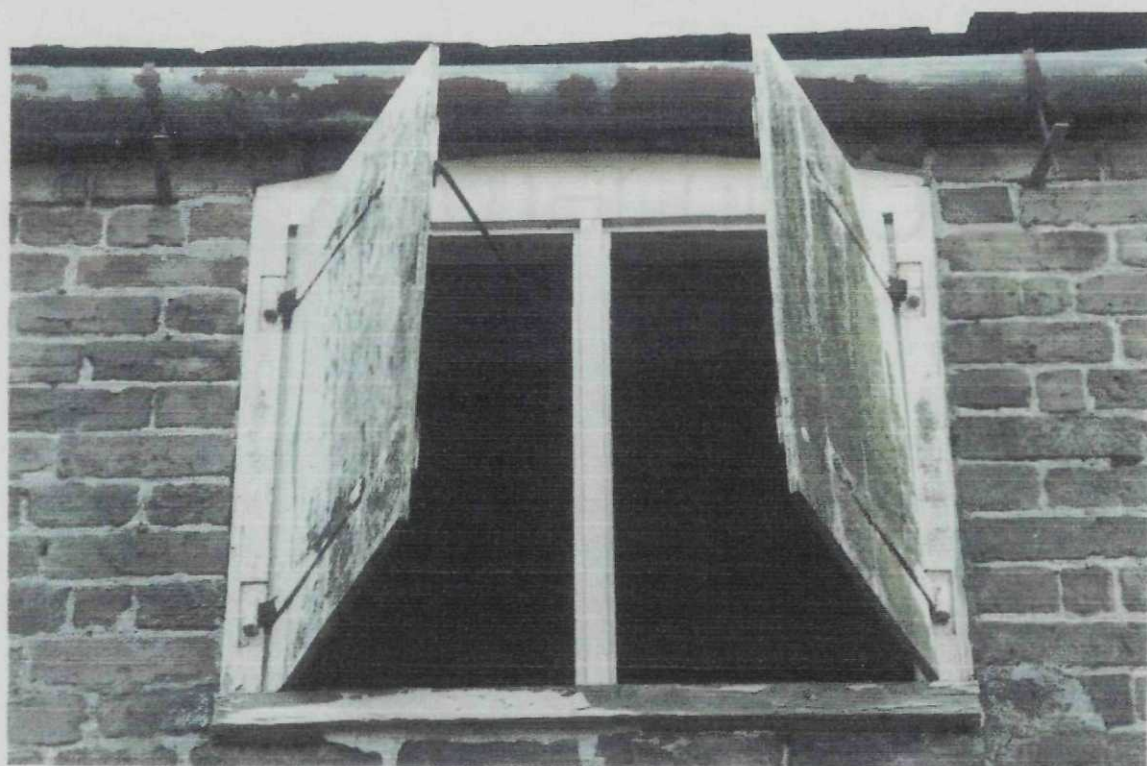
| Y | First floor opening and shutters. New window installed into existing opening and shutters refurbished. |

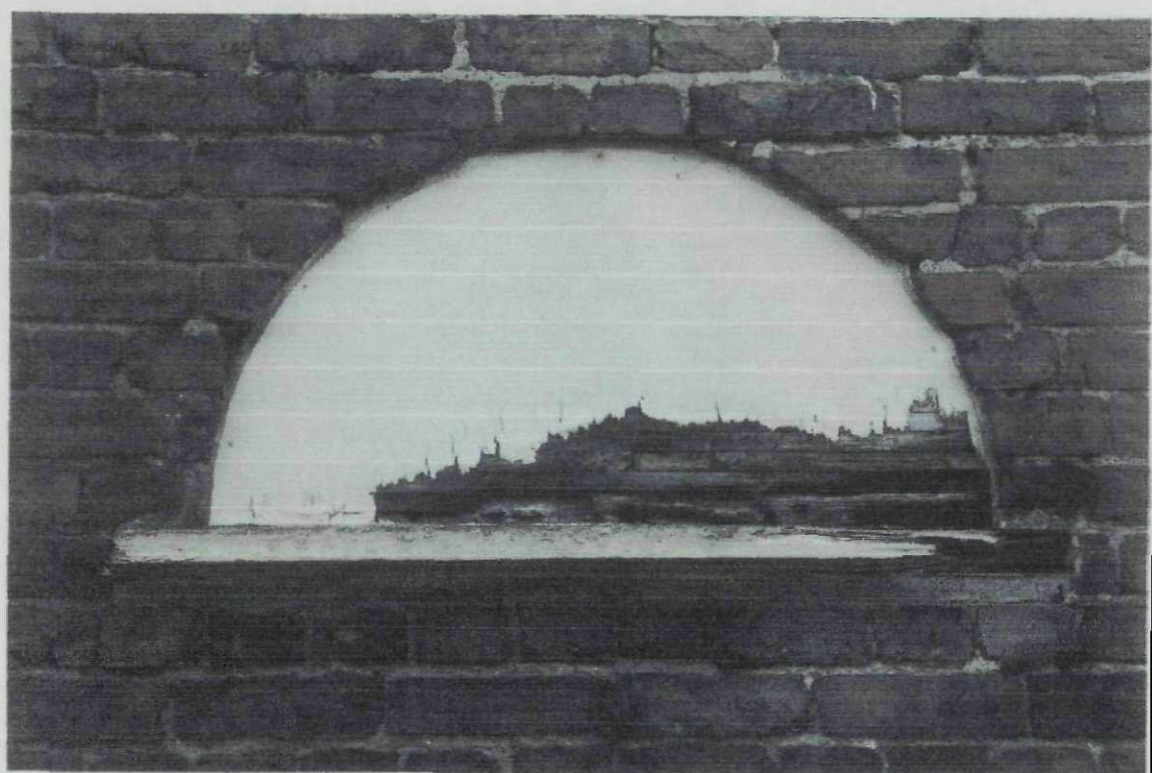
| Z | Brick opening on Northeast elevation. New windows W6 and W7 to be installed. |

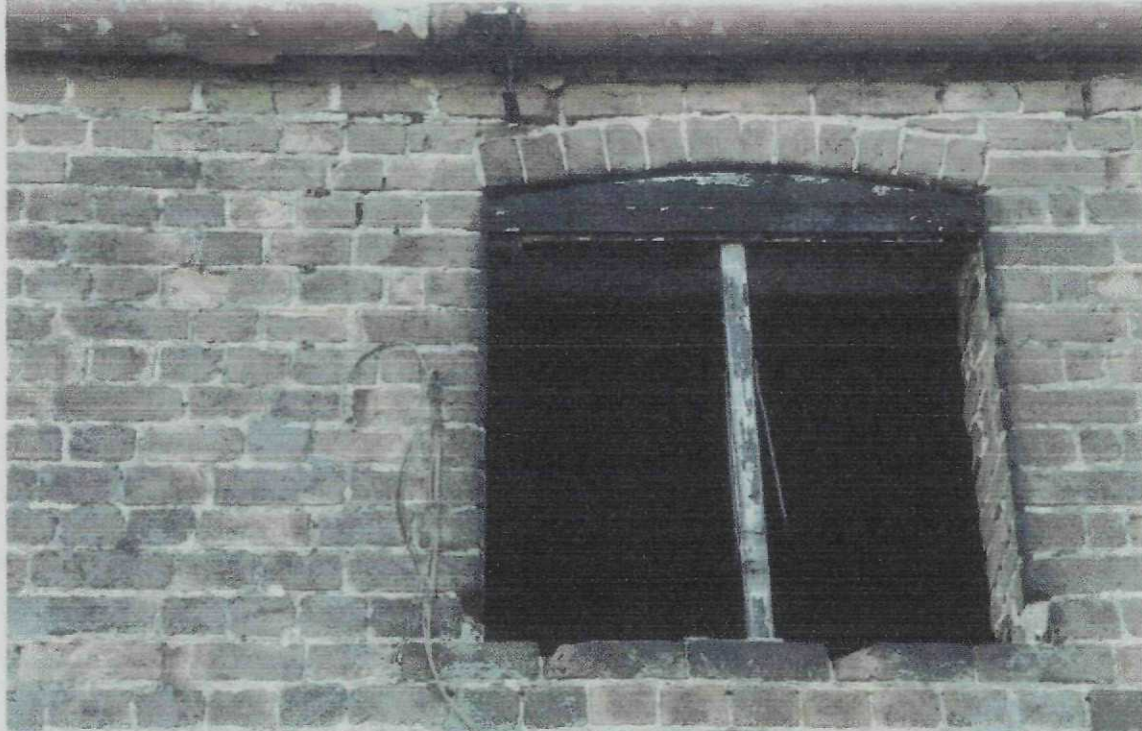
| AA | First floor opening to Northwest elevation. New window W14 to be installed into existing opening. |

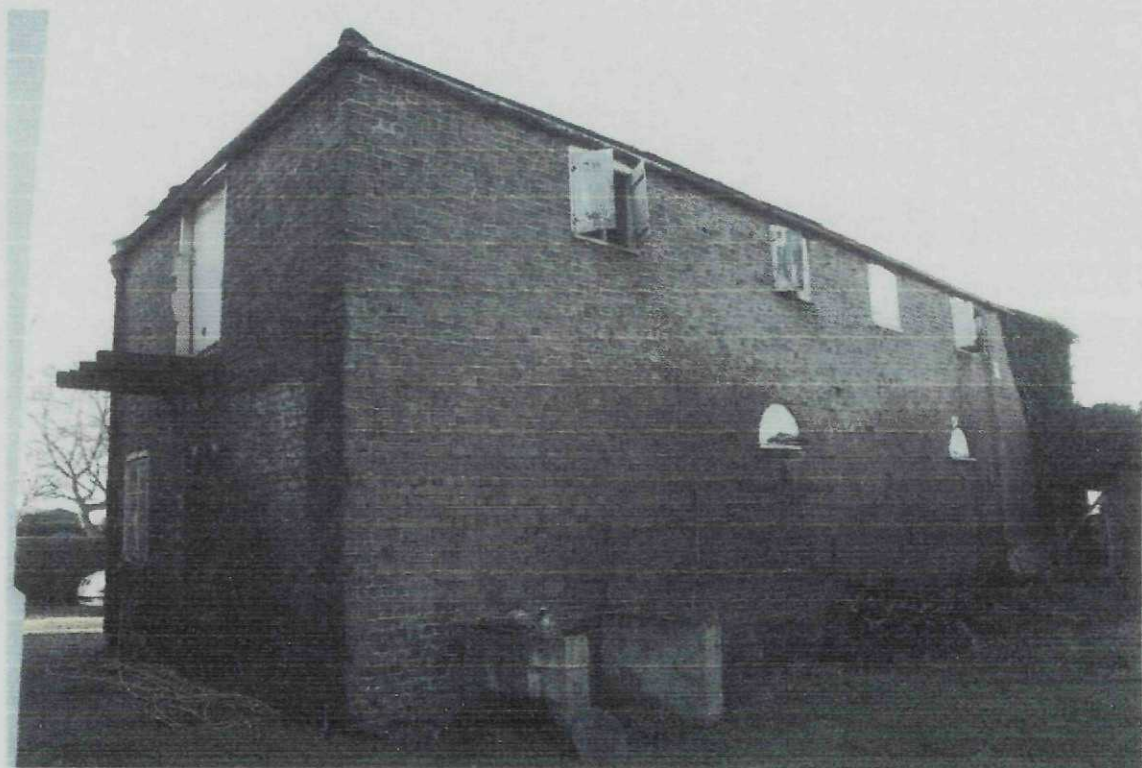
| BB | View of current Northeast elevation. |

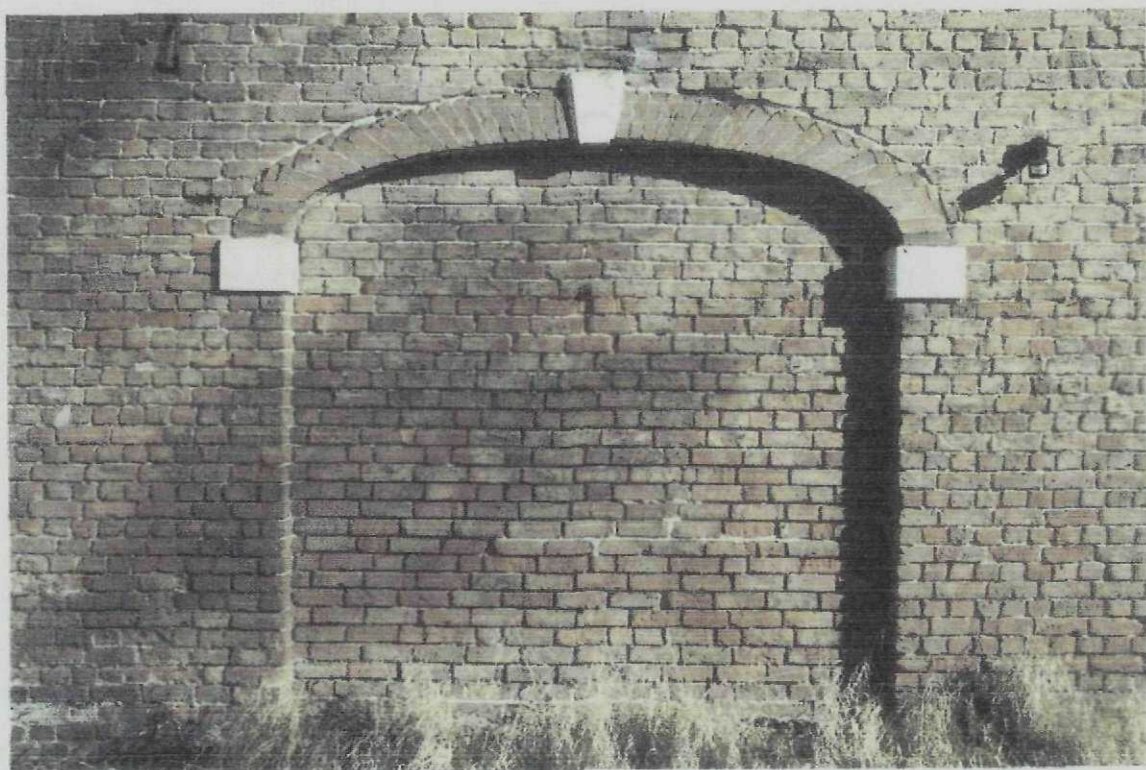
| CC | Brick infill panel within arch to be removed and W4 with doors to be installed. |

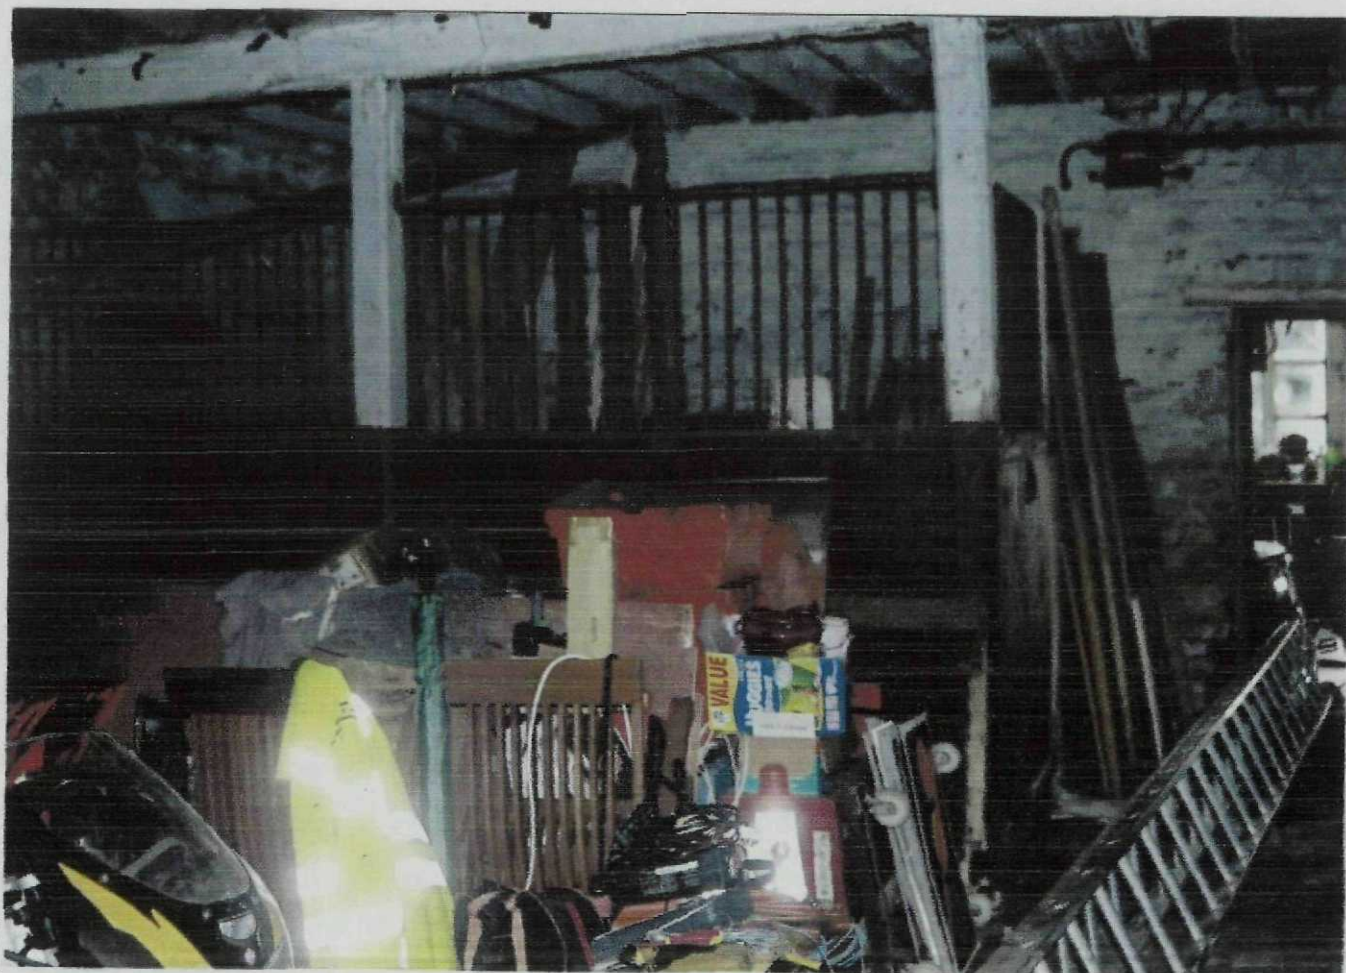
| DD | Ground floor horse box with timber panelling at low level and metal railing above. All to be refurbished and retained within proposed workshop area. |

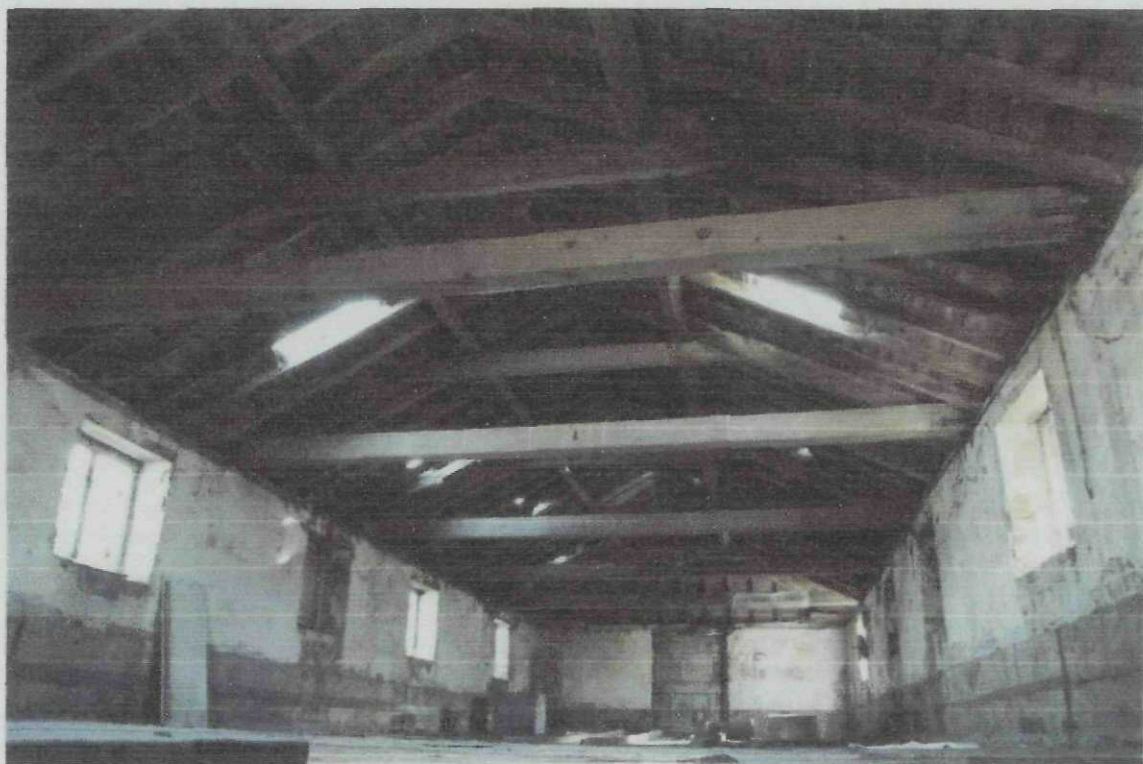
| EE | Internal view of first floor showing existing timber structure, wall and roof openings. |
