**BUILDING SPECIFICATION, DETAILED WORKS  
AND PHOTOGRAPHIC RECORD**

**BARN CONVERSION AT LUTTON HOUSE  
1 LOWGATE, LUTTON**

**Job Ref: 4081  
February 2011**

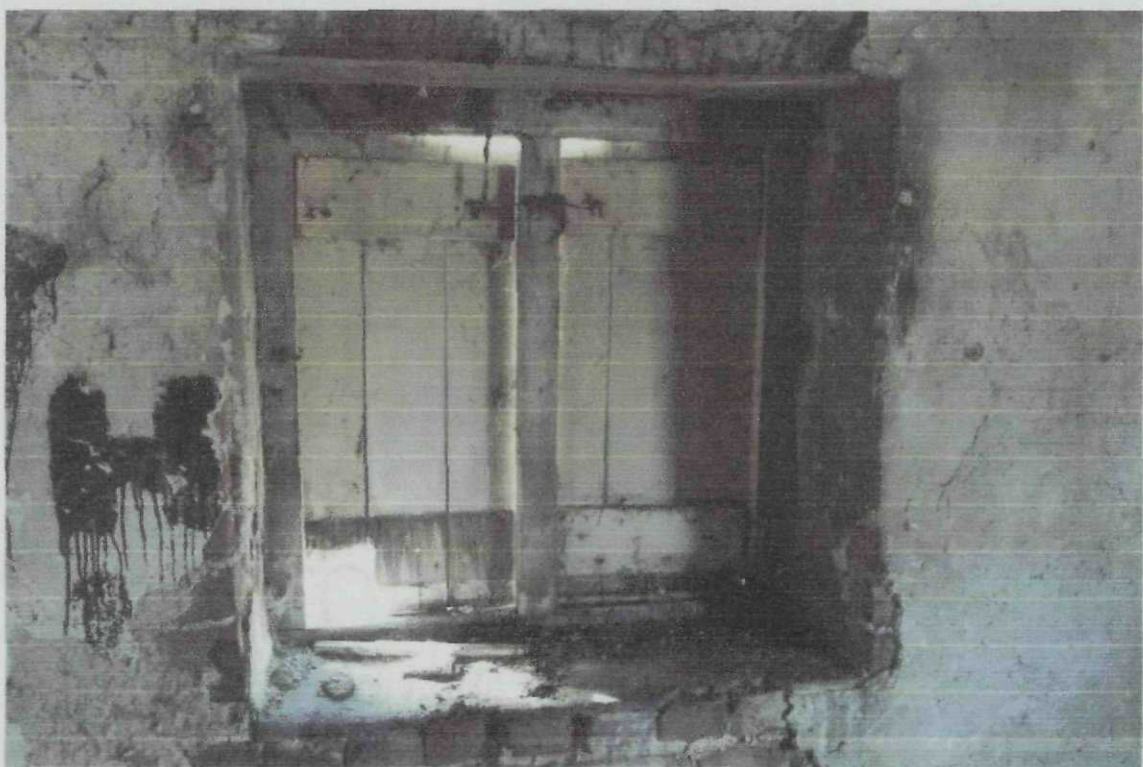
| FF | Internal view of existing opening for window W12. Base rail to shutter to be reinstated. |
