# Inspection Report

## Seas End Hall, Spalding

Reference: J7238

Date: 23 August 2024

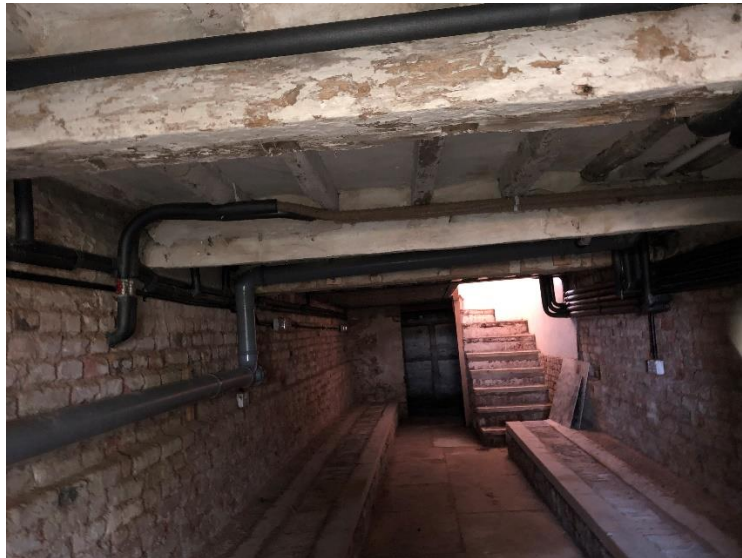
*Figure 3-1 Inside the Basement*

The basement is a circa. 3m wide strip that runs along the full width of the South section of the house. It is accessed via a stair below one of the house staircases. There is reduced height, with several piped services running through, and brickwork plinths running along both sides. There is an external window at one end.

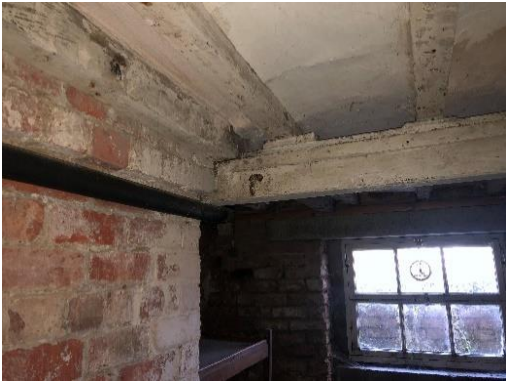
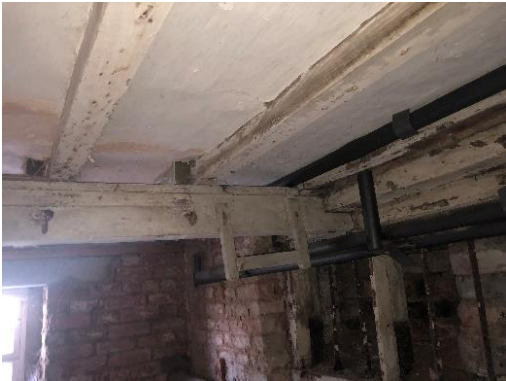
| Beam no. | Photographs with comments | |
|---|---|---|
| 1 | <p>70x150mm deep timber beam and supported joists appear to be in good serviceable condition.</p> | <p>Whilst there are no apparent defects, there is a lack of support to the beam end. We recommend this is rectified either with installation of a short timber post or filling the recess with brickwork to provide support.</p> |

The basement contains brickwork walls supporting the floor above, which is partially timber joists supported on timber beams built into the masonry walls. One of the beams is lacking end support, which should be rectified by providing either a timber post or masonry to support the beam end. The brickwork walls are susceptible to rising damp, and a timber specialist should assess the extent of rot within the timber members. If there is significant timber section loss, then the member should be replaced with a steel beam for which the design is provided.

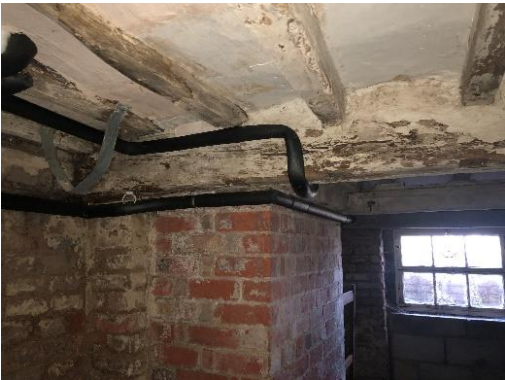
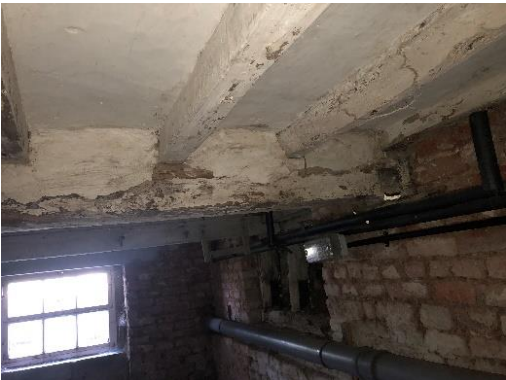
The brickwork walls enclosing the basement are susceptible to rising damp. The ends of the timber beams are built into the wall, and it is unknown whether damp proof courses have been installed to protect the timber from rot. The old timber members should be investigated by a timber specialist to determine the extent of rot.

| Beam no. | Photographs with comments | |
|---|---|---|
| 2 | <p>The timber beam is not a modern regular timber section. Approximate size is 210x230mm deep. We recommend that a timber specialist investigates the extent of rot in the beam, with the member replaced if significant loss of section is found.</p> | |

### 3.3 Basement Beam 1, 2, 3 Replacement Design

A beam design is provided in case investigation and testing finds that the condition of the existing timber member is unsuitable and requires replacement.

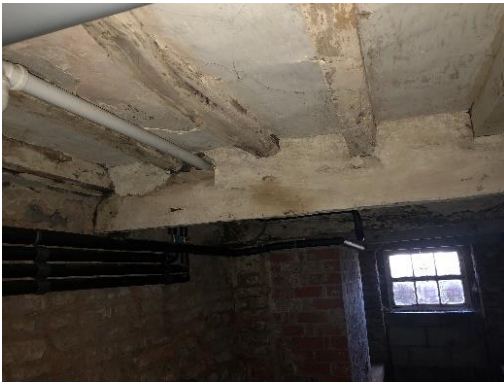
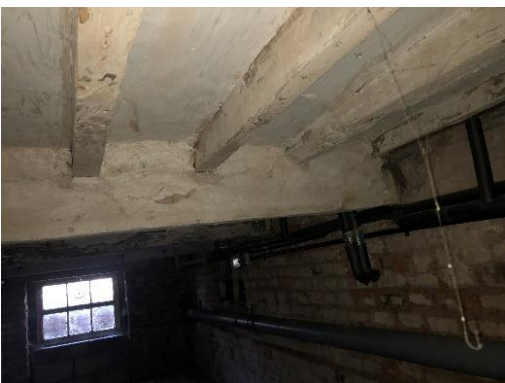
| 3 | <p>80x170mm deep timber beam and supported joists appear to be in good serviceable condition.</p> | |

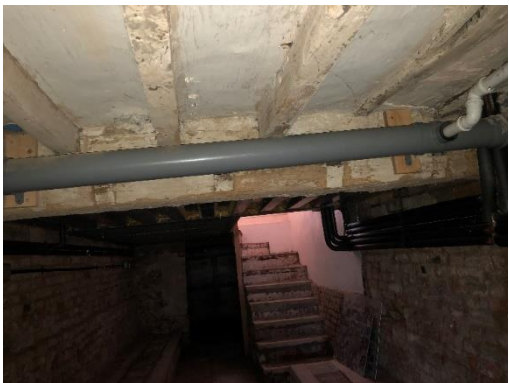
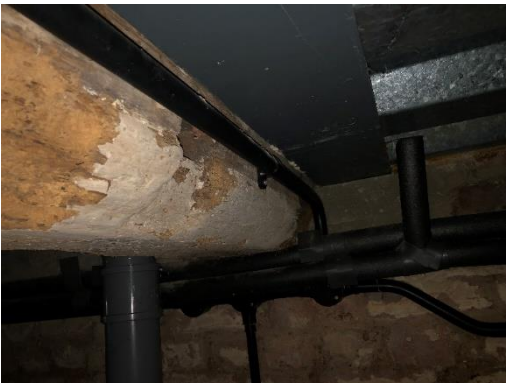
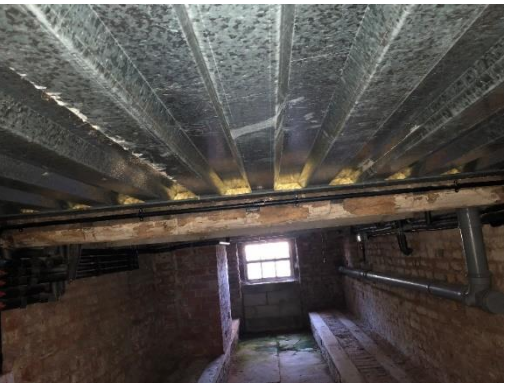
| 4 | | <p>The timber beam is not a modern regular timber section. Approximate size is 230x260mm deep. It supports timber joists from one side only and most likely the masonry wall above. We recommend that a timber specialist investigates the extent of rot in the beam, with the member replaced if significant loss of section is found.</p> |

### 3.4 Basement Beam 4 Replacement Design

A beam design is provided in case investigation and testing finds that the condition of the existing timber member is unsuitable and requires replacement. Site investigation is recommended to confirm that the beam supports the masonry wall above.

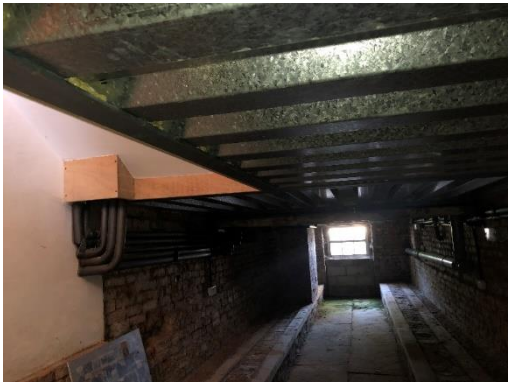
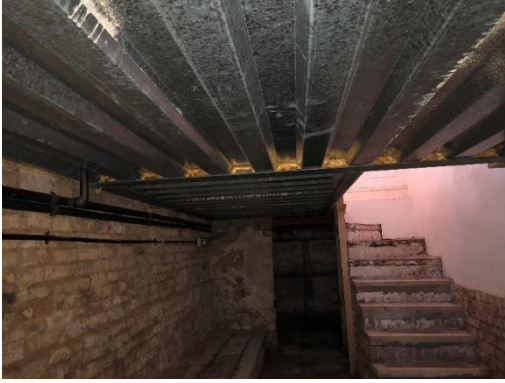
| <p>5, 6, 7,<br/>8, 9</p> | <p>Modern concrete slab on steel composite decking supported on steel beams. Beams supported on padstones in the brickwork wall. Structure in good condition.</p> | |

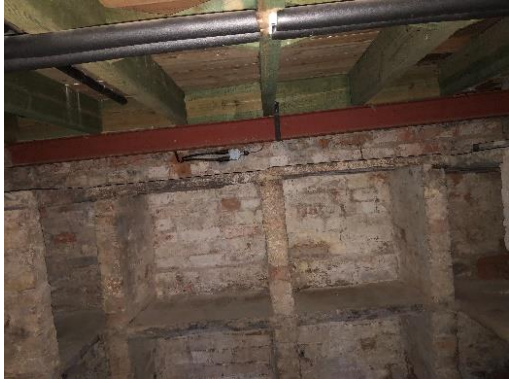
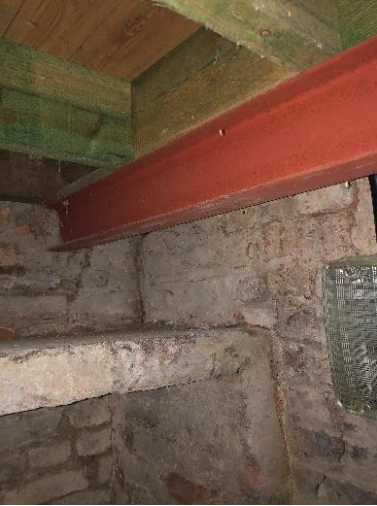
| <p>10, 11</p> | <p>Modern timber joists supported on steel beams. Structure in good condition.</p> | |

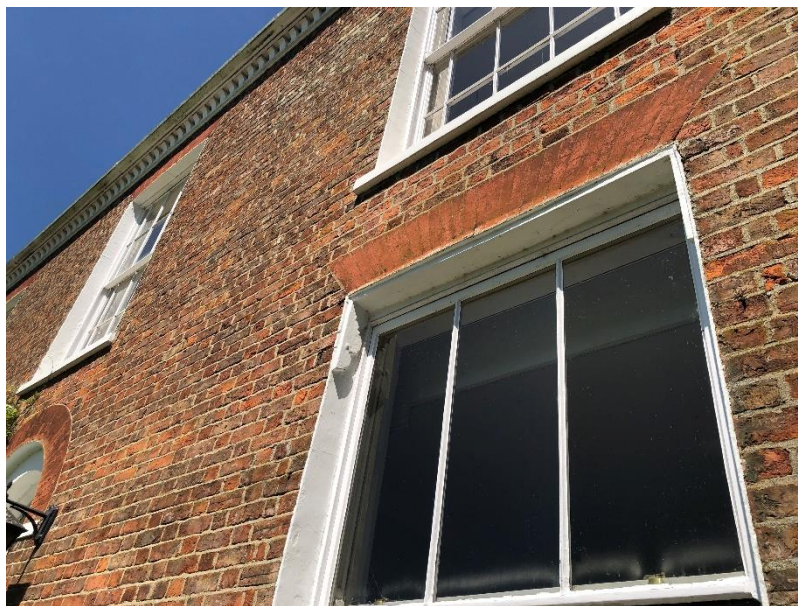
*Figure 4-1 External Window Header*

In general, the brickwork headers are in good condition, showing little sign of movement. In some areas, the bricks have slipped a little and the header has dipped, however remedial works are not considered necessary for such minor movement.

It is unknown whether structural lintels are present over the windows. This should be investigated, with the option to then install new lintels or to strengthen the existing lintels to prevent further deflection.

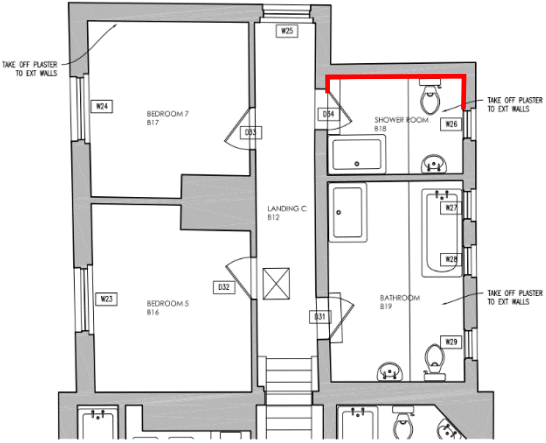
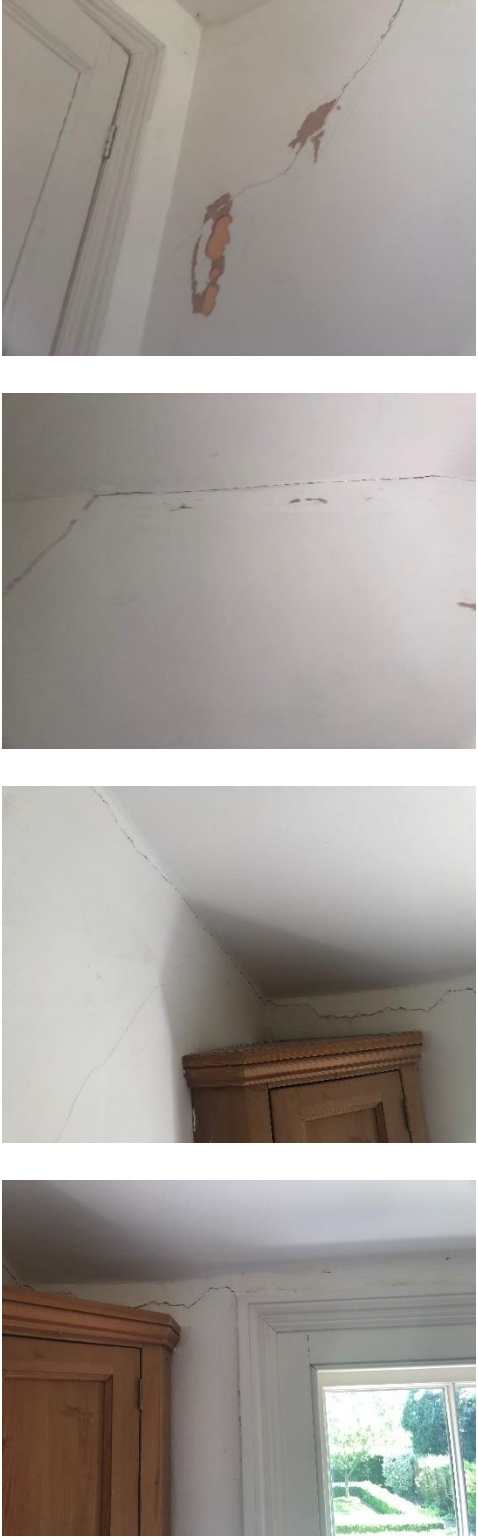
| Location Key with Comments | Photographs |
|---|---|
| <p>Cracking to the inside of the first floor external wall. Crack to the top and sides of the wall panel, in the order of 1mm wide. Crack has extended through top of window frame. This section of the house appears to be the oldest. The wall looks to have been recently plastered, which suggests the movement is active.</p> | |

The arrangement of cracks within the first floor shower room and bathroom suggest minor localised settlement of the external corner wall. The wall appears to have been recently plastered which suggests that the movement is active. The plaster is less accommodating of movement compared to the external brickwork with lime mortar.

Externally there are trees in the vicinity that will cause changes in the soil moisture content through the seasons. British Geological Society maps indicate the site contains Tidal Flat Deposits (clay and silt) over West Walton Formation (mudstone and siltstone). If the foundations supporting this section of the house are shallow and bearing in the clay strata, they would be susceptible to movement from soil volume change.

Another potential cause of movement could be related to the foul water drainage system. If the drainage serving the shower room and bathroom is leaking, this may have caused softening of the supporting ground and foundation settlement.

Installation of crack gauges with regular monitoring will establish whether the movement causing cracks in the walls is ongoing or has stopped.

We recommend that trial holes are excavated to determine the foundation type and geological conditions where settlement has occurred. The bearing strata can then be assessed with soil laboratory testing to determine volume change potential. This would then be evaluated with the proximity of trees and their water demand to establish whether the foundations meet modern design standards. The locations of proposed trial holes has been marked on the ground floor plan in Appendix A.

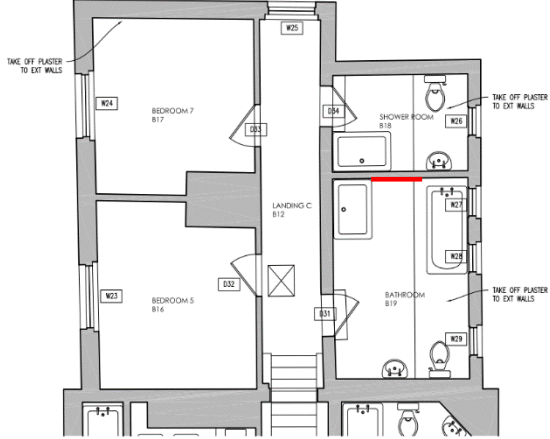
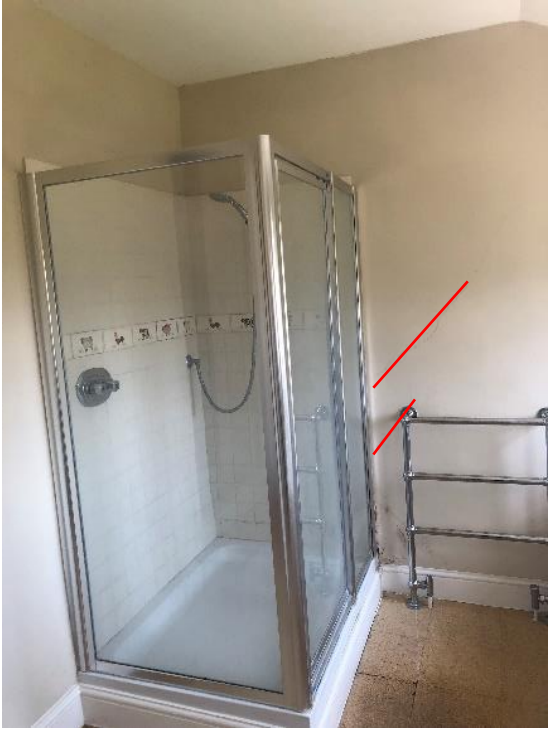
| Location Key with Comments | Photographs |
|---|---|
| <p>Diagonal cracks in the first floor internal wall adjacent to the shower cubicle. Crack width in the order of 0.5mm. No signs of movement on the opposite side of the wall which is tiled.</p> | |
