HISTORIC BUILDING SURVEY

Seas End Hall
Moulton Seas End
Spalding
Lincolnshire
PE12 6LB

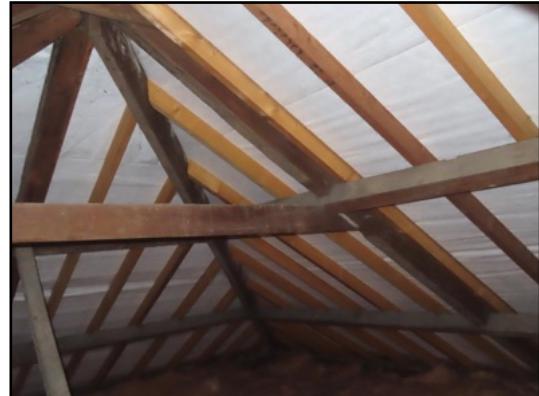
Significant strengthening work has been undertaken to the roof structures above the front and central structures and I understand this was carried out by the current owner in recent years. Many of the rafters have been replaced although within the roof above the front structure most of the roof timbers are original. The supporting purlins and collar beams are all original. The roof above the rear structure has not been strengthened and all of these roof timbers are original.

The roof above the front structure shows no signs of significant deflection, weakness or structural disrepair. The strengthening work appears to have been carried out to a satisfactory standard.

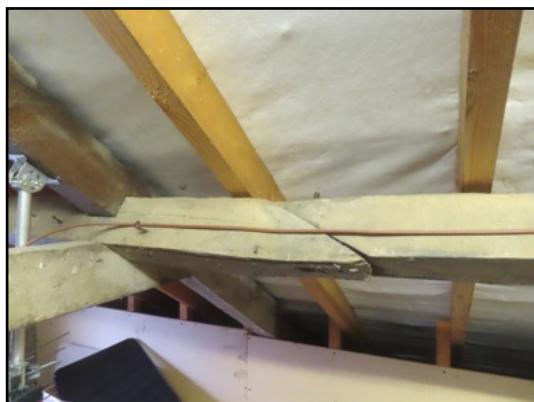
The roof above the central structure has also had most of its rafters replaced although the original purlins remain and towards the rear these purlins have come apart at a splice joint, although large metal bolts have been driven through these splice joints to help keep them together and provide further support. This arrangement is

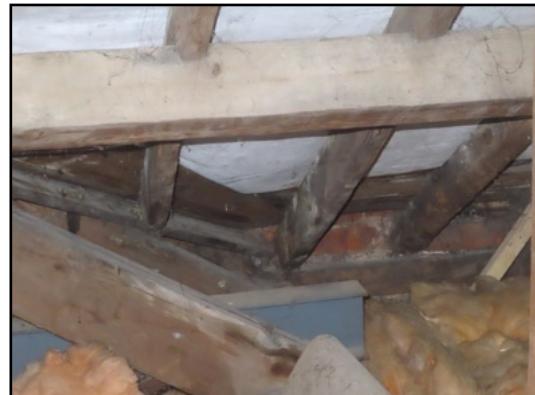
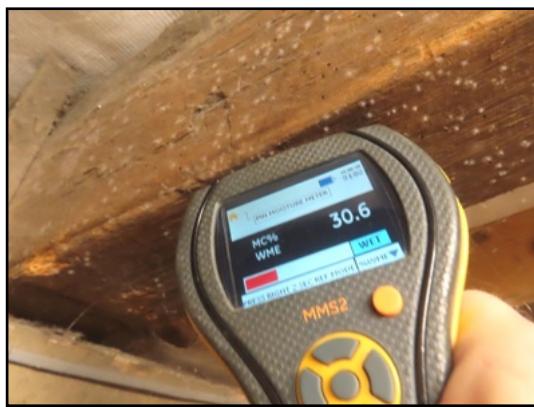
The chimney to the rear of the central structure is leaking and causing dampness to roof timbers. See comments in Section 5.5. Elsewhere, the dampness within the roof timbers may be as a result of previous rainwater ingress before the roof coverings were

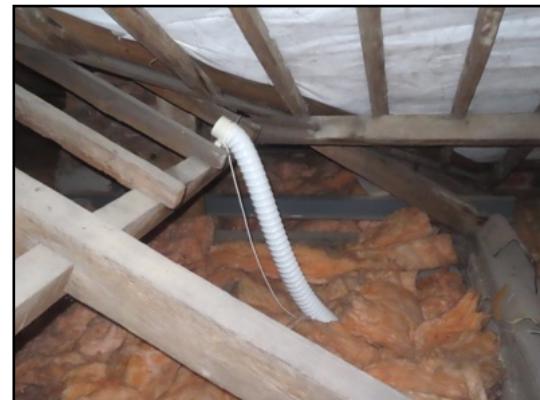
To the rear left-hand corner of the roof space above the front structure there is a pipe from an extractor fan in the en-suite bathroom to the master bedroom which is discharging water vapour into the roof space rather than externally. This is a poor arrangement and will increase the moisture content of the roof timbers

above and I recommend this pipe is extended through a vertical pipe which should run through the roof slope above to discharge this water vapour externally. This work however would require listed building consent as it would alter the outward appearance of the building.

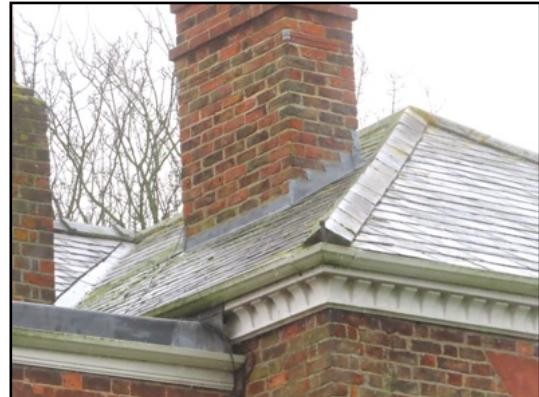
To the right-hand side of the chimney to the rear of the central structure water is leaking through the sarking membrane and dripping onto the floor beneath. Some tape has been put across this sarking membrane but it was actively leaking at the time of my visit. This could be due to a defective flashing around this chimney and this also requires repair or replacement.

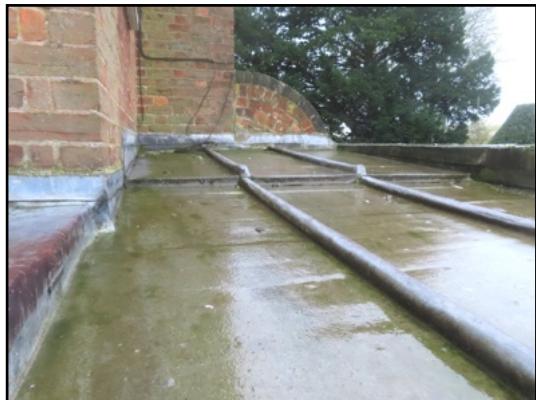
The lead sheeting covering the flat roof above the single-storey structure shows no obvious evidence of disrepair. However, there is slight damp staining to the ceiling beneath in the rear snug and future maintenance

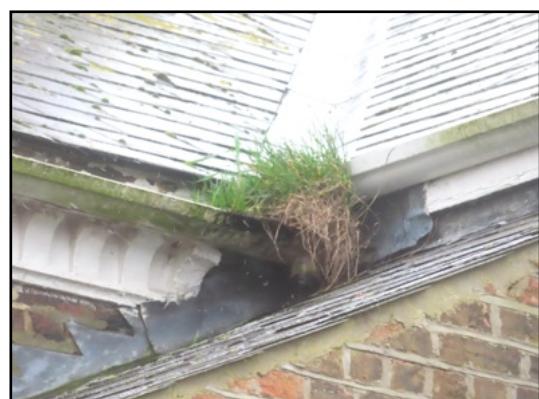
However, the gutter to the rear right-hand corner of the hipped roof above the main front structure is badly blocked and leaking.

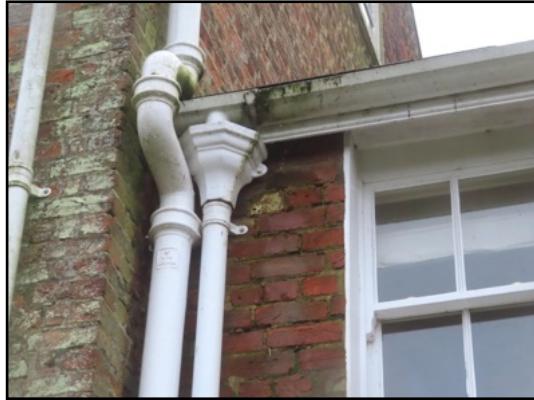
The gutter serving the right-hand roof slope above central structure is also leaking to both the front and rear as the gutter has been poorly laid, with gaps formed where the sections of gutter overlap. At the time of my visit these were leaking badly and causing dampness to this right-hand wall.

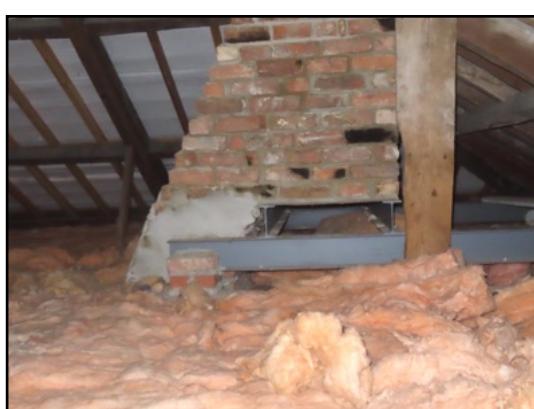
The chimney stacks appear structurally stable where visible from ground level. However, some are leaking.

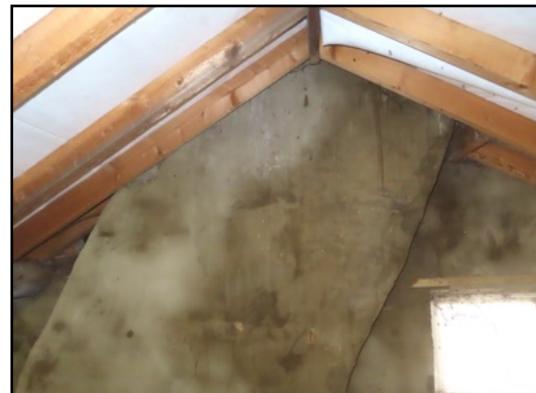
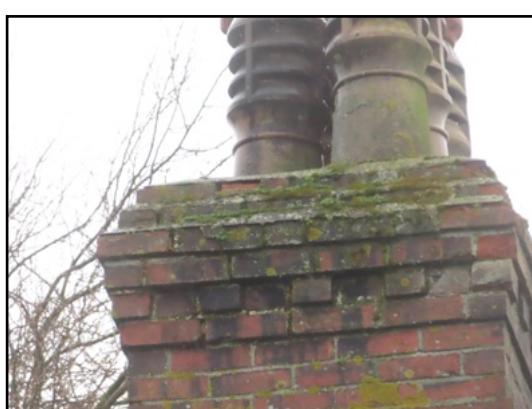
The chimney stack above the rear structure is also leaking with visible dampness to the masonry in the roof space which is also causing some dampness to the surrounding timbers. The mortar flaunchings surrounding the chimney pots to the tops of these stacks appear to have weathered and perished, with further damage

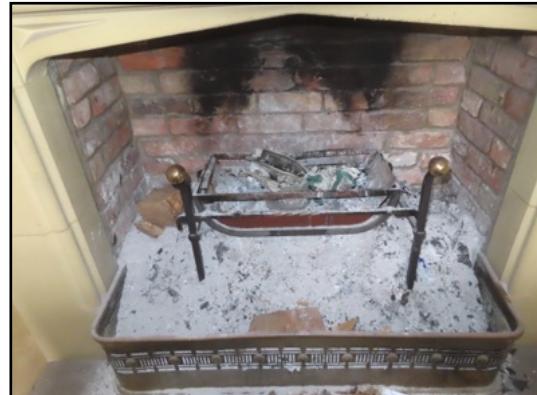
The fireplace in the two front reception rooms have been used and both fireplaces were very full of ash at the time of my inspection. These fireplaces discharge into unlined brick flues and there is a lot of soot and tar staining to the brickwork. I would recommend these flues are checked and swept prior to reuse and then adequately lined. The lining is best done from above so this should be incorporated into the high level repair works.

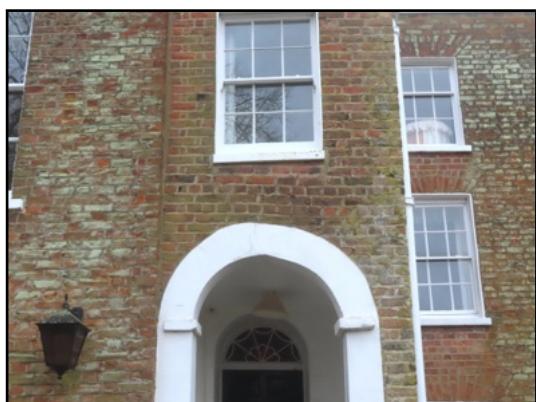
The one area of more significant structural movement is to the two-storey right-hand addition which houses the right-hand entrance porch and the bathroom above. More significant cracking and distortion is visible above and around the archway leading into this porch, indicating some subsidence to the rear right-

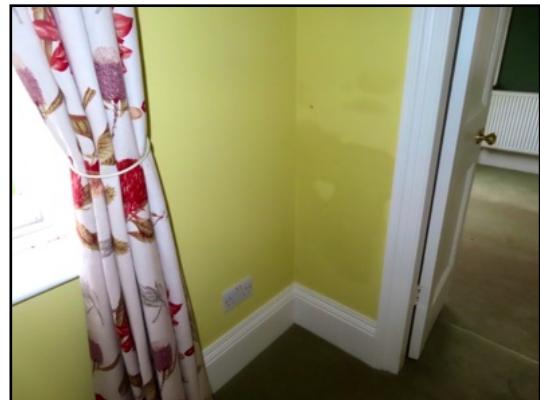
The external and internal walls to the main front structure in front of this cellar are also extremely damp with the plasterwork just above ground floor level being saturated. Severe levels of dampness were found within the two main reception rooms as well as within the playroom to the left-hand side, with the latter being above the cellar. The floors in this structure are raised well above external ground level and the problem does not appear to be simply a case of groundwater ingress but very high levels of moisture are rising up these walls. There are suspended timber floors within these three reception rooms and the void beneath these floors appear to be extremely damp. As detailed in Section 7.1 the floor in the dining room to the front right-hand corner has a spot towards the centre which is

In order to assess and address the cause of this severe dampness it will be necessary to remove the floors in both the main living room and the dining room to the front of the main house and also remove the floor in the playroom to the rear left-hand corner. Further investigation can then be undertaken to assess the cause of this excessive dampness and any leaking pipework will need to be replaced. Once the cause of the problem has been resolved new floors will need to be laid with suitable air bricks to ventilate the sub-floor areas and you are referred to related comments in Section 7.1.

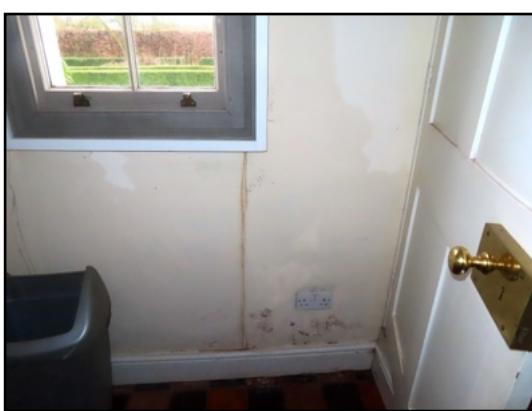
Elsewhere within the main house there are areas of excessive dampness which have caused damage to internal plasterwork, timberwork and decorative finishes. The leaking gutter to the right-hand side of the central structure is causing dampness and damage notably within the scullery to the rear right-hand corner of the kitchen

and there is also excessive dampness to the bases of the chimneys to the rear of the central structure and within the rear structure, most probably caused by rainwater ingress from above. This water will have soaked through the masonry of these leaking chimneys over the years and settled at the bases causing dampness to the chimneys and surrounding walls. The rear wall in the boot room is also very damp at the base and this is mainly due to the vegetation attached on the other side of this wall which is preventing the wall from breathing and expelling water vapour and also causing some moisture ingress.

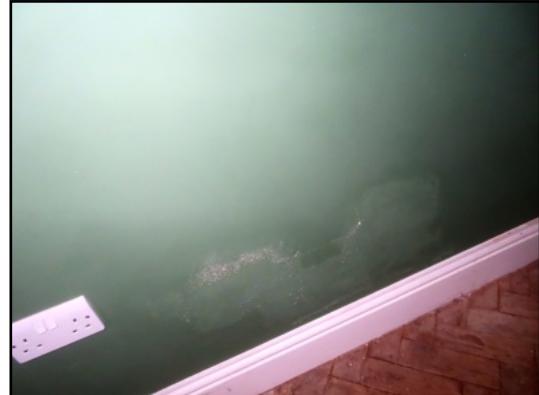
There is also a patch of dampness higher up the wall to the left-hand side of the kitchen and this is in line with a foul drainage pipe and external soil stack. Leaking from this pipework is also a likely cause of this dampness and again repairs will be needed. You are referred to related comments in Section 11.2.

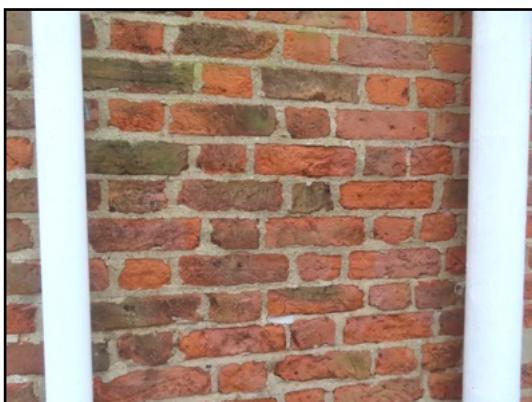
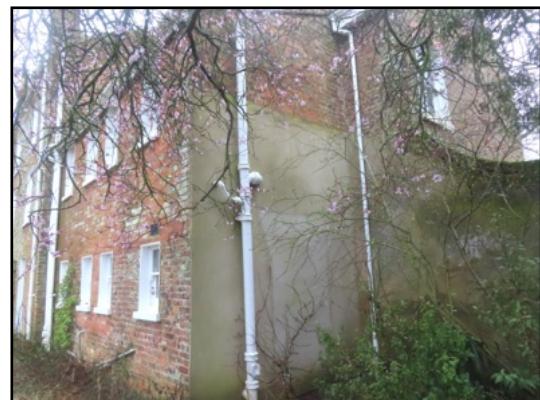
Another cause of interstitial condensation is the use of inappropriate non-breathable materials both externally and internally to the external walls. At some point in the past and possibly as part of the current owner's refurbishment works the external brickwork has been largely repointed using an inappropriate cement mortar

rather than a breathable lime mortar. These walls will originally have been constructed with the bricks laid in a lime mortar which is designed not only to be flexible but also to allow water vapour to diffuse as a gas through these external walls and escape externally. Repointing them in cement only diverts the moisture into the surrounding brickwork where it can be forced back internally and this has been coupled with internal replastering using a modern non-breathable gypsum plaster rather than a lime plaster, trapping this moisture within the brickwork. Also, parts of the rear walls of the rear structure have been clad externally in a cement render and this will also trap moisture in the brickwork and force it

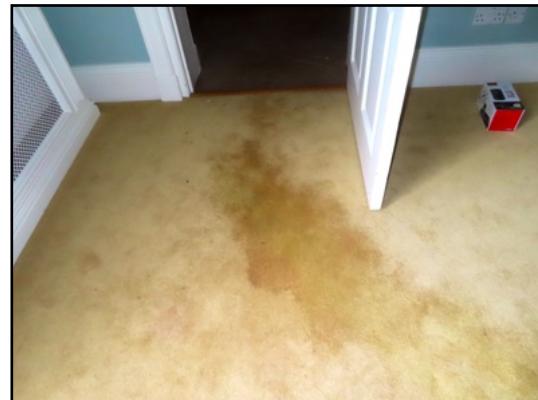
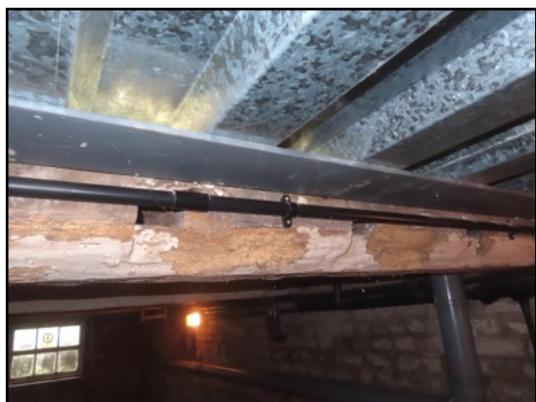
As detailed in Section 6.3 the suspended timber floors within the front structure are extremely damp in some areas and there is a possibility of flooding beneath. There is an area in the centre of the front right-hand reception room where the floor is saturated, indicating a possible leak from the pipework beneath. These floors will need to be lifted and replaced and when they are replaced suitable air bricks should be provided within the adjoining external walls to allow adequate ventilation of these sub-floor voids.

The exposed floorboards and floor joists visible above the cellar are very damp and suffering from rot and some of these joists will need to be removed and replaced.

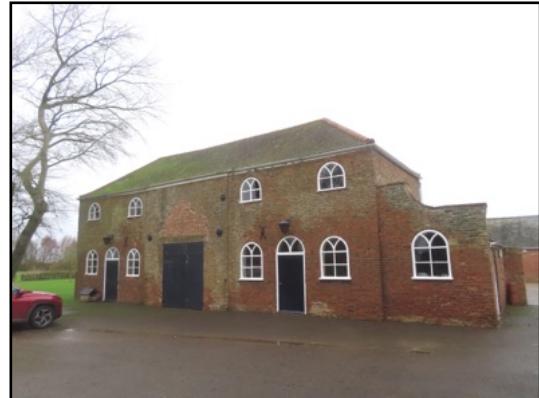
This roof covering has been in place for at least 30 years. Fibre-cement roof tiles normally have a limited lifespan of around 30 years before they need to be replaced.

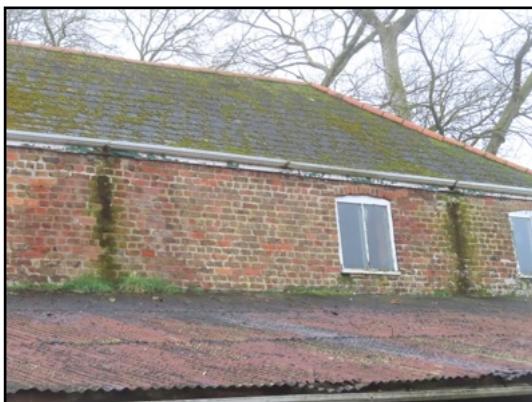
This coach house building has suffered previous movement and some structural repair has been undertaken, including with the insertion of steel tie bars to tie the front and rear walls together. There is evidence of some lateral movement as well as some separation cracking to the front right-hand corner although this structure is currently structurally stable.

The roof tiles appear to be approaching the end of their useful life and you should budget for the likely need to have to replace them fairly soon. They may well contain asbestos fibres, so this would need to be done by a specialist taking appropriate precautions - see below.

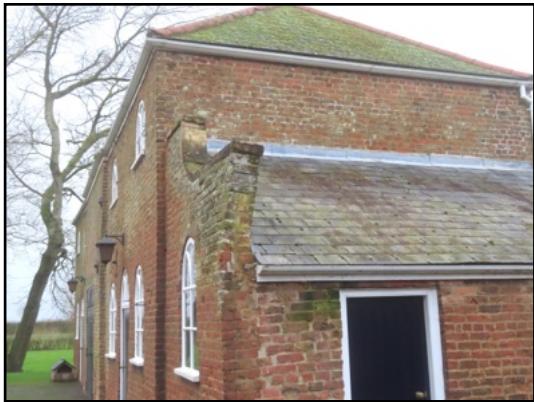
The boiler room structure has suffered some movement, notably to the front right-hand corner although the main structure is stable. However, the front wall terminates in a shaped parapet which is leaning backwards to the point where it is unstable and unsafe. This requires rebuilding as soon as possible.
