## **Arboricultural Report and Impact Assessment to BS 5837:2012**

2 Station Road  
Moulton  
Spalding  
PE12 6QE

8<sup>th</sup> June 2021

210217

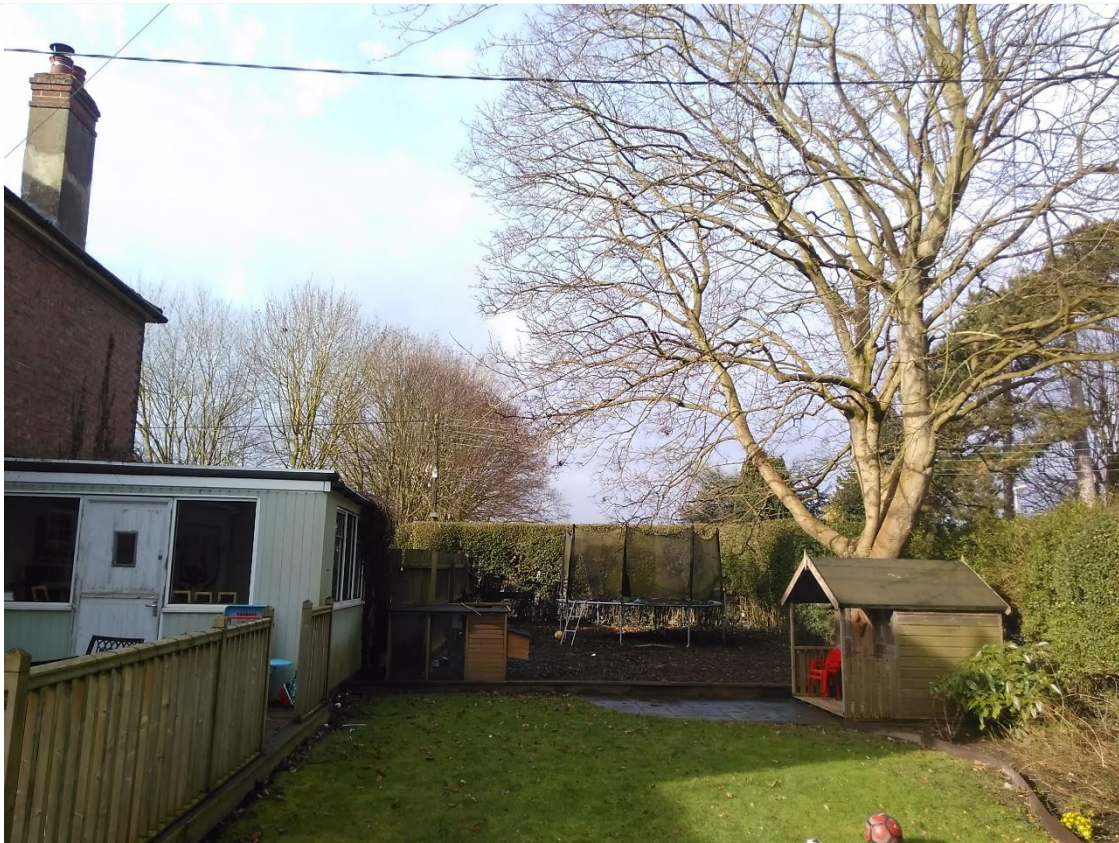
| Tree ID | Common Name | Maturity | Height (m) | Stem Diameter (mm) | RPA Radius (m) | Crown Spread (m) | | | | Structural Condition | Category | Life Expectancy | Physiological Condition | Comment | Recommendations |
|---|---|---|---|---|---|---|---|---|---|---|---|---|---|---|---|
| T1 | Norway Maple | Semi-mature | 13 | 720 | 8.6 | 7 | 7.5 | 6.5 | 6.5 | Good | B1/2 | >40 yrs | Good | Stem measured below crown break at 0.5m. Crown break at 1m. Significant lower primary limbs to S, E and W. E lower limb with bark included union but strong natural bracing above. Intertwined twin leaders with bark included union between, adequate natural bracing above. Minor deadwood in crown with slightly sparse shoot structure in upper crown. A reasonable specimen. | Development Recommendation: Lift the outer 3m of southern crown from 2.5m to 3.5m (see Appendix image 1). |

Image 1 – T1 showing existing crown spread and height

5.3.1. To provide adequate clearance above and adjacent to the northern elevation of the proposed extension T1 will require crown lifting as detailed in Appendix 1. The works are minor in nature and will result in no lasting ill effects.
