# ARBORICULTURAL REPORT

To BS 5837:2012 at:

*Land at*  
**Roman Road**  
**Moulton Chapel**  
**Spalding**  
**Lincolnshire**  
**PE12 0XQ**

Reference: AWA2421

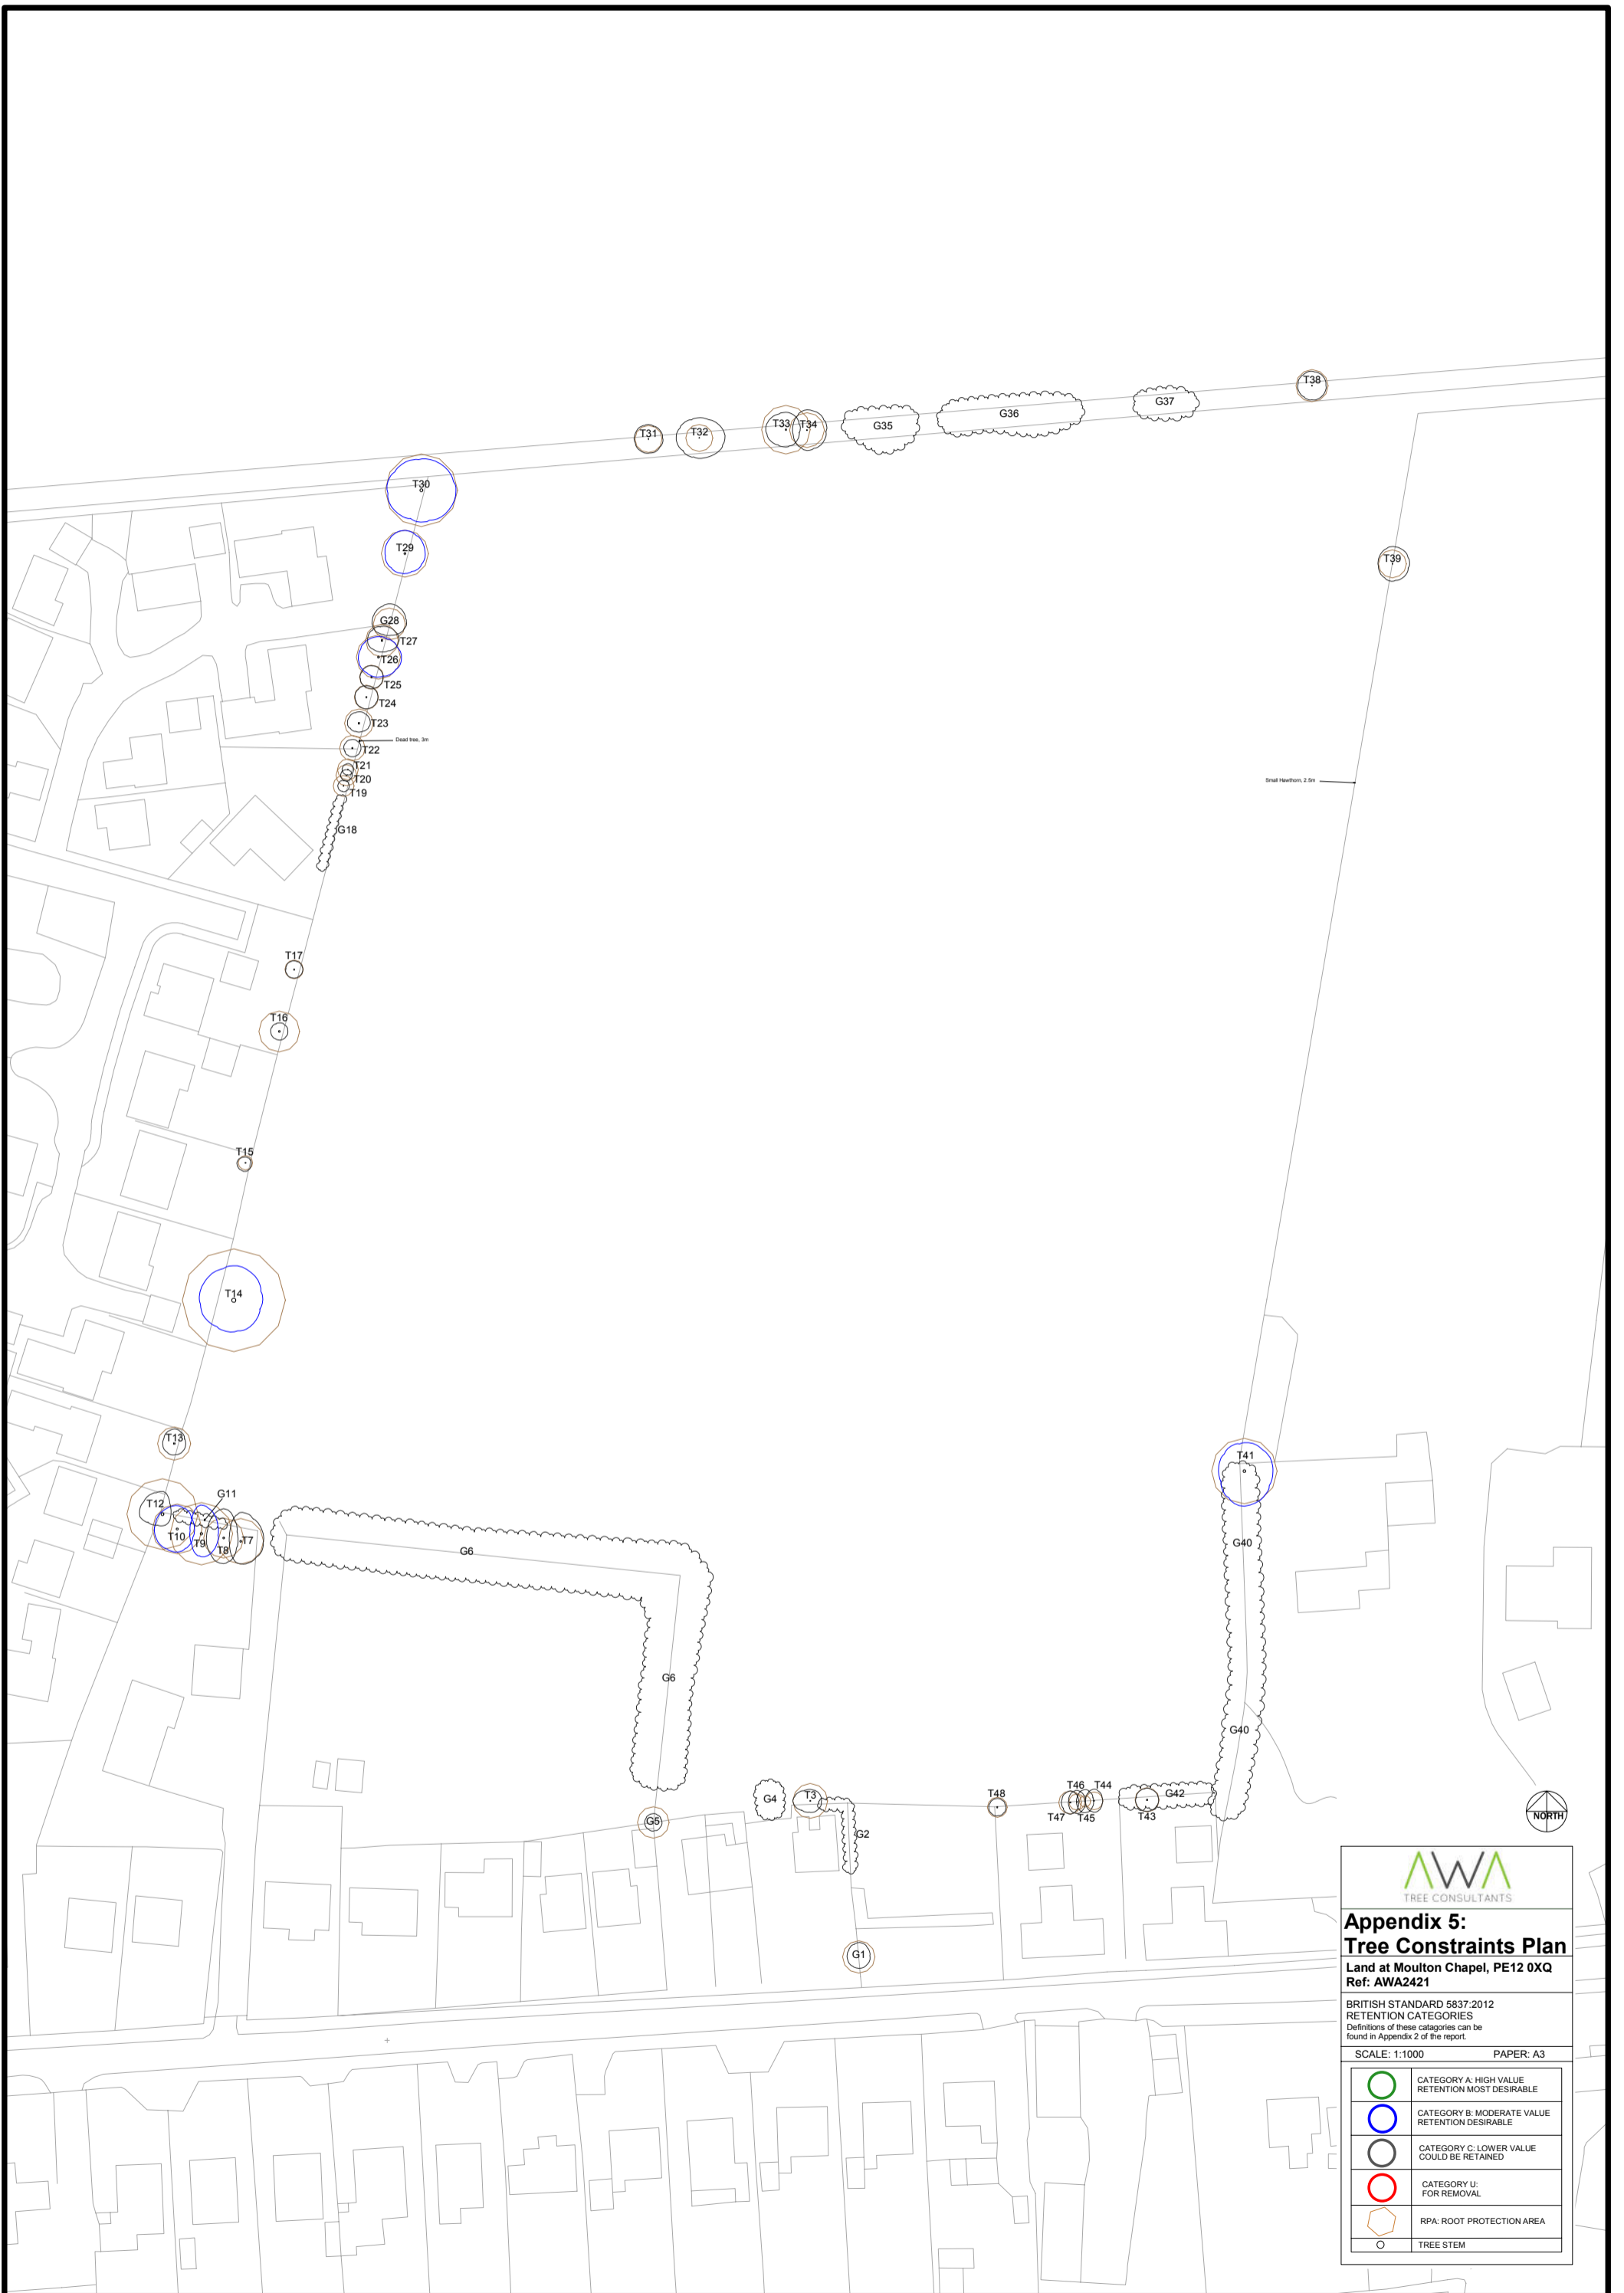
**Appendix 5:**  
**Tree Constraints Plan**  
 Land at Moulton Chapel, PE12 0XQ  
 Ref: AWA2421

- 3.2.11 The tree Root Protection Area (RPA) detailed on the Tree Constraints Plan at Appendix 5, has been used as a layout design tool, to inform on the area around a tree where the protection of the roots and soil structure is treated as a priority.

- 3.3.5 The tree Root Protection Area (RPA) detailed on the Tree Constraints Plan at Appendix 5, should be used as a layout design tool, to inform on the area around a tree where the protection of the roots and soil structure is treated as a priority.
