# Asbestos Survey

**Asbestos Survey Report  
for  
Industrial and Office Units  
8-14 Bear Lane  
Pinchbeck  
Spalding, Lincs  
PE11 3XA**

**Authorised: ..... Date: 3 December 2021  
Survey Report No – 20969**

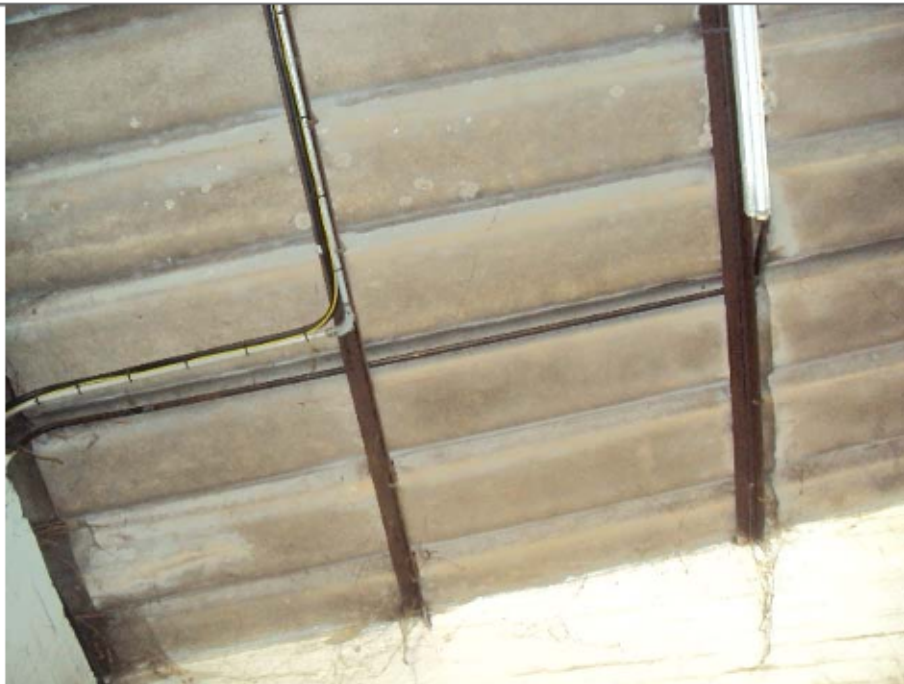
| | Sample No | <i>BLP/EXT/001</i> |

| | Component | <i>Roof and liner sheets</i> |

| Survey Results | | Approximate | Total Area | 350 M sq | Asbestos Type | Chrysotile |
| Location | External | Licensed Material | | No | Product Type | Cement Product |
| Comments | Remove prior to the refurbishment works if likely to be disturbed. | | | | | |

**Recommended:**

**This is a non-licensed asbestos containing material, but if removed it should be disposed of as hazardous waste. Only operatives with a minimum of Cat B asbestos training should work with this material.**

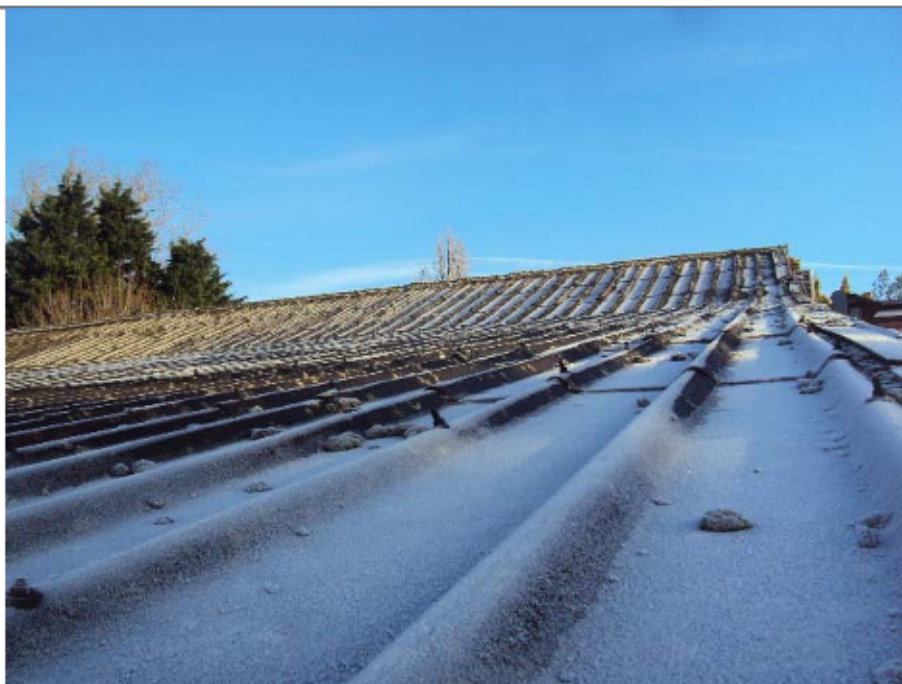
| | Sample No | <i>BLP/EXT/002</i> |

| | Component | <i>Roof and liner sheets</i> |

| Survey Results | | Approximate | Total Area | 90 M sq | Asbestos Type | Chrysotile |
| Location | External | Licensed Material | | No | Product Type | Cement Product |
| Comments | Remove prior to the refurbishment works if likely to be disturbed. | | | | | |

**Recommended:**

This is a non-licensed asbestos containing material, but if removed it should be disposed of as hazardous waste. Only operatives with a minimum of Cat B asbestos training should work with this material.

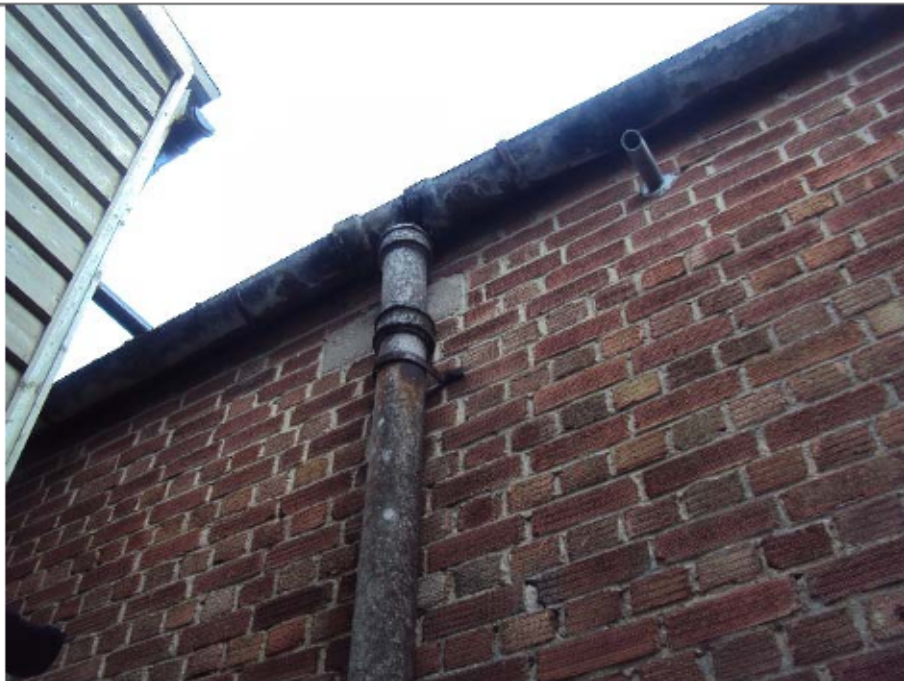
| | Sample No | <i>BLP/EXT/003</i> |

| | Component | <i>Gutter and downpipe</i> |

| <b>Survey Results</b> | | Approximate Total Area | <b>13 M</b> | Asbestos Type | <b>Chrysotile</b> |
| Location | <b>External</b> | Licensed Material | <b>No</b> | Product Type | <b>Cement Product</b> |
| Comments | <b>Remove prior to the refurbishment works if likely to be disturbed.</b> | | | | |

**Recommended:**

**This is a non-licensed asbestos containing material, but if removed it should be disposed of as hazardous waste. Only operatives with a minimum of Cat B asbestos training should work with this material.**

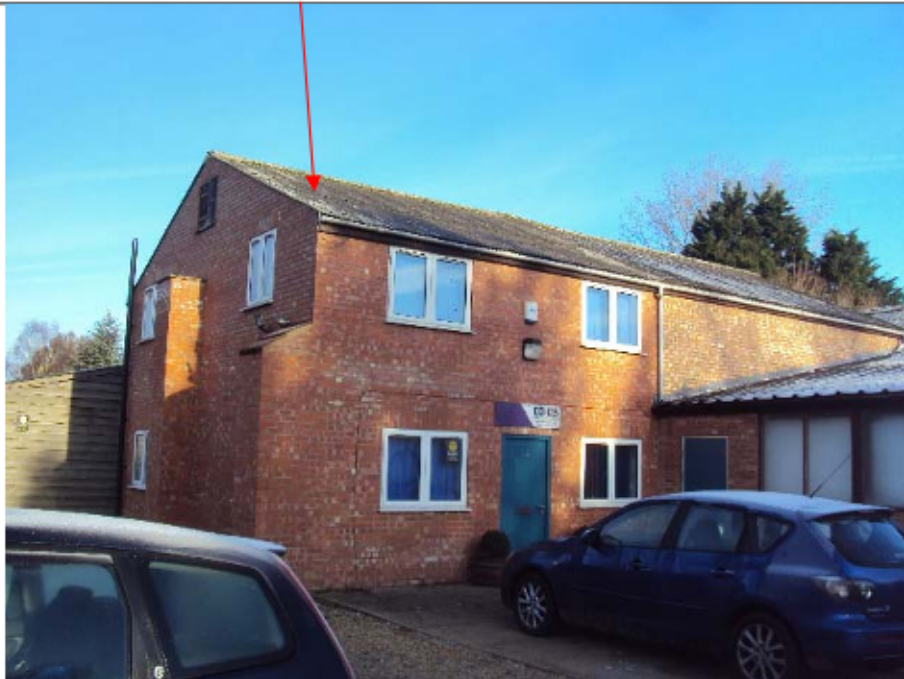
| | Sample No | BLP/EXT/004 |

| | <b>This sample does not contain Asbestos</b> | |
| | Component | Roof sheets |

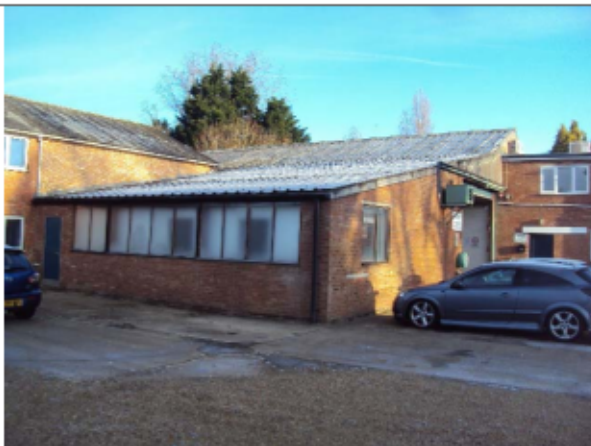
| 1 | | General external view. Samples 001 to 004 refer to the roof coverings and rainwater goods. |

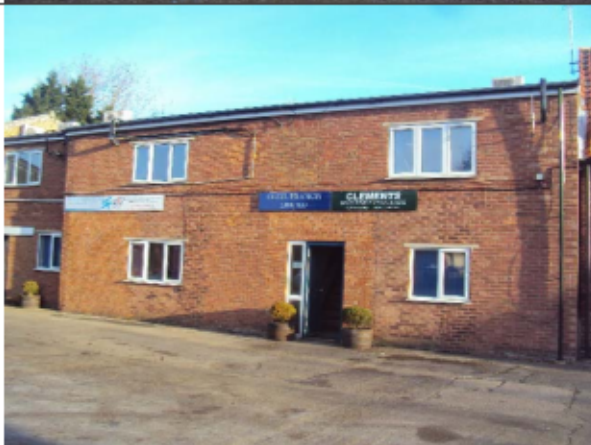
| 2 | | External view of office area. Flat roof (felted), brick walls, plastic window and door frames. No asbestos containing materials seen here. |

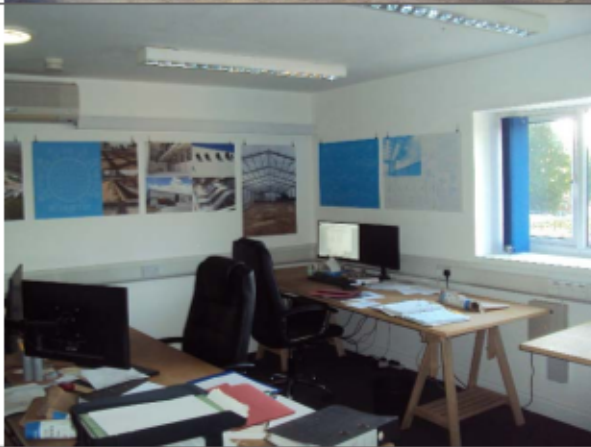
| 3 | | Office areas all inspected. Plasterboard/fibreboard/plaster finishes to walls and ceilings. No asbestos containing materials seen here. |

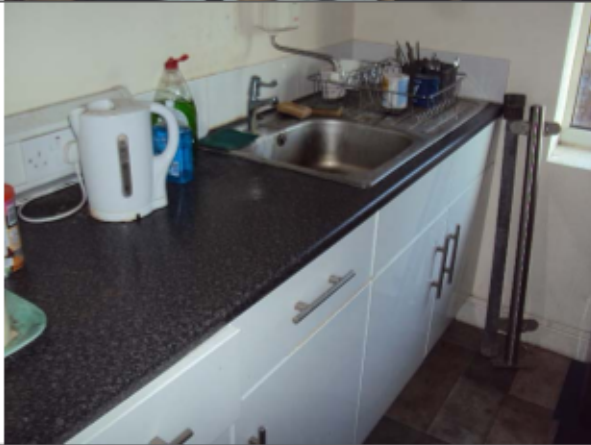
| 4 | | Modern type kitchen fixtures and fittings. No asbestos containing materials seen here. |

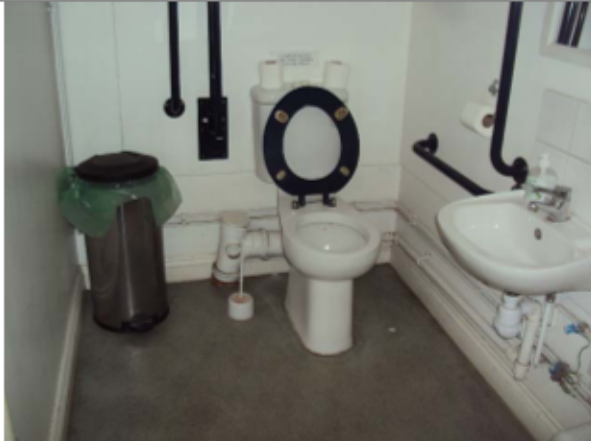
| 5 | | <p>China sanitary units with plastic drainpipes. No asbestos containing materials seen here.</p> |

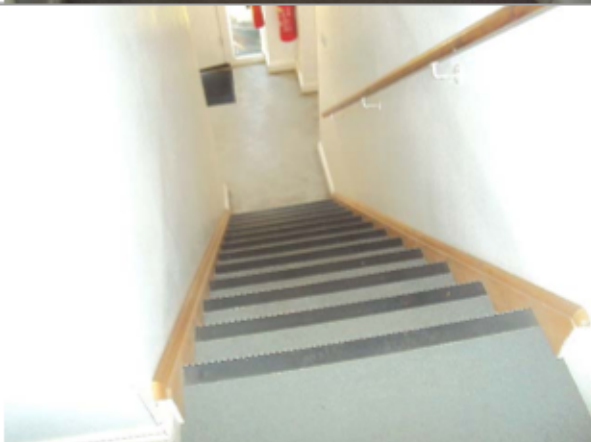
| 6 | | <p>Floor finishes were all inspected. No asbestos containing materials seen here.</p> |

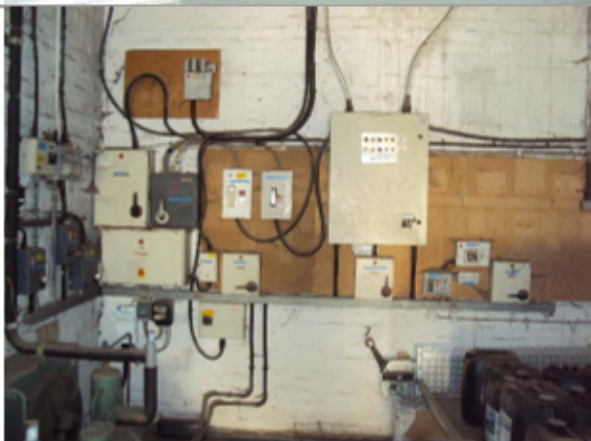
| 7 | | <p>No asbestos containing materials seen here, in or around the electrical installations.</p> |

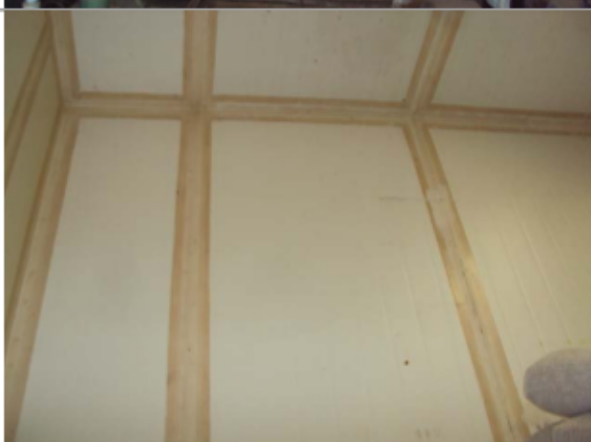
| 8 | | <p>Old cold stores no longer refrigerated. Plastic finish to insulated panels. No asbestos containing materials seen here.</p> |

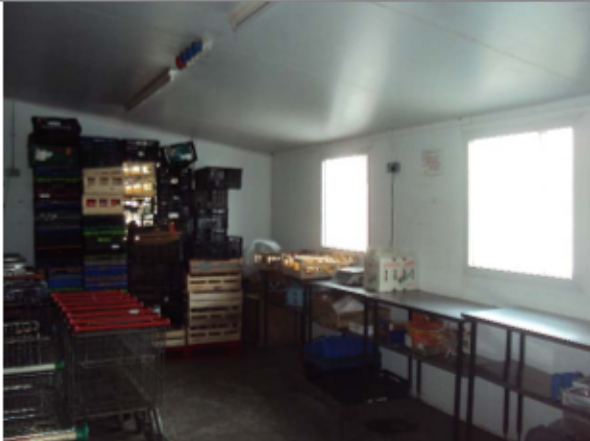
| 9 | | <p>Cleanable finishes to old cold stores. No asbestos containing materials seen here.</p> |

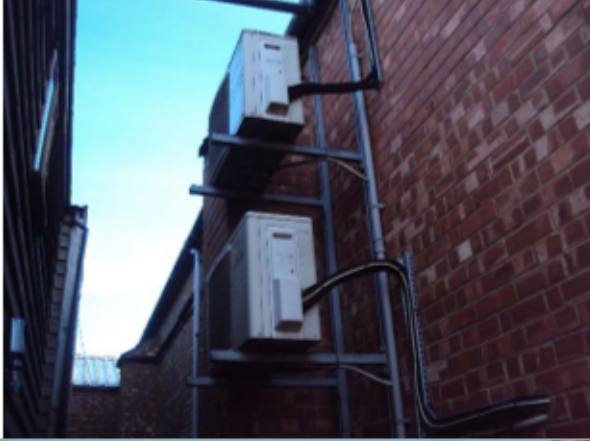
| 10 | | <p>Air conditioning units do not contain asbestos products.</p> |

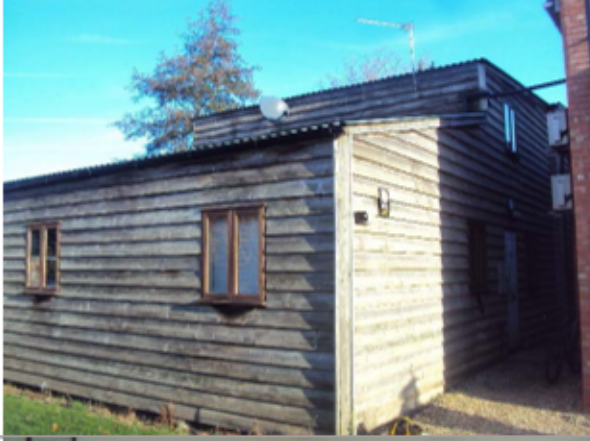
| 11 | | <p>HMO timber framed and clad building. No asbestos containing materials seen here.</p> |

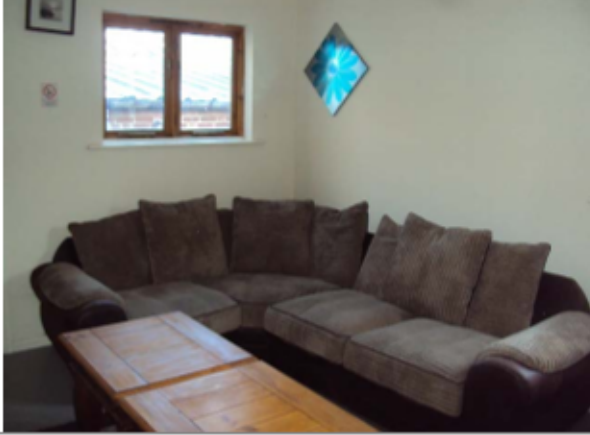
| 12 | | <p>Internal areas of the HMO building were inspected. No asbestos containing materials seen here.</p> |

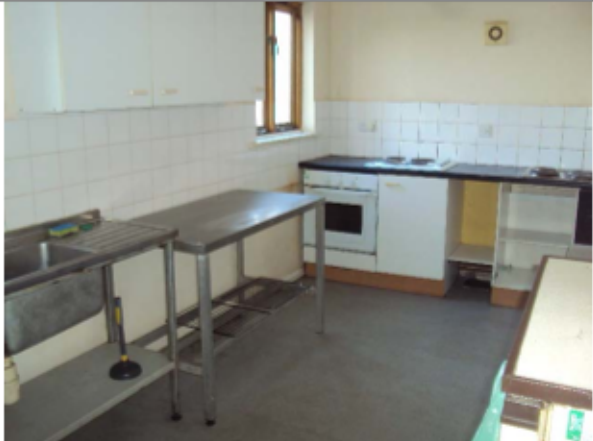
| 13 | | <p>Internal areas of the HMO building were inspected. No asbestos containing materials seen here.</p> |

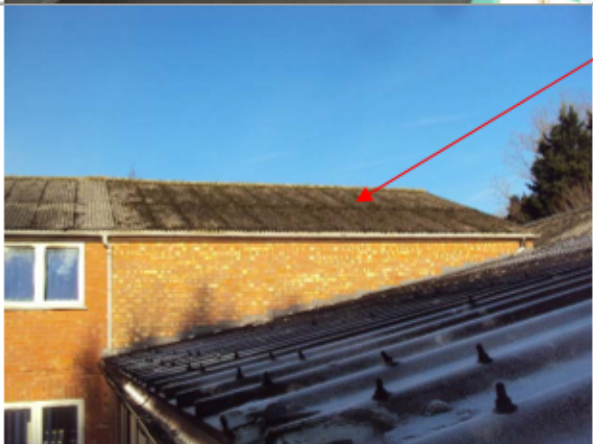
| Room/Area No. | Sample Ref | Component | Approximate Quantity | Comments |
|---|---|---|---|---|
| EXT | BLP/EXT/001 | Roof sheets over room 23 | 65 M sq | Remove prior to the refurbishment works if likely to be disturbed. |

| 14 | | <p>The roof over room 23 is as sample 001.</p> |
