Initial BS5837:2012 Tree Survey  
 Land at Keston Nursery  
 Mill Green Road  
 Pinchbeck  
 Lincolnshire  
 NGR TF23588 25095

Survey by  
 Christopher Barker CEnv dipHort ACIEEM  
 On behalf of AMJ Construction Ltd

# **BS5837 Tree Survey, Land at Mill Green Road, Pinchbeck**

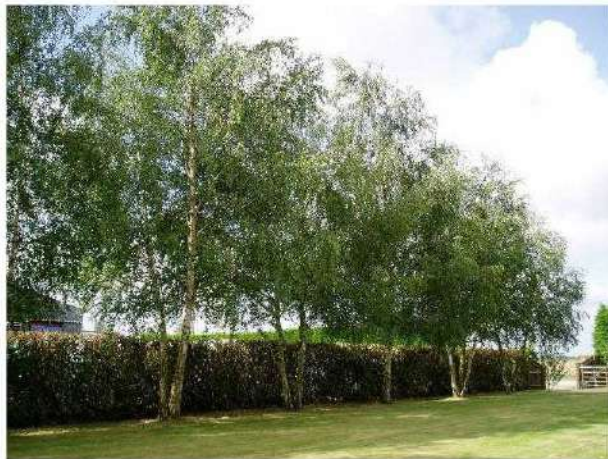
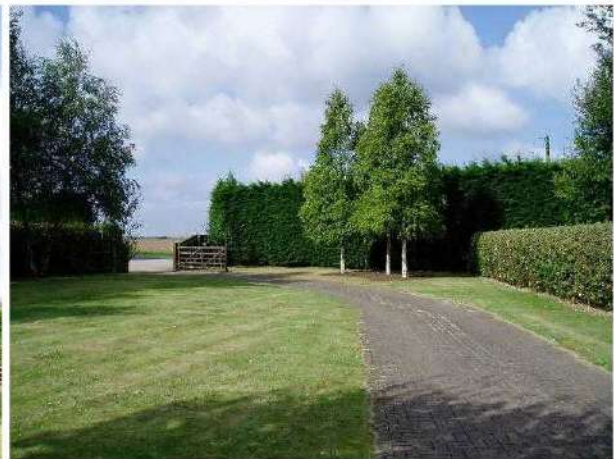
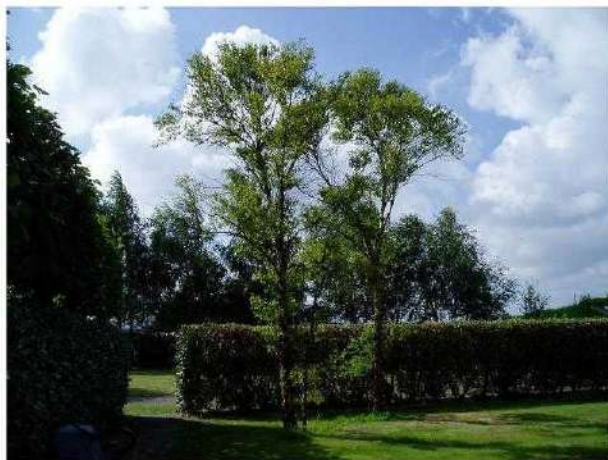
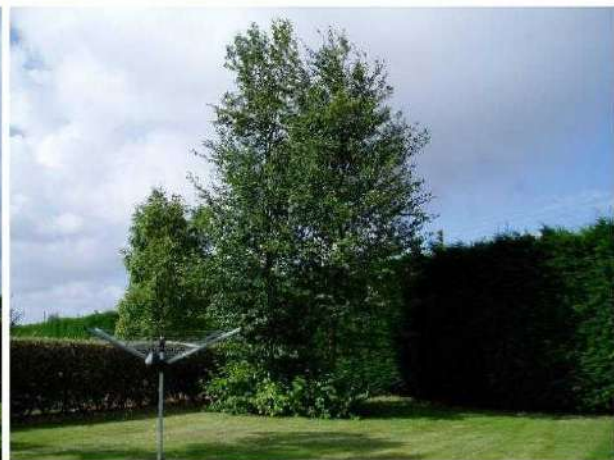
##### Trees G1 – G5 within Gardens

These trees, predominantly Birch, are placed primarily in groups with the garden areas of the two houses purely for visual amenity purposes. The tall Leylandii hedge obscures all views of these trees from Mill Green Road so in terms of visual amenity there would be no loss if they were removed. However, the line of Birch G2 create a nice linear canopy feature that is worth retaining if possible. There are no significant mature trees or trees of large stature within this area. These trees are placed within Category B2 or C2 depending on quality and potential useful life expectancy.

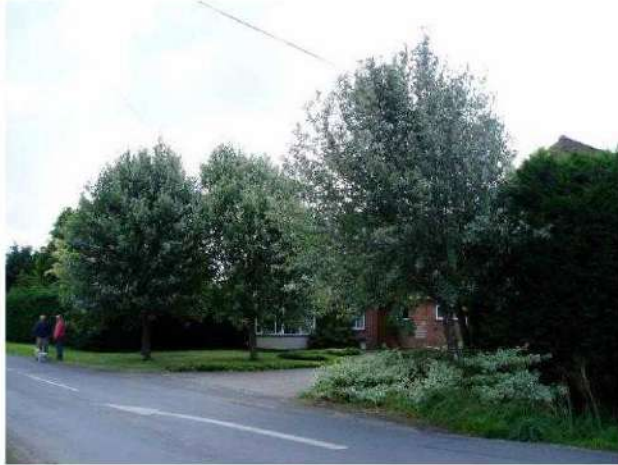
### **Trees G6 and T7 on road frontage**

This group of Whitebeam are in full view of Mill Green Road and provide useful canopy cover and screening to the existing house. These are small trees of quite good quality. They will become crowded over time so consideration should be given to removing any specimens within the centre where space is limited. These trees are placed in Category B2. Nearby Maple G7 is partially hidden by the trimmed hedgerow but the canopy is sufficiently high to be visible and provide some visual amenity along the road frontage. This tree is placed in Category B2 and should be retained if possible.

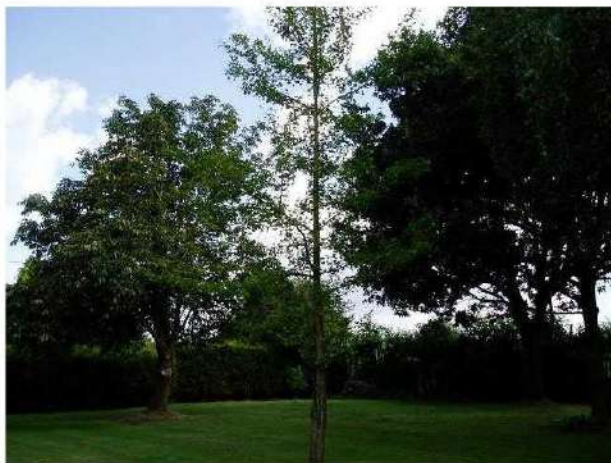
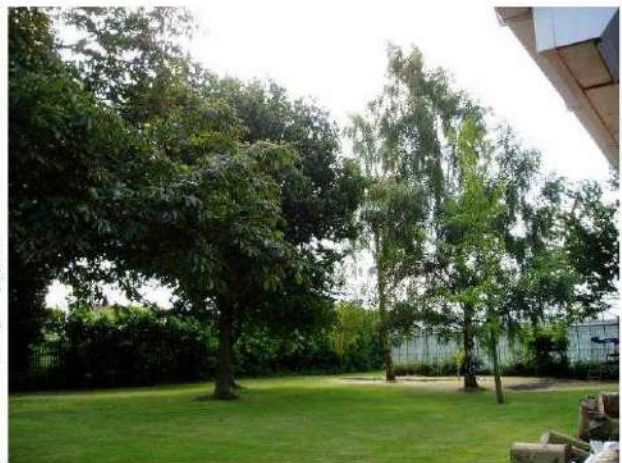
### **Trees T8 – T15 within rear garden area**

This group of individual specimen trees planted within the rear garden of the dormer bungalow house contains a number of large mature specimens. Oak T9 in particular is a tree of good stature and shape with high landscape value placed within Category A2. Many of the larger trees of good quality are placed in Category B2 and recommended for retention, however the trees are becoming quite crowded and it may be prudent to consider removing some of the smaller central trees struggling to develop due to lack of space which are placed in Category C2.

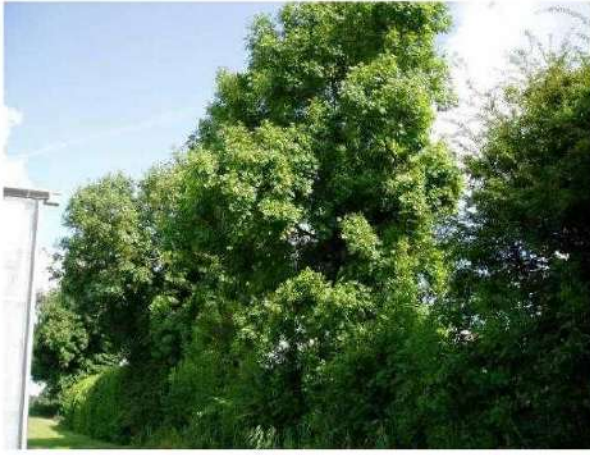
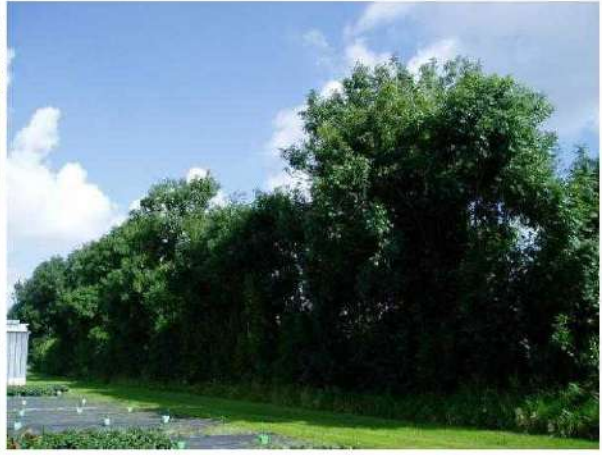
### **Trees G16 – T21 along eastern boundary**

The small trees within G16 are of little significance as they are young, of small stature and are completely hidden from view by the tall Grey Alder hedge and the glasshouses. These trees are placed in Category U.

The boundary is dominated by the tall trimmed Grey Alder hedge but there are a small number of specimen Ash trees of significant stature and maturity scattered along this hedge. These are broad headed trees, many crowded with dense ivy. These trees are placed within Category B2. It is assumed that are within the ownership of the site being positioned within the Alder hedgerow.

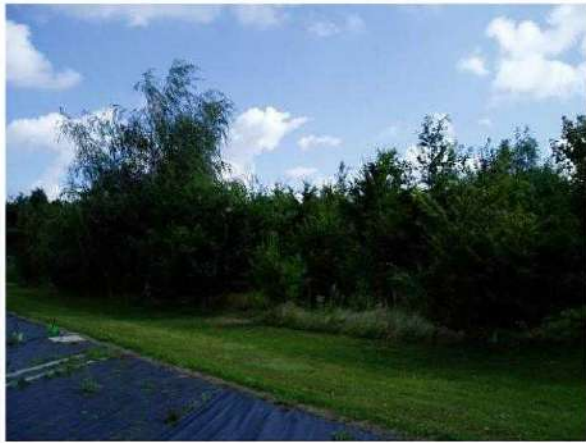
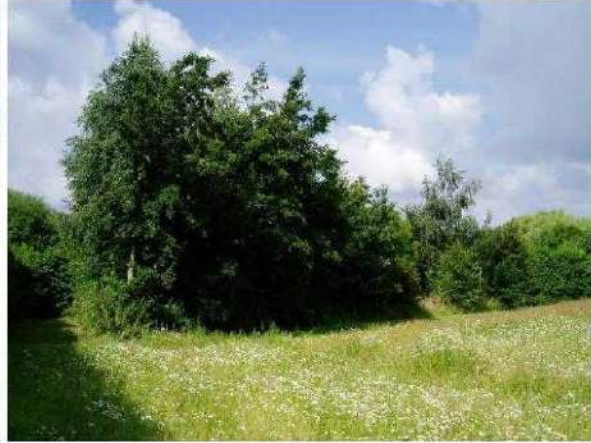
### **Trees G22 and G23 on south boundary**

These two groups of young trees are positioned along the southern boundary of the site area in dense triangular planted areas. Presently these trees are completely screened from view from outside of the site area by the tall boundary hedgerows. If these trees are retained within any proposed development consideration should be given to thinning these to provide space for development and the removal of non-native plant stock should be prioritised. These two small plantations of young trees are placed within Category C2.
