**PRELIMINARY STRUCTURAL REPORT**  
**UPON**  
**STUDIO & OUTBUILDINGS**  
**LEAMLANDS FARM, LEAMLANDS LANE**  
**STARLODE DROVE, WEST PINCHBECK, Lincs.**  
**PE12 9NS**  
**PROJECT No: SW 23-389**  
**DOCUMENT REF: SW 23-389-REP-01**

Mr & Mrs Robinson

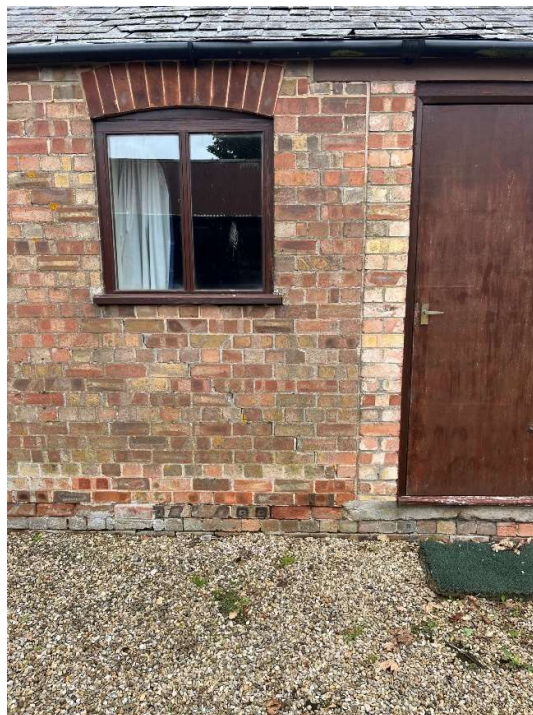
There is a minor historic movement crack below the window looking out of the recording studio into the crew yard.

All cracks in the masonry should be stitched with an appropriate crack stitching detail prior to finishes being applied.

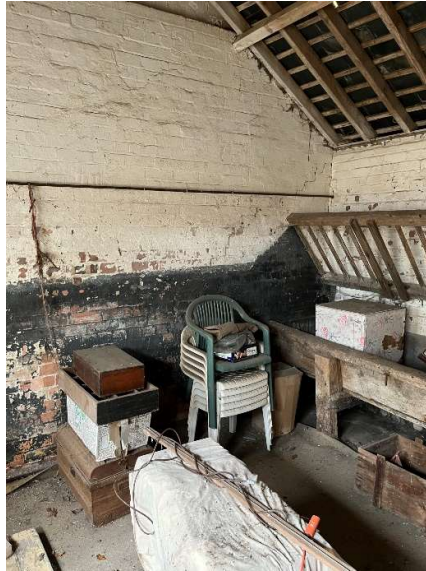
There is a crack in the dividing load bearing solid masonry wall between the garage and store 2.

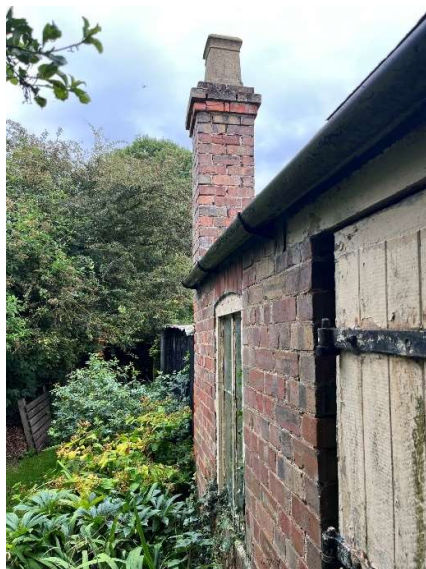
There is a chimney located on the NE corner of store 1 which is exhibiting signs of weathering to the coping and masonry externally.

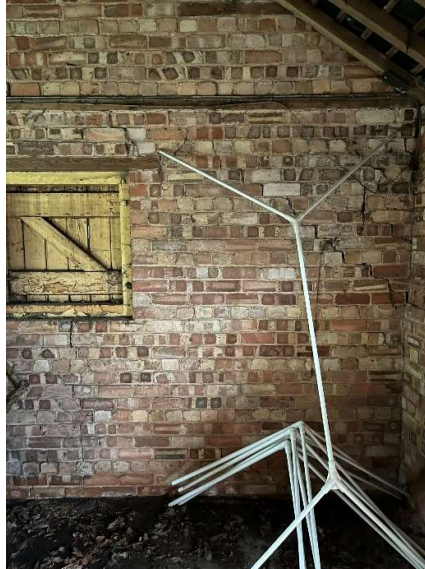
There is a minor diagonal crack in the masonry of the Eastern Gable elevation of Store 1.

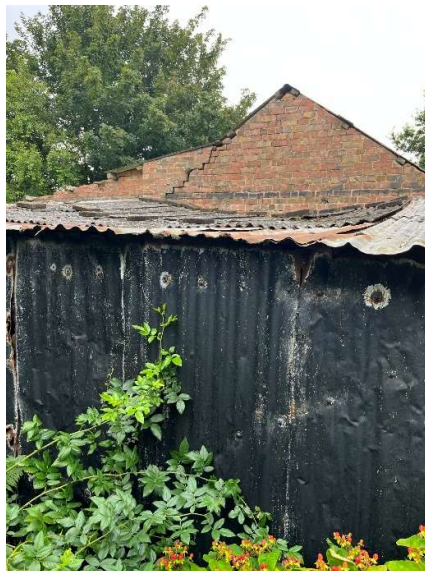
The North elevation of the open sided barn has a large masonry crack where the pig sty lean to structures has been constructed poorly off the side of the gable.

The proposed conversion also proposes the demolition and removal of the poorly constructed and semi-derelict pig sty and lean to sections of the existing structure.

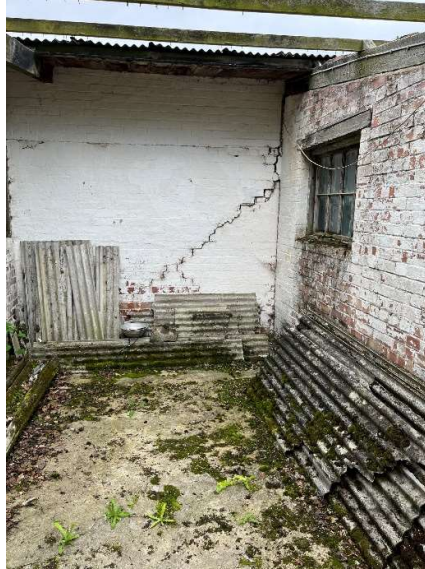
There is a significant diagonal masonry crack on the North side of the Eastern elevation of the open sided barn.

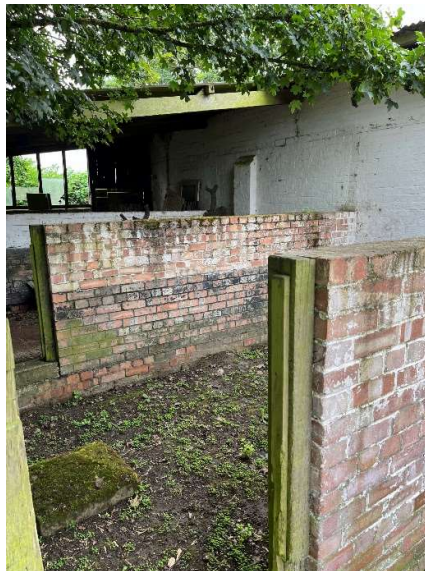
The pig sty structure consists of low level masonry walls with a basic timber roof framing and profiled metal single skin roof cladding.

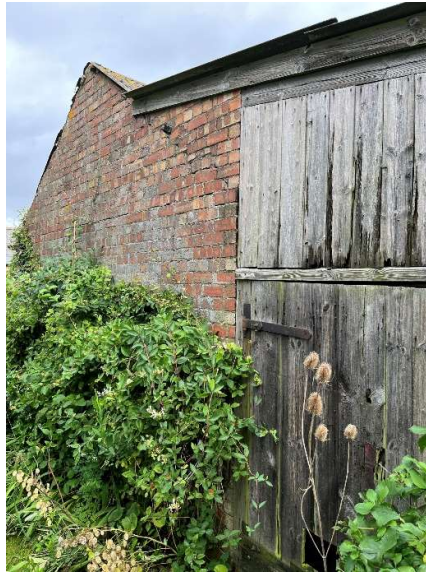
There is a defect along the Southern elevation of the open sided barn where the pig sty has been poorly constructed off the side of the gable and the masonry has not been properly jointed.

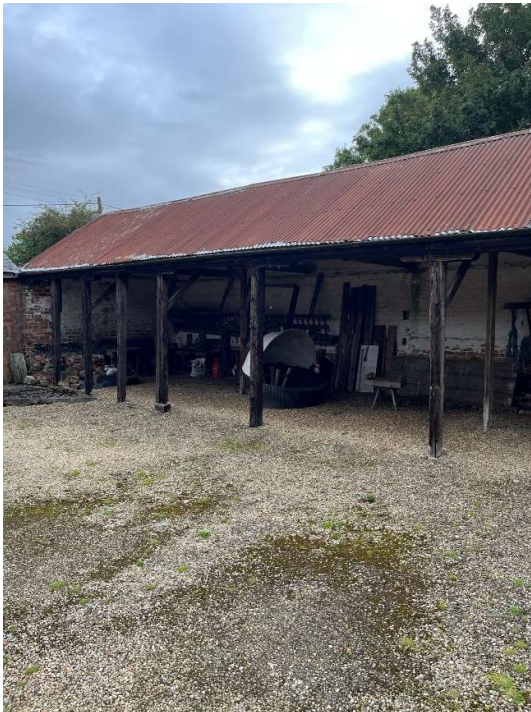
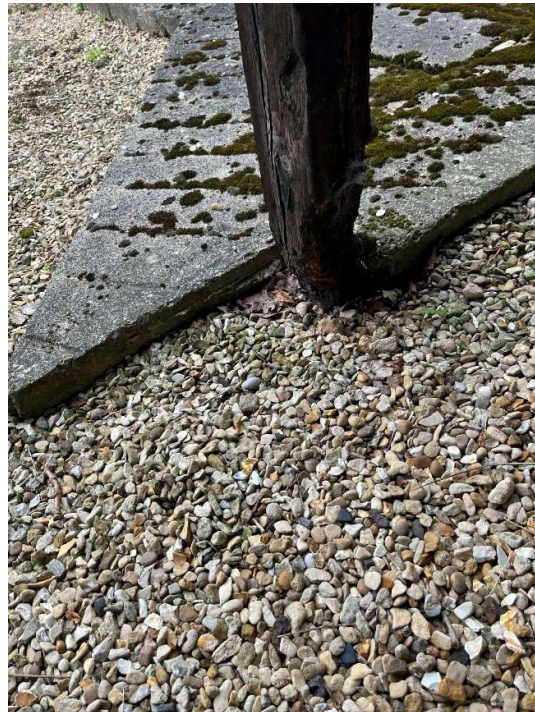
The timber posts and beam framing to the front of the open sided barn is demonstrating signs of deterioration as the beams have some sag and the base of all of the timber posts are experiencing some timber degradation and have reduced sections.

Whilst replacing the cladding to this portion of the roof the structure will require being checked for the new loads and the purlins upgraded and replaced. Defective and deteriorating timbers forming the front of the open sided barn should be replaced.

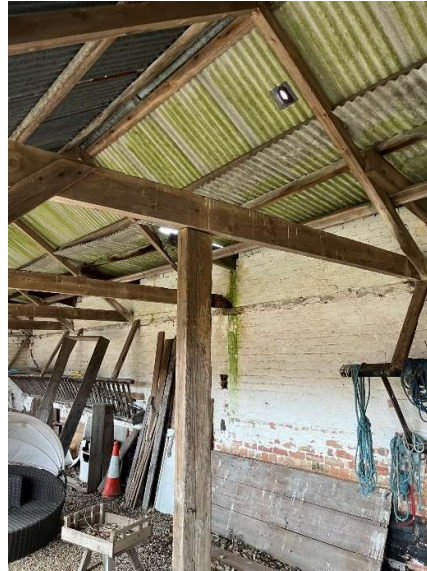
The roof of this area is formed in a similarly manner to the rest of the structure with a truss and cut timber roof.

There is some sag to the purlins on the Eastern elevation.
