## **Structural Inspection**

**Random Cottage  
Beck Bank  
West Pinchbeck**

January 2015

**MK Design Associates**  
*Consulting Structural and Civil Engineers*

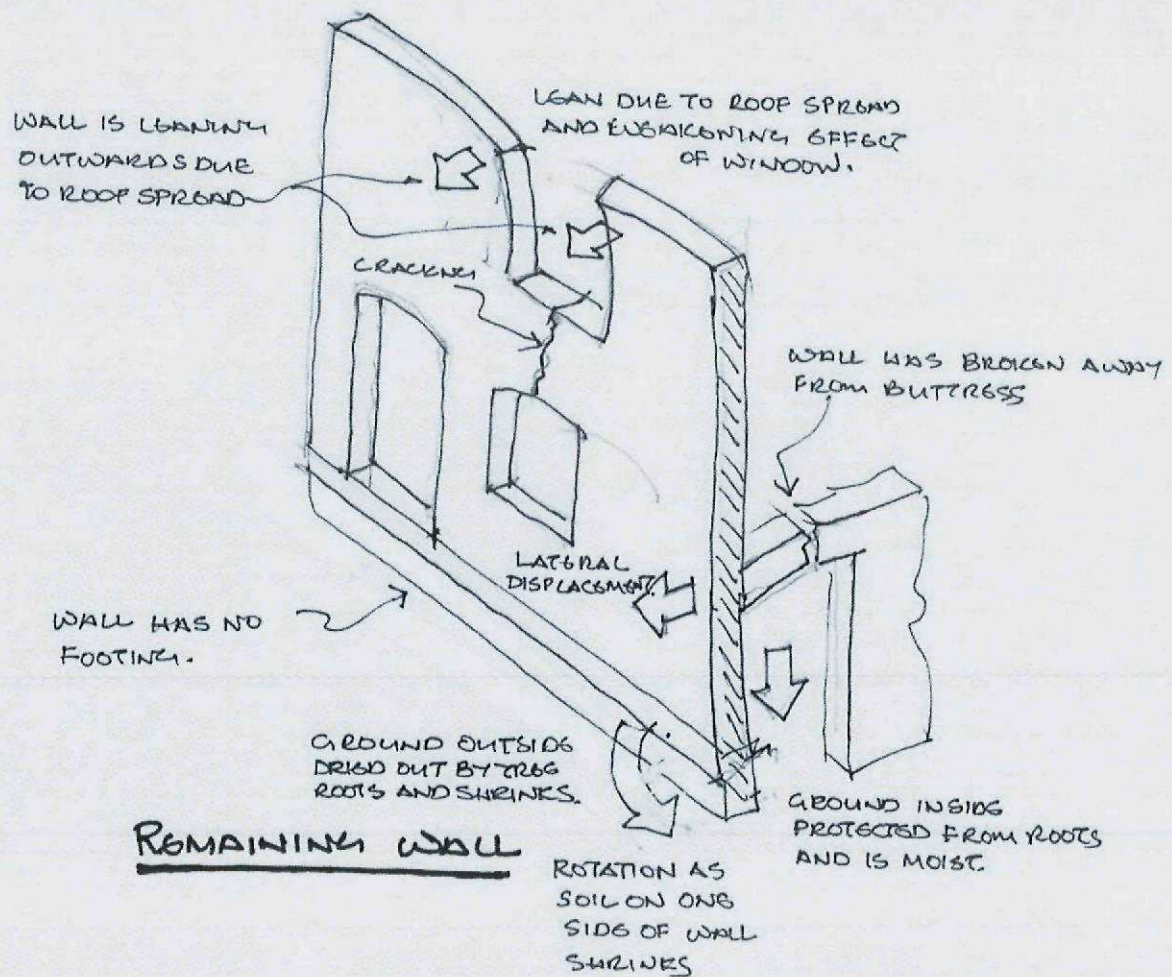
Sheet No  
SK02

WALL IS BASICALLY FREE STANDING WEAKENED UNBUTTRESSED STRUCTURE  
LEANING OUTWARDS BUILT DIRECTLY OFF SUBSOIL WITH NO  
FOUNDATION OFF POOR F&N SOIL.

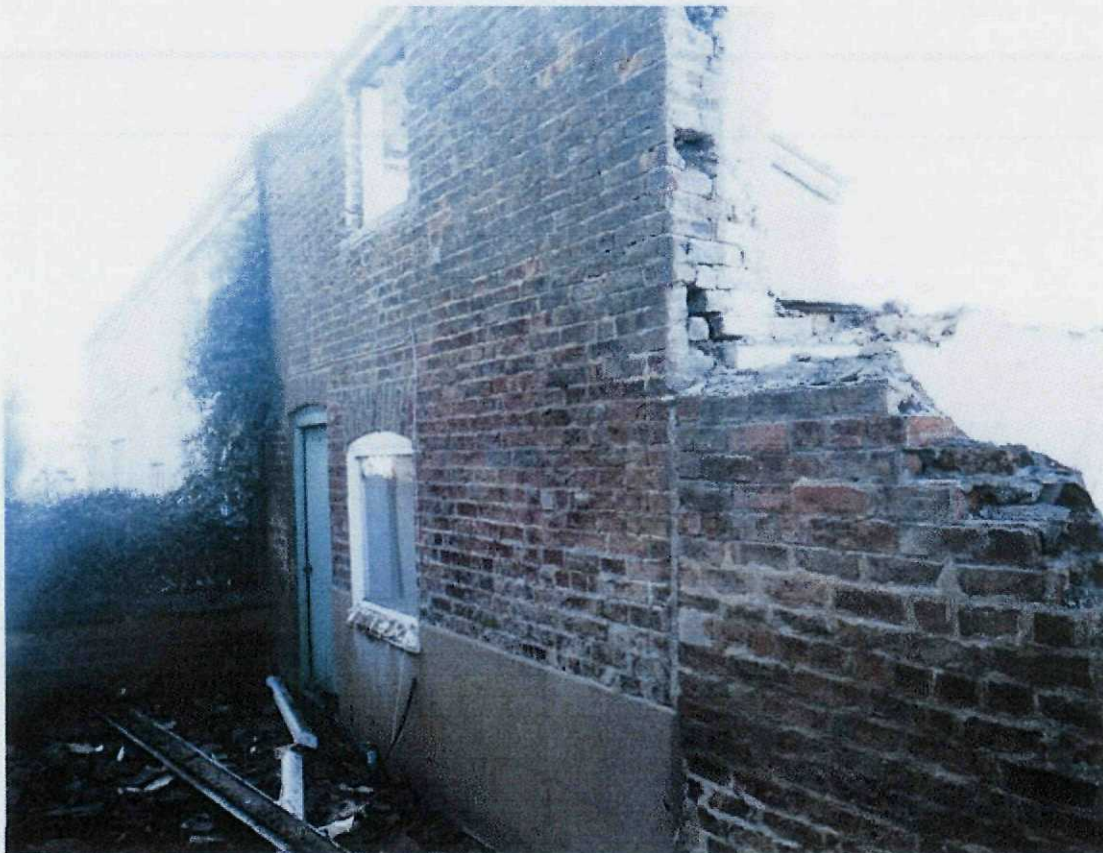
Plate 1 – View from front elevation

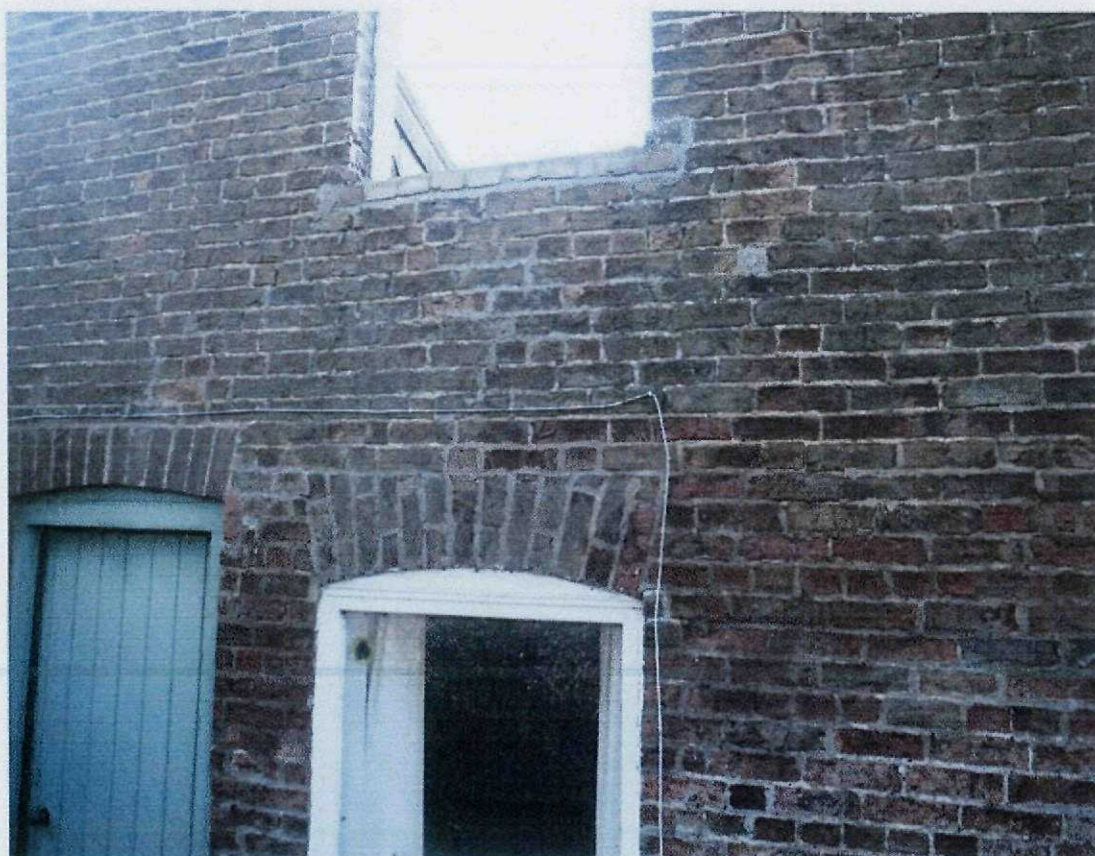
Plate 2 – Close up showing repointed cracking on front elevation

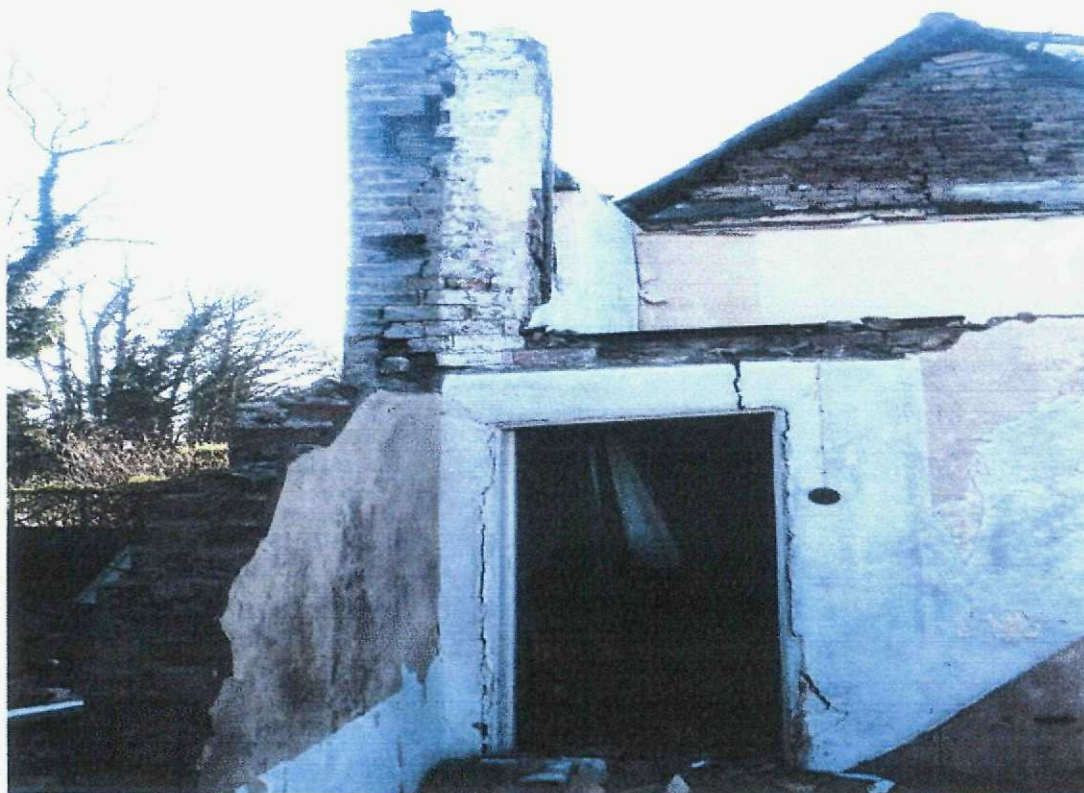
- 4.05 It is clear from Plate 3 that in addition to lateral displacement due to roof spread a very significant amount of vertical displacement is present. The cause of this displacement is not clear but at least some of the movement can be attributed to initial settlement on the soft subsoil. There has obviously been some movement since but the absence of cracking internally on this wall suggests that little movement has occurred since the last redecoration. It is likely to be related to increasing moisture extraction from the trees on the other side of Beck Bank Road with the rate of increase of the extraction reducing as the trees have been matured. This movement has also resulted in a weakened structure where the wall is now completely divorced from its' return buttress as can be plainly seen on Plate 3.

Plate 3 – View on end of wall showing vertical and lateral displacement

We, therefore, recommend that the wall is demolished and rebuilt off a proper foundation with reclaimed material.

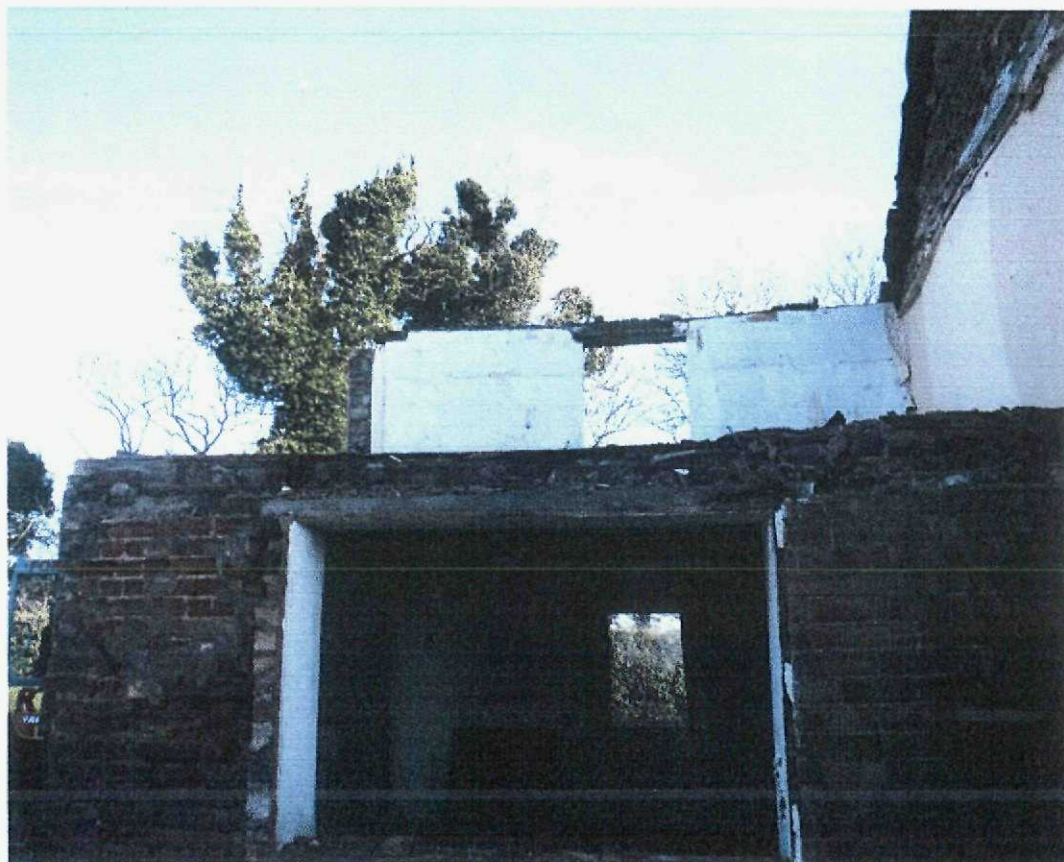
Plate 4 – View from rear

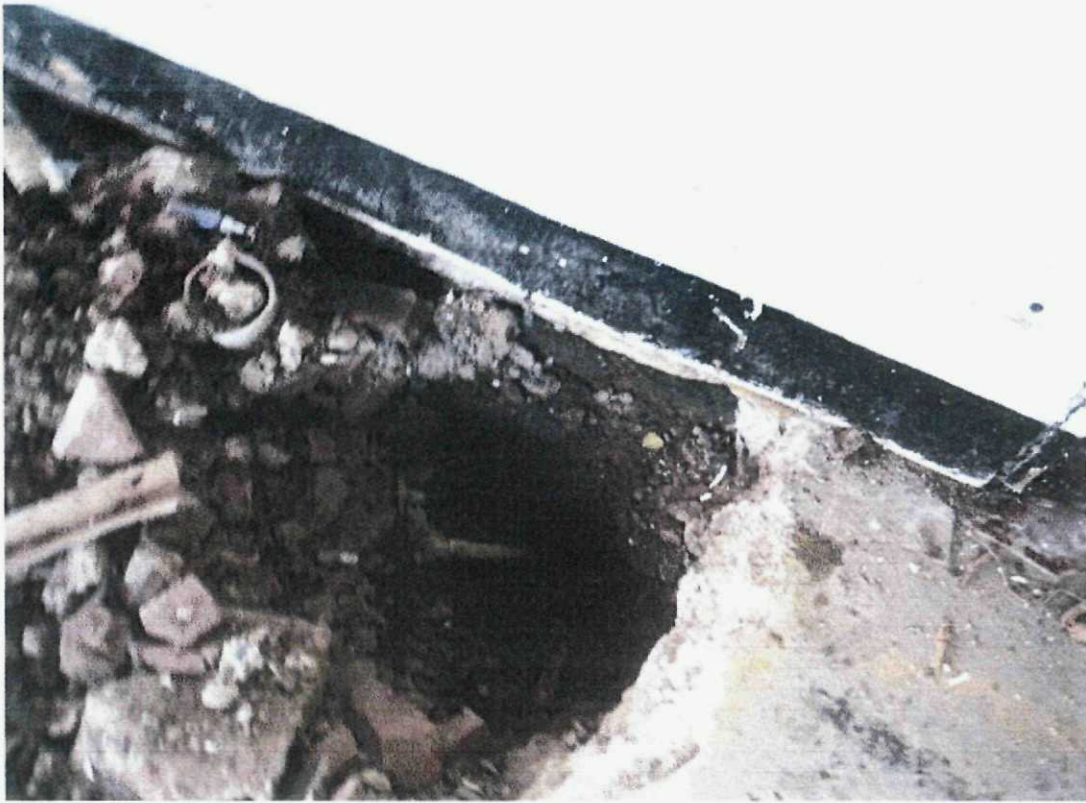
The wall is built directly off the soft subsoil with no spread footing and so has very little resistance to any further disturbance and very little resistance to overturning

Plate 5 – Trial pit against front elevation
