BS5837:2012 Tree Survey  
Land off Surfleet Road  
Pinchbeck  
South Holland  
Lincolnshire  
NGR TF24479 26600

Survey by  
Christopher Barker CEnv dipHort ACIEEM

# **BS5837 Tree Survey, Land off Surfleet Road, Pinchbeck**

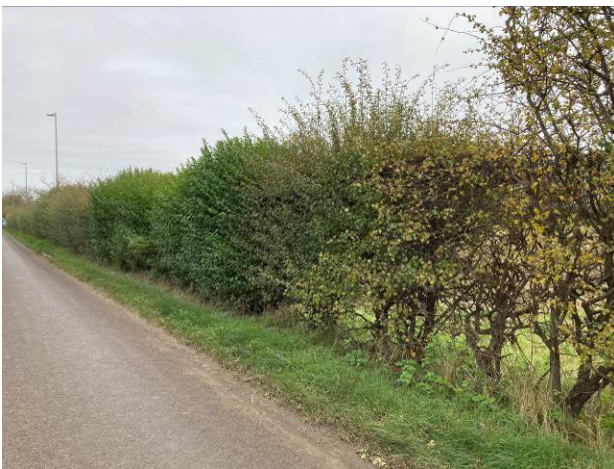
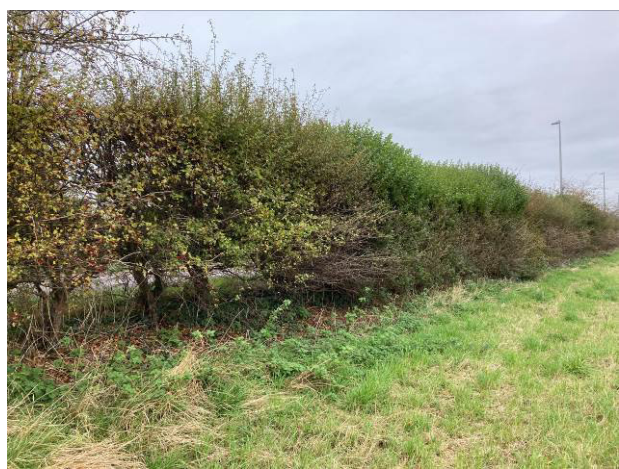
Hedgerow H1

**Hedgerows H1 and H2** run along the western boundary of the survey area screening the field from Surfleet Road. There is a significant gap between the two hedgerows and there are minor gaps within each. However, the majority of the hedgerow lengths are uniform and continuous. Both hedgerows have been seasonally box trimmed and have been placed into Category C2.

| Tree No | Species | Ht (m) | Stem Diam mm@ 1.5m | Canopy Spread (m) | Height of Crown Clearance | Age Class | Est yrs | Overall Condition | Structural condition | Recommendations | BS 5837 Category | RPA Radius (m) |
|---|---|---|---|---|---|---|---|---|---|---|---|---|
| H1 | Hawthorn<br>Rose<br>Privet | 1.5 | <150 | N-1<br>S-1<br>E-1<br>W-1 | 0 | SM | 10+ | G | Box trimmed hedgerow dominated by Hawthorn. Some gaps present along the road frontage but generally uniform.<br>No structural faults visible from ground level | None | C2 | 1.8 |

| Ref | Tree | Category | Impact of development |
|---|---|---|---|
| H1 | Hawthorn, Rose, Privet | C2 | Presumably removed as it is not shown on the development plan but some replacement hedgerow planting is indicated. |

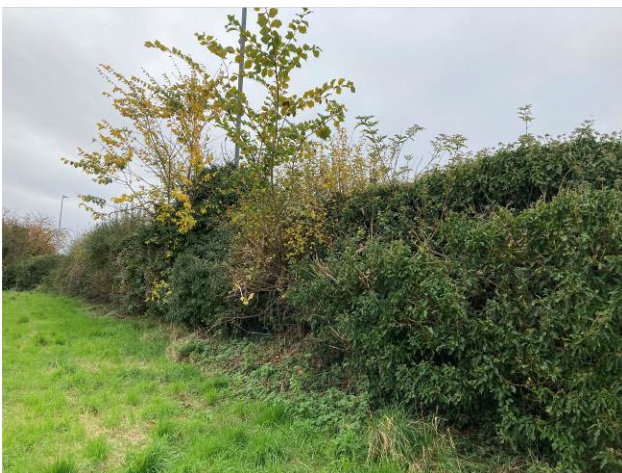
Hedgerow H2

| Tree No | Species | Ht (m) | Stem Diam mm@ 1.5m | Canopy Spread (m) | Height of Crown Clearance | Age Class | Est yrs | Overall Condition | Structural condition | Recommendations | BS 5837 Category | RPA Radius (m) |
|---|---|---|---|---|---|---|---|---|---|---|---|---|
| H2 | Hawthorn<br>Elm | 2 | <150 | N-1<br>S-1<br>E-1<br>W-1 | 0 | SM | 10+ | G | Box trimmed hedgerow dominated by Hawthorn with significant sections of Elm. Some gaps present along the road frontage but generally uniform.<br>No structural faults visible from ground level | None | C2 | 1.8 |

| Ref | Tree | Category | Impact of development |
|---|---|---|---|
| H2 | Hawthorn, Elm | C2 | Presumably removed as it is not shown on the development plan but some replacement hedgerow planting is indicated. |

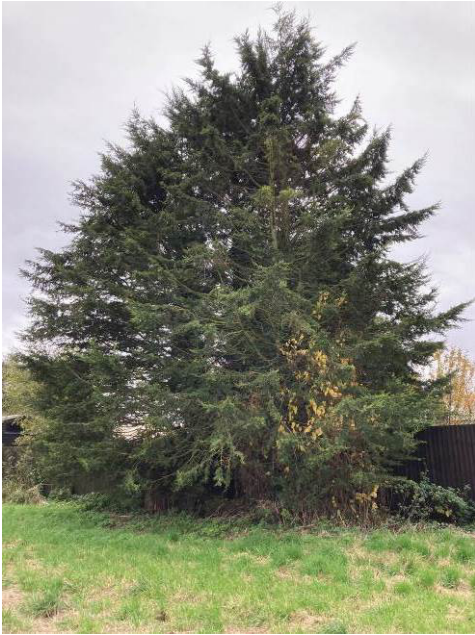
Thuja T3

**Thuja T3** is positioned on the southern boundary of the site growing on a strip of land between the boundary fence and the shallow drainage channel that runs along the boundary of the cultivated field. It is presumably within the field ownership as it lies outside the garden fence which it is quite close to. This is a tree of good quality which has been placed into Category B. However, there may be a possibility of nuisance in the future if this tree causes damage to the adjacent property boundary fencing. **Damson T4** is a young tree situated within the garden of the property to the south and the crown of the tree is visible above the garden fence but appears to have been trimmed back. This tree is placed into Category C.

| Tree No | Species | Ht (m) | Stem Diam mm@ 1.5m | Canopy Spread (m) | Height of Crown Clearance | Age Class | Est yrs | Overall Condition | Structural condition | Recommendations | BS 5837 Category | RPA Radius (m) |
|---|---|---|---|---|---|---|---|---|---|---|---|---|
| T3 | Thuja<br><i>Thuja sp</i> | 10 | <450 | N-4<br>S-4<br>E-4<br>W-4 | 1 | M | 20+ | G | Three merging trees situated adjacent to the boundary fence on the opposite side of the drainage ditch. Dense ivy on the trunks and canopy extending over the field edge.<br>No structural faults visible from ground level | If retained the ivy should be removed from the trunks and provide protection to the crown and RPA. | B2 | 5.4 |

| Ref | Tree | Category | Impact of development |
|---|---|---|---|
| T3 | Thuja | B2 | Not shown on the development plan. If this tree is retained the RPA extends into a landscaped area close to the proposed surface water attenuation area and can be protected by fencing. |

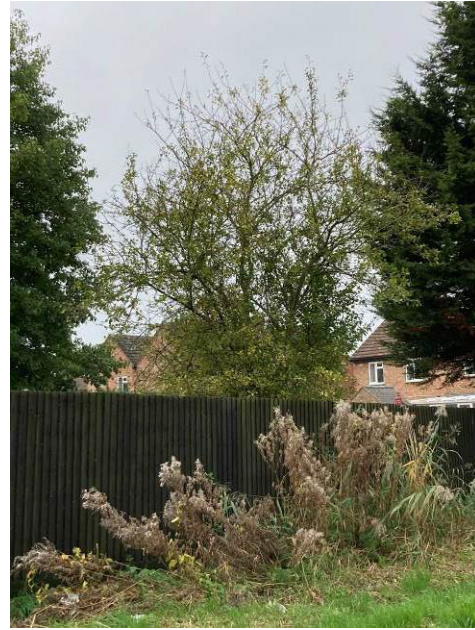
Damson T4

| Tree No | Species | Ht (m) | Stem Diam mm@ 1.5m | Canopy Spread (m) | Height of Crown Clearance | Age Class | Est yrs | Overall Condition | Structural condition | Recommendations | BS 5837 Category | RPA Radius (m) |
|---|---|---|---|---|---|---|---|---|---|---|---|---|
| T4 | Damson<br><i>Prunus domestica</i> | 5 | 150<br>150 | N-1<br>S-2<br>E-2<br>W-2 | 1 | Y | 10+ | F | Two trunks supporting an irregular canopy which has been trimmed on the north side.<br>No structural faults visible from ground level | None | C2 | 2.5 |

| Ref | Tree | Category | Impact of development |
|---|---|---|---|
| T4 | Damson | C2 | This tree lies within an adjacent garden. The canopy poses no constraint. The RPA does not extend into the landscaped area within the site and poses no constraint. |

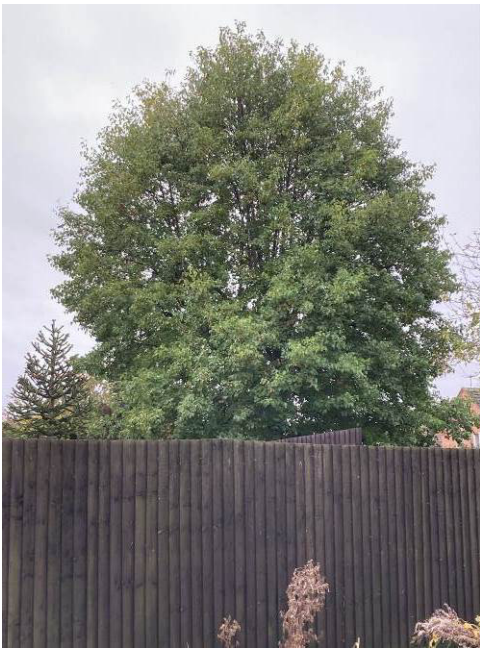
Poplar T5

Situated further to the south within the garden interior set back from the field boundary is **Poplar T4**. This is a tree of reasonable shape and moderate size, the canopy of which does not extend across the garden boundary and encroach the site area surveyed. This tree is visible from the site and has been placed into Category B.

| Tree No | Species | Ht (m) | Stem Diam mm@ 1.5m | Canopy Spread (m) | Height of Crown Clearance | Age Class | Est yrs | Overall Condition | Structural condition | Recommendations | BS 5837 Category | RPA Radius (m) |
|---|---|---|---|---|---|---|---|---|---|---|---|---|
| T5 | Poplar<br><i>Populus nigra</i><br><i>cul</i> | 11 | 400est | N-4<br>S-4<br>E-4<br>W-4 | 2 | SM | 20+ | G | Single trunk supporting a balanced upright canopy which does not extend to reach the field boundary. No structural faults visible from ground level | None | B2 | 4.8 |

| Ref | Tree | Category | Impact of development |
|---|---|---|---|
| T5 | Poplar | B2 | This tree is situated within an adjacent garden and the canopy and RPA do not extend into the proposed development area and pose no constraint to development. |

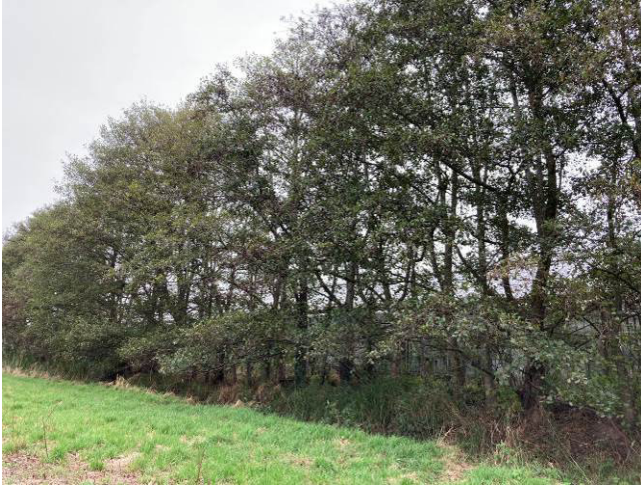
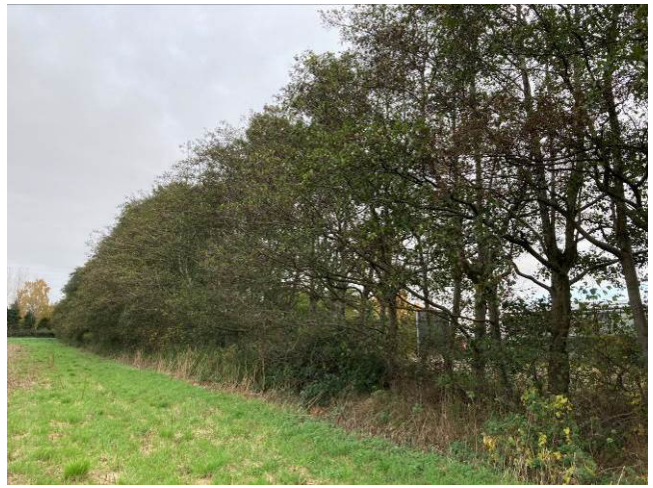
Alder G6 along eastern boundary

The most significant group of trees in the area surveyed is **Group G6** which comprises a long line of Alder. These trees are within the land adjacent to the field surveyed, separated from this by a boundary drainage ditch. The trees are lined along the opposite side of this close to the edge of the drain and form a long, continuous canopy along this boundary effectively screening the glasshouses situated to the east. The trees are of good quality and appear to be of similar stature and age. The drainage ditch may be a partial constrain to rooting on the western side but the calculated RPA of this group, based on the trunk diameter of the largest trees, will extend across the field boundary and the canopy extents of the trees does extend across the field edge. This group is placed within Category B2.

| Tree No | Species | Ht (m) | Stem Diam mm@ 1.5m | Canopy Spread (m) | Height of Crown Clearance | Age Class | Est yrs | Overall Condition | Structural condition | Recommendations | BS 5837 Category | RPA Radius (m) |
|---|---|---|---|---|---|---|---|---|---|---|---|---|
| G6 | Alder<br><i>Alnus glutinosa</i> | 10-14 | <400 | Varies up to 5m on the west | 1 | SM | 20+ | G | A dense line of Alder planted behind the boundary drainage channel but with the merging canopy extending across this over the edge of the field area survey. This screen planting shelters to the glasshouses to the east. No structural faults visible from ground level | Protect the canopy and RPA where this extends across the site boundary. | B2 | 4.8 |

| Ref | Tree | Category | Impact of development |
|---|---|---|---|
| G6 | Alder | B2 | The RPA and canopy of this tree group extend into the field and will lie within the edge of the residential gardens or landscaped area. The RPA of this group will have to be protected by fencing but does not pose a constrain to development based on the plan provided. Lying along the eastern edge of the development these trees will cast shade during the morning period but this will reduce towards midday. |

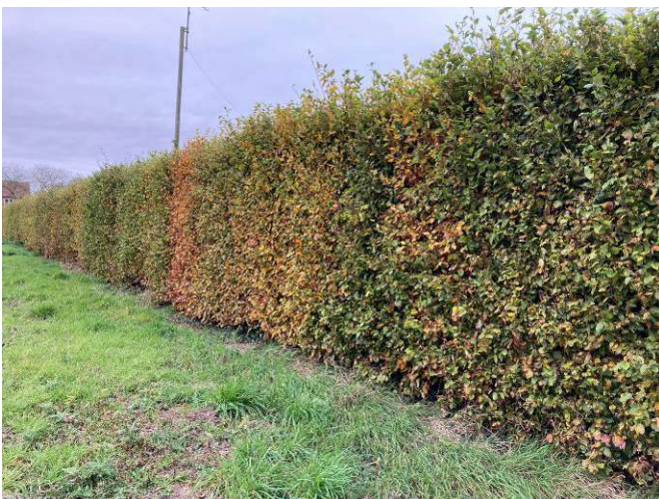
Hedgerow H7 is a uniform box trimmed Beech hedge running along the boundary of the garden adjacent to the northern boundary of the field. This is a good quality hedgerow providing effective screening to the residential garden and it is placed within Category B.

| Tree No | Species | Ht (m) | Stem Diam mm@ 1.5m | Canopy Spread (m) | Height of Crown Clearance | Age Class | Est yrs | Overall Condition | Structural condition | Recommendations | BS 5837 Category | RPA Radius (m) |
|---|---|---|---|---|---|---|---|---|---|---|---|---|
| H7 | Beech<br><i>Fagus sylvatica</i> | 2 | <150 | N-1<br>S-1<br>E-1<br>W-1 | 0 | Y | 20 | G | Dense trimmed boundary hedgerow around the residential garden adjacent to the field. No structural faults visible from ground level | Protect the RPA where this extends across the site boundary. | B2 | 1.8 |

| Ref | Tree | Category | Impact of development |
|---|---|---|---|
| H7 | Beech | B2 | This hedgerow lies outside the proposed development area and poses no constraint to development. |
