**Barn and Stables**

**Dovehirne Farm**

## **Visual Structural Inspection and Report**

**Project No. 4654**

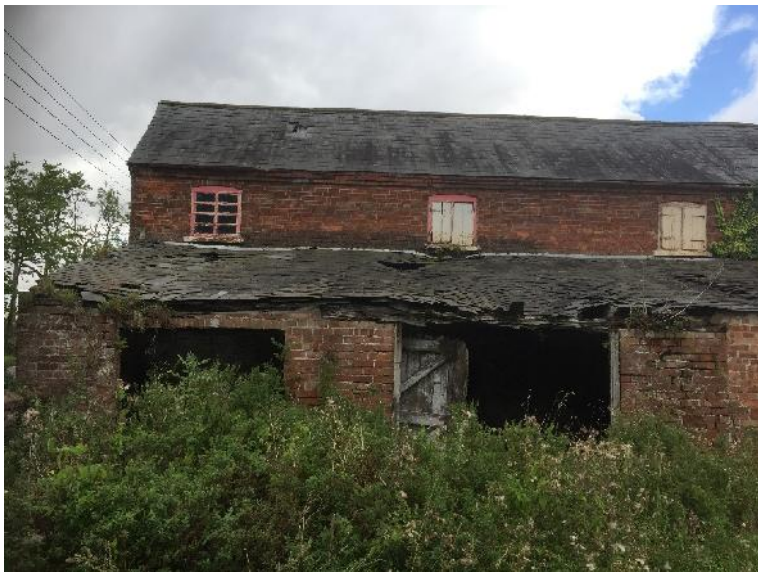
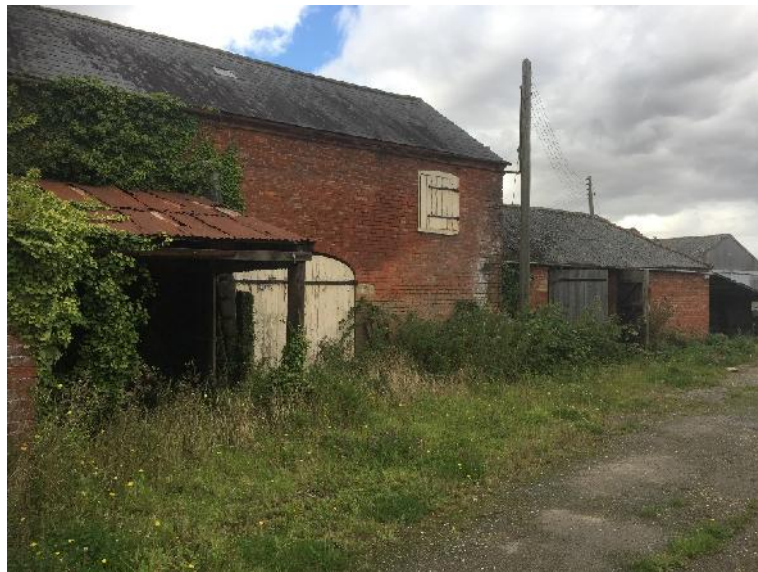
#### **East Elevation – Photographs 1 & 2**

- 4.04 We noted a section of roof slates were missing over the two storey section of Barn.
- 4.05 Ivy was evident to the brickwork, centrally within the elevation.
- 4.06 Eroded brickwork and weathered mortar joints were noted to the right hand side of the barn door. **Photograph 3.**

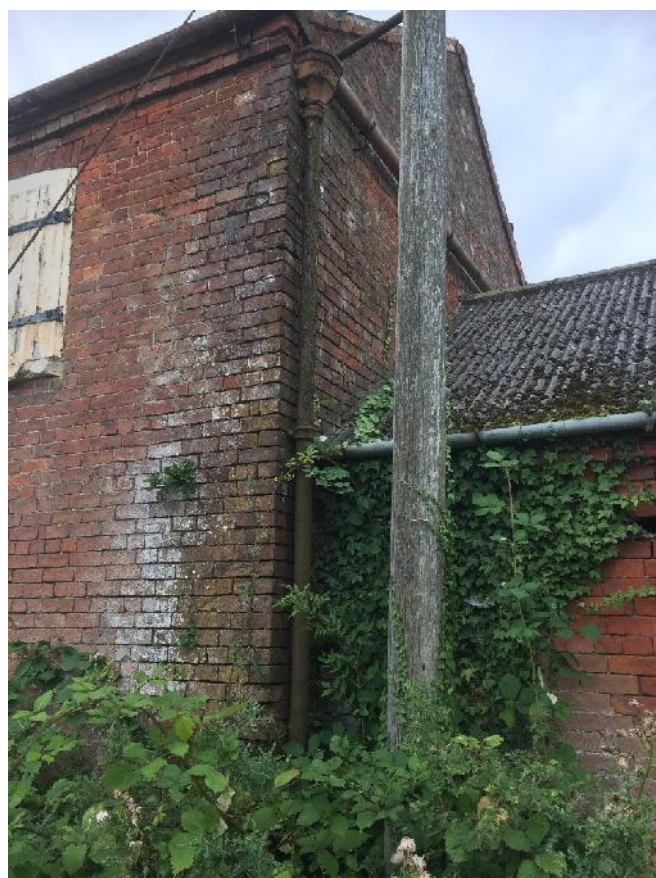
**Photograph 4**

- 4.07 The brickwork corner at the junction of two storey and single storey was weathered, a cast iron downpipe and hopper were noted. **Photograph 4.**
- 4.08 Between the large door and single door opening, the brickwork was dislodged, cracked and in poor condition. **Photograph 5.**
- 4.09 The single storey lean-to structure was in poor condition. The roof had partly collapsed, with the remaining roof severely distorted and undulating. The timber lintels were severely decayed, and vegetation was evident around the wall plate and brickwork at eaves level.
- 4.10 An open, covered area was formed to the north of the lean-to. This was constructed with a timber corner post and eaves beams supporting a corrugated steel sheeted roof.

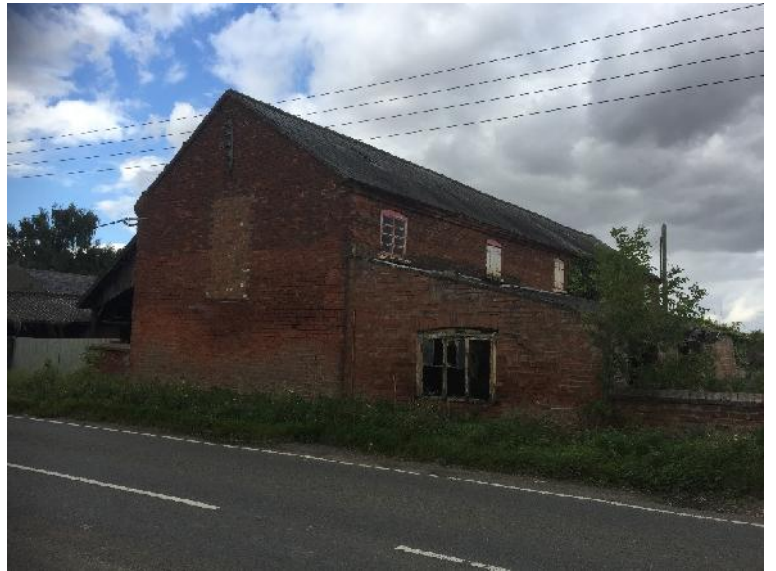
Photograph 6

#### **South Elevation – Photograph 6**

- 4.11 Areas of brickwork were eroded and weathered within the two storey gable between ground and first floor level.
- 4.12 Severe stepped cracking and dislodged brickwork was noted to the right hand side of the window of the lean-to structure. **Photograph 7.**

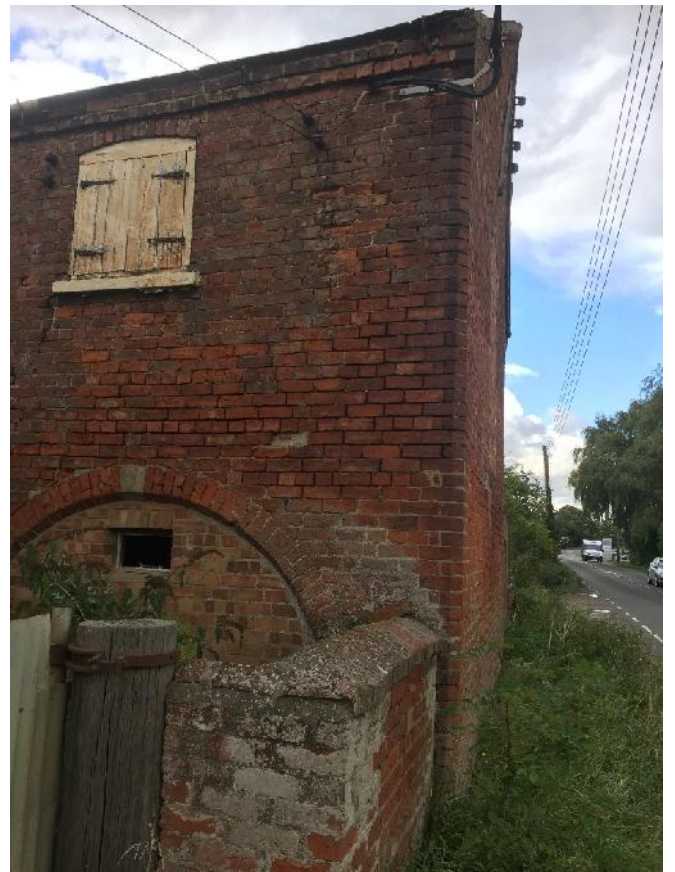
Photograph 8

- 4.13 We noted eroded and weathered mortar joints to the south west corner of the two storey barn around first floor level. **Photograph 8.**
- 4.14 The single storey stables were partially covered with vegetation. **Photographs 9 & 10.**

- 6.07 Any severely eroded bricks to be chopped out and replaced as identified. Weathered mortar joints to be raked out and repointed to make good and weatherproof.

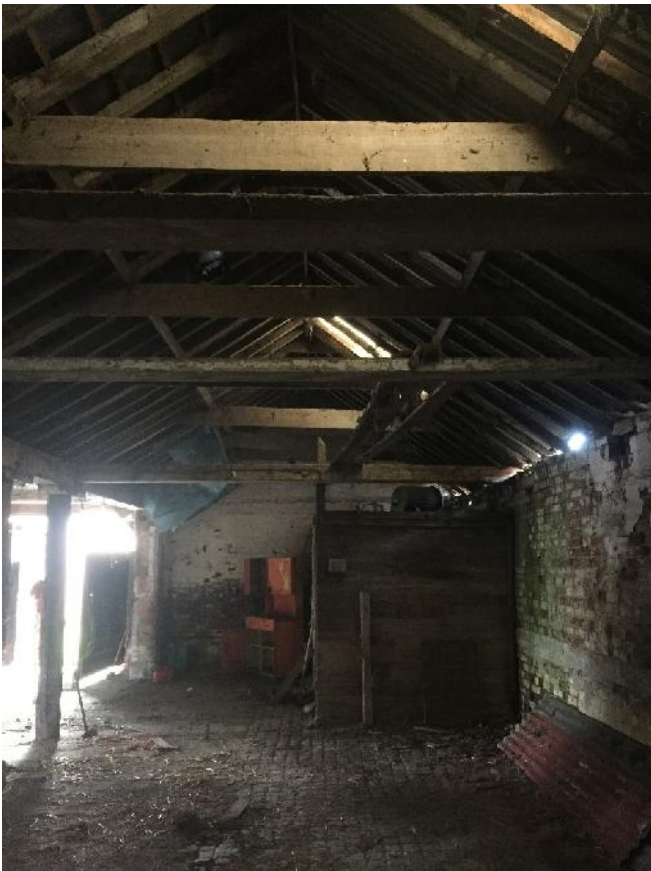
**Photograph 11**

- 5.01 The pitched roof comprised several principal rafters with eaves ties supporting purlins and common rafters between. The northern pitch was covered with cement particle corrugated sheeting, and the southern pitch was felted and covered with slate tiles. **Photograph 11.**
- 5.02 The lintel above the single door facing east had dropped, causing brickwork over to crack. **Photograph 12.**
- 5.03 Stepped diagonal cracking at high level was noted within the brickwork to the north east corner.

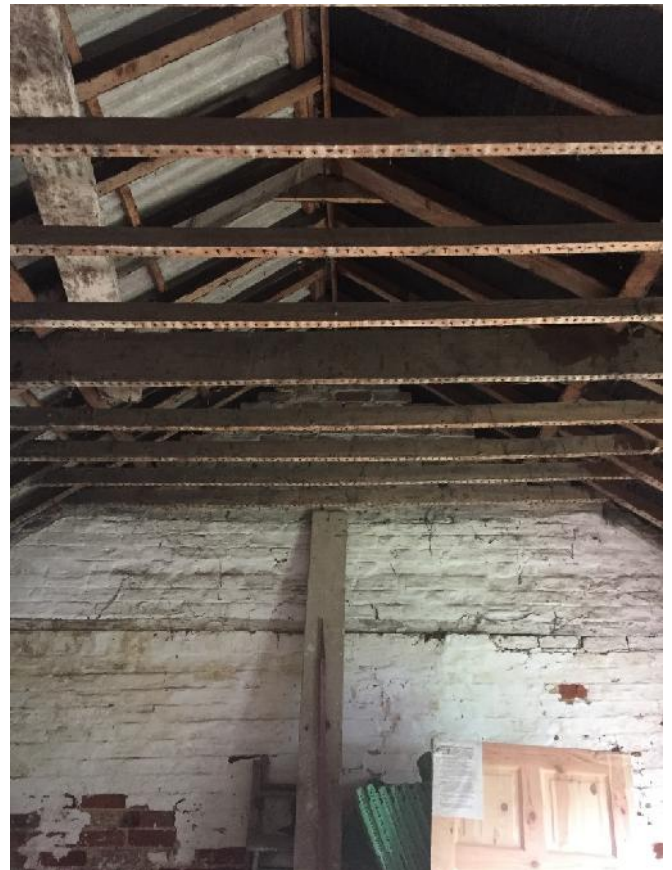
Photograph 16

- 5.04 Facing the crew yard, a central timber post supported timber eaves beams. One side of the opening was partially boarded with timber.
- 5.05 The floor was constructed with concrete; areas were cast with grooves in a square pattern for drainage.
- 5.06 Within the stable facing west, we noted vertical cracking at each internal corner of brickwork. Evidence of the brickwork at eaves leaning is also apparent. **Photographs 13, 14 and 15.**
- 5.07 The roof over the stable was formed with timber rafters and collars supporting purlins. **Photograph 16.**

- 6.01 The timber roofs over the lean to barn and stables were in poor condition and we recommend that, as part of the conversion, these should be stripped off and replaced with new timber roof.

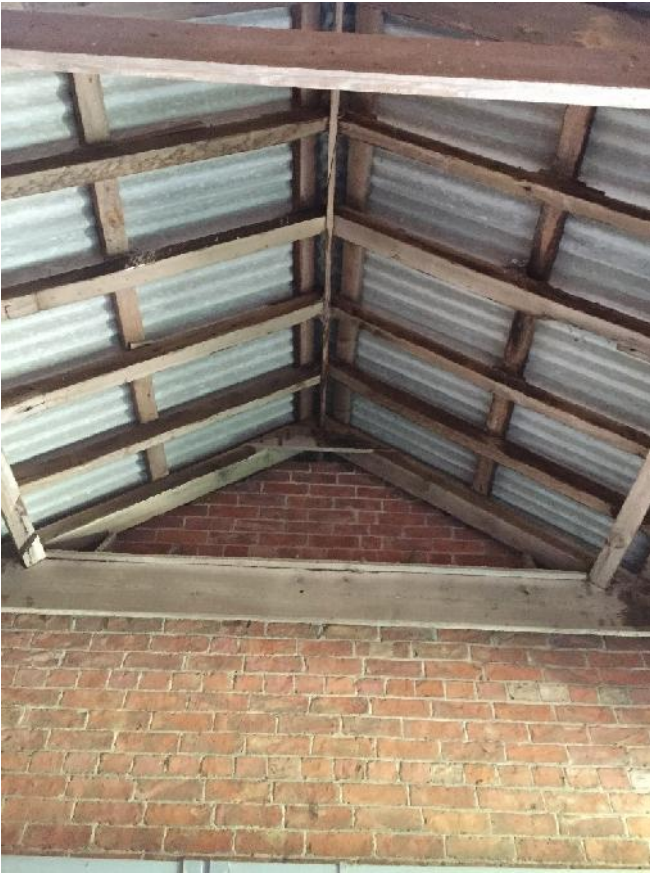
**Photograph 17**

- 5.08 The single storey roof joining onto the north barn was formed with timber purlins spanning between masonry walls to support rafters and cement particle corrugated sheeting. **Photograph 17.**

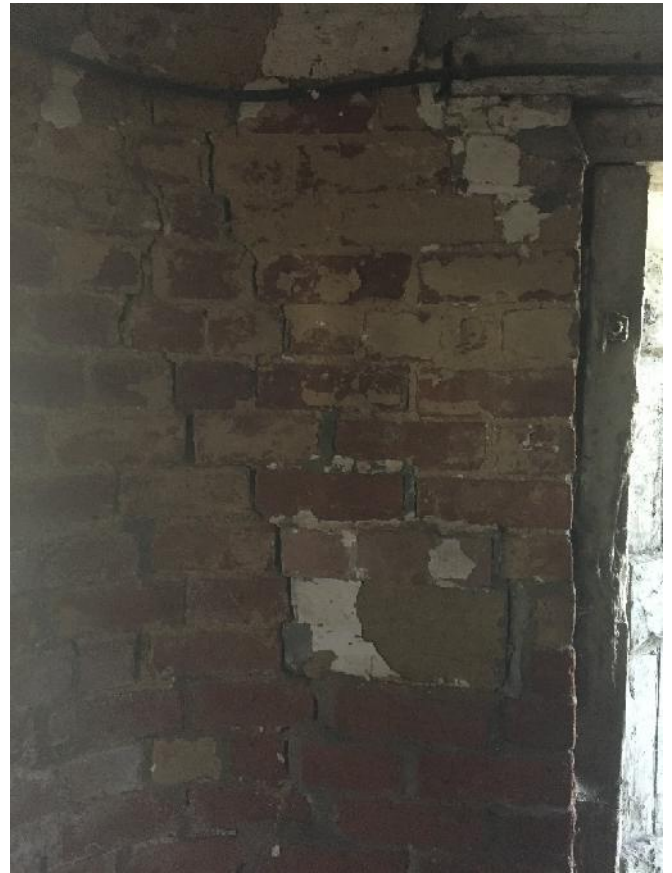
**Photograph 18**

- 5.09 The floor was constructed with concrete oversite.
- 5.10 We noted loose brickwork over the door opening and cracking to the radial brickwork in the store adjacent the corn bins. **Photograph 18.**

- 6.02 We advise that cracked and damaged brickwork to the south gable of the lean-to be partially rebuilt.
- 6.03 The brick archways over the doors to the barn should be strengthened and repaired with a “Helibar” or similar system to form a beam lintel and stitch the cracks.

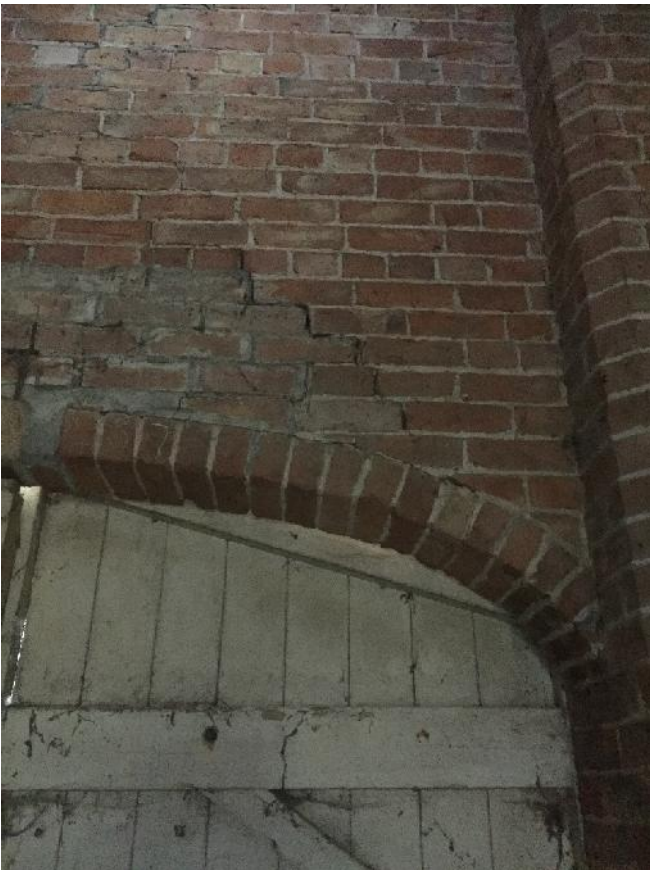
**Photograph 19**

- 5.13 We noted cracking within the brickwork and arches over the door openings to the area with the timber staircase. **Photograph 19.**
- 5.14 The floor was constructed with concrete oversite.

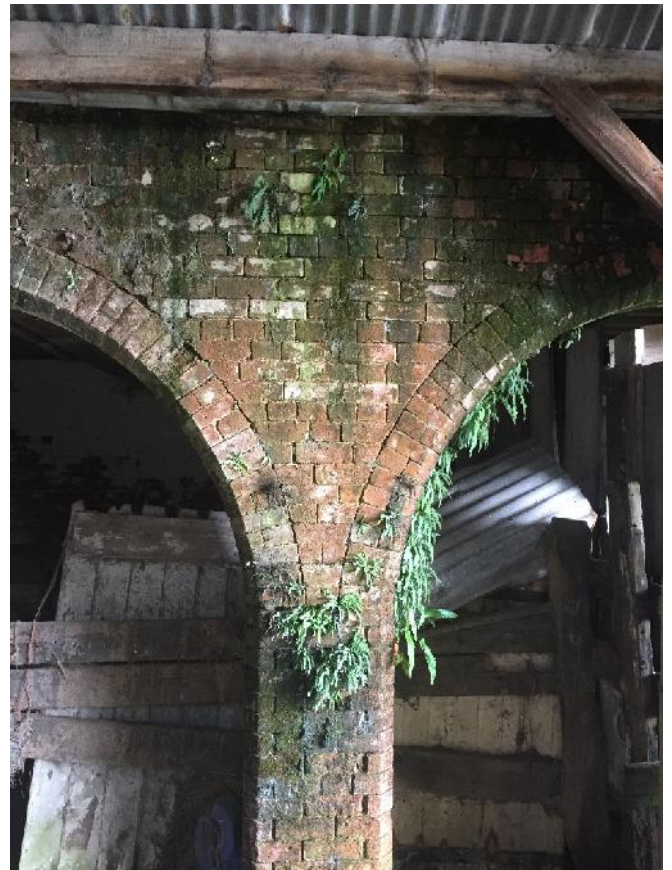
**Photograph 20**

- 5.18 We noted damp brickwork with vegetation growing on the brick face due to poor and leaking guttering. **Photograph 20.**

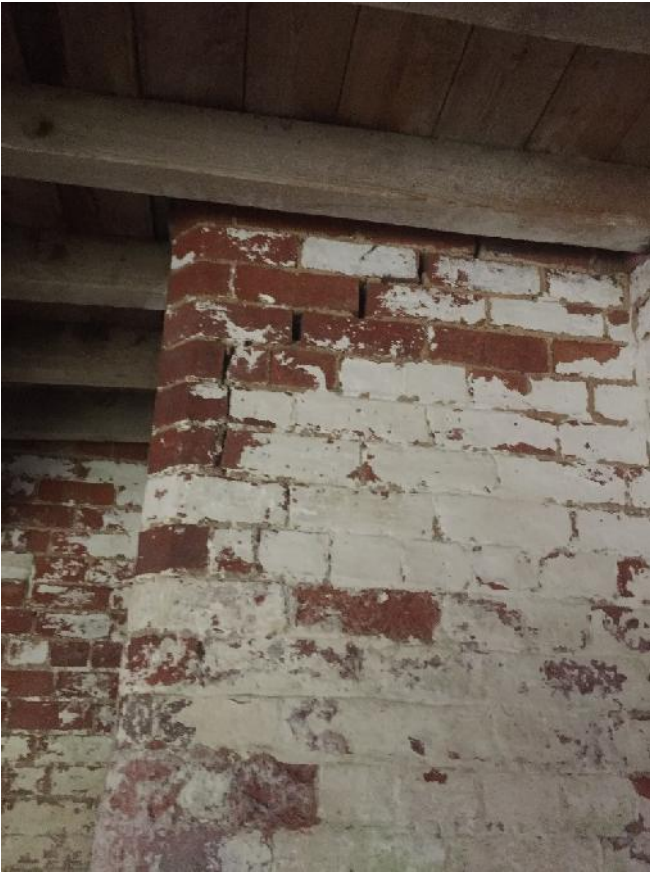
Photograph 21

- 5.19 The east elevation external brickwork was damp at low level.
- 5.20 The brickwork forming the stair enclosure was cracked in a stepped diagonal pattern at high level. **Photograph 21.**

- 6.06 All severe diagonal stepped cracking noted to corners of walls and over openings should be repaired with a “Helibar” or similar crack stitching technique to strengthen.

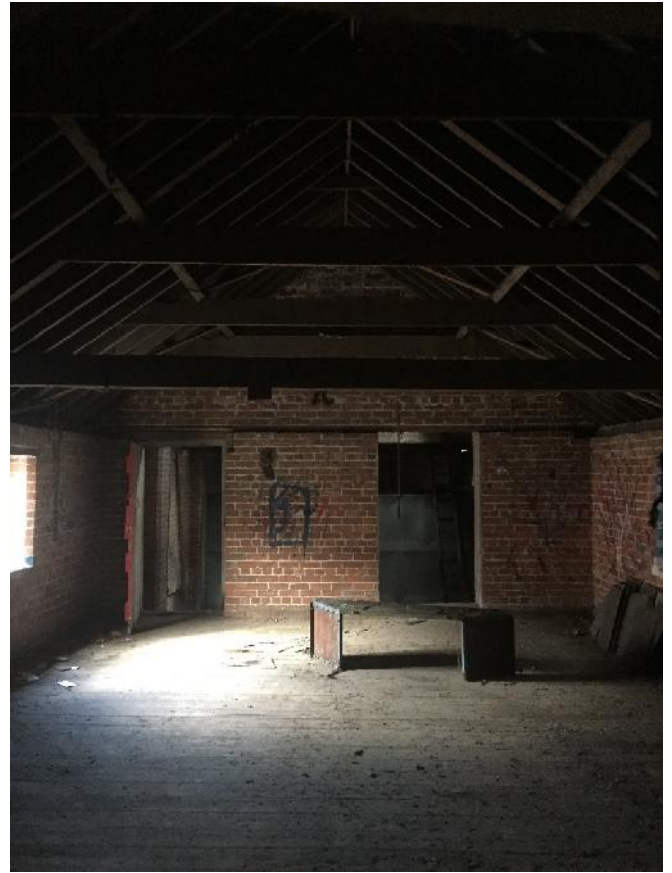
Photograph 22

- 5.21 The roof over the first floor area was felted and formed with purlins supporting rafters with mid height collars. **Photograph 22.**
- 5.22 Between the stud wall and internal brick gable a timber eaves tie was evident.

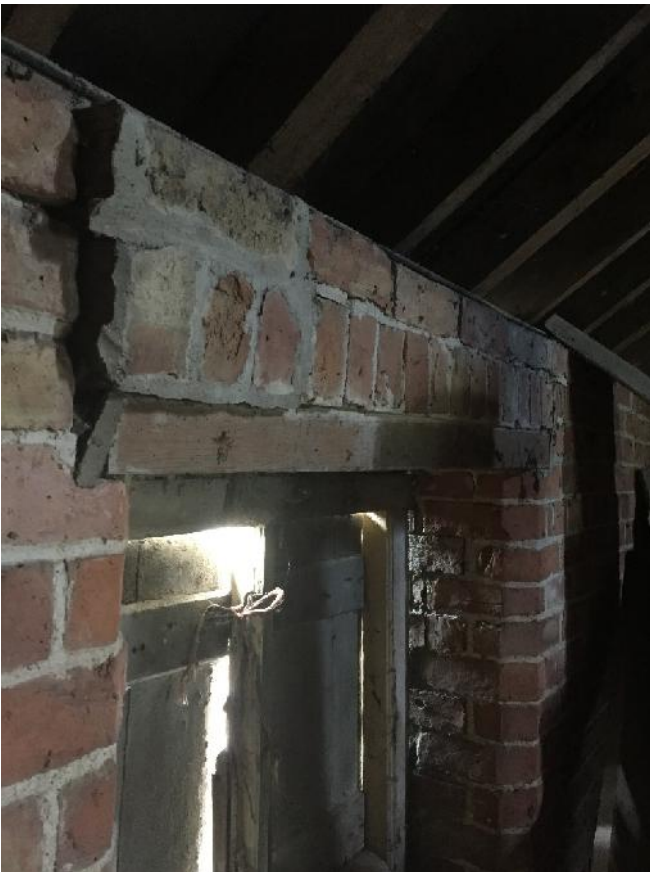
Photograph 23

- 5.23 We noted cracking and inward rotation of brickwork over the window facing east, situated close to the southern corner. **Photograph 23.**
- 5.24 The roof to the lean to barn was formed with timber beams supporting a prop and line of purlin with rafters, battens and slate tiles over. One of the timber beams was severely decayed and broken, causing the roof structure to partially collapse. **Photographs 24, 25 & 26.**

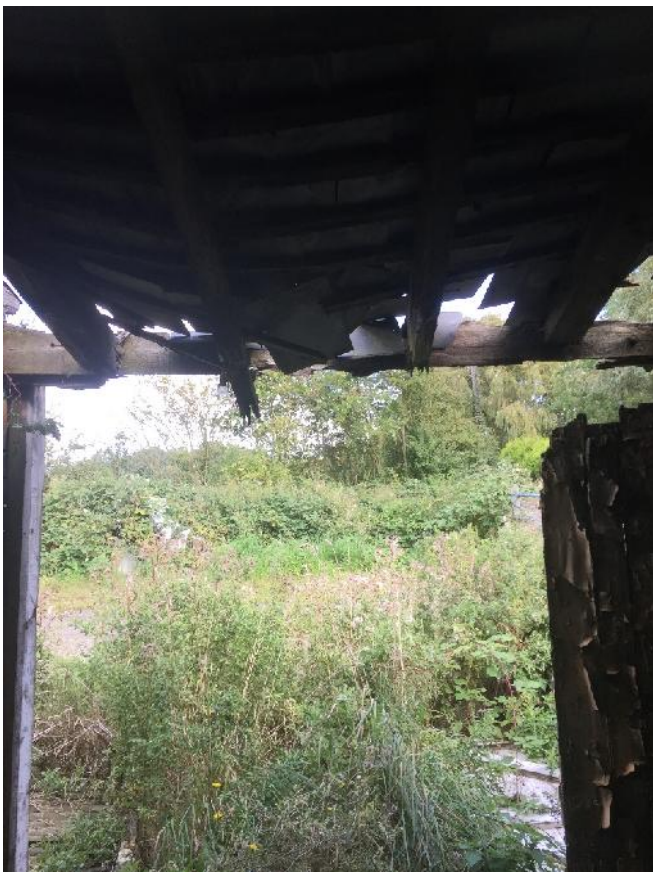
**Photograph 27**

- 5.25 The floor was constructed with concrete oversite.
- 5.26 The timber lintels over the large openings had failed. **Photograph 27.**
- 5.27 Severe cracking to the brickwork around the south facing window was noted and the brickwork was damp. **Photograph 28.**

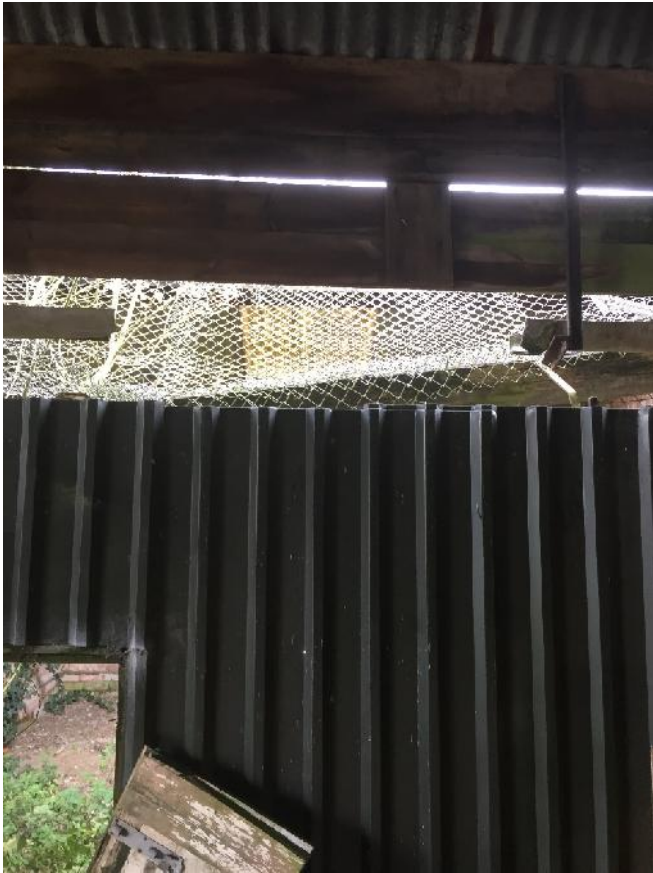
Photograph 29

- 5.28 The northern section of stables, two timber trusses supported purlins and rafters overlaid with steel corrugated roof sheets.
- 5.29 The floor was constructed with concrete oversite.
- 5.30 Within the open section facing east, timber posts supported eaves beams and the scissor roof trusses over the crew yard area.
- 5.31 The roof over the central and southern section of stables were formed with three lines of timber purlins down each slope; the purlins were supported off 9" thick brickwork gable walls. The purlins supported cement particle corrugated roof sheeting.
- 5.32 Over one area the purlins had collapsed and the cement particle gutter was broken. **Photograph 29.**
- 5.33 The floor to these areas was formed with earth and stone rubble.

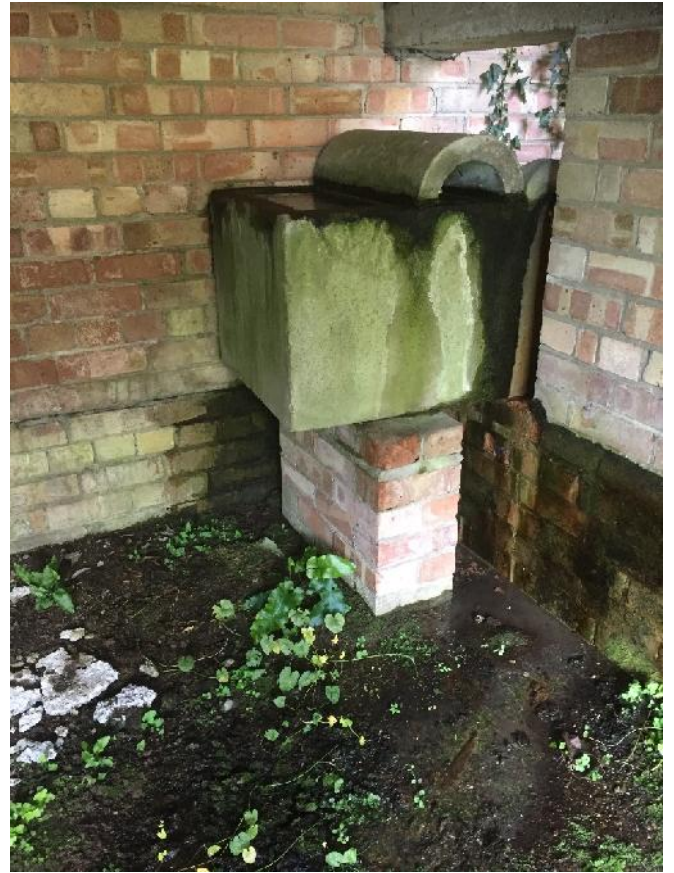
Photograph 30

- 5.34 Between two compartments, a water tank was present and leaking from the overflow was noted. The brickwork at low level local to this area was damp. **Photograph 30.**
- 5.35 Towards the south west corner a damp proof membrane was visible, five brick courses above internal ground floor level.
- 5.36 The roof infill over the crew yard was formed with timber scissor trusses supporting purlins, and steel corrugated roof sheeting. **Photograph 31.**
- 5.37 Towards the north a section of concrete floor slab was constructed and the remaining floor was earth.
