**Bridge House**

## **Visual Structural Inspection and Report**

**Project No. 9116**

**October 2023**

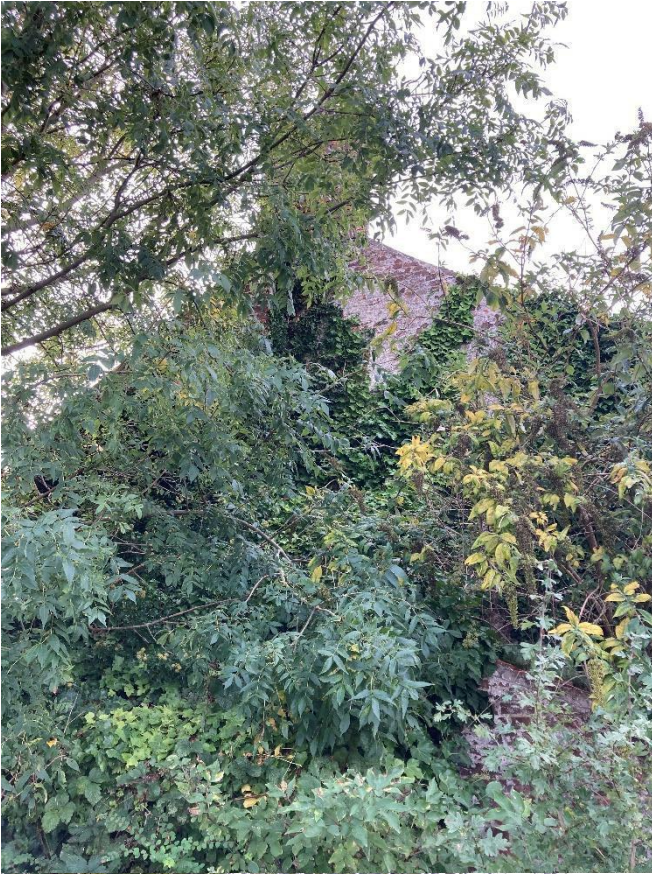
**Photograph 1**

- 4.01     No access was available due to the presence of a large Ash tree and densely populated smaller species of trees. **Photograph 1.**
- 4.02     The single storey storage area is just visible behind the trees and ivy. **Photograph 2.**

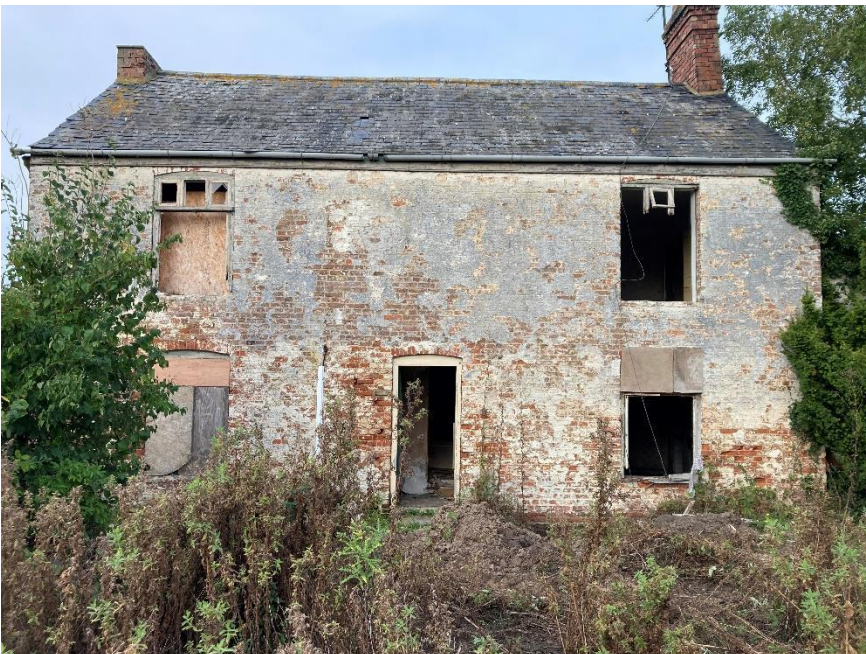
**Photograph 3**

#### **East Elevation – Photograph 3**

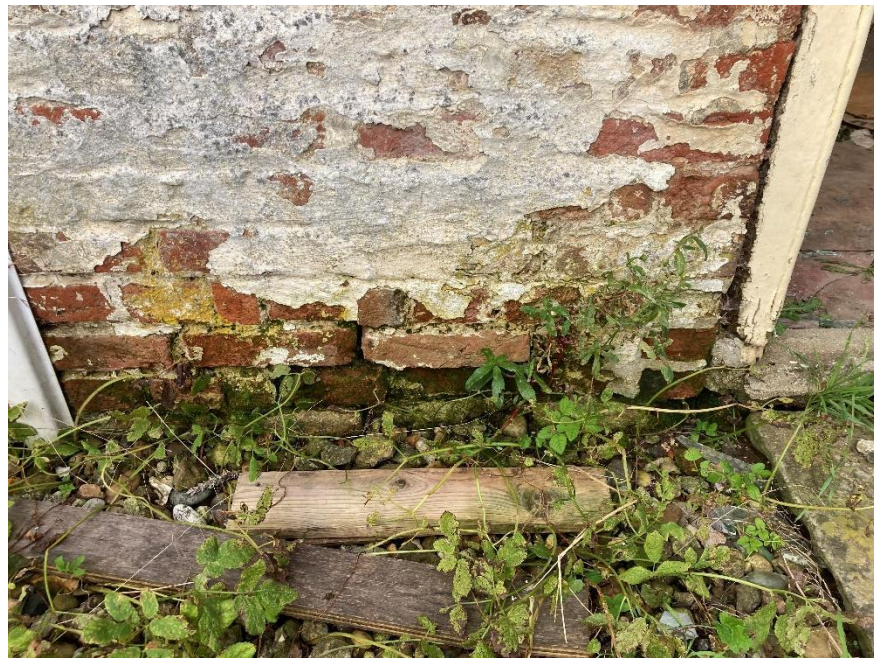
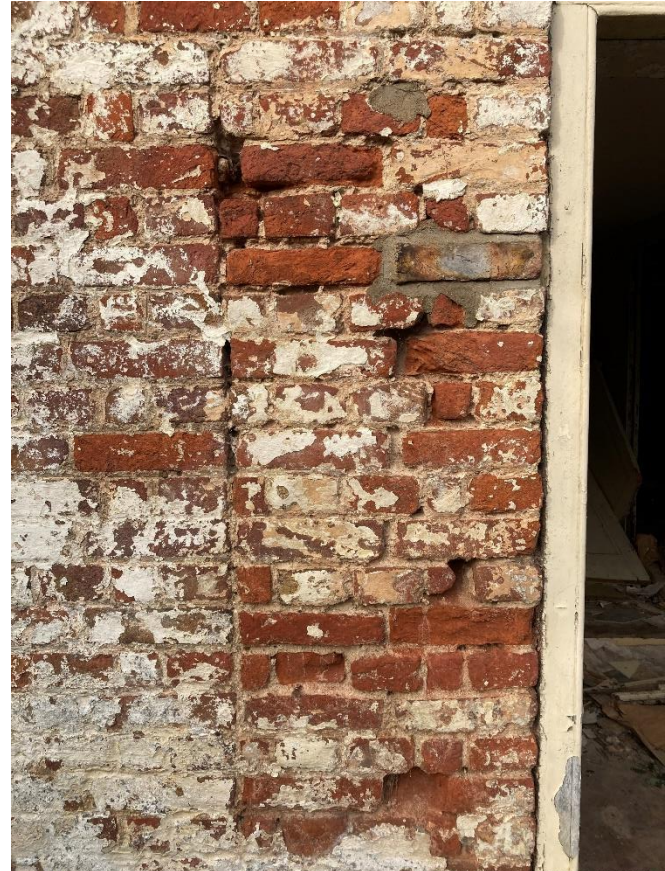
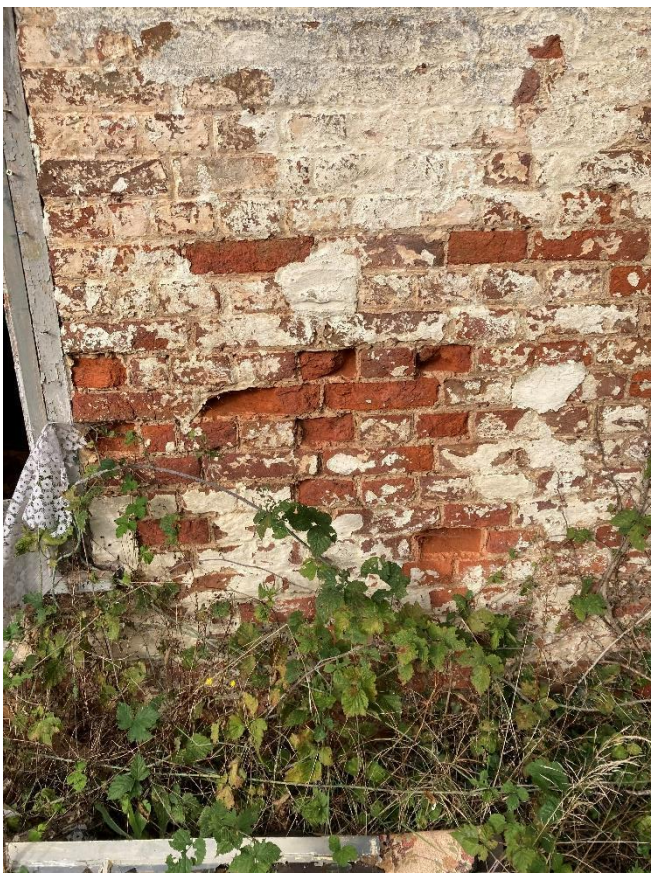
- 4.03     We noted areas of damp, eroded and spalled brickwork at low level. **Photographs 4, 5 & 6.**
- 4.04     A trial hole was excavated to expose foundation and subsoils (refer to appended trial hole log for description). **Photograph 7.**
- 4.05     We noted cracking within the brickwork between the ground floor and first floor windows. **Photograph 8.**

- 6.01 Following our inspection it is clear that the building has been neglected over recent years and the main building fabric is in poor condition. The roof displayed movement and bowing as the purlins are not supported vertically (just merely tied), so would need to be replaced or strengthened. Ceilings will need to be repaired to receive new finishes so it is likely that the roof would need to be removed. Internal masonry partitions are built off the first floor joists which are not likely to be suitable by modern standards to support these loads and deflections were noted. Ground floors have cracked and damp was noted: these would need to be replaced. Due to the presence of trees and shrinkable subsoils influencing the type of ground floor, the new floors should ideally be suspended beam and block to provide a clear void below to allow for shrinkage and heave. The external brickwork has suffered extensively from ground movement and weathering: the rendering would need to be removed, allowing the brickwork to breathe. This may cause damage to the already fragile brick face.

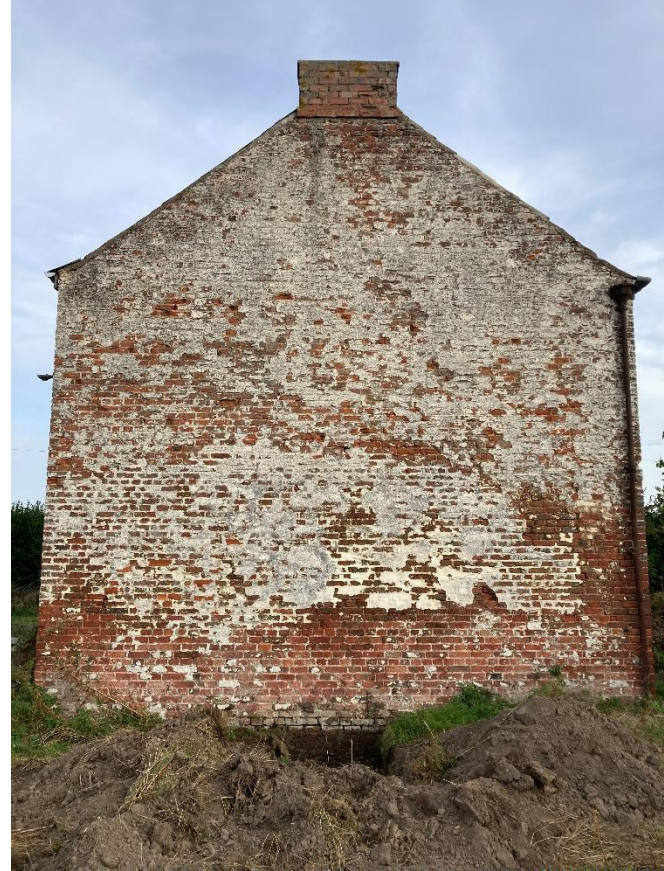
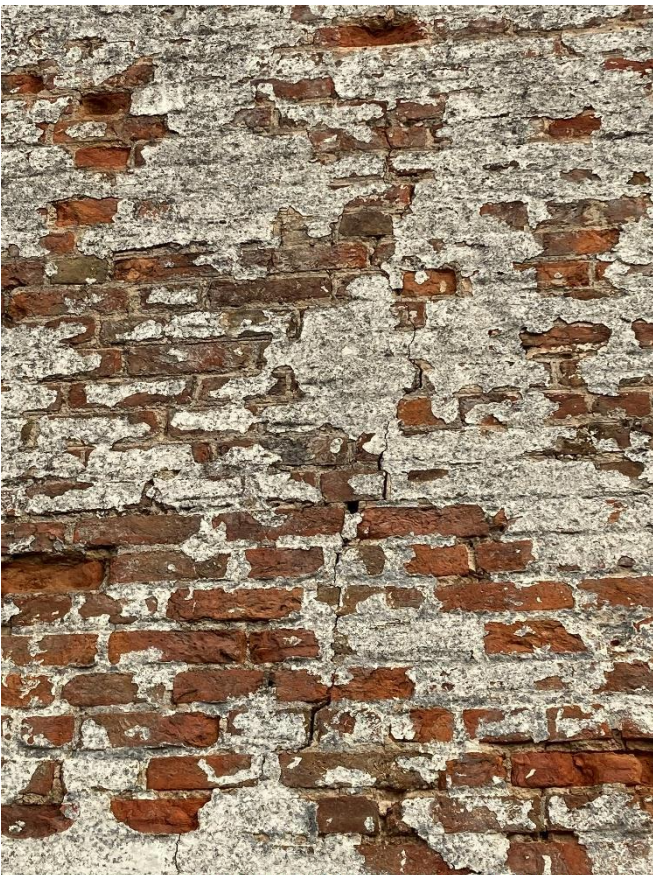
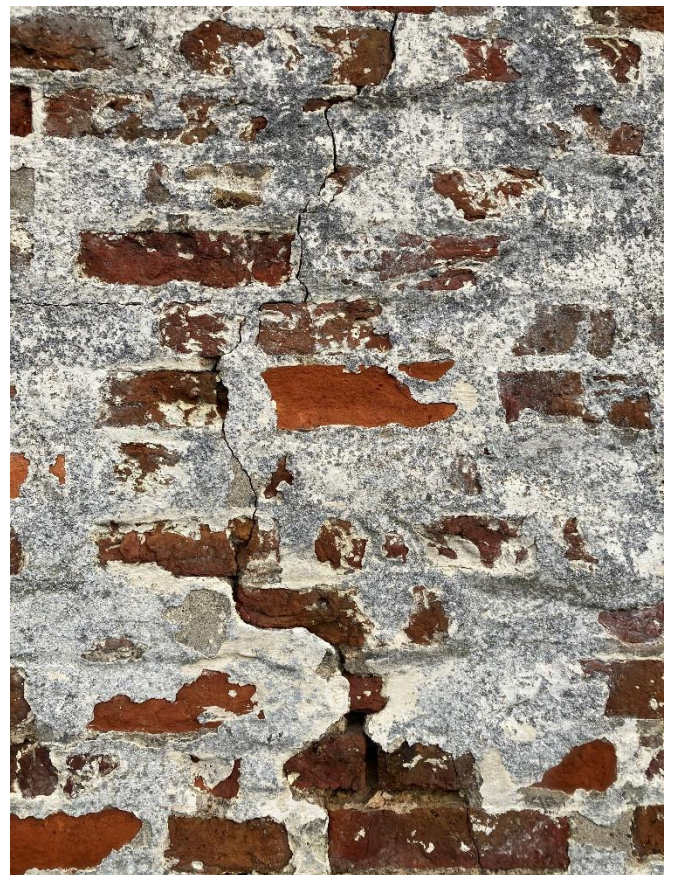
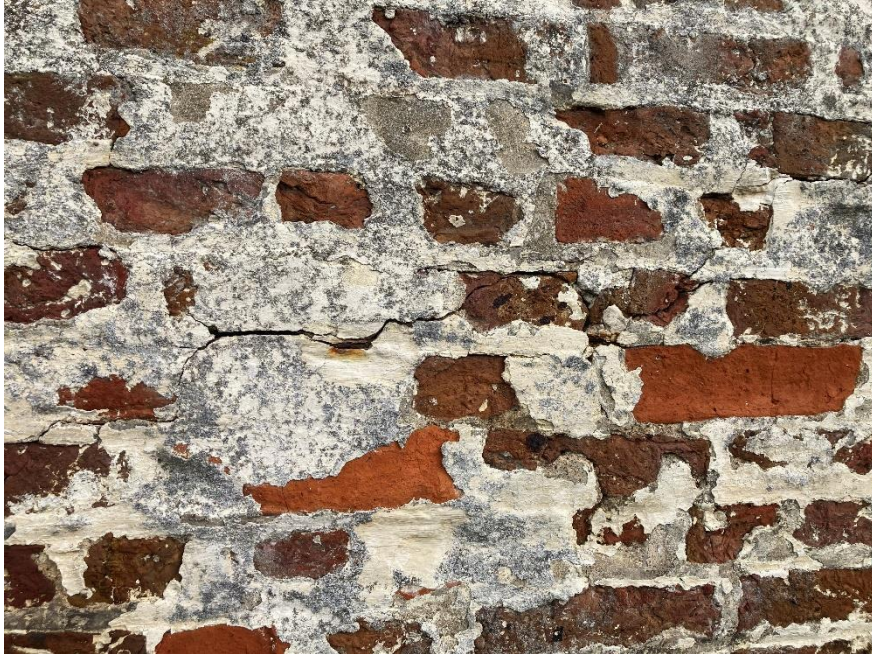
- 4.06     We noted a full height staggered vertical crack and several horizontal cracks within the gable end. Eroded, spalled and crumbling brickwork was noted. The gable wall is not plumb and an outward bulge in the centre of the wall was evident. The chimney has been reduced in height. **Photographs 9, 10, 11 & 12.**
- 4.07     A trial hole was excavated to expose foundation and subsoils. **Photograph 13.**

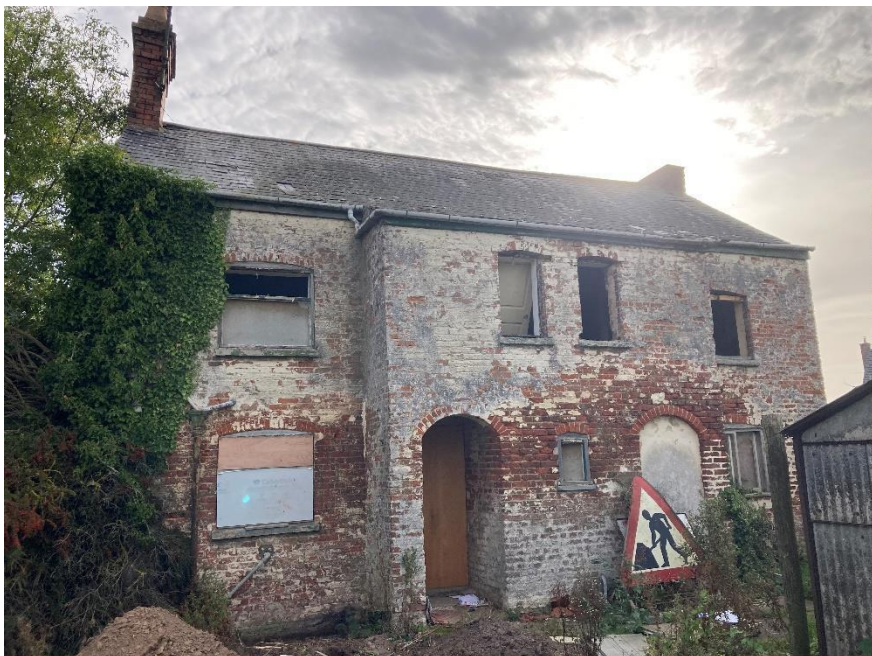
**Photograph 14**

#### **West Elevation – Photograph 14**

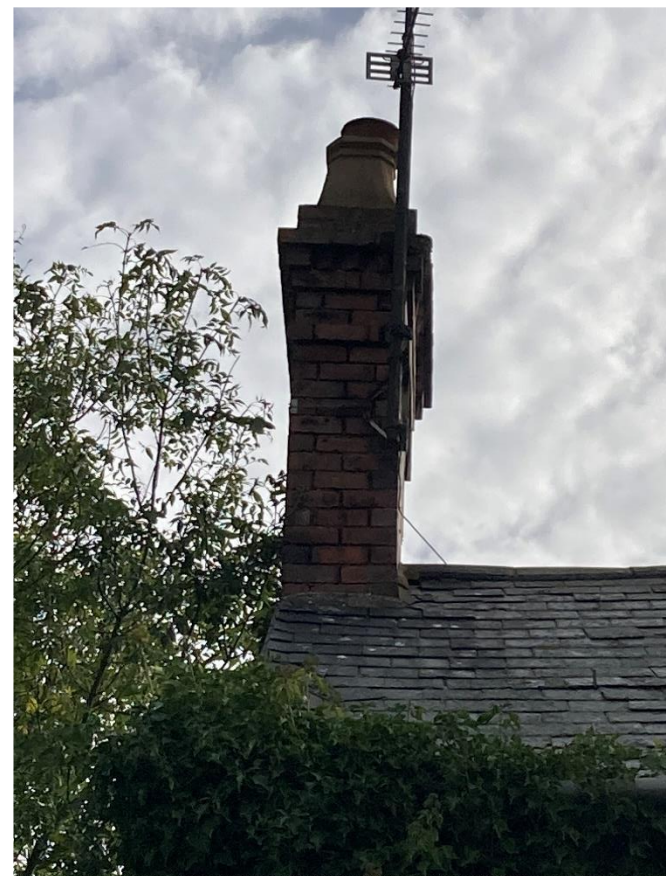
**Photograph 15**

- 4.08     The chimney stack appeared to be out of plumb and leaning inwards towards the roof. **Photograph 15.**
- 4.09     We noted extensive areas of damp, eroded and spalled brickwork. **Photographs 16, 17 & 18.**
- 4.10     A trial hole was excavated to expose the foundations and subsoils. **Photograph 19.**

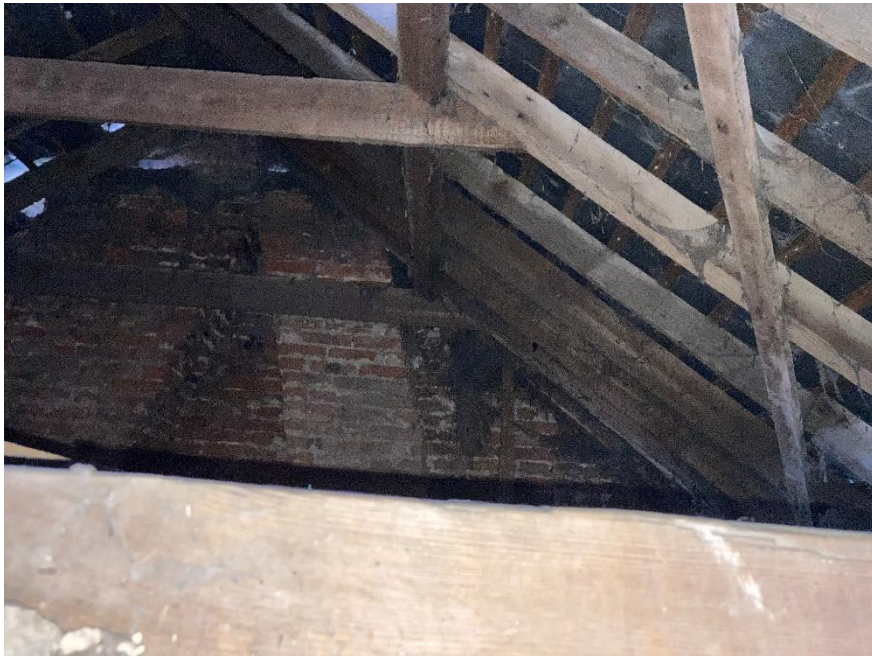
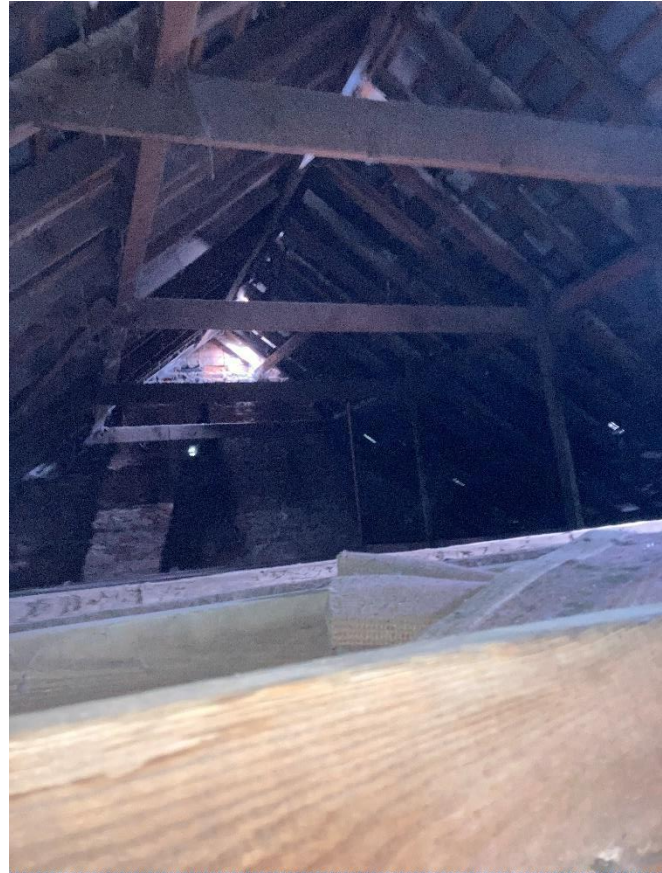
- 5.01 Viewing from the loft access hatch in the landing, the roof construction was noted. Purlins are tied and supported by mid-height collars. **Photographs 20 & 21.**

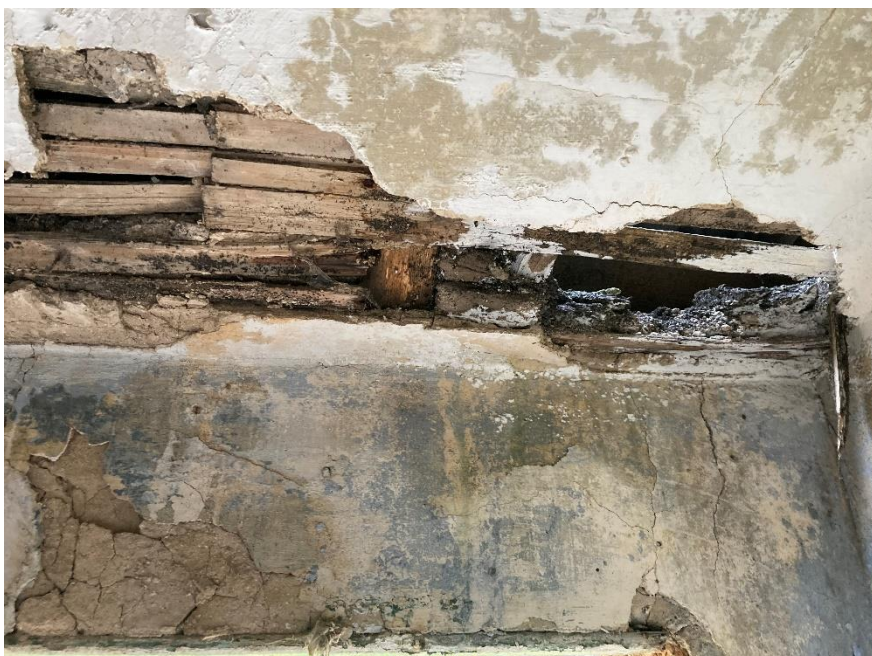
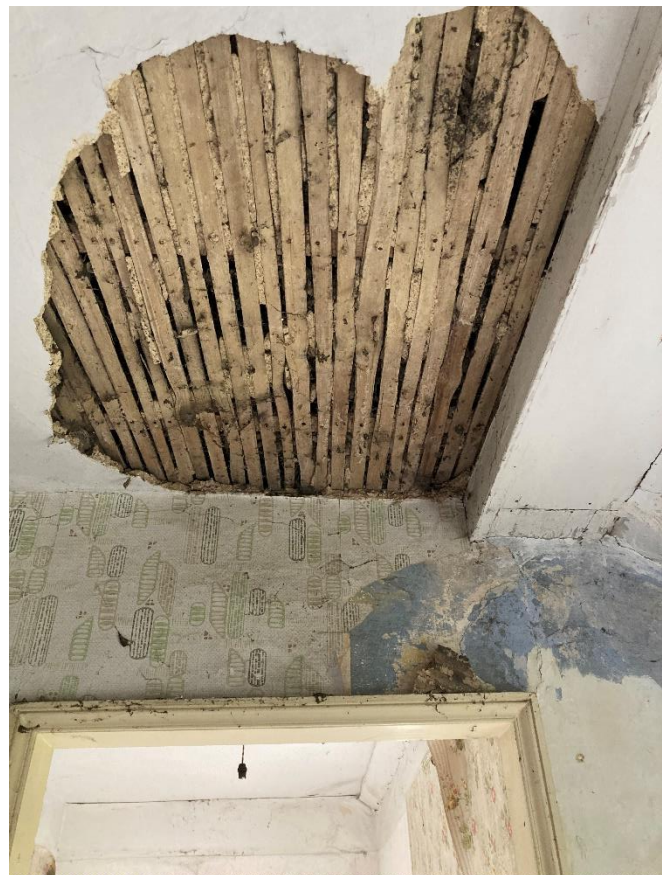
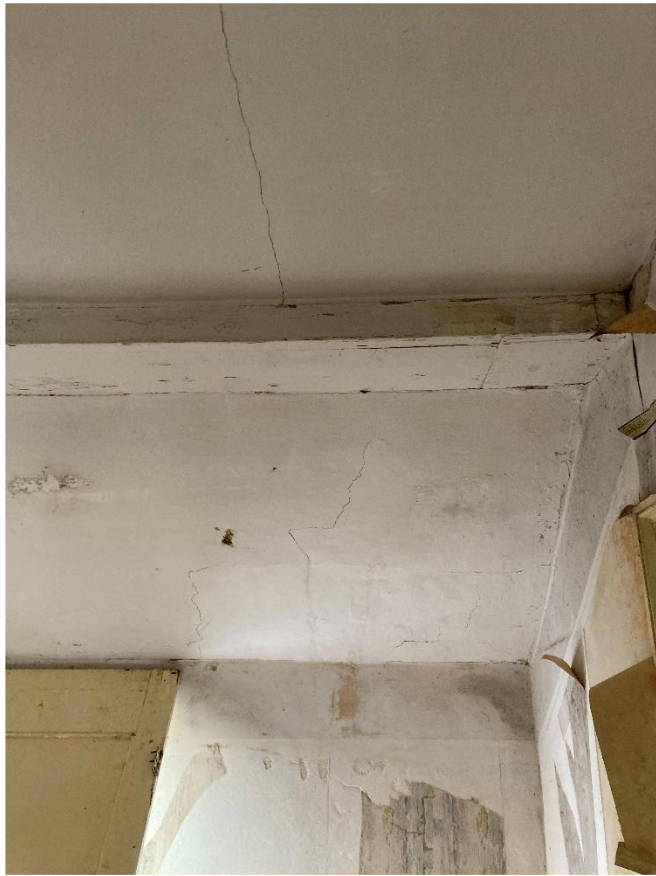
- 5.02 The first floor ceiling finishes are in poor condition throughout, plaster had broken away leaving exposed laths. **Photographs 22, 23 & 24.**
- 5.03 Cracking in the external eaves wall to the Bathroom was evident. **Photograph 25.**

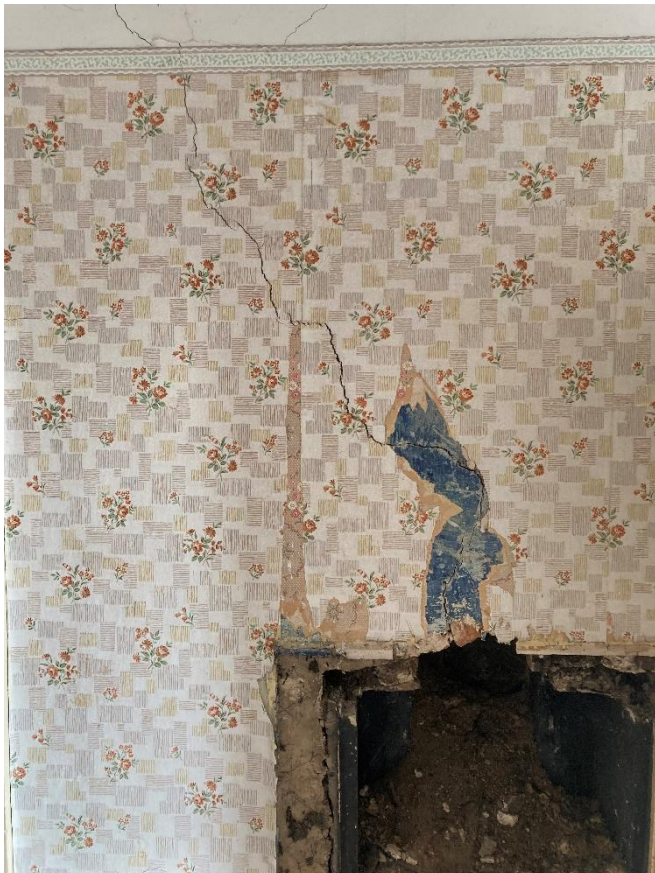
**Photograph 26**

- 5.04 Cracking in the external north gable Bedroom wall was evident. **Photograph 26.**
- 5.05 We noted full height cracking in the corner of the chimney stack to the south east. **Photograph 27.**

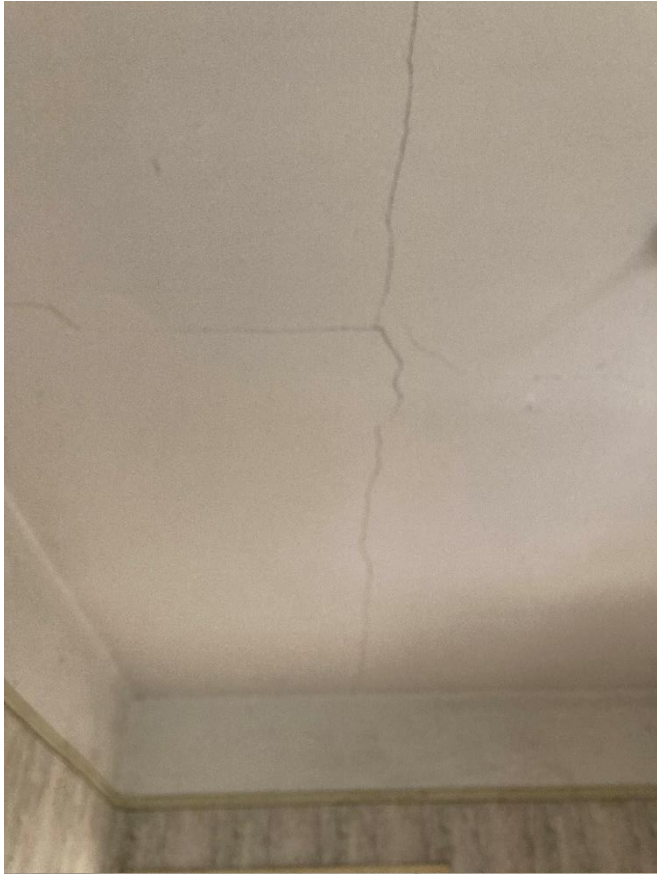
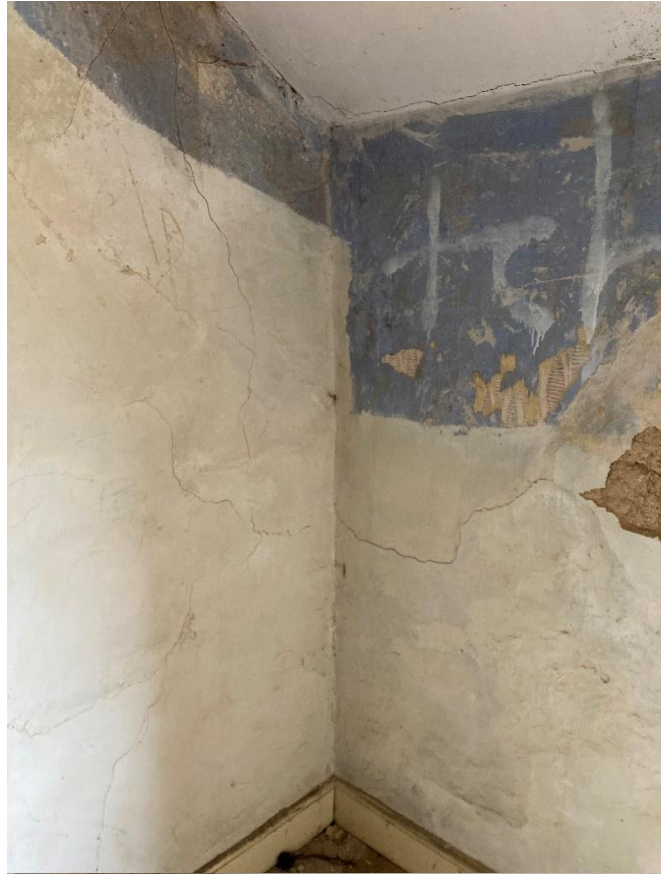
- 5.06 Random cracking in the ceilings and walls was evident throughout the ground floor. **Photographs 28 & 29.**
- 5.07 We noted that the first floor was unlevel in the northern Bedroom and sloped towards the centre of the building. Random cracking was evident in the concrete ground floors.
