SETCHFIELD ASSOCIATES LIMITED

STRUCTURAL INSPECTION REPORT

Client	Mr J Carter
Property	Nunnerley House Farm, Leaveslake Drove, Pinchbeck, PE11 3QJ
Date	November 2025
Project	SAL-25-077

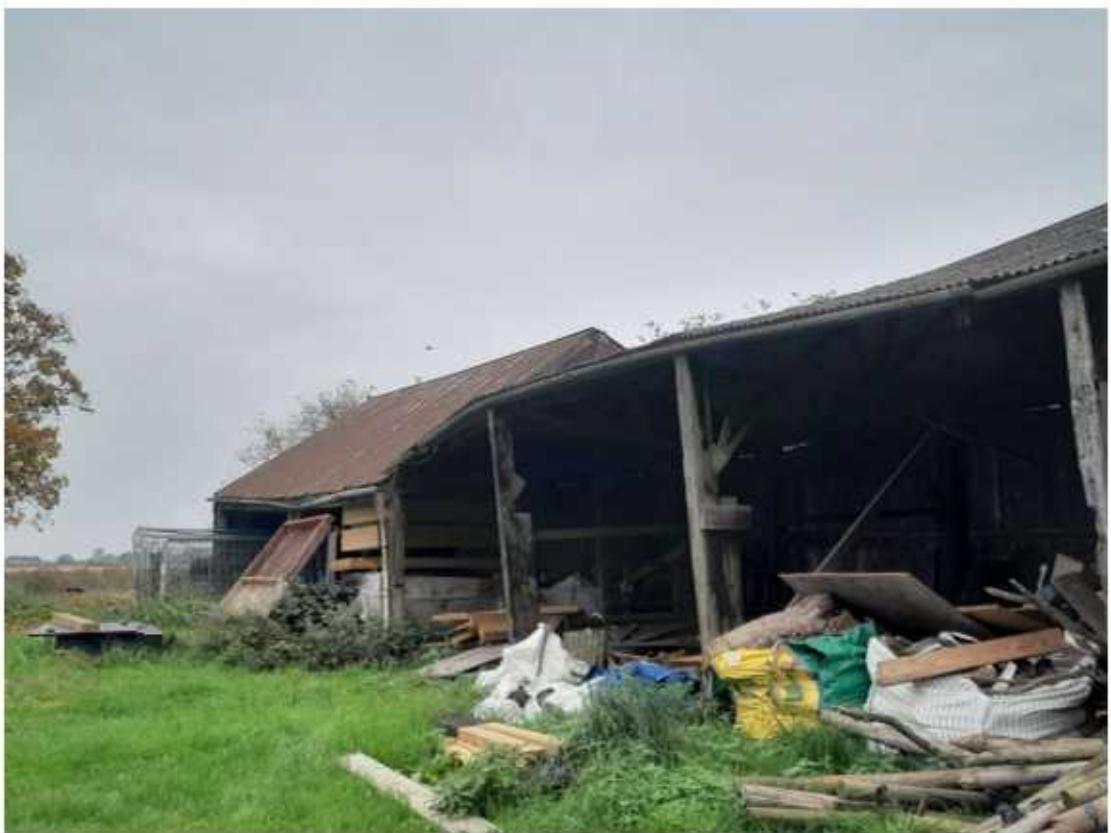
The existing building has a duo pitched roof profile clad with asbestos cement roof sheets and metal profiled sheets. The structure is clad on three elevations with a mixture of asbestos cement and metal cladding panels. One of the long elevations is fully exposed. See photographs 1 to 3.

Photograph no 1 – External elevation.

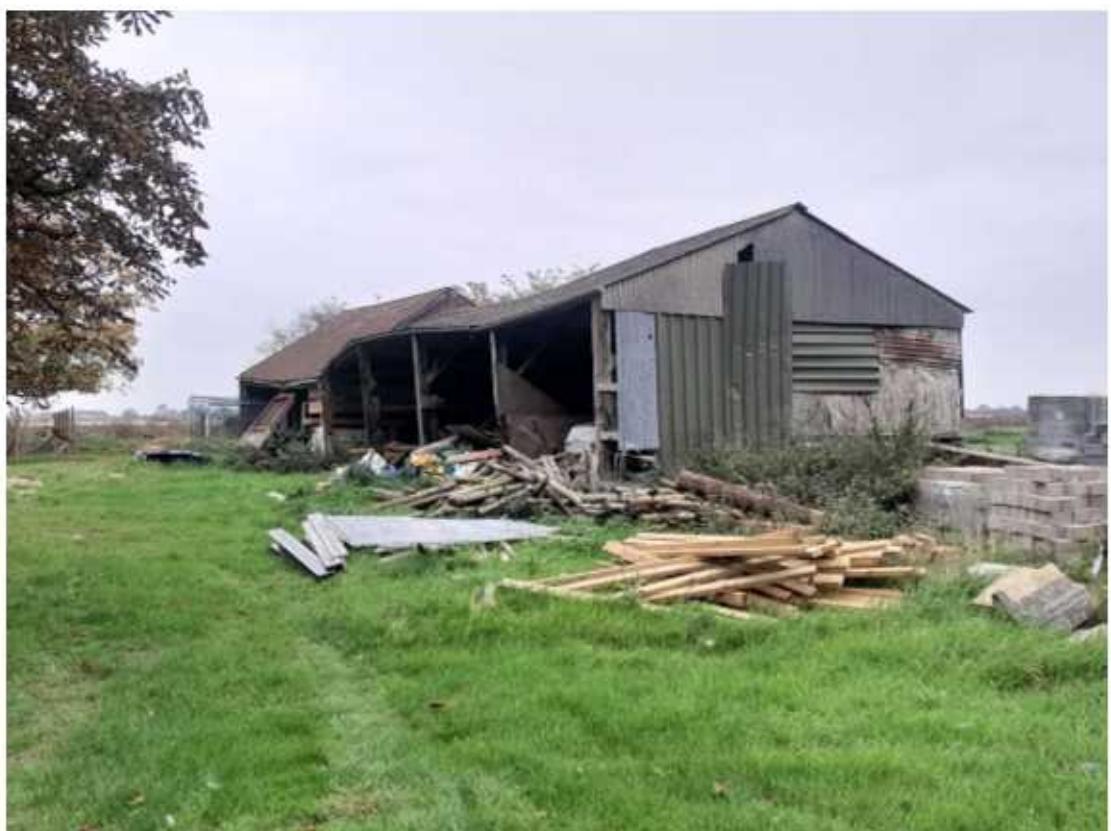
Photograph no 2 – External elevation.

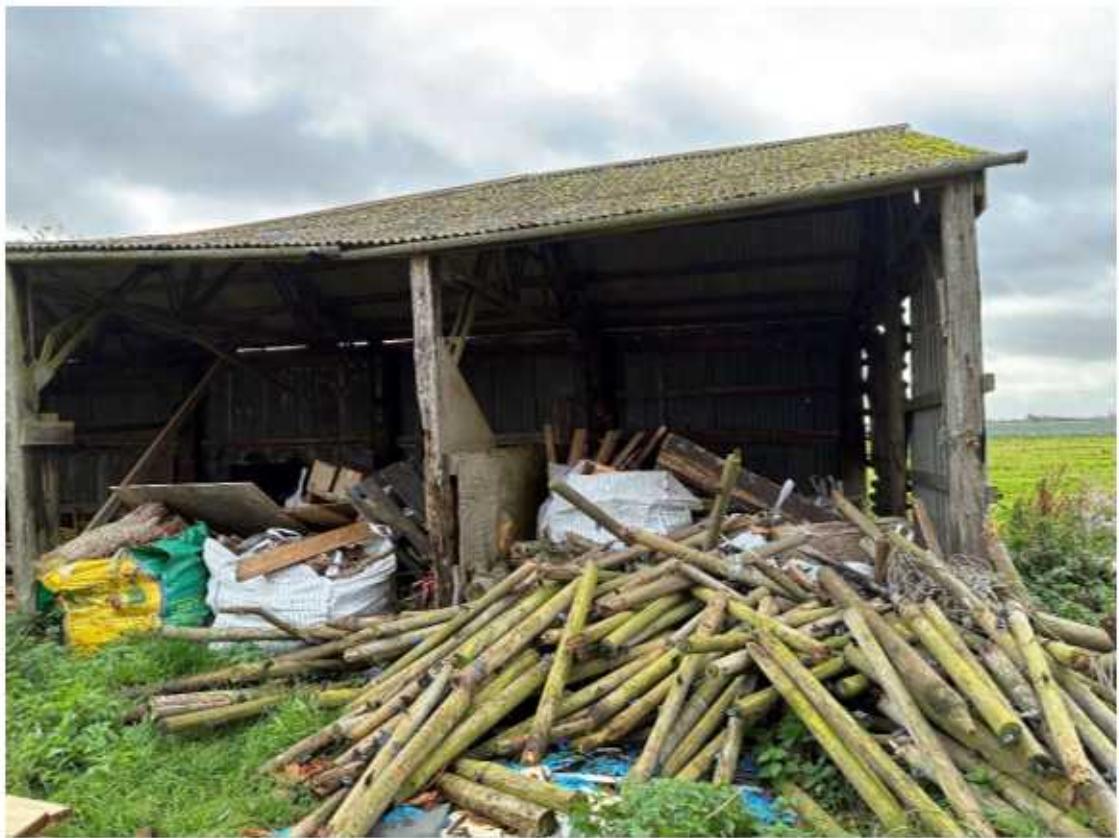
Photograph no 3 – External elevation.

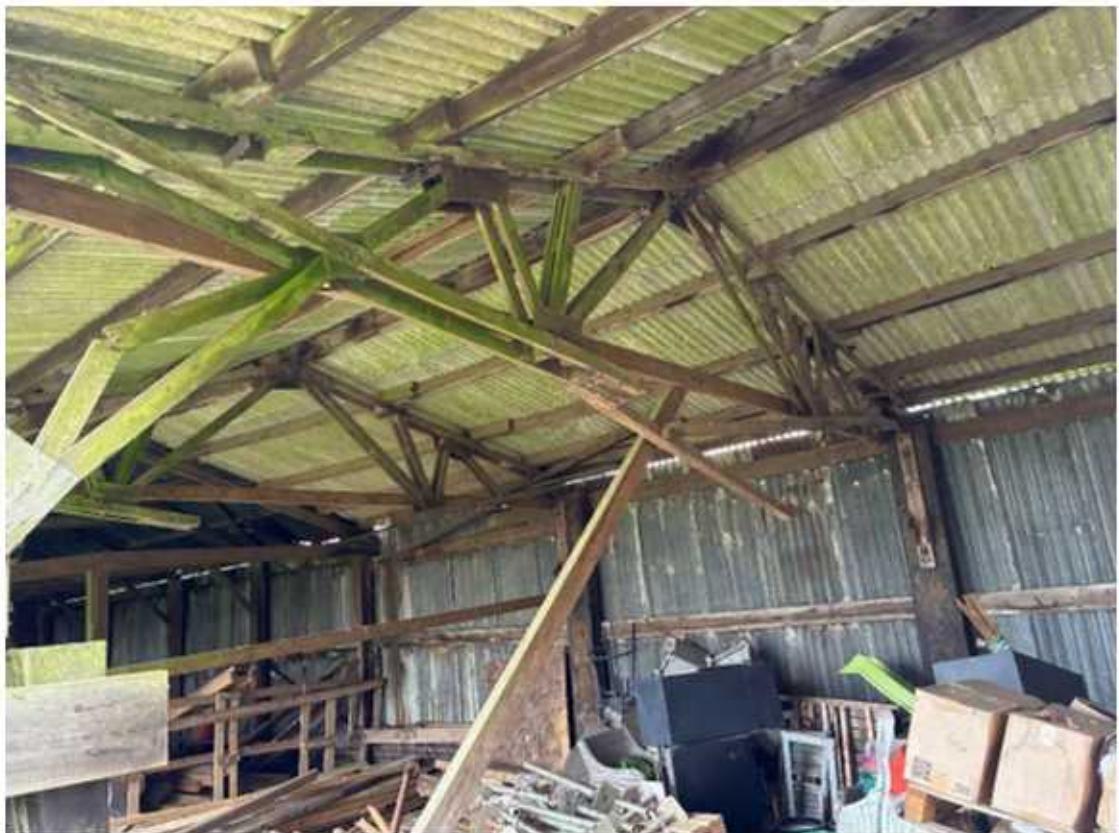
Photograph no 4 – Roof trusses and posts.

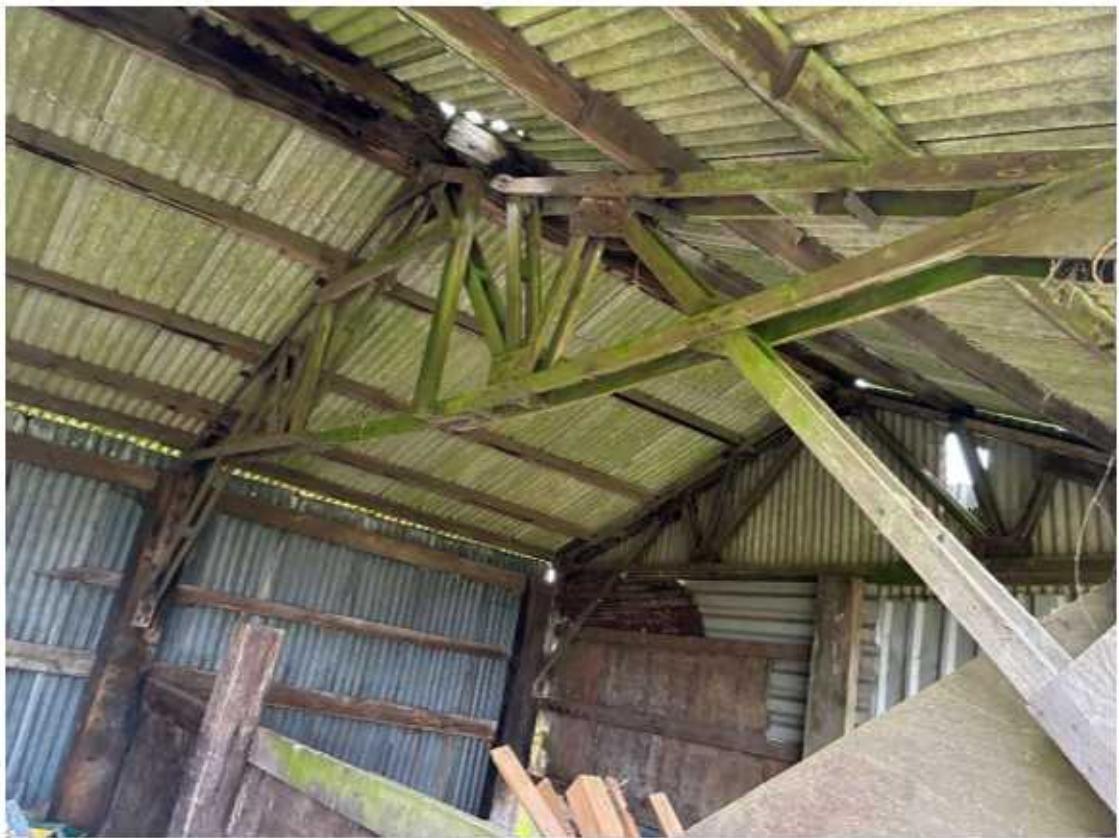
The roof structure is supported by two distinct types of cut timber roofs. The metal clad roof section is supported by A-frame timbers with purlins spanning between each frame. See photographs 6 and 7. The asbestos cement roof is supported by timber trusses that have been formed on site with purlins spanning between each truss. See photographs 4,5 and 8. The roof trusses and A-frames are supported by vertical timber posts on either side of the building.

Photograph no 5 – Roof trusses.

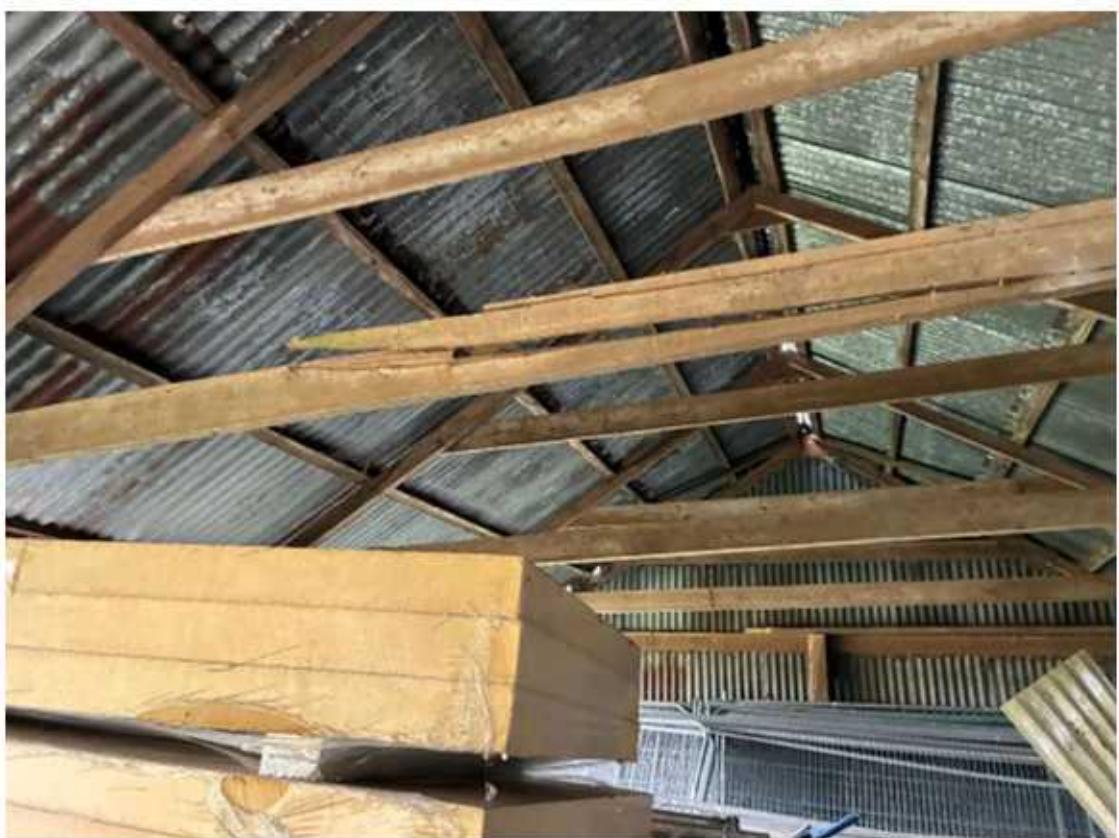
Photograph no 6 – Roof structure.

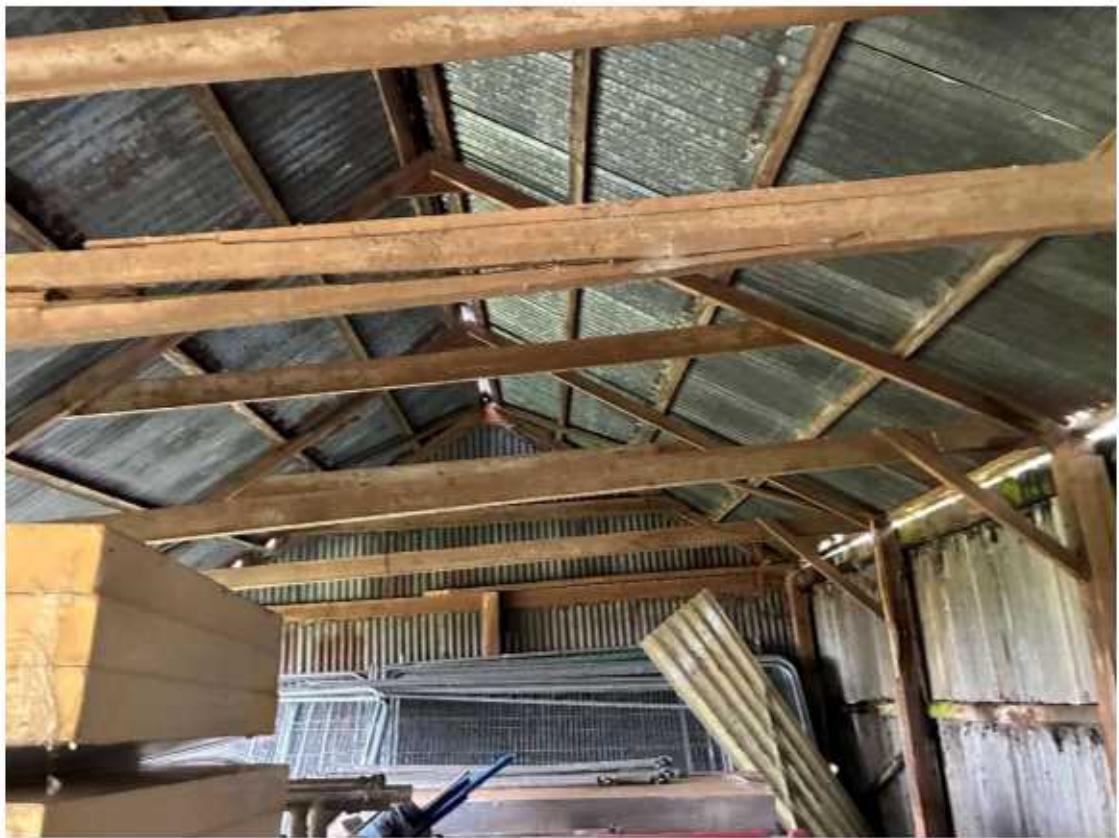
Photograph no 7 – Roof structure.

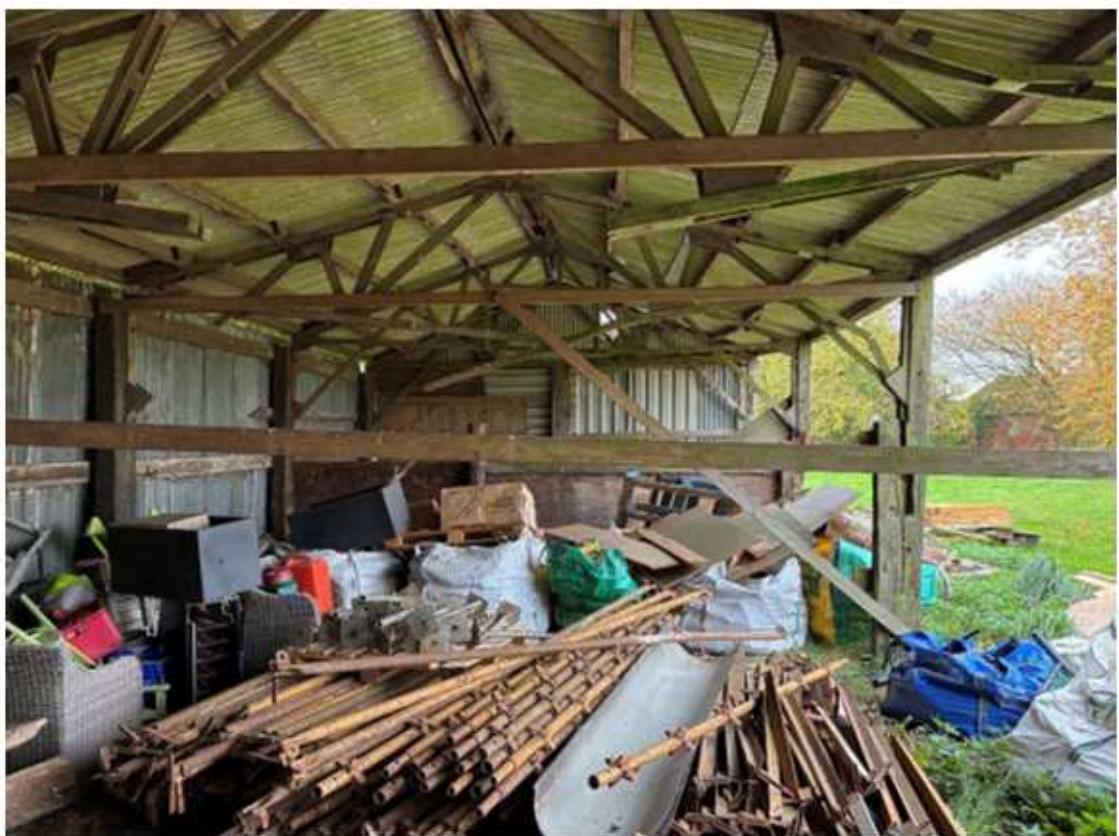
Photograph no 8 – Roof structure and supporting posts.

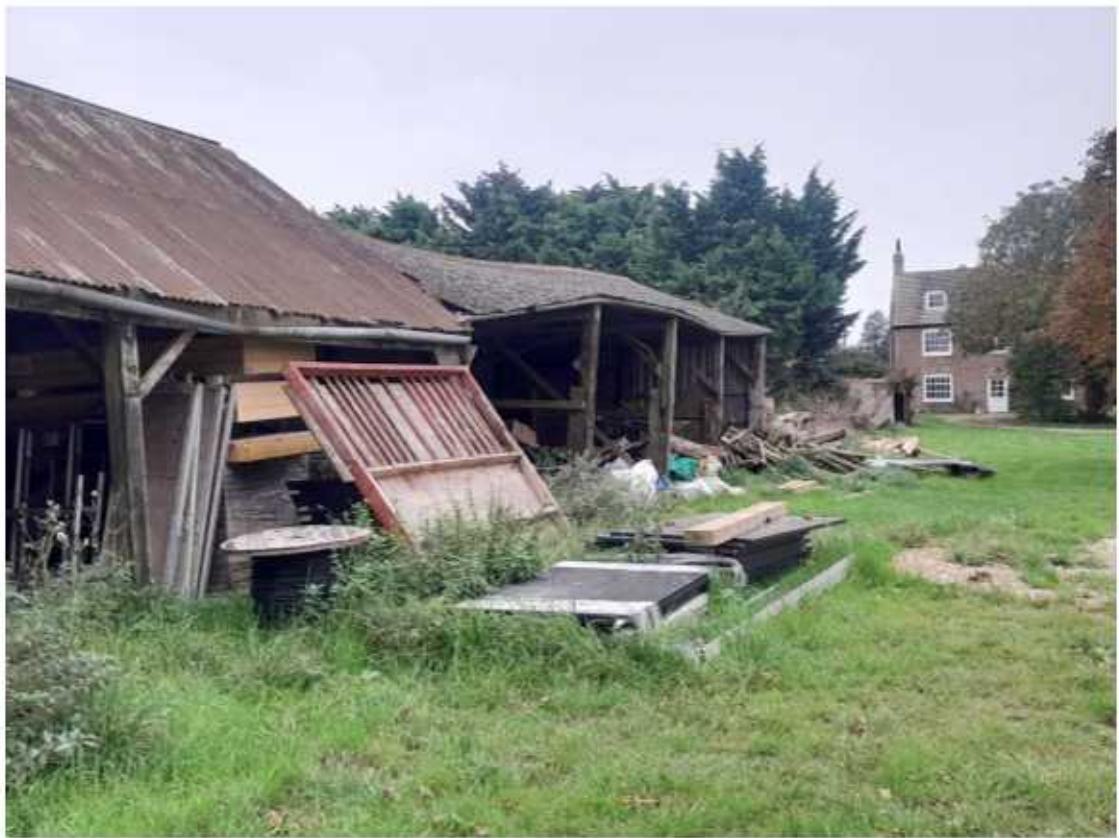
Photograph no 9 – External elevation.
