BS5837:2012 Tree Survey  
Land adjacent to Pennyfields  
Pinchbeck  
Lincolnshire  
NGR TF23769 25095

Survey by  
Christopher Barker CEnv dipHort ACIEEM

| | Report ref:<br><b>P1332 /0517 /01</b> | |

# **BS5837 Tree Survey, Land adjacent to Pennyfields, Pinchbeck**

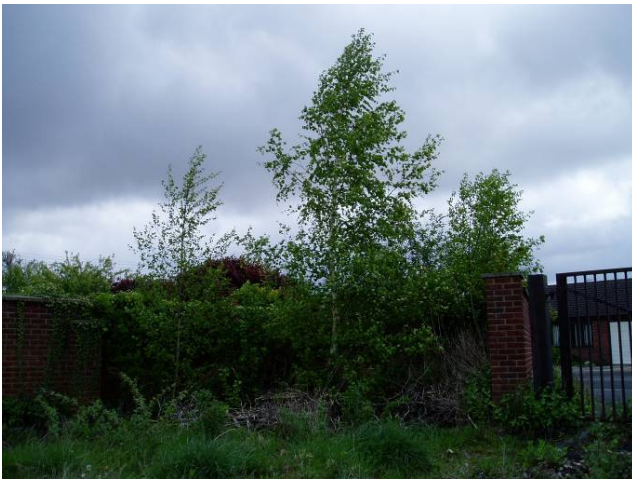
Birch T1

**T1 Birch** is a small, probably self-seeded Birch situated in the south eastern corner of the site. It has reasonable space and has good shape and is placed within Category C. There are smaller Birch nearby that will compete for space is allowed to remain and if it is decided to retain this tree as a specimen then the smaller trees should be removed.

| Tree No | Species | Ht (m) | Stem Diam mm@ 1.5m | Canopy Spread (m) | Height of Crown Clearance | Age Class | Est yrs | Overall Condition | Structural condition | Recommendations | BS 5837 Category | RPA Radius (m) |
|---|---|---|---|---|---|---|---|---|---|---|---|---|
| T1 | Birch<br><i>Betula pubescens</i> | 6 | <150 | N-2<br>S-2<br>E-2<br>W-2 | 0 | Y | 10+ | G | Single trunk supporting an upright ascending lightly branching canopy. Juvenile Birch under canopy. Negligible roost potential. No structural faults visible from ground level. | Could potentially be retained in this position. Remove juvenile Birch to reduce competition. | C2 | 1.8 |

| Tree | Category | Recommendation |
|---|---|---|
| T1 Birch | C2 | Could potentially be retained in this position. Remove juvenile Birch to reduce competition. |

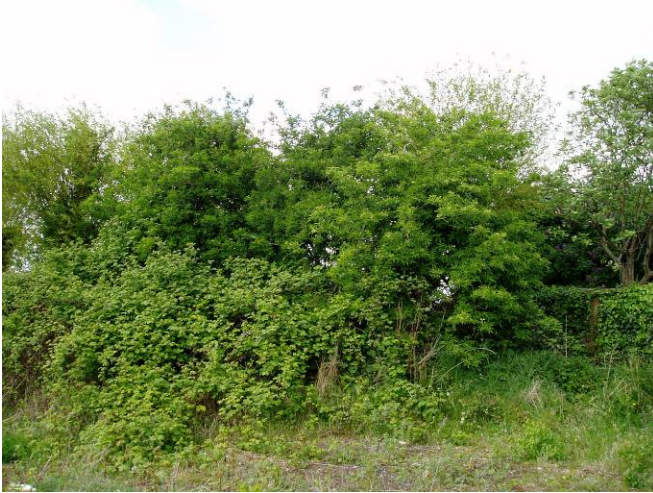
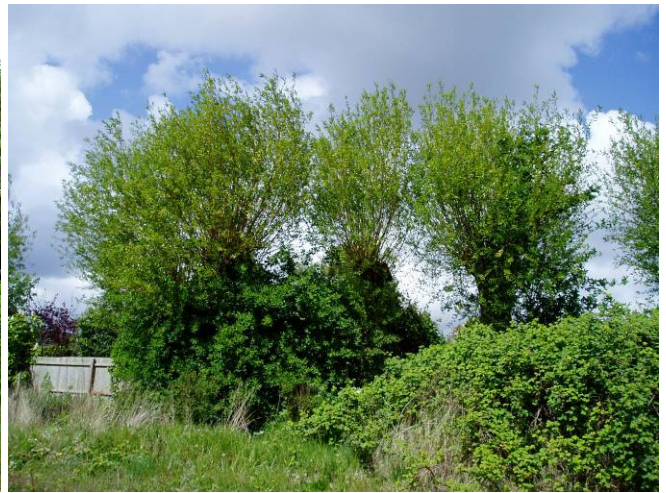
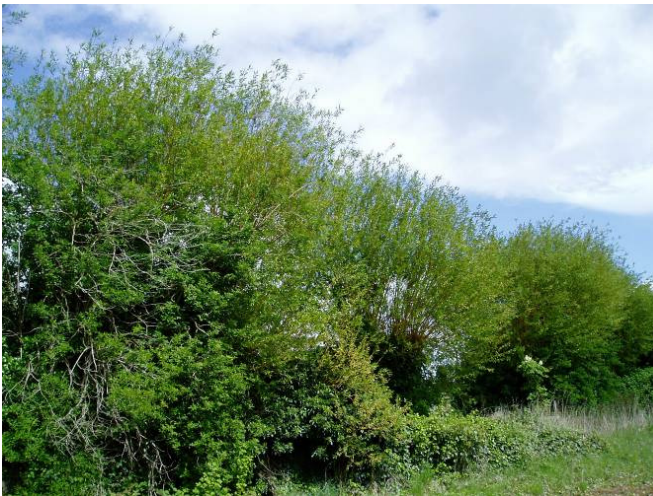
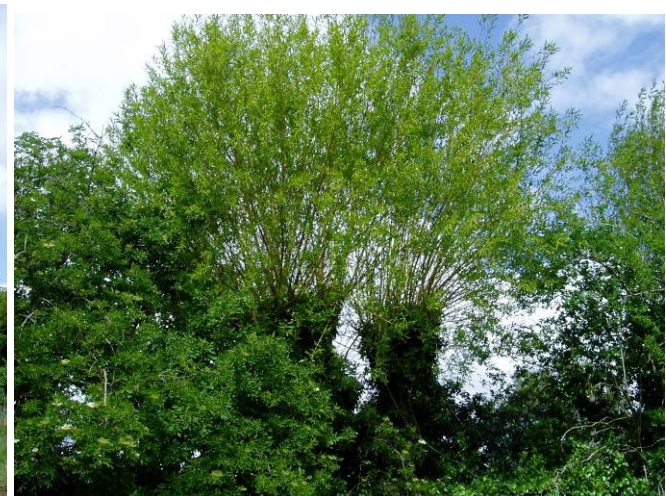
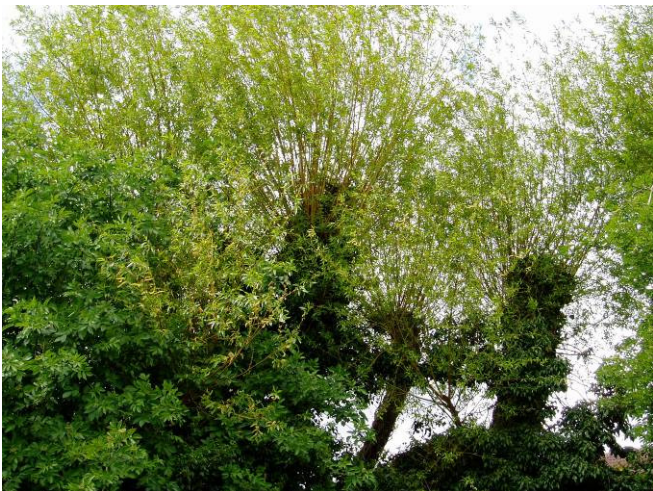
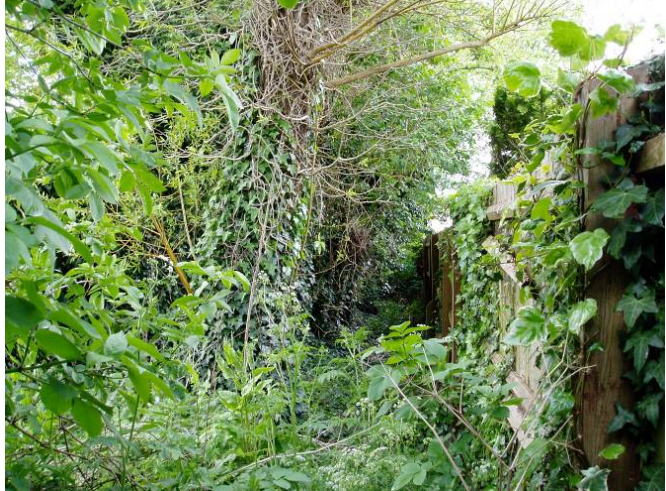
**G2 Willow.** There appear to be eleven Willow trees in total and all have been severely pollarded at approximately 5m height to remove the entire crown. The trees are now regenerating at that height producing very densely branching round crowns of young very vigorous growth. These were mature trees of significant stature planted close to the boundary.

If allowed to continue to regenerate without management these trees will merge to form a dense irregular and very crowded canopy along the northern boundary with limited amenity value and the potential to cast dense shading to the north. For this reason the trees are placed in Category C. However, with good management to thin out the dense rejuvenation, remove the dense Ivy choking the crowns and maintain the trees at a reasonable size, the visual amenity and landscape value of the trees could be increased along with the useful life expectancy and the Category would be B. It might be prudent to consider removing two or three of the Willow to create space for the remainder.

Willow G2 close to the boundary fence

| Tree No | Species | Ht (m) | Stem Diam mm@ 1.5m | Canopy Spread (m) | Height of Crown Clearance | Age Class | Est yrs | Overall Condition | Structural condition | Recommendations | BS 5837 Category | RPA Radius (m) |
|---|---|---|---|---|---|---|---|---|---|---|---|---|
| G2 | Crack Willow<br><i>Salix caprea</i> | 7-9 | <500 | Up to 3m on south | 4 | M | 10-20 | F/P | Line of closely pollarded Willow running along the northern boundary of the site 1m inside the boundary fence. All have been topped at approx. 5-6m and are regenerating dense juvenile growth. Negligible roost potential. No structural faults visible from ground level. | The dense rejuvenation growth will need to be thinned out to extend the useful life expectancy of these trees as the visual amenity has been significantly reduced. If retained, remove the dense ivy growth. | B2/C2 | 6.0 |

| Tree | Category | Recommendation |
|---|---|---|
| G2 Willow and Horse Chestnut | B2/C2 | The dense rejuvenation growth will need to be thinned out to extend the useful life expectancy of these trees as the visual amenity has been significantly reduced. If retained remove the dense ivy growth. The calculated RPA is shown as extending south into the development area close to the proposed new buildings. However, the ground conditions where the original building were located combined with the severe pollarding will have significantly reduced rooting requirement. |

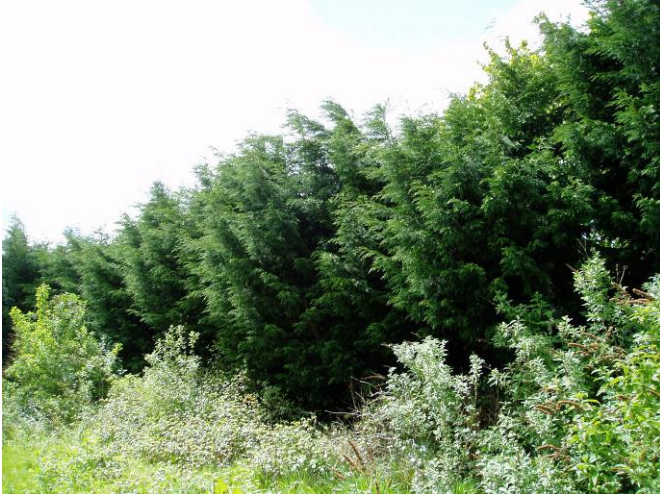
**G4 Leylandii** is a dense vertical screen planted along the western boundary of the site to hide the adjacent garden. These trees do not appear to have been topped and are in need of trimming to maintain the vegetation as a 'vertical hedge'. The group is placed in Category U. If reduced and trimmed effectively to a lower height and spread they will maintain useful screening along this boundary.

| Tree No | Species | Ht (m) | Stem Diam mm@ 1.5m | Canopy Spread (m) | Height of Crown Clearance | Age Class | Est yrs | Overall Condition | Structural condition | Recommendations | BS 5837 Category | RPA Radius (m) |
|---|---|---|---|---|---|---|---|---|---|---|---|---|
| G4 | Leylandii X<br><i>Cupressocyparis Leylandii</i> | 6-7 | <250 | Up to 4m on east | 1 | SM | 10 | F | Very dense line of Leylandii planted to screen the boundary. Not topped but trimmed at low level on the east side. Negligible roost potential. No structural faults visible from ground level. | If these trees are to be retained as a useful screen they must be topped at 2.5m or lower and properly trimmed. | U | 3.0 |

| Tree | Category | Recommendation |
|---|---|---|
| G4 Leylandii | U | If these trees are to be retained as a useful screen they must be topped at 2.5m or lower and properly trimmed. |

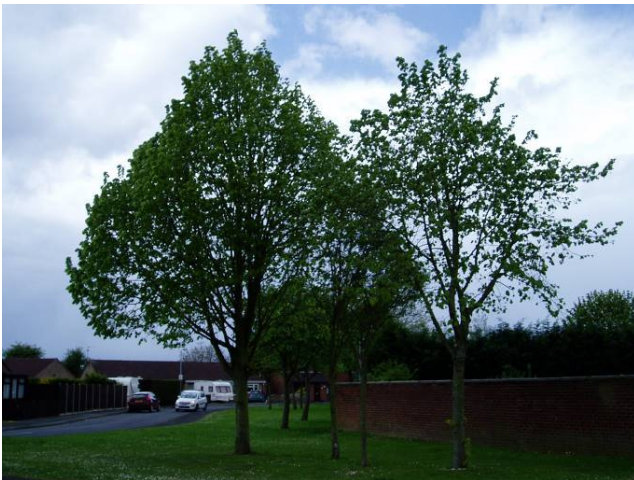
These trees are outside of the site being considered for development but reasonably close to the boundary wall. These are all specimen trees of small to medium stature planted in the grass verge along Pennyfields outside of the boundary wall. T5 – T8 are planted as a group within which there are two Lime and two smaller Rowan. These trees are suffering from crowding but Lime T8 at the western end is still of reasonable quality and could provide useful long term canopy cover and visual amenity value. T5 at the eastern end has become unbalanced but if the crowding Rowan are removed both Lime could recover to better shape and stature. These trees are placed in Category U and B. Since they are outside of the site, the work suggested would have to be completed by the landowner or organisation responsible for these trees.

| Tree No | Species | Ht (m) | Stem Diam mm@ 1.5m | Canopy Spread (m) | Height of Crown Clearance | Age Class | Est yrs | Overall Condition | Structural condition | Recommendations | BS 5837 Category | RPA Radius (m) |
|---|---|---|---|---|---|---|---|---|---|---|---|---|
| T5 | Lime<br><i>Tilia cordata</i> | 6 | 220 | N-3<br>S-3<br>E-3<br>W-3 | 3 | SM | 10 | G | Single trunk with an upright poorly developed quite sparse crown with all lower branches recently removed. Appears to be stressed. Negligible roost potential. No structural faults visible from ground level. | None | U | 2.6 |
| T6 | Rowan<br><i>Sorbus acuparia</i> | 5 | 100 | N-2<br>S-2<br>E-2<br>W-2 | 2 | Y | <10 | P | Single trunk supporting a sparse poorly developed crown. Negligible roost potential. No structural faults visible from ground level. | None | U | 1.8 |
| T7 | Rowan<br><i>Sorbus acuparia</i> | 5 | 120 | N-2<br>S-2<br>E-2<br>W-2 | 2 | Y | <10 | P | Single trunk supporting a sparse poorly developed crown. Negligible roost potential. No structural faults visible from ground level. | Not impacted by the development. The owner should consider removing this to provide space for T8 | U | 1.8 |
| T8 | Lime<br><i>Tilia cordata</i> | 7 | 285 | N-3<br>S-4<br>E-4<br>W-4 | 3 | SM | 20+ | G | Single trunk supporting an ascending round crown crowded by T7 on the north side with low branches recently removed. Negligible roost potential. No structural faults visible from ground level. | None. Specimen tree of reasonable quality. | B2 | 3.4 |

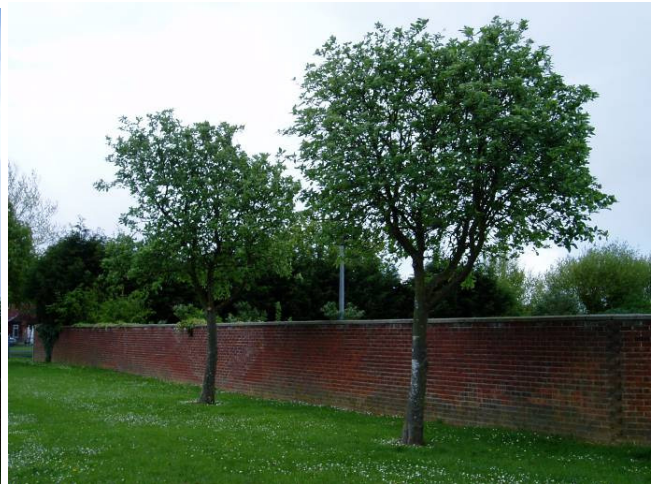
T9 – T10

Whitebeam T9 and T10 are both of good quality at the present time with no obvious defects or problems. Both are individual specimen trees of small stature planted in the road verge to the south of the proposed development area outside of the boundary wall. Both trees have good shape and sufficient space to develop into reasonable trees in this position. Both trees are placed in Category B.

| Tree No | Species | Ht (m) | Stem Diam mm@ 1.5m | Canopy Spread (m) | Height of Crown Clearance | Age Class | Est yrs | Overall Condition | Structural condition | Recommendations | BS 5837 Category | RPA Radius (m) |
|---|---|---|---|---|---|---|---|---|---|---|---|---|
| T9 | Whitebeam<br><i>Sorbus aria</i> | 5 | 205 | N-2<br>S-2<br>E-2<br>W-2 | 3 | SM | 20+ | G | Single trunk supporting a round lightly branching balanced canopy. Negligible roost potential. No structural faults visible from ground level. | None. Specimen tree of reasonable quality. | B2 | 2.4 |
| T10 | Whitebeam<br><i>Sorbus aria</i> | 5 | 200 | N-2<br>S-2<br>E-2<br>W-2 | 3 | SM | 20+ | G | Single trunk supporting a round lightly branching balanced canopy. Negligible roost potential. No structural faults visible from ground level. | None. Specimen tree of reasonable quality. | B2 | 2.4 |

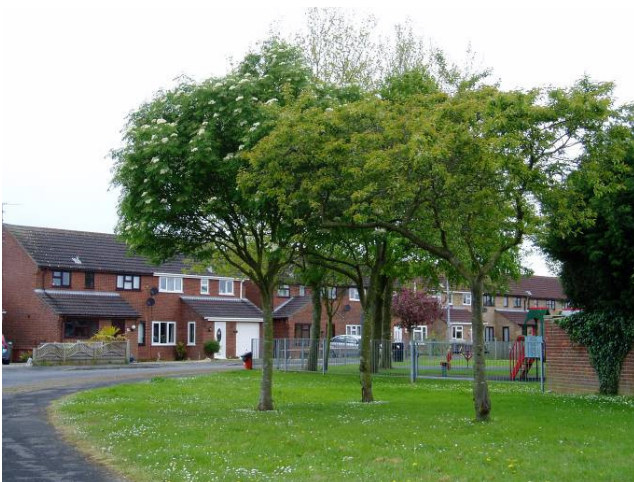
Further east is a group of three individual specimen trees T11 – T13 comprising two Cherry and One Rowan. These are also planted in the road verge to the south of the proposed development area outside of the boundary wall. These trees are placed in Category B and C. Rowan T12 closer to Pennyfields is the better quality tree with sufficient space to develop a balanced crown. Cherry T11 is of reasonable quality but Cherry T13 behind the others has limited space to develop. It might be prudent to consider removing T13 to provide additional space for the other two trees to continue to develop.

| Tree No | Species | Ht (m) | Stem Diam mm@ 1.5m | Canopy Spread (m) | Height of Crown Clearance | Age Class | Est yrs | Overall Condition | Structural condition | Recommendations | BS 5837 Category | RPA Radius (m) |
|---|---|---|---|---|---|---|---|---|---|---|---|---|
| T11 | Cherry<br><i>Prunus avium</i><br><i>Cul</i> | 4 | 150 | N-2<br>S-3<br>E-2<br>W-2 | 3 | Y | 10 | F | Single trunk supporting a round irregular crown merging with T12/T13. Negligible roost potential. No structural faults visible from ground level. | None. Tree of reasonable quality. | C2 | 1.8 |

| Tree No | Species | Ht (m) | Stem Diam mm@ 1.5m | Canopy Spread (m) | Height of Crown Clearance | Age Class | Est yrs | Overall Condition | Structural condition | Recommendations | BS 5837 Category | RPA Radius (m) |
|---|---|---|---|---|---|---|---|---|---|---|---|---|
| T12 | Rowan<br><i>Sorbus acuparia</i> | 5 | 160 | N-3<br>S-3<br>E-3<br>W-3 | 3 | SM | 20 | G | Single trunk supporting a high ascending canopy.<br>Negligible roost potential.<br>No structural faults visible from ground level. | None. Tree of reasonable quality. | B2 | 1.9 |
| T13 | Cherry<br><i>Prunus avium</i><br><i>Cul</i> | 4 | 165 | N-3<br>S-2<br>E-3<br>W-2 | 3 | SM | 10 | F | Single trunk supporting a flat topped canopy with significant dead wood in the interior suppressed by T12 on south side.<br>Negligible roost potential.<br>No structural faults visible from ground level. | Not impacted by the development. The owner should consider removing to provide space for T11 and T12 to develop. | C2 | 1.9 |
