BS5837:2012 Tree Survey  
Land north of Otway House  
Spalding Road,  
Pinchbeck  
Lincolnshire  
NGR TF 24382 25164

Survey by  
Christopher Barker CEnv dipHort ACIEEM

| | Report ref:<br><b>P1162C/ 0916 /01</b> | C B E Consulting<br>Highbank, 5 Grantham Road, Navenby<br>Lincoln. LN5 0JJ.<br>Telephone (01522) 810086.<br>www.cbeconsulting.co.uk |

# **BS5837 Tree Survey, Land NORTH OF Otway House, Pinchbeck**

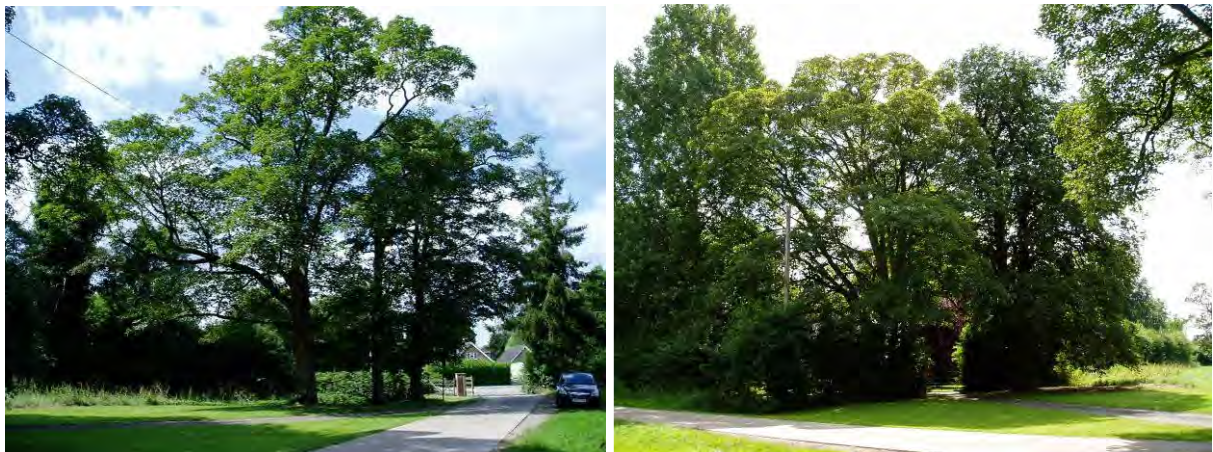
##### **Trees T1 – T5 along Otway House entrance road**

These five broadleaved trees are divided into a group of three merging together on the south side of the access road and a pair of large trees on either side of the garden entrance. These are all large broad headed mature trees of reasonable to good quality. All five are shown as being retained within the proposed development scheme and are placed in Category B2. If the access road is upgraded some root protection may be required. It is unlikely any facilitation pruning will be needed.

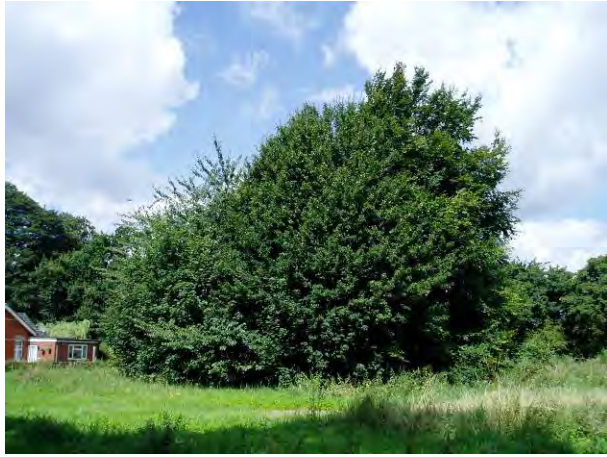
Group G6 is a dense canopy dominated by Field Maple on the eastern side which merges with Cherry, Beech and Sycamore into a dense and broad, rather irregular canopy area. This is very dense and crowded. This group is placed within Category C2 due to the crowding and likely impact on the quality and longevity of the trees that will result. It is likely some or all of this tree group may need to be removed to facilitate the proposed development.

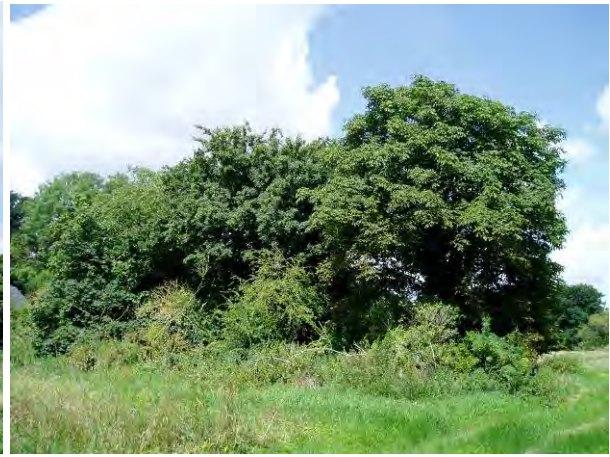
Group G7 extending across the centre

Group G7 covers an extensive area along the western boundary and extends across to the centre of the site towards T8. This linear canopy composes dense Horse Chestnut, Field Maple, Hawthorn and an occasional Purple Beech. Some of the trees within this group may be inside the margin of the adjacent garden but the density of the vegetation makes the precise location of the boundary fence difficult to distinguish. It is likely some of the trees around the margin of this group will need to be trimmed back or possibly removed. This tree group provides useful screening to the site and is placed within Category C2.

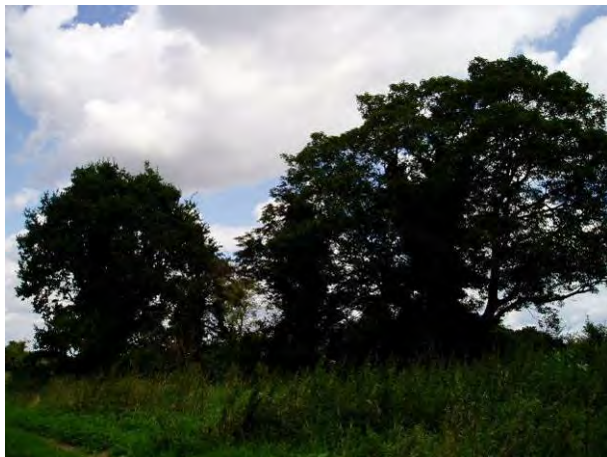
Trees T8 (right) to T11.

Trees T8 – T11 form a merging canopy extending a hedgerow line from the adjacent field across the centre of the southern section of the site. Tree T9 is a large Sycamore and this dominates the eastern end of this line of four trees with a large broad headed crown. Tree T8 is an Oak which is smaller but dominates the western end of the line of trees. T10 and T11 are smaller under canopy trees suppressed by the large trees. The development plan indicates the canopy in this location will be retained. Trees T8 and T9 are placed in Category B2. Tree T10 and T11 are placed in Category U due to the poor quality of the canopy. These latter could be removed to provide space and reduce shadow into the development area.

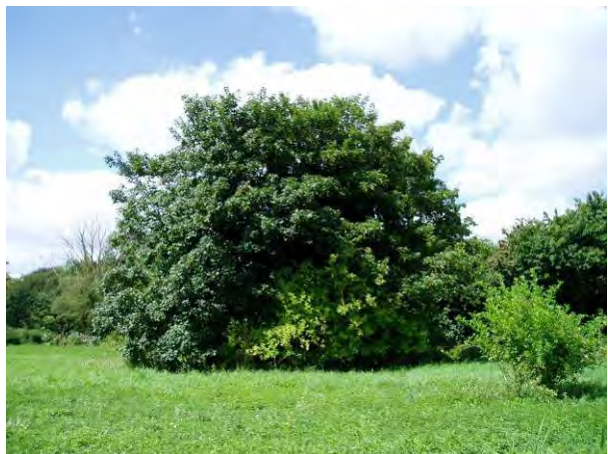
Positioned in the centre of the site Group G13 comprises three Sycamore and an Oak all of roughly similar size creating a large round canopy sitting separate from the boundary trees within the interior of the field. Whilst individually these are not trees of high quality, they are reasonable and create a large canopy area that is attractive and is shown as being retained within a landscaped area of the development. Canopy lifting and removal of under canopy seedlings would improve the visual amenity of these trees in the context of residential development. The group is placed within Category B2.

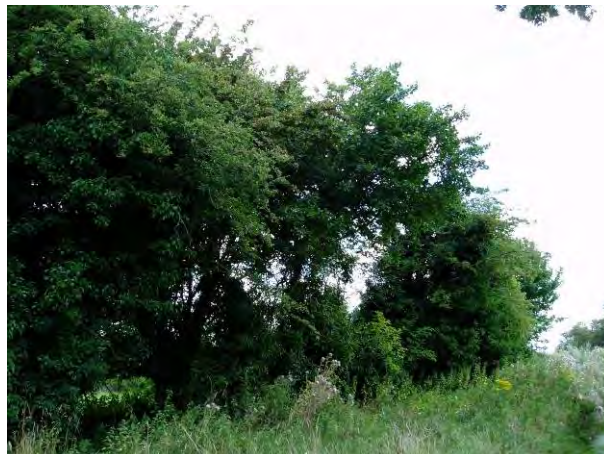
To the north of this extending across the centre of the site to a pinch point where there is a small culvert supporting an access track over the drainage ditch, Group G14 comprises untrimmed Hawthorn, Elder and Sycamore crowded with dense ivy. This is an out-grown hedgerow that will require reduction and trimming to be retained within the development. Some facilitation pruning will be needed at the western end where the access road passes close by. It is placed within Category C2.

Untrimmed hedgerow G14

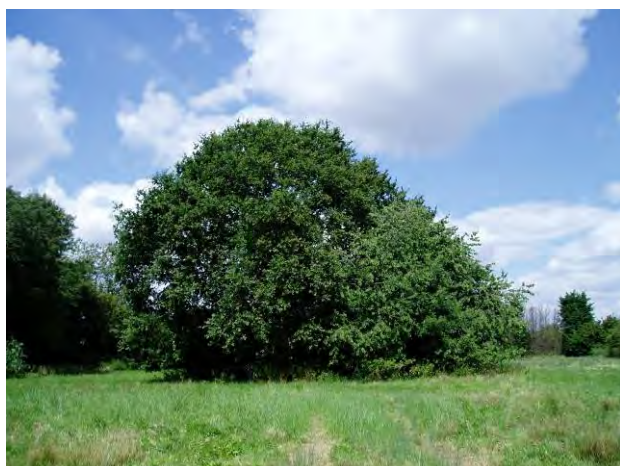
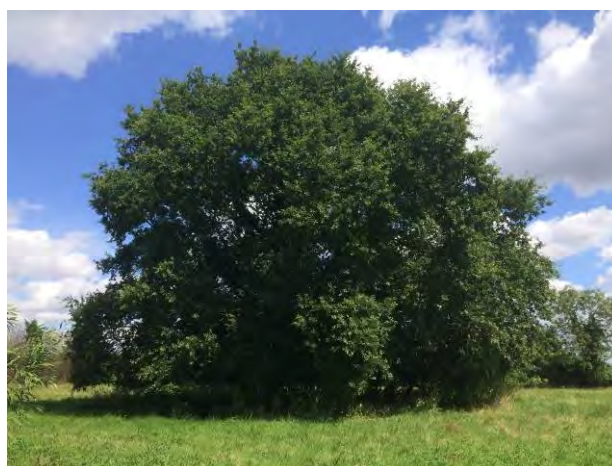
Similar to G13 this is a small group of trees sitting in the centre of the northern field separate from the boundary trees. It comprises three mature Oak trees supported primarily by Cherry with some juvenile Ash and Sycamore present. The Oak are quite large mature trees merging to found a large round canopy area. These trees are shown as being retained within the development area and are placed within Category B2. From a development context some thinning and removal of lower branches may be worthwhile to improve visibility through the small copse.

Group G15 dominated by Oak

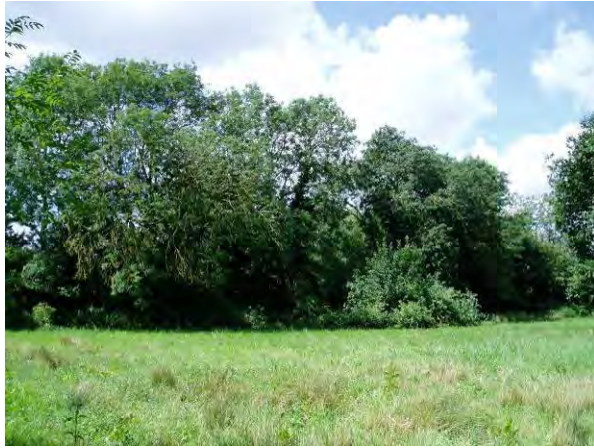
Ash within G16

These trees provide useful screening and canopy cover along the boundary but some facilitation pruning to remove low branches where these extend into garden areas is likely to be required.

There are no individual large mature specimens of great stature or high visual amenity value but the group as a whole provide a uniform screen along the boundary of significant height. These trees provide screening to large residential houses further west and are placed within Category B2. The extent of facilitation pruning required will need to be assessed once a more detailed development plan has been prepared.

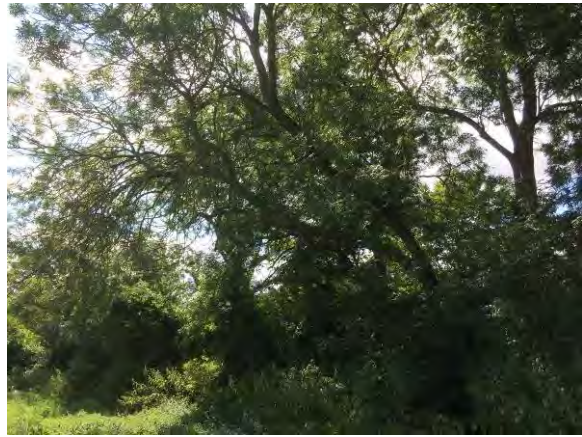
Extending branches from G16

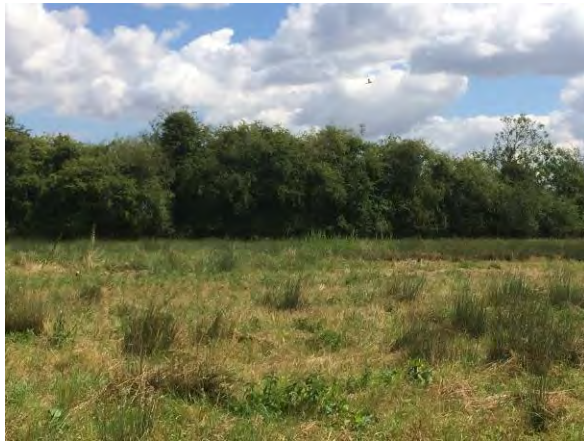
### **Tree Group G17**

Group G17 is an out-grown hedgerows running along the eastern boundary of the site. It is dominated by Hawthorn but contains a small number of juvenile and semi-mature Ash. There are no large mature trees and the group provides useful screening. It is placed in Category B2 and is likely to require annual trimming within the context of any planned development.

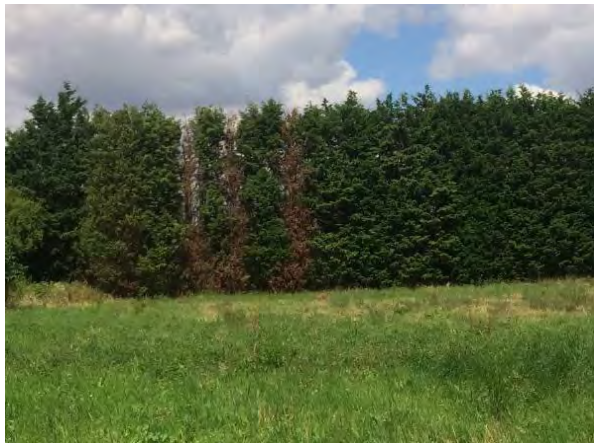
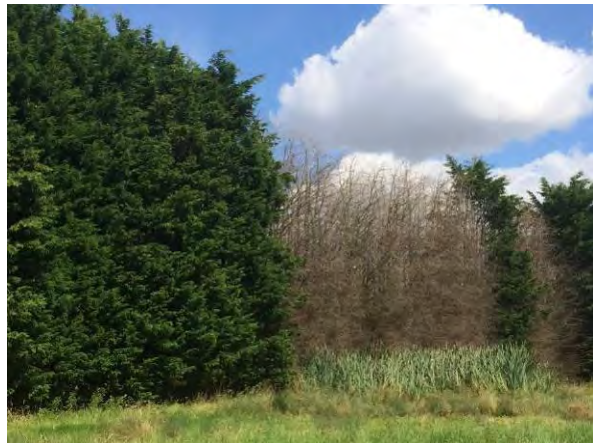
Group G18 Leylandii

The tall leylandii along the northern boundary completely screen this side of the site. Where the ground is waterlogged the trees are dead or dying as can be seen from the photographs below. This group may be along the boundary of the adjacent field. If they are within the development area they should be removed and replaced with a native hedgerow. This group is placed in Category U.

| G18 Leylandii<br>X Cupressocyparis<br>Leylandii | U | Remove dead tree. If these trees are within the site remove and replace with a native species hedge. If outside of the site trim to maintain as a hedge. |

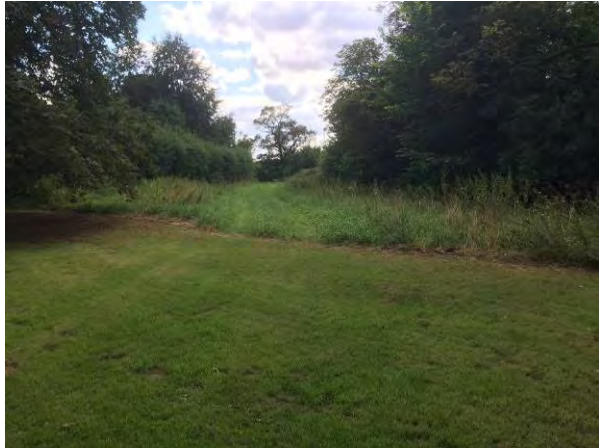
**Tree Group G19**

On the south side of the access road to Otway House lying between the field access and Spalding Road is a dense linear canopy of Elm, Horse Chestnut, Sycamore, Ash and Hawthorn with occasional Hawthorn and Blackthorn. Most of this growth is low and shrubby but individual larger trees, particularly Horse Chestnut and Ash are present creating areas of taller canopy cover. The trees are very crowded and competing for space and there are no individual mature trees of significant stature present. This group would benefit from some thinning and is placed within Category B2 as it will provide useful screening along Spalding Road for approximately 20 years.

| G19 Elm, Horse<br>Chestnut, Dying<br>Sycamore and Horse<br>Chestnut. | C2 | If retained consider thinning and removing dense ivy growth from the larger trees. Provides valuable screening and visual amenity along the eastern side of Spalding Road. |

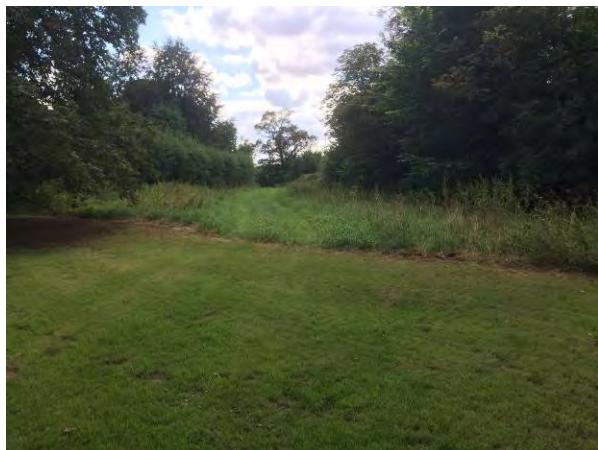
The western side of the strip of land containing the access track is occupied by a dense canopy of Elm, Horse Chestnut, Sycamore, Ash and Hawthorn with occasional Hawthorn and Blackthorn. Most of this growth is low and shrubby but individual larger trees, particularly Horse Chestnut and Ash are present creating areas of taller canopy cover. The trees are very crowded and competing for space and there are no individual mature trees of significant stature present. This group would benefit from some thinning and is placed within Category B2 as it will provide useful screening along Spalding Road for approximately 20 years.

Dense canopy within G1

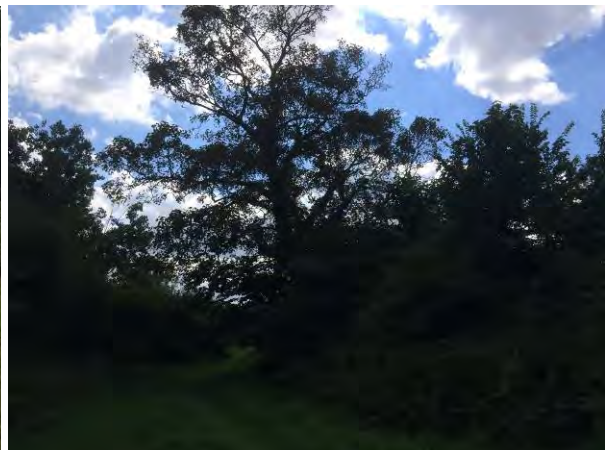
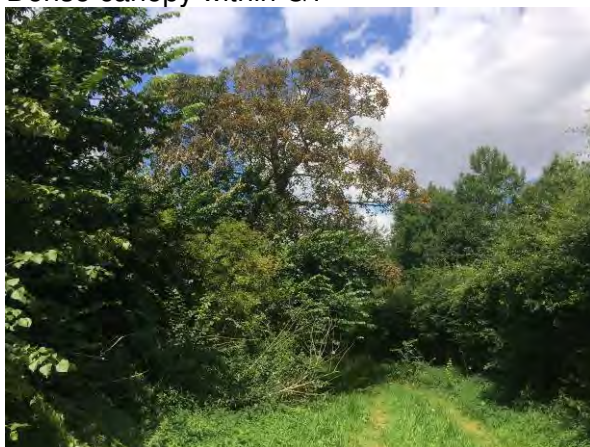
G1 and individual Sycamore T2

G1 with individual Ash t2 centre.

Sycamore T2 is situated near to the access track. This is a tall tree of poor quality with an

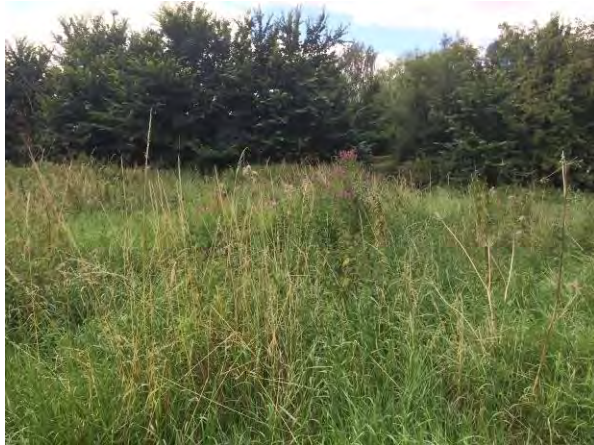
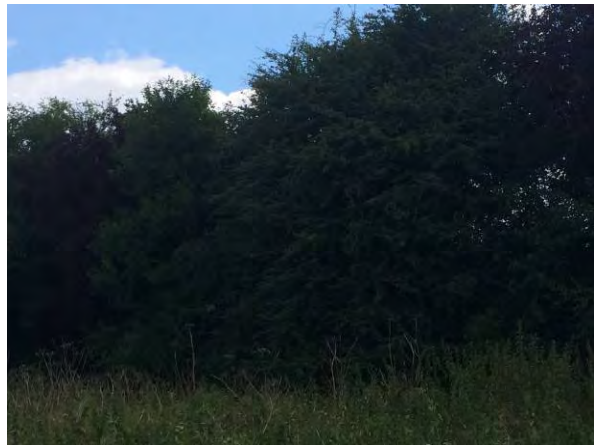
Linear tree group G3

This is a linear canopy dominated by Elm and Hawthorn with occasional Lime. It is growing as an untrimmed hedgerows providing dense screening along the western boundary adjacent to Spalding Road. If retained and maintained as a boundary screen this vegetation can provide screening for at least 10 years and the linear group is placed within Category C2.

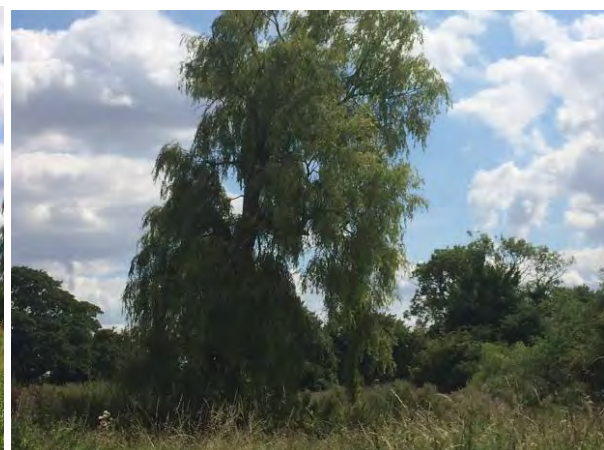
Willow T5

Nearby is a solitary Willow tree. This remnant of a once larger tree is in poor condition. The canopy is unbalanced and irregular and the single trunk has a large wound and evidence of decay near ground level. This tree is clearly in decline and it is placed in Category U and recommended for removal.

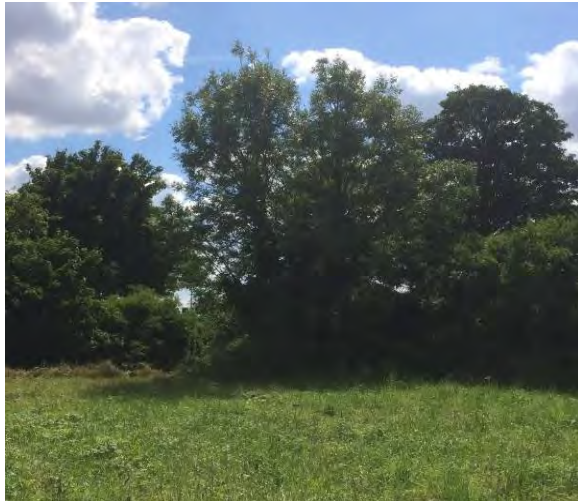
Ash T6

tree of high quality or high visual amenity value in its current condition. It is placed in Category C2 but if it is to be retained in a rear garden as indicated on the conceptual development plan, it would be prudent to remove the dense ivy growth and reduce the canopy to achieve a better shape and improve longevity.

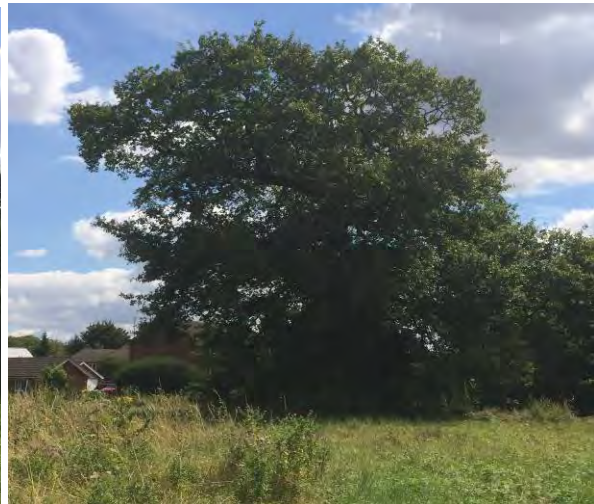
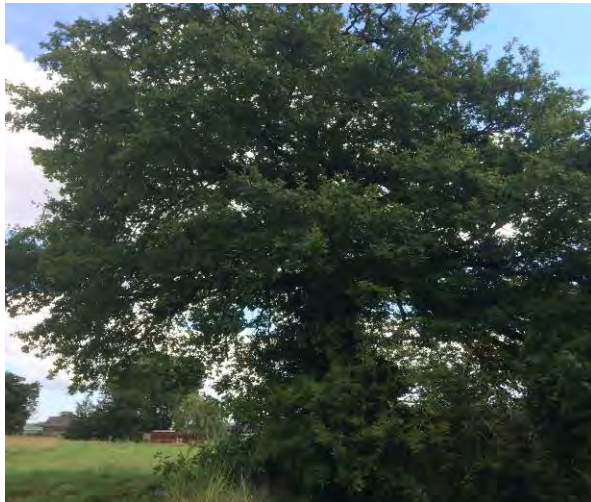
Oak T7 and T8 are both veteran Oak trees with very broad trunks and large spreading crowns typical of the species. Both have some dead wood but this is common to Oak. Generally, both trees appear vigorous and in reasonable health. Given the age of these trees, it is estimated there is at least 20 years of useful life expectancy remaining and both trees are placed in Category B1. These two large trees should be a priority for retention within any development scheme.

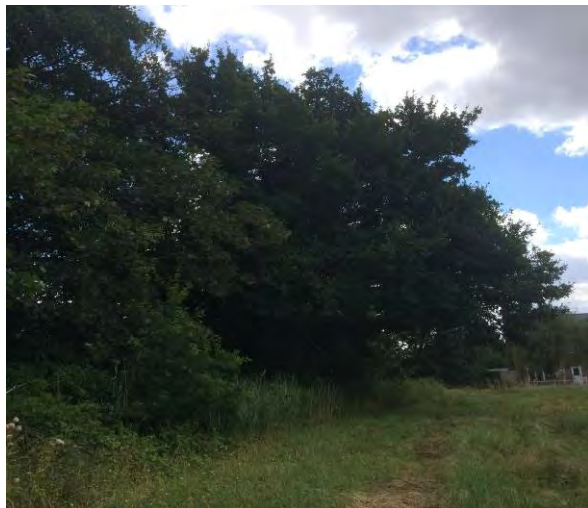
Linear canopy G10

Along the eastern boundary, anchored by Oak T8 at the southern end, is a dense linear canopy of Elm, Hawthorn, Blackthorn and Ash. This linear canopy extends along the entire eastern boundary of the proposed development area and also extends across the centre of the site area, nearly dividing it into two parts. This linear canopy is very dense in places and in need of thinning. It provides excellent screening along this boundary and is placed in Category C2. Near the northern end of this are two Ash trees, situated close enough together to form one large merging crown as can be seen in the photograph below. These are poor quality trees that appear to be in decline. Both are placed in Category C2. If retained close to houses or gardens, pollarding of these crowns may be beneficial.

| Tree | Category | Recommendation |
|---|---|---|
| G10 Hawthorn,<br>Blackthorn, Ash and<br>Elm. | C2 | Inside the Conservation Area. Dense linear canopy screening the eastern boundary. Retain. Consider thinning and thinning. |
