# Money Bridge Lane, West Pinchbeck

## Structural Condition Survey

**Project:** Proposed barn conversion at Money Bridge Lane, West Pinchbeck

**Project no:** 541

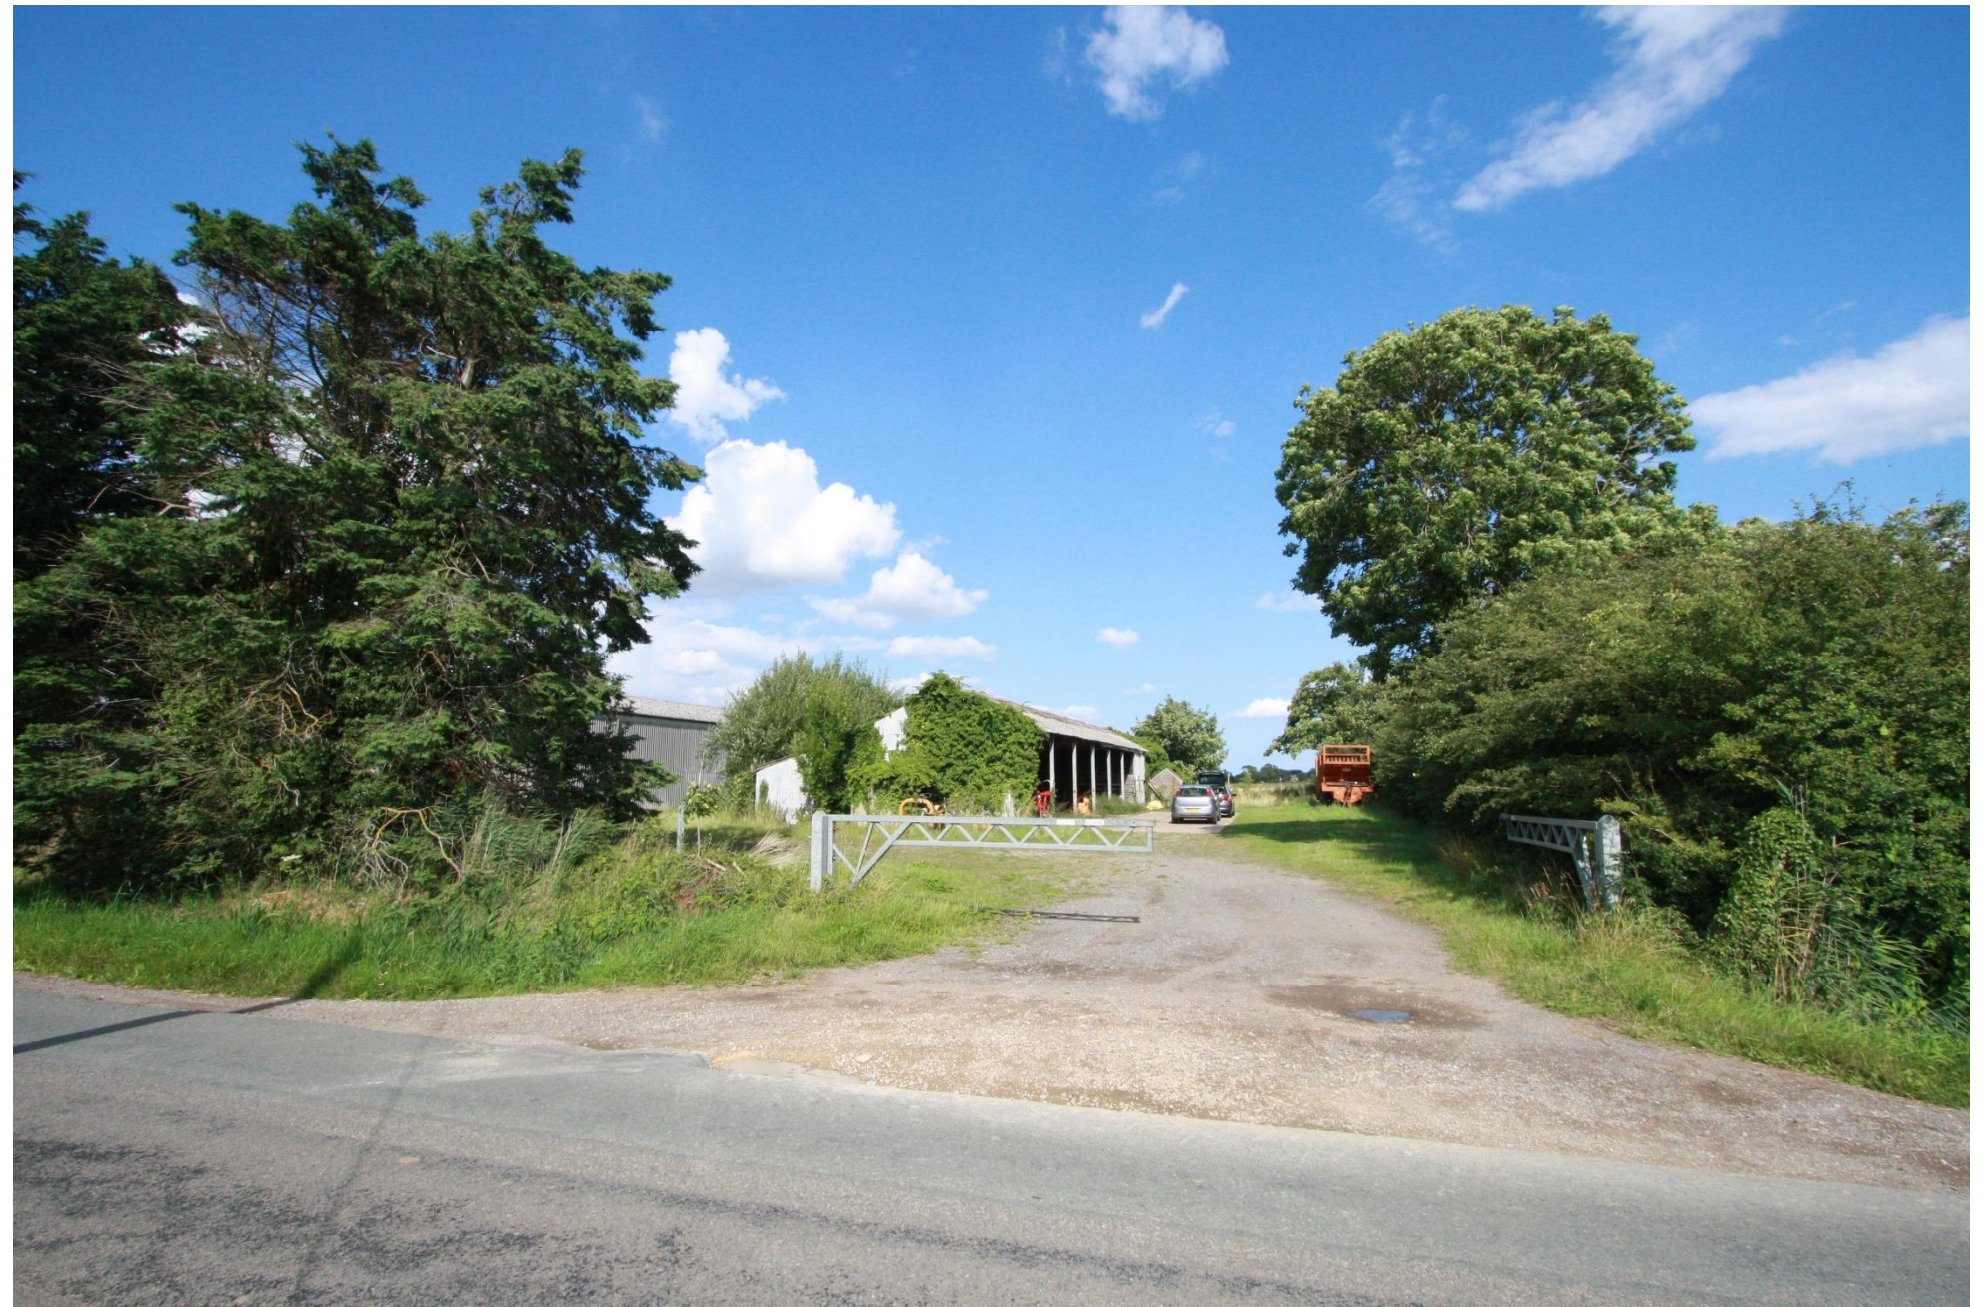
There is an existing mature hedge to the south of the building forming the southern boundary to the site. There are also several trees abutting the boundary to Money Bridge Lane to the west. There are also numerous self-sewn trees around the barn.

**Existing Hedge to the South and Trees Along Money Bridge Lane**

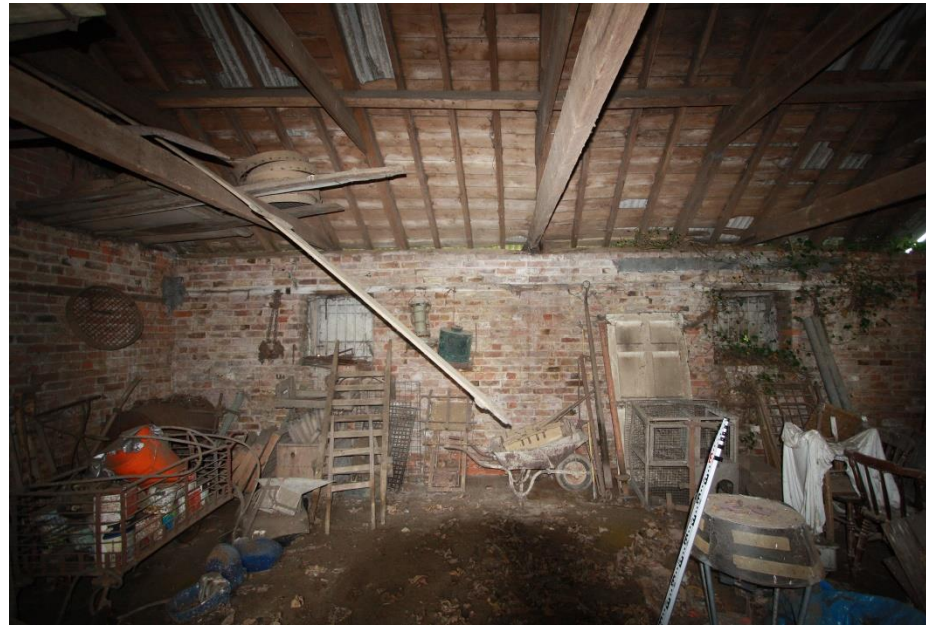
Image illustrating the good condition of the traditional roof to the brick built element of the barn

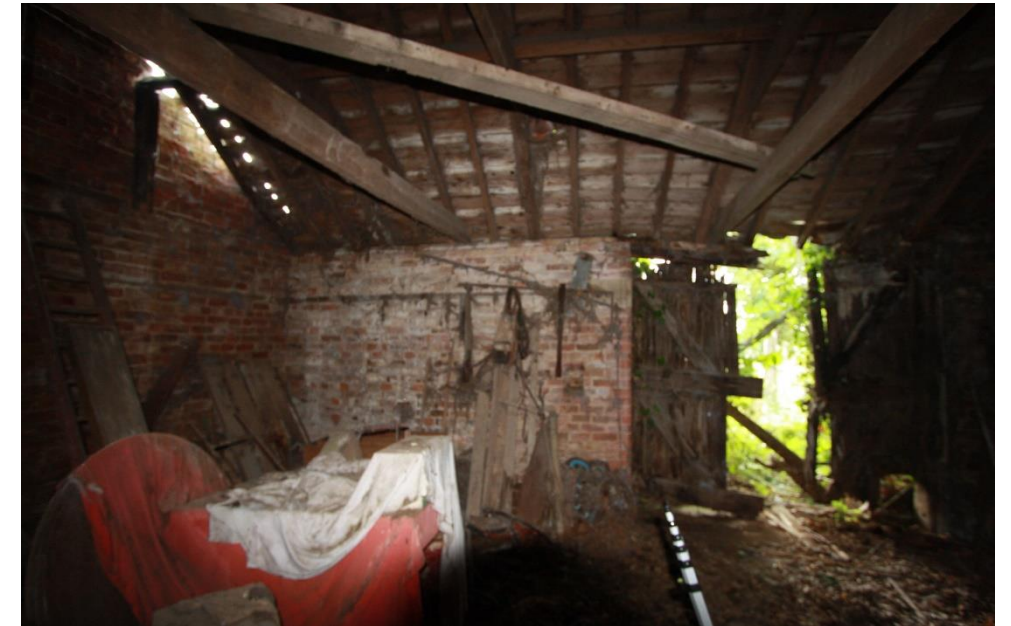
*Current Condition:* Generally the roof is in good condition. Two areas within the brick built barn to the eastern side of the barn require attention due to the failure of rainwater goods and the subsequent water damage to the roof structure. These damaged roof elements can easily be replaced or refurbished. Some minor roof sag is apparent to the lean-to type roof of the remaining barn. This is likely caused by under sizing of the purlins during construction and can be remedied by the introduction of new roof purlins where required.

Image illustrating the damage to the roof structure above the double doors at the gable verge due to the failure of rainwater goods

- All external vegetation removed from all elevations including self-sewn trees and landscaping adjacent to the building
- Damaged/ rotten rafters and lintels to the brick element of the barn replaced
- New rainwater goods installed
- Damaged corrugated metal sheets replaced
- Rotten members of windows and doors replaced and painted to protect from future damage

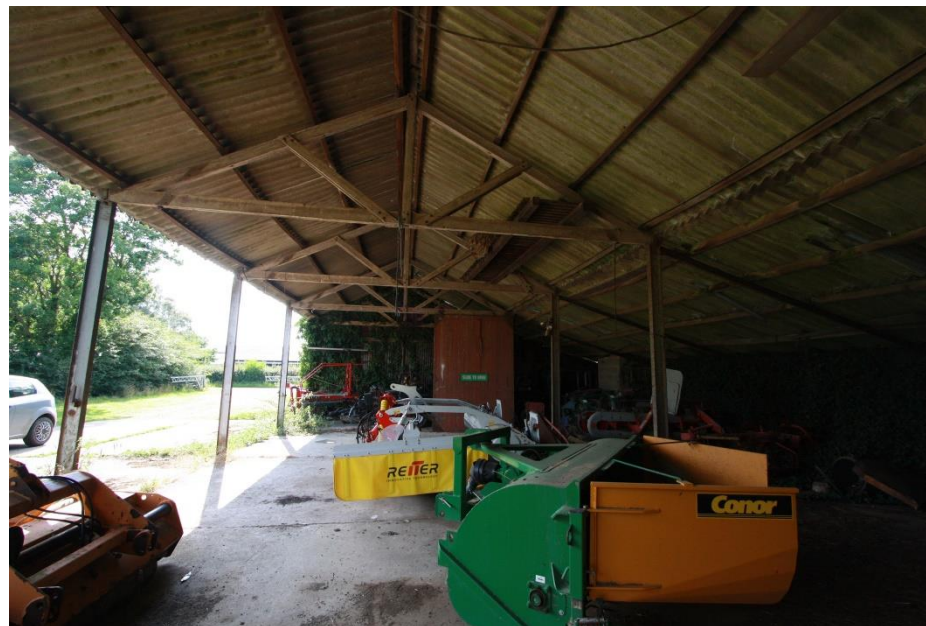
Image illustrating roof trusses with timber purlins and corrugated sheet roofing over

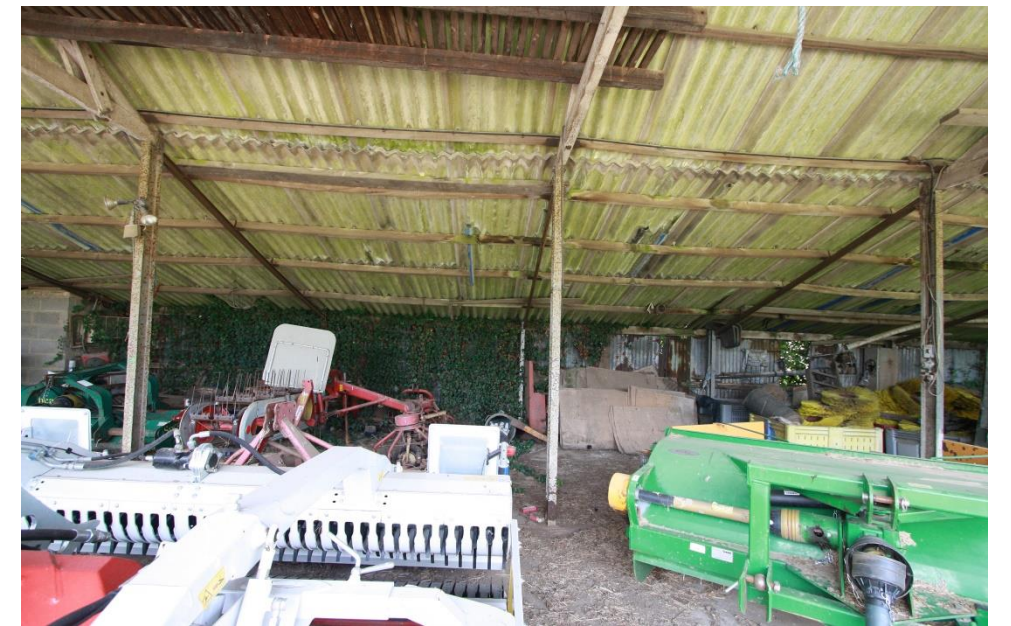
Image illustrating minor 'sag' to some timber purlins

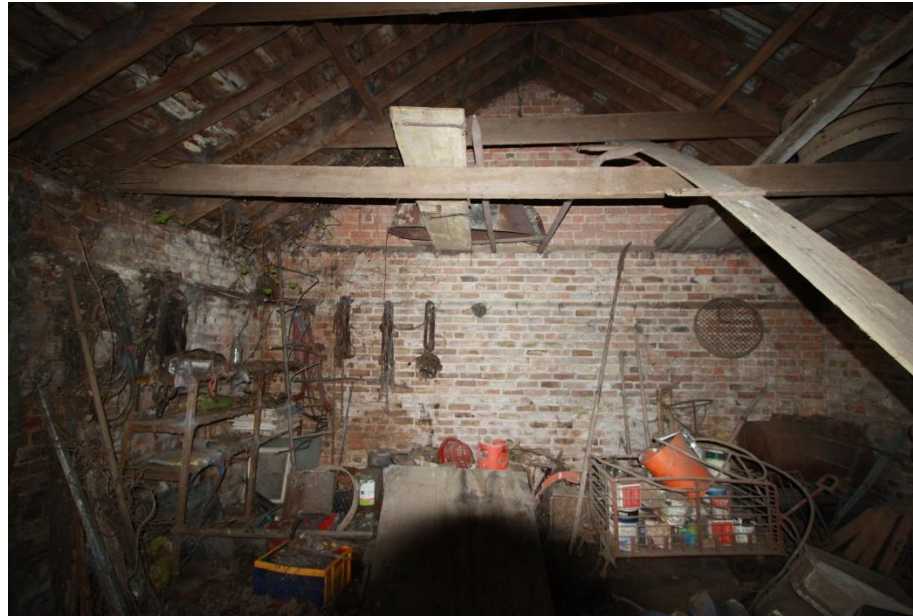
Image illustrating the good condition of the facing brickwork internally

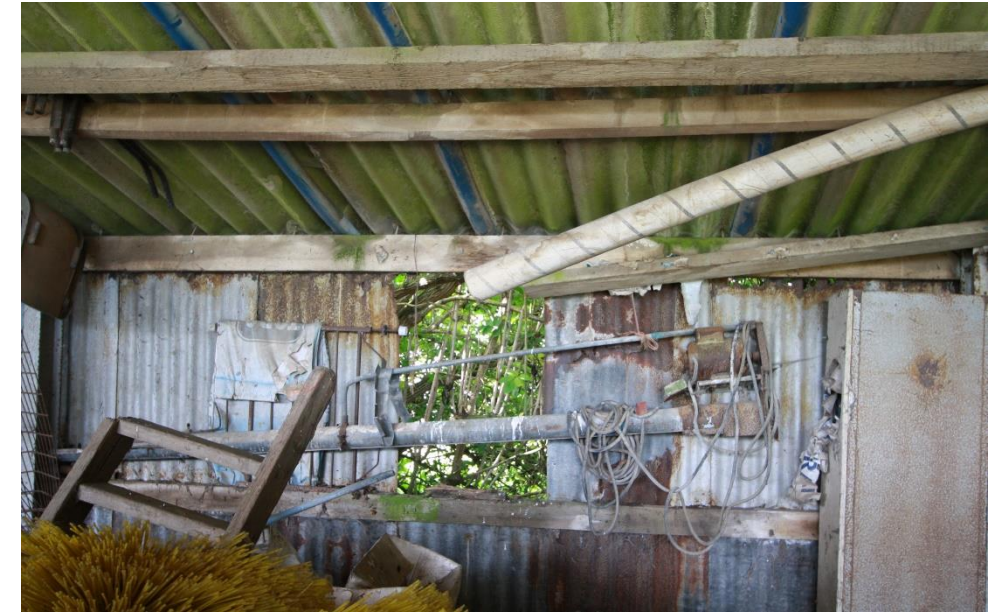
*Current Condition:* Generally both the brickwork and corrugated metal sheeting are in good condition. Some movement around openings is apparent within the brickwork element likely caused by settlement of the building due to the self-sewn trees/ scrub landscaping around parts of the barn. There are visual rust marks on most of the corrugated sheet metal cladding and small holes have started to appear in some areas. Again the likely cause is a mix of the lack of rainwater goods and branches from the self-sewn trees rubbing on the sheet metal removing the zinc coating. The angle iron structure behind the cladding appears sound and in good order for its age.

Image illustrating damage to metal corrugated sheeting

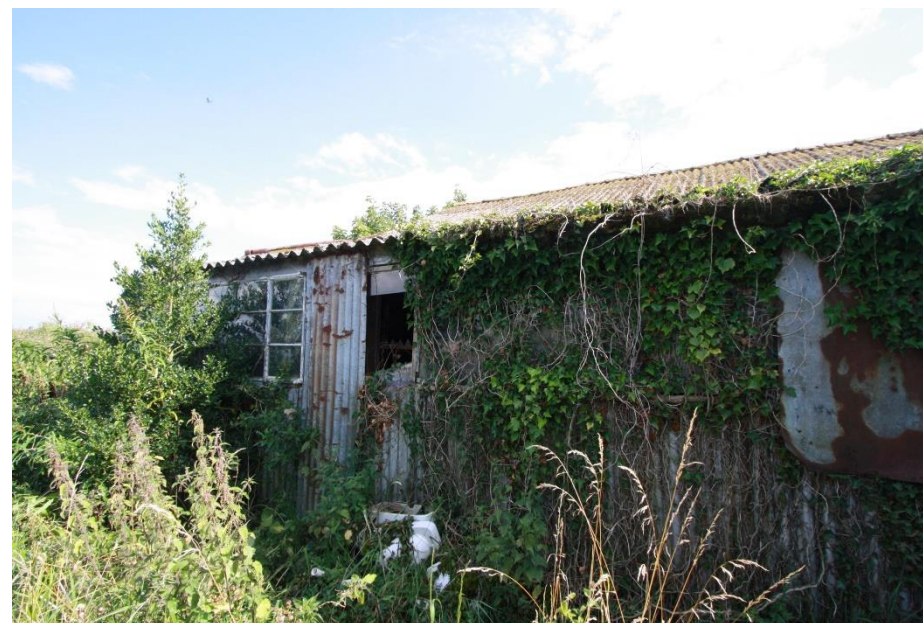
External image of steel windows and corrugated sheet metal

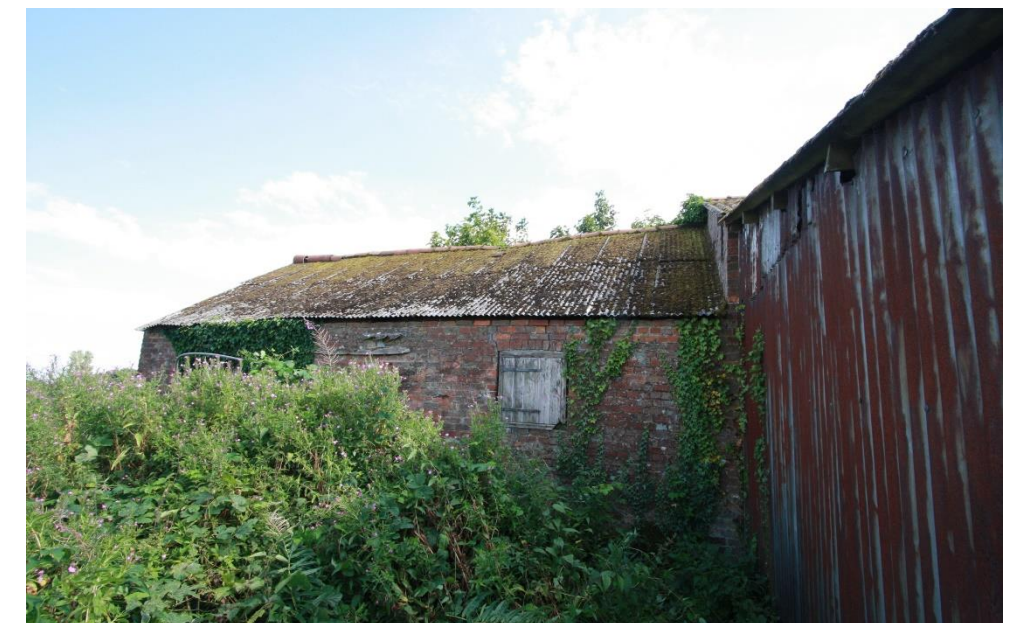
External image of brickwork northern elevation

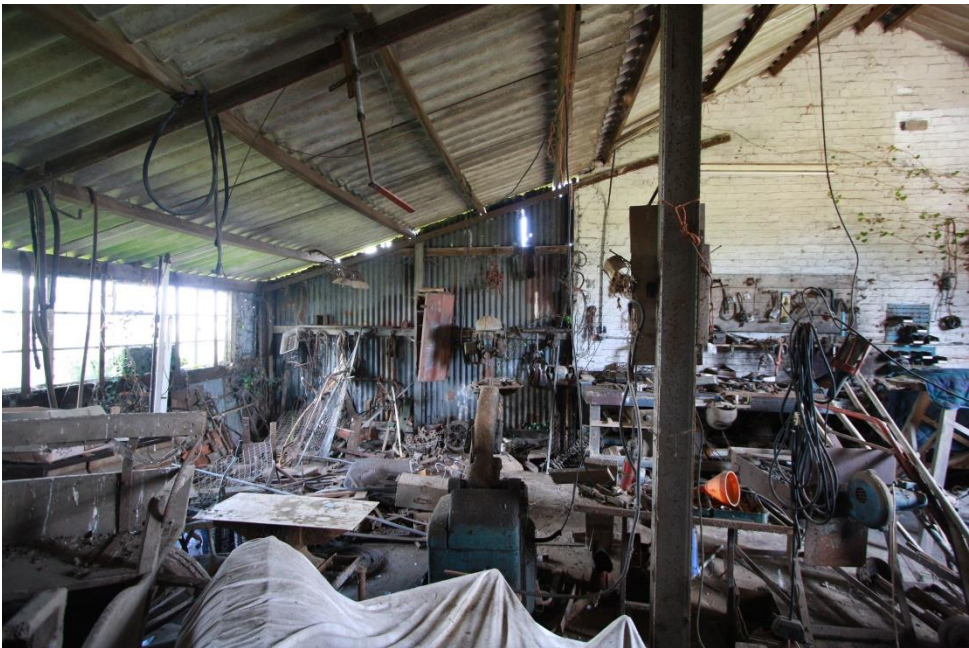
**Image illustrating painted brick wall, corrugated metal wall and steel windows**
