## STRUCTURAL APPRAISAL REPORT

**Existing Barns at;-  
The Laurels,  
Wood Lane,  
Quadring Eaudyke,  
Spalding,  
Lincolnshire  
PE11 4SS**

| <b>Reference:-</b> | JC/18/09/4660 | <b>Issued:-</b> March 2019 |

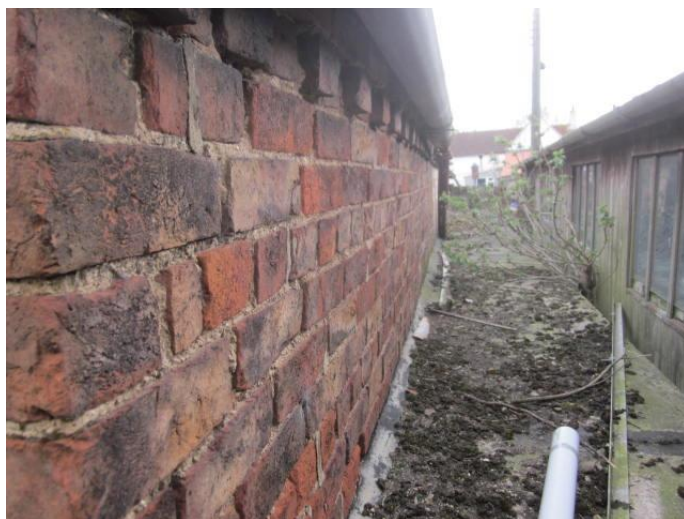
Furthermore, a 'drier tunnel' has been constructed adjacent to the flank (West facing) elevation wall at some point during the lifetime of the building. The 'drier tunnel' is constructed to a height of approximately 1.5m and is capped with a concrete slab. This arrangement continues for the full length of the flank elevation wall and is presumably tied into the barn masonry to some degree. It is likely that this structure has provided a buttressing effect to the flank wall of the barn and therefore the wall has remained reasonably plumb even though it will have accommodated lateral thrust from the effective roof structure.

**Photograph # 5** (Barn 1 – West Facing Elevation) – Dryer Tunnel Structure visible

- 5.2.2 Consideration should be given to retain this 'drier tunnel, structure as part of any conversion in order that it can continue to assist with the barns overall stability.

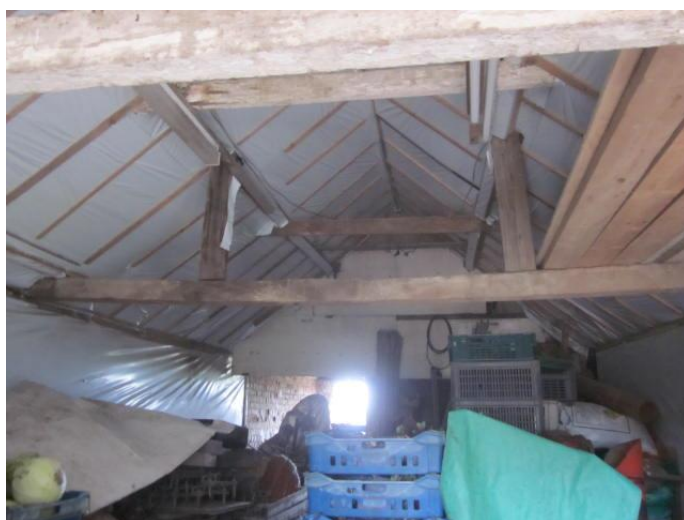
**Photograph # 6** (Barn 1 – Roof - Internal)

- 5.1.2 The roof structure could not be fully inspected due to a polythene underlining that had been placed to the underside of the roof timber, however in the areas that timbers were exposed it could be seen that the timbers were slender and predominantly untied.

- 5.1.3 The majority of the roof timbers can be seen to be accommodating significant stress with deflection and distortion noted throughout. Towards the rear of the barn, the roof incorporates a small, hipped end arrangement which can be seen to have partially collapsed.

- 5.1.4 The continued wetting and water penetration due to missing finishes has encouraged decay and the failure of timber elements.
- 5.1.5 A full replacement roof structure is deemed necessary as part of any conversion.

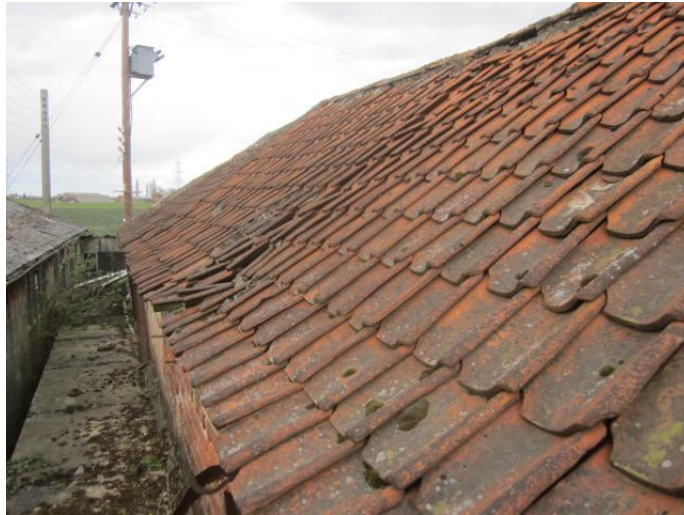
**Photograph # 7** (Barn 1 – Roof - External)

- 5.1.1 The current roof covering is clay pantile. Many areas of missing tiles were noted. It is envisaged that some of the original roof covering could be set-aside and reinstated as part of any proposed conversion scheme.

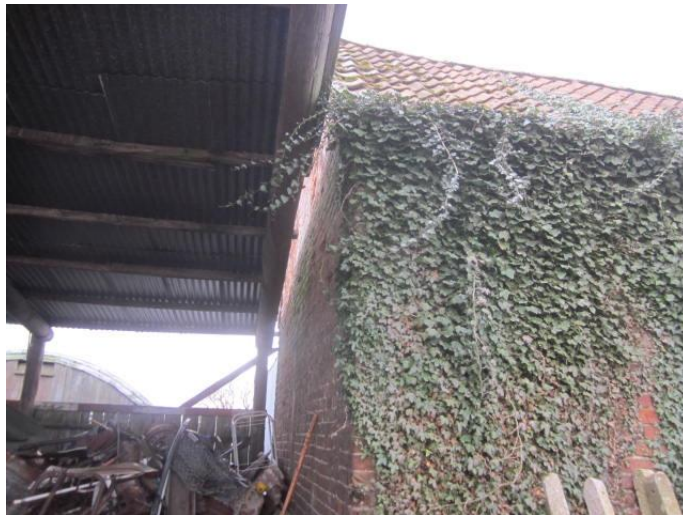
**Photograph # 16** (Barn 2 – East facing Gable Elevation)

Notable cracks were observed within the masonry of the East facing gable elevation, and also at the junction between the flank elevation and the cross wall that is located within the barn. Both of these areas can be assisted using the application of the Helifix system.

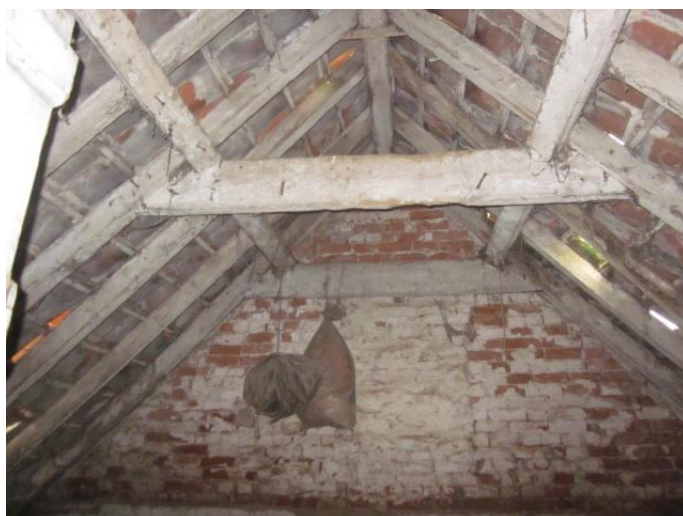
**Photograph # 18** – (Barn 2 – Roof - Internal)

- 5.3.1 Full inspection of the roof structure was not possible due to height limited access; however, the roof structure appears to have performed reasonably well. The roof is tied in parts, however, there may have been a degree of roof spread accommodated by the roof structure in the past, evident via the distortion of masonry to the rear elevation. When viewed externally, the ridge line of the roof is sagging, and dishing on the roof slopes is apparent.

- 5.3.2 The current roof covering is pantile. As such the roof has accommodated a reasonable degree of loading throughout its lifetime without undue deflection, however we cannot guarantee the long-term continuing performance of the roof in its current form and we therefore recommend that a replacement roof structure is considered as part of any conversion.

- 5.3.3 Following a more detailed inspection of the roof timbers carried out by specialists in the field of damp and timber decay it may be deemed possible for some of the roof elements to be retained, however careful consideration will need to be given to ensure that damp and timber decay are not trapped within the fabric post completion, and significant levels of new timbers may need to be introduced in order to provide an adequate degree of strengthening. Any timber repairs, including that of any decayed rafter feet, purlin / beam ends and wall-plates as advised by the specialist should be undertaken.

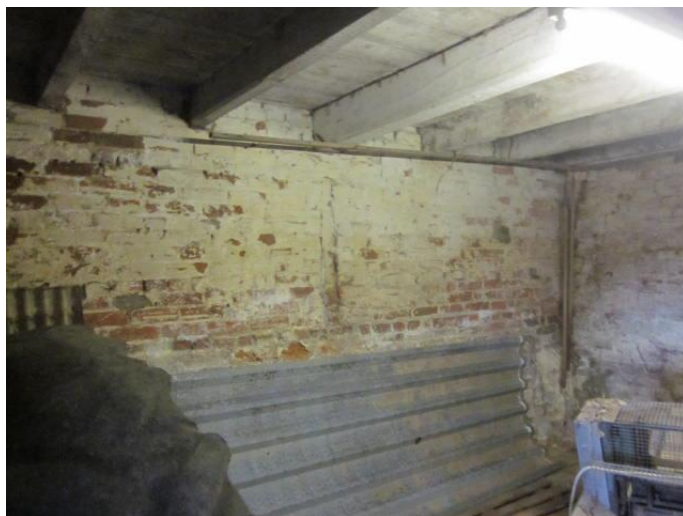
**Photograph # 21** – (Barn 2 – First Floor (underside))

- 5.5.1 The part first floor that is present within barn 2 consists of floor boards over floor joists spanning between loadbearing walls. Whilst a number of the timbers were displaying signs of decay, it is expected that the majority of the floor could be retained as part of any conversion. Any strengthening required to resist undue deflection can normally be achieved via the introduction of additional joists as required.

- 5.5.2 Following a thorough inspection by an experience joiner, together with the results of a damp and timber survey conducted by a specialist it may be deemed necessary to conduct localised repair to joists, especially at the locations where they are supported on the masonry walls. Due to previous exposure and decay it is likely that all floorboards will need replacing.
