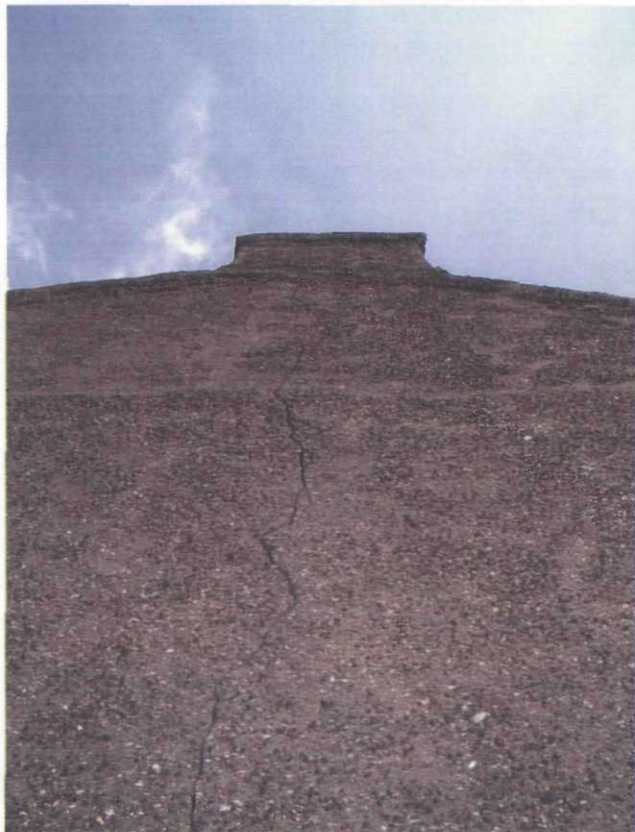
**Name:** IMGP1734

**Description:** Left hand elevation, vertical cracking/differential settlement

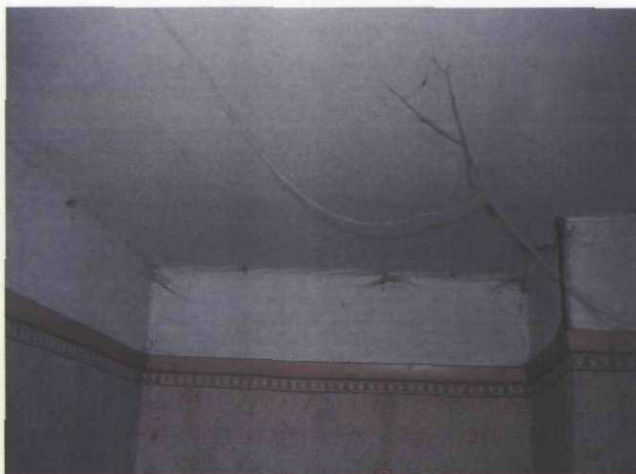
**Name:** IMGP1738

**Description:** Cracking/distortion to ground floor ceilings

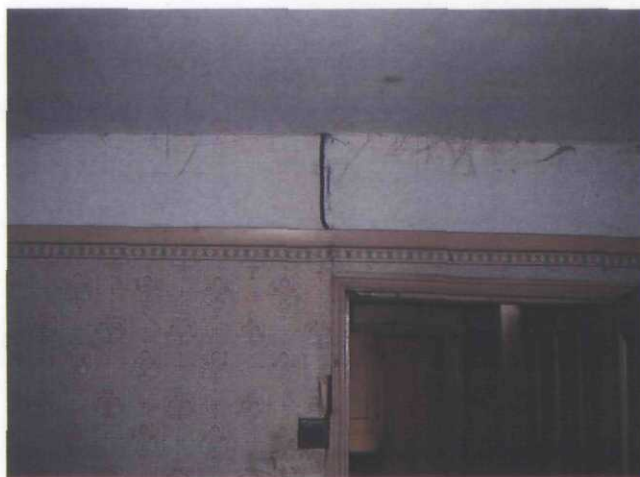
**Name:** IMGP1739

**Description:** Cracking/distortion over reception room door

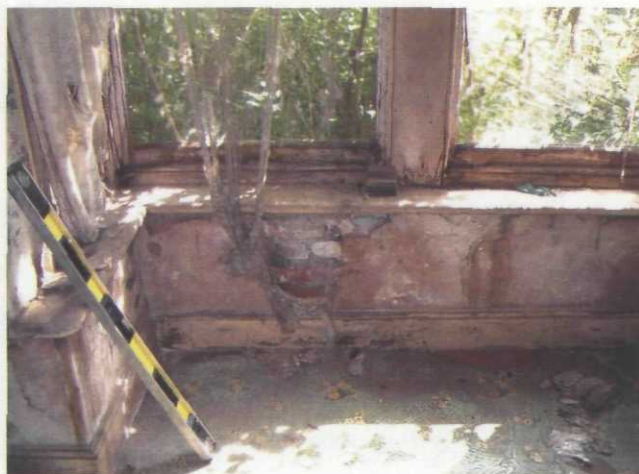
**Name:** IMGP1740

**Description:** Perished brickwork under bay window sill
