**Tree Safety Survey 16th September 2021** inspected by Sara Bright

**Spalding Grammar School**

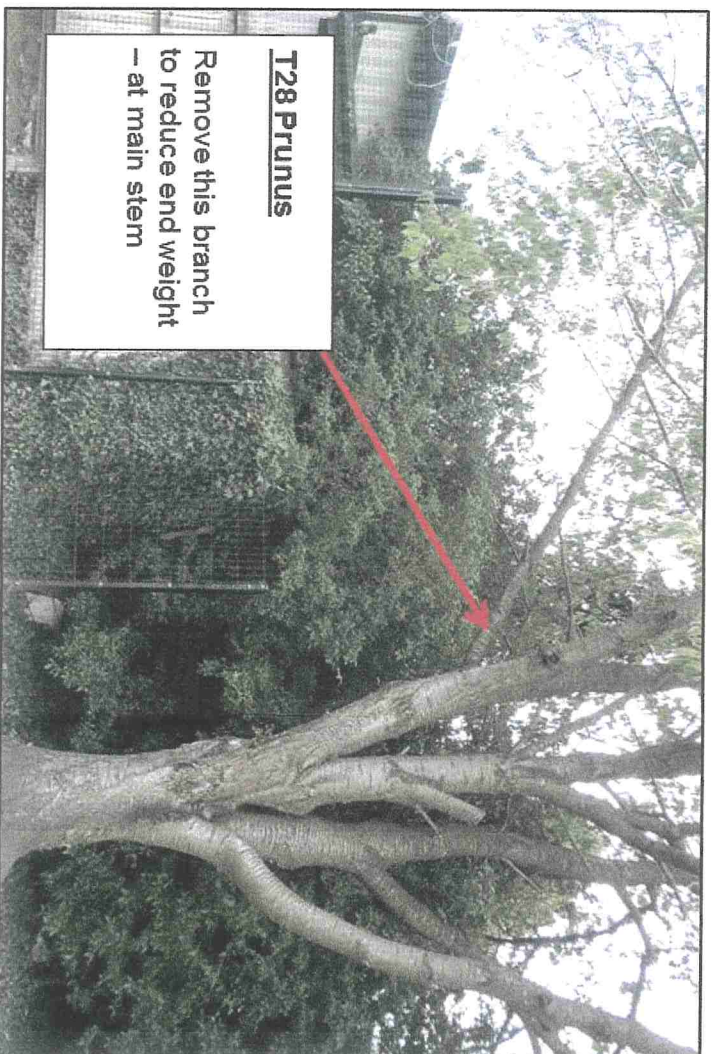
| 28 | S3 | Prunus species | mature | tree on the boundary, appears to be in moderate condition; poor pruning in past and wound development, one stem has area of decay at 2m leading to neighbouring school, some low target deadwood, OHB's to neighbour | remove one branch see photo below | 3 months |
