### **STRUCTURAL APPRAISAL**

#### **BARN**

**South Drive North  
Spalding  
Lincolnshire  
PE11 3ED**

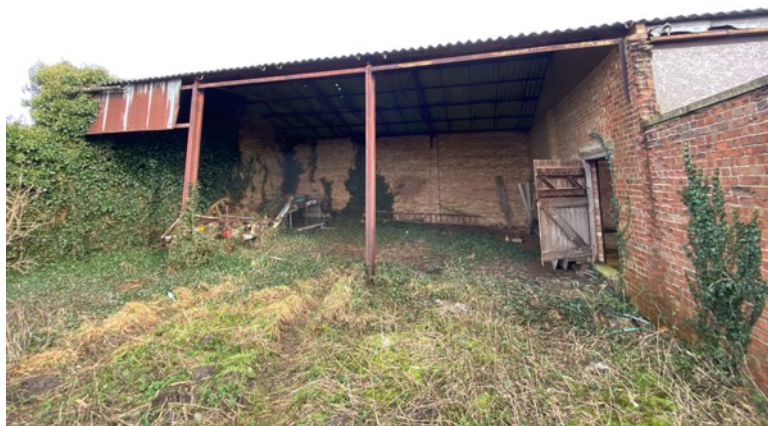
- 2.1 Part of the building has a concrete floor which, although it is highly unlikely to have a damp proof membrane, will be sufficient for domestic loading. It is likely to be a minimum of 8" thick, of coarse agricultural quality, yet with an expansion joint running on an east-west axis which will ensure its structural longevity. It would be quite capable to cover this with a damp proof membrane, insulation and a domestic floor covering, so it is adequate for residential use.
- 2.2 The open covered section of the barn has an earth structure which will require removal and replacement with a more appropriate concrete sub-base.

*The open section will require a new floor*

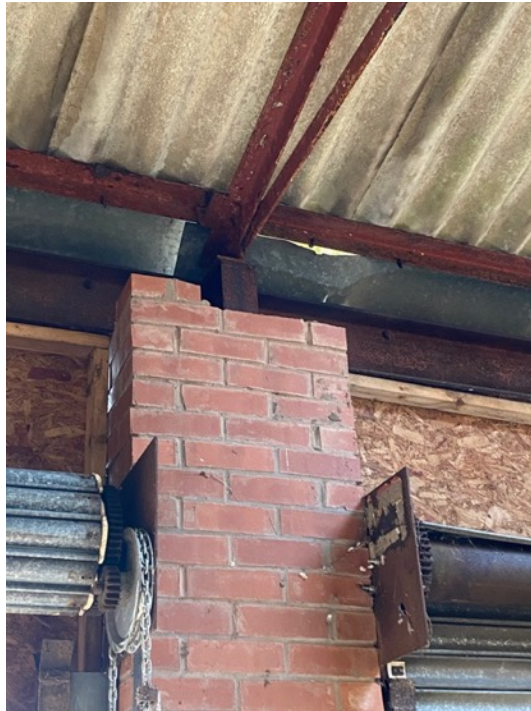
- 3.1 The walls are constructed in 225mm solid brick masonry, with intermediate supports of 300mm for additional structural purposes. The walls to the enclosed section are in good condition generally with the fletton brickwork and cement mortar in sound condition. There is a more recent engineering brick pier, in between the two roller shutters, which

provides lateral support for the steelwork sitting above and this will require some minor modification at its head where it abuts the roof, as below:

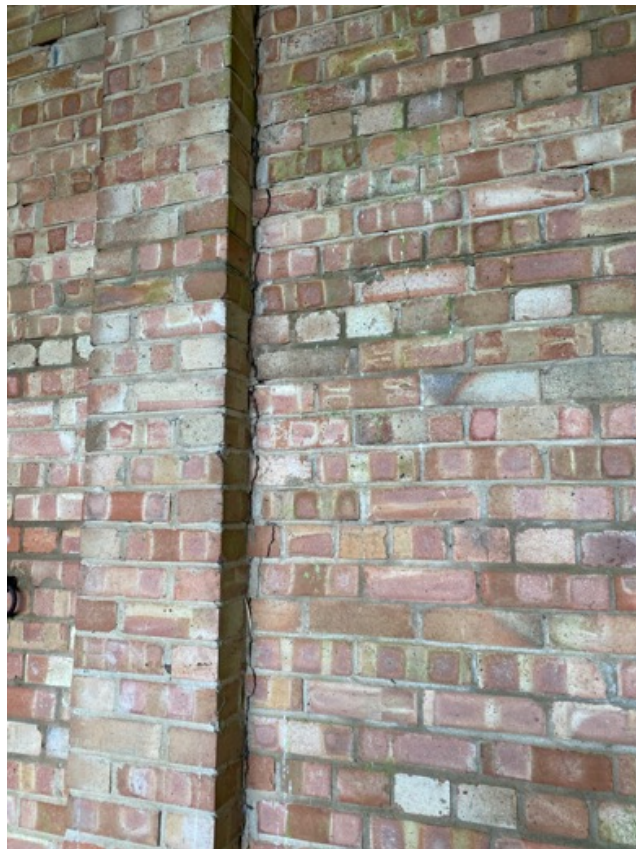
- 3.2 The open section is of similar fletton brickwork and, although there is a hairline crack running down the right hand side to one of the piers, this could readily be repaired with some straps.

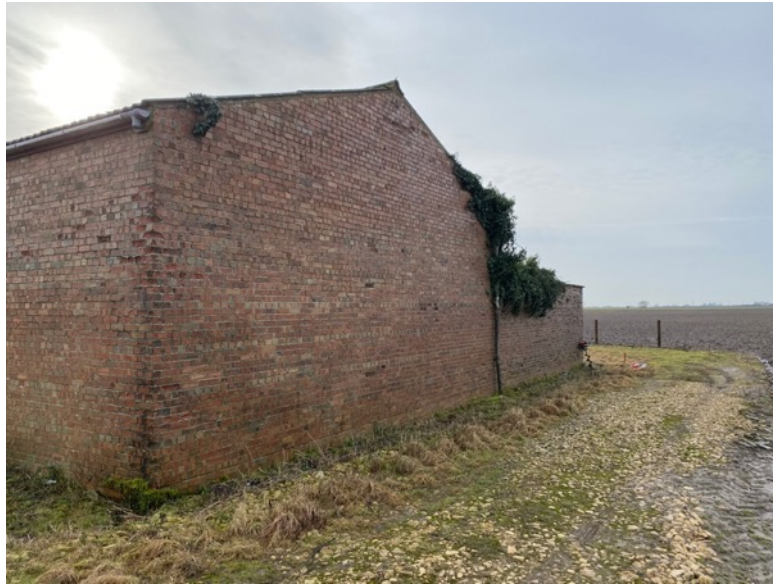
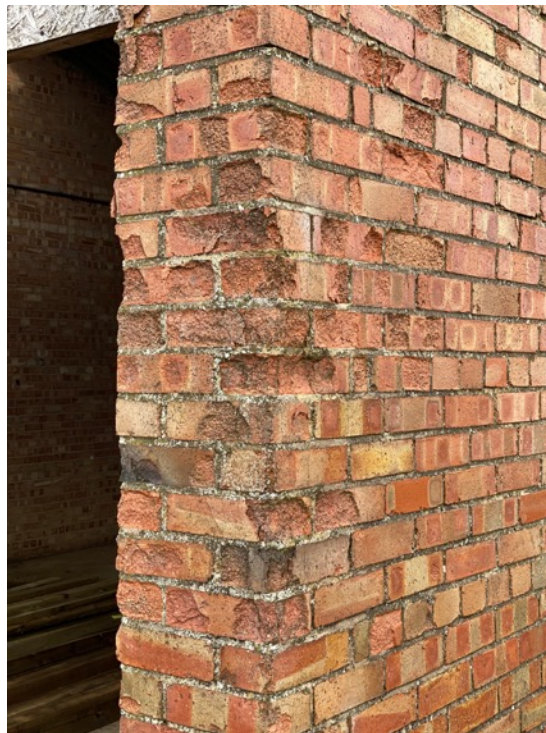
*The south west corner*

- 3.3 Externally, the brickwork is in reasonable condition although some bricks, particularly at low level on the north east corner require some repair, as below. There are several other examples of spalling brickwork but all of these are readily repairable.

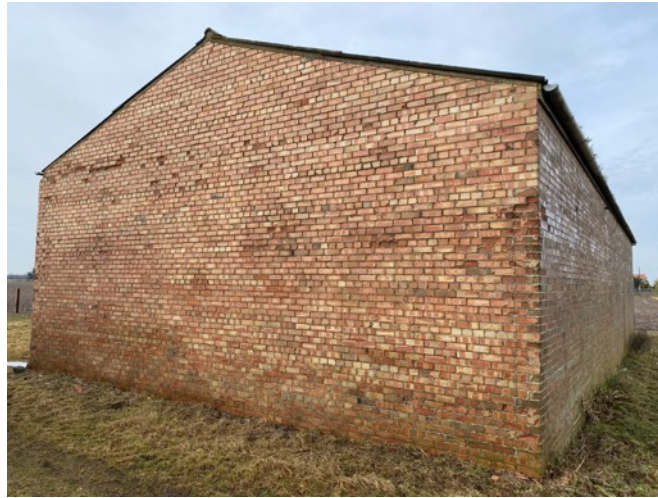
*The south elevation*

- 3.4 It may be appropriate to clad the building in timber, or some other weathering material which will prevent any further deterioration in the brickwork. There are several minor

hairline cracks running vertically through the external brickwork which correspond with the crack internally adjacent to the pier and the abutment of the two spaces – this is probably due to thermal expansion and an external cladding and dry lining internally will provide the necessary weathering/support.

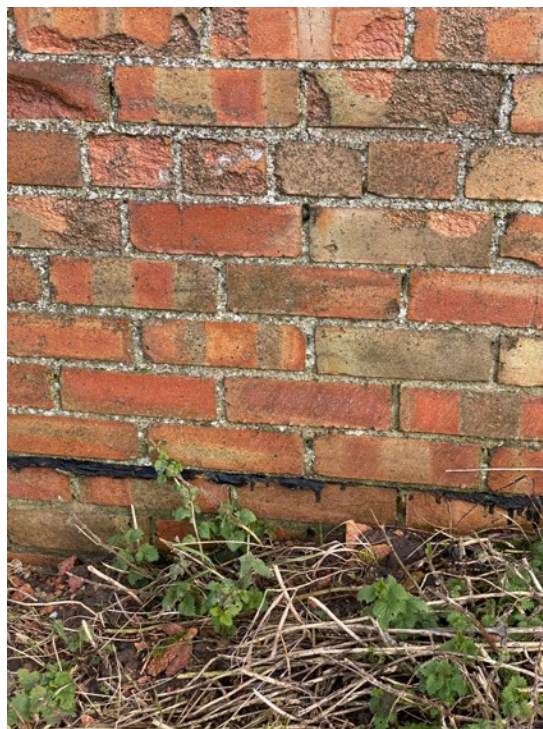
- 3.5 Essentially, the brickwork is reasonably sound and capable of use as an external wall for the building subject to additional weathering to domestic standards and dry lining internally to allow for compliance with Part L of the Building Regulations (thermal performance).
- 3.6 Strangely, part of the open section of the barn has an historic damp proof course which does not appear to be evident elsewhere on the building. Clearly this was part of a much bigger structure originally as a study of the historic plan suggests.

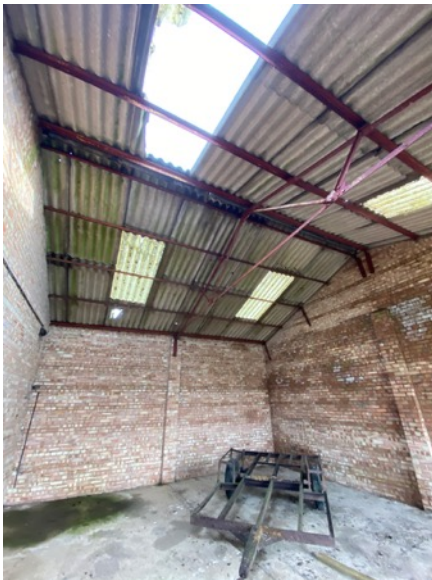
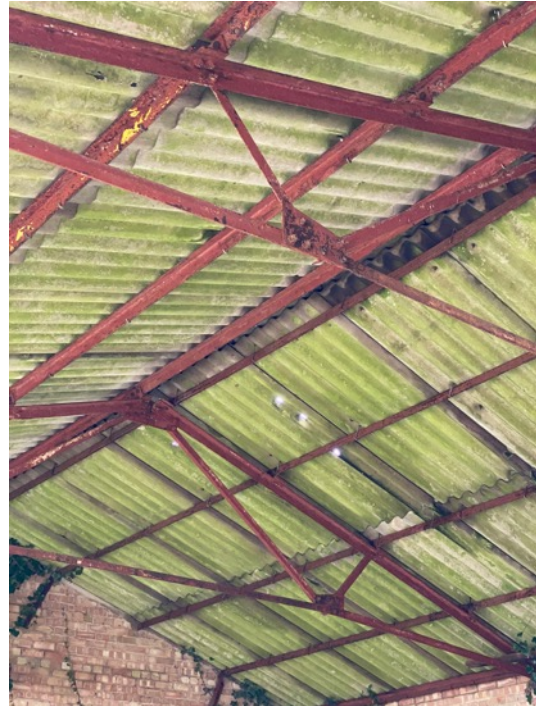
- 4.1 The roof covering is asbestos and this will, of course, have to be removed and disposed of in accordance with current legislation. It could then be replaced with a flat roof system which will sit on the existing steel trusses.

- 4.2 The steel trusses are in reasonable condition although they all require shot blasting and re-priming to prevent any further rust. Given that they have been subject to some leaks in the roof they are in decent condition and would be capable of taking the loading from an alternative roof covering, subject to Structural Engineer's calculations. However, the additional support to the roof structure that will be provided by internal partitions etc., should be sufficient to enable the roof structure to remain in place. It is the one area of structure which will require some detailed attention for Building Regulations compliance as the roof covering will have to be removed and replaced with (most likely) a heavier material.
