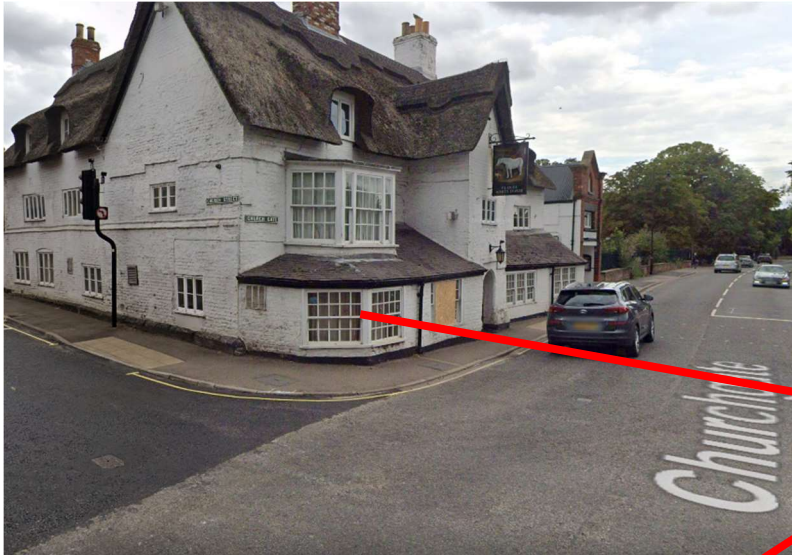
Image from Google images

This is a google image prior to the collision, this is effectively 2 damaged sliding sash windows making up the one corner unit shown in this image.
