**STATEMENT OF THE CONDITION OF THE
FABRIC OF THE BUILDING AT The UPPER FLOORS**

**CONVERSION OF FIRST, SECOND AND THIRD FLOORS
TO RESIDENTIAL FLATS TOGETHER WITH
ALTERATIONS TO SHOPFRONT AND REAR OF BUILDING**

SPALDING NEWS 24 MARKET PLACE SPALDING

Statement regarding the condition at 25.06.25.

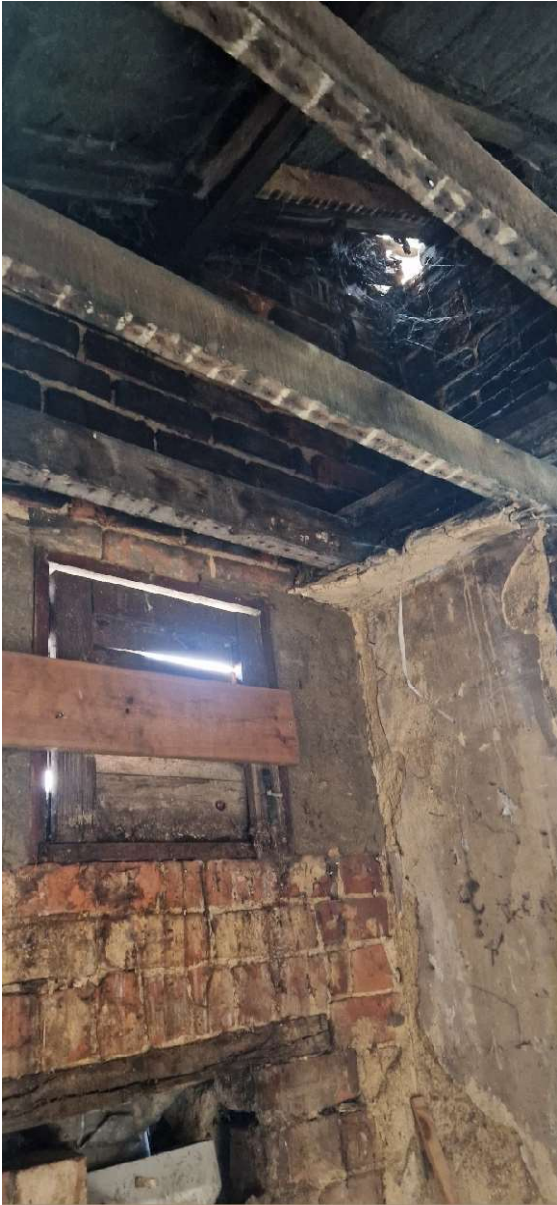
The roof is finished with concrete interlocking tiles and is continuous from eaves to ridge. The front slope of the roof is slate. The rear slope roof covering is generally complete although there is one missing tile on the rear slope near the ridge which may correspond with a hole in the roof visible from inside. There is one chimney which appears to be flashed and sealed appropriately.

There are two openings, one at second floor level and one at third floor level, which have timber panels both of which have gaps between panels and frame.

Hole at high level in roof and hatch below with gaps between panel and frame

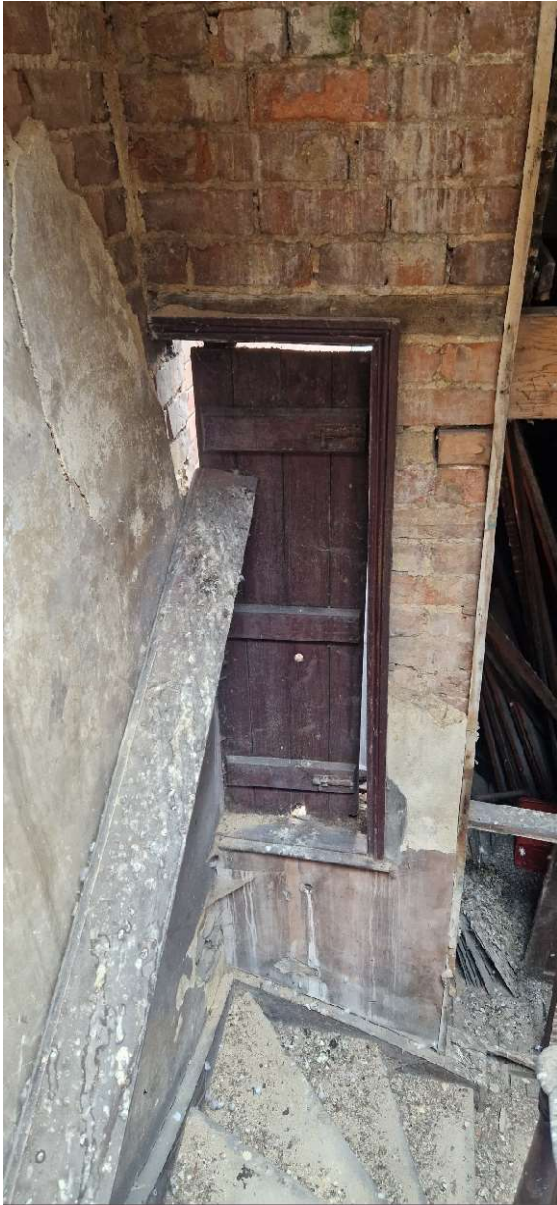
Hatch at first floor level with gaps between panel and frame

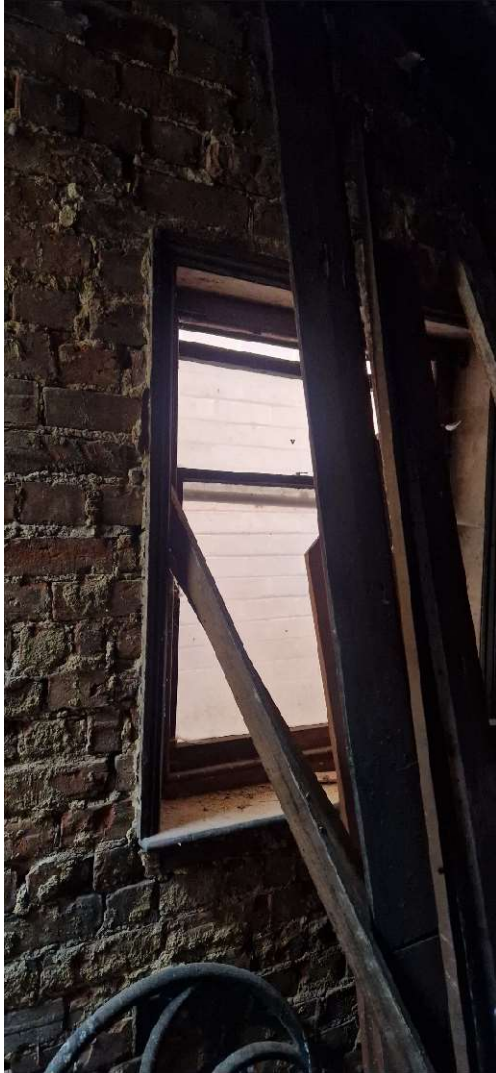
The windows to the front elevation are glazed in timber frames, windows at the rear are metal framed. All units visible appear intact. There is no cracked or broken glass. One window at second floor level towards the rear was slightly open at the time of inspection.

Slightly open window at first floor level

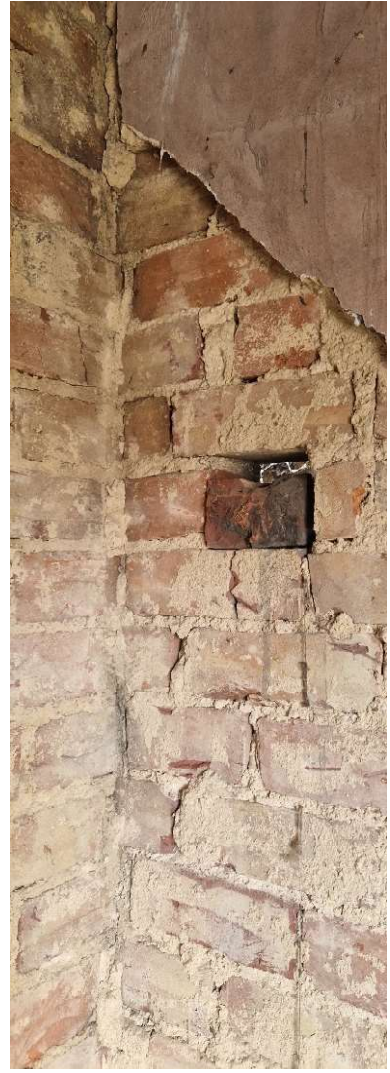
The walls appear to be generally sound, there is one small hole in the brickwork on the top floor.

Small area of missing brick, partly blocked

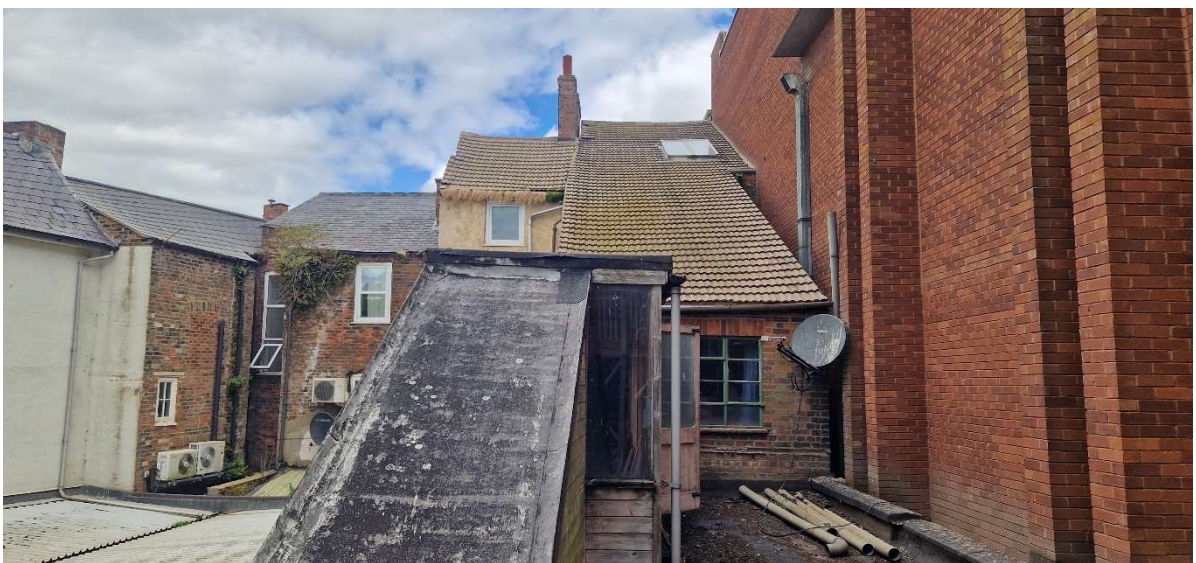
Rear elevation from flat roof

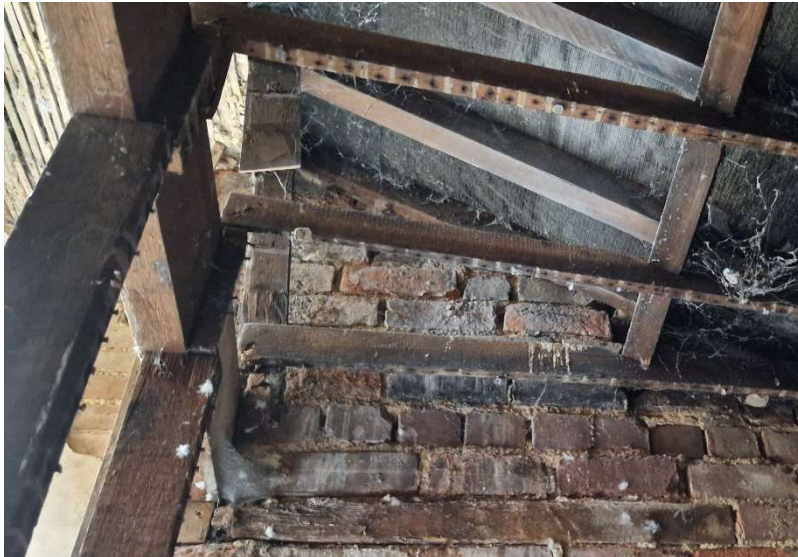
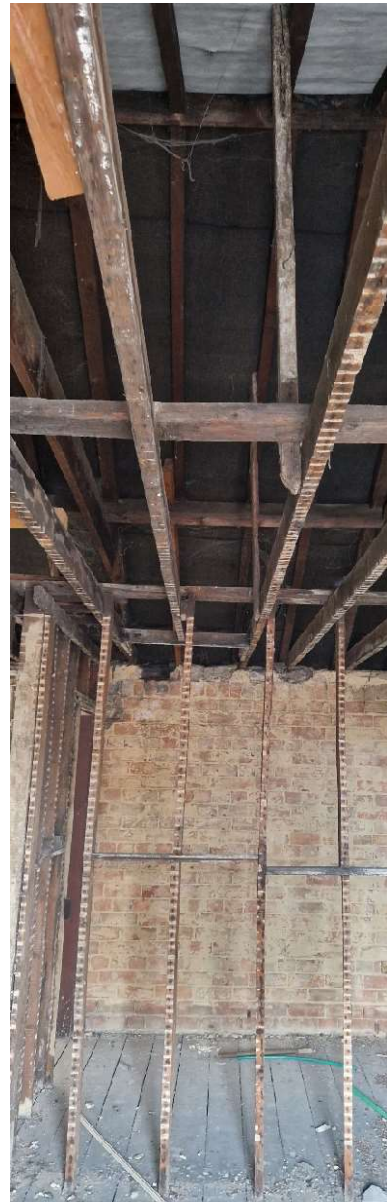
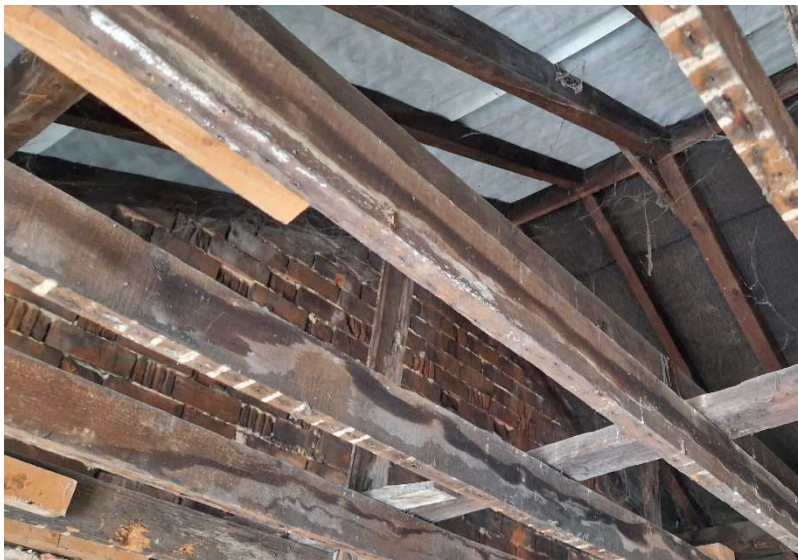
The Roof timbers are exposed internally and the underside of the roof has roofing felt which appears to be intact.

General internal views of roof
