Gas Membrane Installation  
Validation Report  
Seagate Homes  
Millfield  
Phase 2  
Spalding Common  
Spalding  
PE11 3JZ  
V1 07/10/24

## Appendix 1 – Site Survey Sheets

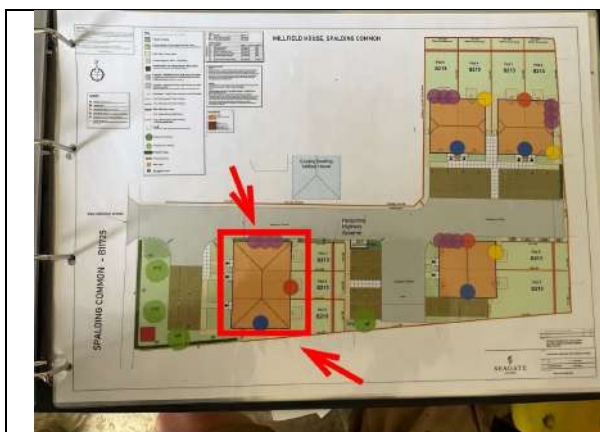
Area highlighted is where today's inspection took place.

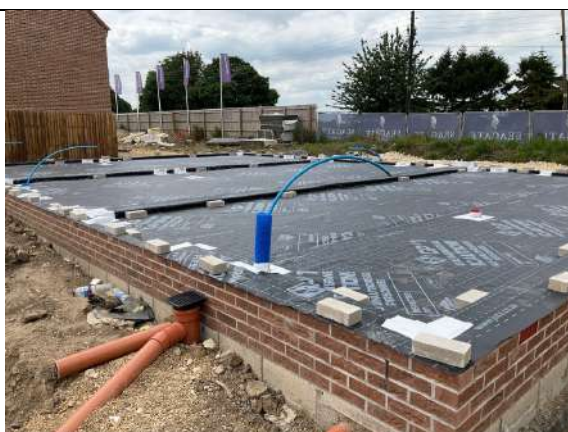
Overview of the full footprint installation to Plots 1-2-3.

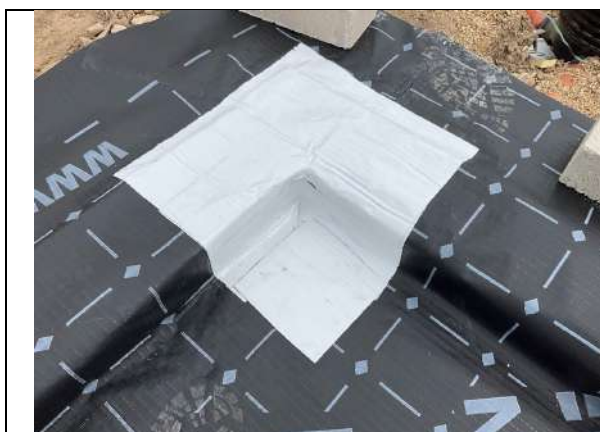
Plot 1. Corner details were sealed using SAGM.

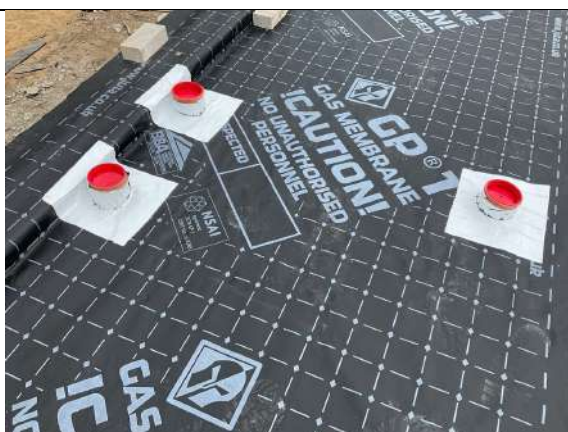
Plot 1. All pipe penetration's were sealed with SAGM.

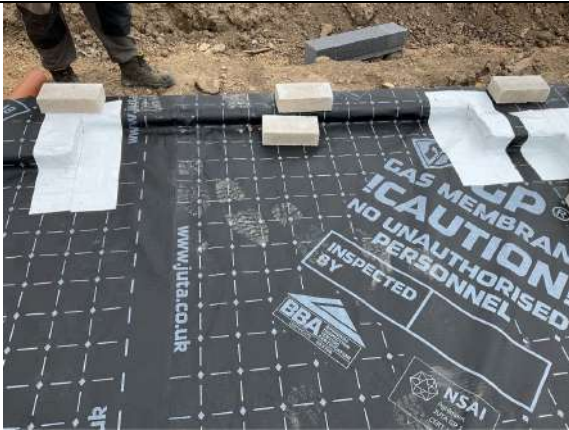
Plot 1. Door threshold details successfully sealed using SAGM.

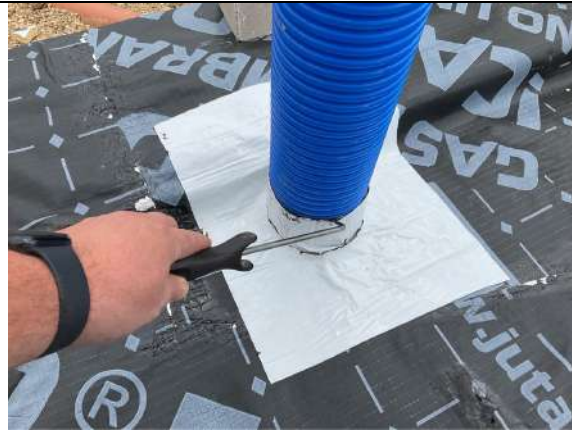
Plot 1. Pick & probe test to sealed pipe penetration's.

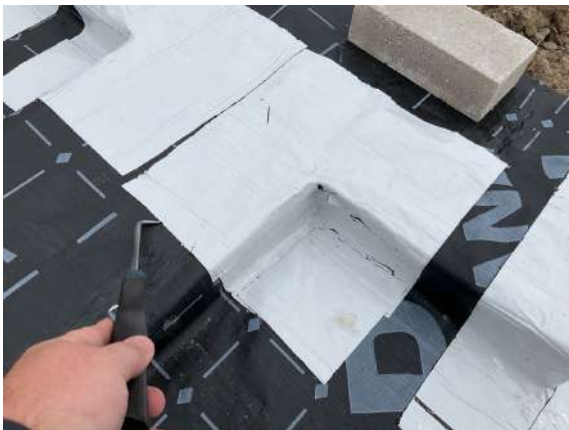
Plot 2. Pick testing to sealed corner details.

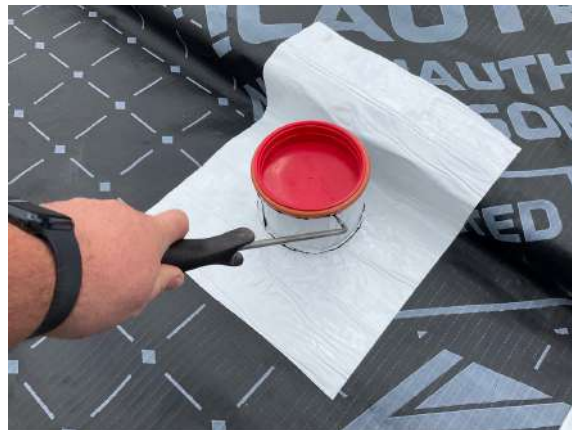
Plot 2. Pick testing upon all sealed pipe entry's.

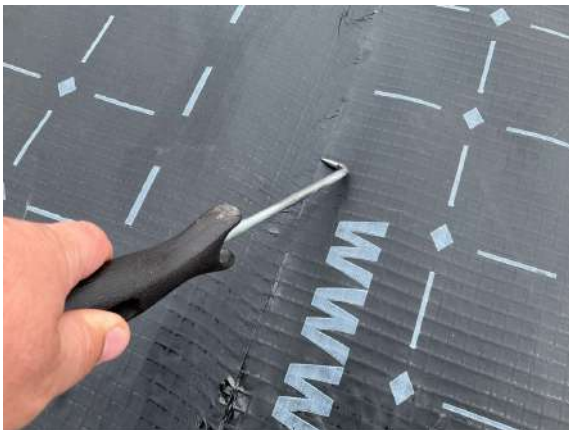
Plot 2. Pick testing along hand welded lap joints.

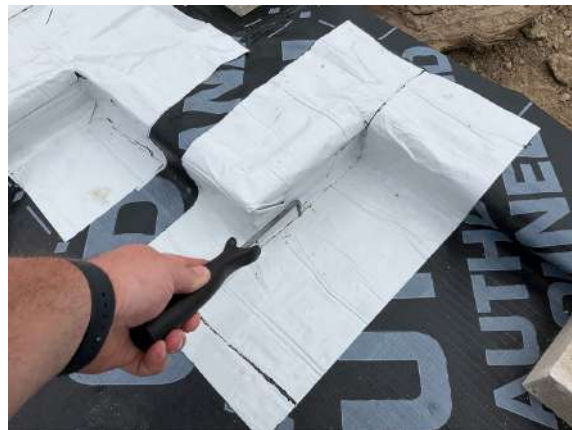
Plot 2. Pick & probe testing to sealed door threshold details.

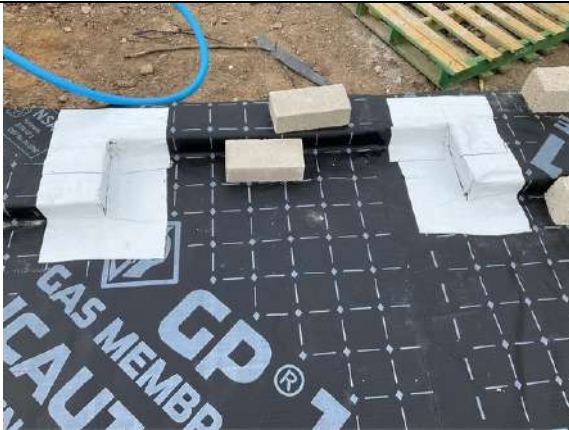
Plot 3. Door threshold details were sealed with SAGM.

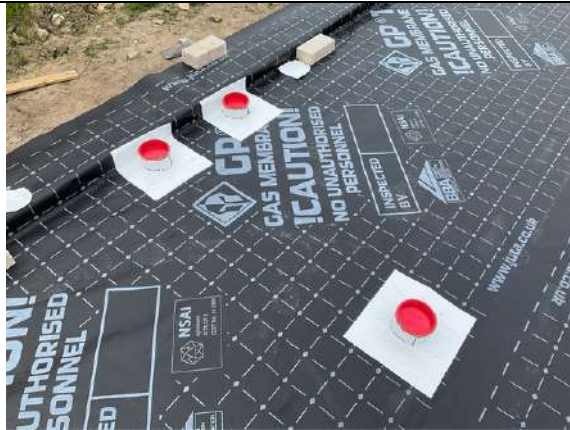
Plot 3. Pipe penetration's successfully sealed using SAGM.

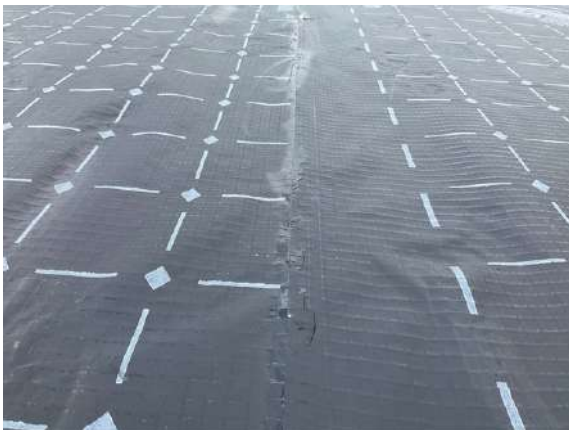
Plot 3. Overview along a hand welded membrane lap joint.

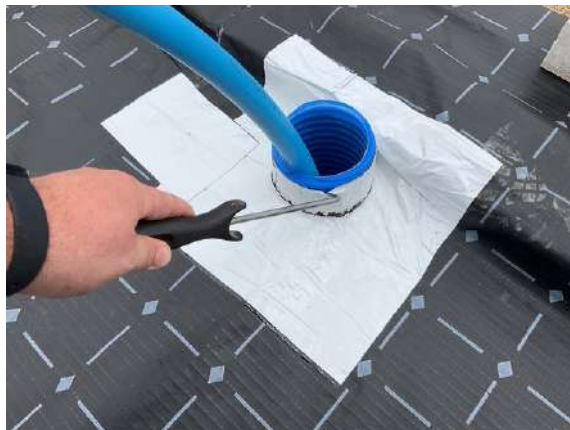
Plot 3. Pick & probe test upon sealed pipe penetration's.

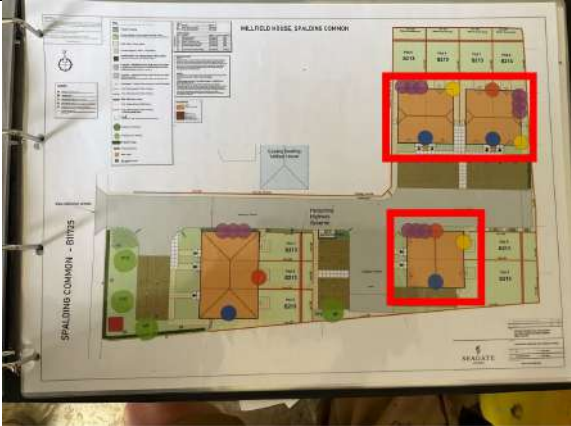
Areas highlighted red is where today's inspection took place.

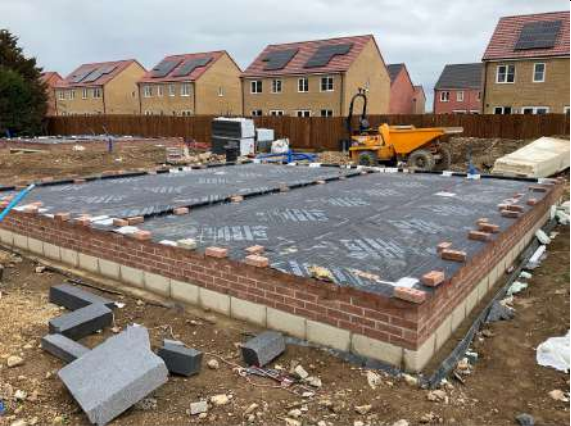
Overview of the full footprint installation to Plots 4 & 5.

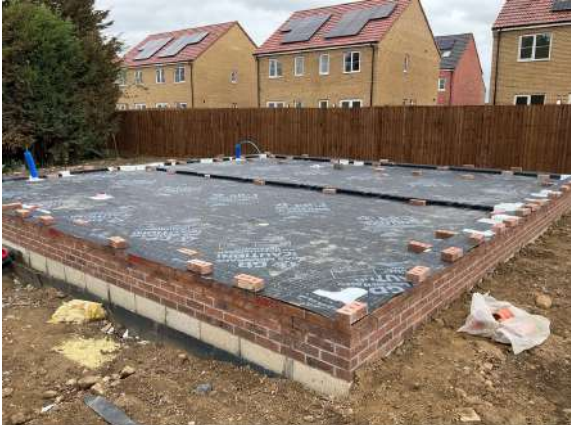
Overview of the full footprint installation to Plots 6 & 7.

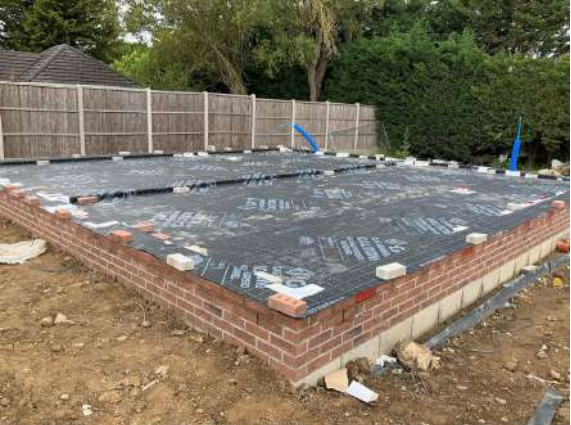
Overview of the full footprint installation to Plots 8 & 9.

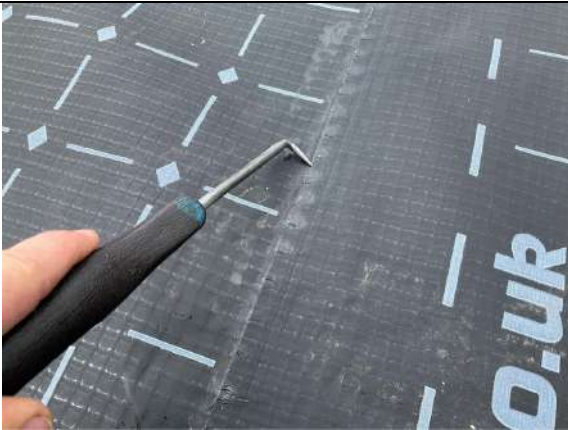
Plot 4. Pick testing along hand welded membrane lap joints.

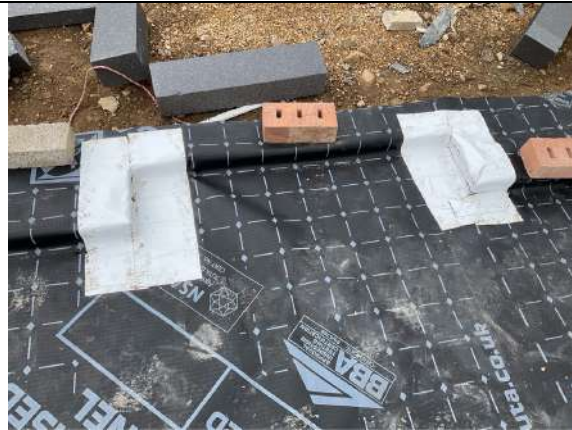
Plot 4. Door threshold details sealed using SAGM.

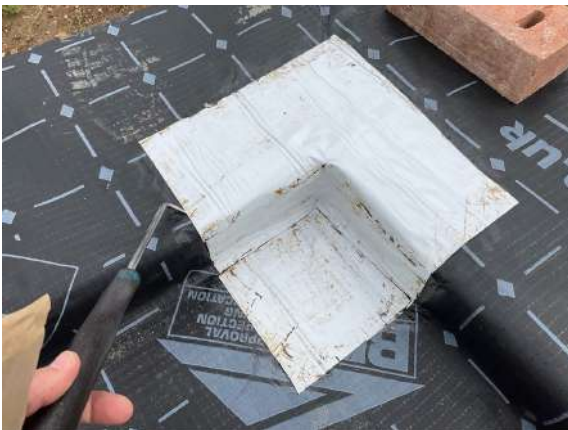
Plot 4. Pick & probe testing to sealed corner details.

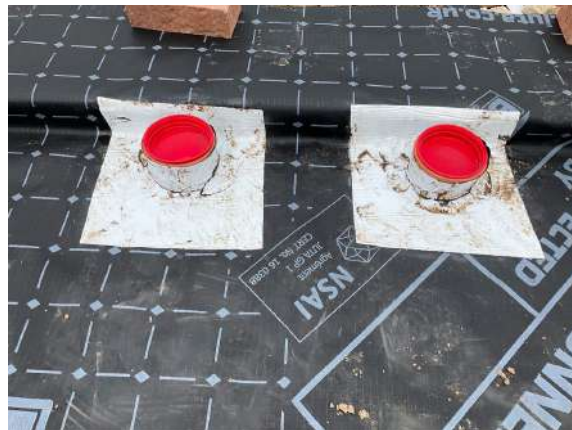
Plot 5. Pipe penetration's were sealed using SAGM.

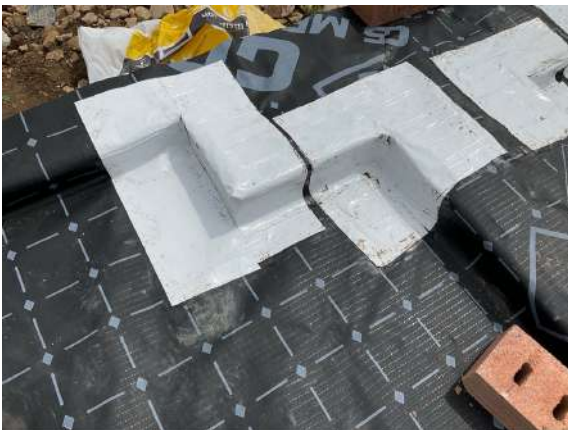
Plot 5. Corner and door threshold details were sealed with SAGM.

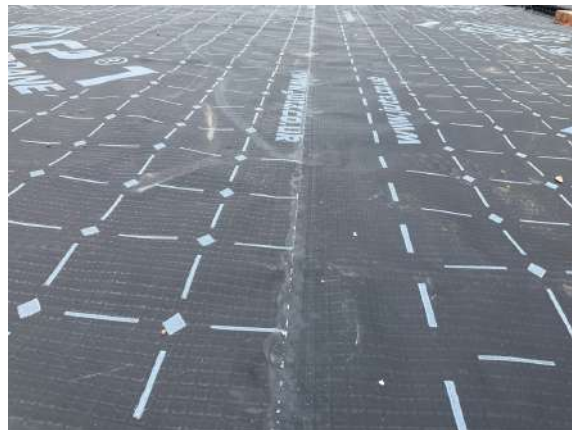
Plot 5. Overview along a hand welded membrane lap joint.

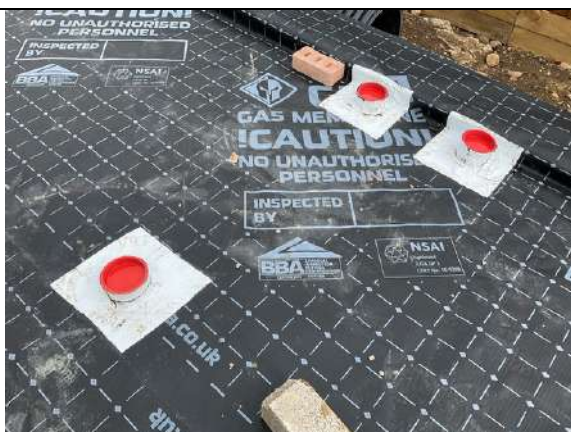
Plot 6. All pipe penetration's were successfully sealed with SAGM.

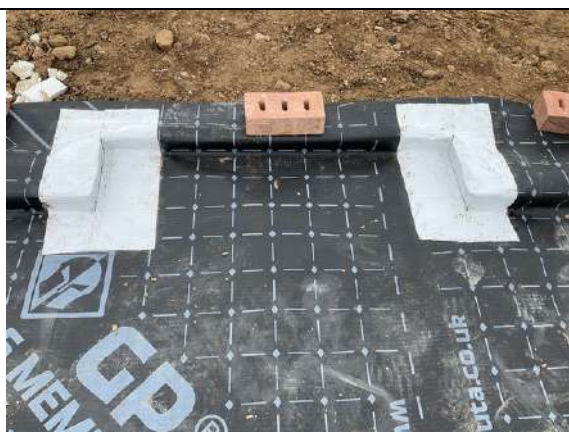
Plot 6. Door threshold details sealed with SAGM.

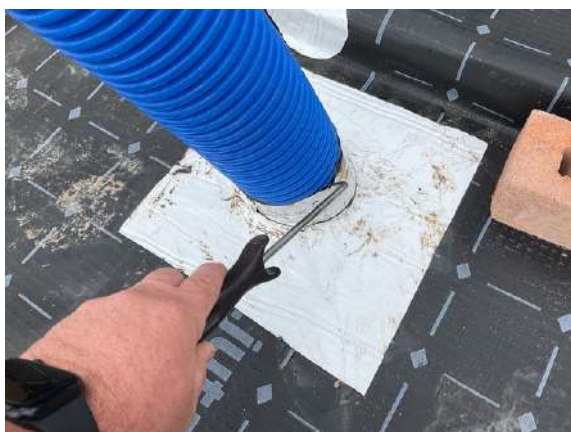
Plot 6. Pick & probe testing to all sealed pipe entry's.

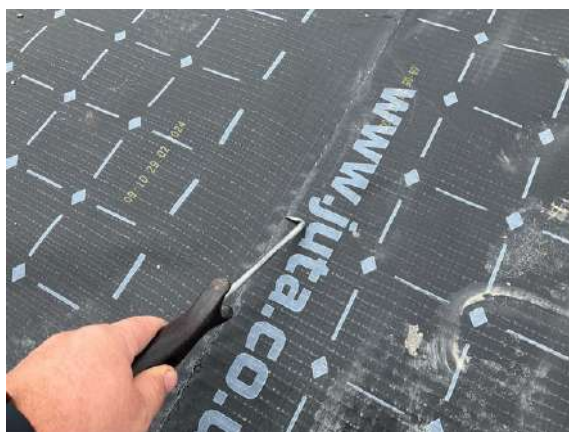
Plot 7. Pick testing along hand welded lap joints.

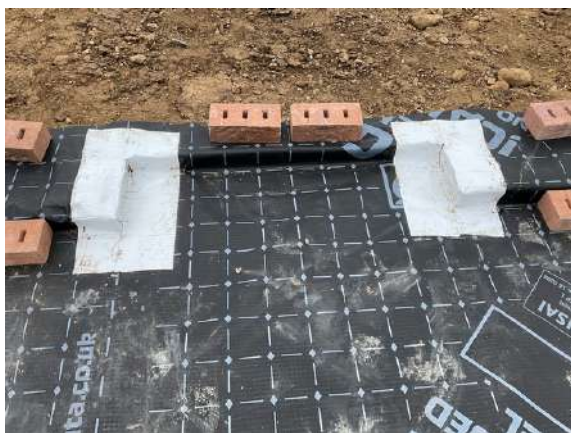
Plot 7. Door thresholds were sealed using SAGM.

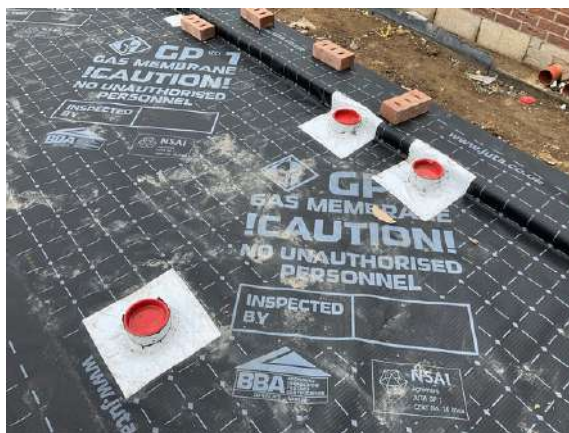
Plot 7. Pipe penetration's sealed using SAGM.

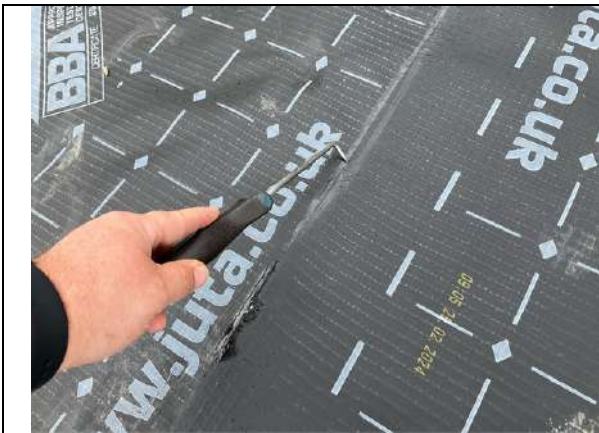
Plot 8. Pick & probe testing along hand welded lap joints.

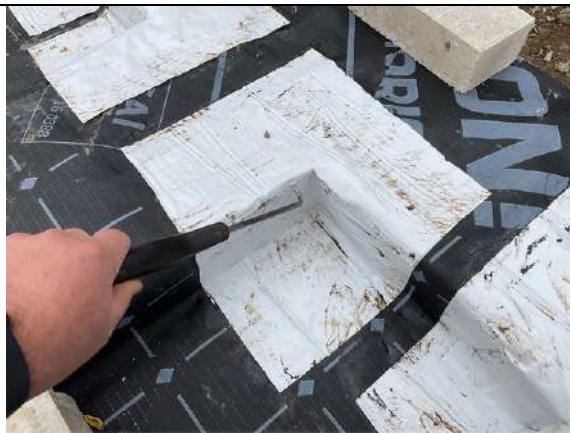
Plot 8. Pick testing to sealed corner details.

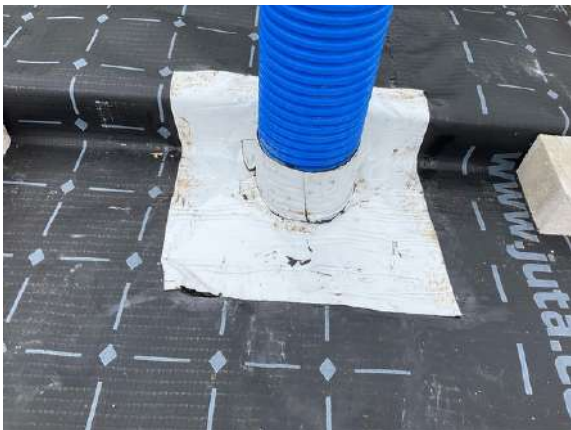
Plot 8. Pipe penetration's were sealed with SAGM.

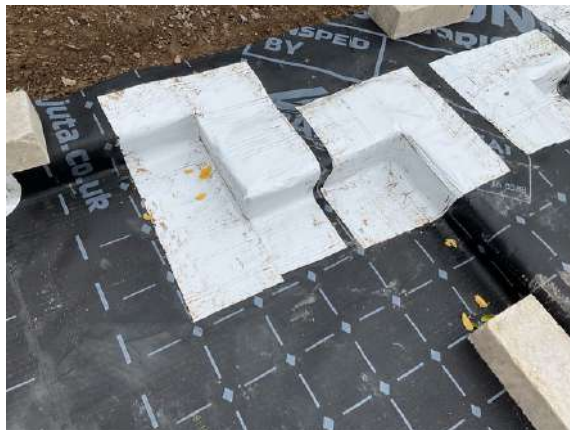
Plot 9. Door threshold and corner details were sealed using SAGM.

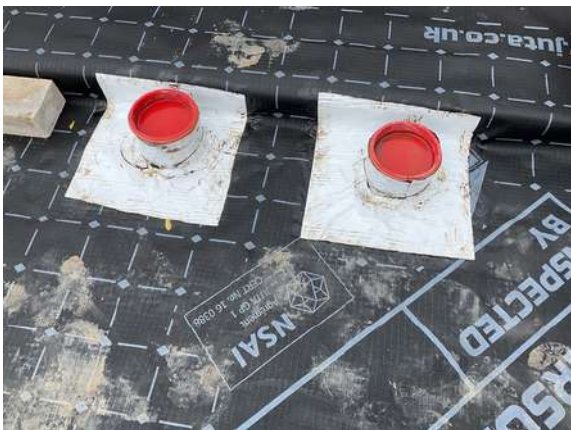
Plot 9. Pipe penetration's were successfully sealed with SAGM.

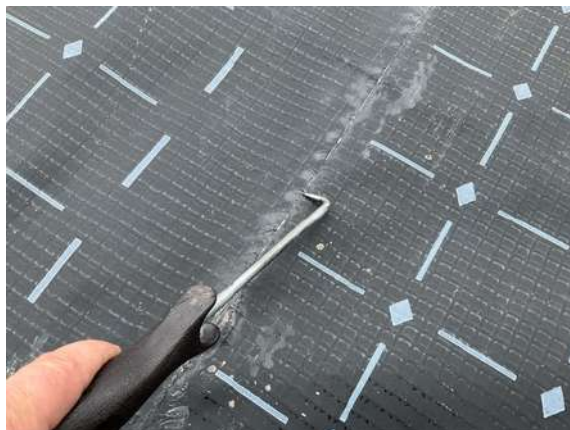
Plot 9. Pick and probe testing along all hand welded lap joints.
