## SCHEDULE OF WINDOW CONDITION

Proposed Window Refurbishment / Replacement at The Square, Spalding – Schedule of Windows Condition

Reference Project: A1424  
Tender issue 02.10.19

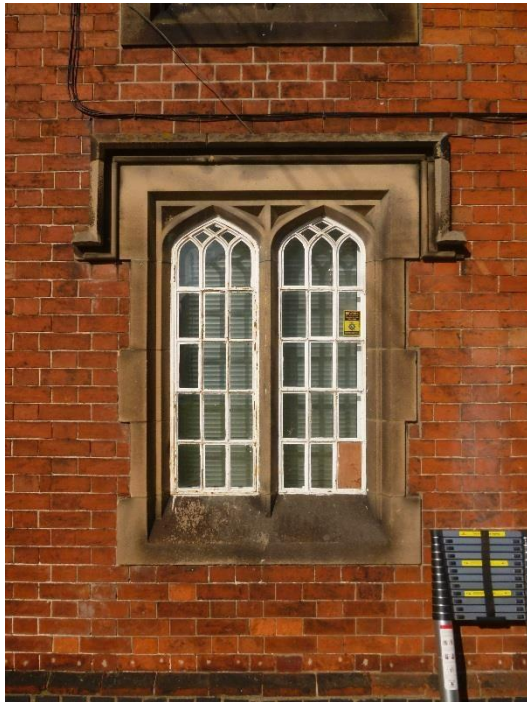
### Window Ref: GFW01

Cast iron window set in stone. LH opening casement and RH fixed glazing. Opening casement shows no sign of being openable as paint covering seal unbroken. Areas of window indicate window rust grinning through as can be seen. The recent redecoration within the last 3 years indicate substantially set in rust to the window sections. Bottom right hand pane of fixed sash broken and has plywood insert as a temporary repair. Stone generally OK with advice on repairs to be sought from a specialist stone mason.

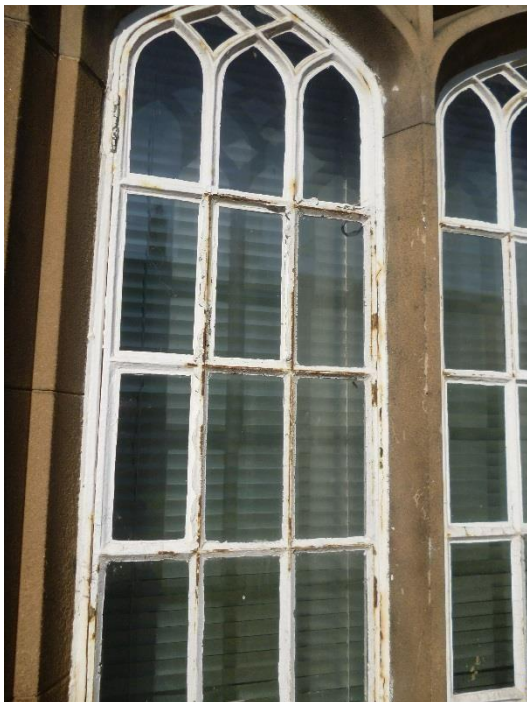
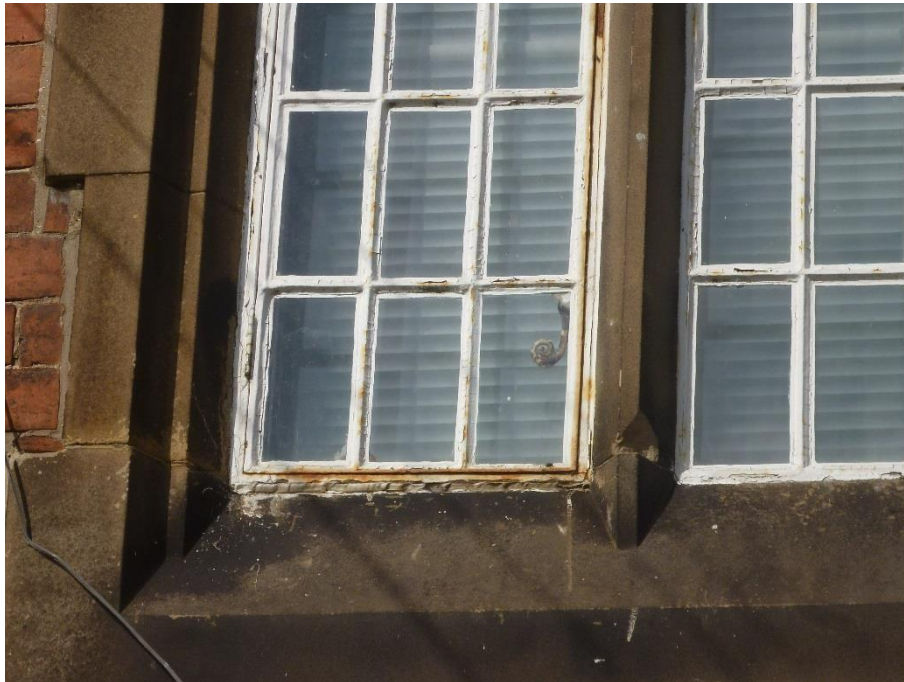
Window Ref: FFW01

Cast iron window set in stone. LH opening casement and RH fixed glazing. Opening casement shows signs of being openable as paint covering does not seal edges of casement.

Areas of window indicate heavier rust grinning through as can be seen. The recent redecoration within the last 3 years indicate substantially set in rust to the window sections.

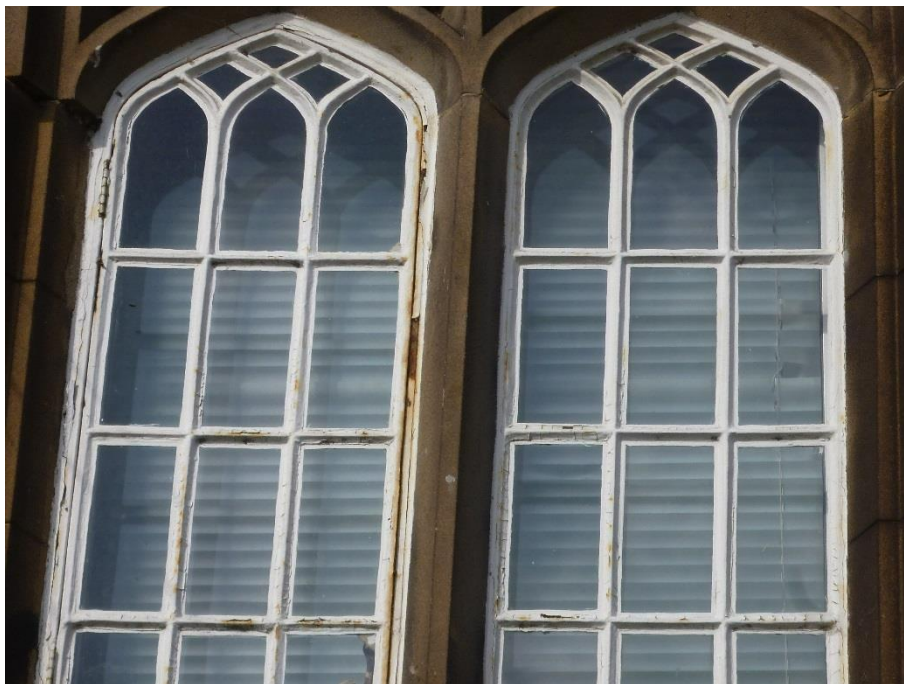
Stone Mullion damaged / split at cill seating on RH side.

Historic stone misalignment of head stooling to jamb stone sections. (Allowance to be made for window proposal works).

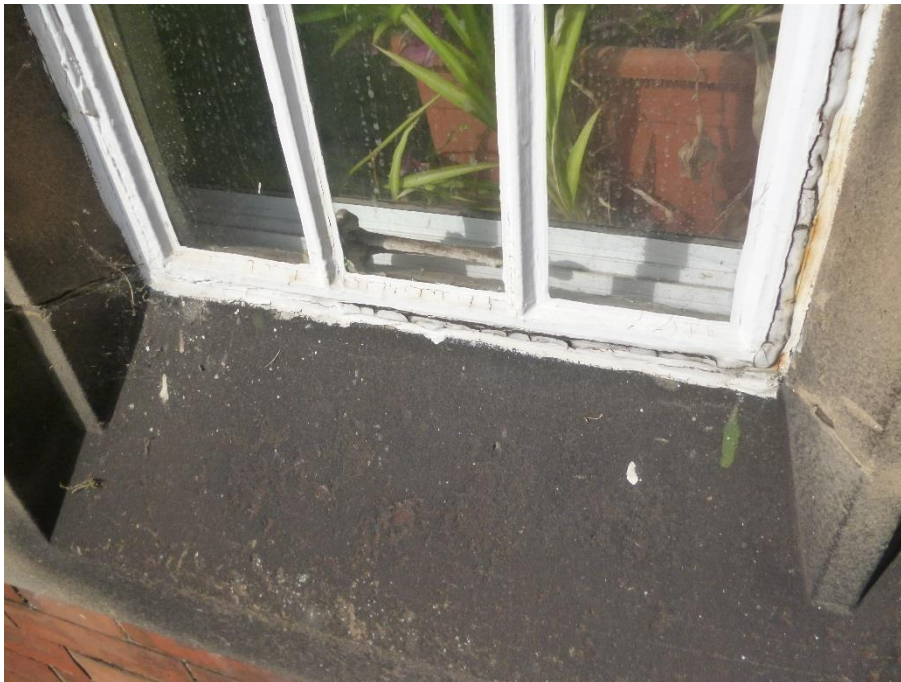
Window Ref: GFW02

Cast iron window set in stone. LH opening casement and RH fixed glazing.  
One left hand mid-side window pane replaced since decoration on LH casement.  
One window pane broken (fourth pane) up on right side of opening casement.  
RH casement in good condition.

Opening casement shows no sign of being openable as paint covering seal split but unbroken.

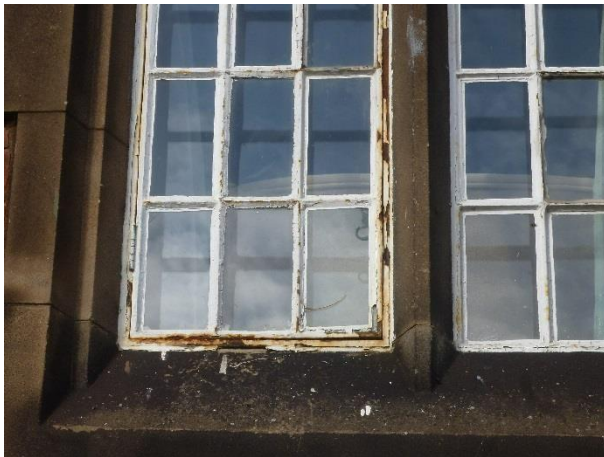
Ref: FFW02

Paint broken off / in places and heavy rust evident to frame. Frame bedding seal broken at mid base length of frame.

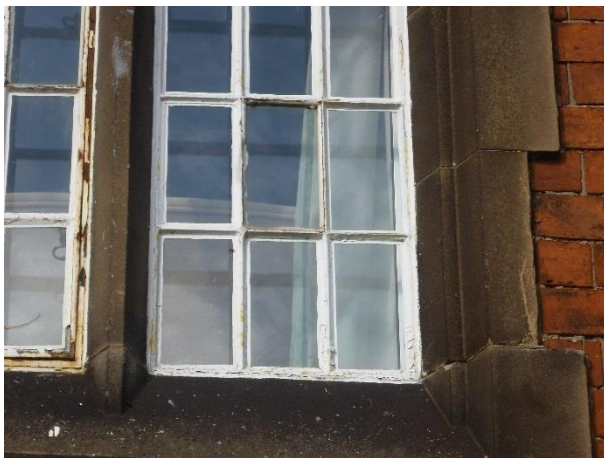
Central 2<sup>nd</sup> window pane up replaced since decoration.

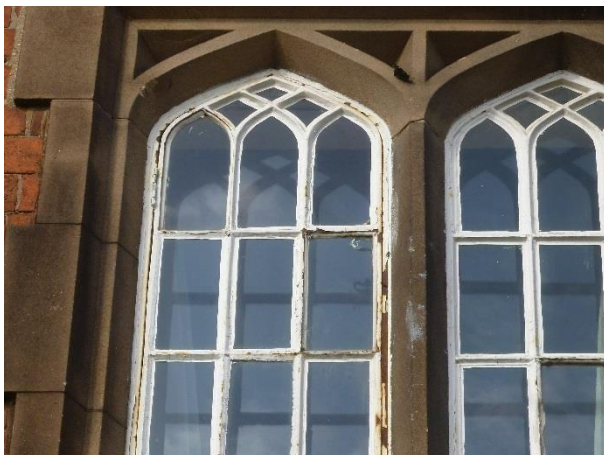
Paint broken off / in places and heavy rust evident to frame and opening casement.

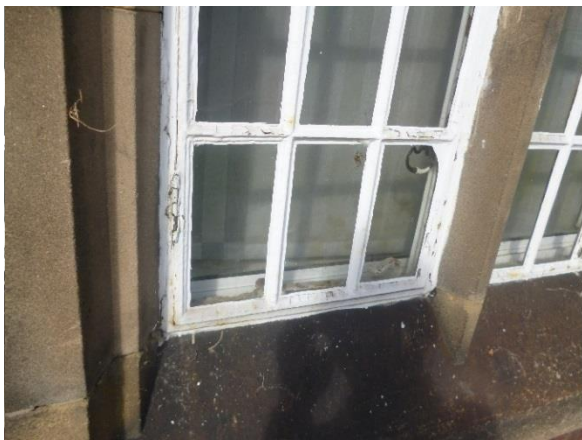
Window Ref: GFW03

Paint broken off / in places and rust grinning through paint in places.

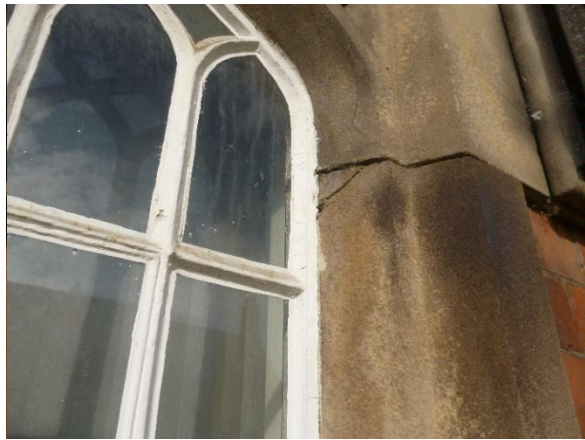
Stone cracked / split towards top of RH jamb section. Possibly due to ferrous fixings of window frame.

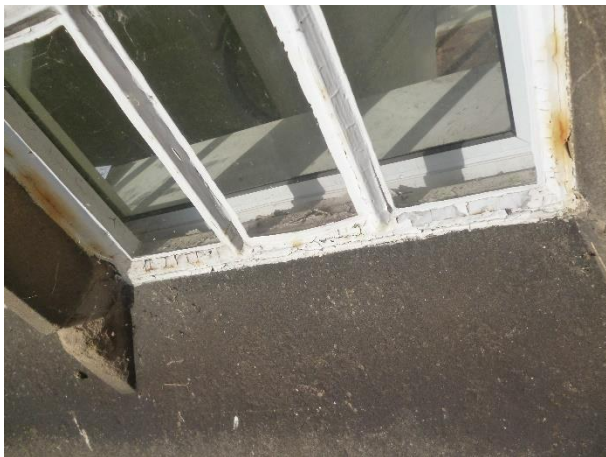
Window Ref: GFW04

Cast iron window set in stone. LH opening casement and RH fixed glazing.  
Opening casement shows signs of being openable as paint covering does not seal edges of casement.  
Centre bottom pane of LH opening casement smashed.  
Central stone mullion seating on stone cill which shows signs of heavy weathering.

Stone cill mullion seating heavily weathered and locally breaking up.

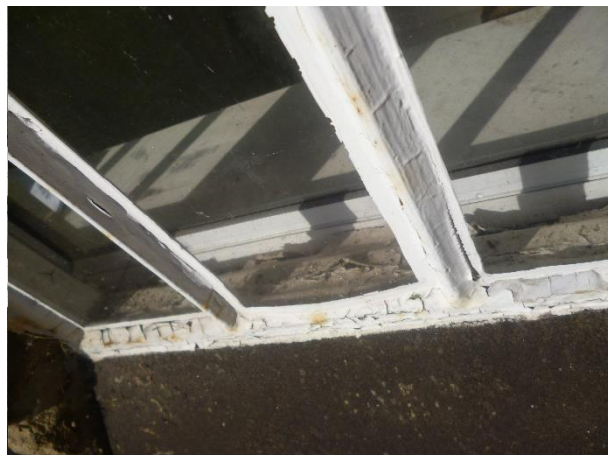
Third pane up on LH side of RH Fixed window recently replaced since recent redecoration.

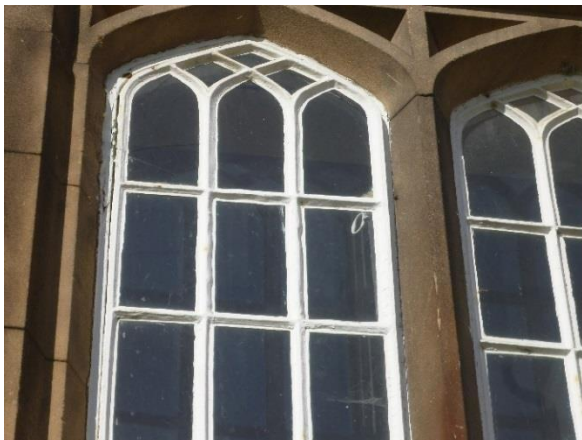
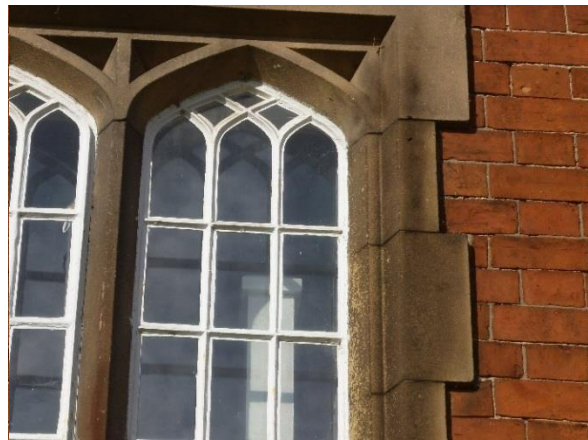
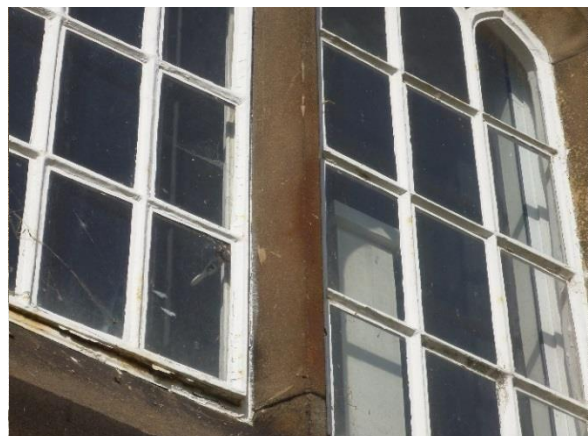
Ref: FFW04  
(Type B)

Cast iron window set in stone. LH opening casement and RH fixed glazing. Opening casement shows signs of being openable as window casement is already partially open as images.

Small damaged piece of stone locally to top LH stone head ribbon detail.

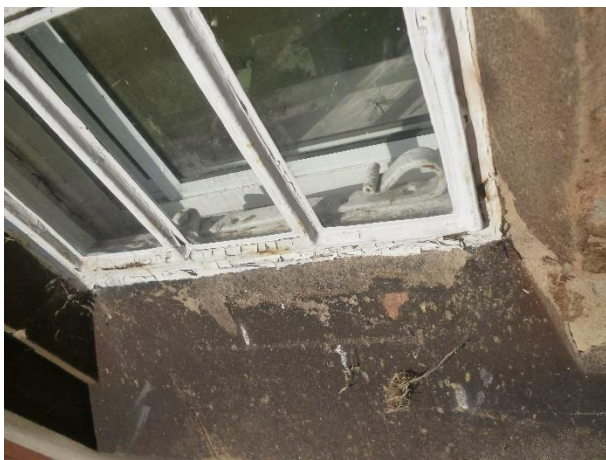
Window Ref: GFW05

Cast iron window set in stone. LH opening casement and RH fixed glazing. Opening casement shows signs of not being operable as paint covering still seals edges of casement.

Stone mullion seating of stone cill is heavily weathered and crumbling away. Crack through stone cill section beneath opening casement.

Crack through stone head section above opening casement from pinnacle of gothic arch.

Large piece of stone damage to stone ribbon head detail above RH fixed casement.

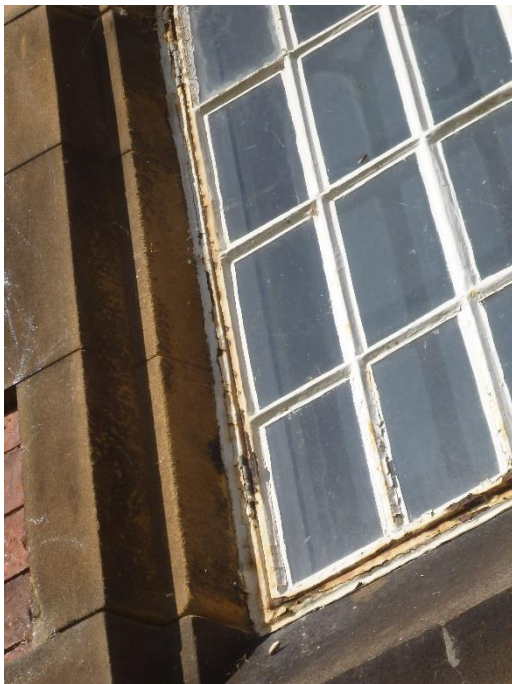
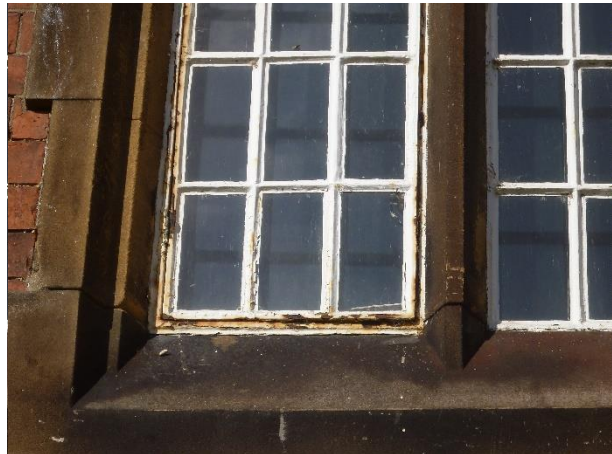
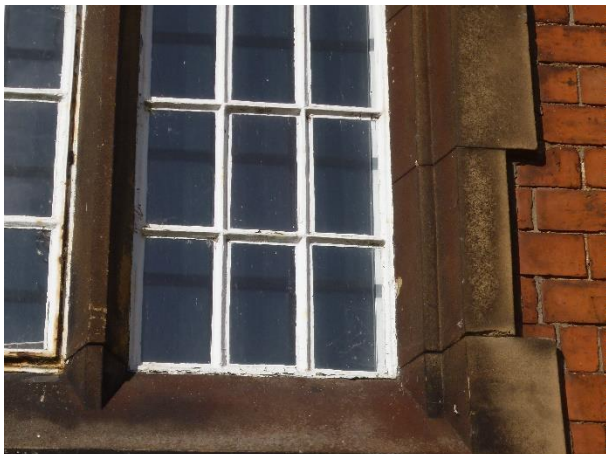
Ref: FFW05

Cast iron window set in stone. LH opening casement and RH fixed glazing. Opening casement shows signs of being openable as paint covering broken and edges of casement heavily corroding.

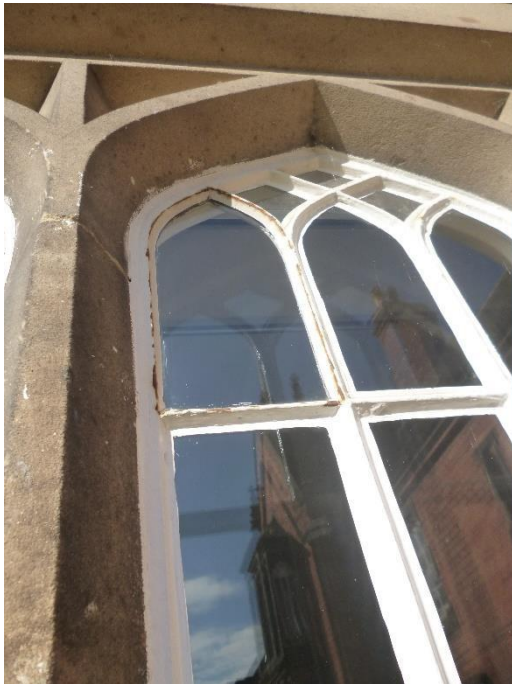
Window Ref: GFW06

Bottom right hand pane of opening casement cracked. Sections of putty glass bedding has detached, paint de-bonded and cast iron window and frame exposed.

Corroding window frame edges.

Debonding putty, cracked glazing and corroding frame.

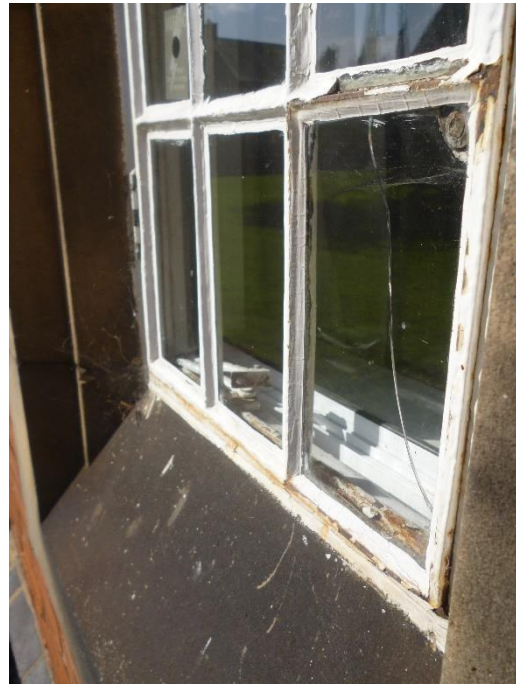
Debonding putty, cracked glazing and corroding frame.

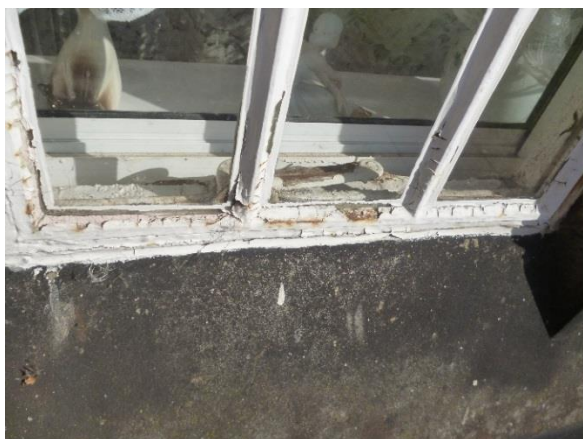
Window Ref: GFW07

Stone mullion base and partial seating of stone cill is heavily weathered and crumbling away. Split section of stone mullion on opening casement side of mullion bearing.

Small area of stone weathering to top central section of head ribbon detail. Paint is very glazed / cracked and peeling in most locations.

Paint coating failing and corrosion coming through.

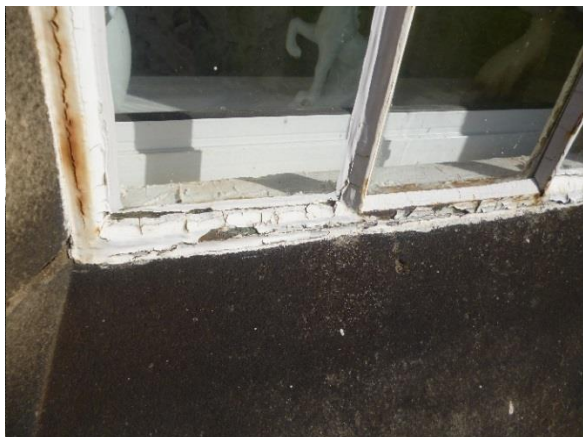
Mullion seating and base of mullion weathering and split.

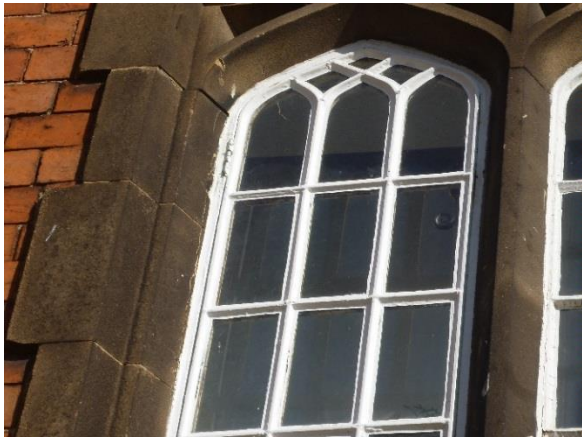
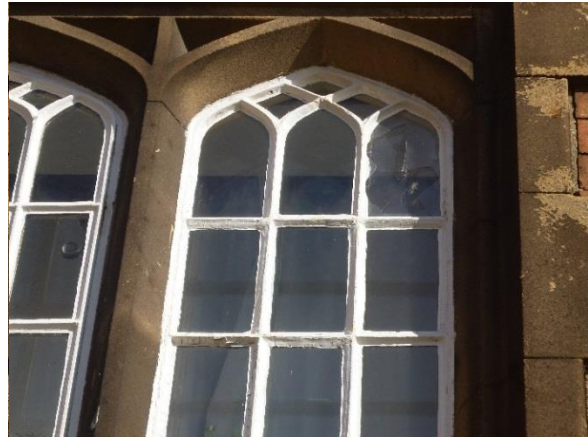
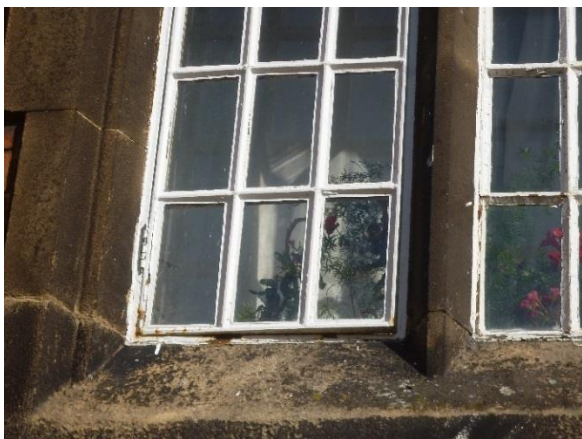
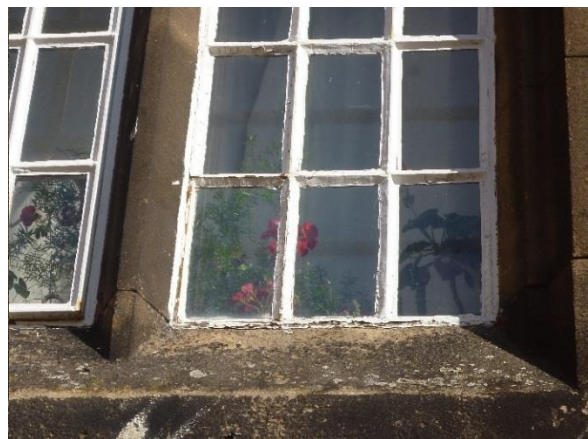
Ref: FFW07

Cast iron window set in stone. LH opening casement and RH fixed glazing.  
Opening casement shows signs of being openable as overpainting to edges of casement is less evident.  
Top RH shaped glass pane damaged to RH fixed casement.

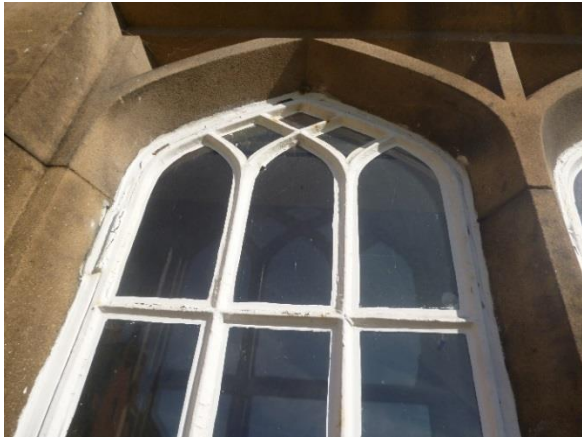
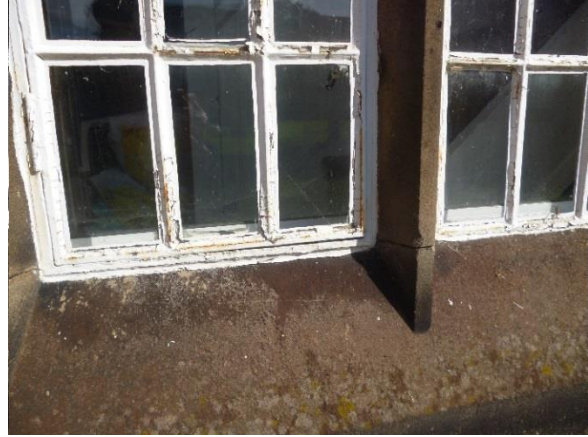
Window Ref: GFW08

Cast iron window set in stone. LH opening casement and RH fixed glazing.  
Opening casement shows signs of not being openable as overpainting to edges of casement is more evident.  
Paint is very glazed / cracked and peeling in most locations.

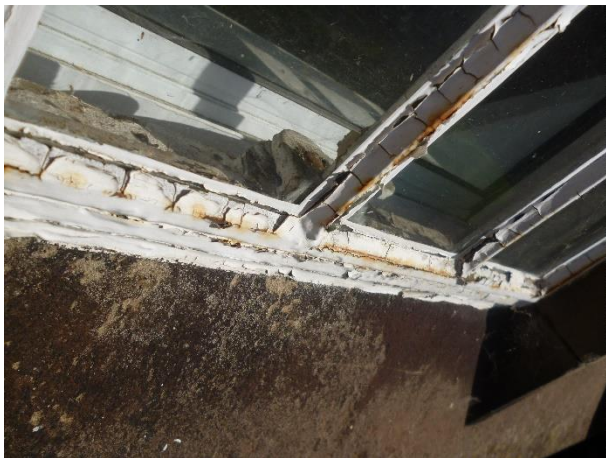
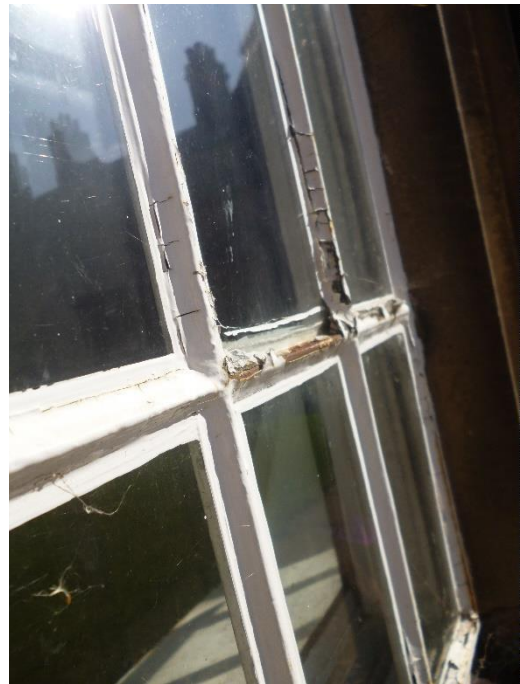
Missing sections of glazing putty and paint coating failing.

Window stay no longer fitted. Has been removed.

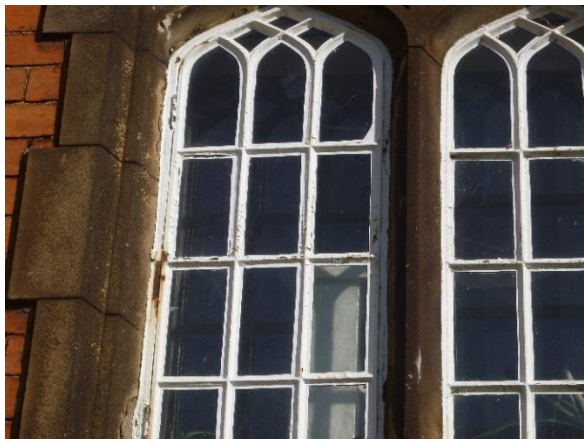
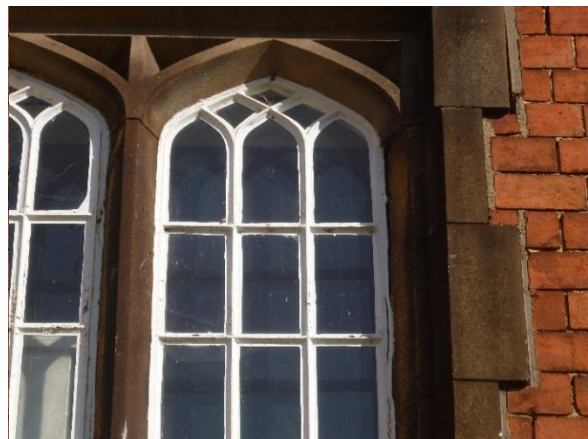
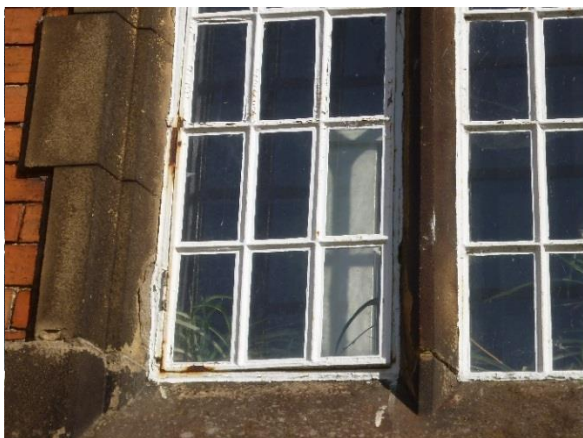
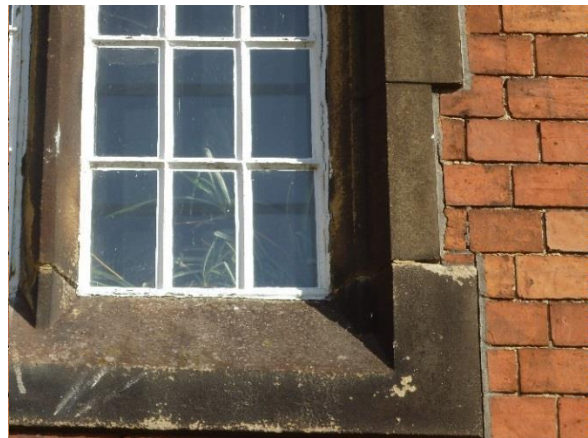
Cast iron window set in stone. LH opening casement and RH fixed glazing. Opening casement shows signs of not being openable as paint covering still seals edges of casement.

Stone split and local weathering damage to LH jamb of opening casement and LH side of stone mullion seating.

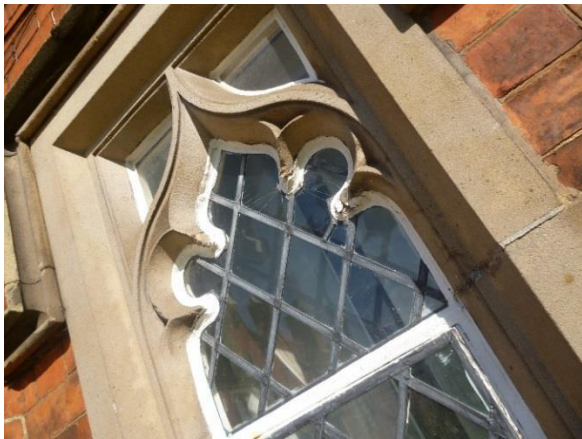
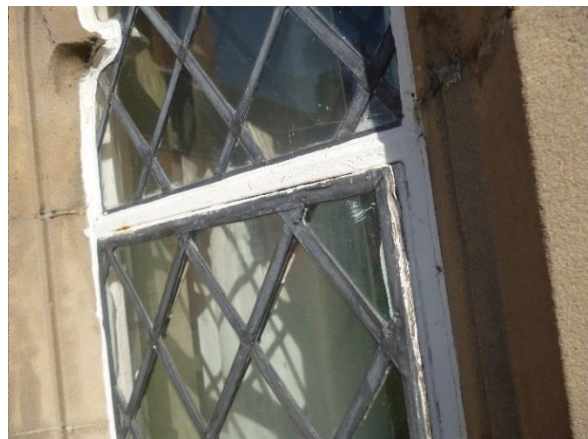
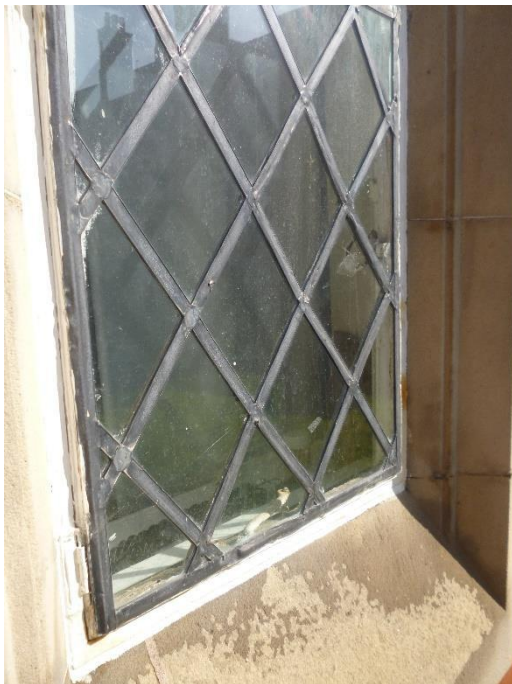
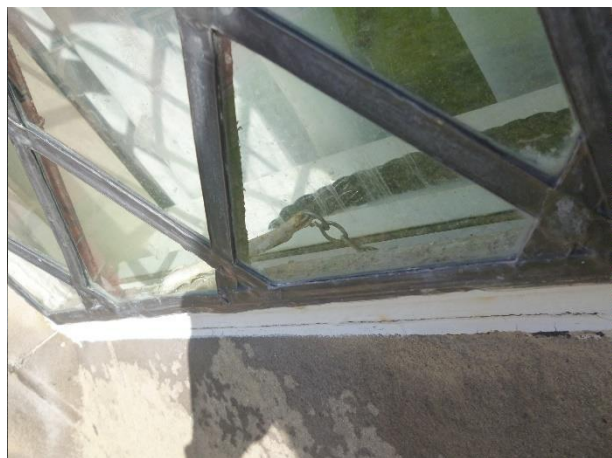
Window Ref: GFW09

Leaded light glass window set directly in stone with Trefoil head detail and 2 pane segments set within stone head detail.  
Stone slender edges of Trefoil detail are heavily weathering and delicate.  
Glazing around the stone detail is damaged and cracking. Possible due to the weathering expansion / contraction of the stone detail surround.  
Lower leaded square casement, side hung glazing casement appears to be a recent replacement.

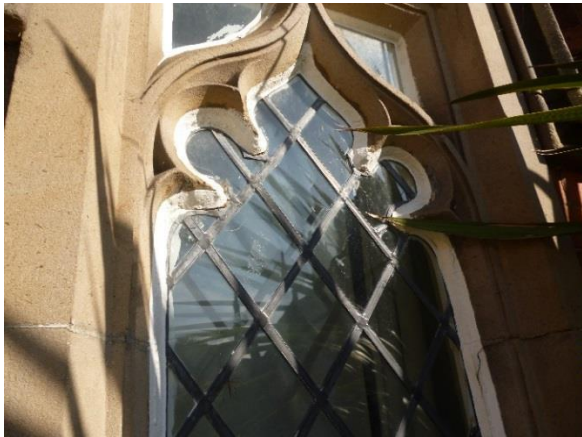
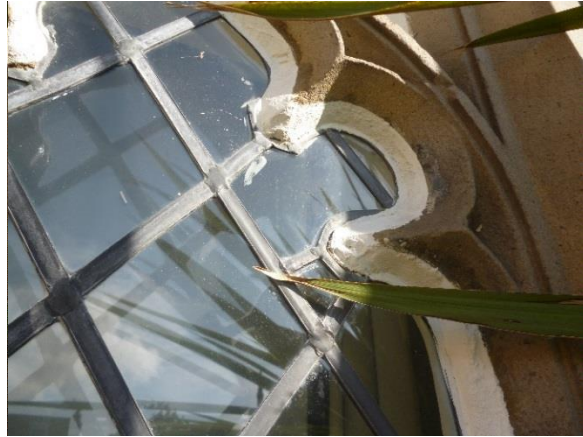
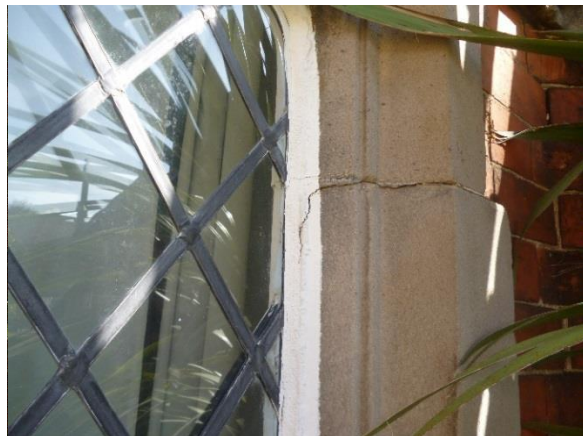
Window Ref: GFW10

Leaded light glass window set directly in stone with Trefoil head detail and 2 pane segments set within stone head detail.  
Stone slender edges of Trefoil detail are heavily weathering and delicate.  
Glazing in good condition and stone surround details appear to have had recent repair work.

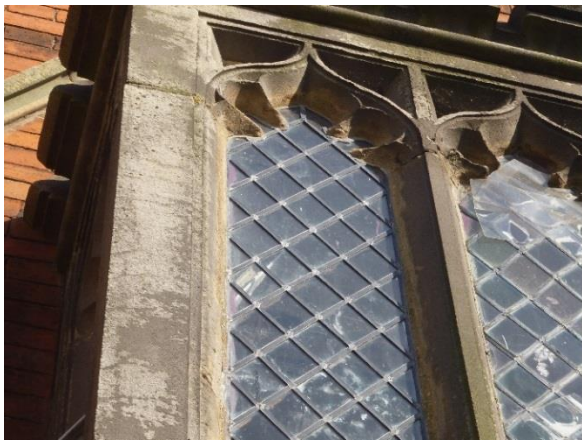
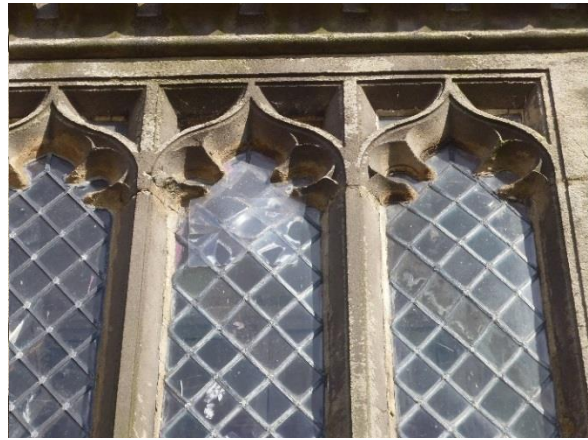
Ref: FFW10

Stone slender edges of Trefoil detail are heavily weathering and delicate in each. Left to right, the first panel (LH) appears in reasonable condition. The second panel (central) of glazing around the stone detail is damaged and cracking. A temporary repair is evident with some silicone bonded plastic over the outer face to seal the glazing.

The third panel (RH) is heavily bowing due to thermal expansion and will require some remedial works / resetting.

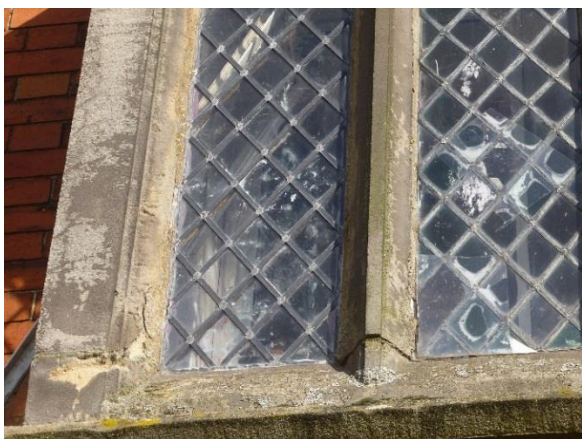
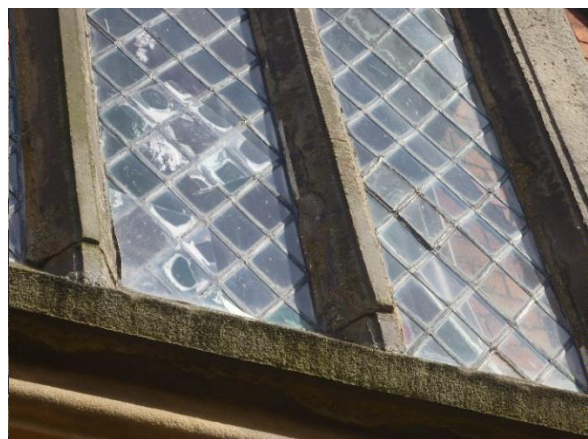
Weathering damage and stone crack to bottom left of Panel 1.

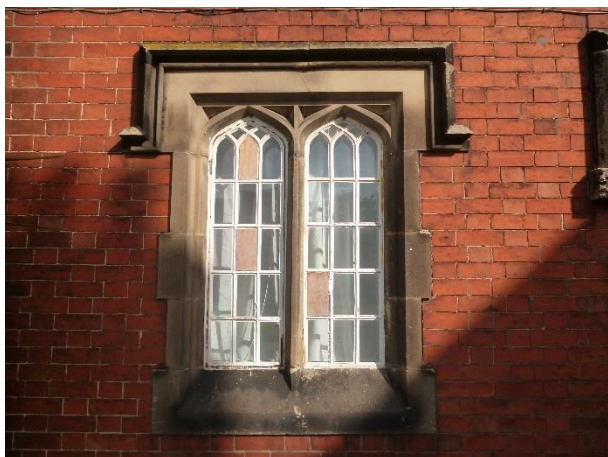
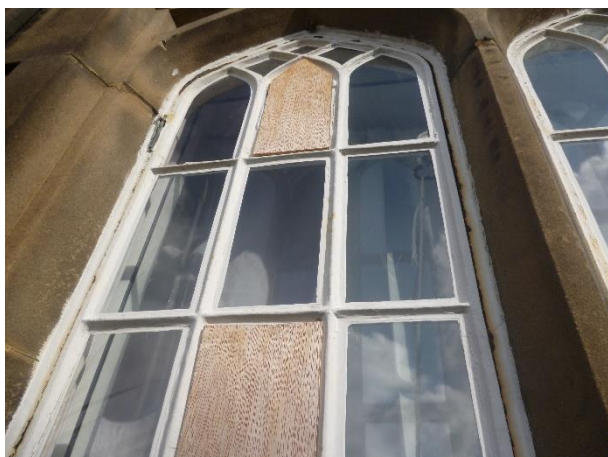
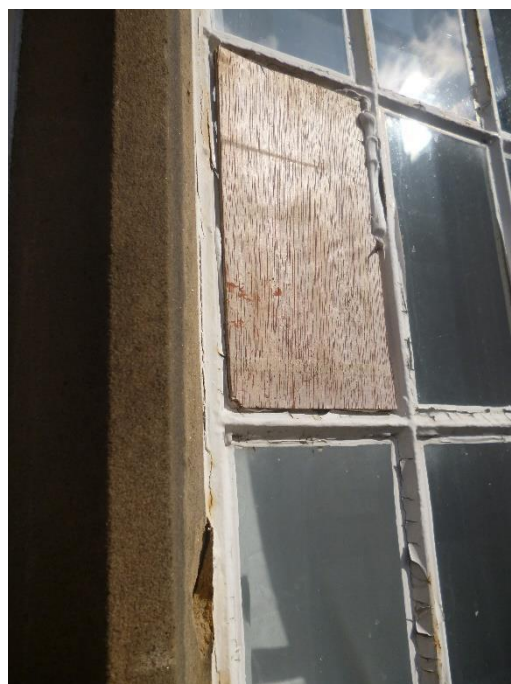
Window Ref: GFW11

Cast iron window set in stone. LH opening casement and RH fixed glazing.  
Opening casement shows signs of being openable as overpainting to edges of casement is less evident and corrosion appearing to full perimeter.  
Heavy corrosion evident to bottom left corner of opening casement.  
Paint is very glazed / cracked and peeling in most locations.

1 Nr. Glass pane temporarily repaired with plywood insert to fixed sash.

2 Nr. Glass panes temporarily repaired with plywood inserts to opening casement.

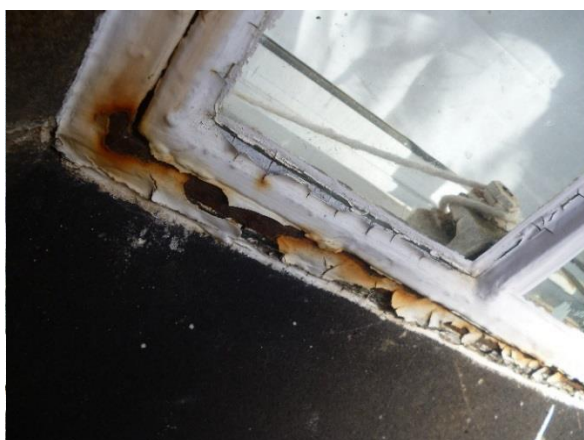
Heavy corrosion evident at lower left pane.

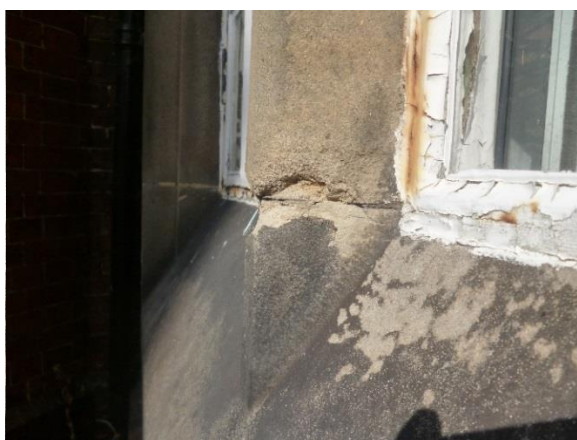
Weathering damage to Mullion and mullion seating.

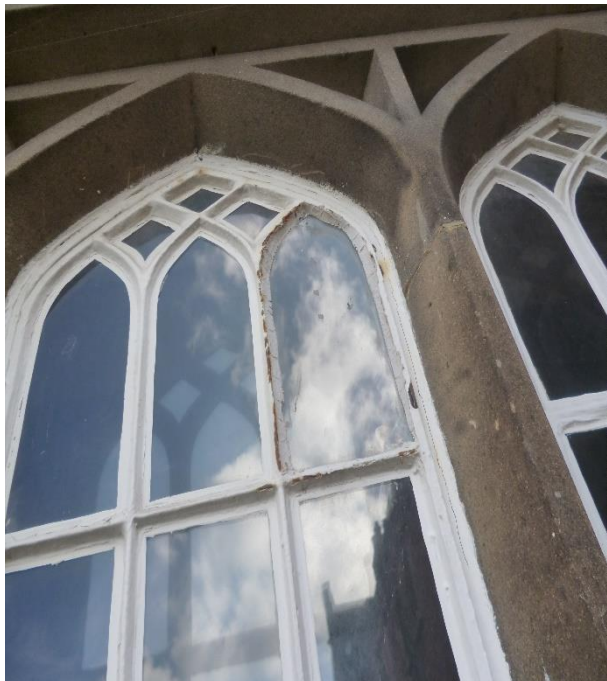
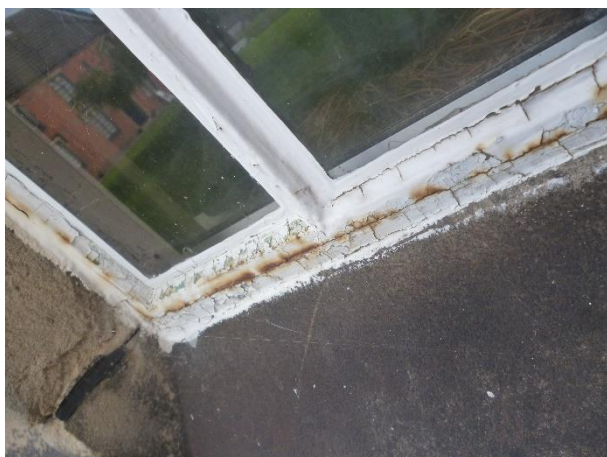
Window Ref: GFW12

Cast iron window set in stone. LH opening casement and RH fixed glazing.  
Opening casement shows signs of not being openable as paint covering still seals edges of casement.  
Perimeter of top right hand glazing pane in casement showing signs of corrosion breaking through the failing paint covering.

Central pane of casement broken.

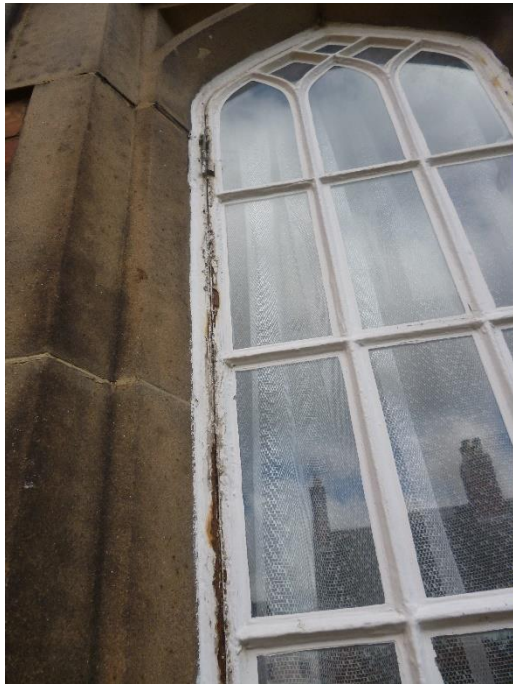
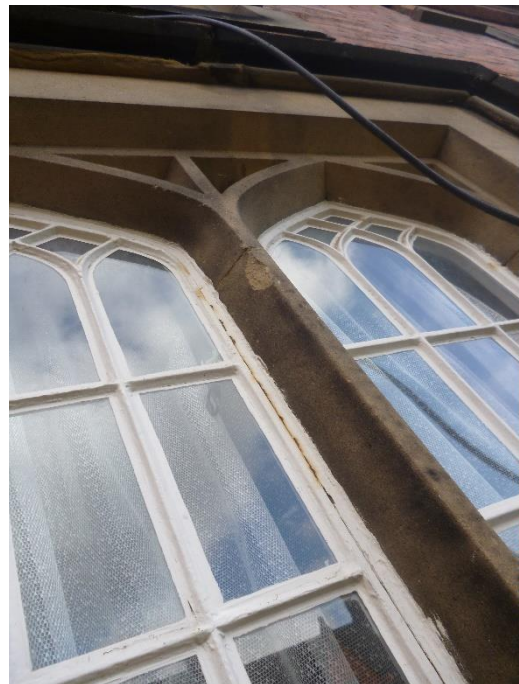
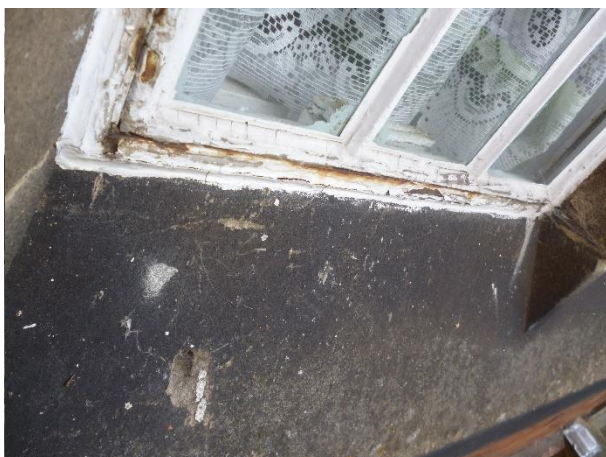
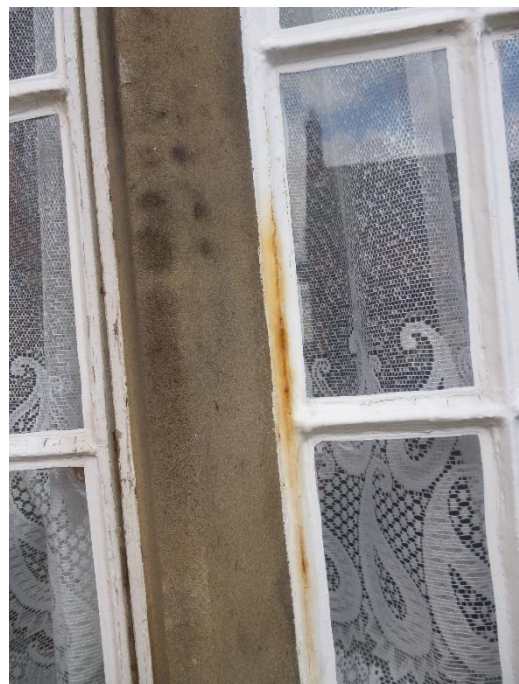
Window Ref: GFW13

Cast iron window set in stone. LH opening casement and RH fixed glazing. Opening casement shows signs of being openable as overpainting seems to be less evident and casement edge clear. Perimeter of fixed casement and opening casement showing signs of corrosion breaking through the failing paint covering.

Small section of damage to upper section of stone mullion.

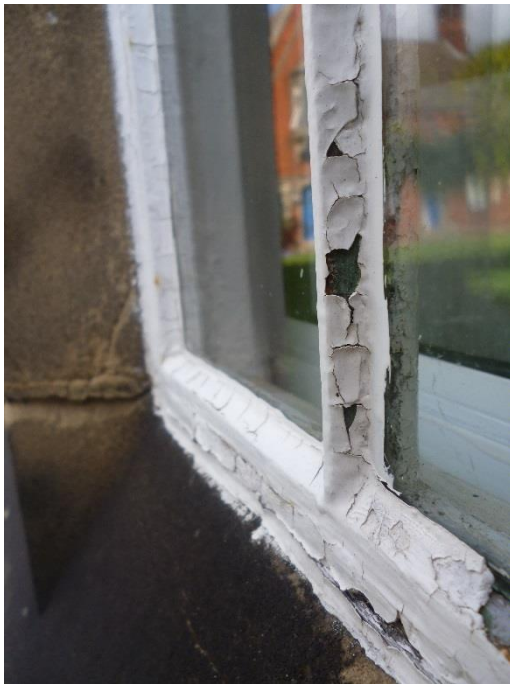
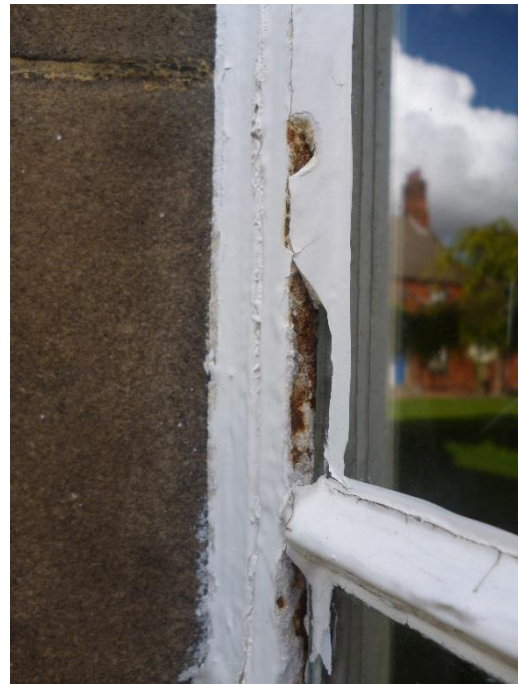
Window Ref: GFW17

Cast iron window set in stone. LH opening casement and RH fixed glazing. Opening casement shows signs of not being operable as it appears very overpainted. Perimeter of fixed casement and opening casement showing slight signs of corrosion breaking through the failing paint covering. A number of sections of glazing putty have detached and fallen out. Previous repair evident to Stone mullion base and seating of stone cill. Large plywood covering pattress applied to opening casement concealing nine panes of glass.

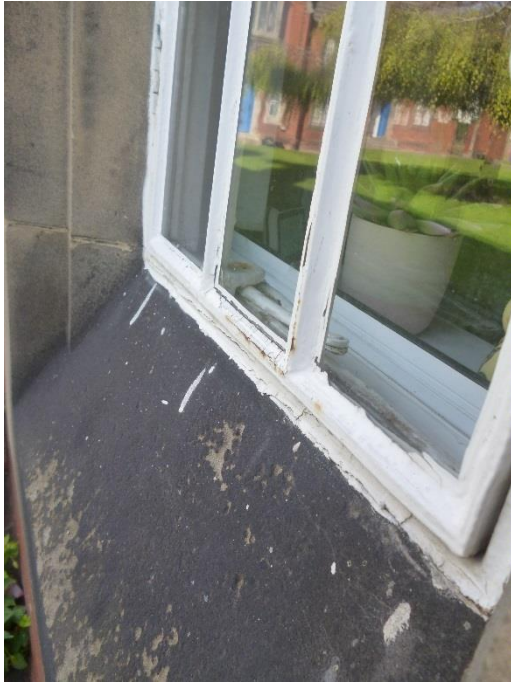
Window Ref: GFW18

Cast iron window set in stone. LH opening casement and RH fixed glazing. Opening casement shows signs of being openable as overpainting seems to be less evident, casement edge clear and casement partly open as image. Perimeter of fixed casement and opening casement showing heavy signs of corrosion breaking through the failing paint covering. Top LH pane of glass within the opening casement is smashed. Re-pointing re to stone mullion and mullion seating.

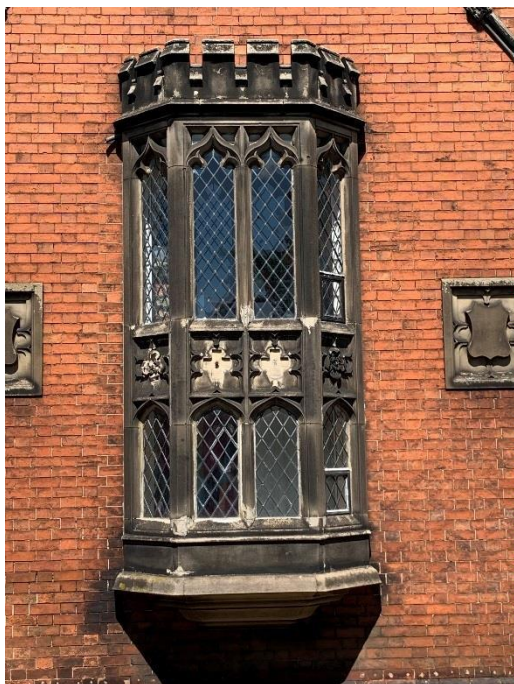
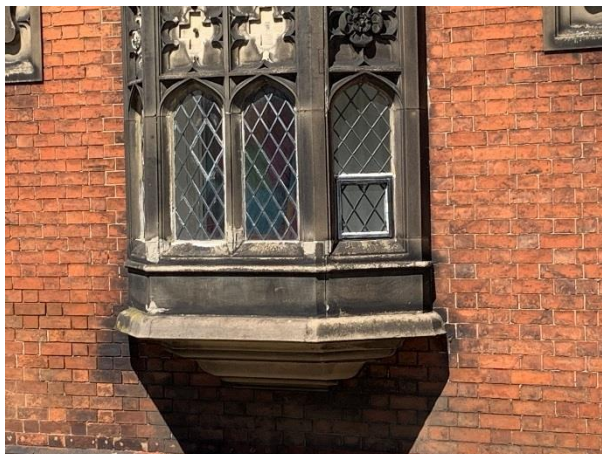
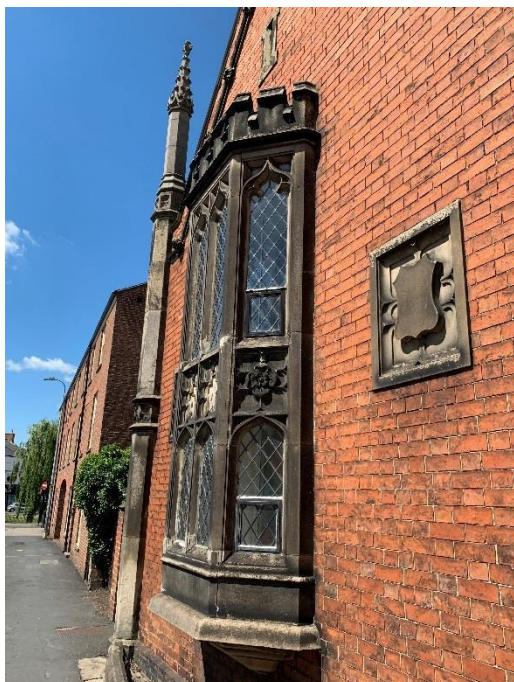
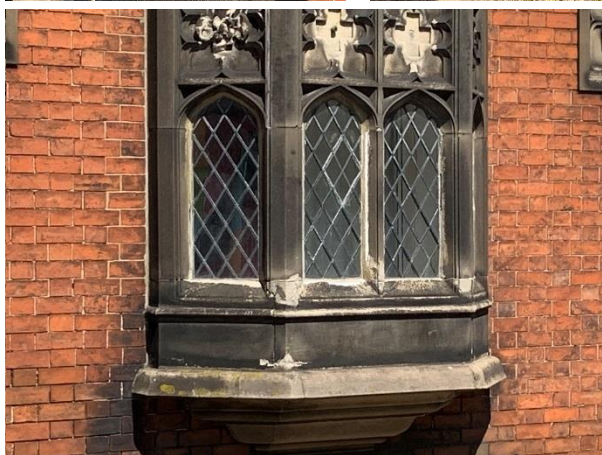
### Window Ref: GFW19 and FFW22

Stone mullions seating and cill profile seating showing signs of a recent repair.

Bottom hung inward opening metal casement.

Stone Damage At corners of bay base.

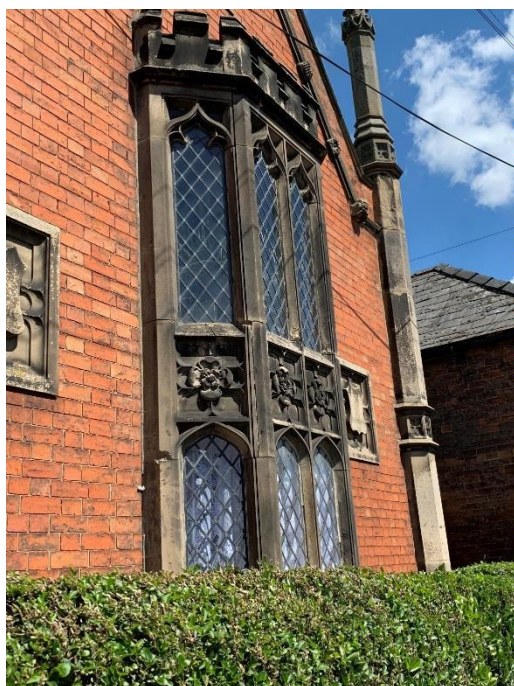
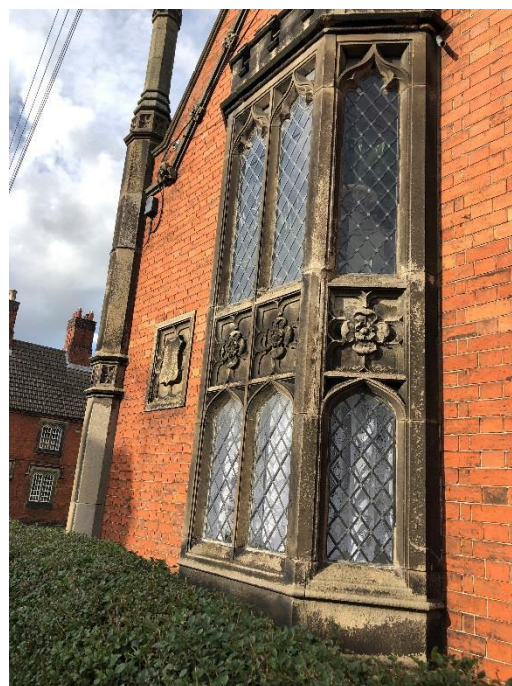
Window Ref: GFW20 and FFW23

Stone mullions seating and cill profile seating showing signs of a requiring repair. LH cill section cracked and Requires repair. Abutment stone frame section damaged at top left section of GFW20.
