Project:  
**Proposed Conservation Works to  
Spalding War Memorial  
Ayscoughfee Hall Gardens  
Church Gate  
Spalding  
PE11 2RA**

Drawing Title:  
**Roof Finishes Plan as existing  
identifying works required**

**LBC APPLICATION ISSUE**

| <b>A1660-13</b> | <b>T1</b> |

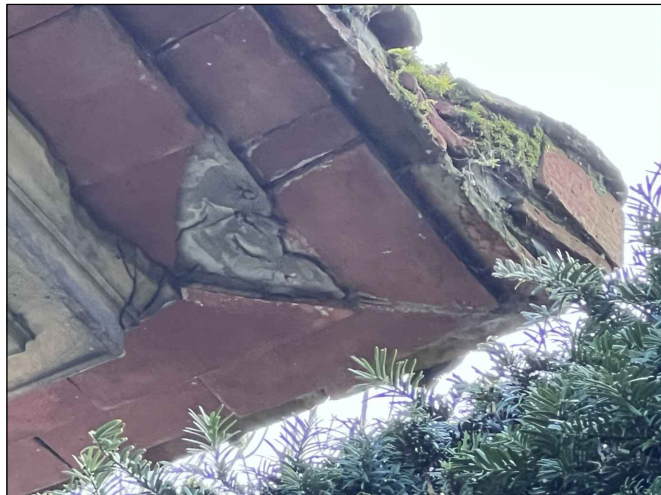
- et1 -  
1no. broken tile in lowest course above crack in cornice.
- et2 -  
2no. broken tiles in lowest course above crack in cornice.
- et3 -  
5no. previously badly repaired tiles at north-west corner of roof, in lowest 2 courses. New to be installed with 45° join to match remaining corners.
- et4 -  
1no. broken tile in lowest course above arch keystone on west elevation.
- et5 -  
1-2no. broken tiles in lowest course at south-west corner of roof.
- et6 -  
1no. broken tile in lowest course above crack in cornice.
- et7 -  
2no. dislodged tiles in lowest course above crack in cornice.

Repair to be undertaken to damage / missing eaves tiles (et) by removal and replacement with new to match, of plain tiles in the following locations:

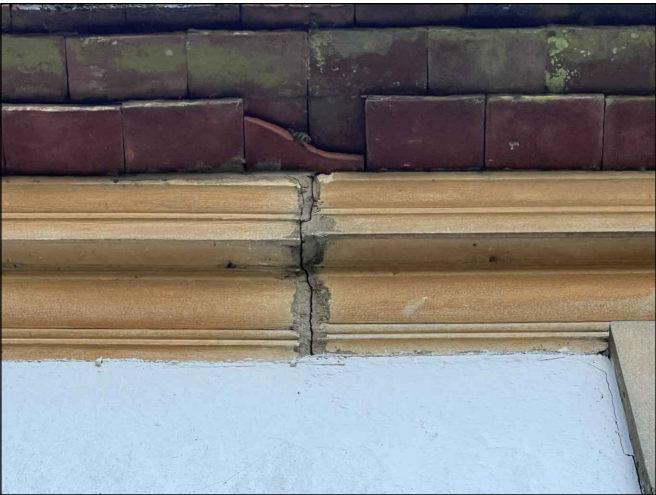
SC1 and et1

- SC1 -  
1no. vertical crack through full depth of cornice.
- SC2 -  
1no. diagonal crack through full depth of cornice.
- SC3 -  
1no. vertical crack through full depth of cornice.
- SC4 -  
1no. vertical and 1no. diagonal crack through full depth of cornice.
- SC5 -  
Eroded cornice corner piece to be rebuilt.
- SC6 -  
1no. diagonal crack through full depth of cornice.
- SC7 -  
1no. vertical crack through full depth of cornice.
- SC8 -  
1no. diagonal crack through top section of cornice.
- SC9 -  
1no. diagonal crack through full depth of cornice.
- SC10 -  
1no. diagonal crack through full depth of cornice.
- SC11 -  
Eroded cornice corner piece to be rebuilt.

Repairs to be undertaken to repairable cracks and eroded stone (sc) in stone cornice in locations as indicated on plan and described below.
