Client:  
**South Holland District Council**

Project:  
**Proposed Conservation Works to  
Spalding War Memorial  
Ayscoughfee Hall Gardens  
Church Gate  
Spalding  
PE11 2RA**

**Elevations as existing  
identifying works required**

| <b>A1660-14</b> | <b>T1</b> |

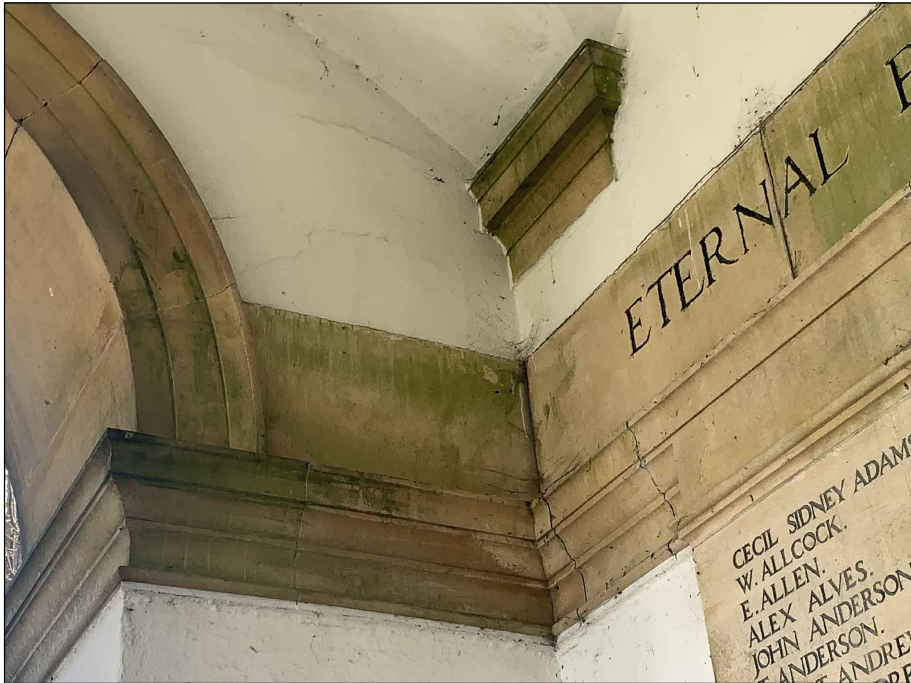
In general the works required are limited to the thorough cleaning and repointing of joints and minor cracks.

Image of stone cornice, frieze and corbel

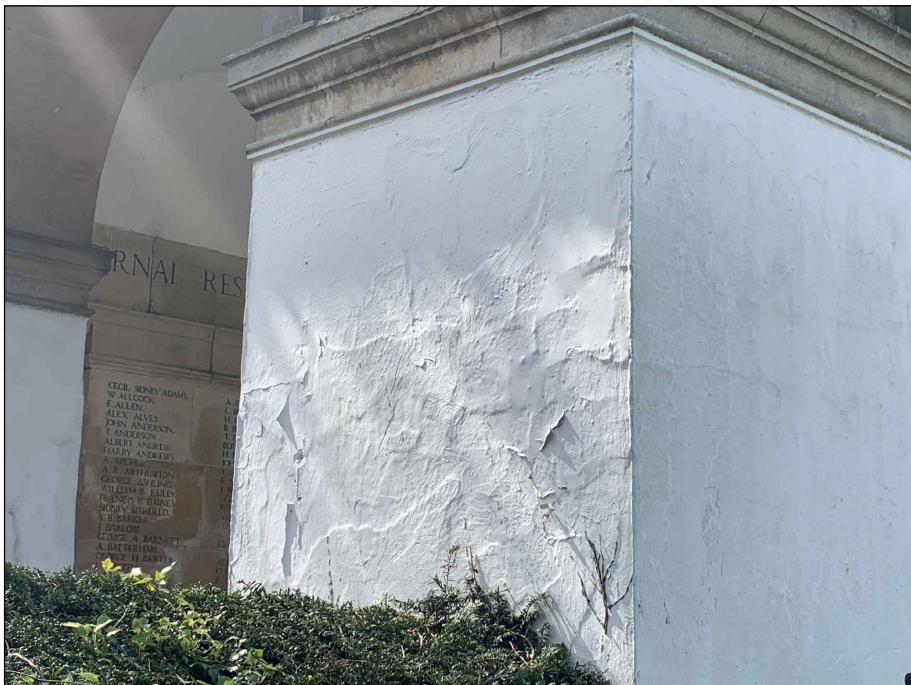
The existing render has deteriorated significantly and is cracked extensively. The render has been previously patched repaired possibly with an unsuitable render mix. The finish is therefore inconsistent and the overall appearance is poor. Cracks shown here are indicative only, but are intended to give a general feel for the state of the surface. More minor cracks, defective paint and delamination are not shown. All render is to be carefully removed, any significant substructure cracks are to be made good. Walls then to receive new render to all areas. Specification suitable for application taking account of sample analysis.

Image of render surface (typical)

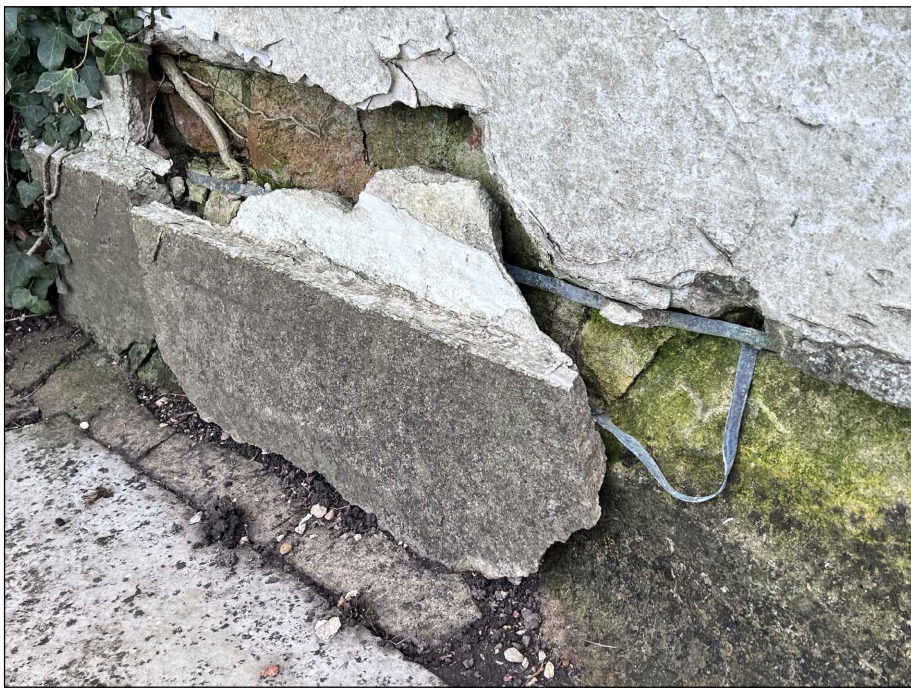
The existing stone skirting has deteriorated badly and in areas has been previously replaced, unsuccessfully. The existing skirting is to be carefully removed throughout. New stone skirting is to be provided to the base of all walls and piers except along the south elevation. To the south elevation a new reconstituted stone skirting is to be installed. The profile, size, material and finish of the skirting is to match those original sections that remain.

Image of eroded skirting detail

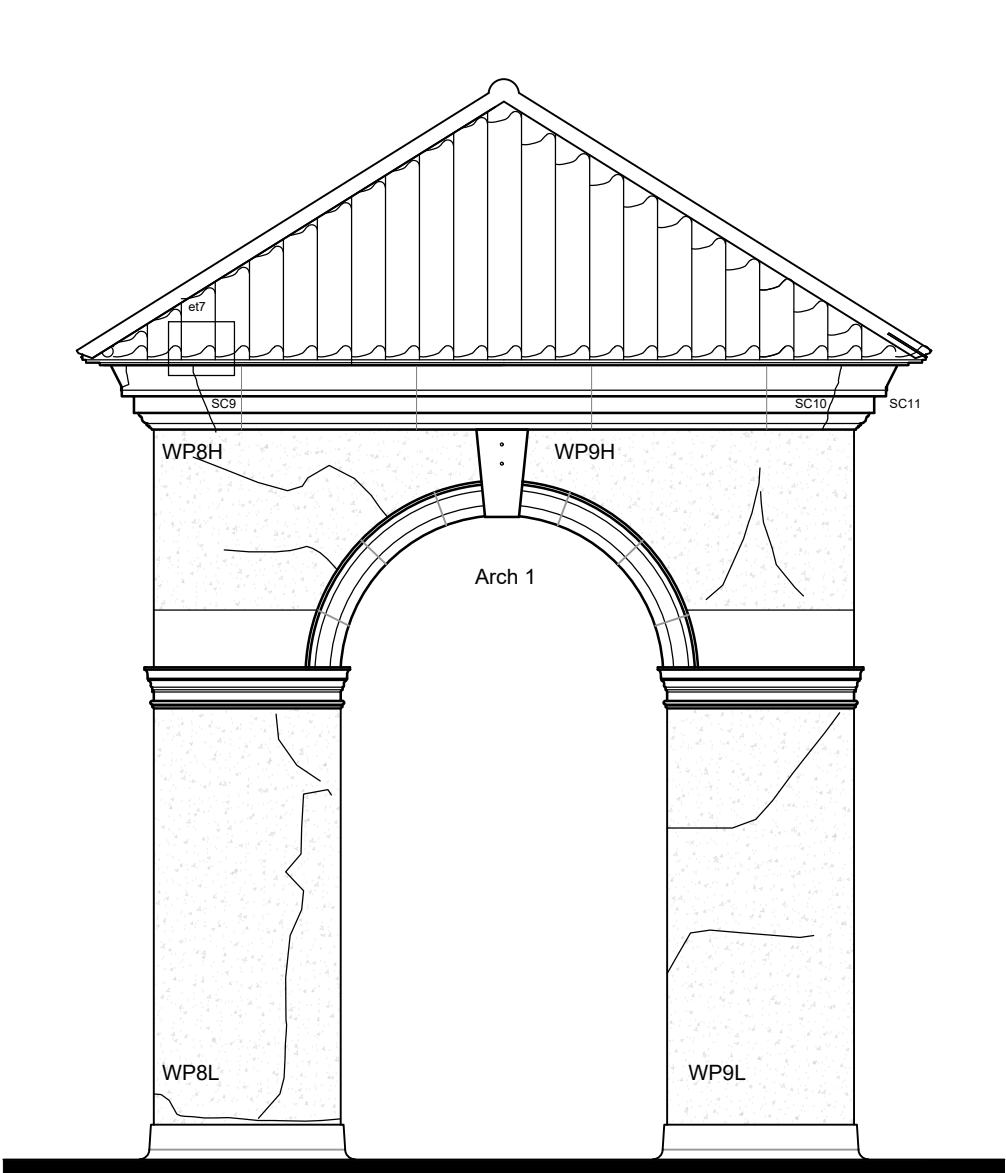
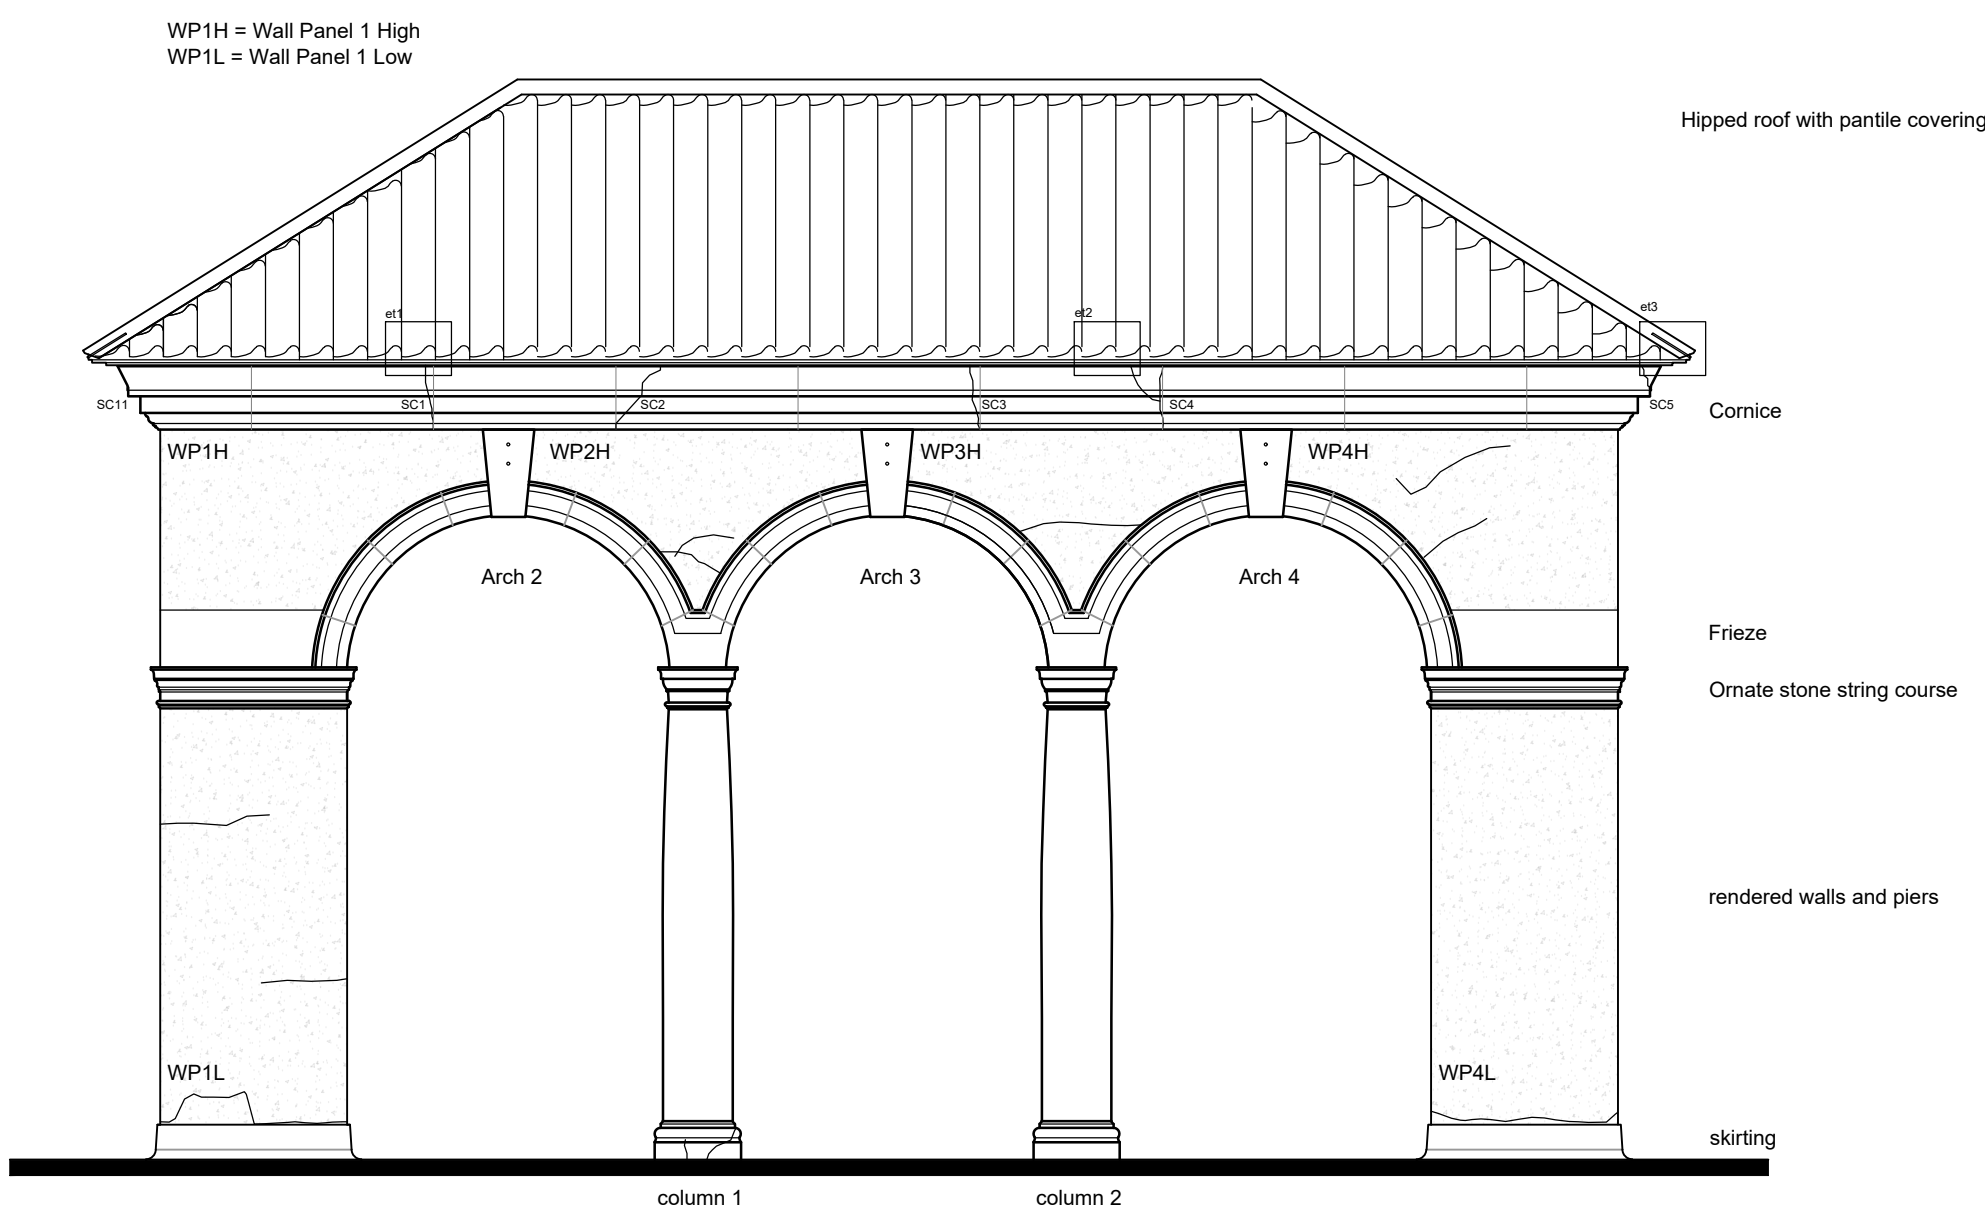
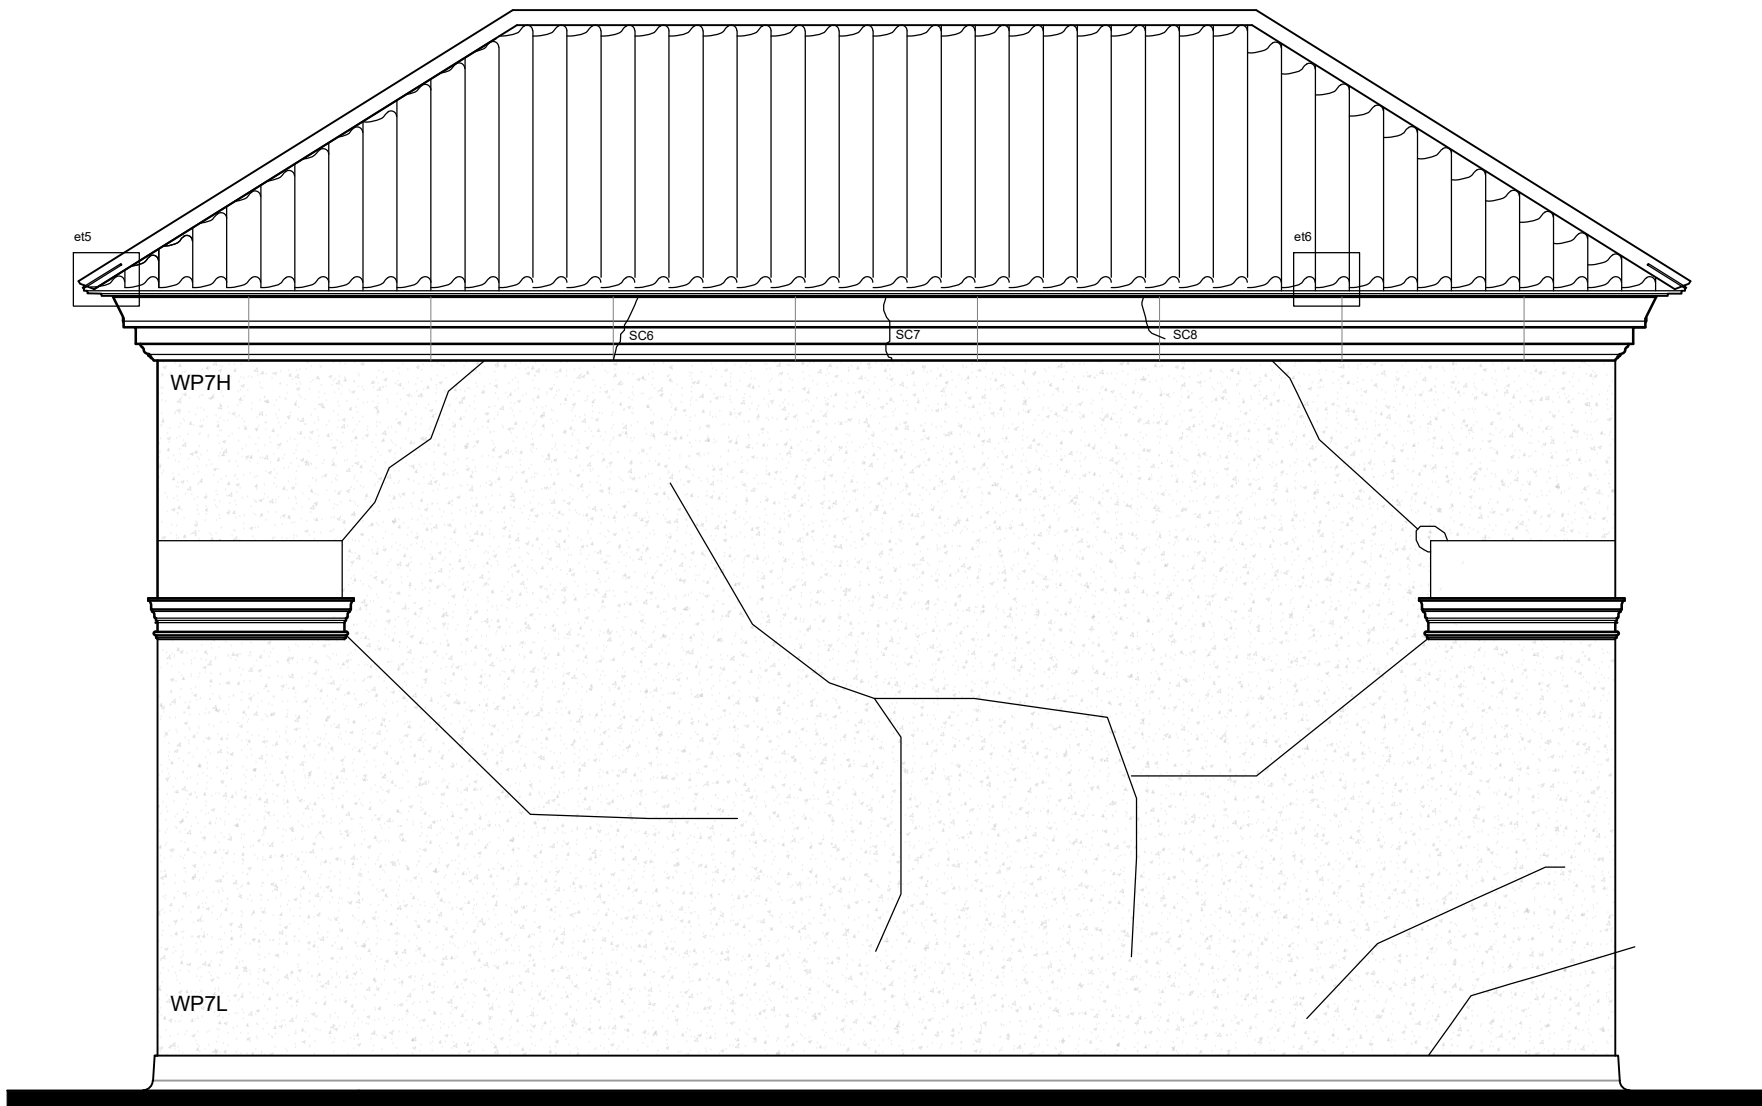
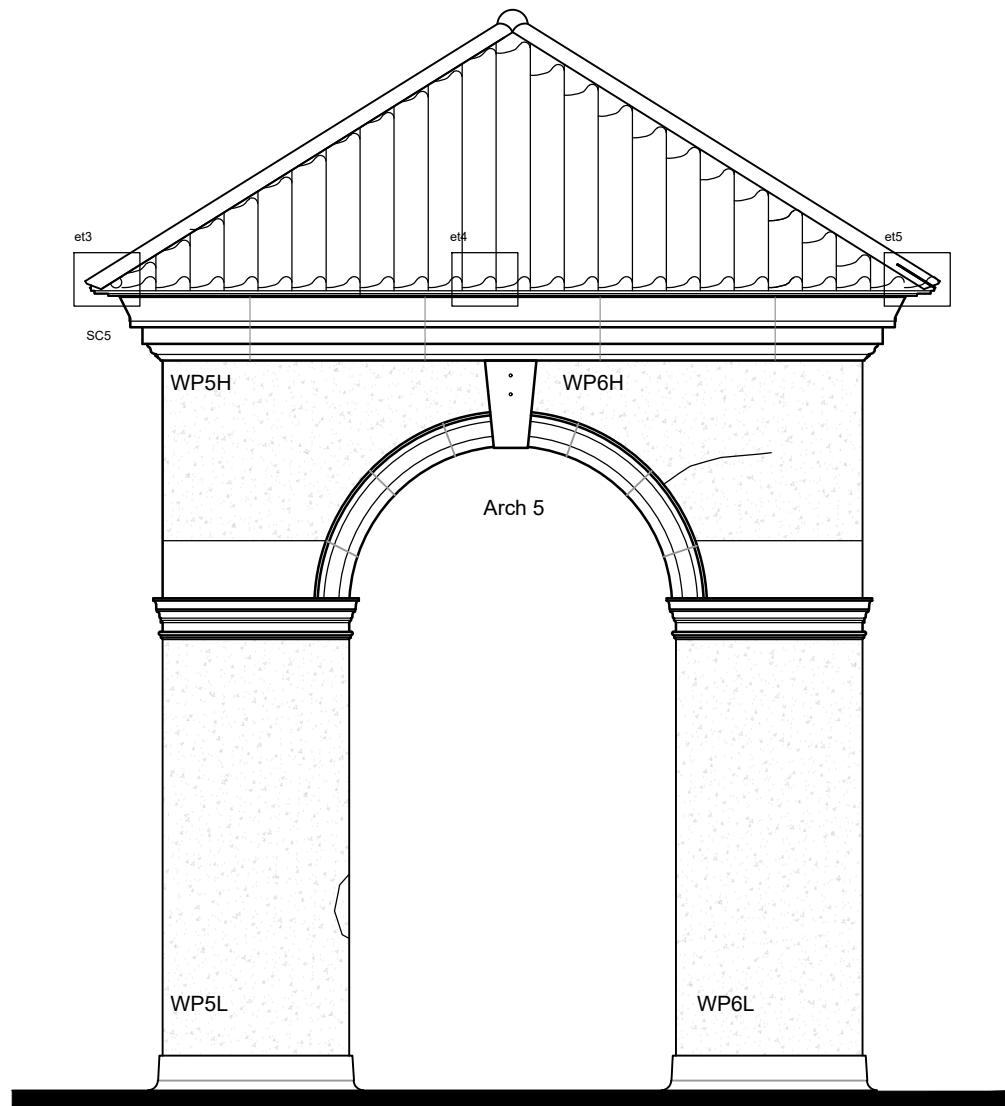
In general the condition of the arches and keystones is reasonable. There is slippage of the voussoir stones to arches 2 and 5. In both cases the Contractor will be required to have these assessed by a Conservation Accredited Engineer and suitable structural intervention is to be implemented if recommended as essential. Should intervention not be required then all minor cracks and gaps are to be filled and made good. Joints between voussoirs are to be repointed as appropriate. All 5 keystones have had fixings attached to the outer faces in the past. These have since been removed, but the fixing holes (2 to each arch) are to be made good.

Damage is evident to both columns 1 and 2. Repairs are required as follows:

Column 1  
The base plinth is badly damaged and repair work comprises the cutting out of damaged areas on the north face of the column, and the replacement using matching stone, carved to profile. This relates to the square plinth and the profiled section between this and the base of the column shaft. The shaft and capital are to be DOFF cleaned and minor cracks and depressions are to be repaired throughout.

Column 2  
This is generally in better condition than column 1, though some mortar repairs have been implemented on the base, which may not be of an appropriate mortar mix. This mortar is to be examined and if cementitious, it is to be carefully removed and refilled using a suitable lime mortar mix (provided its removal does not cause damage to the surrounding stone). The shaft and capital are to be DOFF cleaned and minor cracks and depressions are to be repaired throughout.
