# CONDITION SURVEY REPORT

SPALDING WAR MEMORIAL,  
SPALDING, LINCOLNSHIRE

Job Ref. No: 2450

Date of Inspection: 03.03.2023

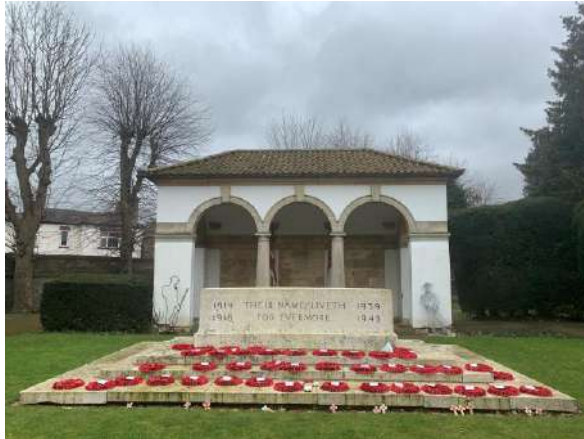
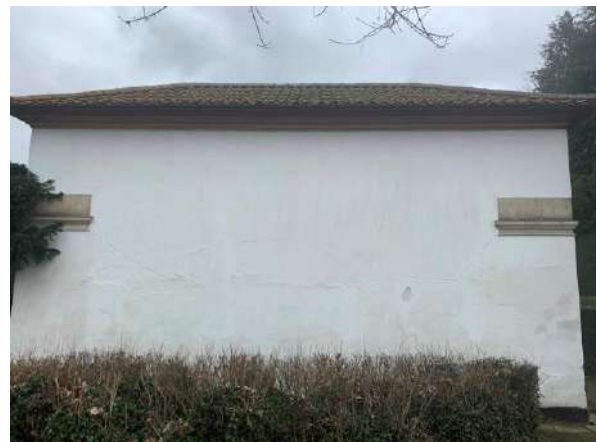
| ROOF COVERING | | | |
|---|---|---|---|
| <b>4.1.1 Roof Covering</b> | A shallow hipped roof of red clay pantiles with sprocketed eaves, which seems likely to be the original 1922 covering. | | [1] [2] |
| <i>Condition</i> | On the basis of a purely visual inspection, the roof appears to be in good order, with no sign of slipped, broken or delaminating tiles. The mortar bedding was hard to clearly inspect but appeared to be intact and free from cracking. However, there is a significant build-up of moss which no-doubt impedes the shedding of rainwater. Also, given the apparent age of the covering, it is likely the timber battens will be in need of replacement. | | |

| ROOF COVERING | | | |
|---|---|---|---|
| <i>Repair Needs</i> | i) Remove moss gently with a natural bristle brush.<br><br>ii) While not a priority, re-covering the roof would be beneficial in the long-term. This would involve laying new tanalised battens on a breather membrane and re-using the existing pantiles with a lime mortar bedding.<br><br>iii) The moss removal should be repeated on an annual basis as part of the memorial's ongoing maintenance regime. | <b>A</b><br><br><b>D</b><br><br><b>M</b> | |

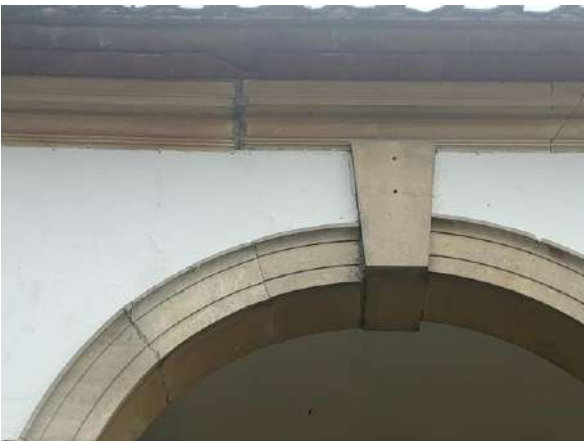
| ROOF COVERING | | | |
|---|---|---|---|
| <b>4.1.2 Eaves</b> | Deep projecting eaves with soffits of plain clay tiles. | | [3] |
| <i>Condition</i> | There are a few cracked and missing soffit tiles but otherwise the soffits are in reasonable order. | | |

| WALLING | | | |
|---|---|---|---|
| <b>4.3.1 Cornicing</b> | There is a cornice moulding of bath stone around the external perimeter of the building. | | [3] [5] |
| <i>Condition</i> | Cracked in placed but otherwise in good condition. | | |

| <b>4.3.3 String Course</b> | Moulded stone string course around much of the perimeter. | | [3] [5]<br>[7] |
| <i>Condition</i> | Generally, in good condition, although in places the finely moulded projecting aris at the top has crumbled away. | | |
| <b>4.3.4 Arches</b> | Three stone arches to the front plus a single arch to each side end. | | [3] [5]<br>[7] |
| <i>Condition</i> | One side of the easternmost arch to the front elevation has noticeably slipped against its keystone. This could potentially be due to historic settlement but nevertheless represents a structural concern. The other arches appear to be in good condition, although each keystone bears a pair of fixing holes from where hanging basket brackets have been secured in the past. | <b>B</b> | |

| ROOF COVERING | | | |
|---|---|---|---|
| <i>Repair Needs</i> | Replace all broken / missing tiles. | <b>B</b> | |

| WALLING | | | |
|---|---|---|---|
| <i>Repair Needs</i> | Rake-out and fill cracks. | C | |

| <i>Repair Needs</i> | <p>i) The dropped arch should ideally be reset, although at the very least 'tell-tales' should be installed to monitor movement.</p> <p>ii) Remove residual fixings from keystones and fill holes.</p> | <b>A</b><br><br><b>D</b> | |

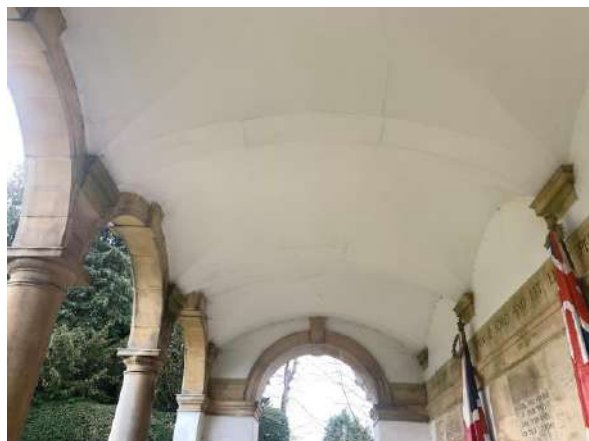
| ROOF STRUCTURE & CEILING | | | |
|---|---|---|---|
| <b>4.2.2 Ceiling</b> | A fine vaulted ceiling, presumably formed of lathe and plaster. | | [4] |
| <i>Condition</i> | There are a number of seemingly historic cracks evident but otherwise the ceiling appears to be in good order. | | |

| ROOF STRUCTURE & CEILING | | | |
|---|---|---|---|
| <i>Repair Needs</i> | Rub-down, fill cracks and redecorate. | C | |

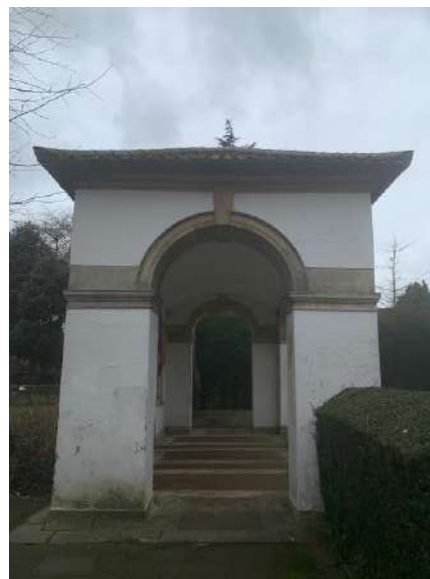
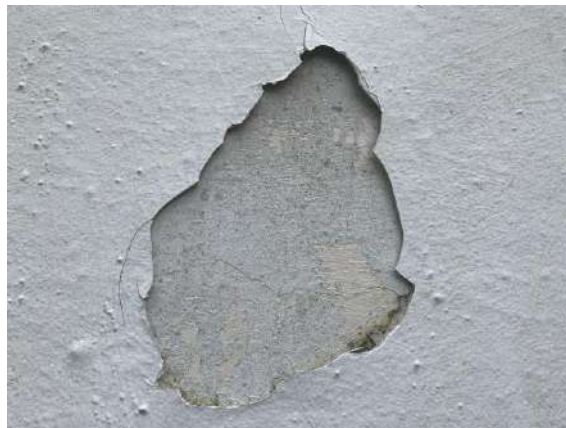
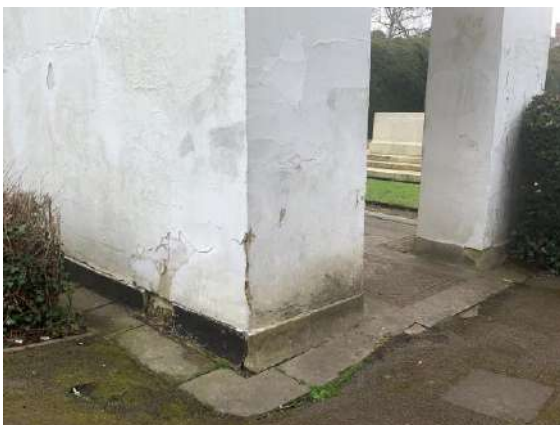
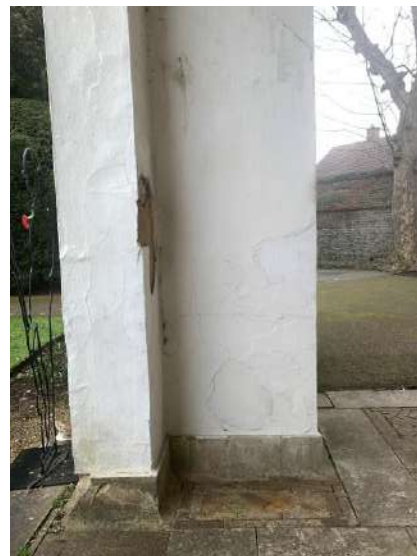
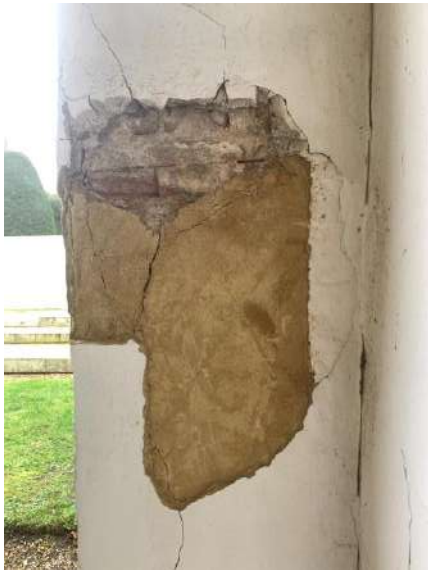
| WALLING | | | |
|---|---|---|---|
| <b>4.3.2 Rendered Walls</b> | The walls are of white painted render on solid brickwork. | | [2] [6]<br>[7] [8]<br>[10] [11]<br>[12]<br>[13] |
| <i>Condition</i> | Overall the condition is poor. The render has fallen away in patches and in other areas is pulling away from its substrate. There is plenty of scaring in the surface finish to demonstrate the render has been repeatedly patched-up over the years, particularly at lower level and seemingly with unsuitable cementitious mixes. The paint finish is also delaminating in swathes across the wall surface. | | |

| <i>Repair Needs</i> | <p>i) All loose/friable paintwork should be scraped back to firm edge.</p> <p>ii) All loose/friable render should be hacked back to brick, as should all hard/cementitious renders. The render should then be reinstated in a lime-based mix to match the make-up of the original render as closely as possible.</p> <p>iii) Re-decorate the render in a breathable mineral paint.</p> <p>Note: Given the likely amount of material removed in the repairs outlined above, serious consideration should be given to completely re-rendering the walls of whole building. If such an approach were to be adopted, careful consideration should also be given as to whether a paint finish should be re-applied. Paint analysis should ideally be commissioned to establish how the building was originally finished. This was probably in limewash, which may well account for why the later layers of paintwork are delaminating to such an extent. Certainly, the current colour finish in brilliant white seems stark and inappropriate.</p> | <b>B</b> | |

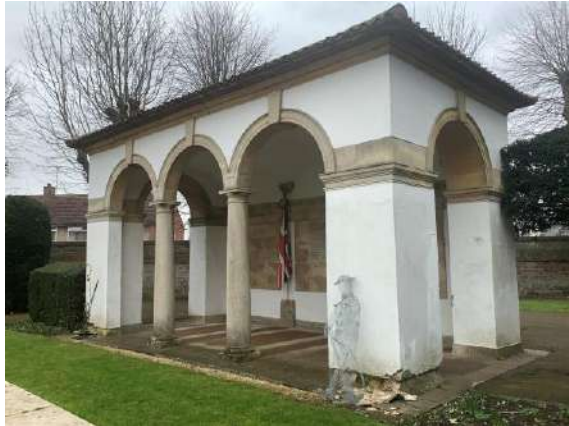
[7]

| <i>Condition</i> | Slight damage to stonework at base of easternmost column base but otherwise in good order. | | |
| <i>Condition</i> | The plinth is generally in a very poor state of repair. Many of the stones are badly eroded and others, which have subsequently been re-faced in concrete, have also since failed. This is symptomatic of a long-standing problem of damp, which is further evidenced by the presence of an electro-osmotic damp course. | | |

| LANDSCAPING | | | |
|---|---|---|---|
| <i>Condition</i> | The tarmac is generally sound but in places is eroding at its edges. The incline towards the building is a significant concern because the associated surface water runoff probably represents the primary underlying reason for the building's ongoing problem with damp and consequential fabric decay. | | |

| <i>Repair Needs</i> | Chop-out failed stonework and piece in new. | <b>B</b> | |

| LANDSCAPING | | | |
|---|---|---|---|
| <i>Repair Needs</i> | Re-surface adjacent footpaths (ideally in a more permeable material) and overhaul the surrounding surface water drainage strategy, so as to avoid water concentrating on the footprint of the memorial. | B | |

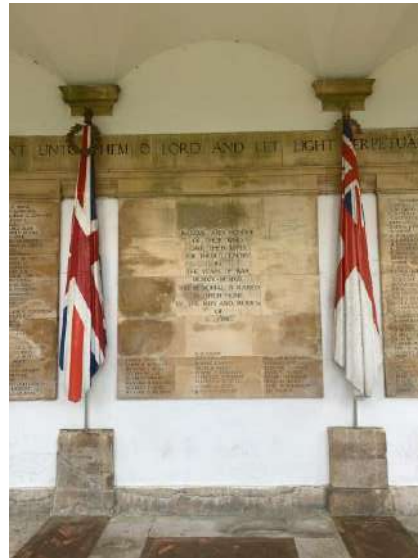
| MEMORIAL PANELS | | | |
|---|---|---|---|
| <b>4.5.1 Memorial Panels</b> | There are three stone panels set on the inside face of the rear wall. The central panel has the dedication and the names added in 2015; the outer panels are inscribed with the names of the fallen in black-painted incised lettering. | | [8] [22]<br>[23]<br>[24] |
| <i>Condition</i> | The stonework is very discoloured and patchy in appearance making it hard to read the inset lettering. It is uncertain whether or not the lettering was originally painted black but it seems likely this is a more recent addition to help make the letters more legible. In places the black paint has disappeared through surface erosion of the stonework. | | |
| <b>4.5.2 Flags</b> | On the rear wall are two painted flags of carved stone: the Union Flag (left) and White Ensign (right). The tops of the flagpoles are ornamented with pinnacles and encircled by laurel wreaths. | | [8] [25]<br>[26]<br>[27] |
| <i>Condition</i> | The laurel wreath to the White Ensign flag is partially missing. The laurel wreaths and pinnacles to both flags are somewhat dull looking and were perhaps gilded originally. | | |

| MEMORIAL PANELS | | | |
|---|---|---|---|
| <i>Repair Needs</i> | <p>i) Carefully remove dirt, algae and black paint from the surface of the stonework through a course of DOFF cleaning, undertaken by a specialist contractor.</p> <p>ii) Re-cut lettering where required.</p> <p>iii) Re-instate black paint to lettering if required.</p> | <p><b>C</b></p> <p><b>C</b></p> <p><b>C</b></p> | |

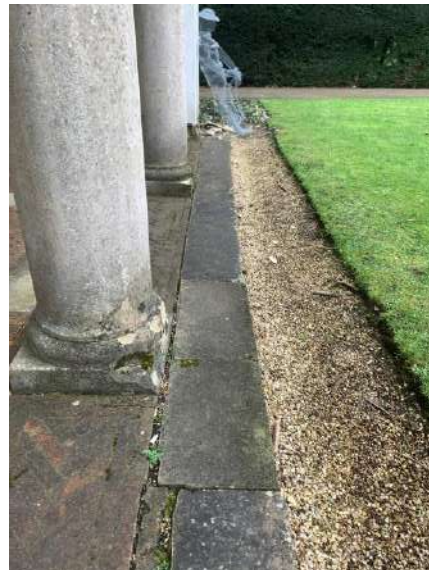
| <b>4.3.5 Columns</b> | Two Tuscan Doric columns of bath stone | | [7] [14] |

| <i>Repair Needs</i> | Cut out damaged corner and piece in new stone. | <b>C</b> | |

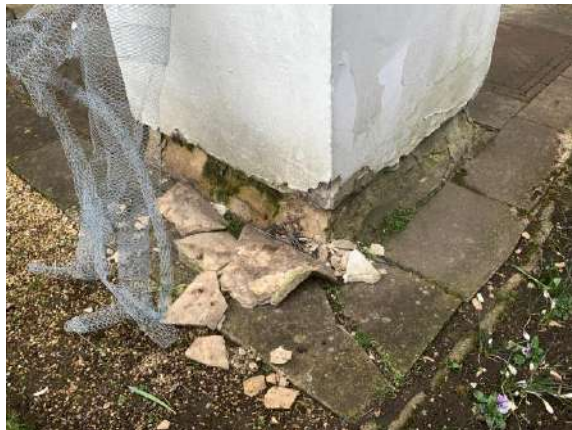
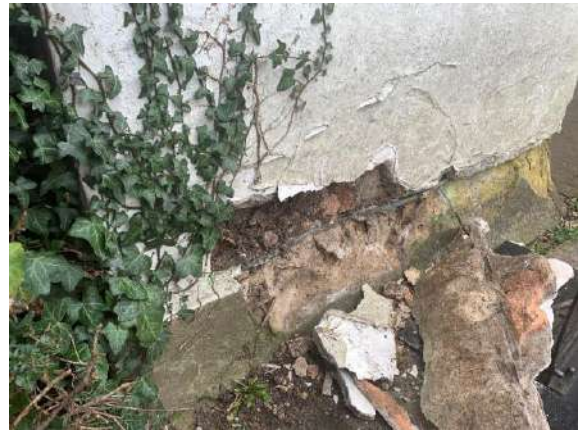
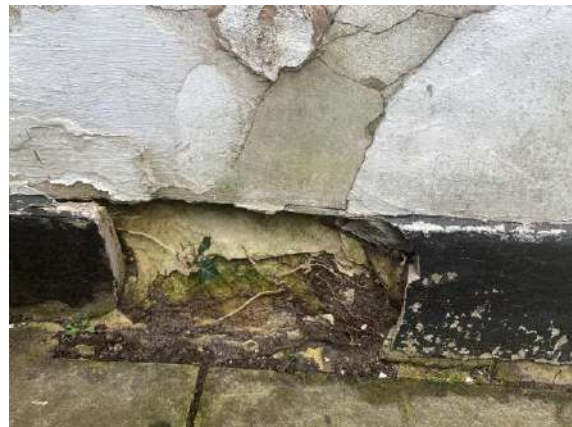
| <b>4.3.6 Plinth Base</b> | There is a profiled plinth of bath stone at the base of the building's entire perimeter. | | [7] [15]<br>[16] [17] |

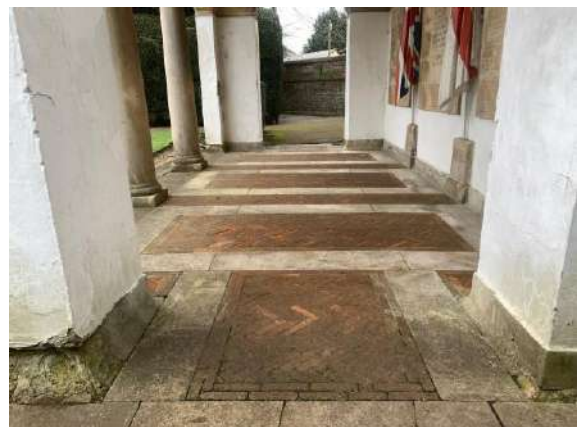
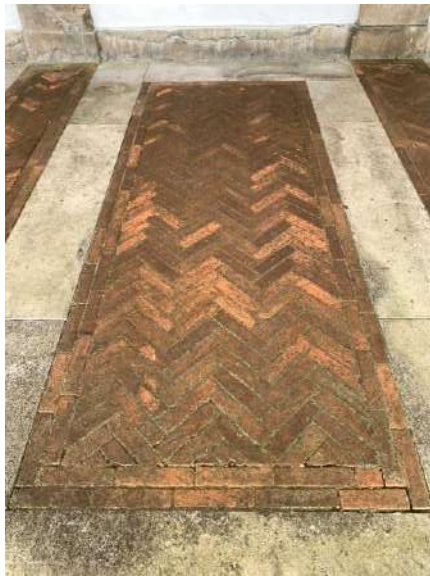
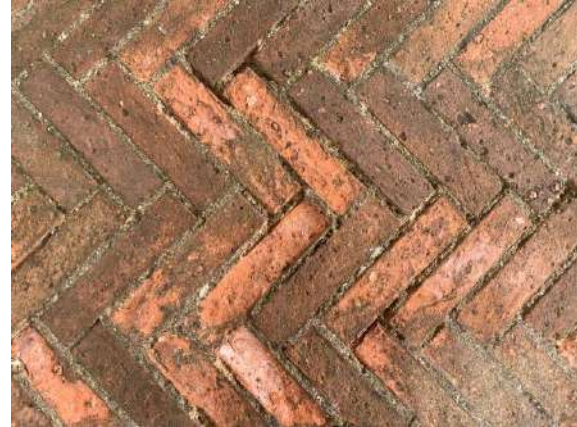
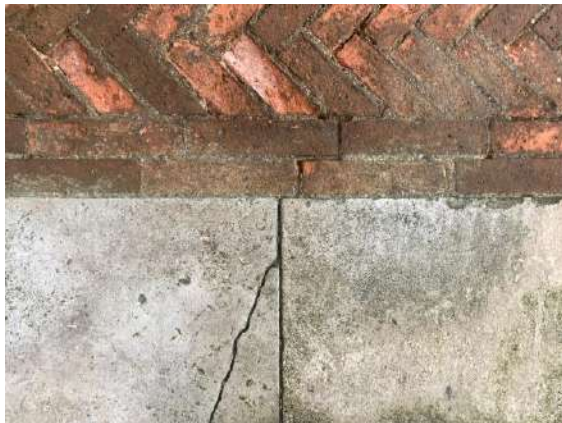
| FLOOR | | | |
|---|---|---|---|
| <b>4.4.1</b> | Inset panels of tightly-jointed, red herringbone brickwork with surrounds of bath stone. | | [18]<br>[19]<br>[20]<br>[21] |
| <i>Condition</i> | <p><u>Brickwork:</u> The herringbone brickwork is in reasonable condition and well-bedded, although approximately 10% of the bricks have lost their wearing surface, which has led to some starting to erode. This erosion is likely caused by the freeze-thaw cycle, brought on by two primary factors:</p> <ul style="list-style-type: none"> <li>▪ The soft bricks have re-pointed at some stage in an inappropriately hard cementitious mortar.</li> <li>▪ Surface water is being allowed drain across the floor from the surrounding hard-landscaping.</li> </ul> <p><u>Stonework:</u> The stone surrounds are somewhat stained by algae and their bedding joints have mostly eroded away.</p> | | |

| FLOOR | | | |
|---|---|---|---|
| <i>Repair Needs</i> | <p>i) Rake-out plant growth and loose material from between bedding joints and re-point in lime mortar where necessary.</p> <p>ii) Carefully remove dirt and biological deposits from the surface of the brickwork and stonework through a course of DOFF cleaning, undertaken by a specialist contractor.</p> | <p><b>B</b></p> <p><b>C</b></p> | |

| | <p>iii) As part of an on-going maintenance regime, cleaning of floor should be repeated on an annual basis by hand with fresh water and a natural-bristle brush but without the use of chemical or household products.</p> <p>Note: While it may be desirable to remove the cementitious pointing, this is <u>not</u> recommended to be attempted, as the process of mortar removal would likely cause more damage to the adjacent bricks than it prevents. Similarly, it is not recommended to attempt to cut-out and replace the eroding bricks, as to-do-so would likely spoil the visual integrity of the herringbone pattern.</p> | <b>M</b> | |

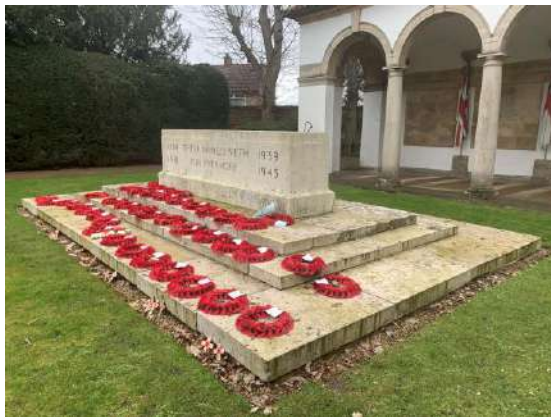
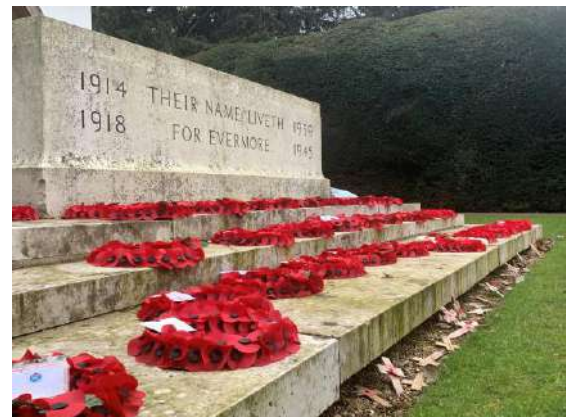
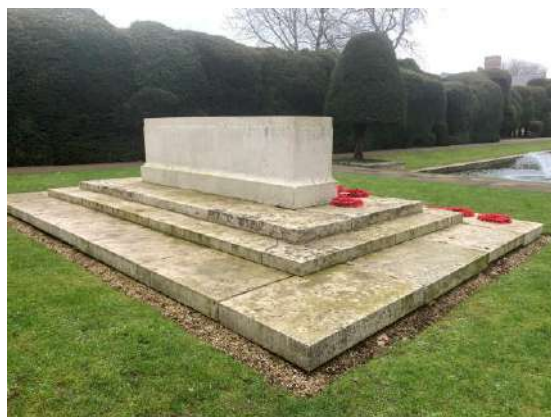
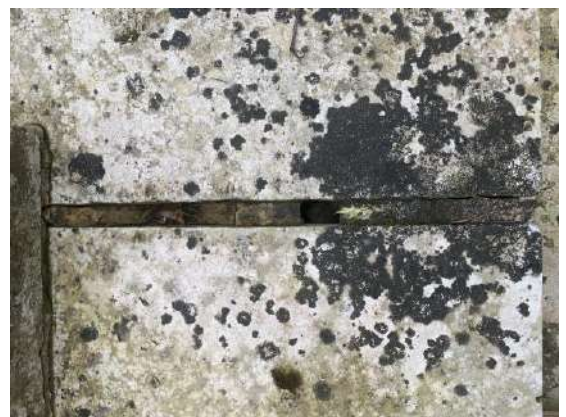
| STONE OF REMEMBRANCE | | | |
|---|---|--|---|
| <b>4.7.1 Steps</b> | A plinth of three stone steps provides a base to the monument. | | [33]<br>[34]<br>[35]<br>[36] |
| <i>Condition</i> | The infill mortar to the joints between the various slabs of stone has mostly eroded away and has left the stonework vulnerable to water ingress. The surface of | | |

| | the stonework is also highly discoloured by lichen and algae. | | |
| <b>4.7.2 Memorial Stone</b> | Carved from a single block of portland stone, the memorial bears an inscription on the north face that reads 'THEIR NAME LIVETH / FOR EVERMORE' with '1914 / 1918' to the left and '1939 / 1945' to the right. The stone's form appears to be a facsimile of the stones of remembrance that are a standard architectural feature of every Commonwealth War Graves Commission cemetery. | | <p>[33]</p> <p>[34]</p> <p>[35]</p> <p>[36]</p> |
| <i>Condition</i> | In stark contrast to the stones of remembrance maintained in pristine condition by the Commonwealth War Graves Commission, the stonework of this monument is covered in lichen and algae and looks notably shabby. The incised lettering of the inscription has been highlighted in black paint which is never a feature of a Stone of Remembrance and should therefore be removed. The stonework appears otherwise sound. | | |

| <i>Repair Needs</i> | <p>i) Rake-out all remaining mortar and completely repoint the steps in a matching lime mortar.</p> <p>ii) Carefully remove dirt, algae and lichen from the surface of the stonework through a course of DOFF cleaning, undertaken by a specialist contractor.</p> <p>iii) As part of an on-going maintenance regime, cleaning of the stonework should be repeated on an annual basis by hand with fresh water and a natural-bristle brush but without the use of chemical or household products.</p> | <p><b>B</b></p> <p><b>C</b></p> <p><b>M</b></p> | |
| <i>Repair Needs</i> | <p>i) Carefully remove dirt, algae and lichen from the surface of the stonework through a course of DOFF cleaning, undertaken by a specialist contractor.</p> <p>ii) Remove black paint from the inscription and re-cut lettering if necessary.</p> <p>iii) As part of an on-going maintenance regime, cleaning of the stonework should be repeated on an annual basis by hand with fresh water and a natural-bristle brush but without the use of chemical or household products.</p> | <p><b>B</b></p> <p><b>C</b></p> <p><b>M</b></p> | |
