**Existing Barns**

**Bridge Farm  
Holbeach Road  
Spalding  
PE12 6JP**

**Visual Structural Appraisal  
Report for Proposed Conversion  
to Residential Dwelling**

Report No: **5557 / 01**

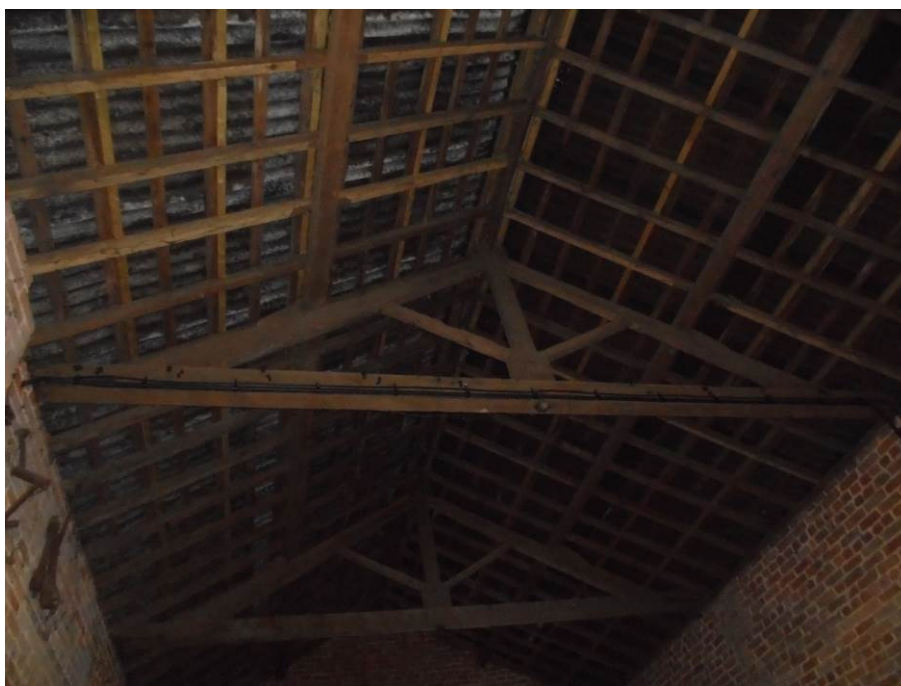
Plate 1

- 3.1.5 The roof comprises of three timber king post roof trusses, mid height purlin and ridge beam supporting intermediate rafters. The roof is covered with corrugated roof sheeting which is supported via timber counter battens spanning between the rafters (Plate 1). Given the age and appearance of the roof sheeting, it is likely that it is made from asbestos cement. (This should be confirmed).
- 3.1.6 There was evidence of undulations to the external roof sheeting suggesting possible sag to the counter battens.
- 3.1.7 Generally the roof appeared to be in good structural condition and appears to be supporting the current loads adequately. Structural design checks will be required for the counter battens, rafters and purlins to confirm their adequacy.

- 6.3 Roofs
  - 6.3.1 The timber roof structure to 'Barn A' appears to be in good order; it should be possible to retain, but this may require some strengthening. A design calculation check will be required.

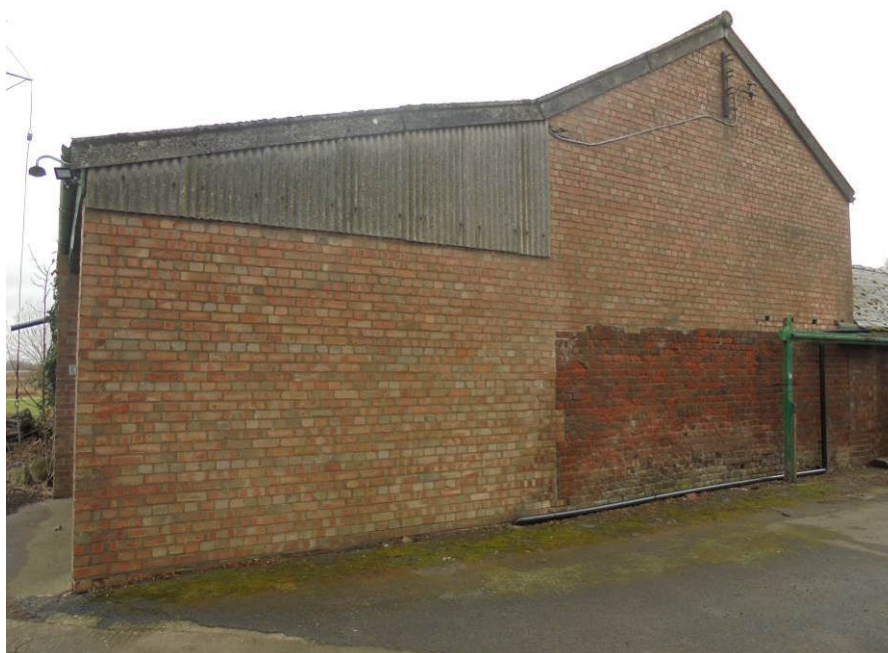
Plate 2

- 3.2.2 The south-east and south-west walls appear to have been extended vertically to match the wall height and roof pitch of the central 'Barn A' (Plate 2).

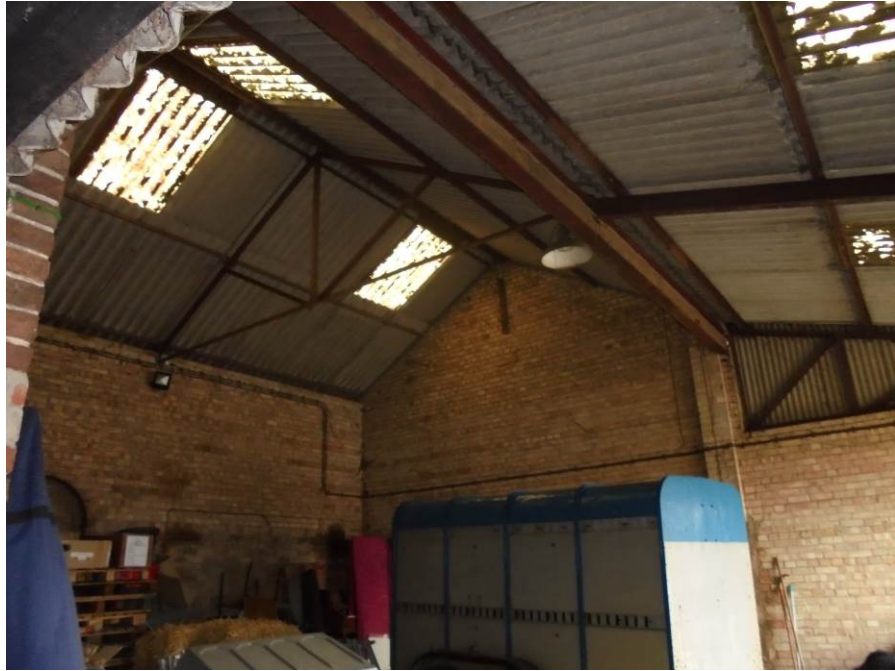
Plate 3

- 3.2.6 The roof comprises of cement board (considered likely to be asbestos), supported by steel purlins which are supported by a central truss fabricated from steel angles (Plate 3).

- 6.3.2 The steel roof structure to 'Barn B' is unlikely to support the loads from a traditional tiled replacement roof. We suggest this is replaced. The steel beam supporting the roof will require calculation to determine if it is adequate for the new roof loadings.

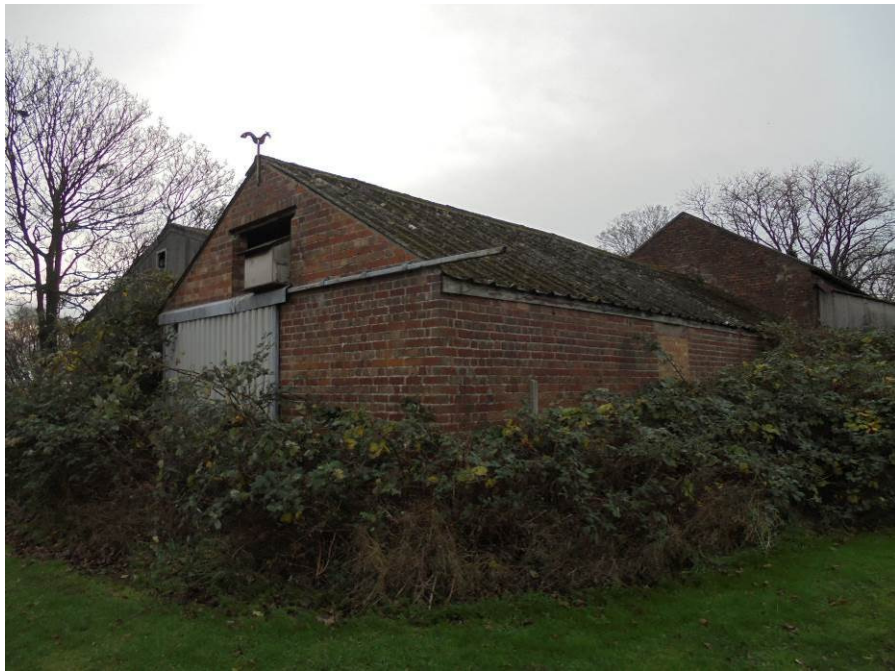
Plate 4

- 3.3.1 The walls are constructed from standard format clay brickwork in 'English Bond' which is 215mm thick. (Plate 4). The walls were found to be plumb with level bed joints.
- 3.3.2 There is an internal wall across the barn mid-way along its length. The cross wall has a large unsupported opening (See 5.3).
- 3.3.3 The floor is constructed from in-situ concrete throughout.

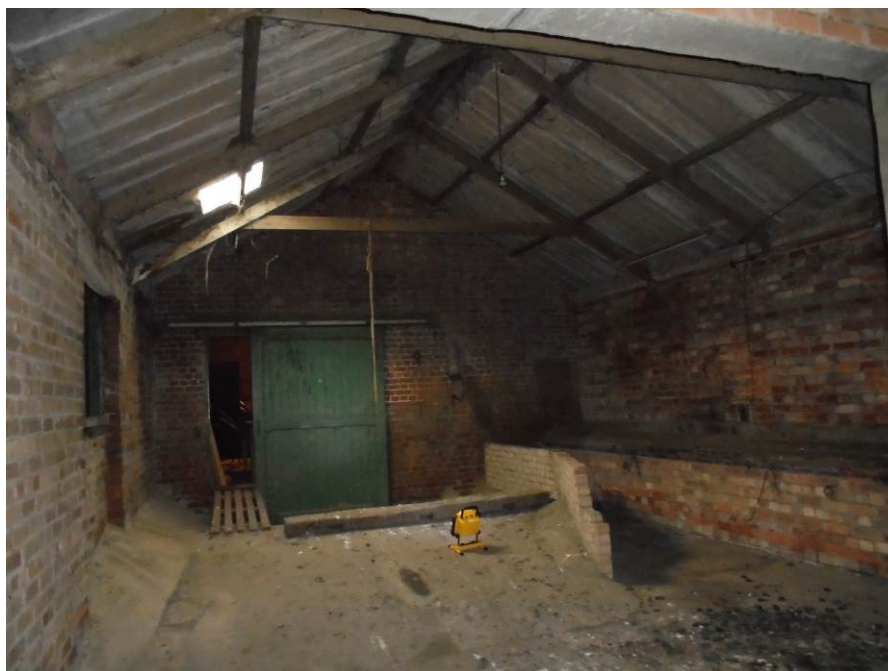
Plate 5

- 3.3.4 A section of ramped floor and a trough (dated 1973) has been formed adjacent to the gable wall of 'Barn A' (Plate 5). We understand this was to allow grain to be transferred.
- 3.3.5 The floors were in fair condition, but we do not know the floor thickness or details of the formation.
- 3.3.6 The roof structure comprises of widely spaced timber rafters supporting four timber purlins and a ridge beam. A number of the rafters have a raised horizontal tie, forming trusses (Plate 6).

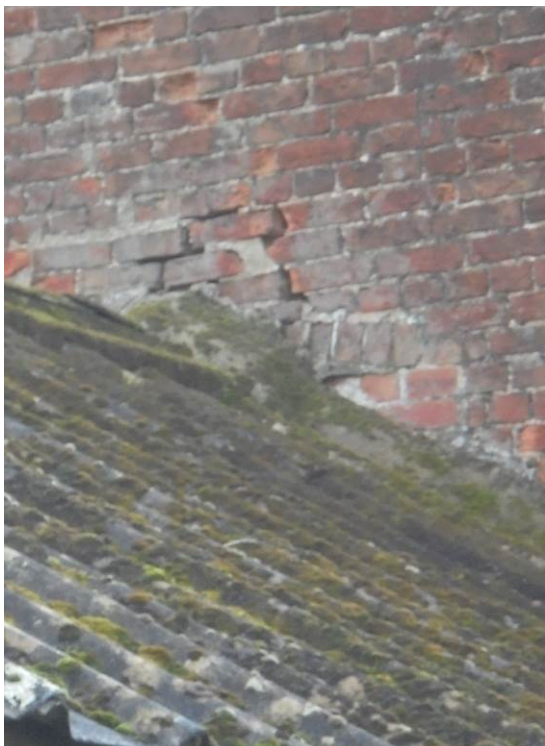
Plate 7

- 4.1.1 External gable wall at junction with 'Barn C' ridge- Loose brickwork (Plate 7).  
*Remove and repoint.*

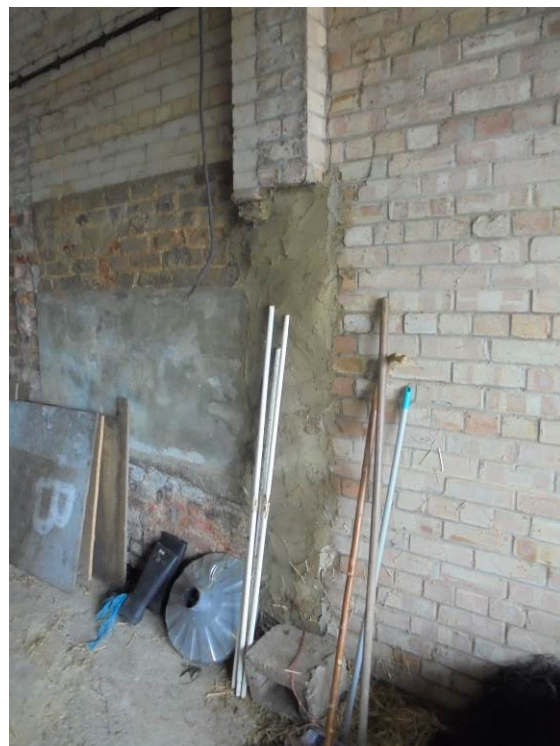
Plate 8

- 4.2.1 Gable wall inside - Bottom of brick pier removed (Plate 8).  
*Recommend pier is reconstructed immediately*  
*New method of lateral restraint for gable wall required as pier alone is insufficient for residential property.*

- 5.1 We consider the property to be in good structural condition given the buildings age.
- 5.2 The roof to 'Barn C' is unlikely to be proven structurally adequate to current codes but appears to be suitable for the current agricultural use. This should be periodically inspected to look for signs of movement or distress, particularly after heavy snow or high winds.
- 5.3 The walls above the large unsupported opening within the cross wall of 'Barn C' (Plate 14) is at risk of collapse. **Temporary props should be installed.**
- 5.4 The missing section of masonry pier to the south-west gable wall of 'Barn B' should be reinstated.

- 6.3.4 Any timberwork which is to be retained should be inspected by a specialist and treated as necessary
- 6.4 Walls
  - 6.4.1 The gable wall panel to 'Barn B' is not considered to have adequate lateral restraint to resist design wind loads. Nor is the small masonry pier deemed adequate. A scheme to strengthen the panel and to provide additional support will be required as part of the conversion works.

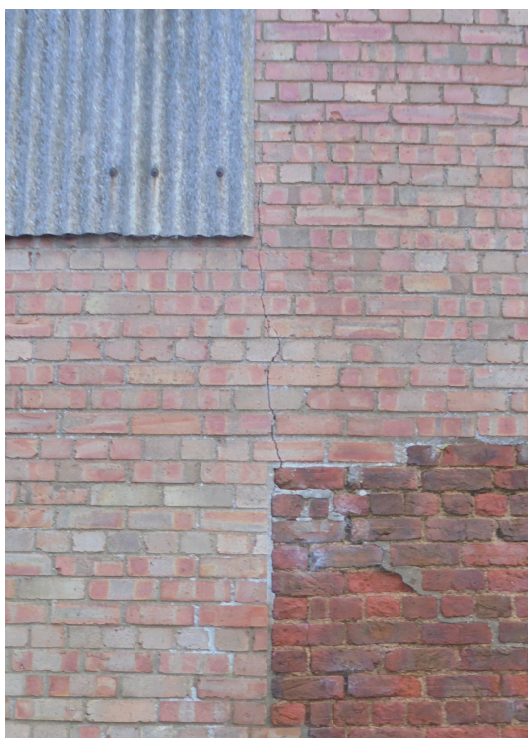
Plate 9

- 4.2.2 Gable wall - Vertical crack in new masonry in line with end of original wall. New and original walls are not toothed, unknown if ties have been installed (Plate 9).  
*If lean-to section is to be retained, provide crack stitching across vertical butt joint. Replace fractured bricks and stitch bed joints.*

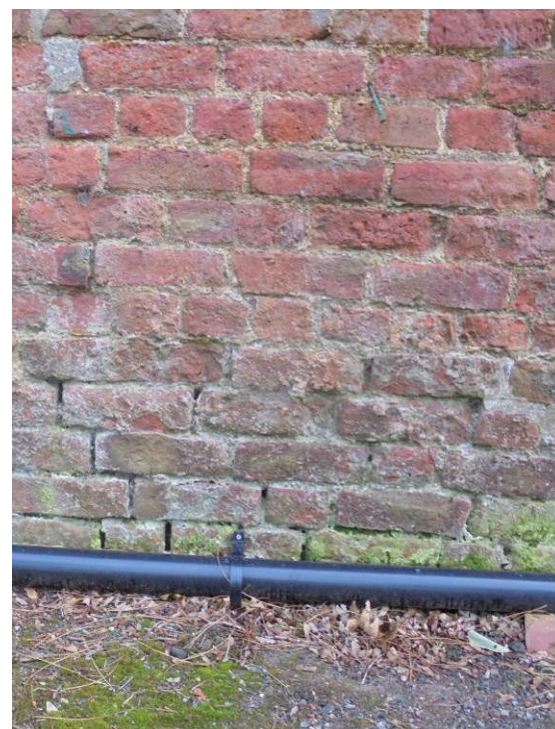
Plate 10

- 4.2.3 Gable wall, low level - Brickwork mortar joints weathered back from face (Plate 10).  
*Rake out mortar joints and point with lime mortar*
- 4.2.4 Side wall Inside – Vertical crack extends from the top of the original wall upwards to eaves level where it is estimated to be 5mm wide (Plate 11). Crack could also be seen externally in line with the adjoining roof ridge (Plate 12).  
*Remove fractured bricks; install Heli-Bar crack stitching. Final details are to be developed.*

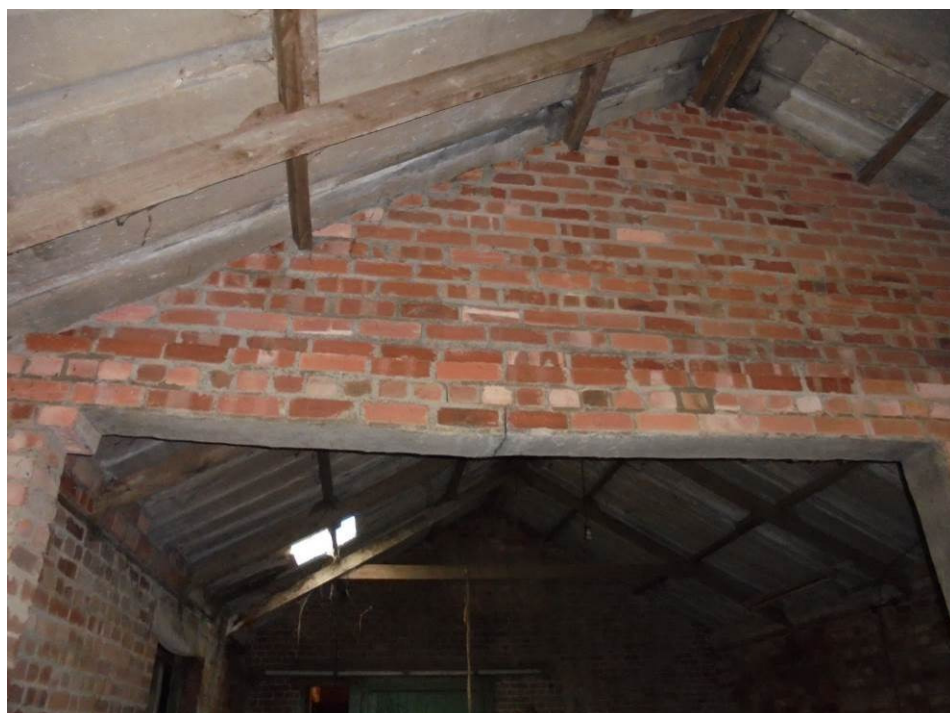
Plate 14

- 4.3.1 The walls above the large unsupported opening within the cross wall of 'Barn C' is at risk of collapse (Plate 14). **Temporary props should be installed.**
