Project:  
**Ayscoughfee Hall Museum & Gardens  
Church Gate, Spalding, PE11 2RA**

**Proposed works to North Gates (at end  
of The Chestnut Avenue)**

| Drawing Title:<br><b>Annotated photographs showing<br/>existing visible defects and previous<br/>repairs.</b><br><b>LBC APPLICATION ISSUE</b> |

| Drawing Number:<br><b>A1572-51</b> | Rev:<br><b>P01</b> |

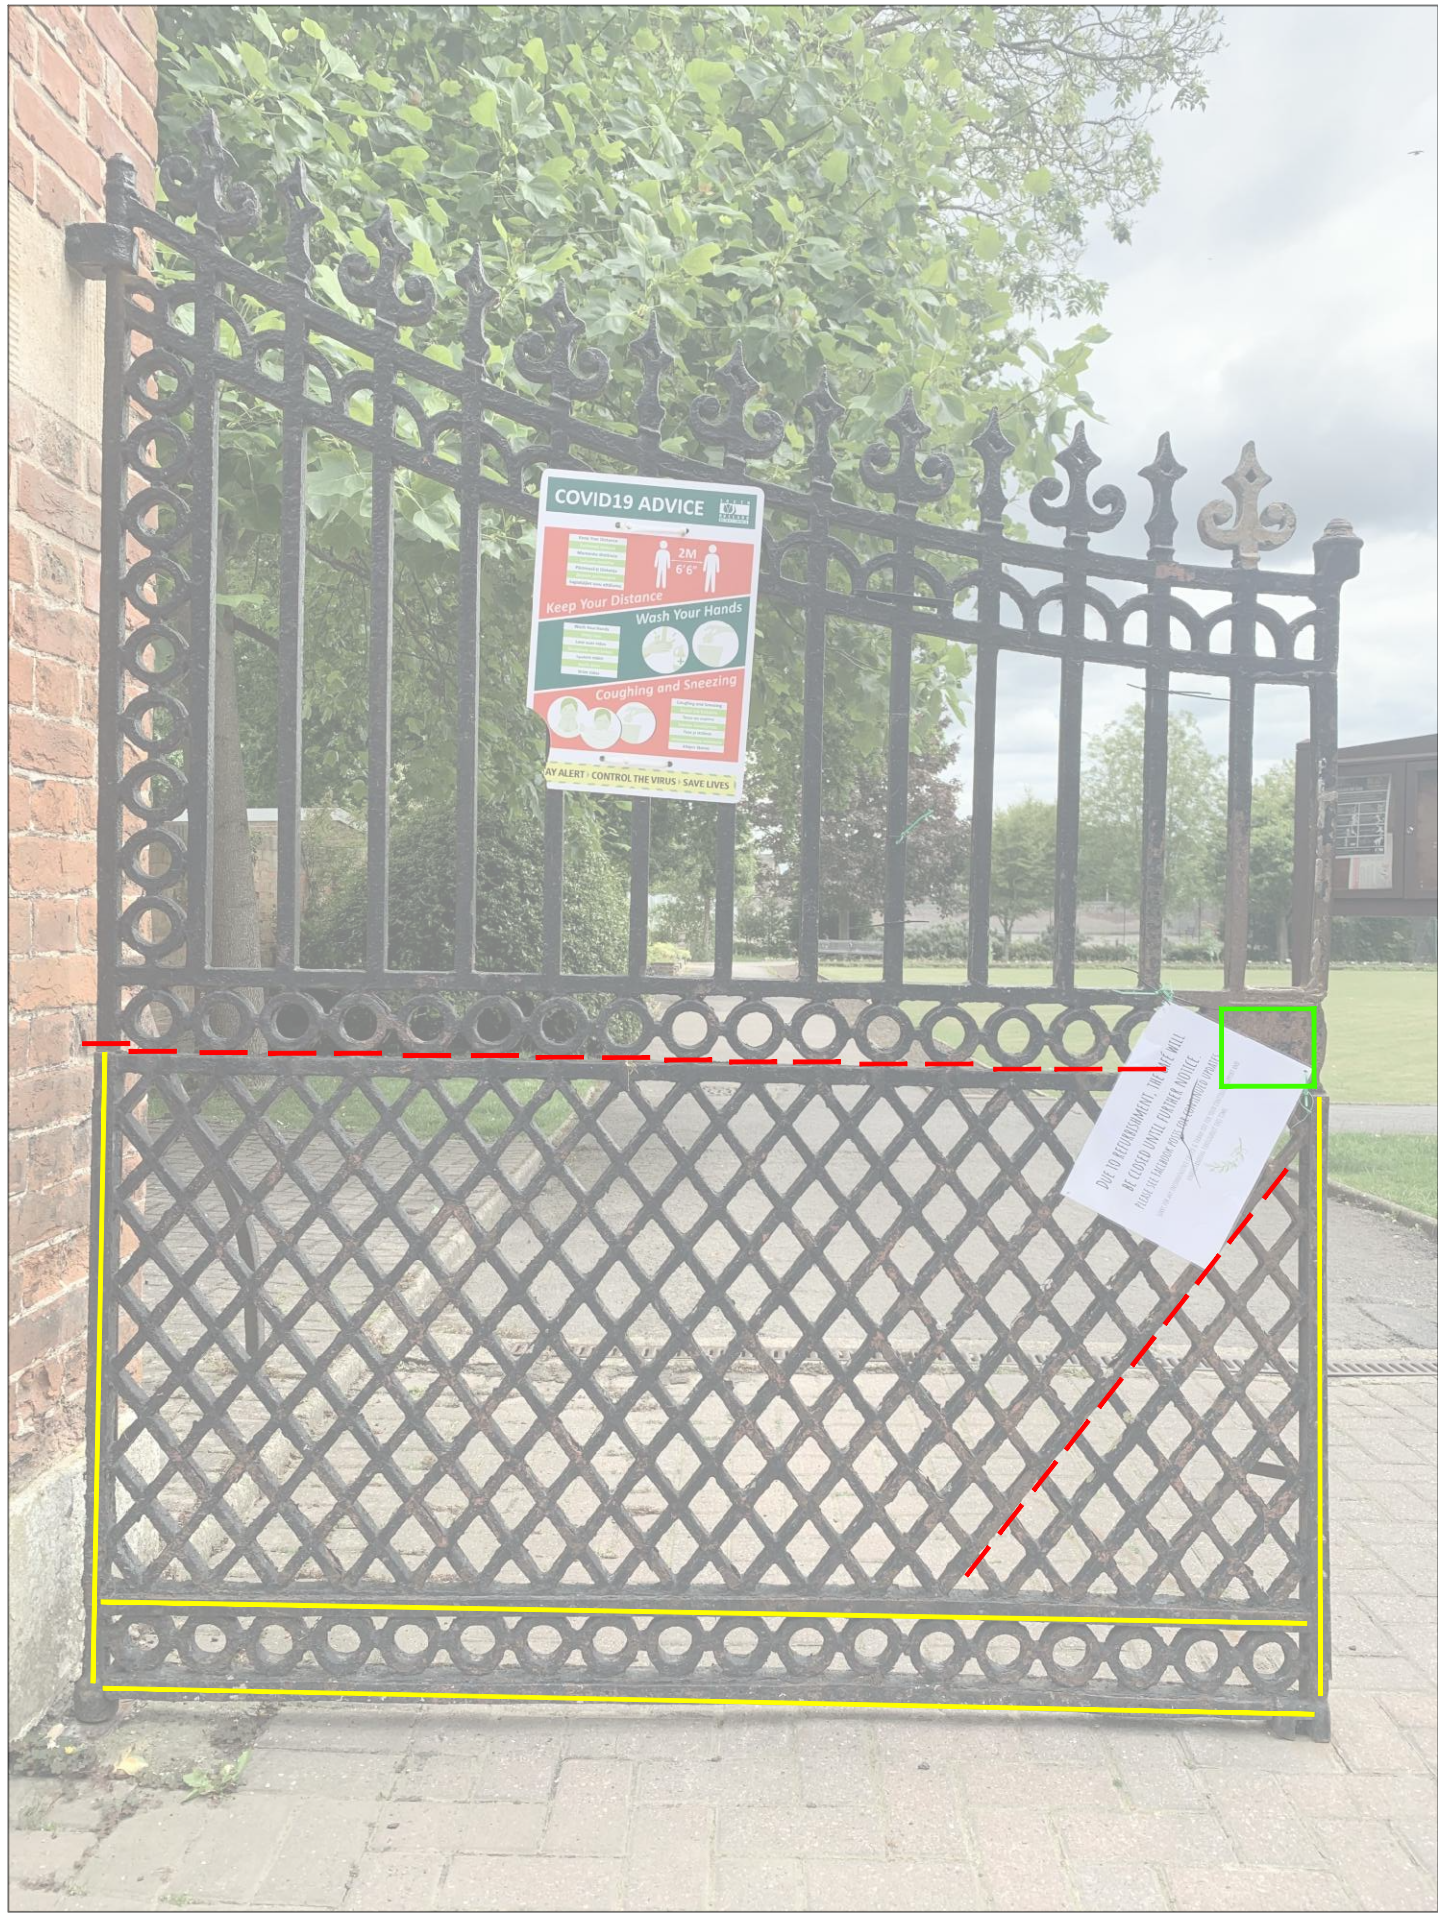
North gate  
(from west)

View of gates from west (the Chestnut Avenue) - showing visible defects and repairs

5. On the south gate 3 vertical pins have been installed within the central rail, again suggesting a interim repair.
6. The north gate has hairline cracks running horizontally at mid-rail level and at an angle of 45 degrees descending from the lock box. These fractures appear to extend through the full thickness of the iron.

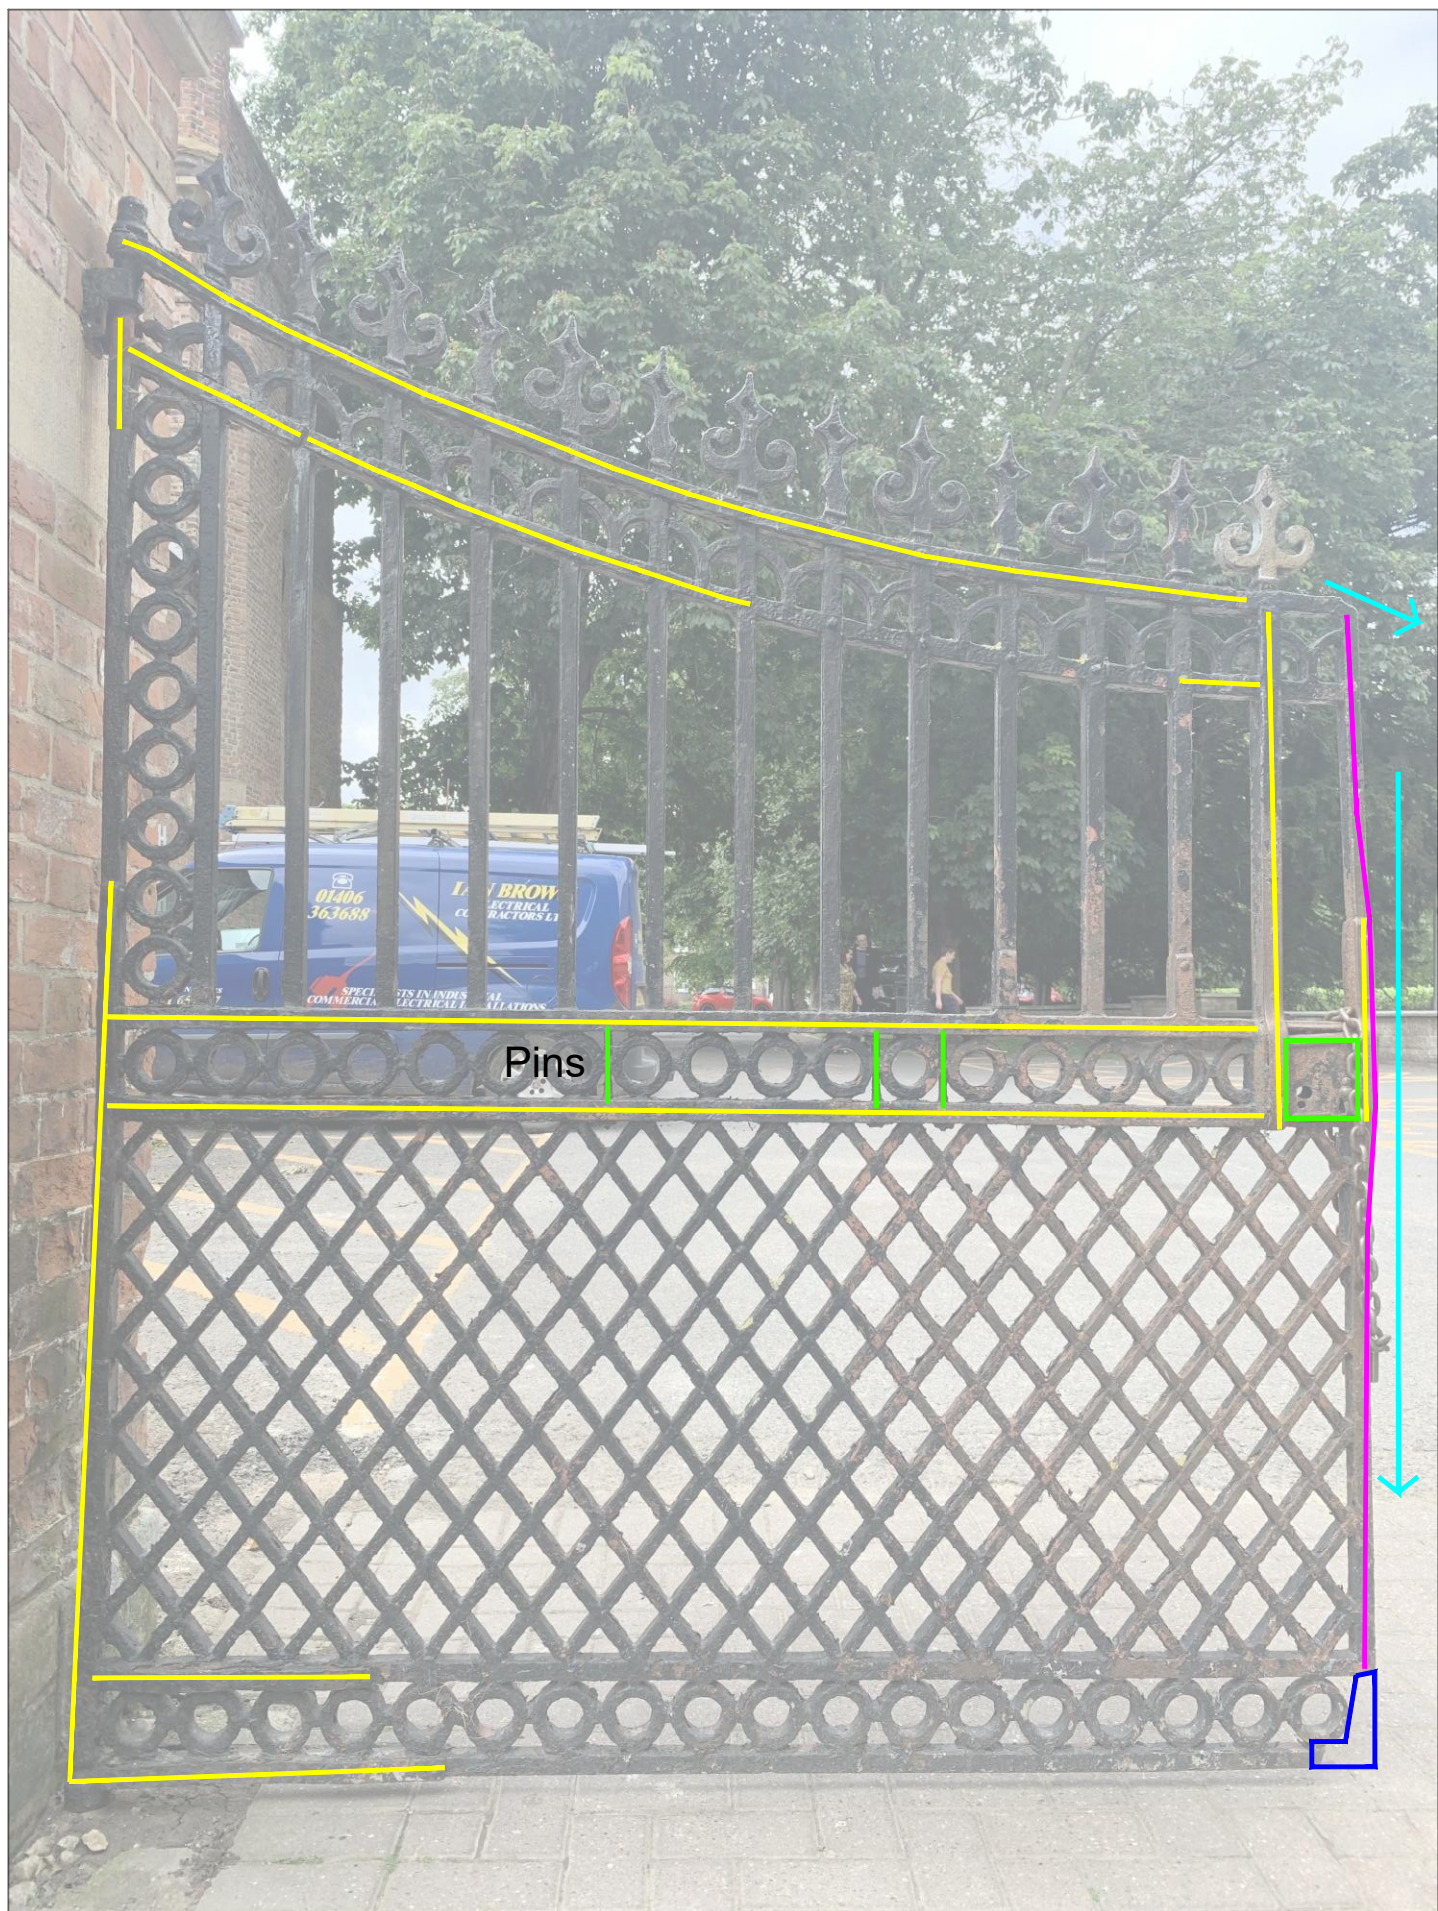
South gate  
(from east)

2. The gates will not close correctly, this is due to distortion within the gates and in particular the south gate.
3. The lock box is not functioning and consequently the gate has been secured by a chain which has further damaged the painted surfaces.

7. There appears to be general distortion in both gates, but particularly the south gate. It is suspected that the shear weight of each gate is either causing or significantly contributing to this.

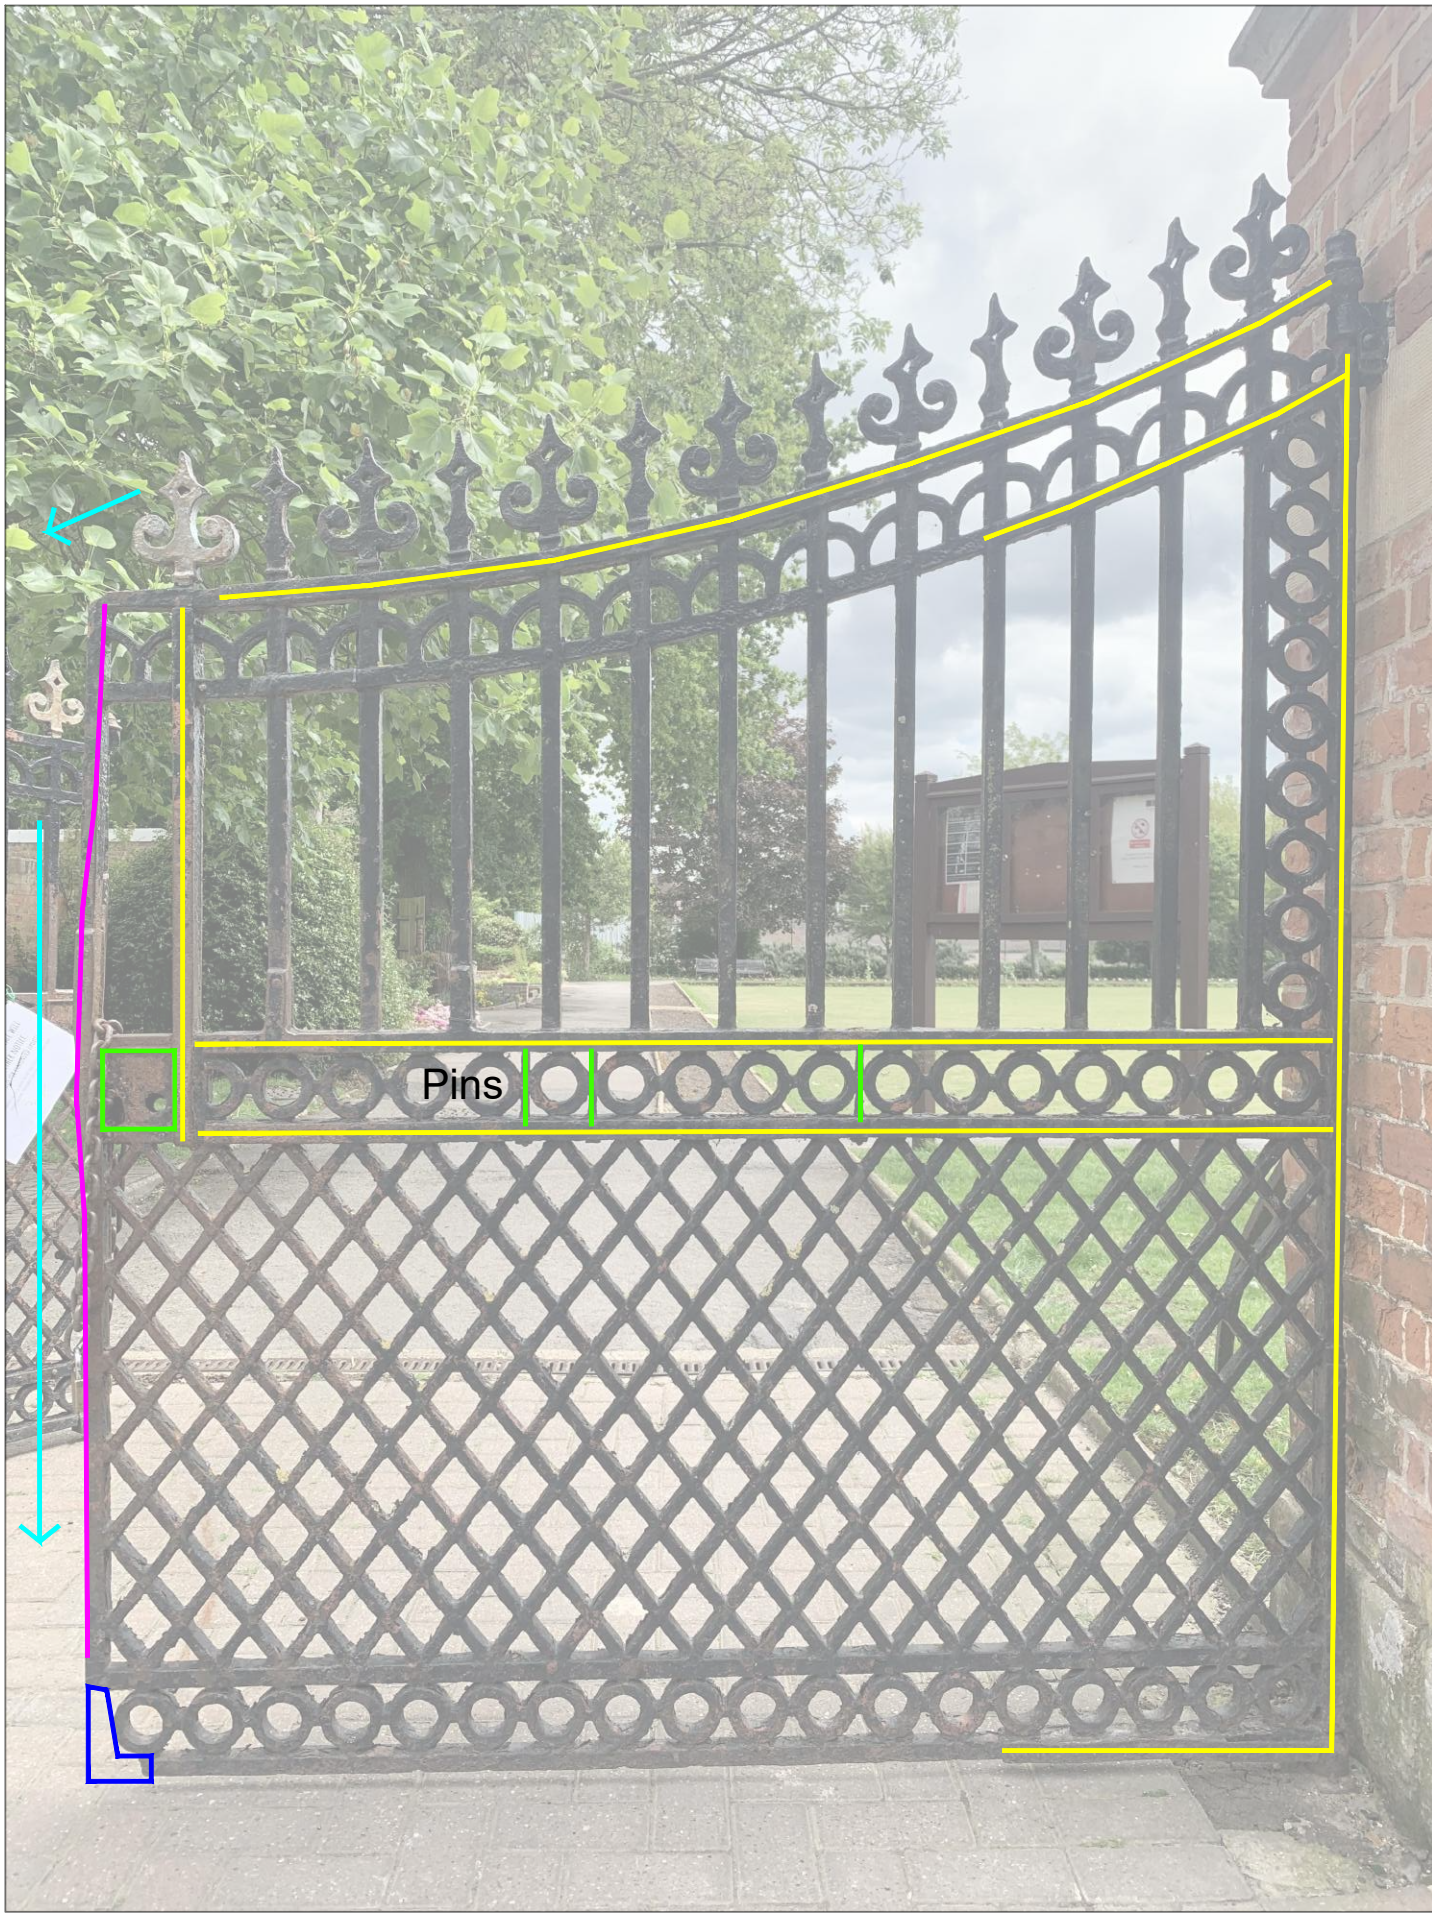
South gate  
(from west)

View of gates from east (inside Ayscoughfee Gardens) - showing visible defects and repairs
