Project:  
**Ayscoughfee Hall Museum & Gardens  
Church Gate, Spalding, PE11 2RA**

**Proposed works to North Gates (at end  
of The Chestnut Avenue)**

| Drawing Title:<br><b>Annotated photographs showing<br/>repair and conservation proposals.</b> |

| Drawing Number:<br><b>A1572-52</b> | Rev:<br><b>P01</b> |

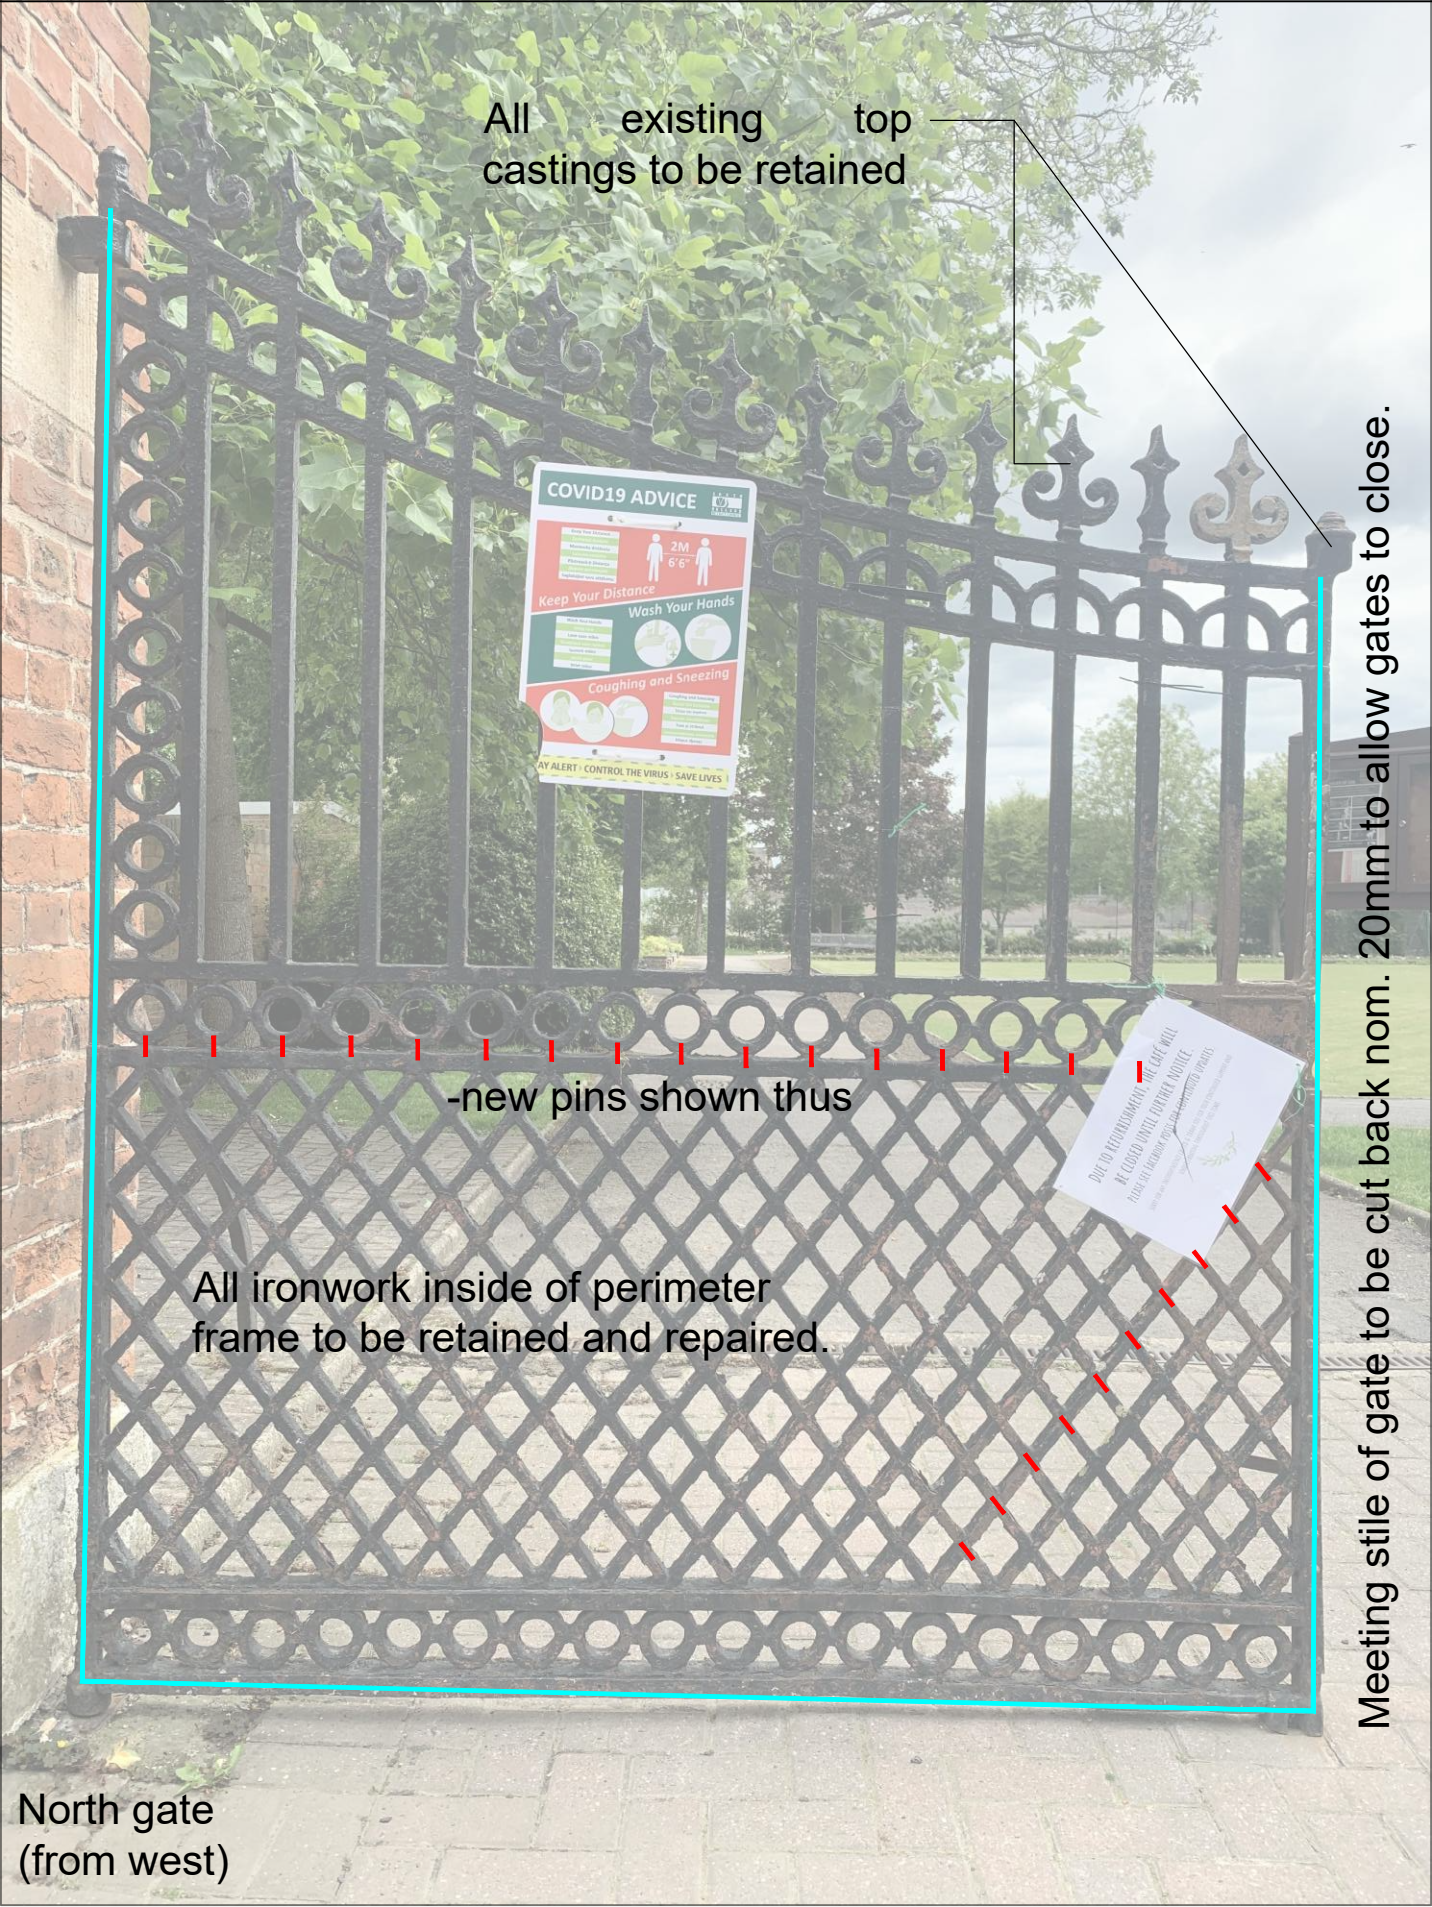
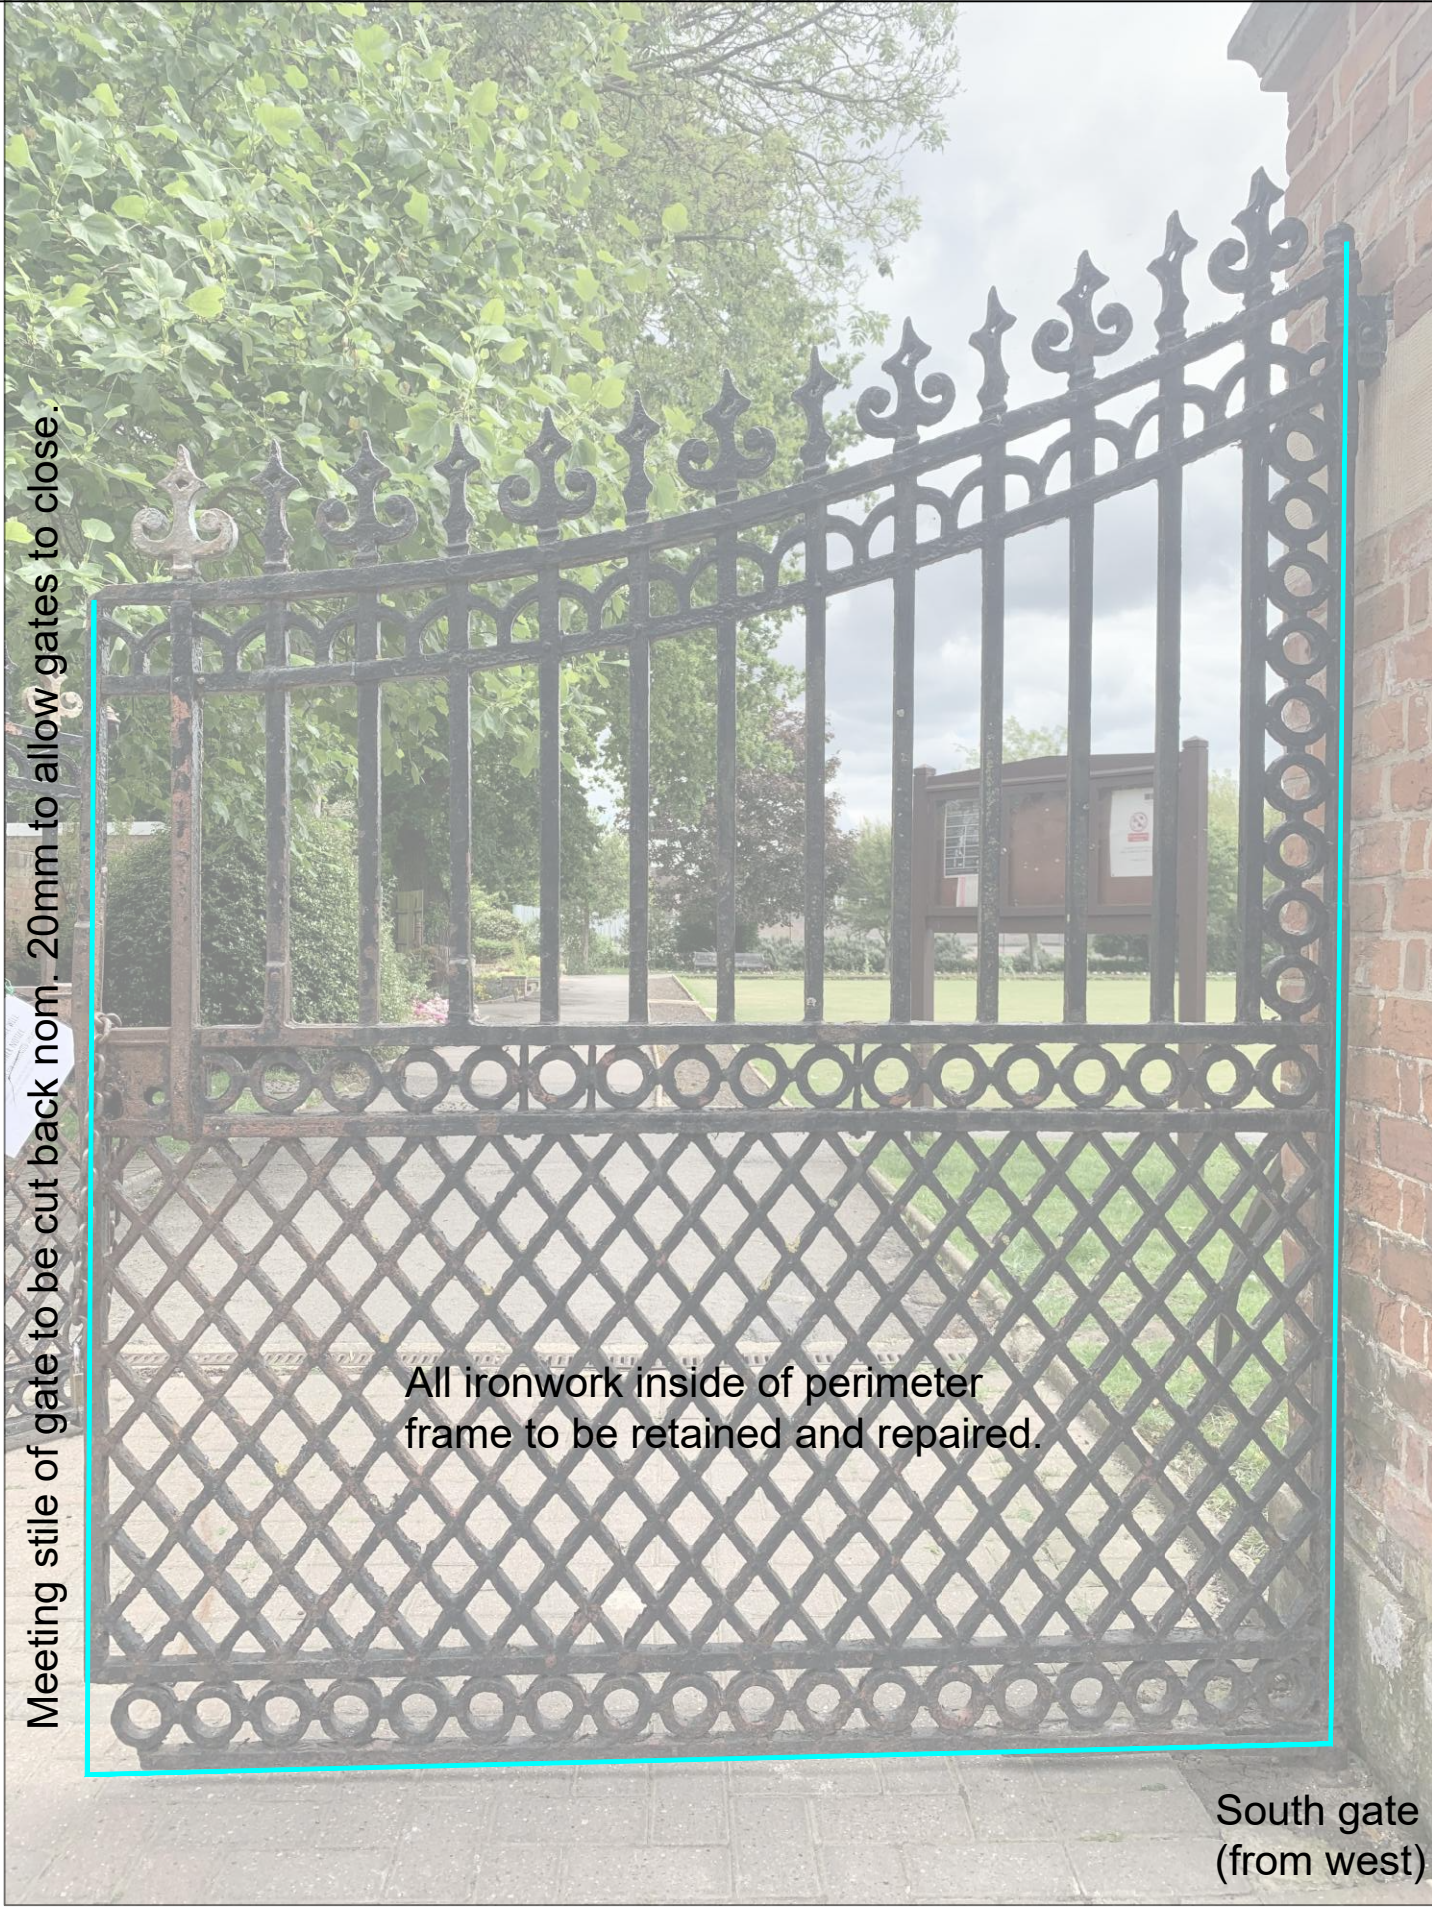
View of gates from west (the Chestnut Avenue) - showing visible defects and repairs

- The gates have distorted over time, particularly the south gate and have been repaired on at least one occasion. It is suspected that this distortion is either caused or worsened by the self-weight of the gates.

- The central iron sections of the gates (latticework etc) have fractured and cracked in areas, though overall the historic fabric remains present and intact. It is suspected however that this has structural integrity only as infill.

- The outer frame of both gates shows the greatest degree of distortion and has evidence of cracking. The repair strapping that has been added to the gates is all attached to either the mid-rail or the perimeter frame (side and base members) of both gates. This suggests that the outer frame has failed historically and that there has been a problem with both distortion and failure for a significant period of time.

- The hinges appear to be a later addition and do not allow for any adjustment of the gates to accommodate distortion or mis-alignment.

- South gate to be carefully removed from hinge points to allow transfer to workshop.
- Existing paint finishes to be removed using controlled media blasting. Media to be selected to minimize surface damage to iron.

- Historic repair strapping to be removed.
- Distorted, cracked outer frame member of gate to be carefully cut away from central lattice and ring ironwork.

- Existing lattice and ring ironwork to be brought back into flat alignment and repaired locally by installing pins tapped and died. Lock edge of gate (lattice work etc) to be cut back nominally 20mm in readiness to attach new perimeter frame. This as an allowance to move the meeting stiles apart slightly to allow the gate to close properly (distortion currently prevents this).

- New steel perimeter frame to be measured and constructed to replace former.
- New steel perimeter frame to be attached ensuring that original details within centre of gate and along top are retained in situ.

- Gate to be prepared and redecorated as specified elsewhere
- Gate to be returned to site and rehung using adjustable hinges in place of existing fixed hinges within pillar brickwork.

- North gate to be carefully removed from hinge points to allow transfer to workshop.
- Existing paint finishes to be removed using controlled media blasting. Media to be selected to minimize surface damage to iron.

- Gate to be prepared and redorated as specified elsewhere
- Gate to be returned to site and rehung using adjustable hinges in place of existing fixed hinges within pillar brickwork.

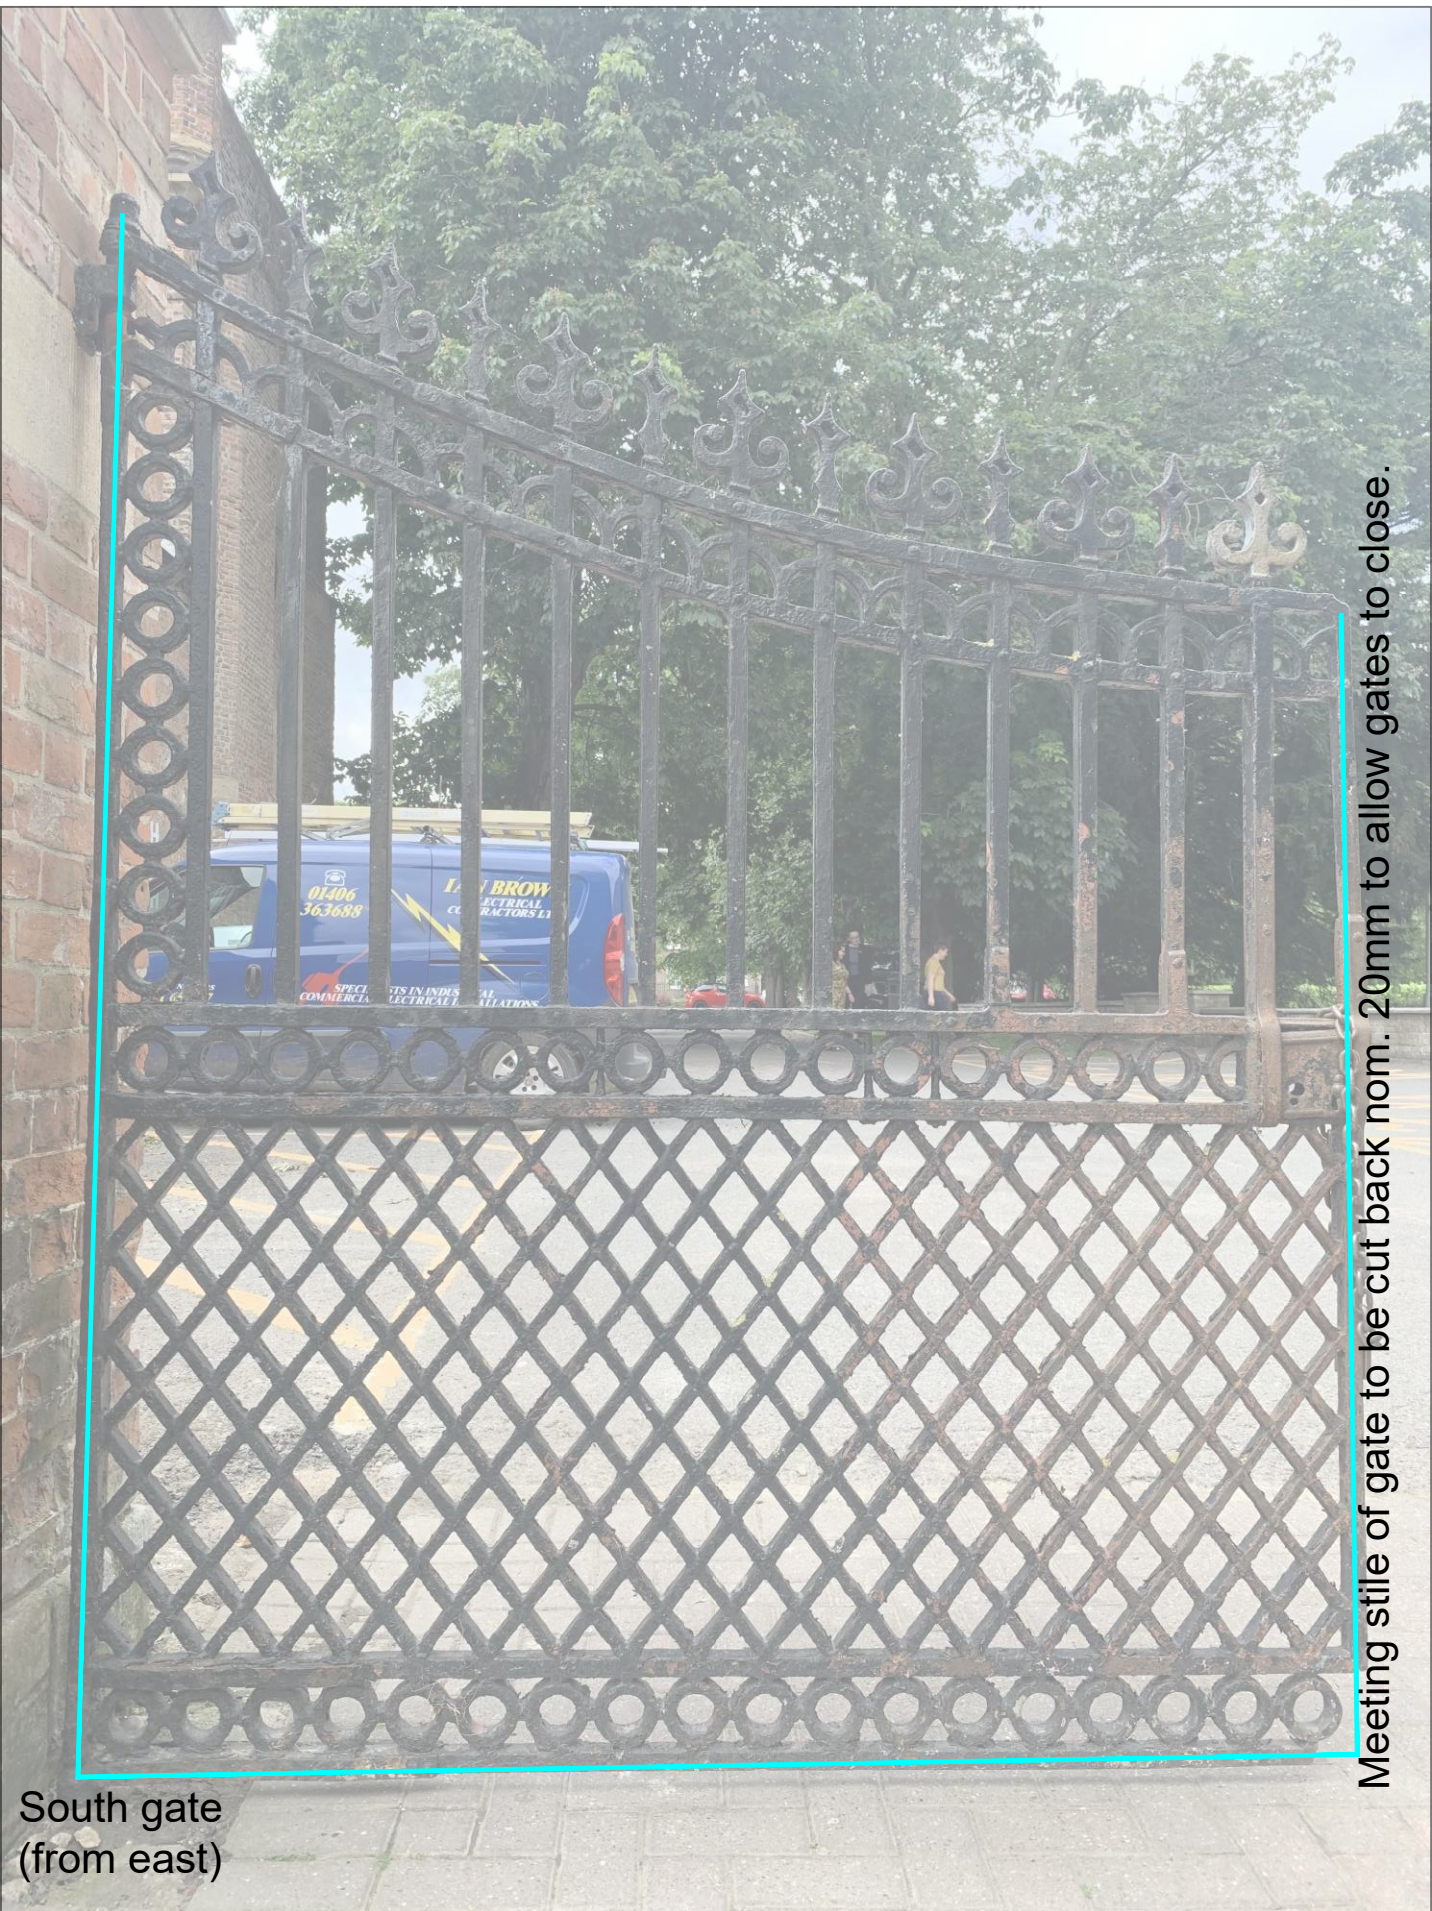
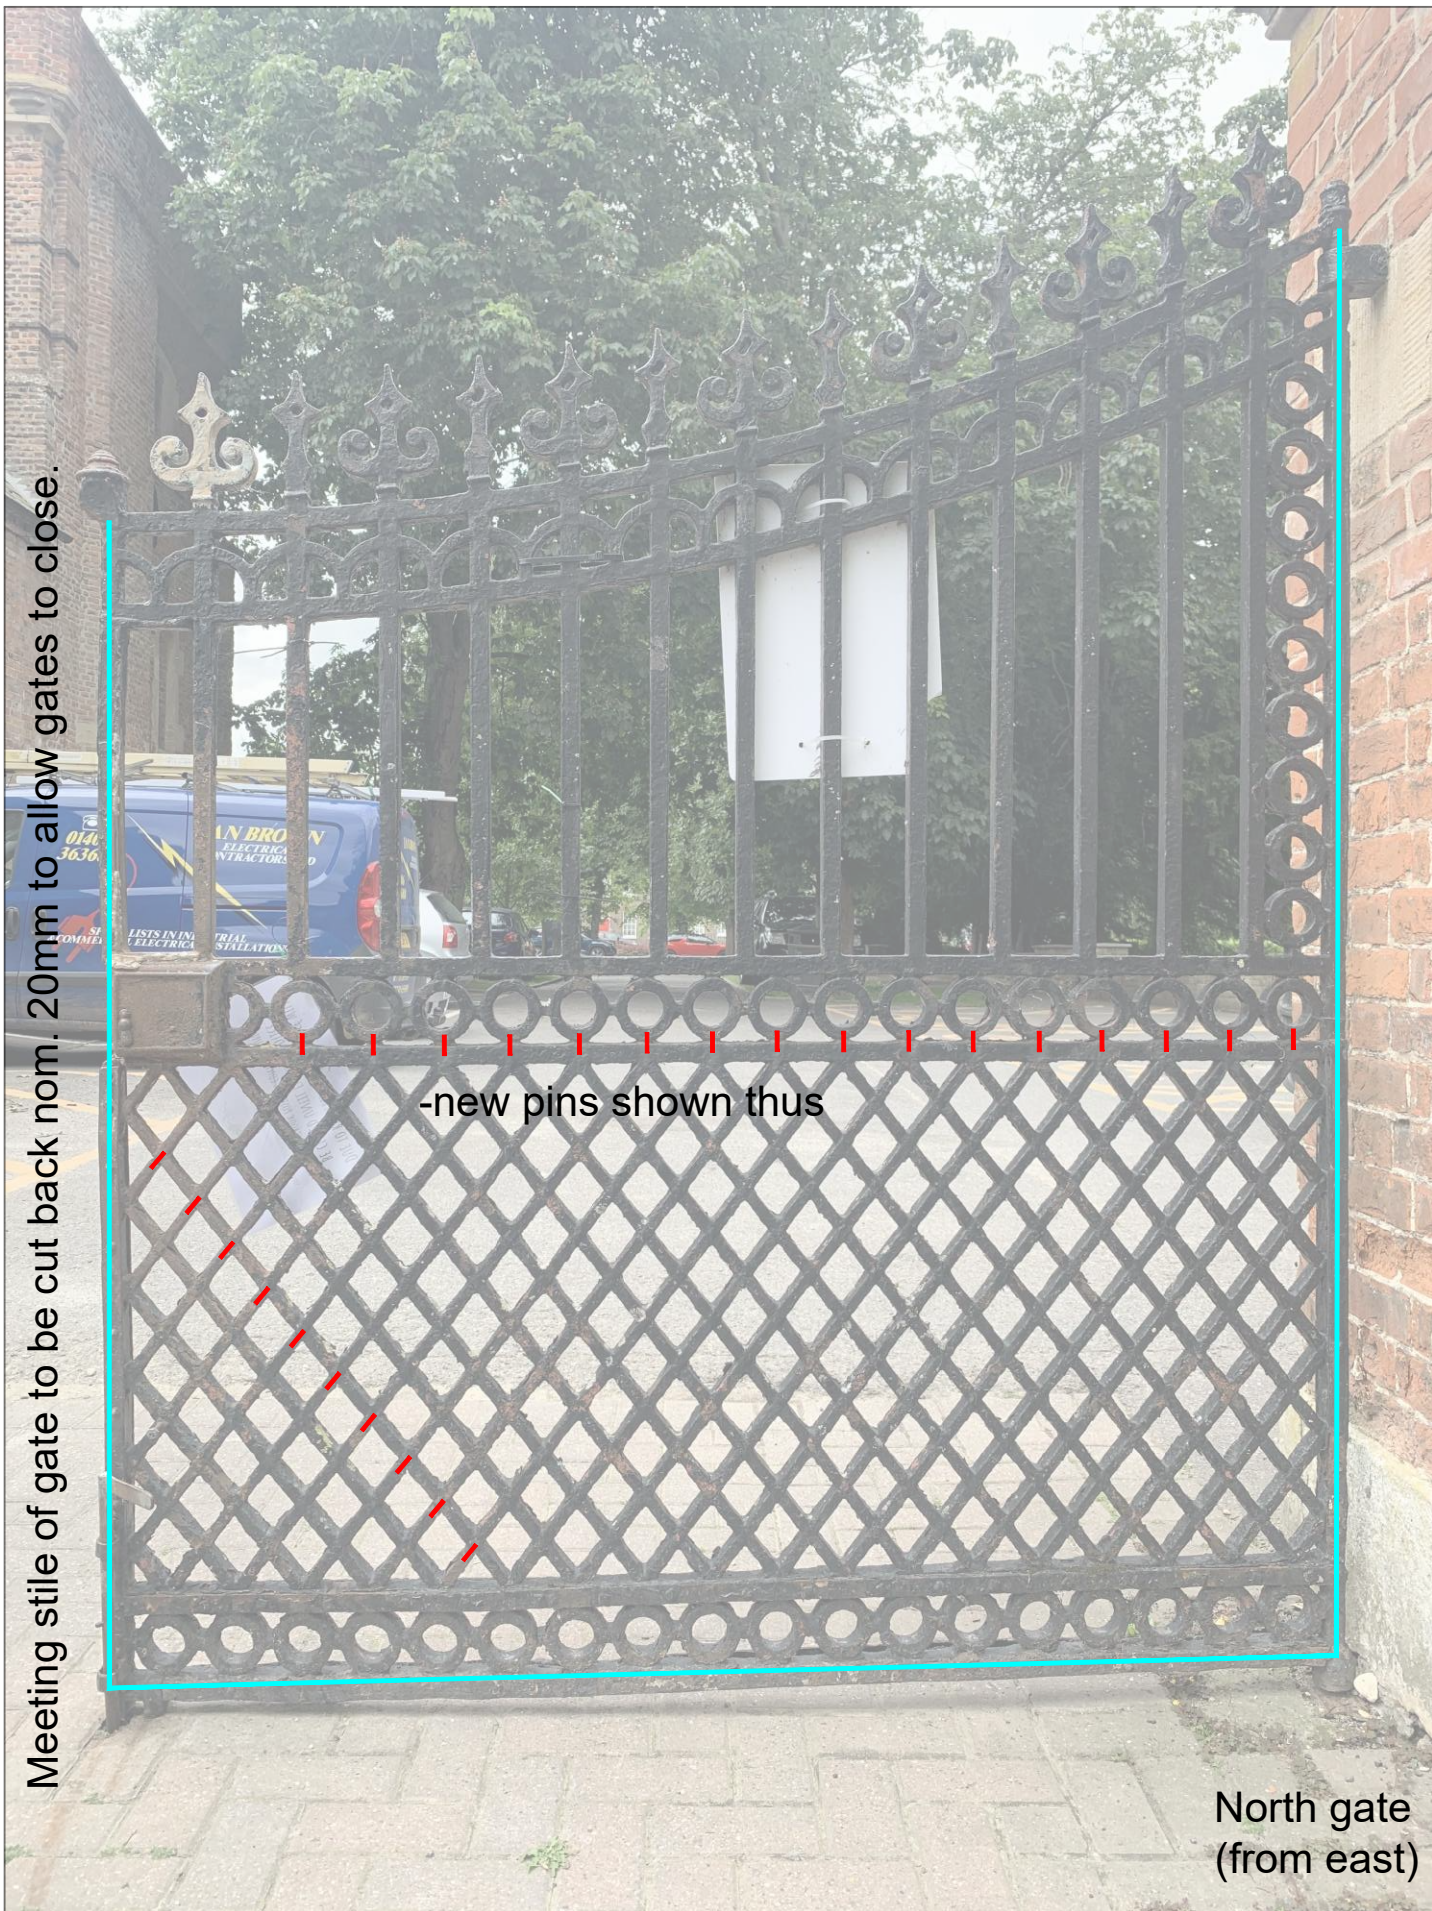
View of gates from east (inside Ayscoughfee Gardens) - showing visible defects and repairs

- The perimeter frame of both gates has fractured in multiple locations and has been heavily strapped historically. This has however not prevented distortion to the extent that it is no longer possible to close the gates. In consultation with Chainbridge Forge, it is not consider feasible to further repair the outer frame in a satisfactory manner that will afford the required structural support for the infill, nor is it feasible to remove the distortion within the existing frame. It is however noted that the curved upper frame members for both gates could be retained and repaired.

- The hinges and floor pivot points for the gates are all fixed and allow no adjustment to stop the gates from clashing. This presents an ongoing problem.

- Preliminary locations for proposed tap and die pin connections.

- Extent of distorted and fractured perimeter frame to be removed and replaced with new in steel.
