# Heritage Impact Assessment

Proposed works to North Gates (at the end of The Chestnut Avenue),  
Ayscoughfee Hall Museum and Gardens, Church Gate, Spalding, Lincolnshire

June 2022

A1572NG– HIA rev P01

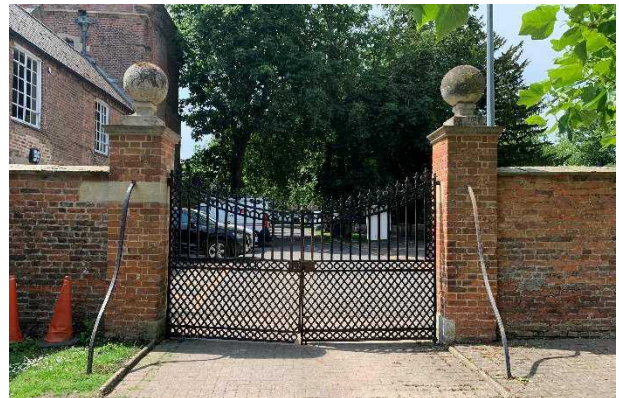
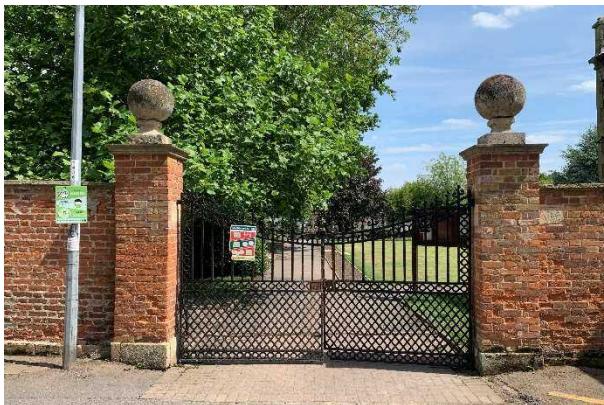
- 1.4 The gates are misshapen and ill-fitting because of decayed elements, the proposals seek to remove the defective parts and replace them with like for like materials using traditional blacksmithing techniques and then re-decorate them in a method based on the Conservation report which also forms part of this application

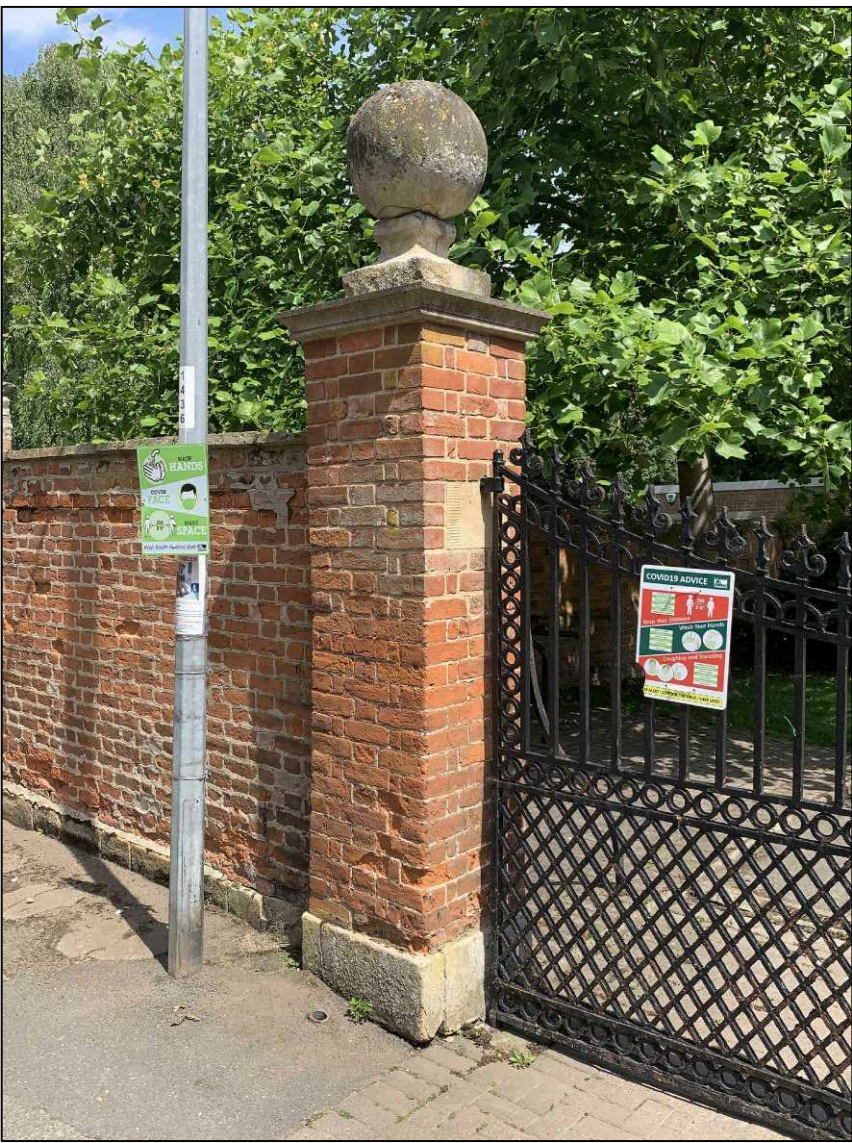
North pillar - top section rebuilt

Note:  
Lower section in finer guage brickwork with white lime mortar with aggregate exposed.  
Upper section has wider mortar joints, mortar is more grey in colour and smoother in texture.  
Conclusion - upper section has been rebuilt recently.

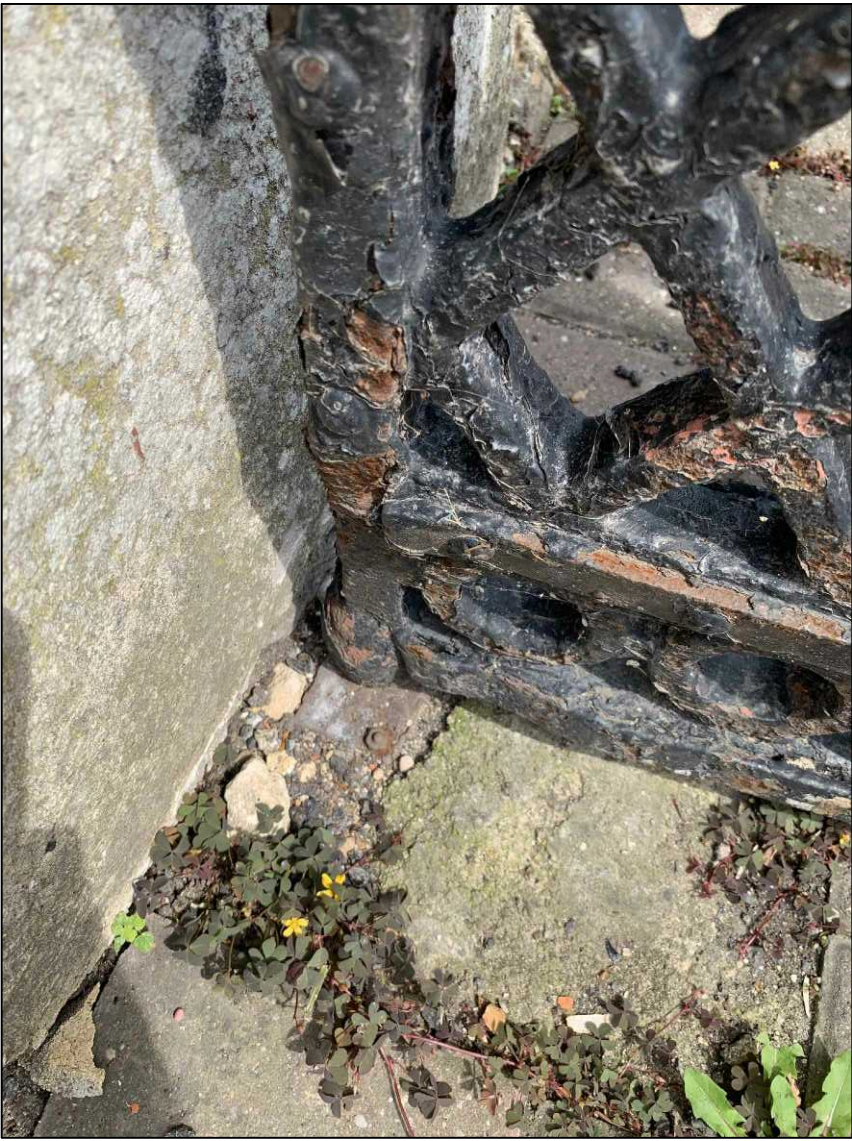
Ground-mount pivot point at north pillar

Note:  
Non-adjustable fitting

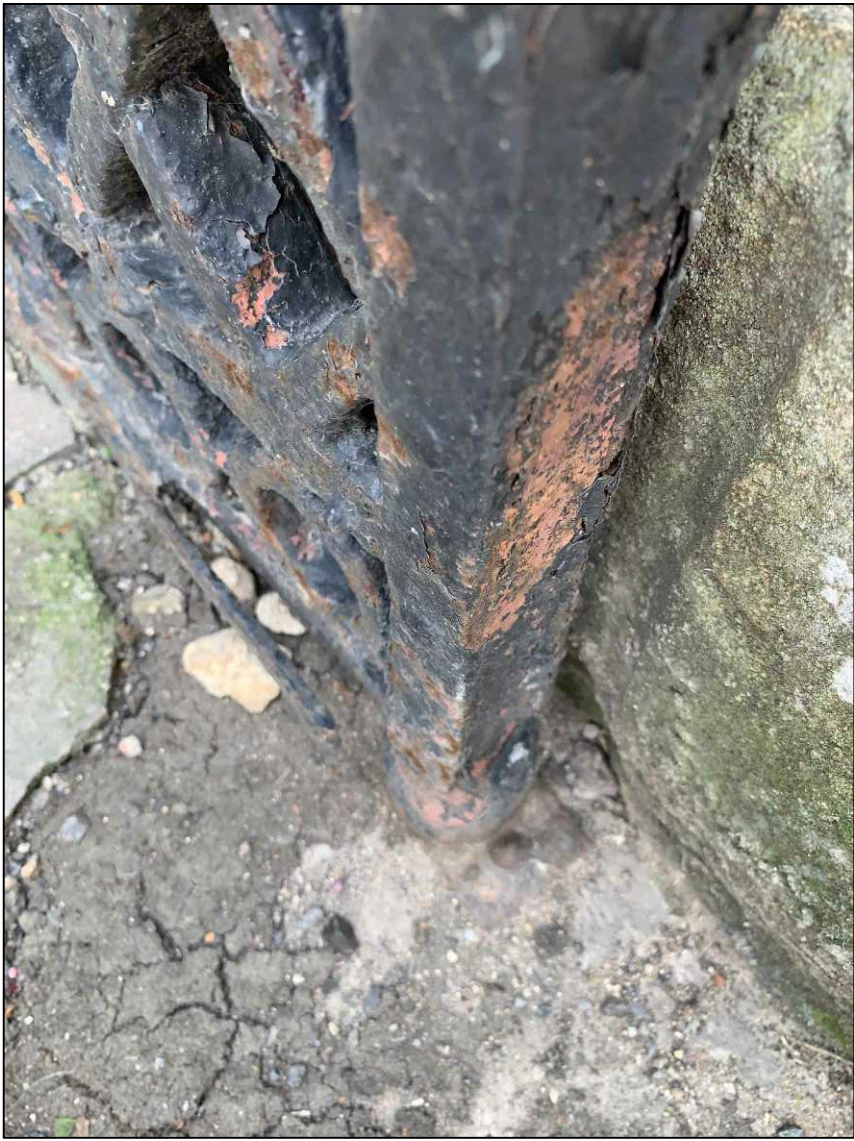
Ground-mount pivot point at south pillar

Note:  
Non-adjustable fitting

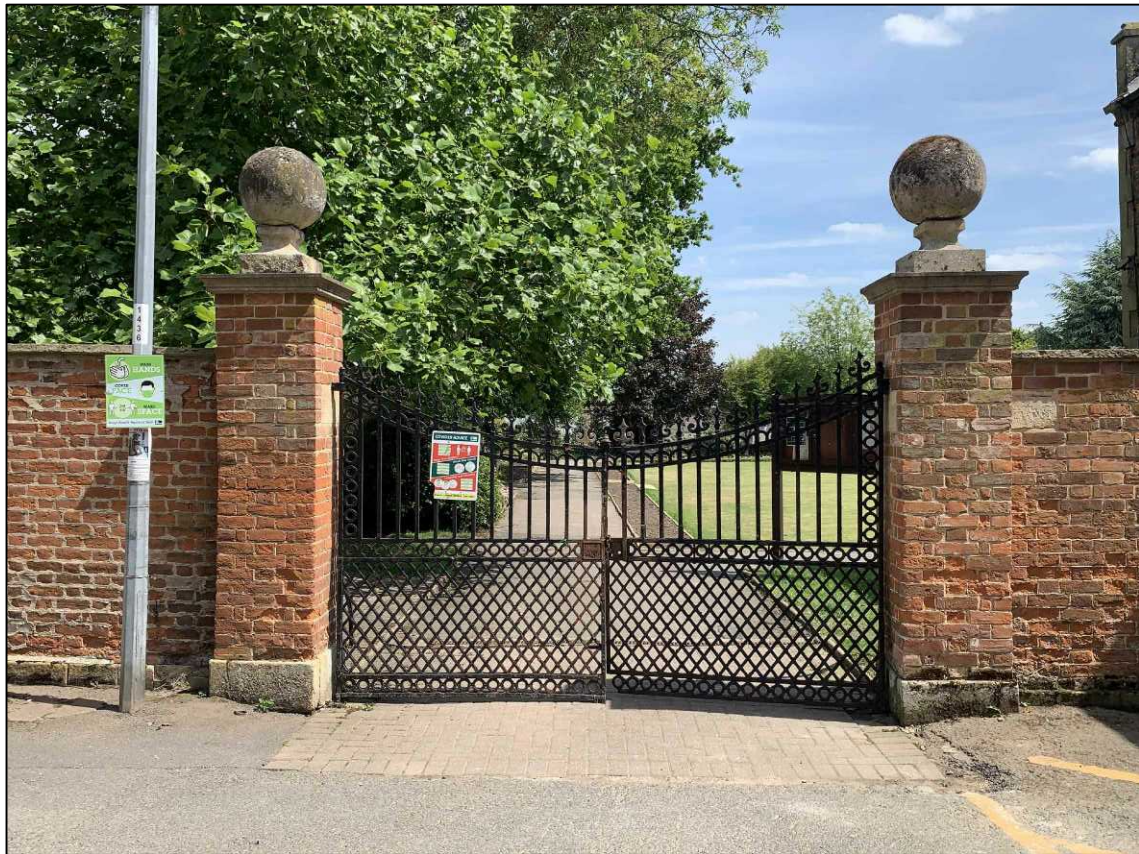
Gates viewed from the West

Gates set between brick pillars, parts of which have been reconstructed relatively recently.

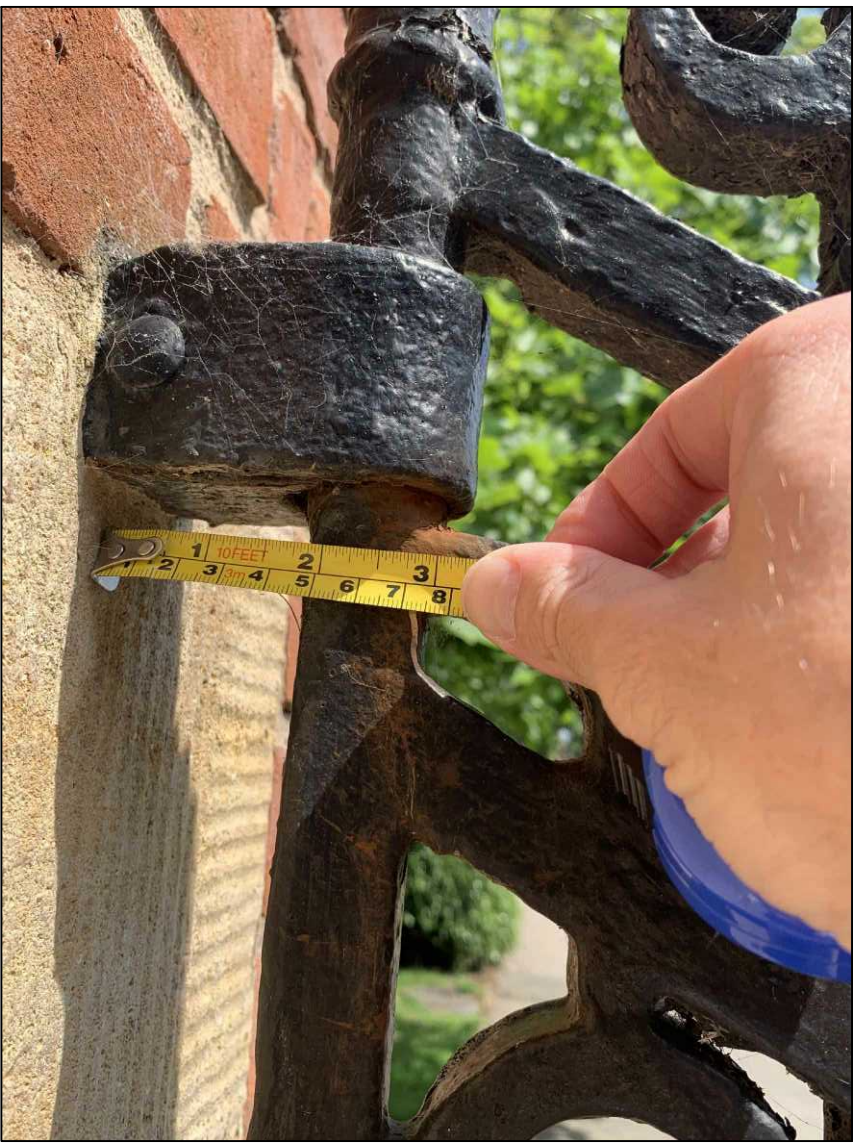
Fixes hinge point on north pillar

Note:  
Fixed hinge does not allow for any realignment of the gates so they cannot be pulled out at the top to prevent clashing at the meeting stiles.

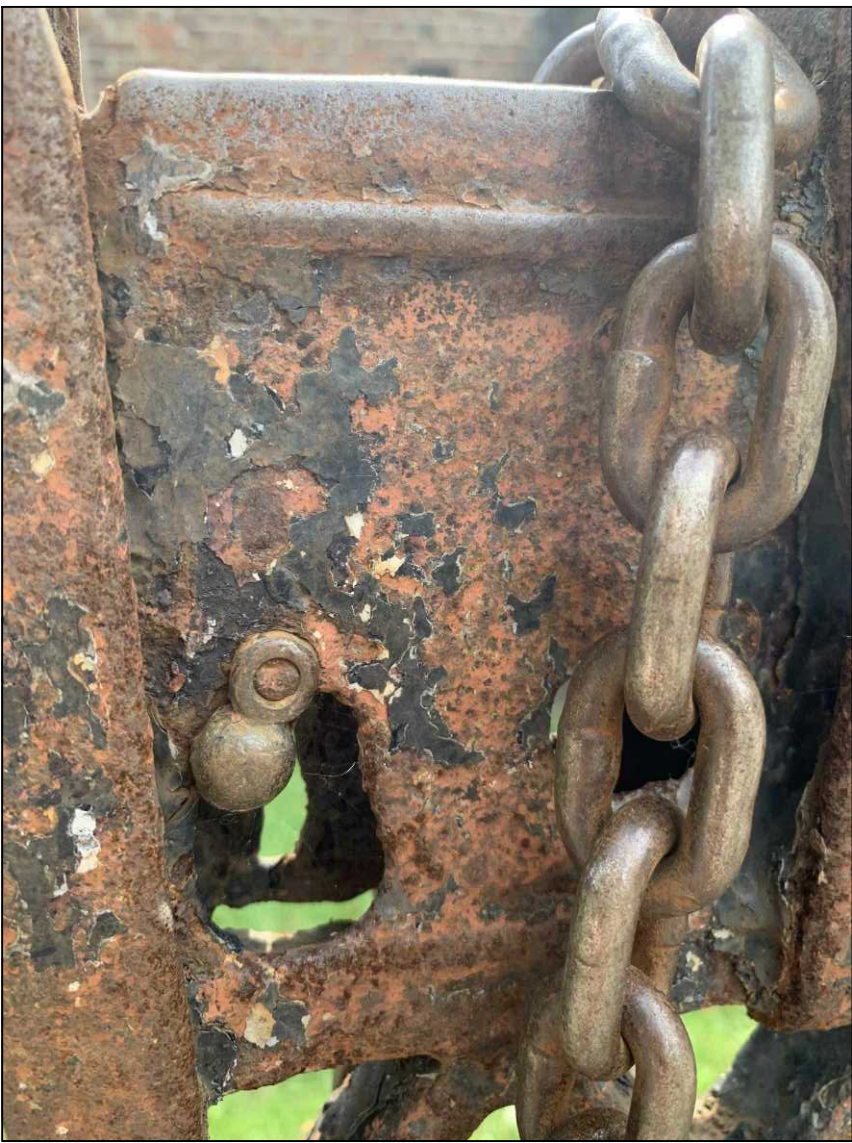
Lock box on south gate

Note:  
Internal mechanism of lock is missing and out lock box is damaged.

- v. Existing lock box to be assessed for damage and reused if repairable. Should this not be the case then new to be fabricated to match existing in all respects.

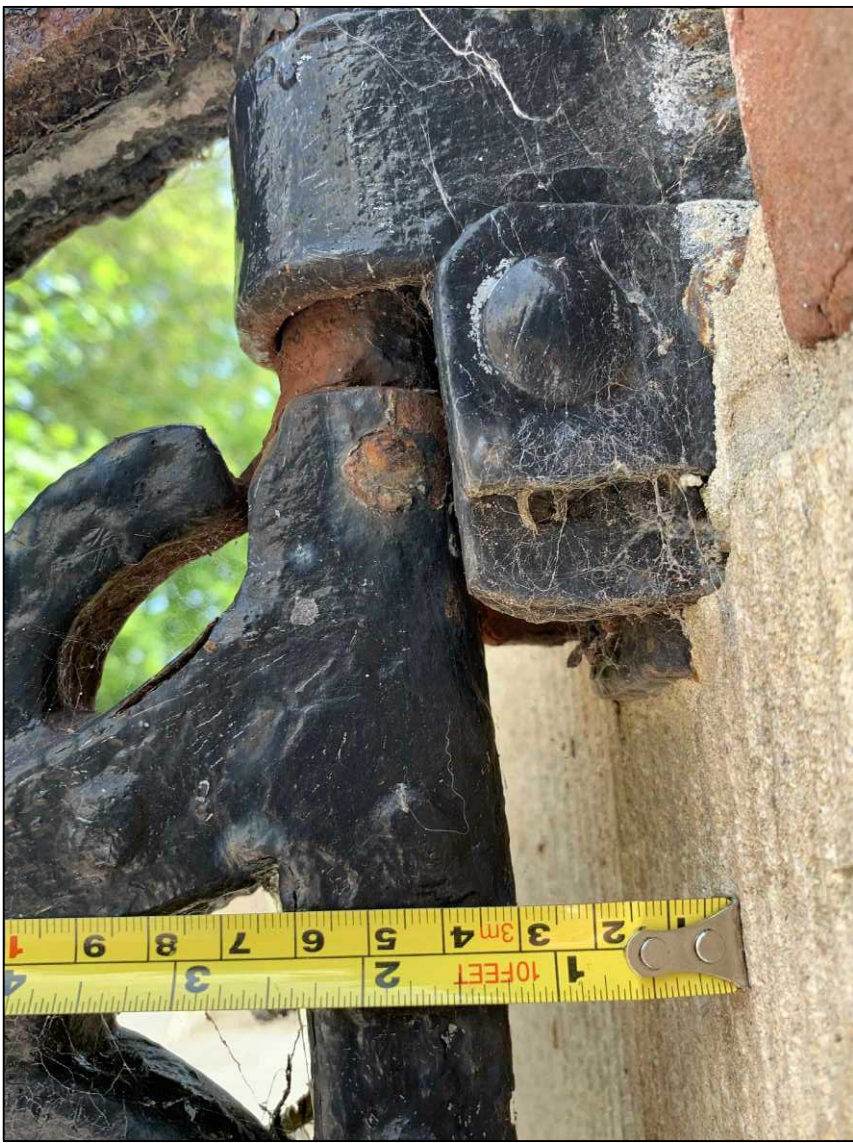
Fixed hinge point on south pillar

Note:  
Fixed hinge does not allow for any realignment of the gates so they cannot be pulled out at the top to prevent clashing at the meeting stiles.

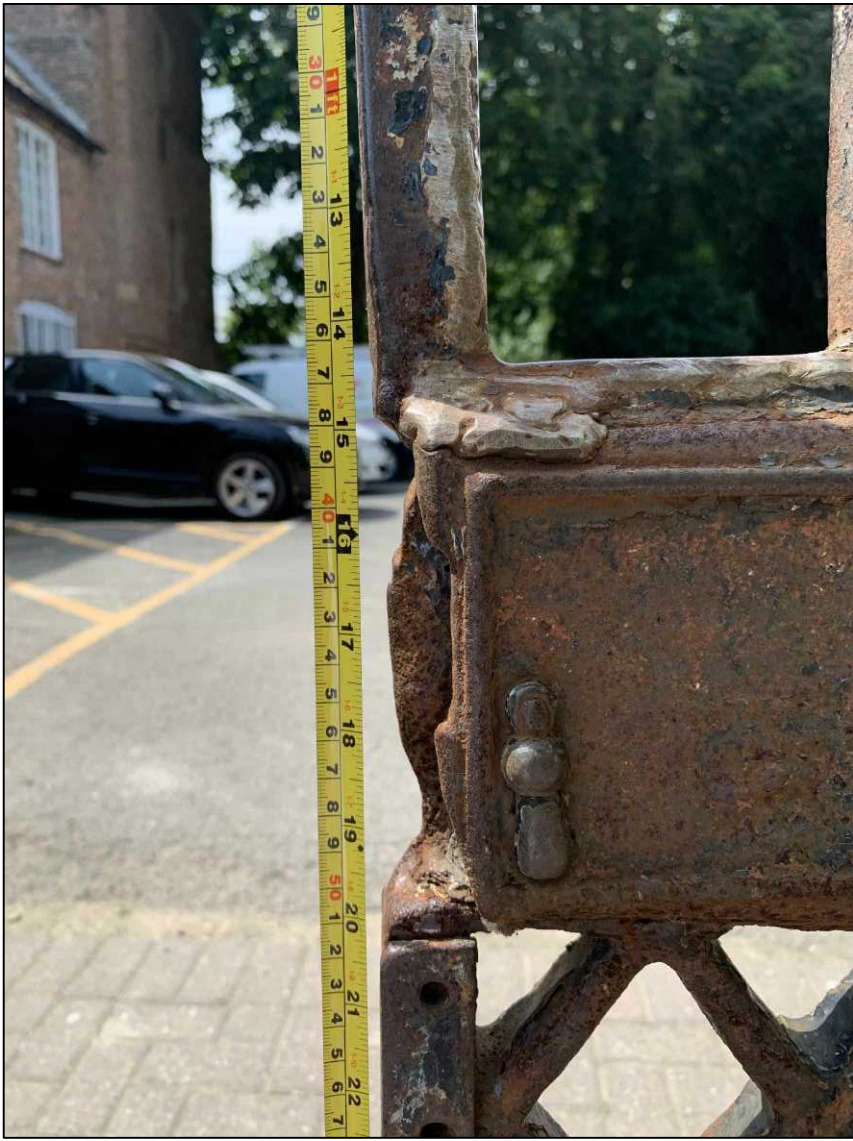
Lock box meeting stile - North gate

Note:  
Lockbox damaged and gate frame badly distorted.

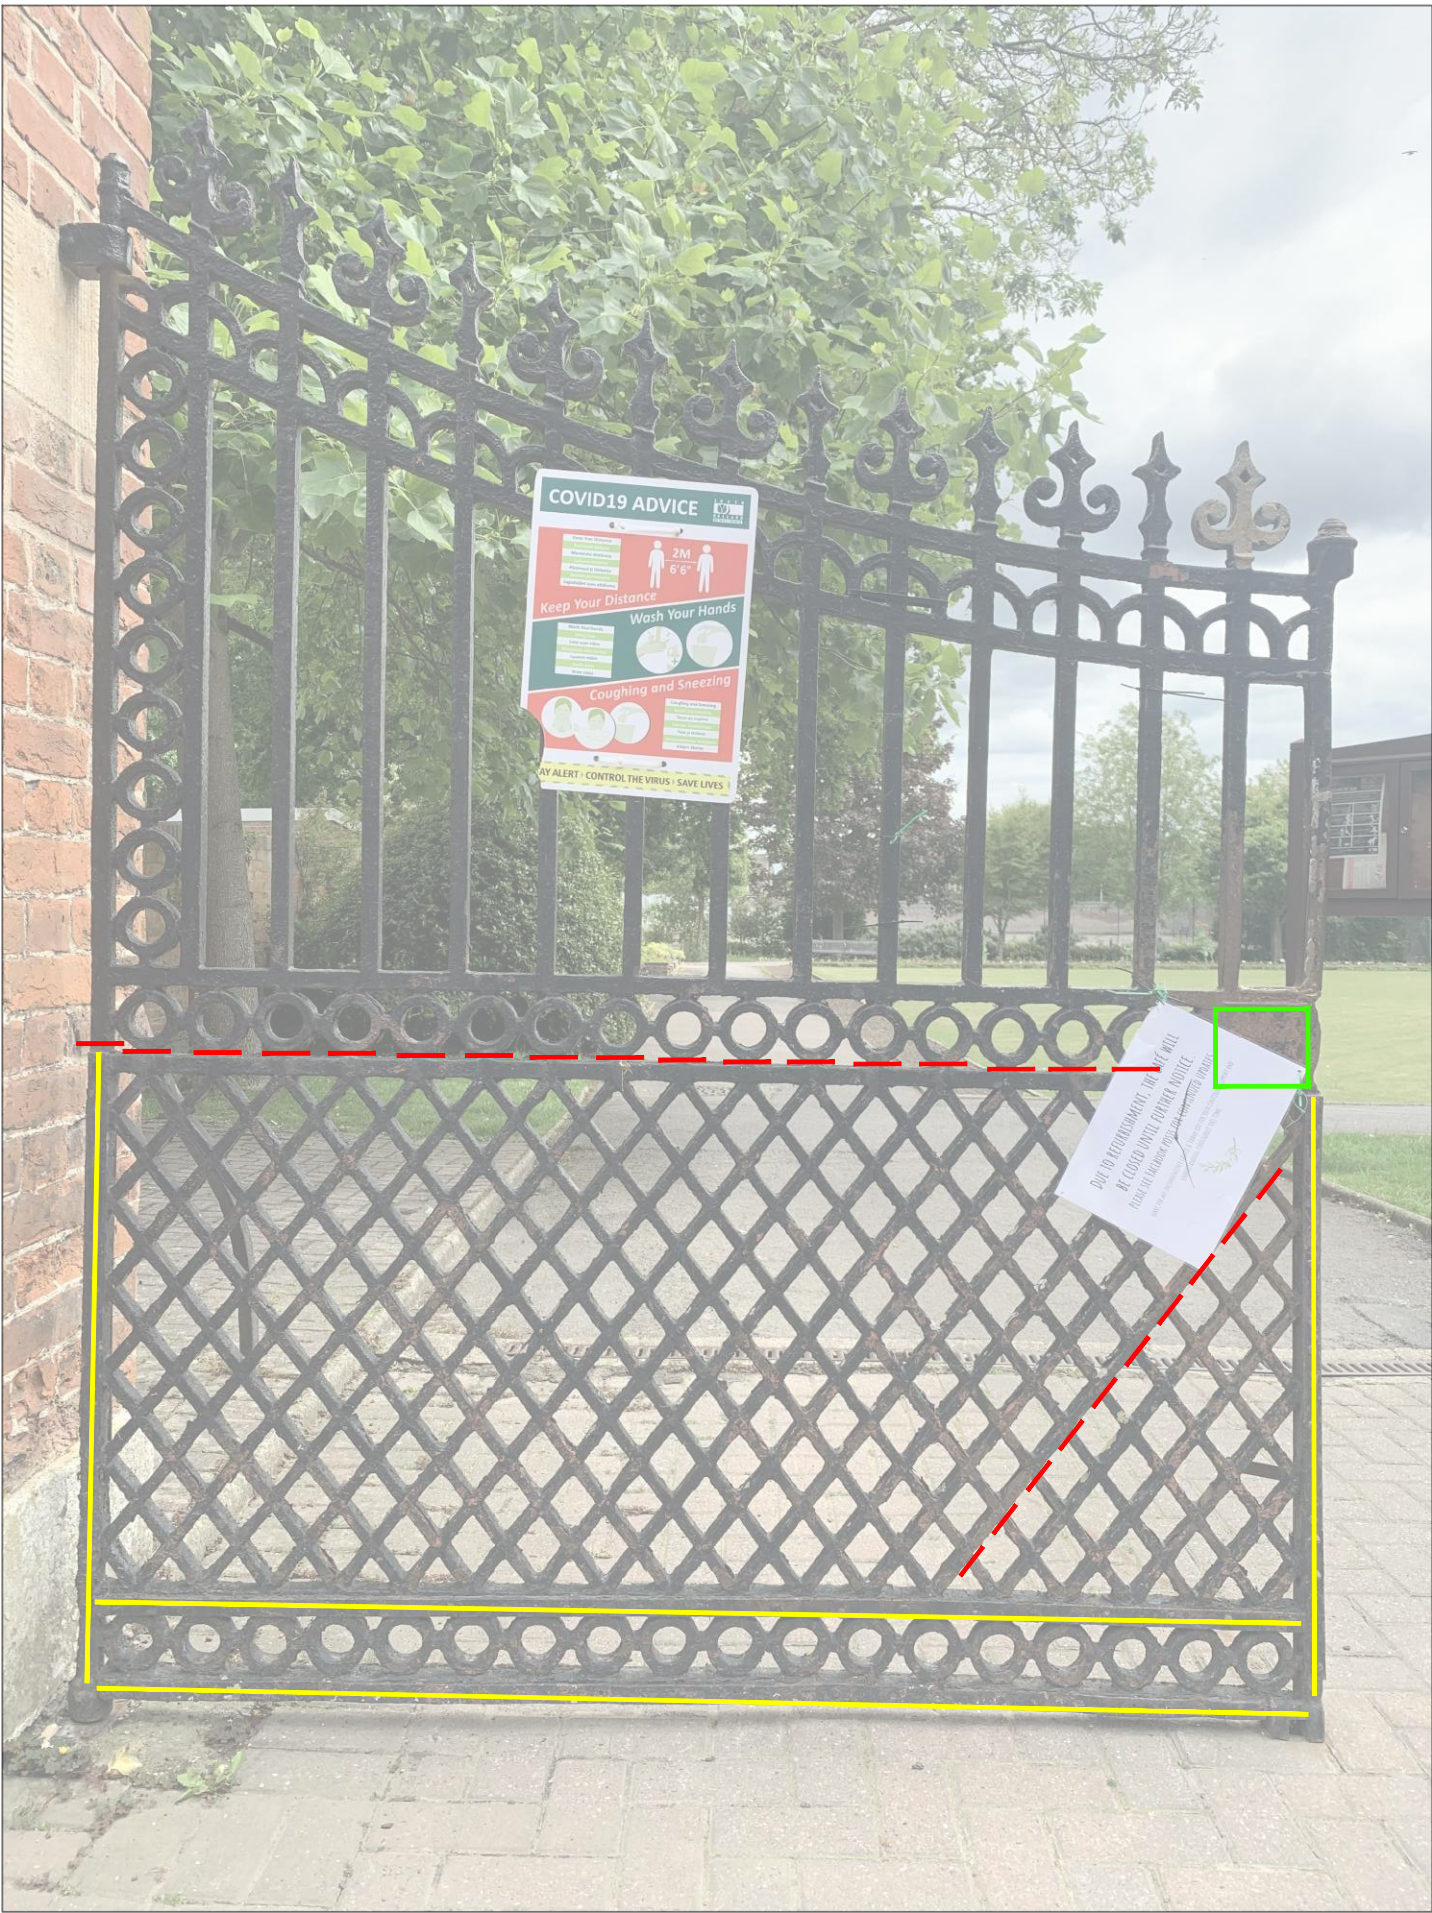
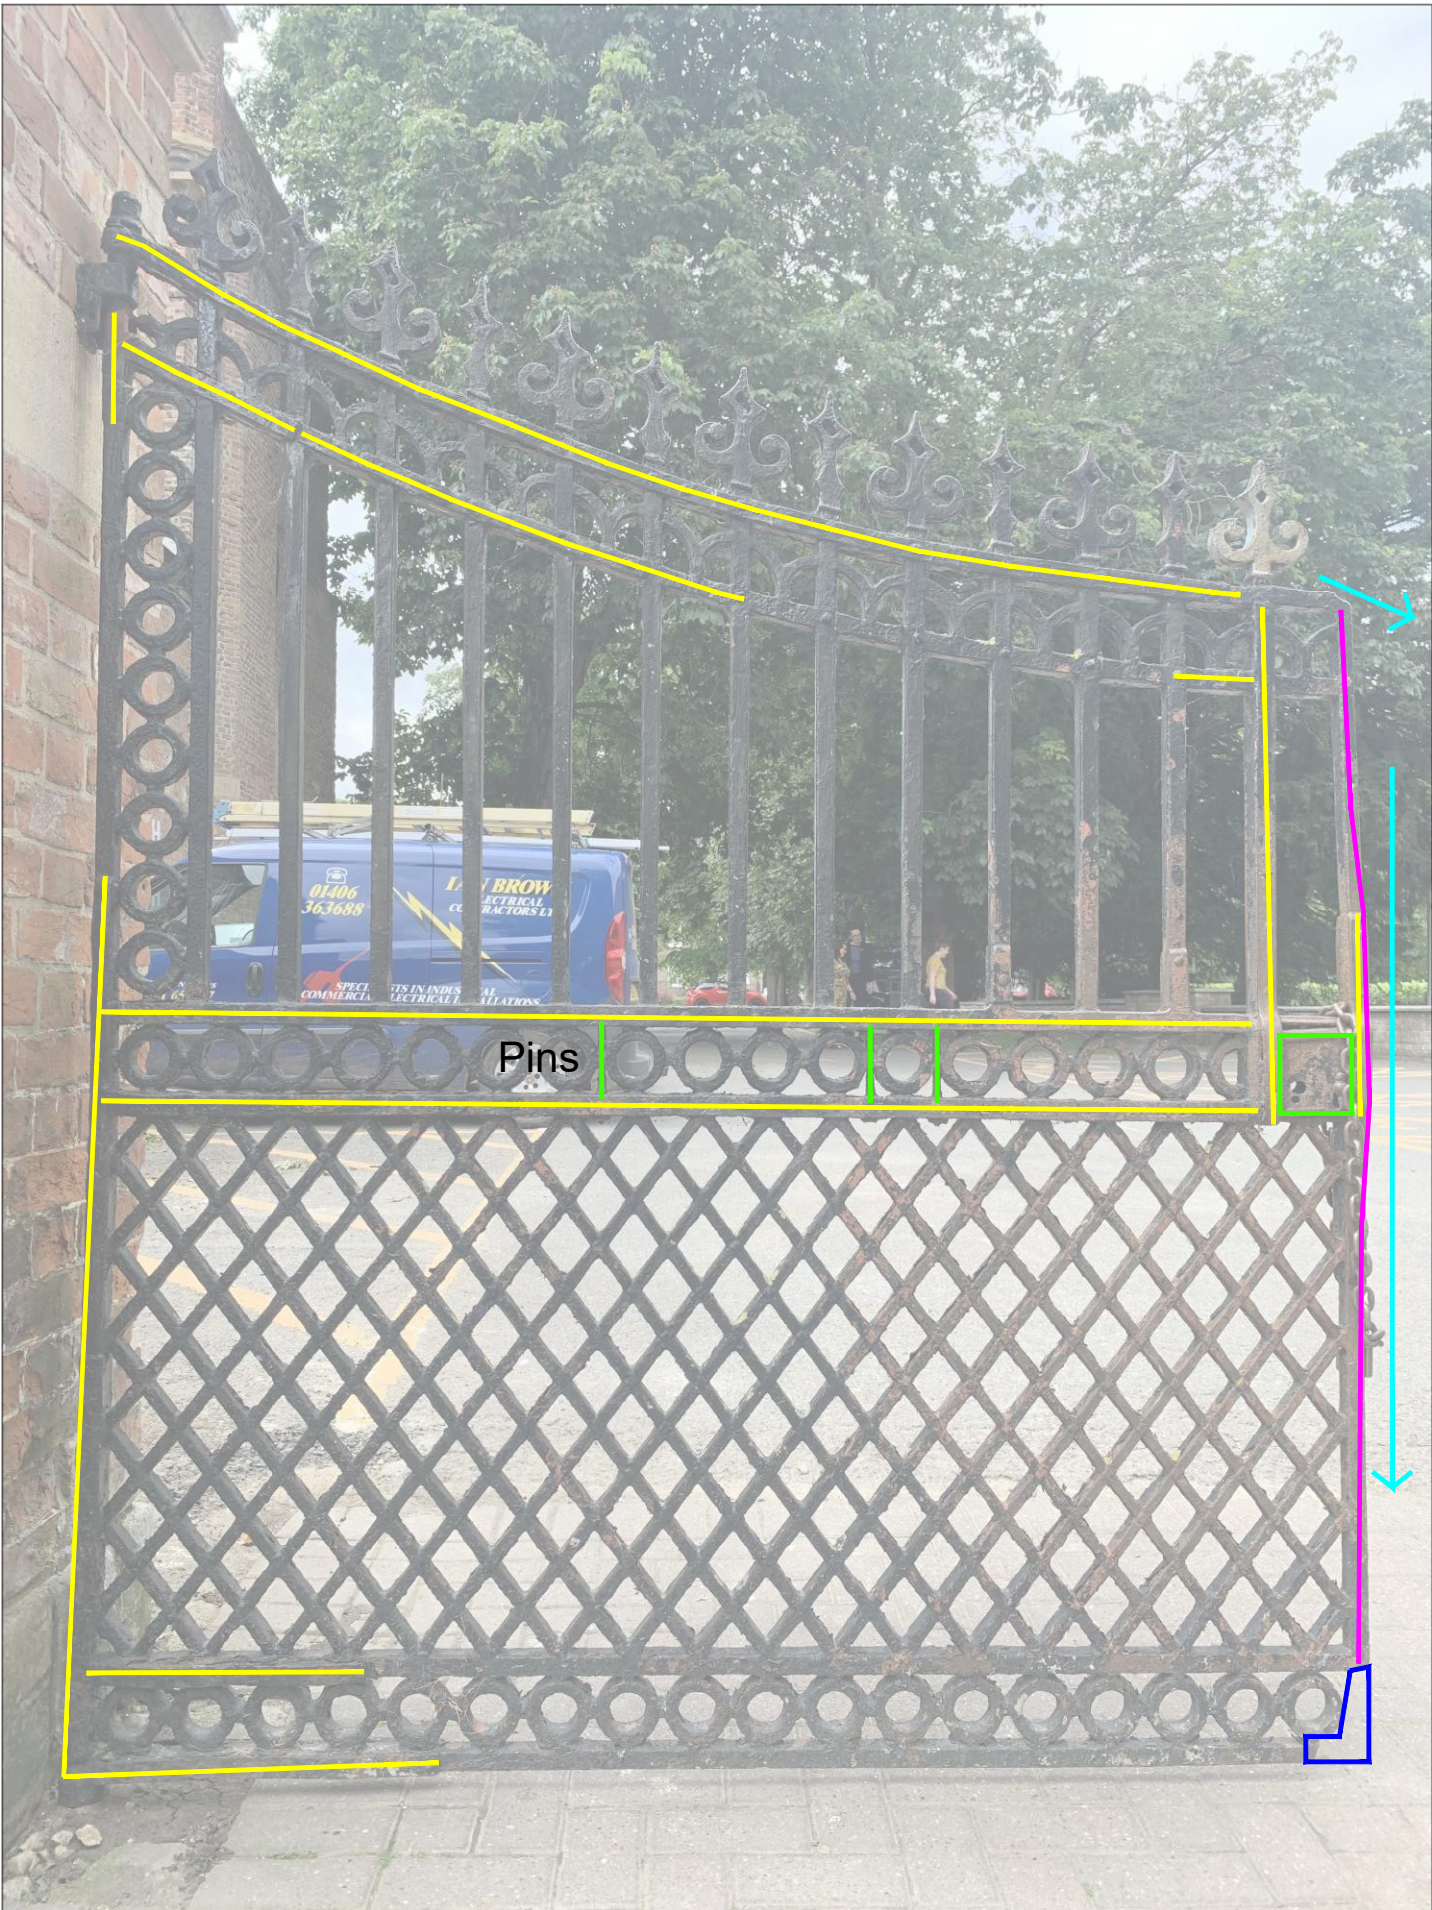
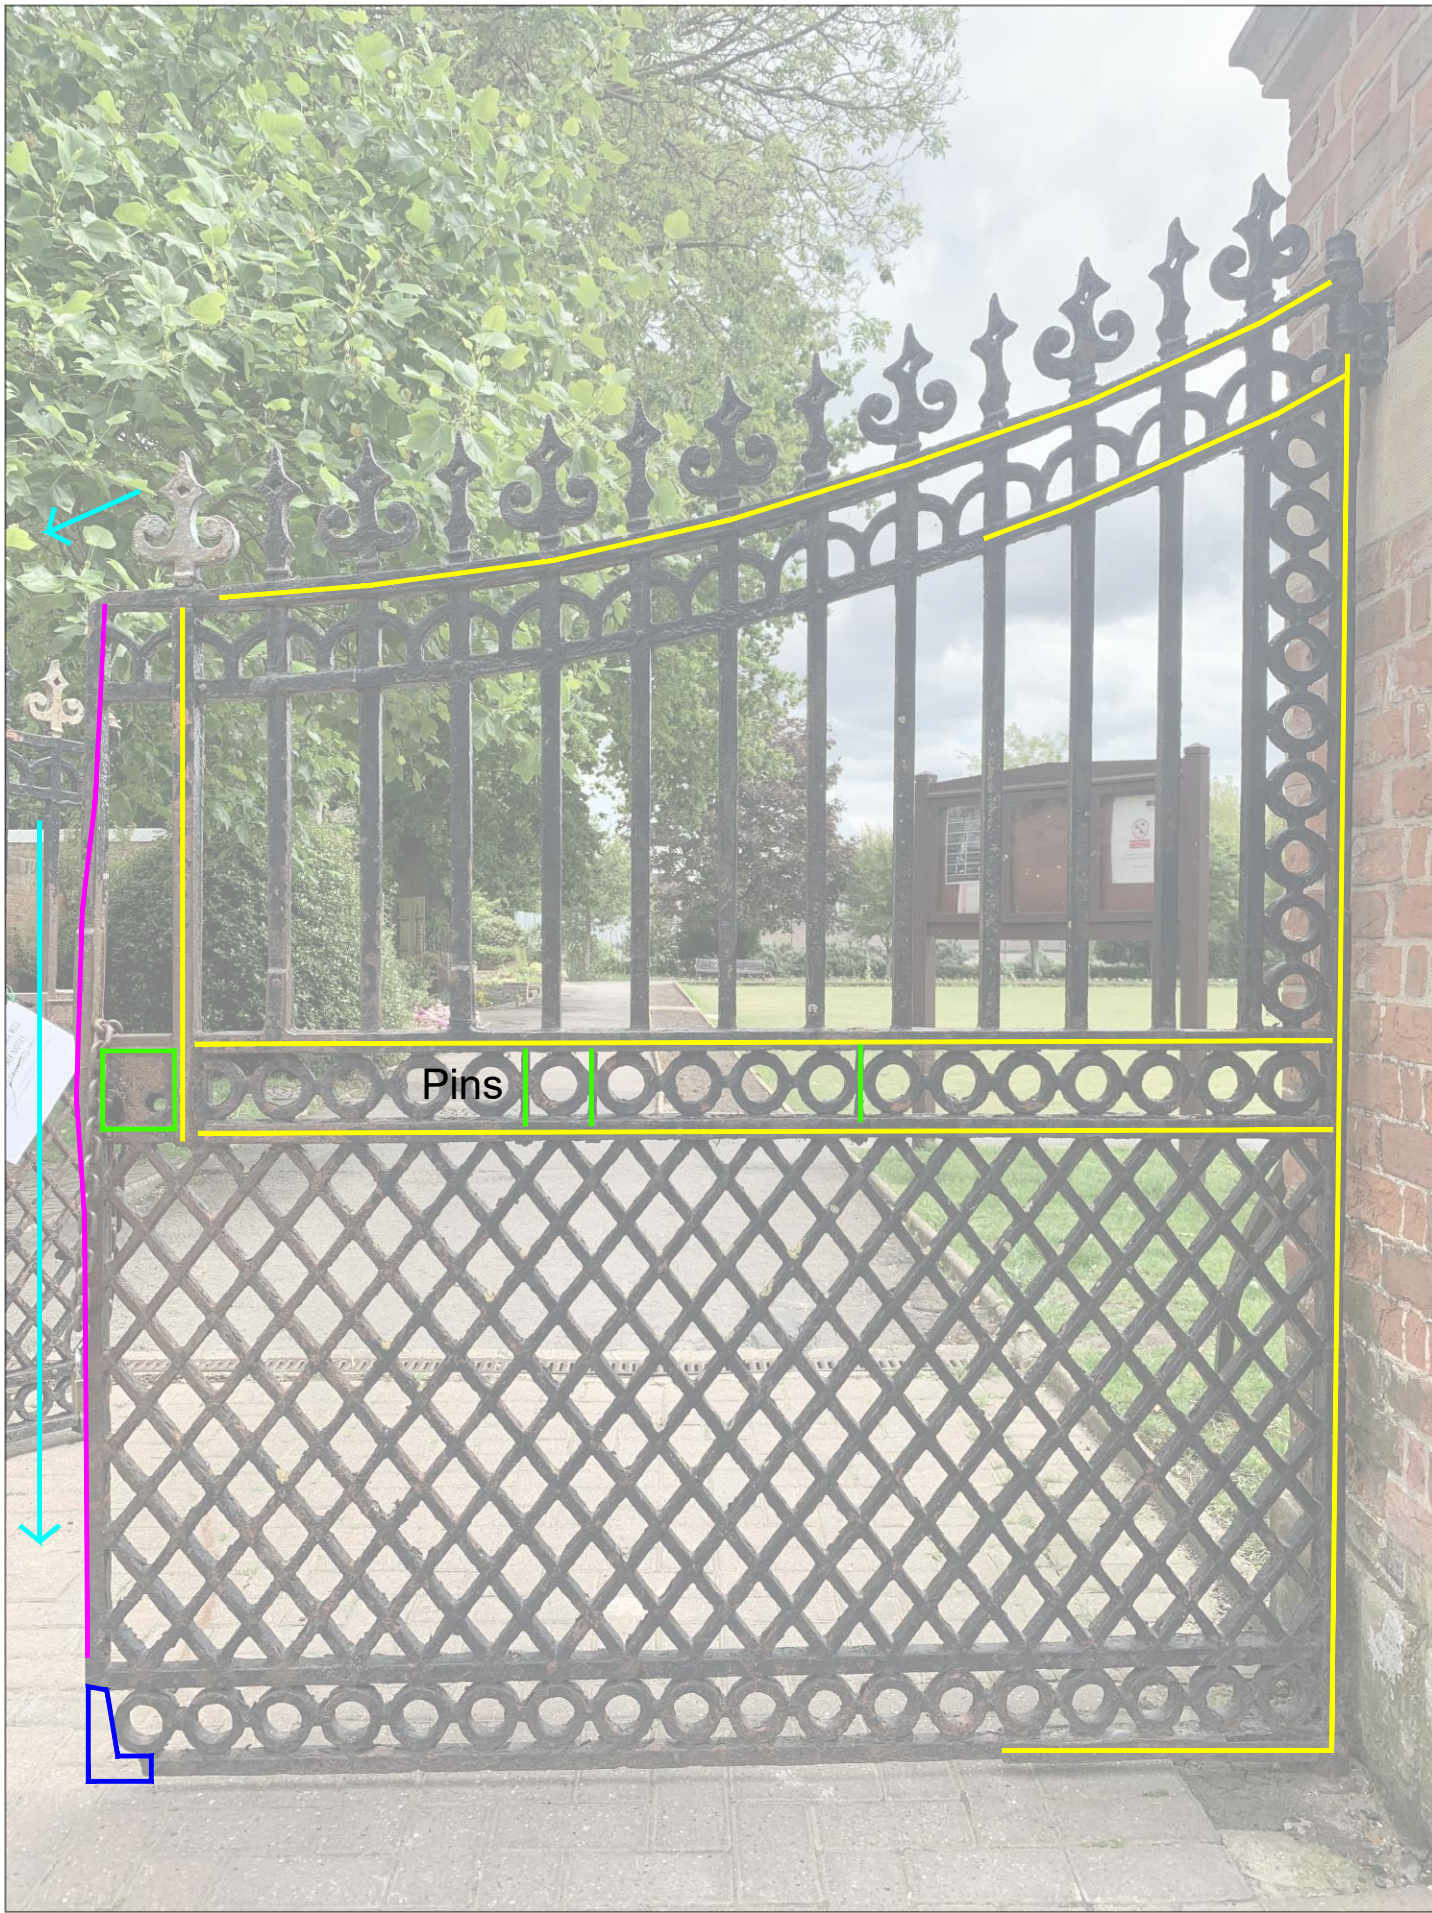
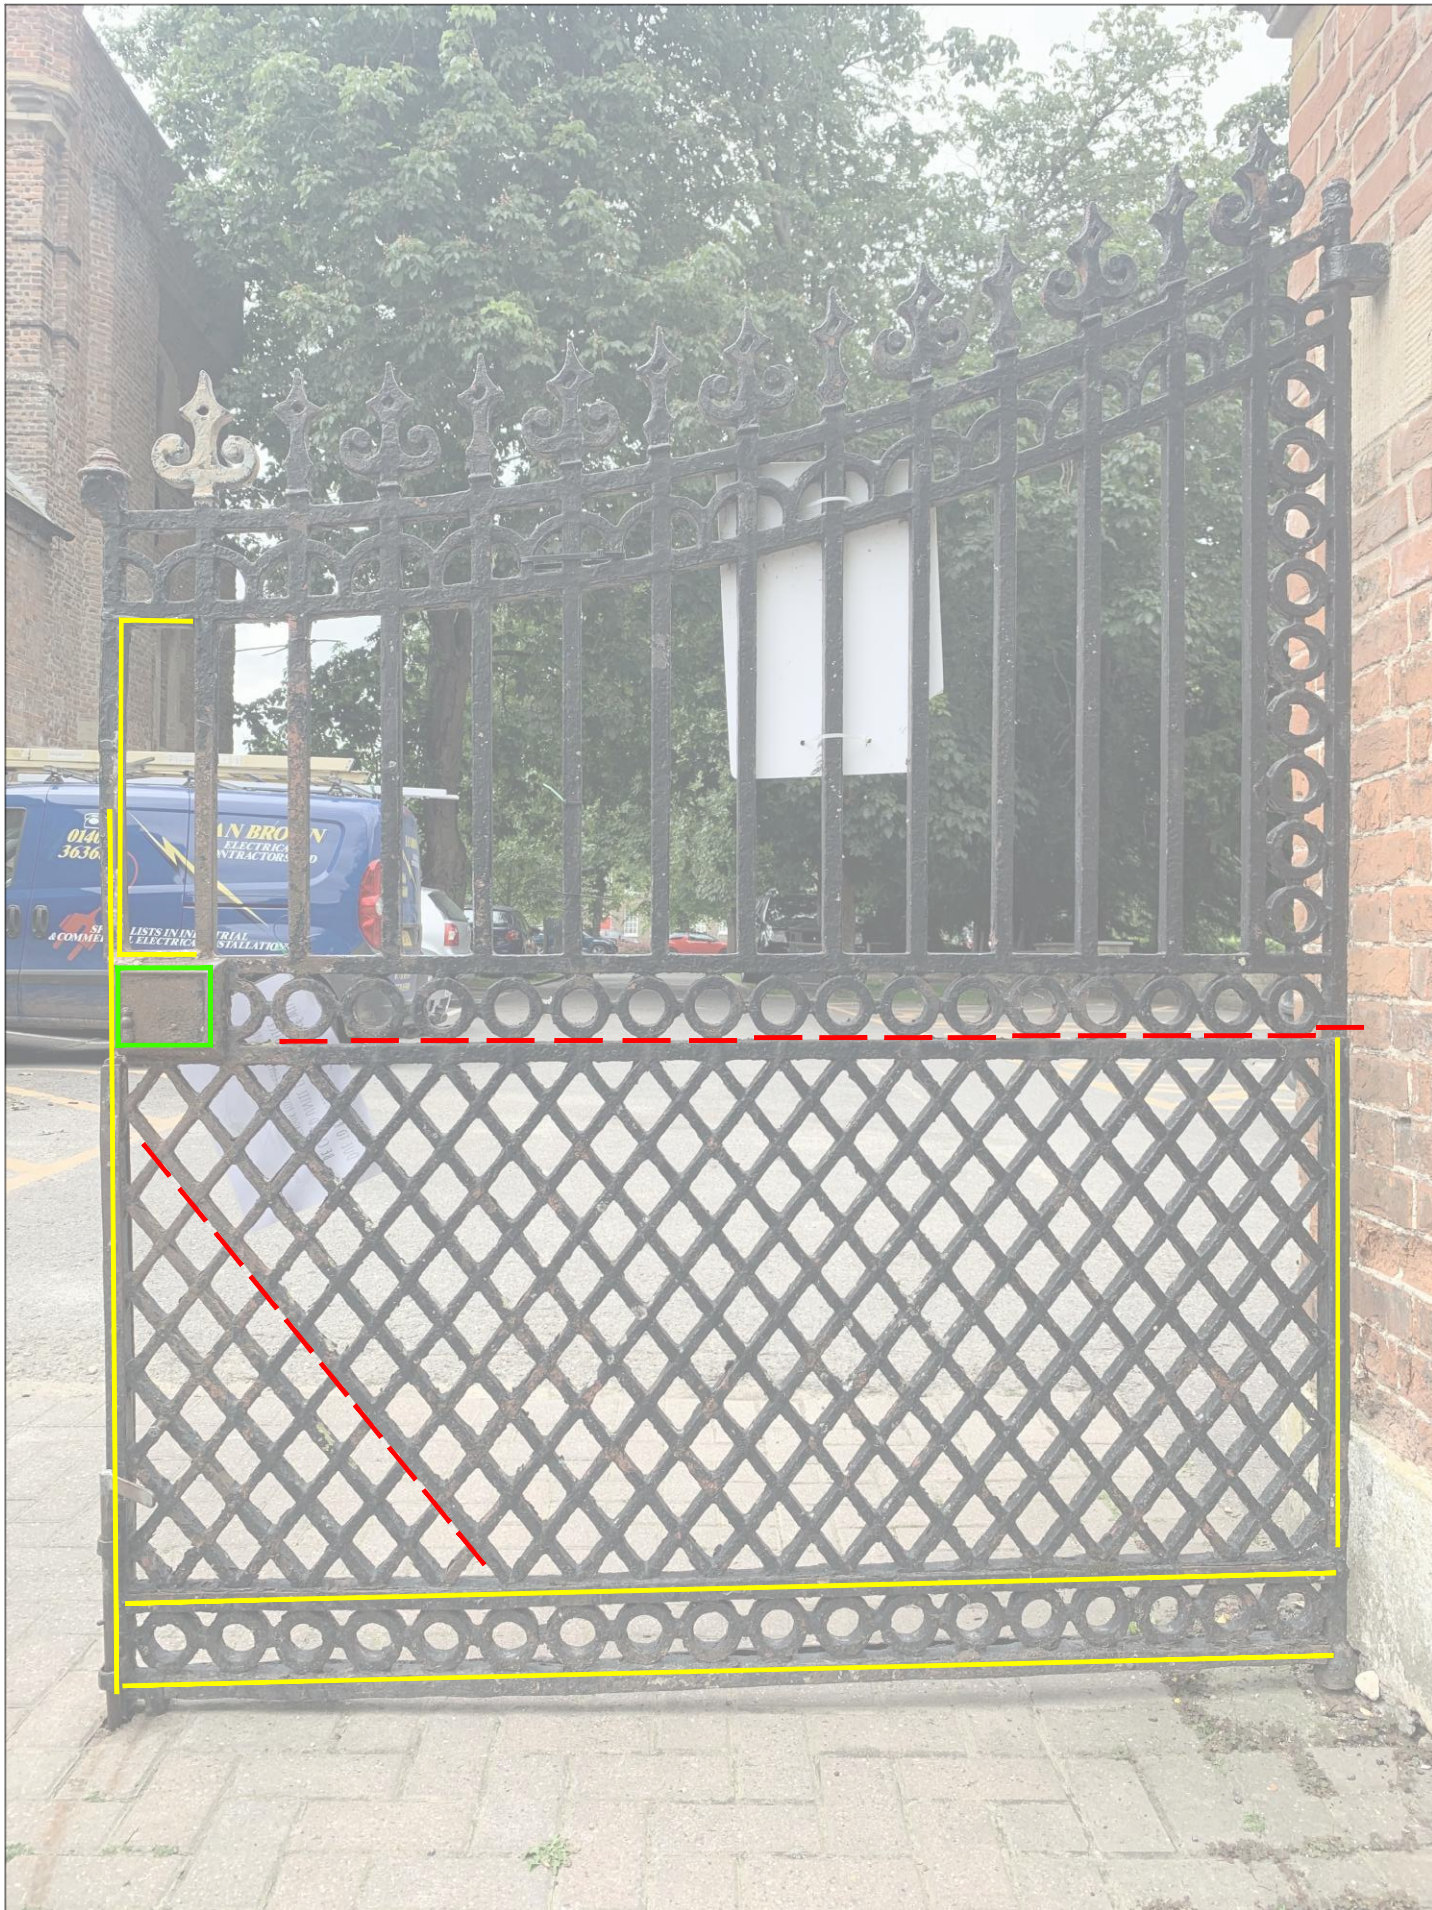
View of gates from west (the Chestnut Avenue) - showing visible defects and repairs

View of gates from east (inside Ayscoughfee Gardens) - showing visible defects and repairs

1. The paint finishings are in poor condition, much of the black paint is peeling to reveal a form of red oxide primer beneath. The decorative outer coating is not therefore providing the optimal level of protection to the iron substrate beneath.

2. The gates will not close correctly, this is due to distortion within the gates and in particular the south gate.
3. The lock box is not functioning and consequently the gate has been secured by a chain which has further damaged the painted surfaces.

4. Both gates have been repaired historically. Both faces of both gates have had strengthening straps applied, these have been fixed using exposed studs. There is a considerable amount of strapping which would suggest significant failure, particularly in the outer frame of each gate.

5. On the south gate 3 vertical pins have been installed within the central rail, again suggesting a interim repair.
6. The north gate has hairline cracks running horizontally at mid-rail level and at an angle of 45 degrees descending from the lock box. These fractures appear to extend through the full thickness of the iron.

1. To repair the gates and eliminate distortion as far as practically possible such that the gates can be closed correctly and that they can be used to fulfil their original purpose.
2. To repair cracks and fractures within the gates to minimize the risk of further deterioration.
3. To retain as much of the the original fabric as it is practical to achieve, whilst ensuring the structural integrity of the gates.
4. To repair the locking mechanism such that this can be used to secure the gates. Should the existing lock components be missing or damaged beyond repair then to install new, sensitive to the design of the gates.
5. To remove all previous decoration, prime and redecorate the gates to provide optimum protection to the ironwork.
6. To return the gates to their original colour, as they would have appeared in the early 19th C.
