# Heritage Impact Assessment

Proposed works to North Gates (at the end of The Chestnut Avenue),  
Ayscoughfee Hall Museum and Gardens, Church Gate, Spalding, Lincolnshire

June 2022

A1572NG– HIA rev P01

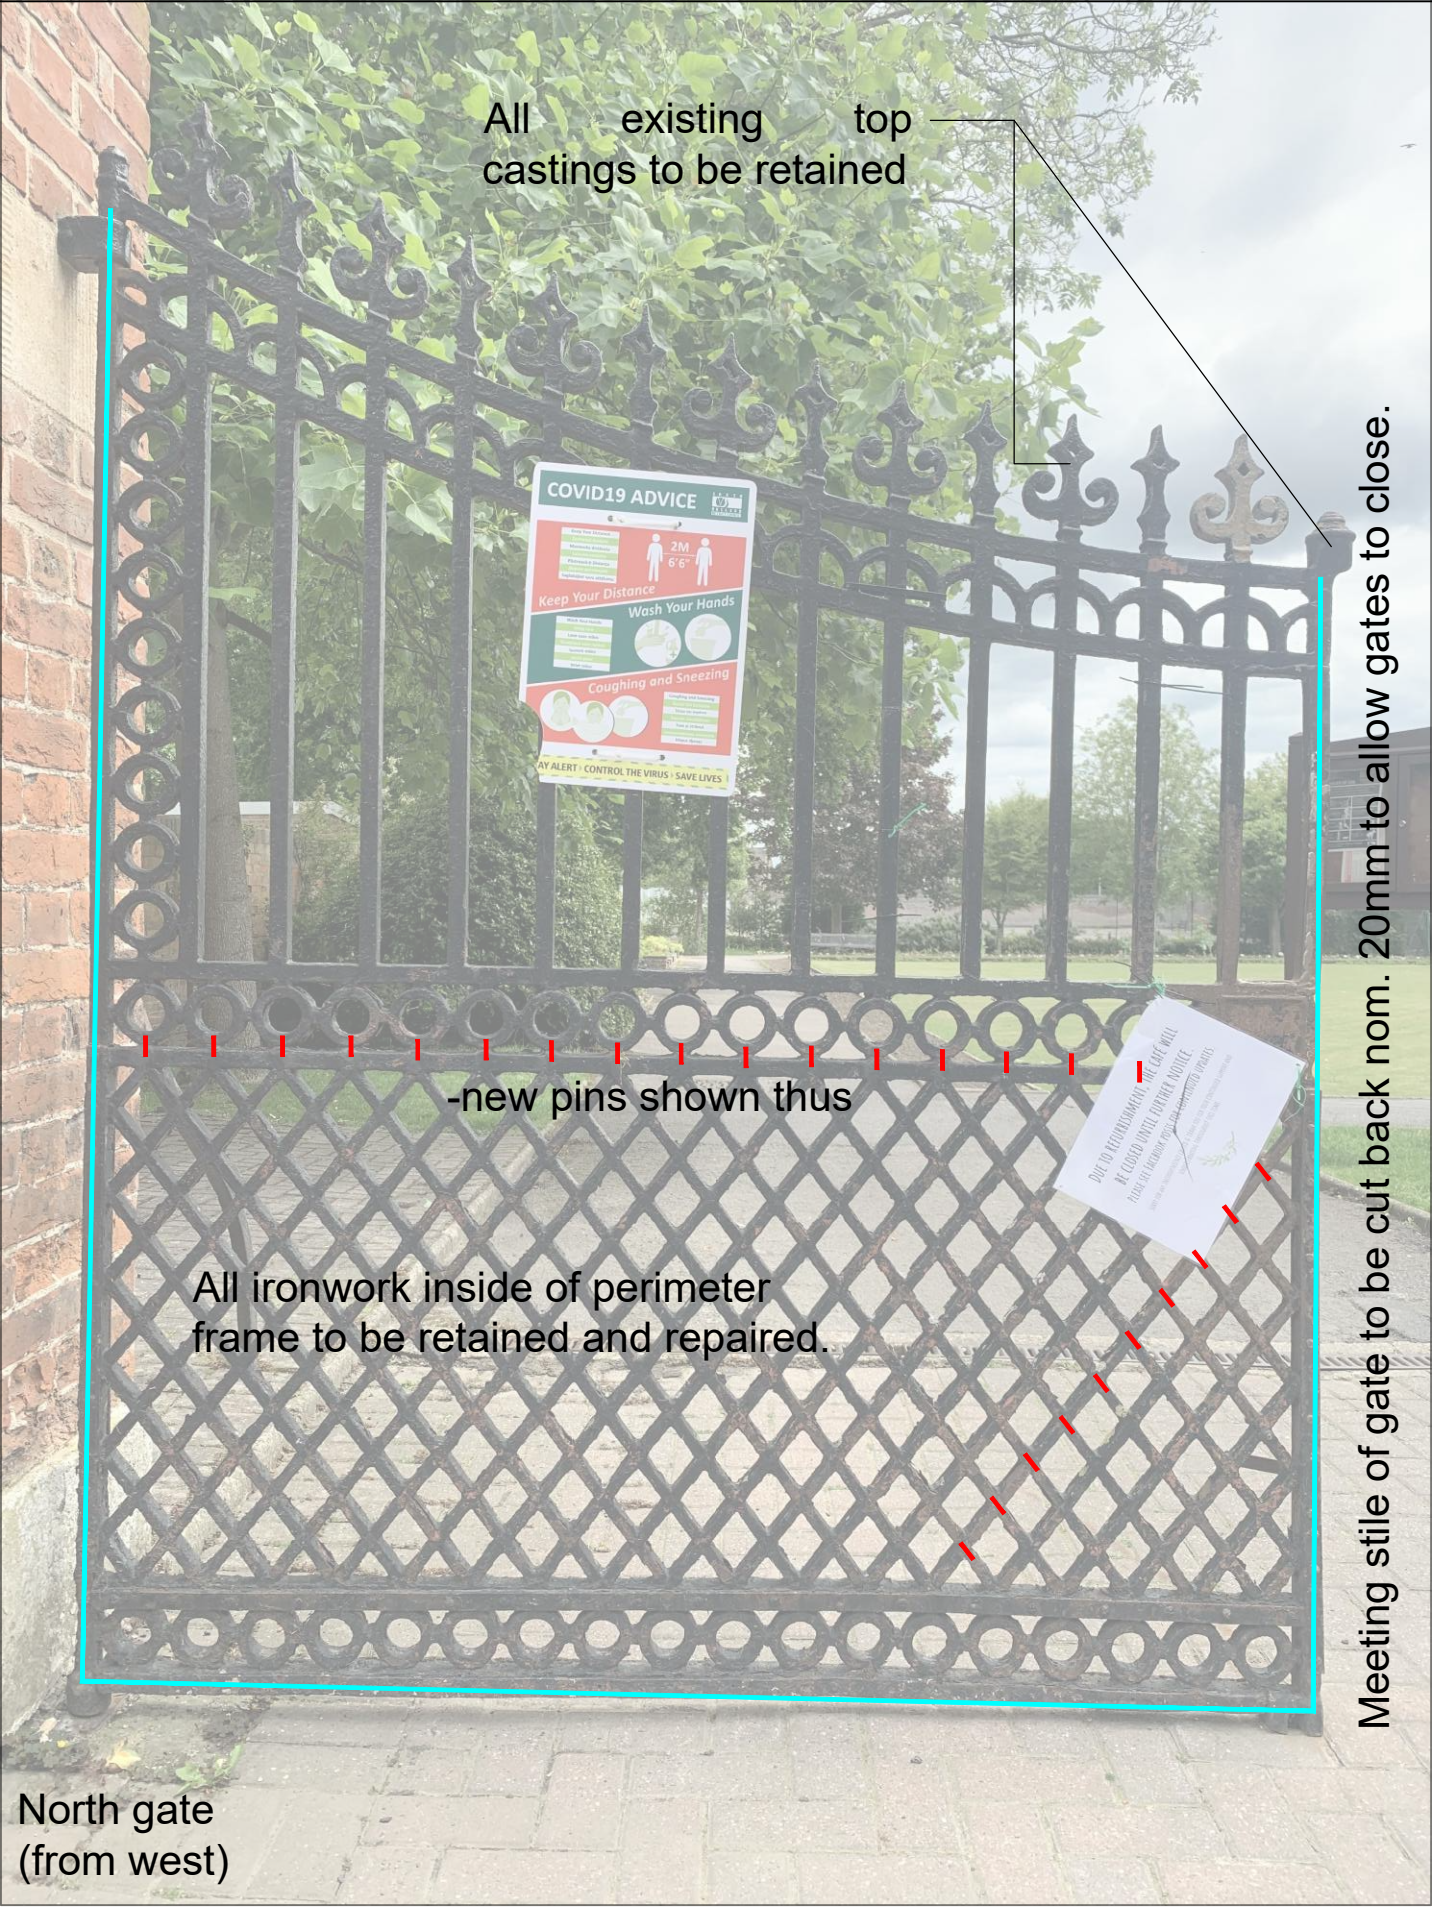
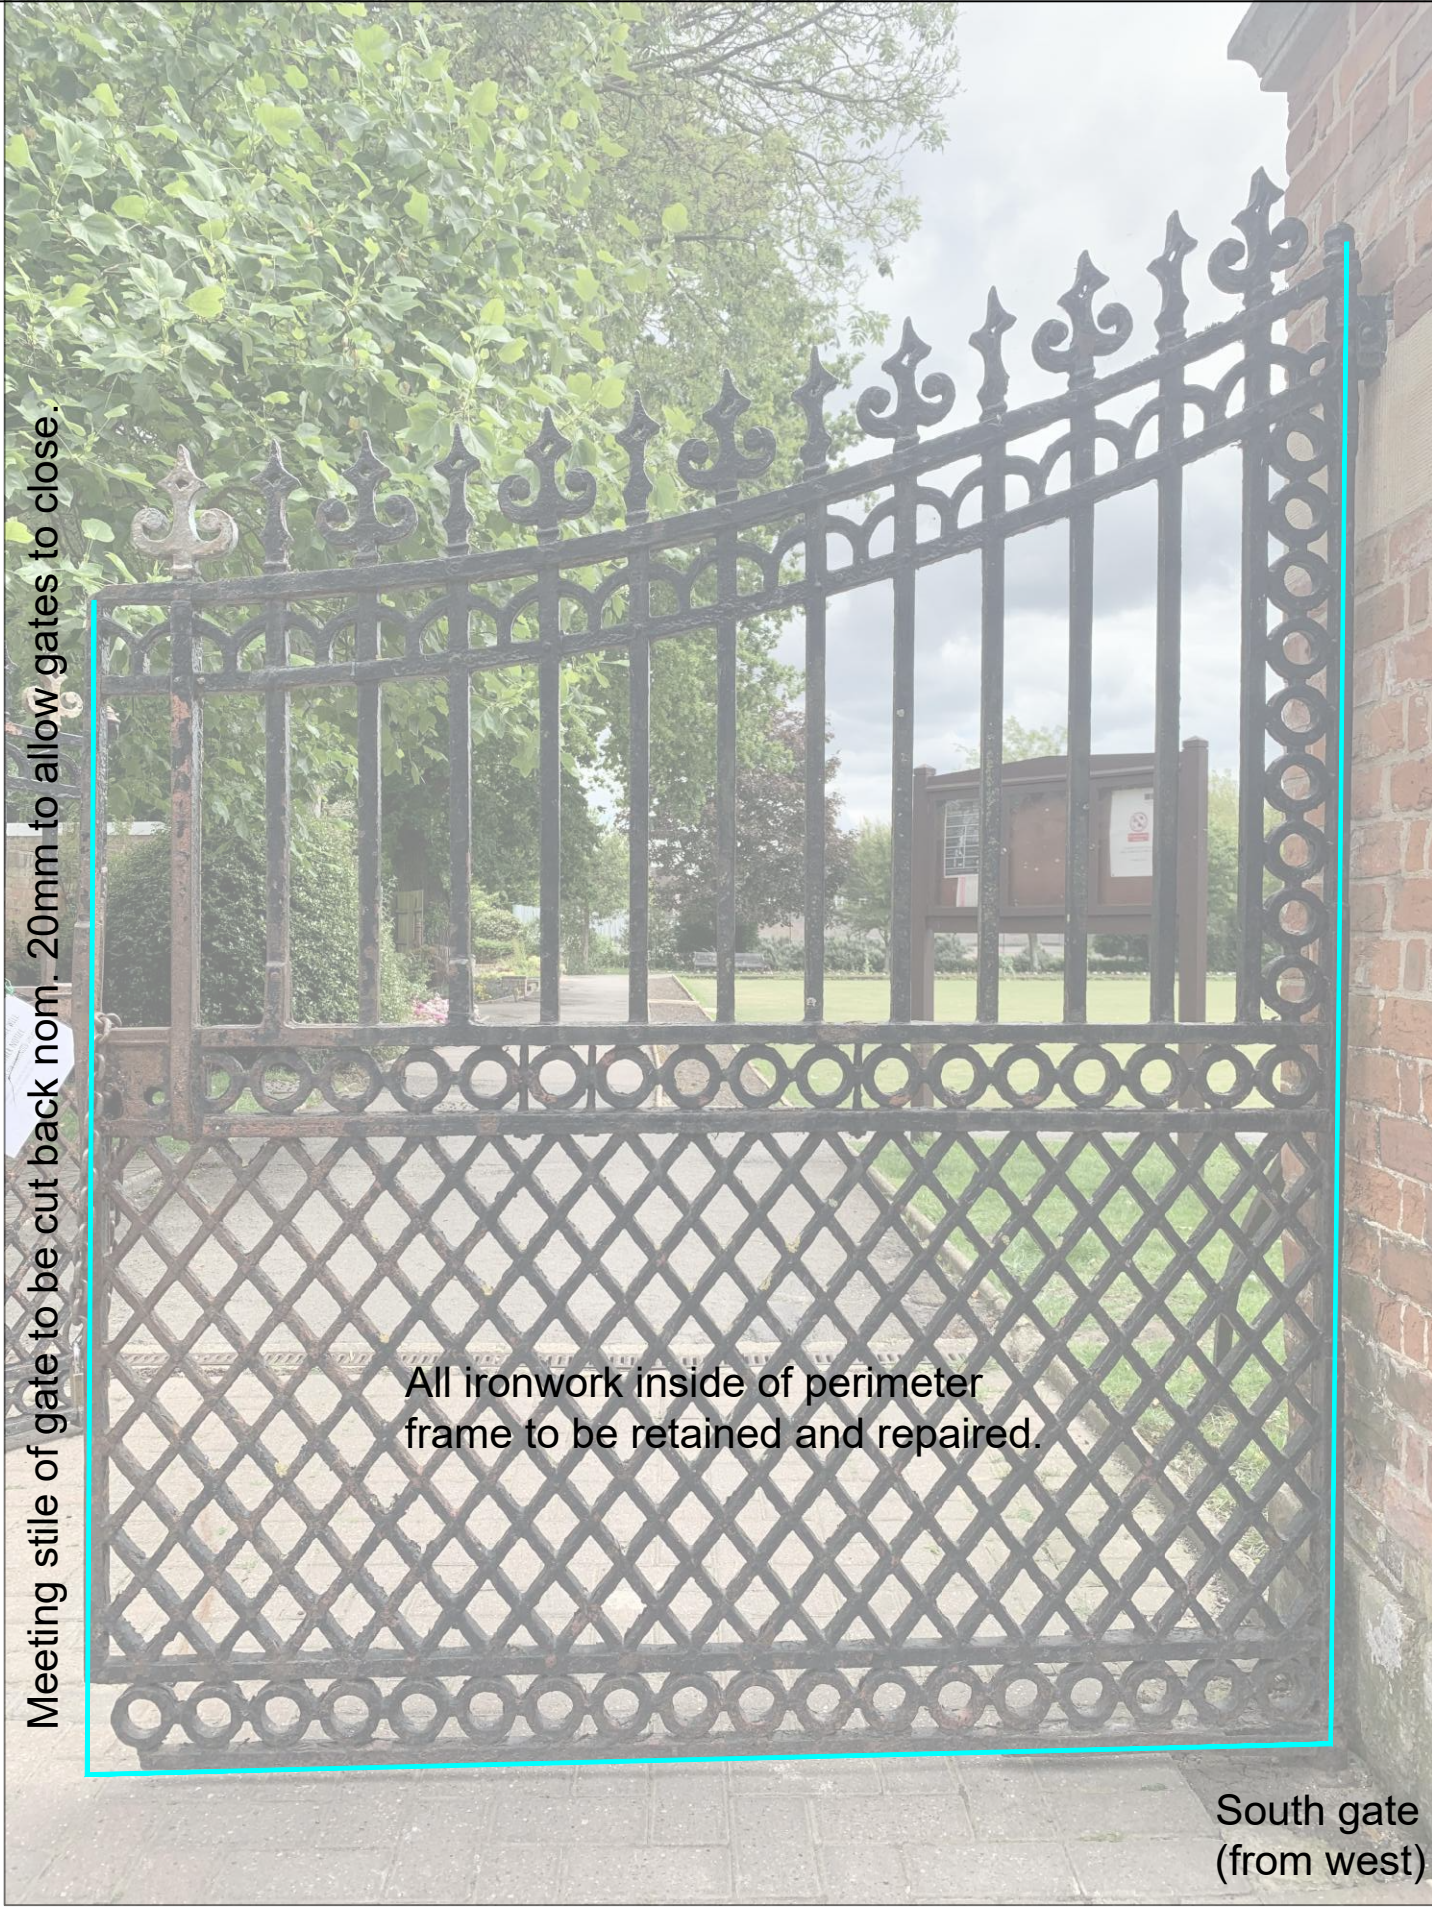
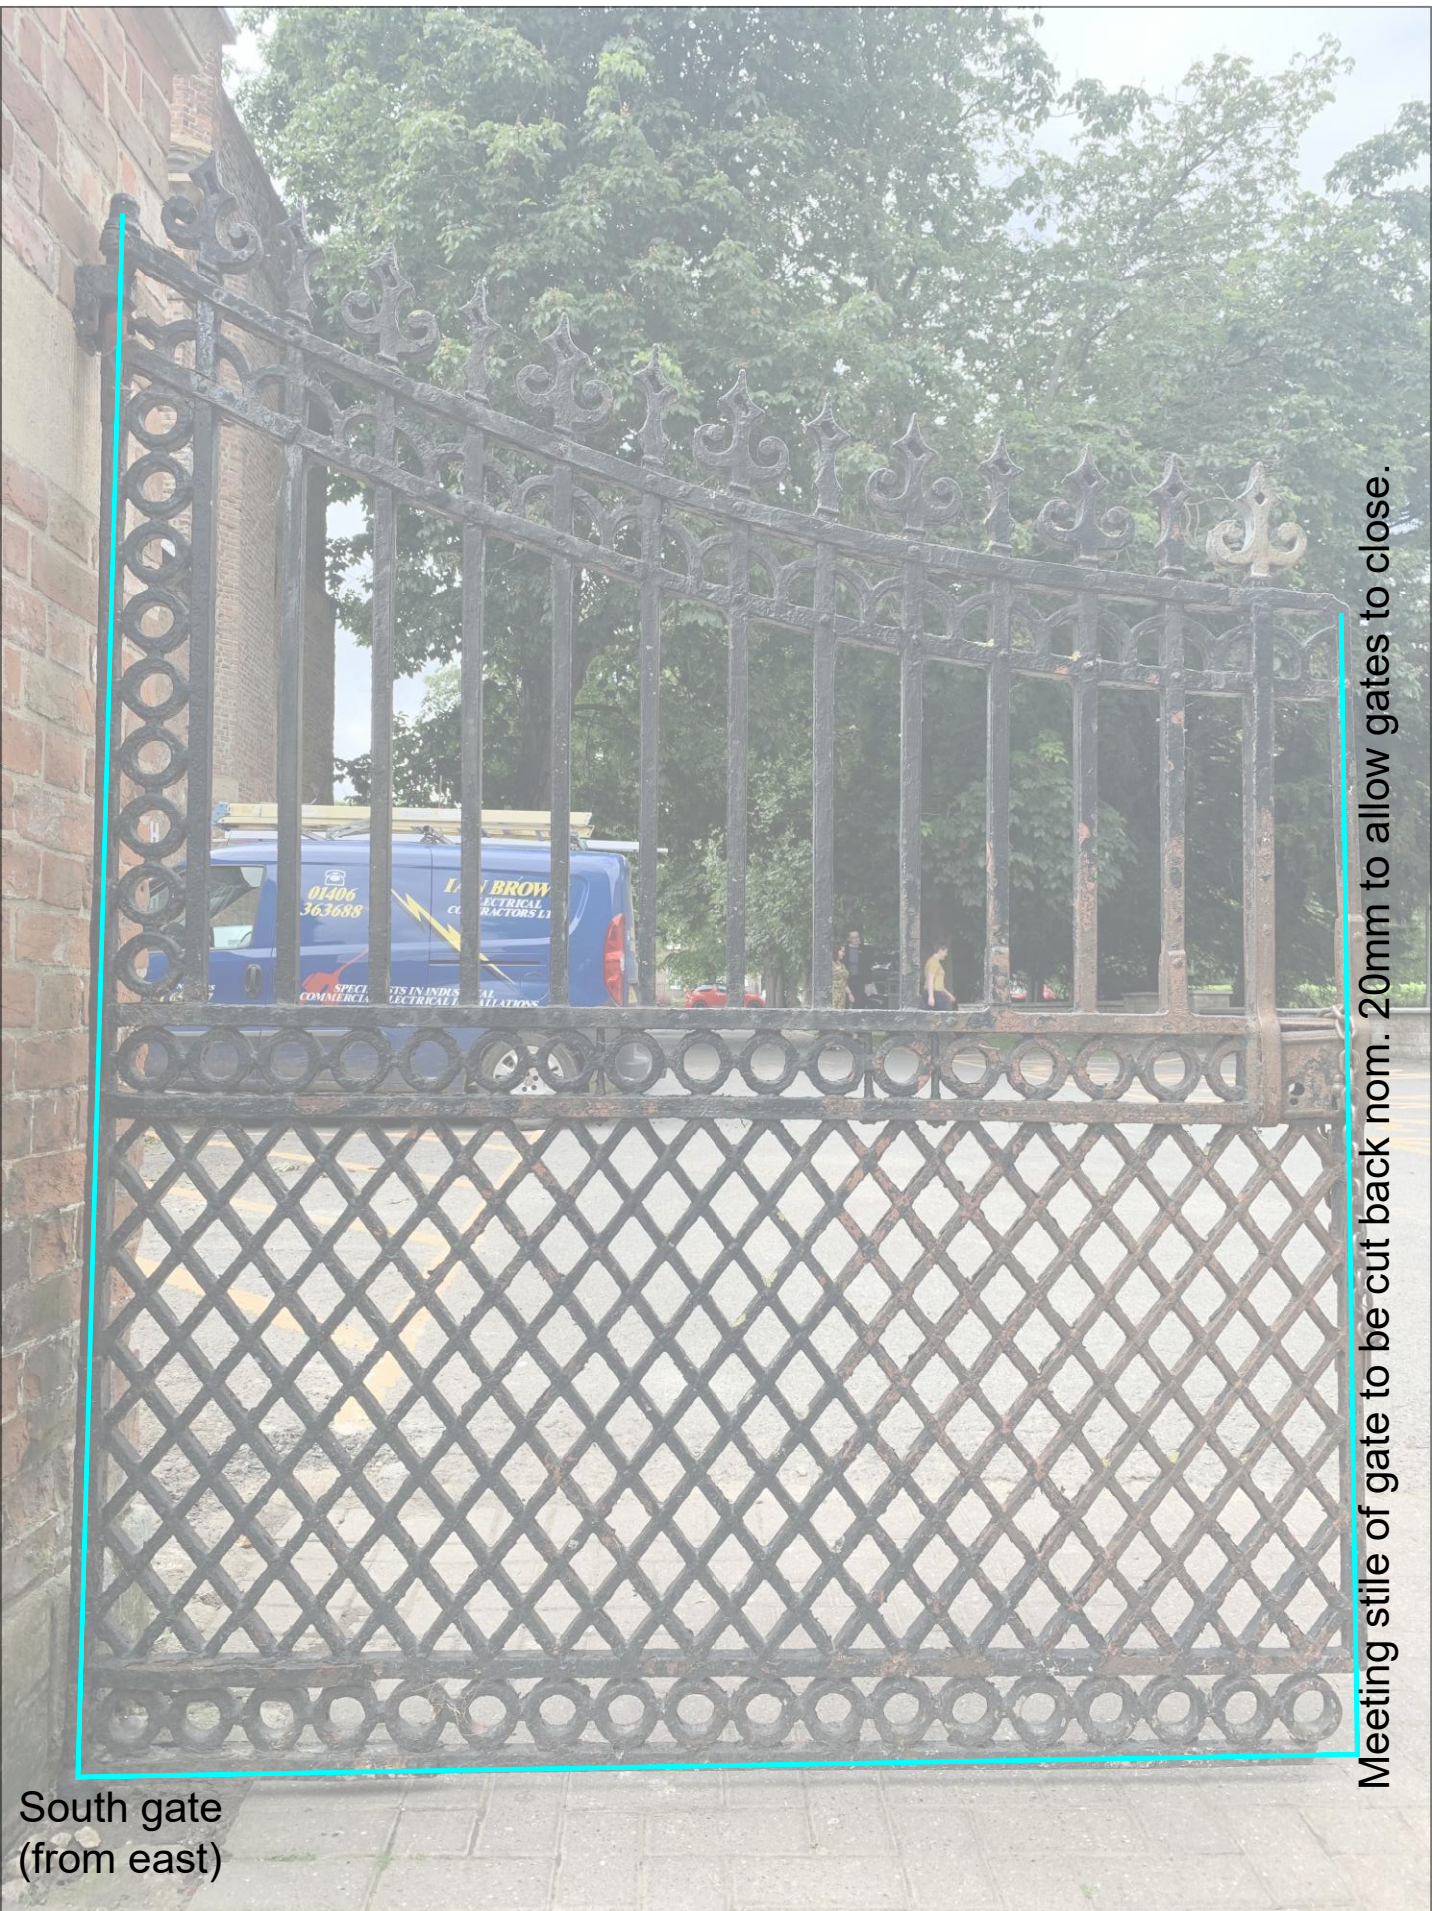
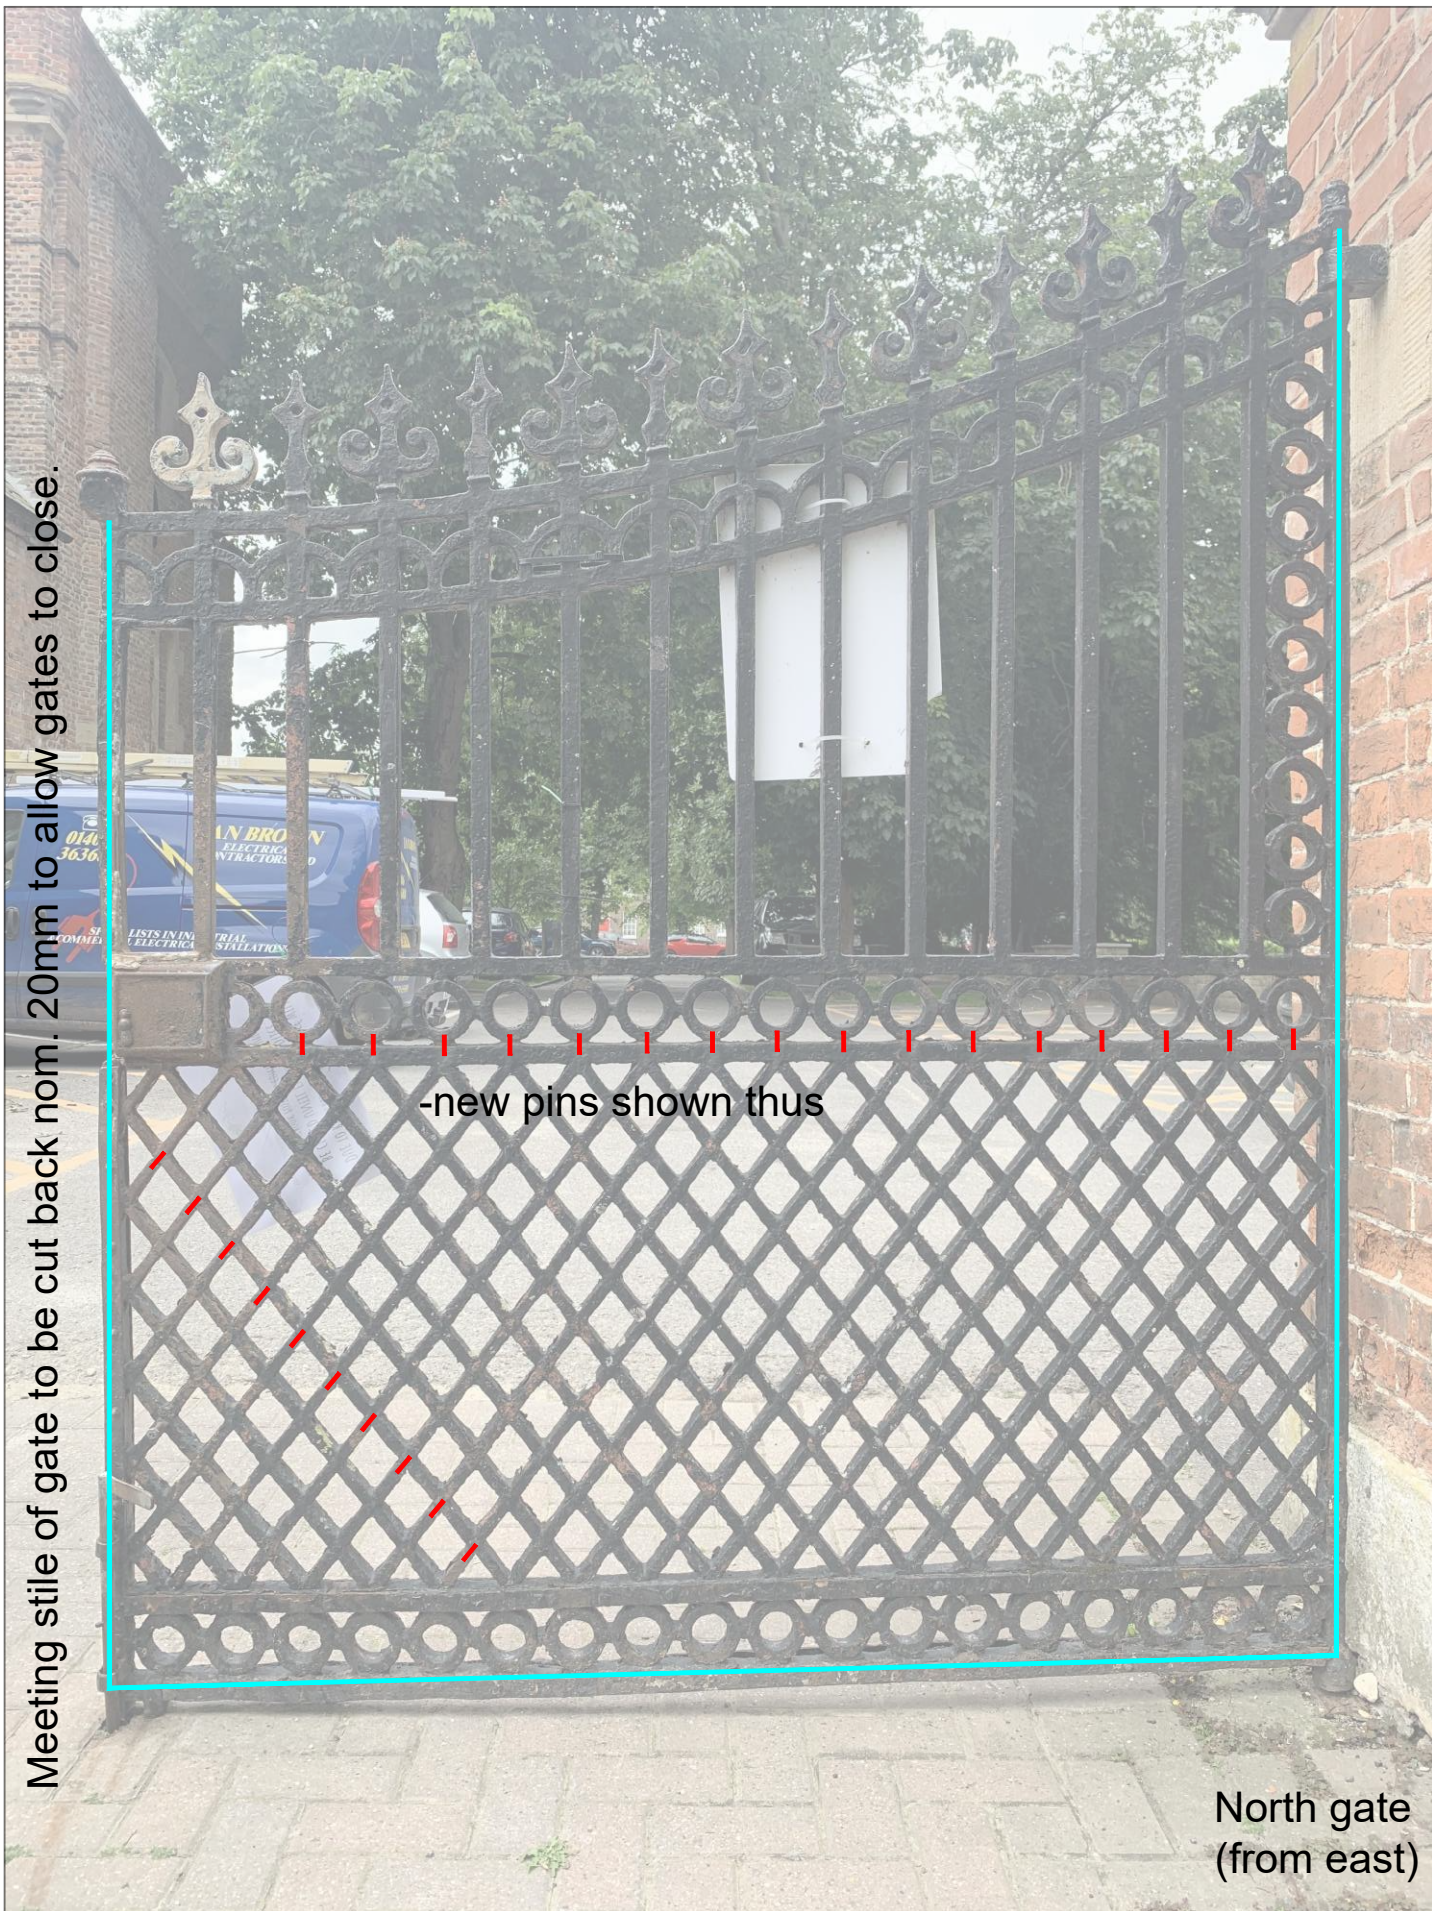
View of gates from west (the Chestnut Avenue) - showing visible defects and repairs

View of gates from east (inside Ayscoughfee Gardens) - showing visible defects and repairs

- a. The gates have distorted over time, particularly the south gate and have been repaired on at least one occasion. It is suspected that this distortion is either caused or worsened by the self-weight of the gates.

- b. The central iron sections of the gates (latticework etc) have fractured and cracked in areas, though overall the historic fabric remains present and intact. It is suspected however that this has structural integrity only as infill.

- c. The outer frame of both gates shows the greatest degree of distortion and has evidence of cracking. The repair strapping that has been added to the gates is all attached to either the mid-rail or the perimeter frame (side and base members) of both gates. This suggests that the outer frame has failed historically and that there has been a problem with both distortion and failure for a significant period of time.

- 1. South gate to be carefully removed from hinge points to allow transfer to workshop.
- 2. Existing paint finishes to be removed using controlled media blasting. Media to be selected to minimize surface damage to iron.

- 3. Historic repair strapping to be removed.
- 4. Distorted, cracked outer frame member of gate to be carefully cut away from central lattice and ring ironwork.

- 5. Existing lock box to be assessed for damage and reused if repairable. Should this not be the case then new to be fabricated to match existing in all respects.

- 6. Existing lattice and ring ironwork to be brought back into flat alignment and repaired locally by installing pins tapped and died. Lock edge of gate (lattice work etc) to be cut back nominally 20mm in readiness to attach new perimeter frame. This as an allowance to move the meeting stiles apart slightly to allow the gate to close properly (distortion currently prevents this).

- 7. New steel perimeter frame to be measured and constructed to replace former.
- 8. New steel perimeter frame to be attached ensuring that original details within centre of gate and along top are retained in situ.

- 1. North gate to be carefully removed from hinge points to allow transfer to workshop.
- 2. Existing paint finishes to be removed using controlled media blasting. Media to be selected to minimize surface damage to iron.

- Extent of distorted and fractured perimeter frame to be removed and replaced with new in steel.
