# Water Lane Nurseries, Low Road, Spalding

## Structural Condition Survey

### Barn A

July 2024

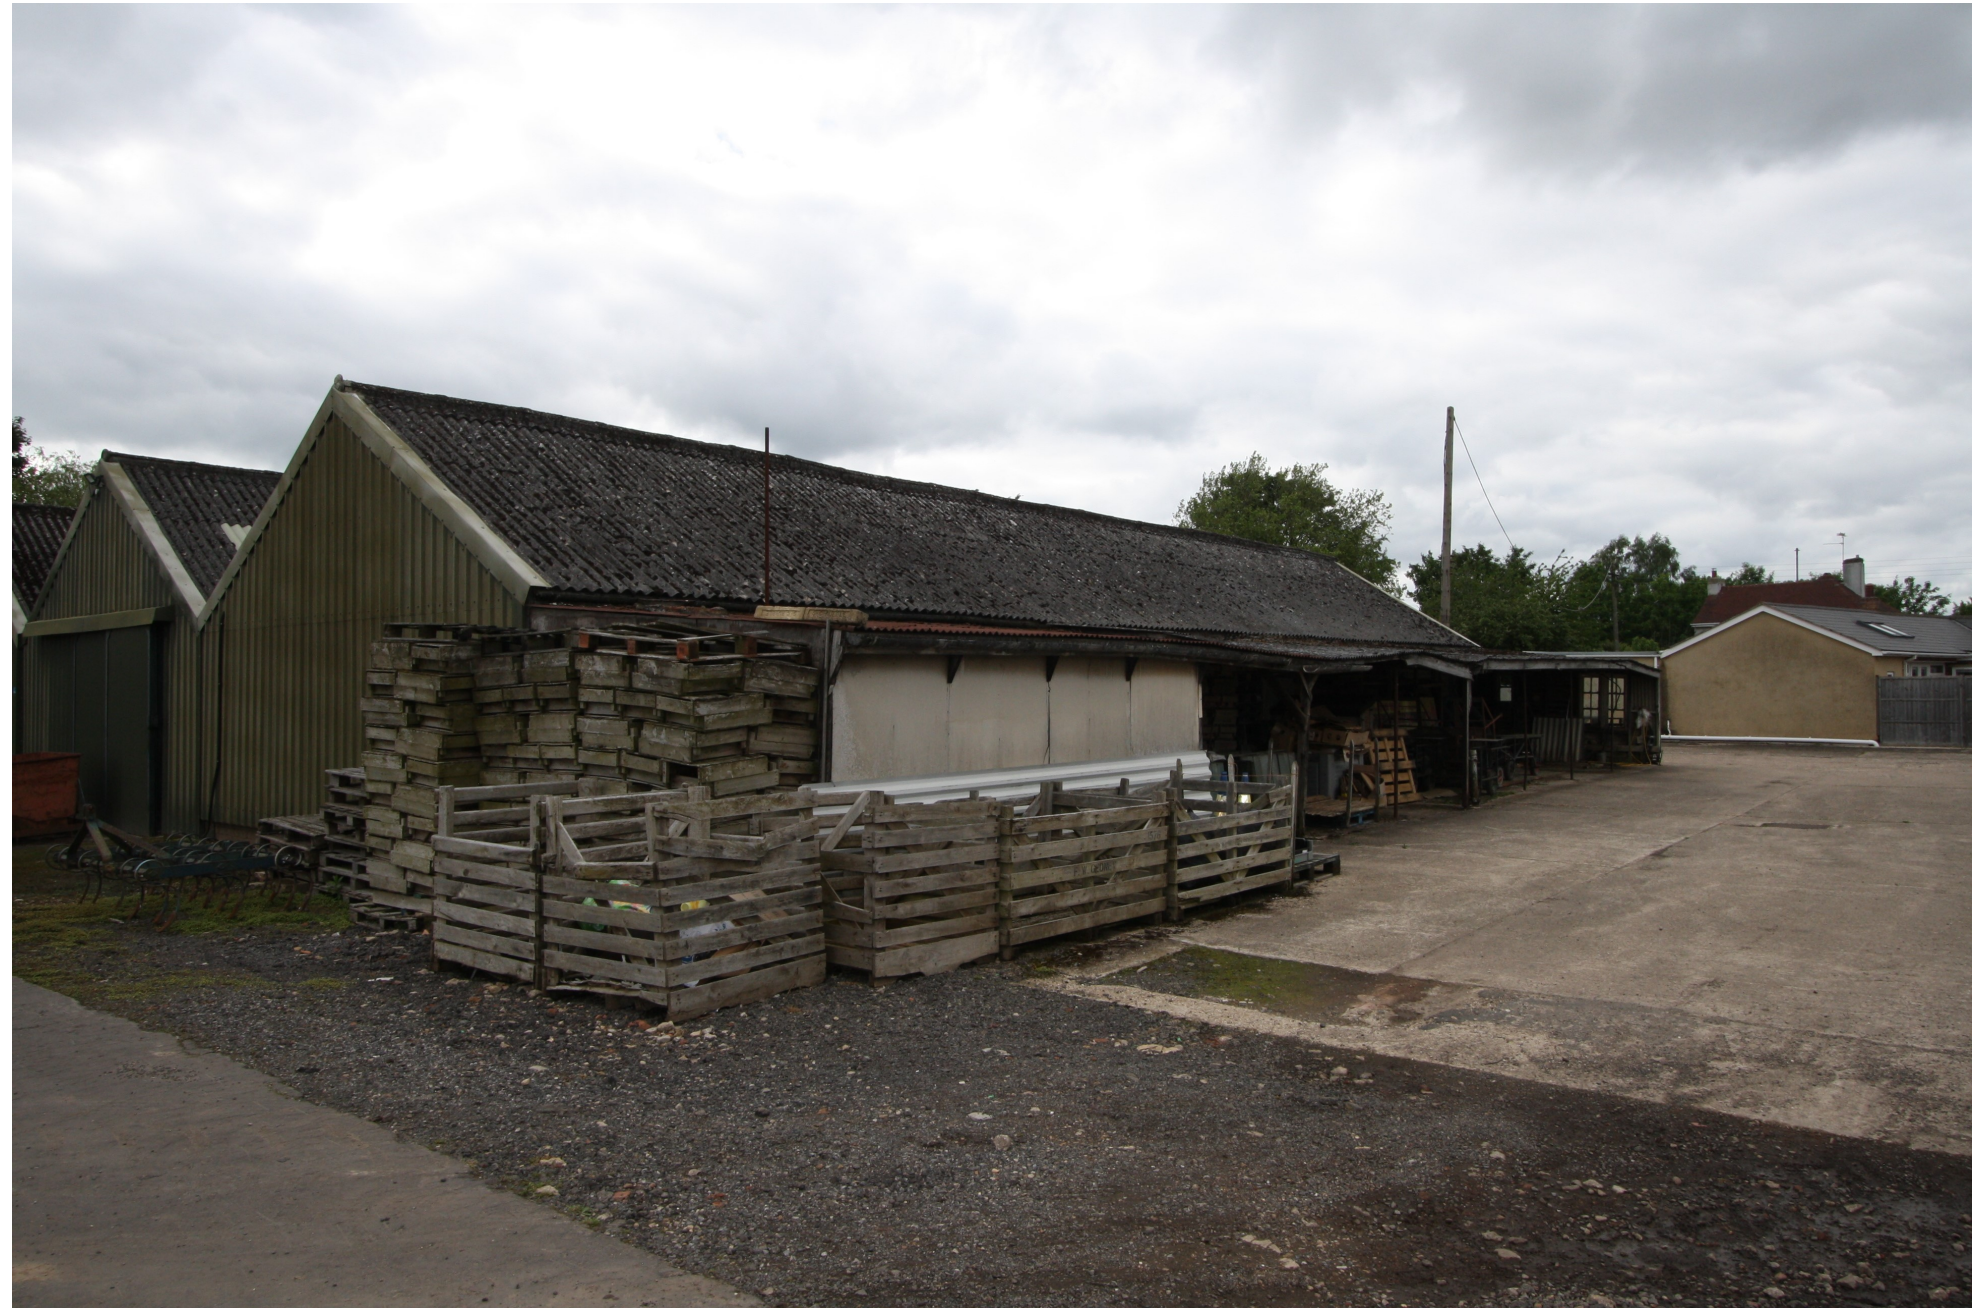
**View from South-East looking at Barn A Main Building  
and Lean-to**

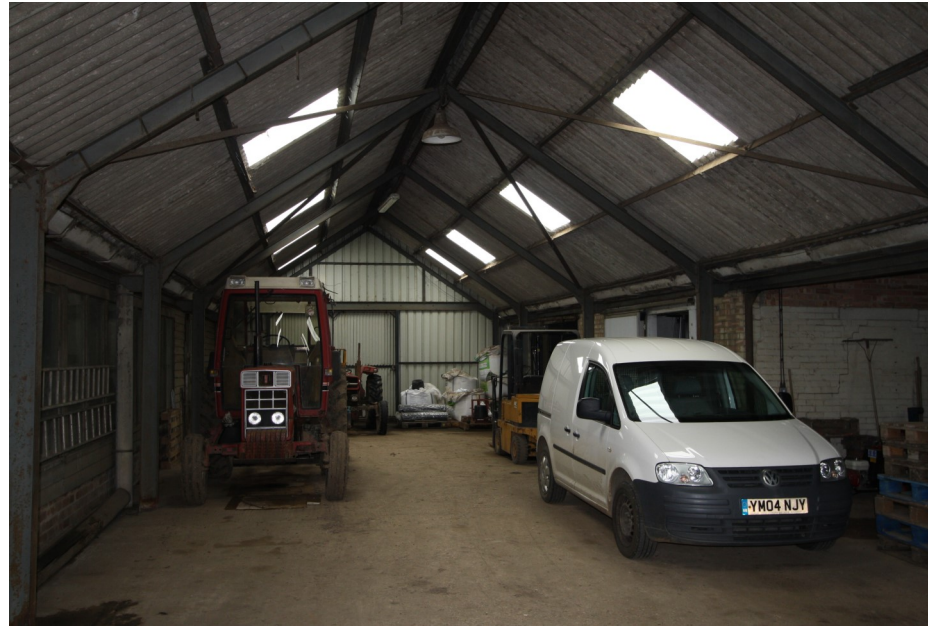
*Current Condition:* Generally the roof is in good condition with no leaks visible.

*Current Condition:* The cladding is in a good condition with limited damage externally.

**Image illustrating the good condition of the portal frame, roof purlins and sheet material**

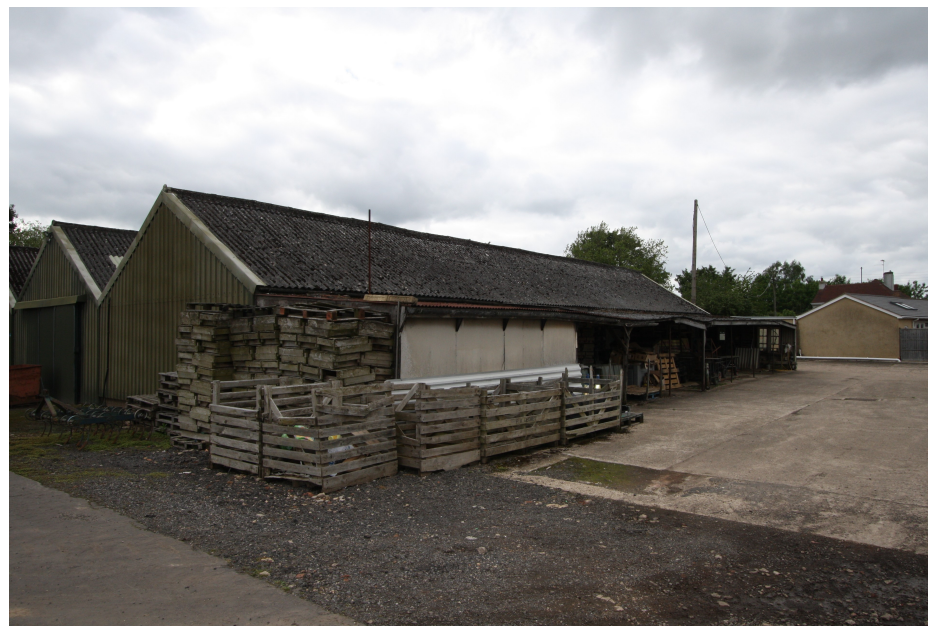
**Image illustrating Lean-to Element of Barn**

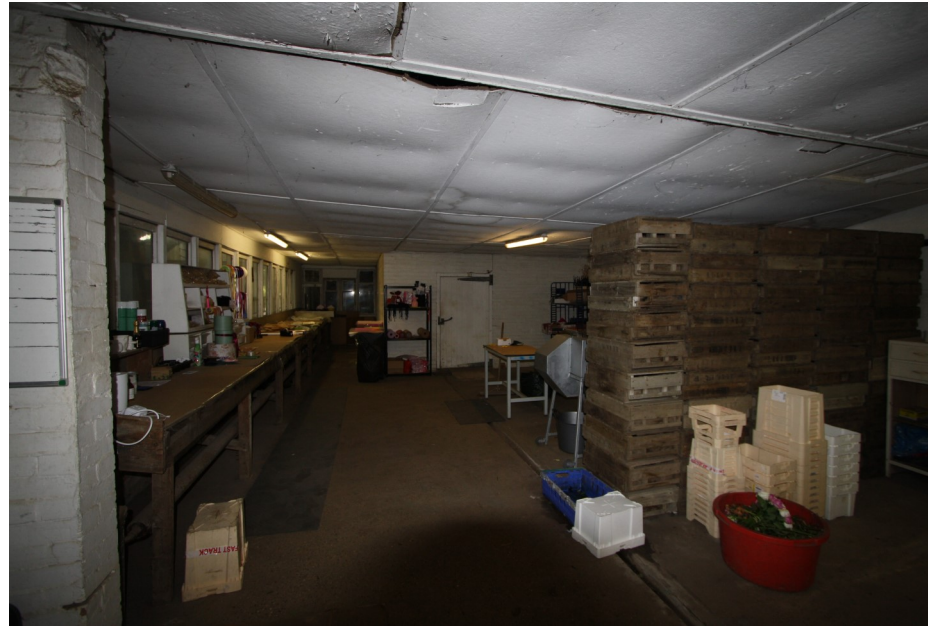
Some areas included plasterboard and suspended ceiling finishes. All ceilings are non-loadbearing and do show signs of the need to be replaced. This is commensurate with the age and use and would be expected given the age of the barn.

**Image Showing Existing Brick Internal Walls and Suspended Ceiling**

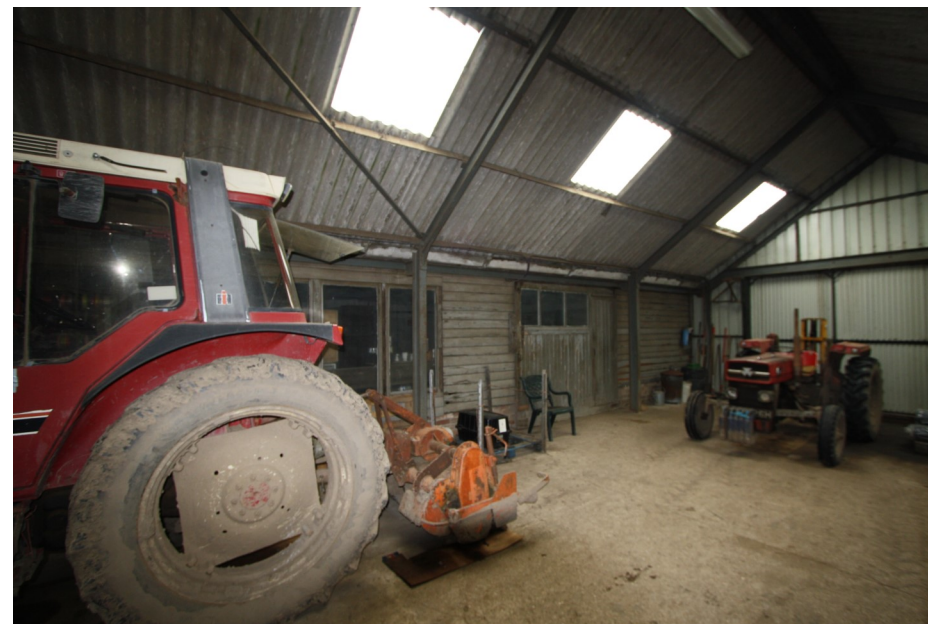
*Current Condition:* The concrete floor is in a good condition with limited cracking.

**Image Showing Existing Timber Partitions and Cast Concrete Floor**
