# Water Lane Nurseries, Low Road, Spalding

## Structural Condition Survey

### Barn B

**Project:** Demolition of existing barns/ green-house and the erection of 9 dwellings on land at Water Lane Nurseries, Low Road, Spalding

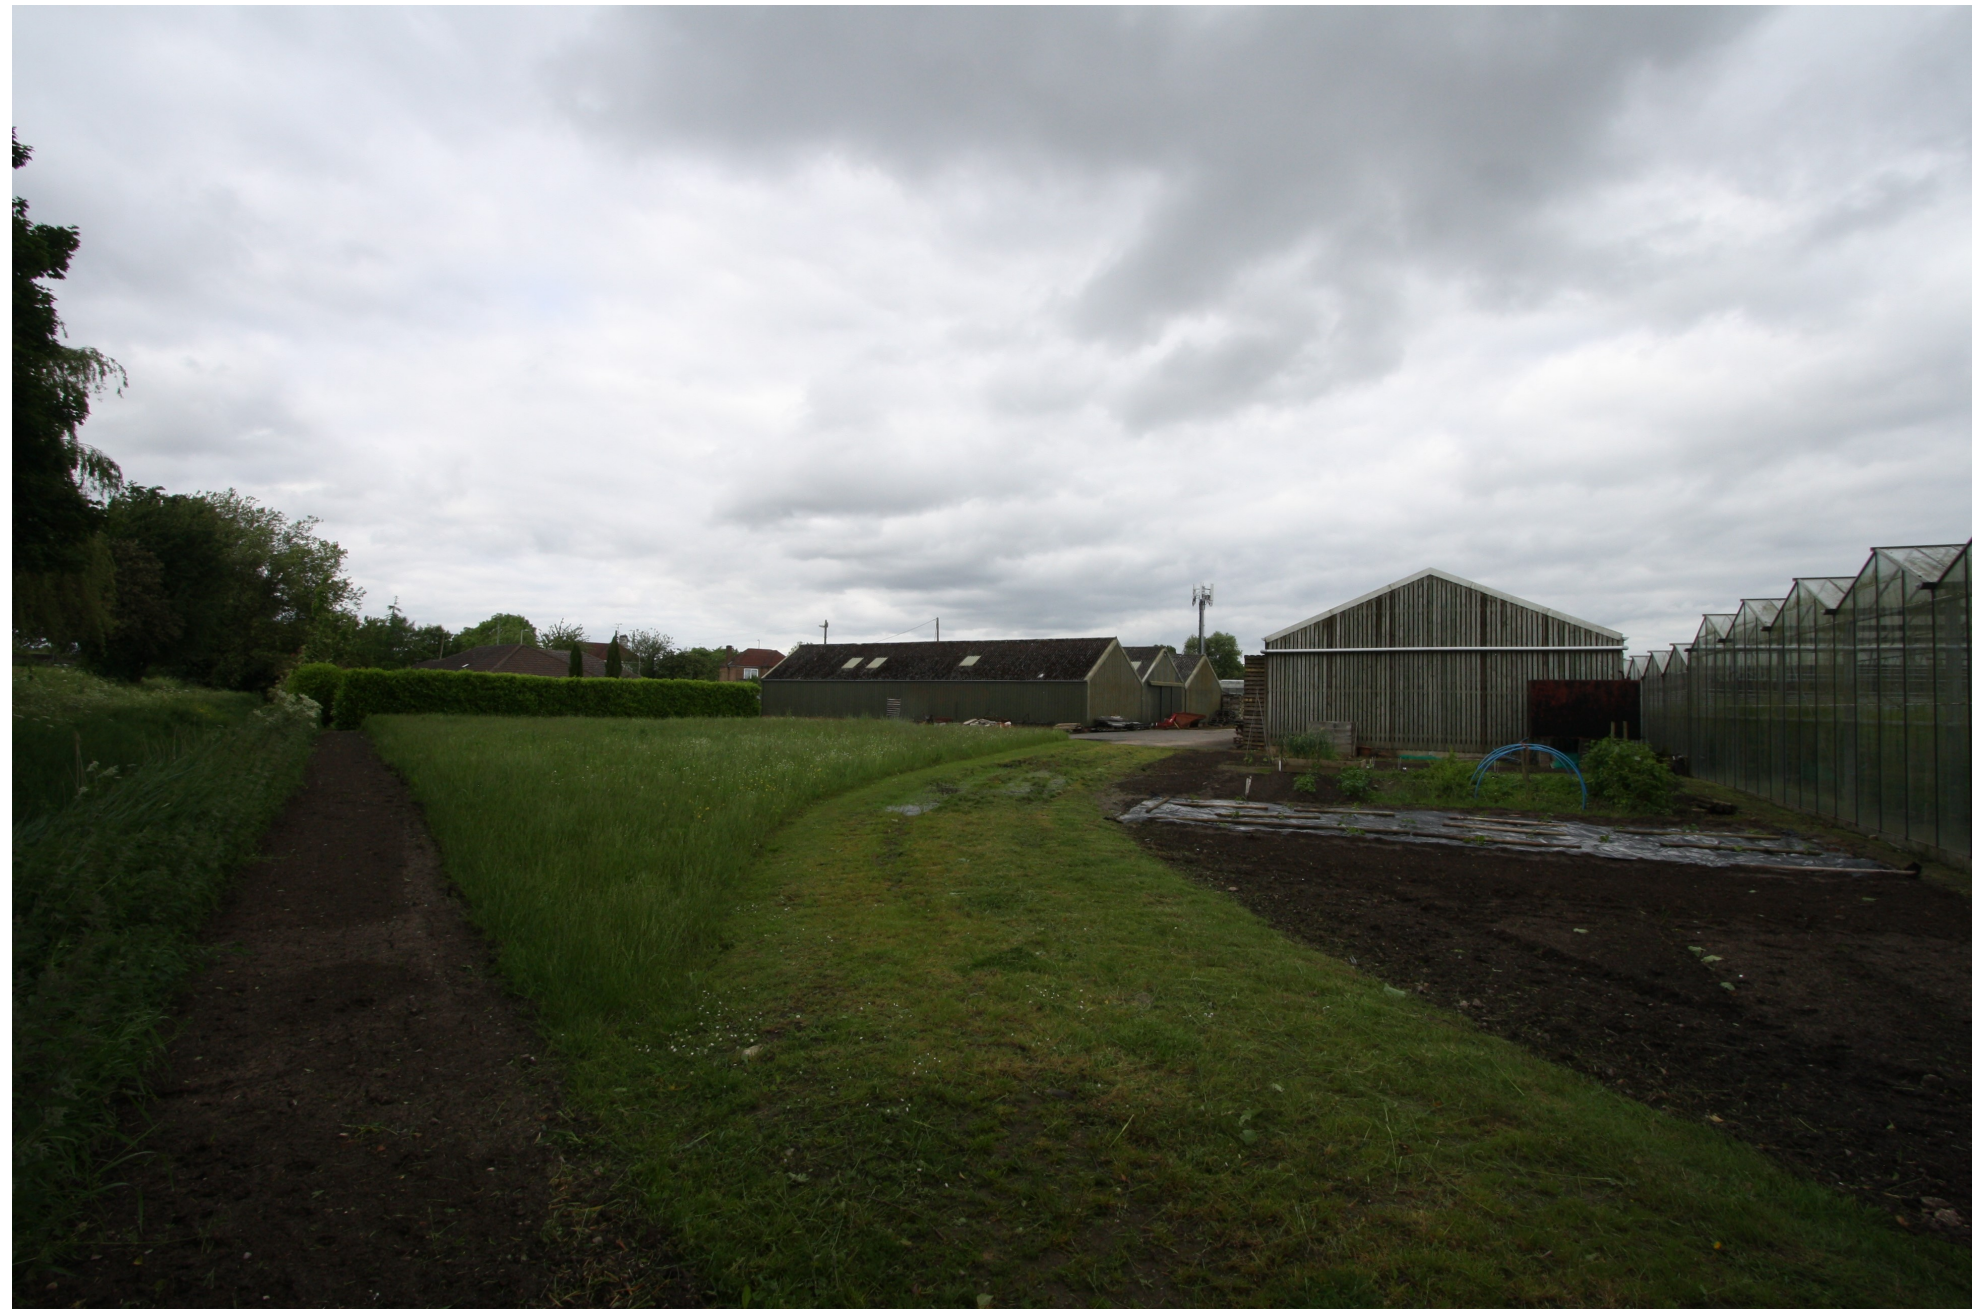
**View of West Elevation of Barn B with Barn in the  
Bakground**

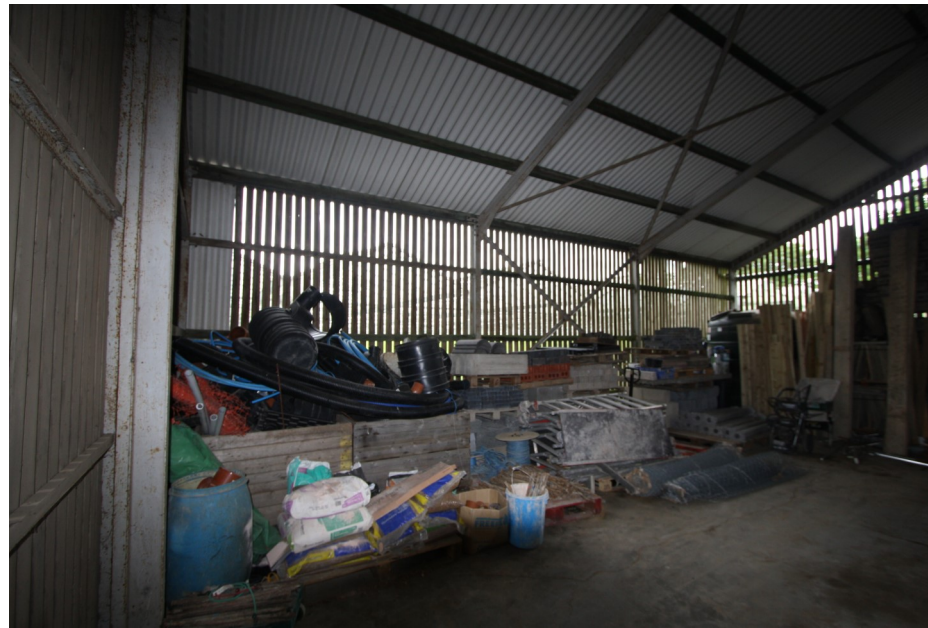
*Description :* The main roof area was open and therefore a visual inspection was possible from ground level. The roof is steel purlins supported by a steel portal frame. The roof is finished in a profiled steel sheet cladding.

*Current Condition:* Generally the roof is in excellent condition with no leaks visible.

**Image illustrating the Excellent condition of the portal frame, roof purlins and sheet material**

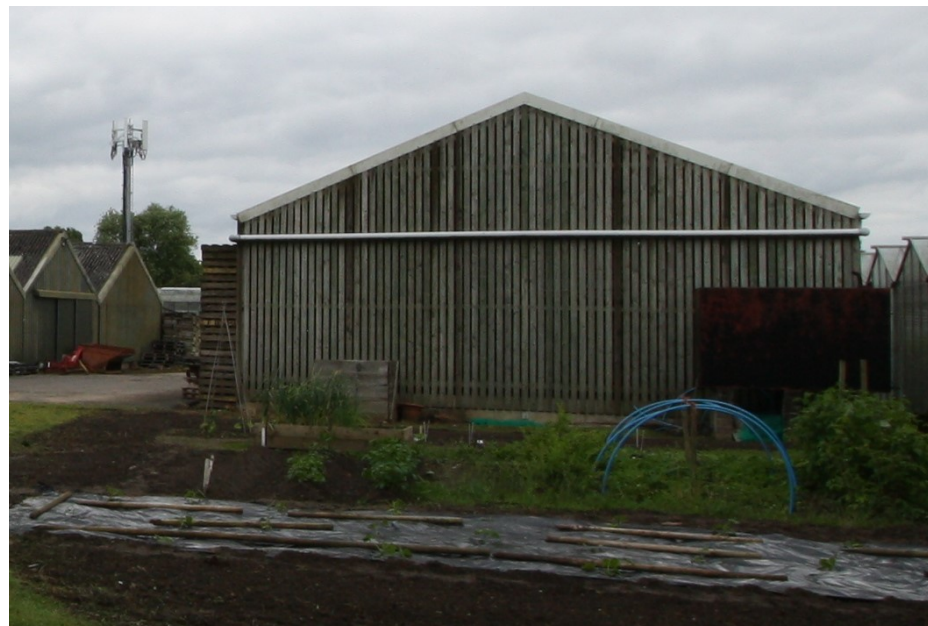
*Description:* The external walls of the building consist of a mix of timber vertical cladding and steel profiled sheet cladding.

*Current Condition:* The cladding is in an excellent condition.

**Image Illustrating Timber Vertical Cladding Boards**

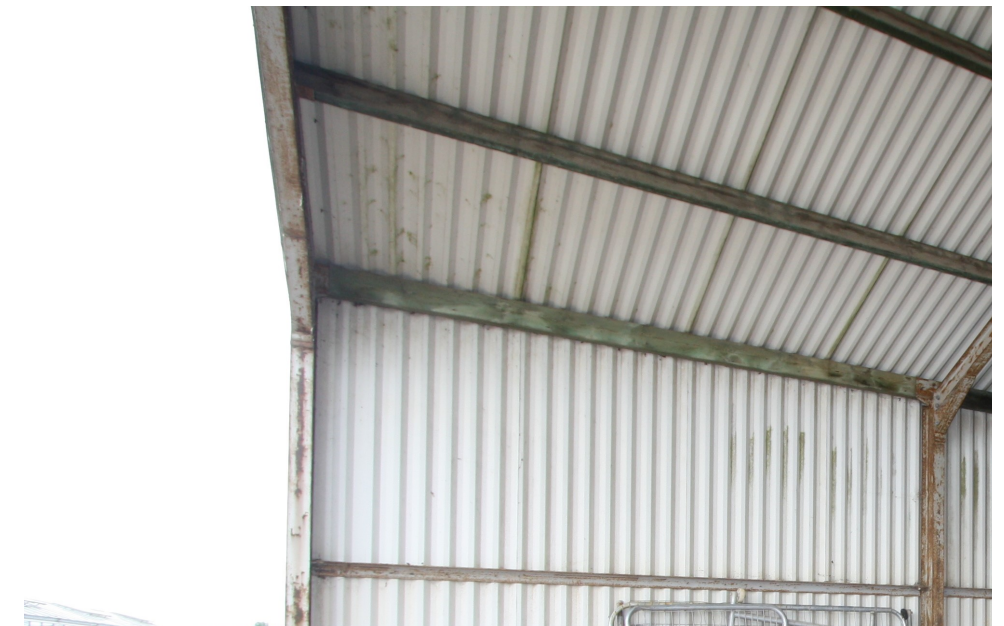
**Image Illustrating Steel Profiled Sheet Cladding**

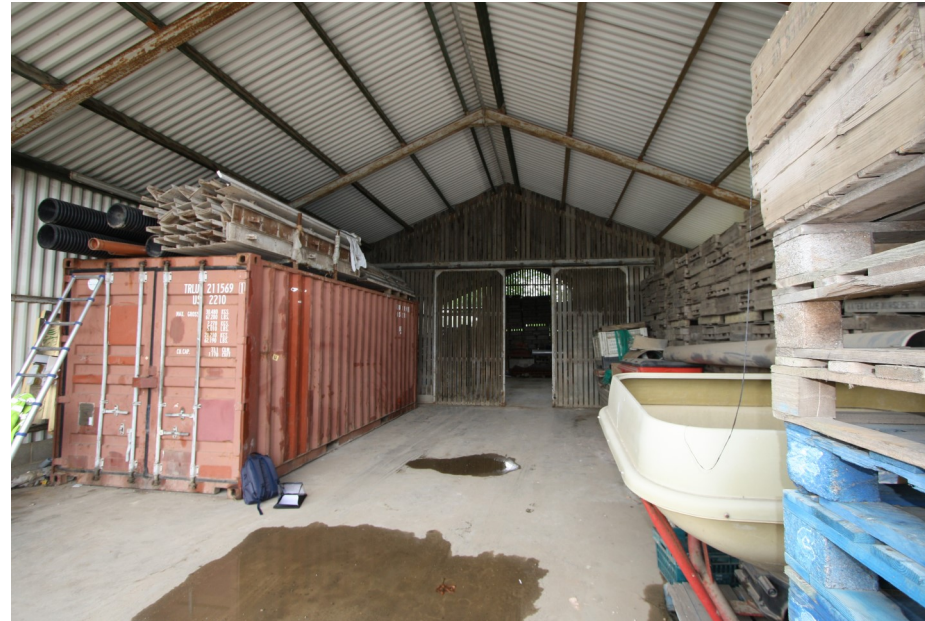
*Current Condition:* . The internal walls themselves appear to be level, true and generally free from significant movement.

*Current Condition:* The concrete floor is in an excellent condition.

*Current Condition:* Excellent condition with limited no rot.

**Image Showing Timber Internal Partition, Doors and Cast Concrete Floor**
