**Ayscoughfee Hall  
Spalding  
Lincolnshire**

**Report on the condition and proposed rebuilding  
of the Mary Ann Johnson Fountain**

**February 2022**

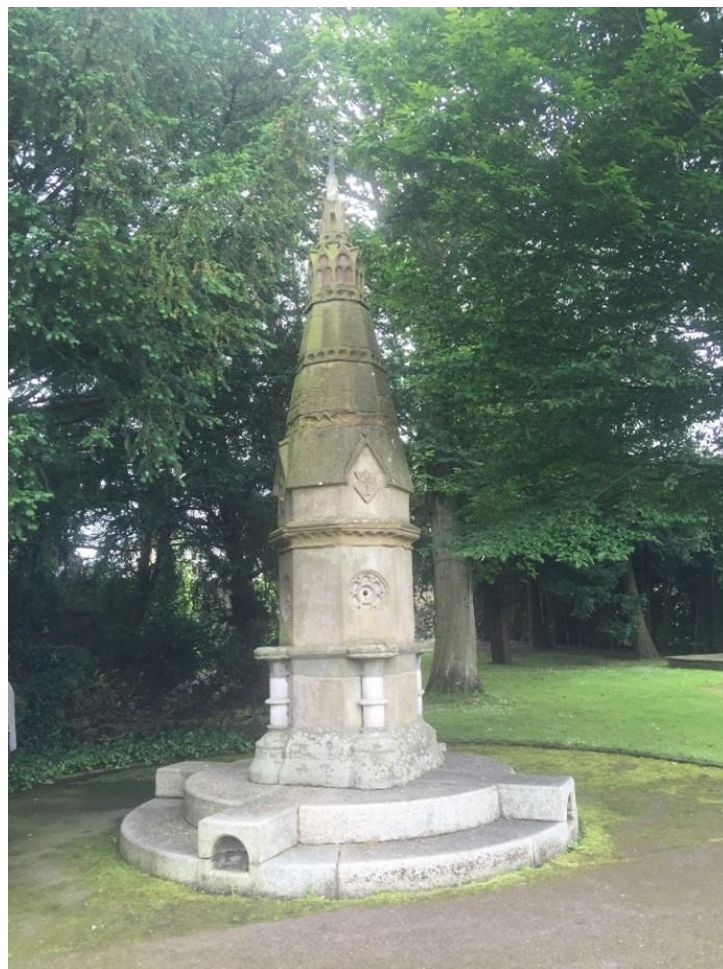
*Plate 1: The fountain prior to dismantling*

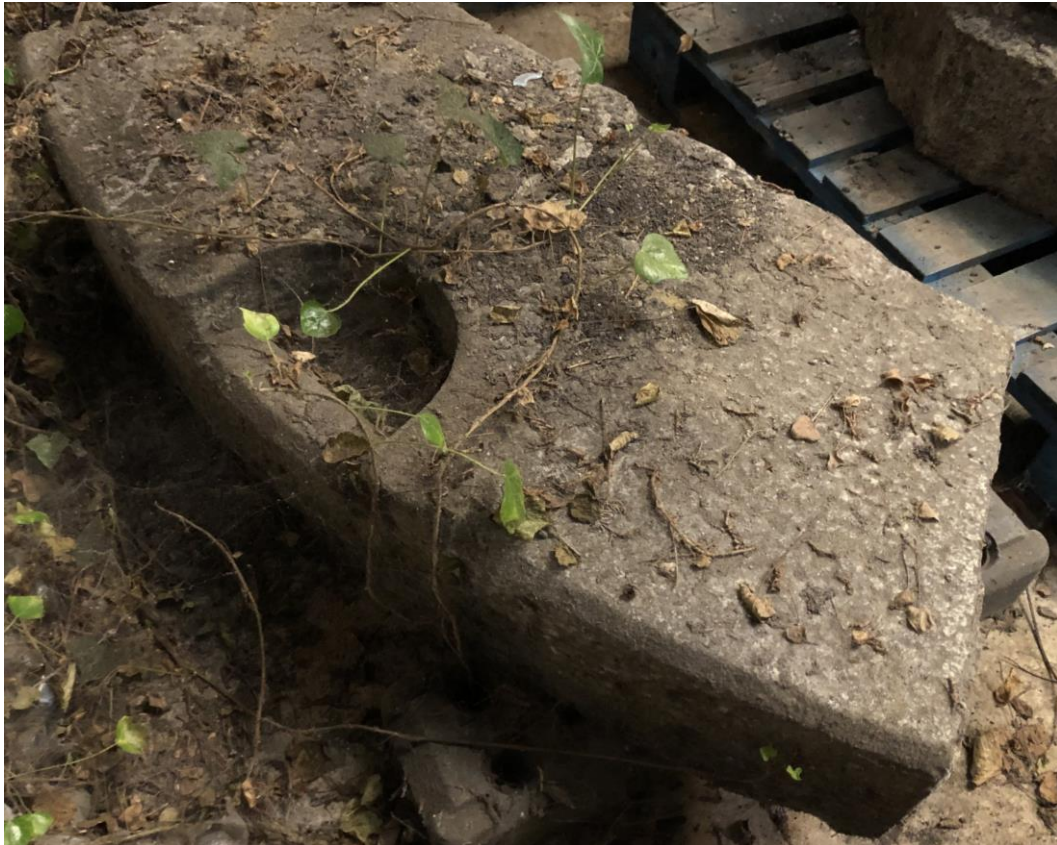
Course A comprises 8 nr stones and would presumably have had a solid (brick) masonry core construction. There are four little bowl-shaped hollows clearly associated with the water. The footprint is circular, with a diameter of 3.55m, and the height of this course being 225mm.

*Plate 3: one of the Course A stones, showing one of the four little bowls or cup hollows. I don't fully understand how these function.*

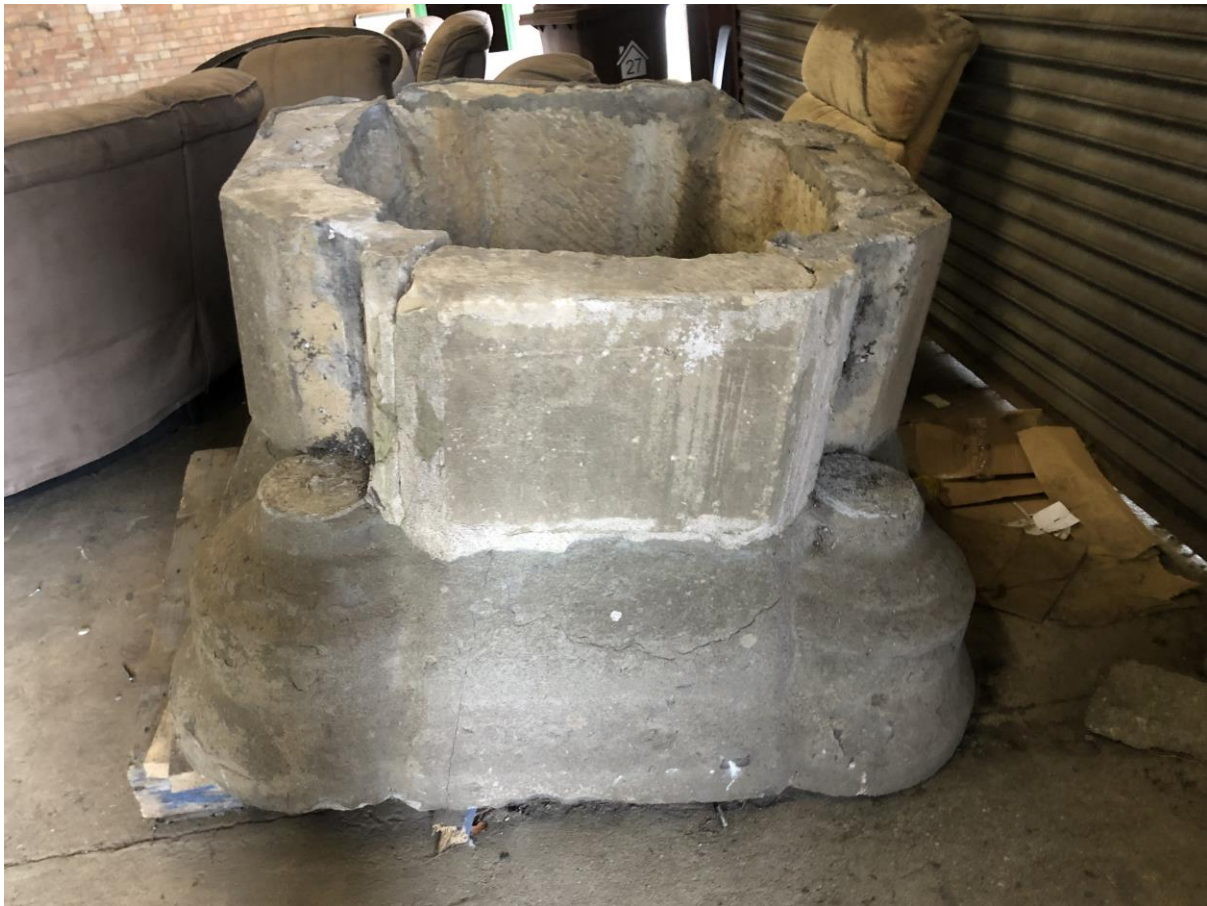
*Plate 4: Courses C and D, still together, showing the hollow construction, and the separate panel on Course D.*

Courses C and D are both on P18 except for the column shafts which are on P7. P18 has collapsed under the weight. The Course C stone, which is an unidentified grey sandstone not used elsewhere on the fountain, is in quite poor condition with a

spalling and disaggregating surface. There is a crack, probably going all the way through, on one side, perhaps a stress fracture from when the pallet collapsed. The two courses, and the 'door' on course D, are cemented together. Course D is potentially very weak at the corners of the octagon due to the thinning of the stone where there are hollows for the columns, and with the separate access stone. It is generally okay but is very dirty, and on one side a weak bed in the stone has started to weather. This last is not actually much of a problem but more a matter of note. There is lots of cement around the access stone.

Course C, where cracked, could benefit from having a stitch or cramps inserted into its rear. These should be of 316 grade stainless steel set into Hilti HY resin, size and shape to be determined. I would move the stones into a better working space before doing this.

Course C could be re-used as it is, accepting the weathering. Indeed, to separate it from course D could cause more damage to both courses. Given that we are looking at a weathered surface to start with then realistically I suggest just brushing off loose material. In conjunction with this some carefully matched lime mortar weathering

fillets along exposed edges of larger but relatively stable delaminations might help prevent water penetration and slow down further weathering.

Courses C and D on P18 are at great risk of damage from careless (or even careful) handling and will need carefully bracing and strapping before any attempt is made to move them.

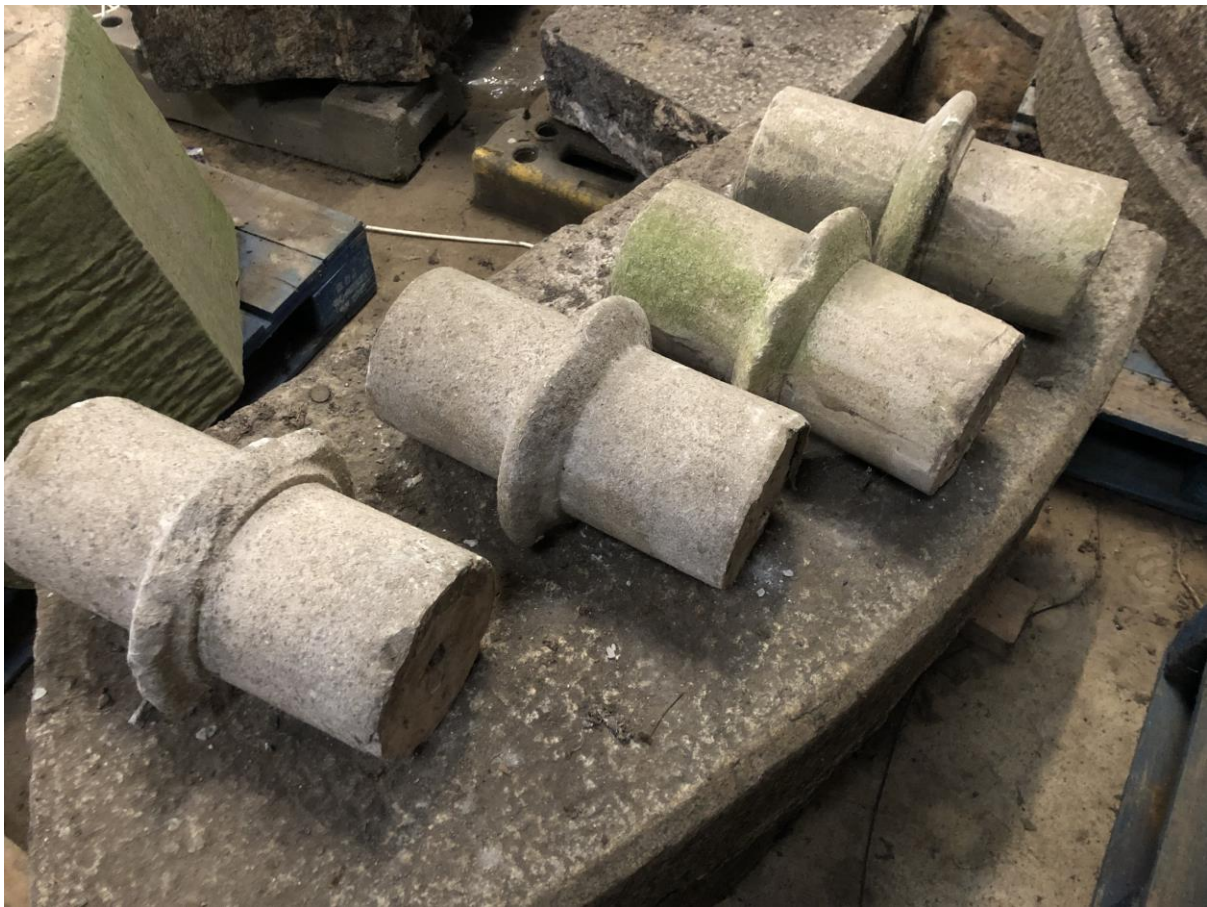
The column shafts are dirty, chipped in places, and have lots of residual cement mortar.

*Plate 5: The Portland limestone column shafts.*

The old slate pins in the little column shafts (course D) could be replaced using 316 grade stainless steel.

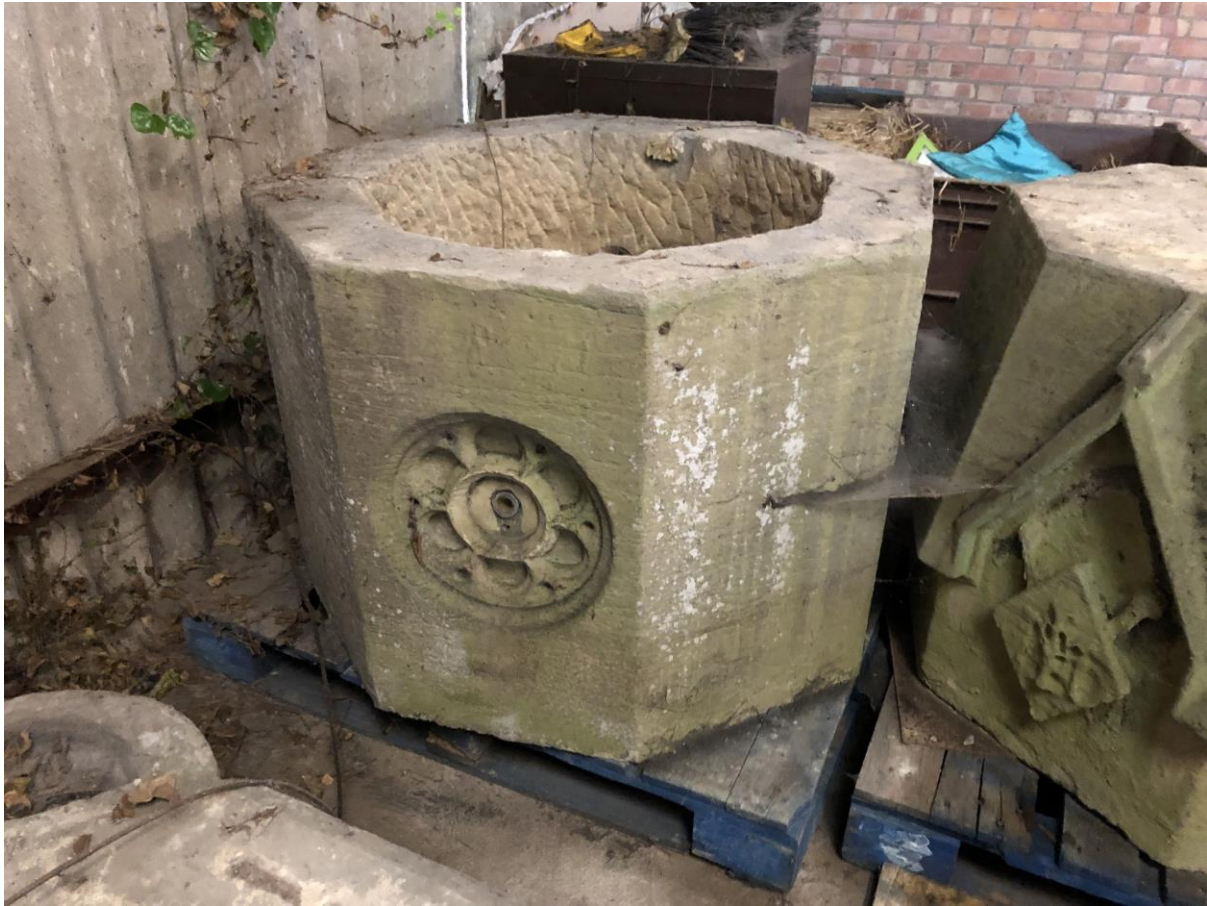
Course F is on P4. It looks weathered but is structurally sound. It is moderately dirty.

*Plate 6: Courses F and, partly visible to the right, H.*

Course H is on P8. It looks weathered but is structurally sound. It is moderately dirty.

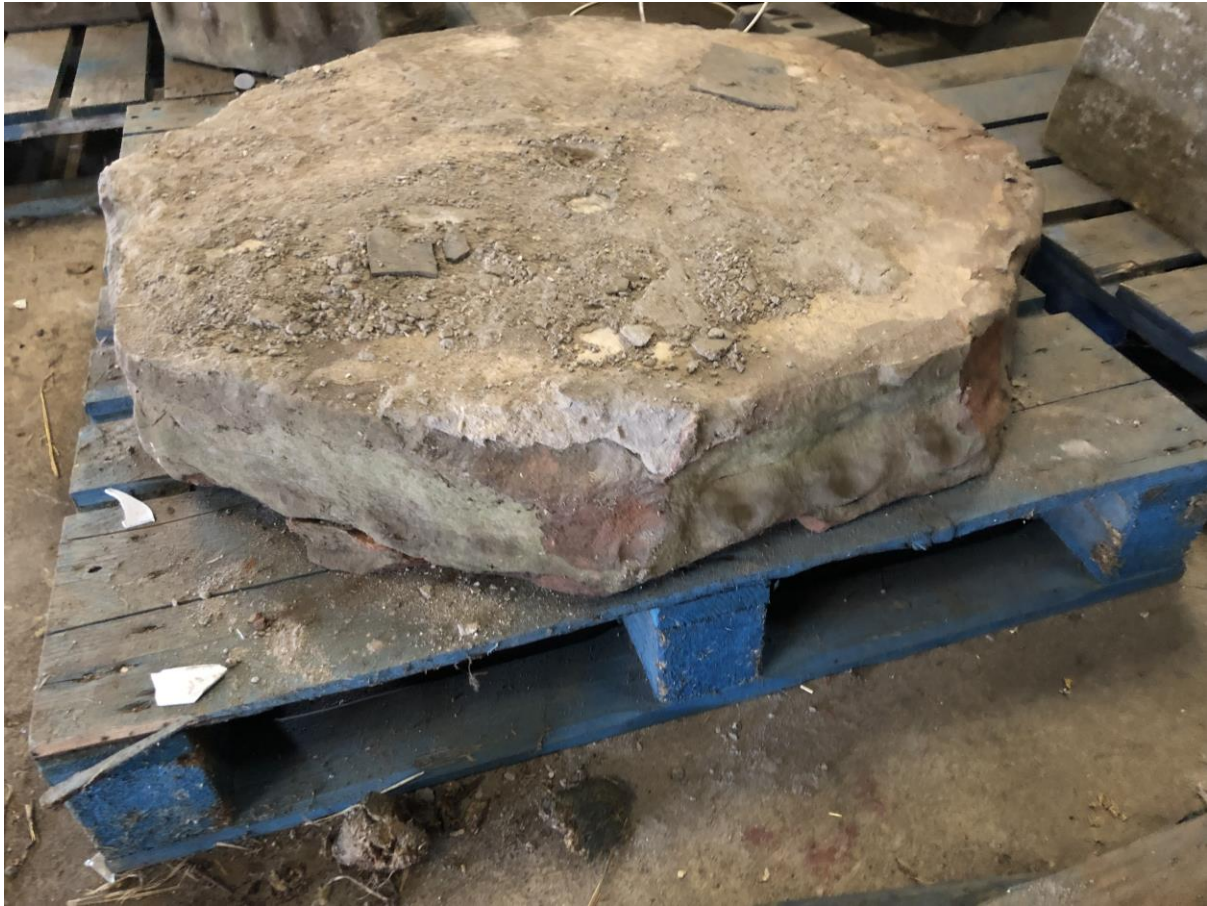
Course I is on P15. It is in very poor condition with the outer, exposed surface breaking up badly due to both disaggregation and delamination. In fact the roundels are really only clearly visible on one of eight faces. There are also some spalls to the underside, perhaps due to handling damage as this is such a fragile piece of stone. However, it probably remains structurally functional – but only just. See plate 7 on the next page.

*Plate 7: Course I.*

Where stones survive I have generally taken the view that if they are able to perform their job structurally then they are okay to re-use. The stone forming course I is however a candidate for potential replacement. It is so weathered that the detail is barely discernible, and it looks to me as if the weathered face may even leave a slight rebate (and water trap) in section between the stones above and below. Weatherings could be made using mortars, but this nonetheless is a strong candidate for a replacement stone.

The red sandstone is typically in poorer condition to the yellow sandstone, and in addition to the measures outlined above I would carry out trials to determine the efficacy of Silex OH (solvent-based silica ester acid consolidant) and Syton X30 (aqueous silica consolidant) to stabilise the disaggregating surfaces. With the Fountain dismantled this can be applied to dry stone, which is preferable for it to be effective.
