**Re: The Square, 4 Church Street, Spalding (Gamlyn Almshouses)**

**Project: Gamlyn Almhouses Spalding**

Requirements: Stonework Report with various areas of the Dressed Masonry of the Gables and internal elevations.

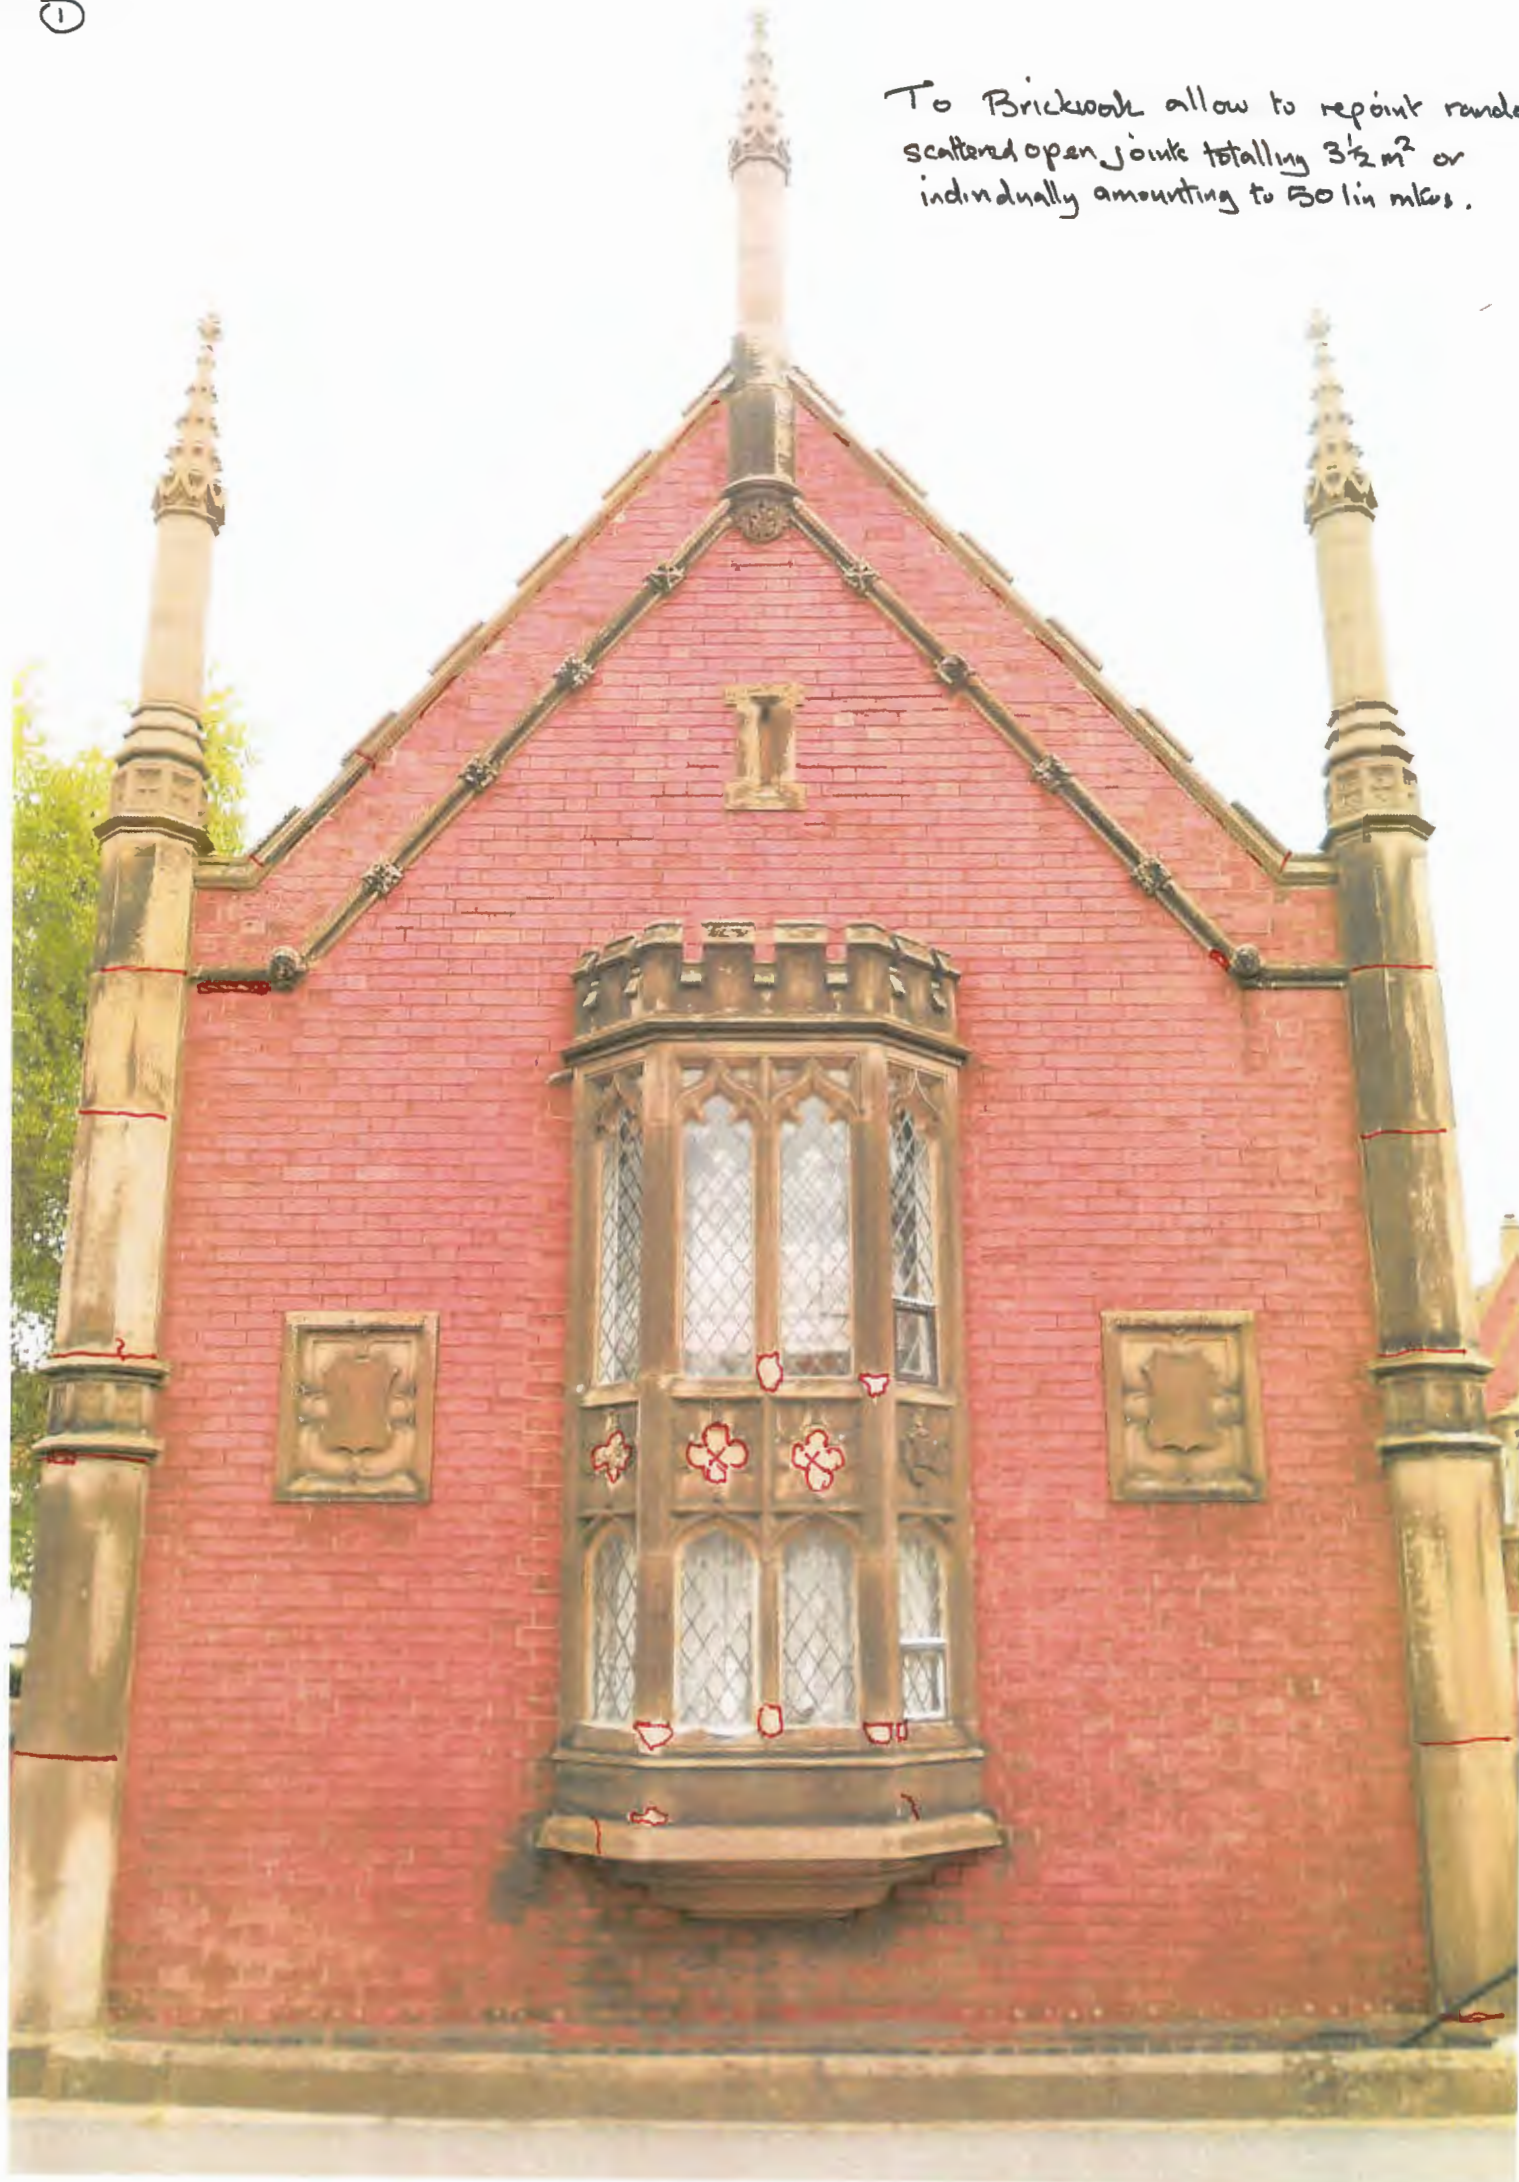
①

To Brickwork allow to repoint random  
scattered open joints totalling  $3\frac{1}{2}m^2$  or  
individually amounting to 50 lin mks.

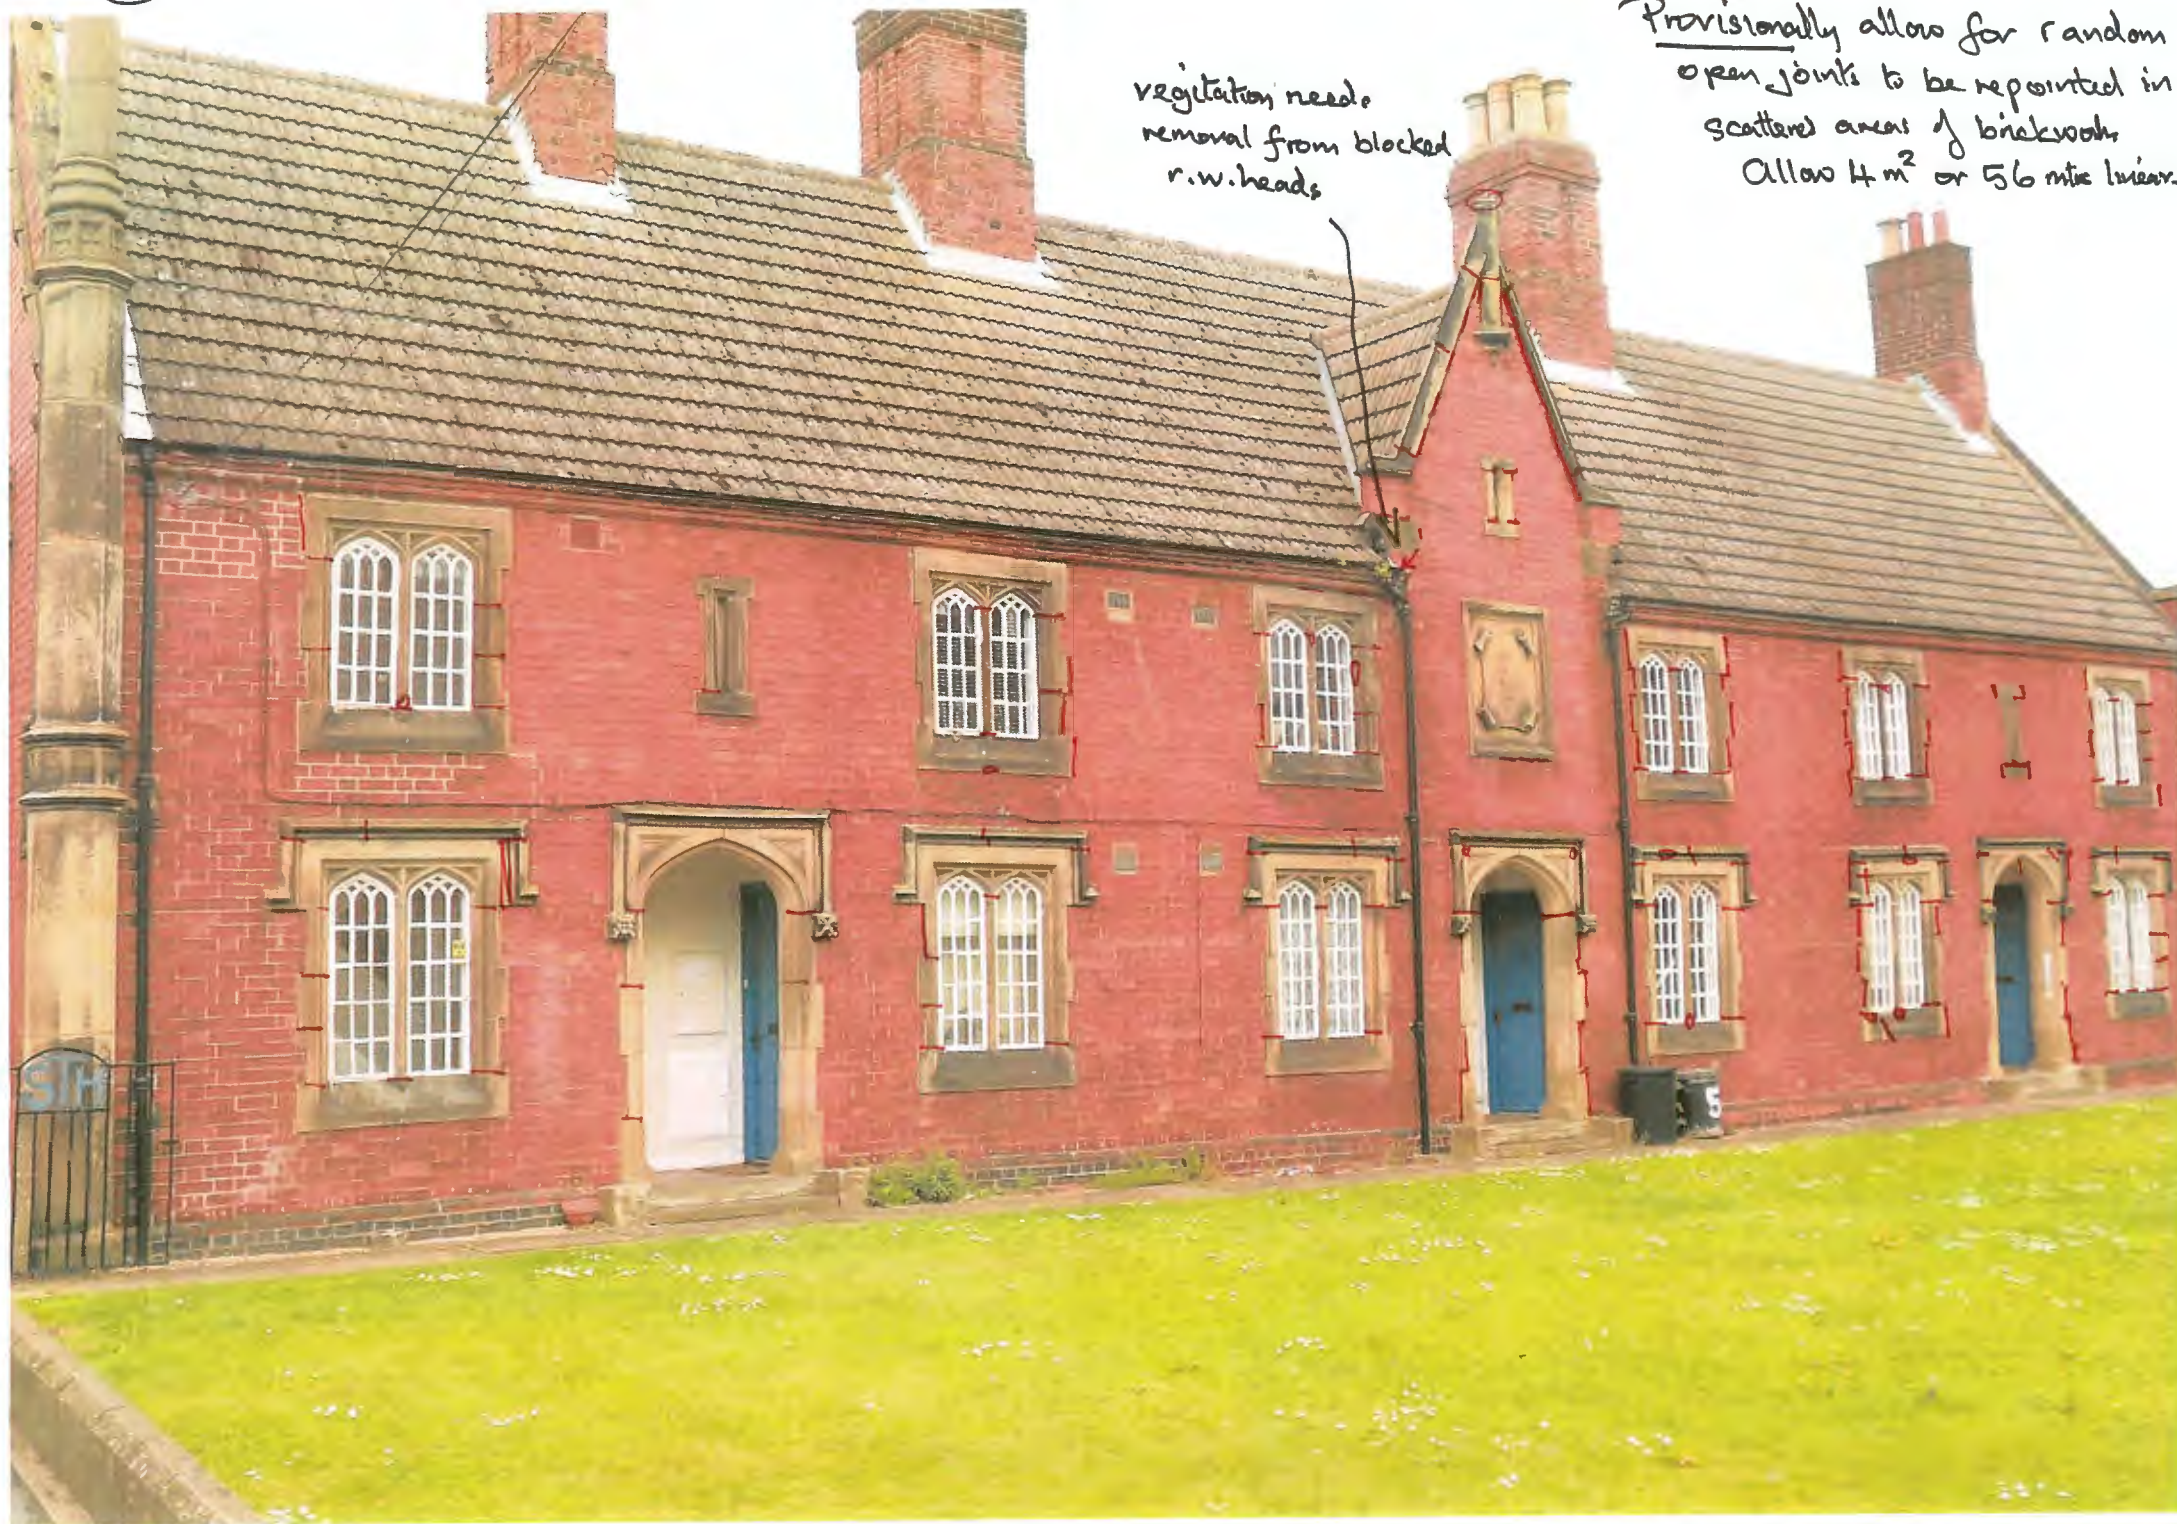
(2)

vegetation needs  
removal from blocked  
r.w. heads

Provisionally allow for random  
open joints to be repointed in  
scattered areas of brickwork  
Allow 4 m<sup>2</sup> or 56 m<sup>2</sup> linear.

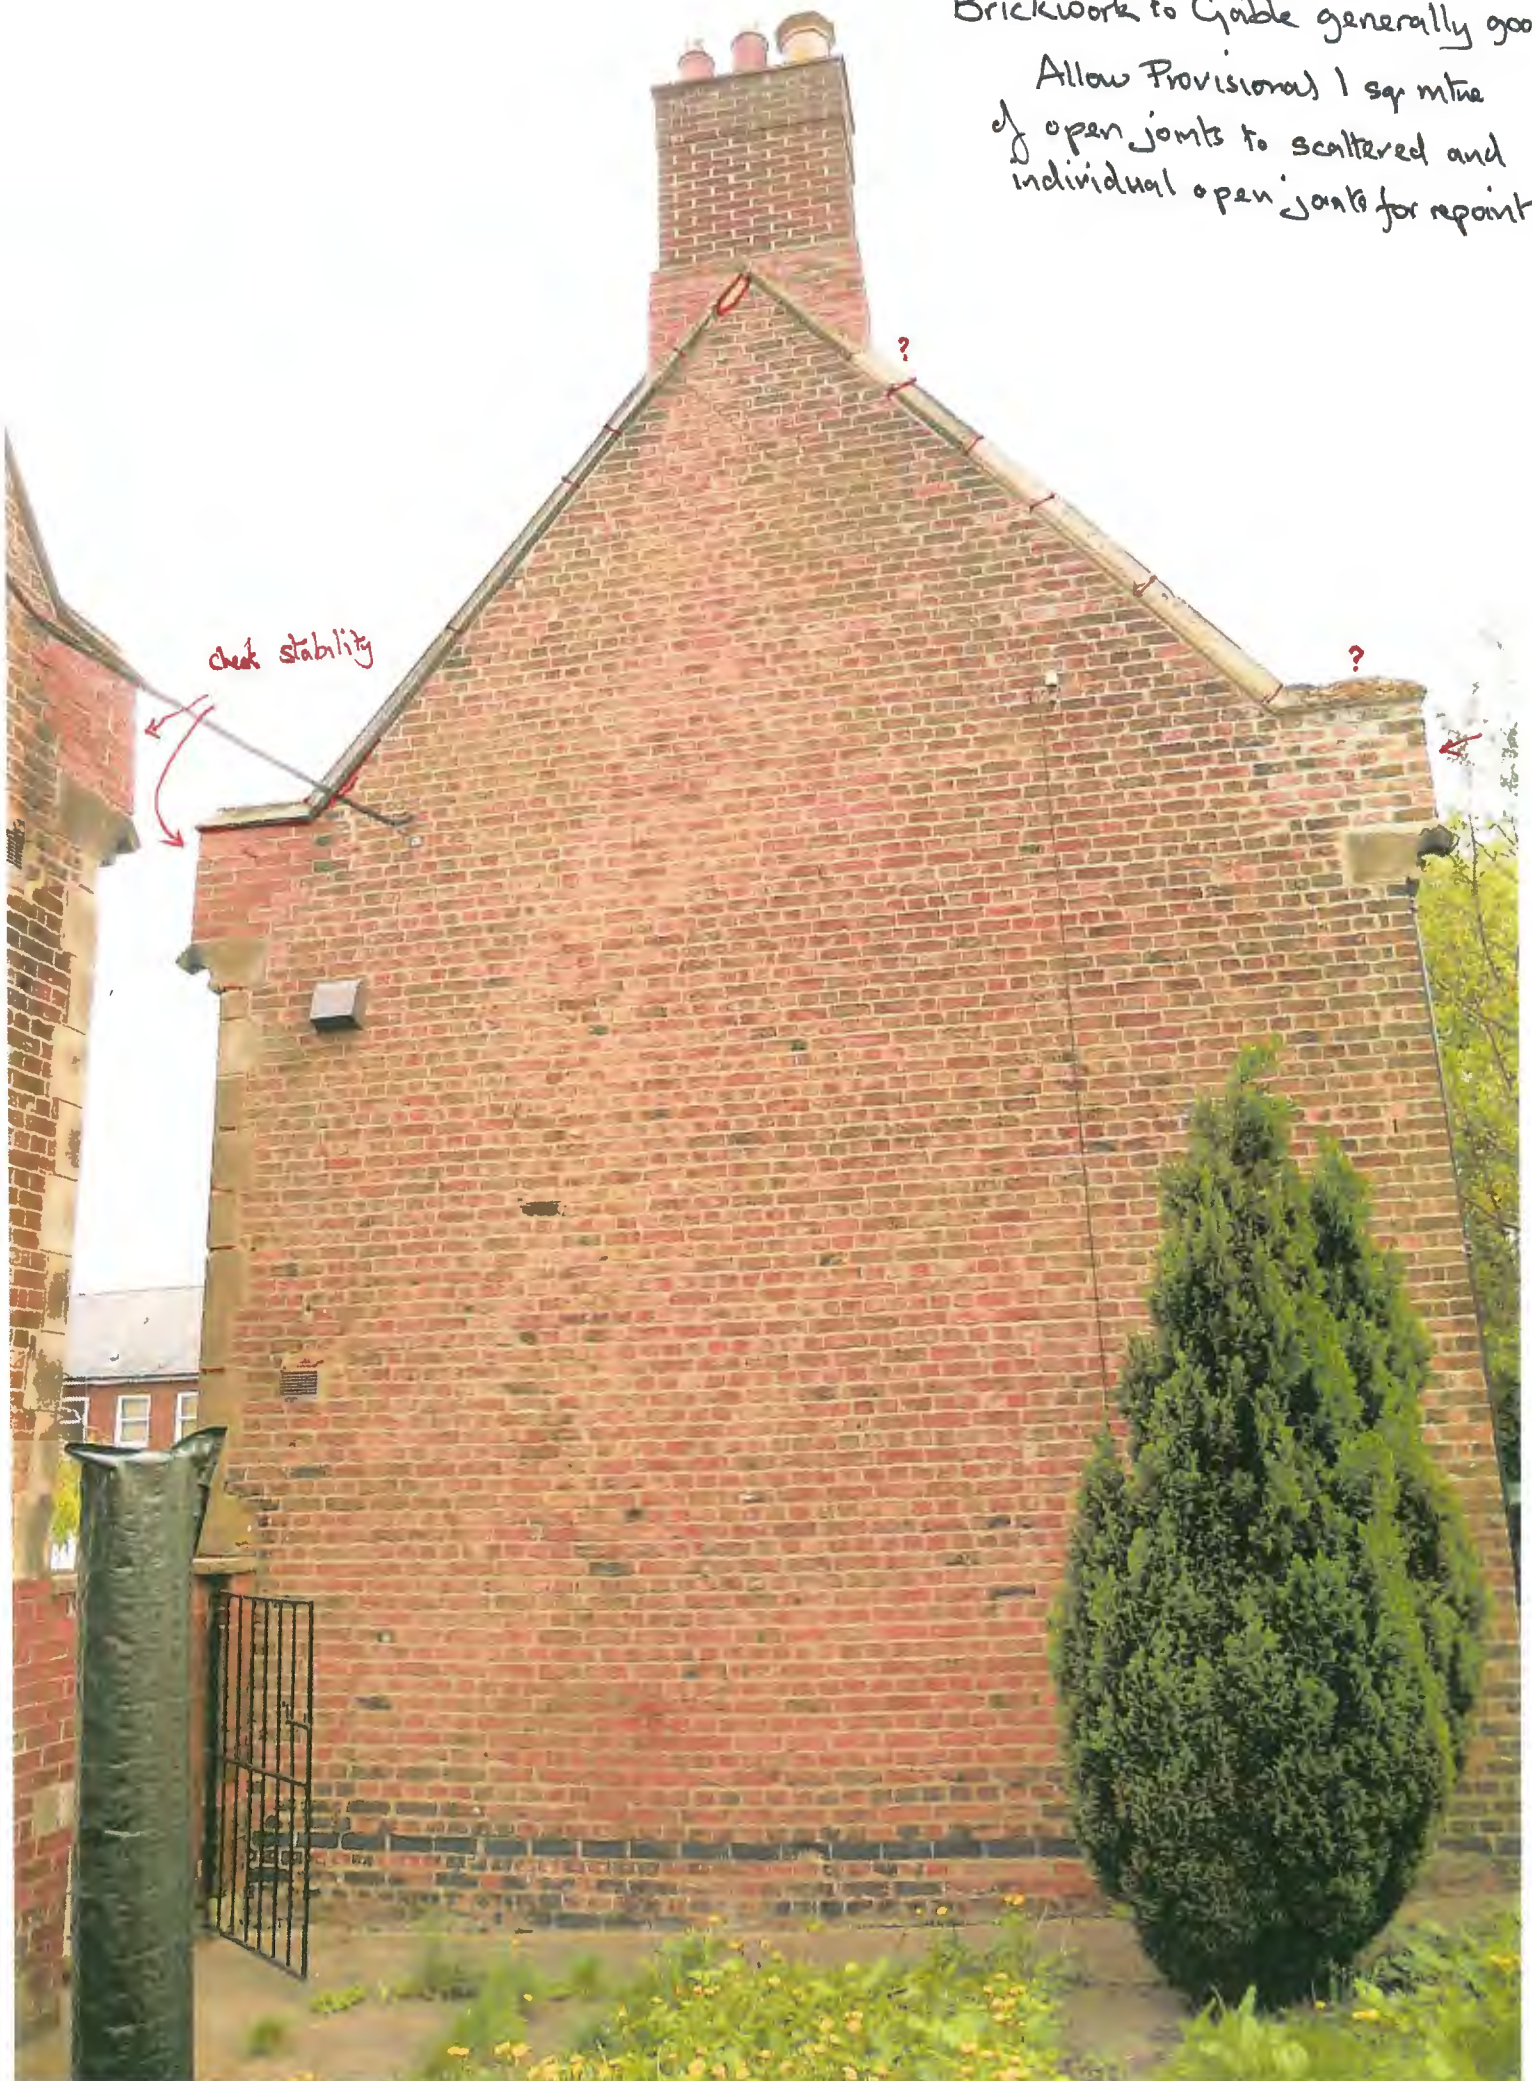
3

Brickwork to Gable generally good  
Allow Provisional 1 sq mtr  
of open joints to scattered and  
individual open joints for repoint.

check stability

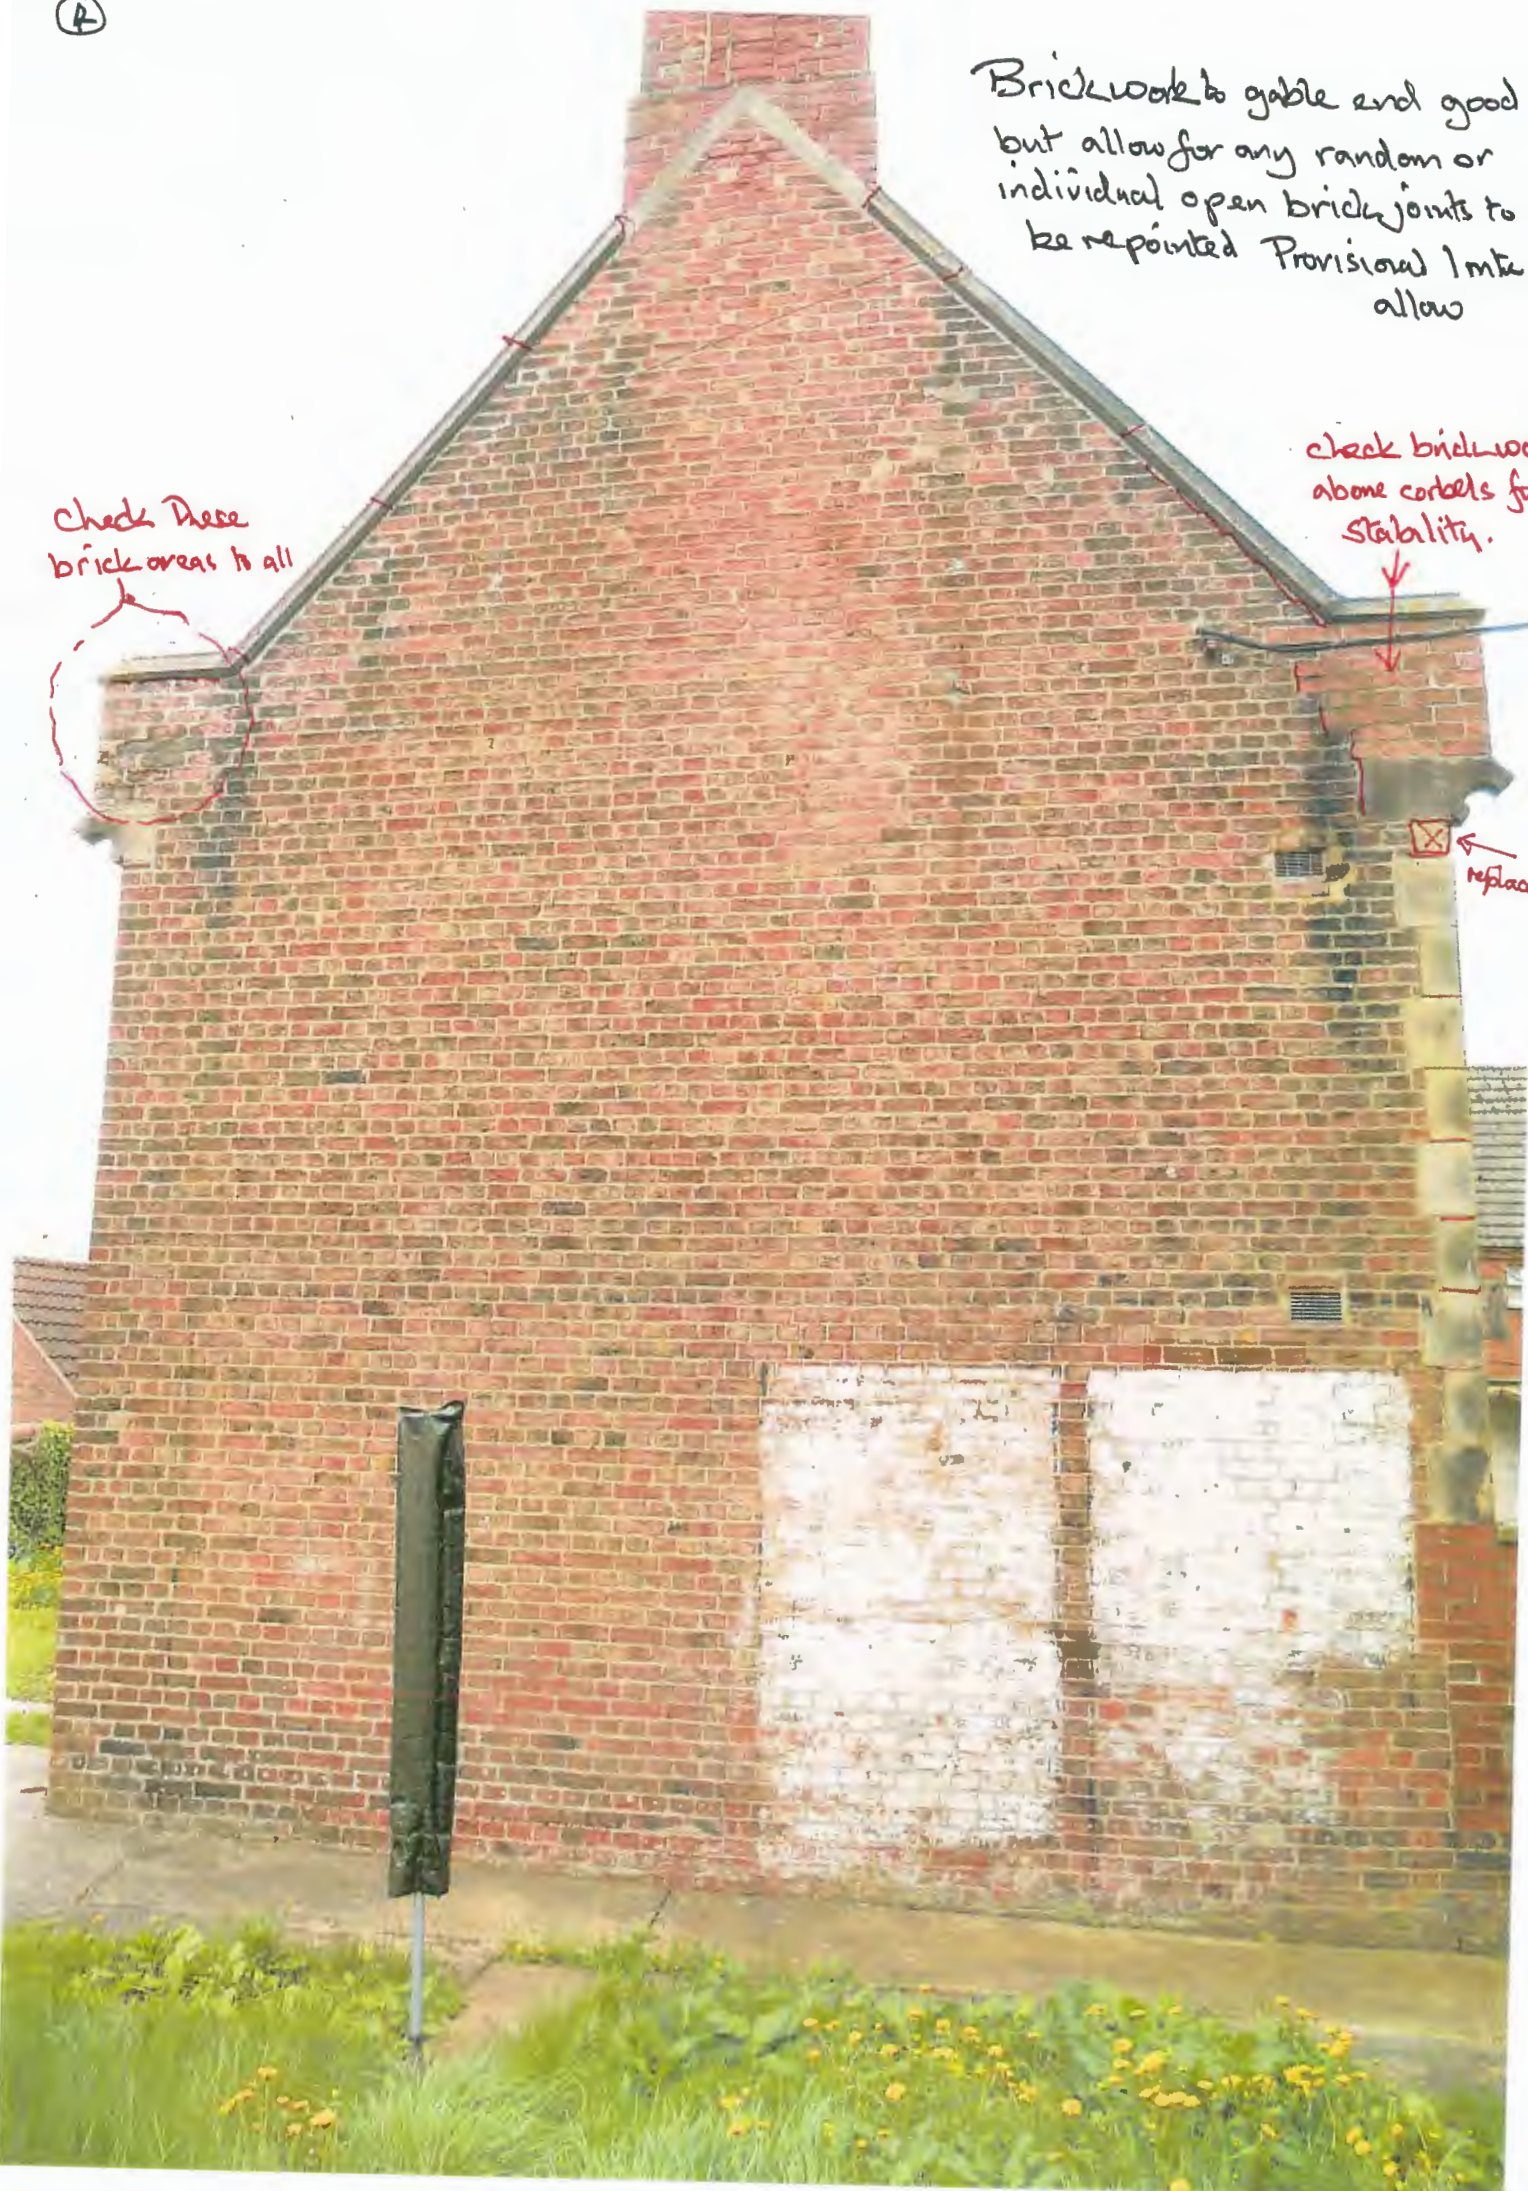
②

Brickwork to gable end good  
but allow for any random or  
individual open brick joints to  
be repointed Provisional Intersay  
allow

check these  
brick areas to all

check brickwork  
above corbels for  
stability.

replace

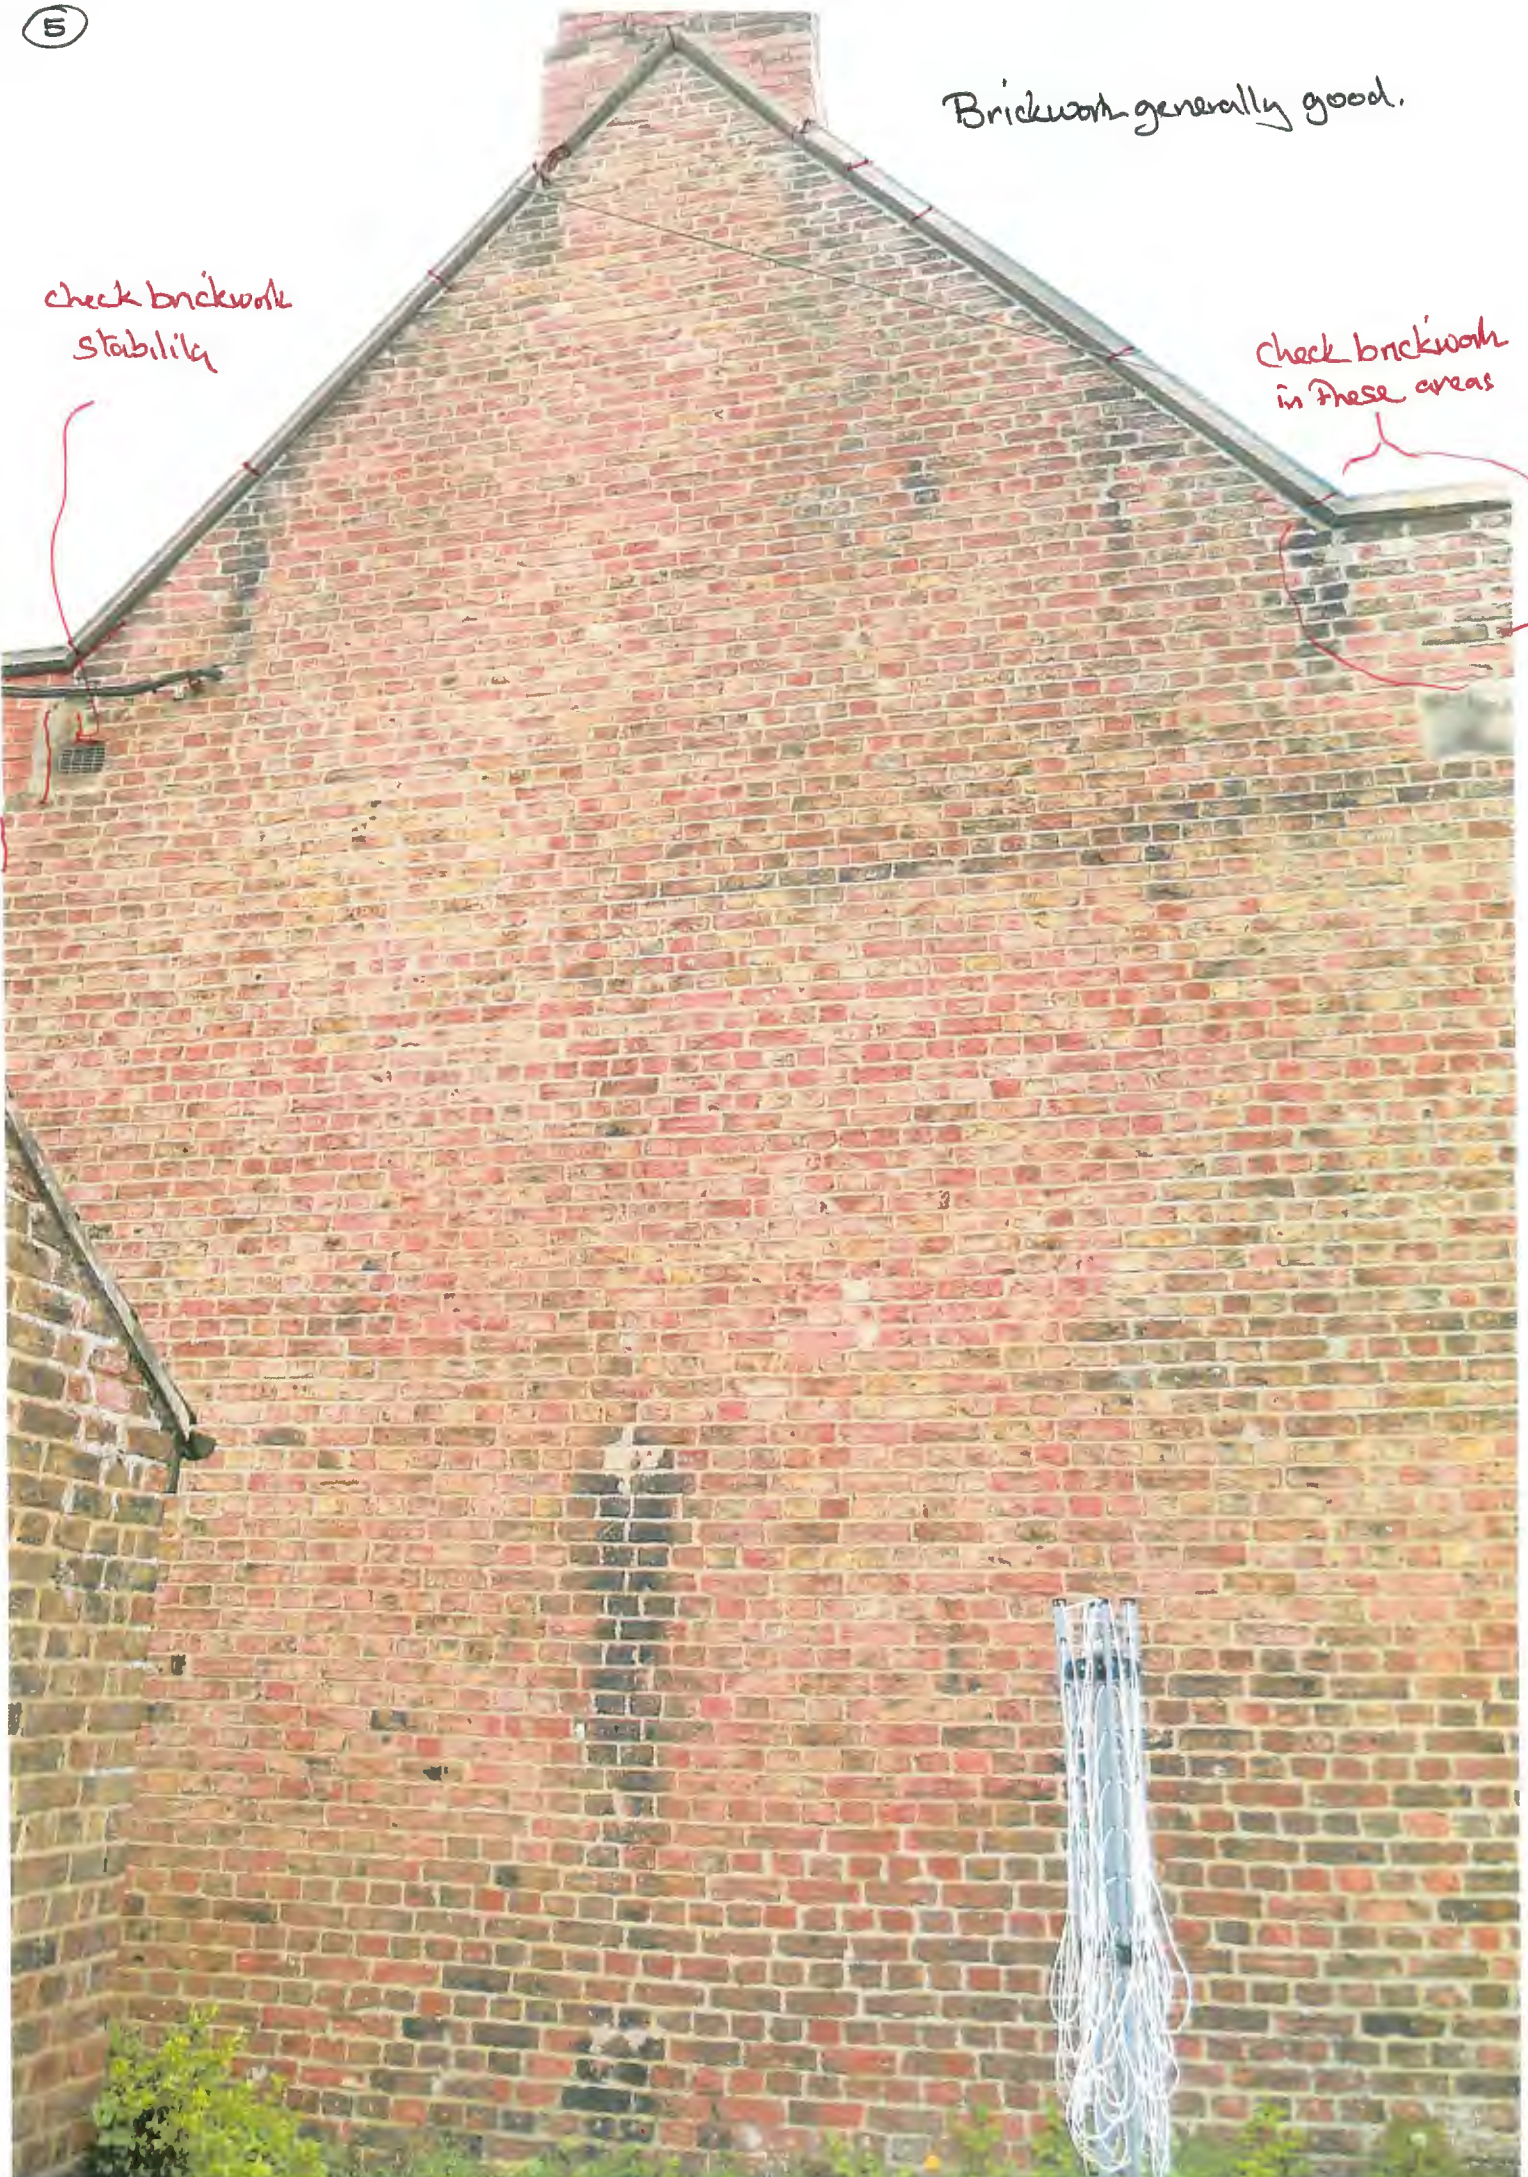
5

Brickwork generally good.

check brickwork  
stability

check brickwork  
in these areas

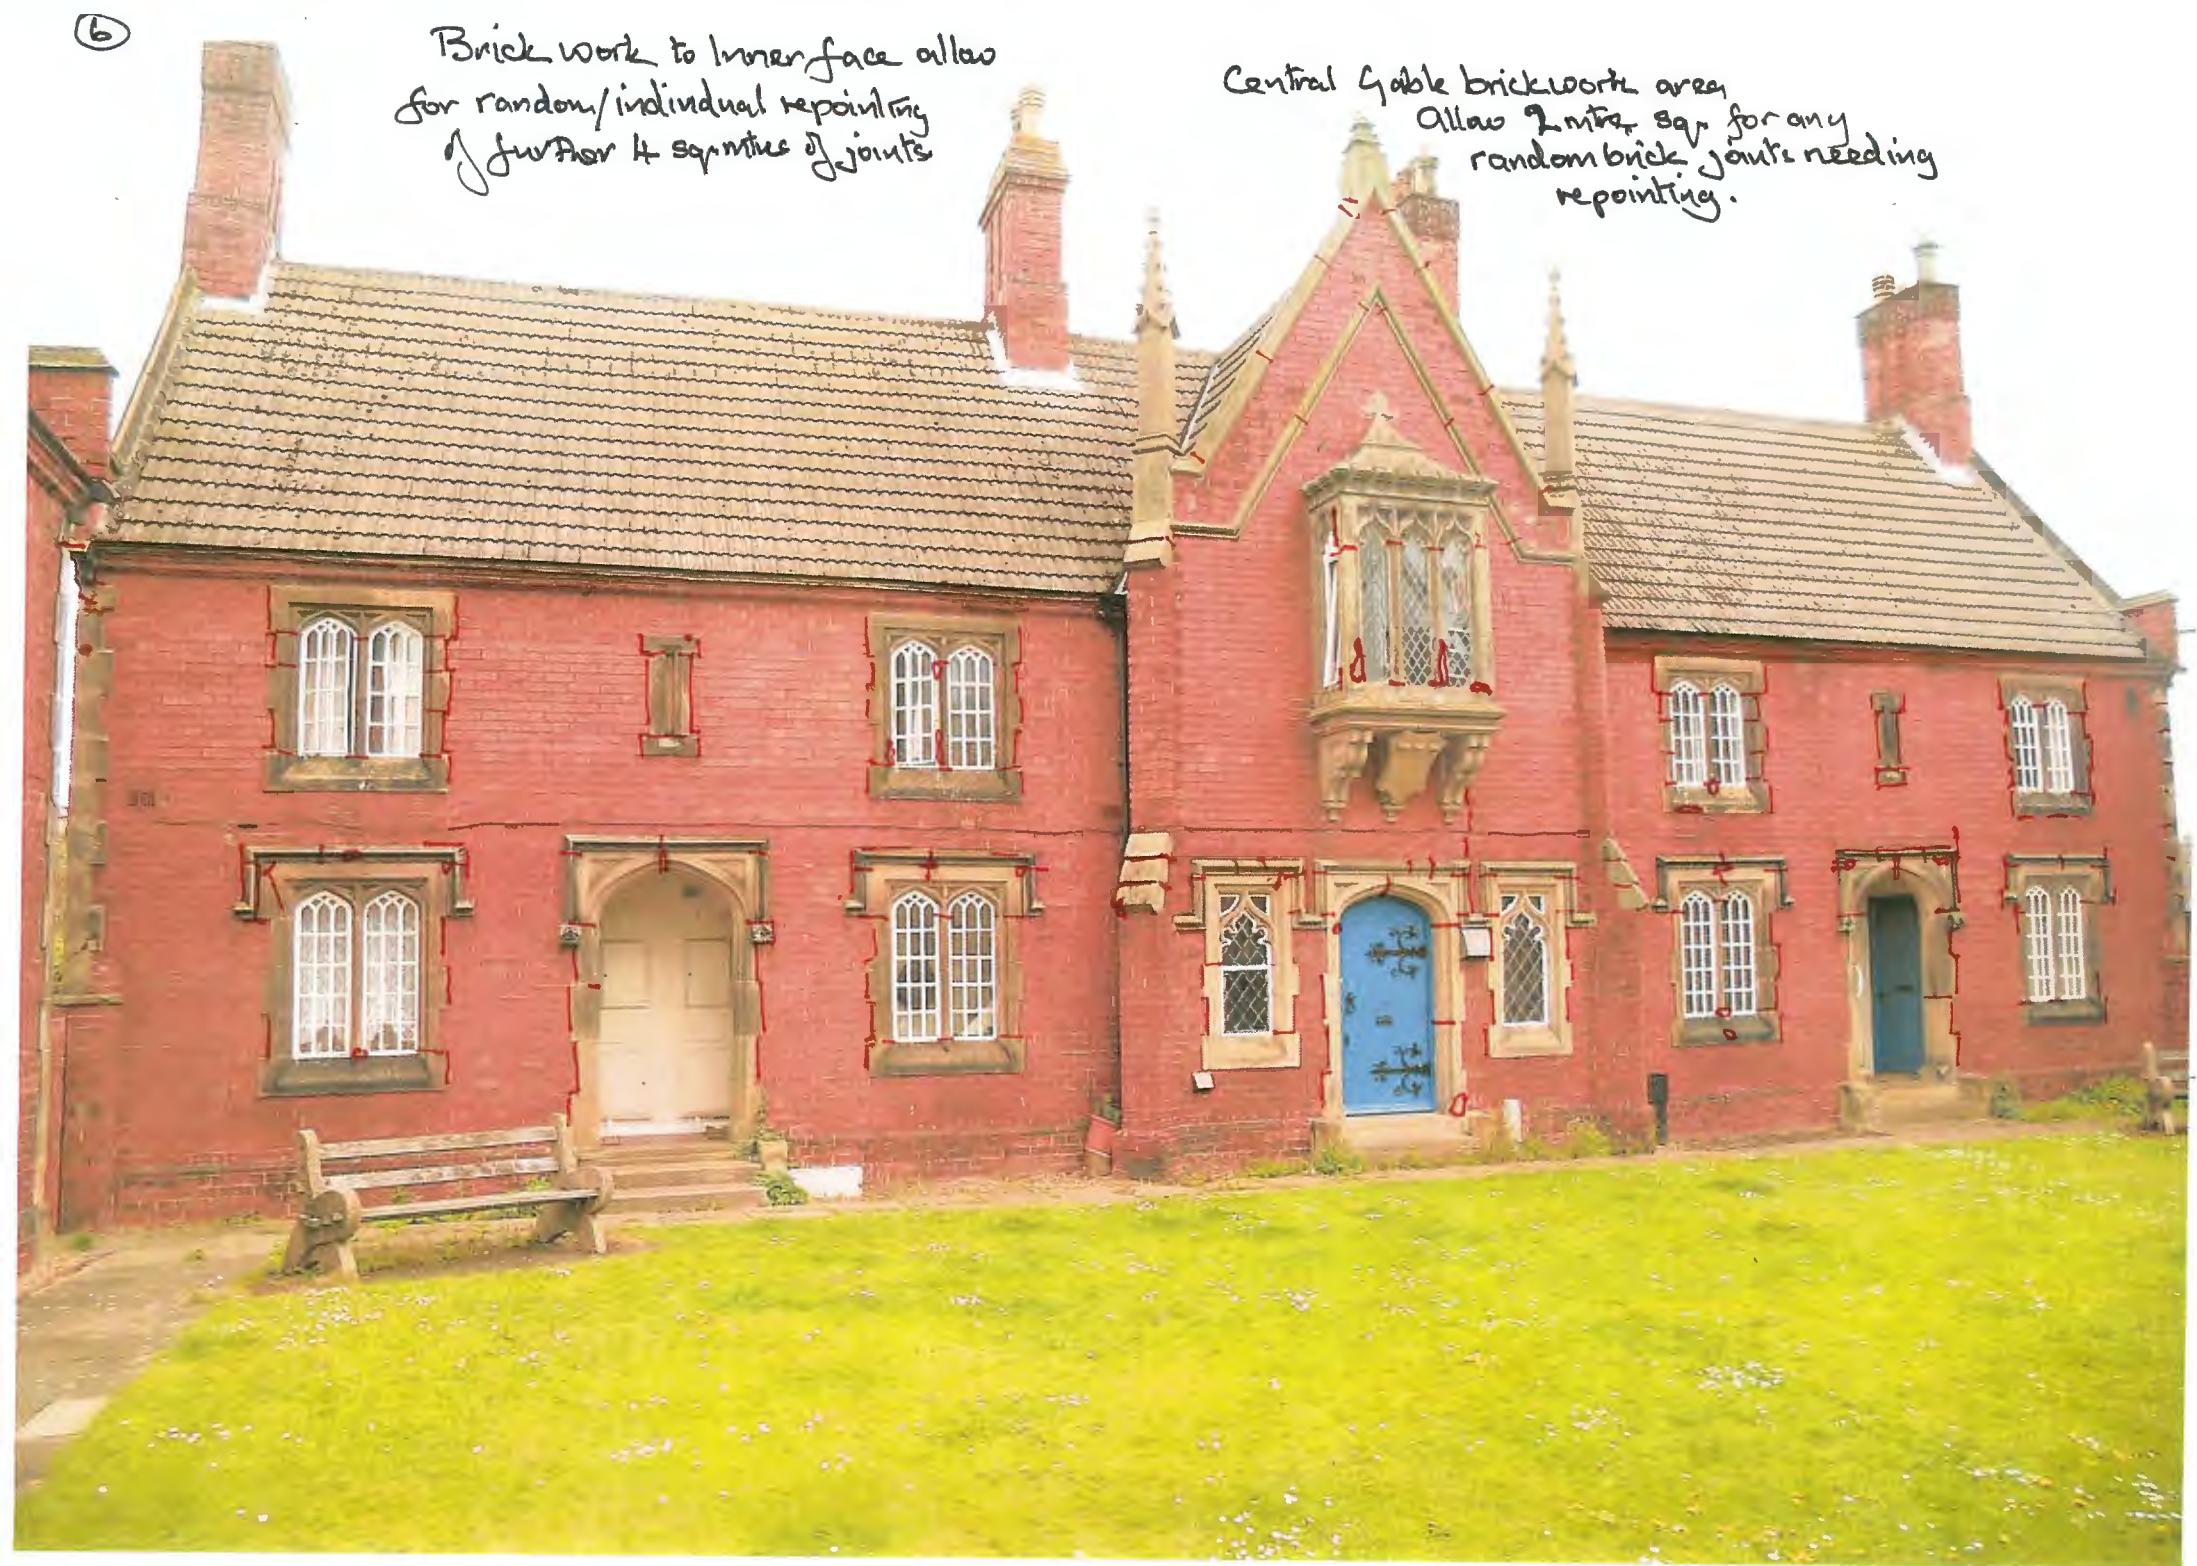
⑥

Brick work to inner face allow  
for random/individual repointing  
of further 4 sqm of joints

Central Gable brickwork area  
Allow 2m<sup>2</sup> sq for any  
random brick joints needing  
repointing.
