**Re: The Square, 4 Church Street, Spalding (Gamlyn Almshouses)**

**Project: Gamlyn Almhouses Spalding**

Requirements: Stonework Report with various areas of the Dressed Masonry of the Gables and internal elevations.

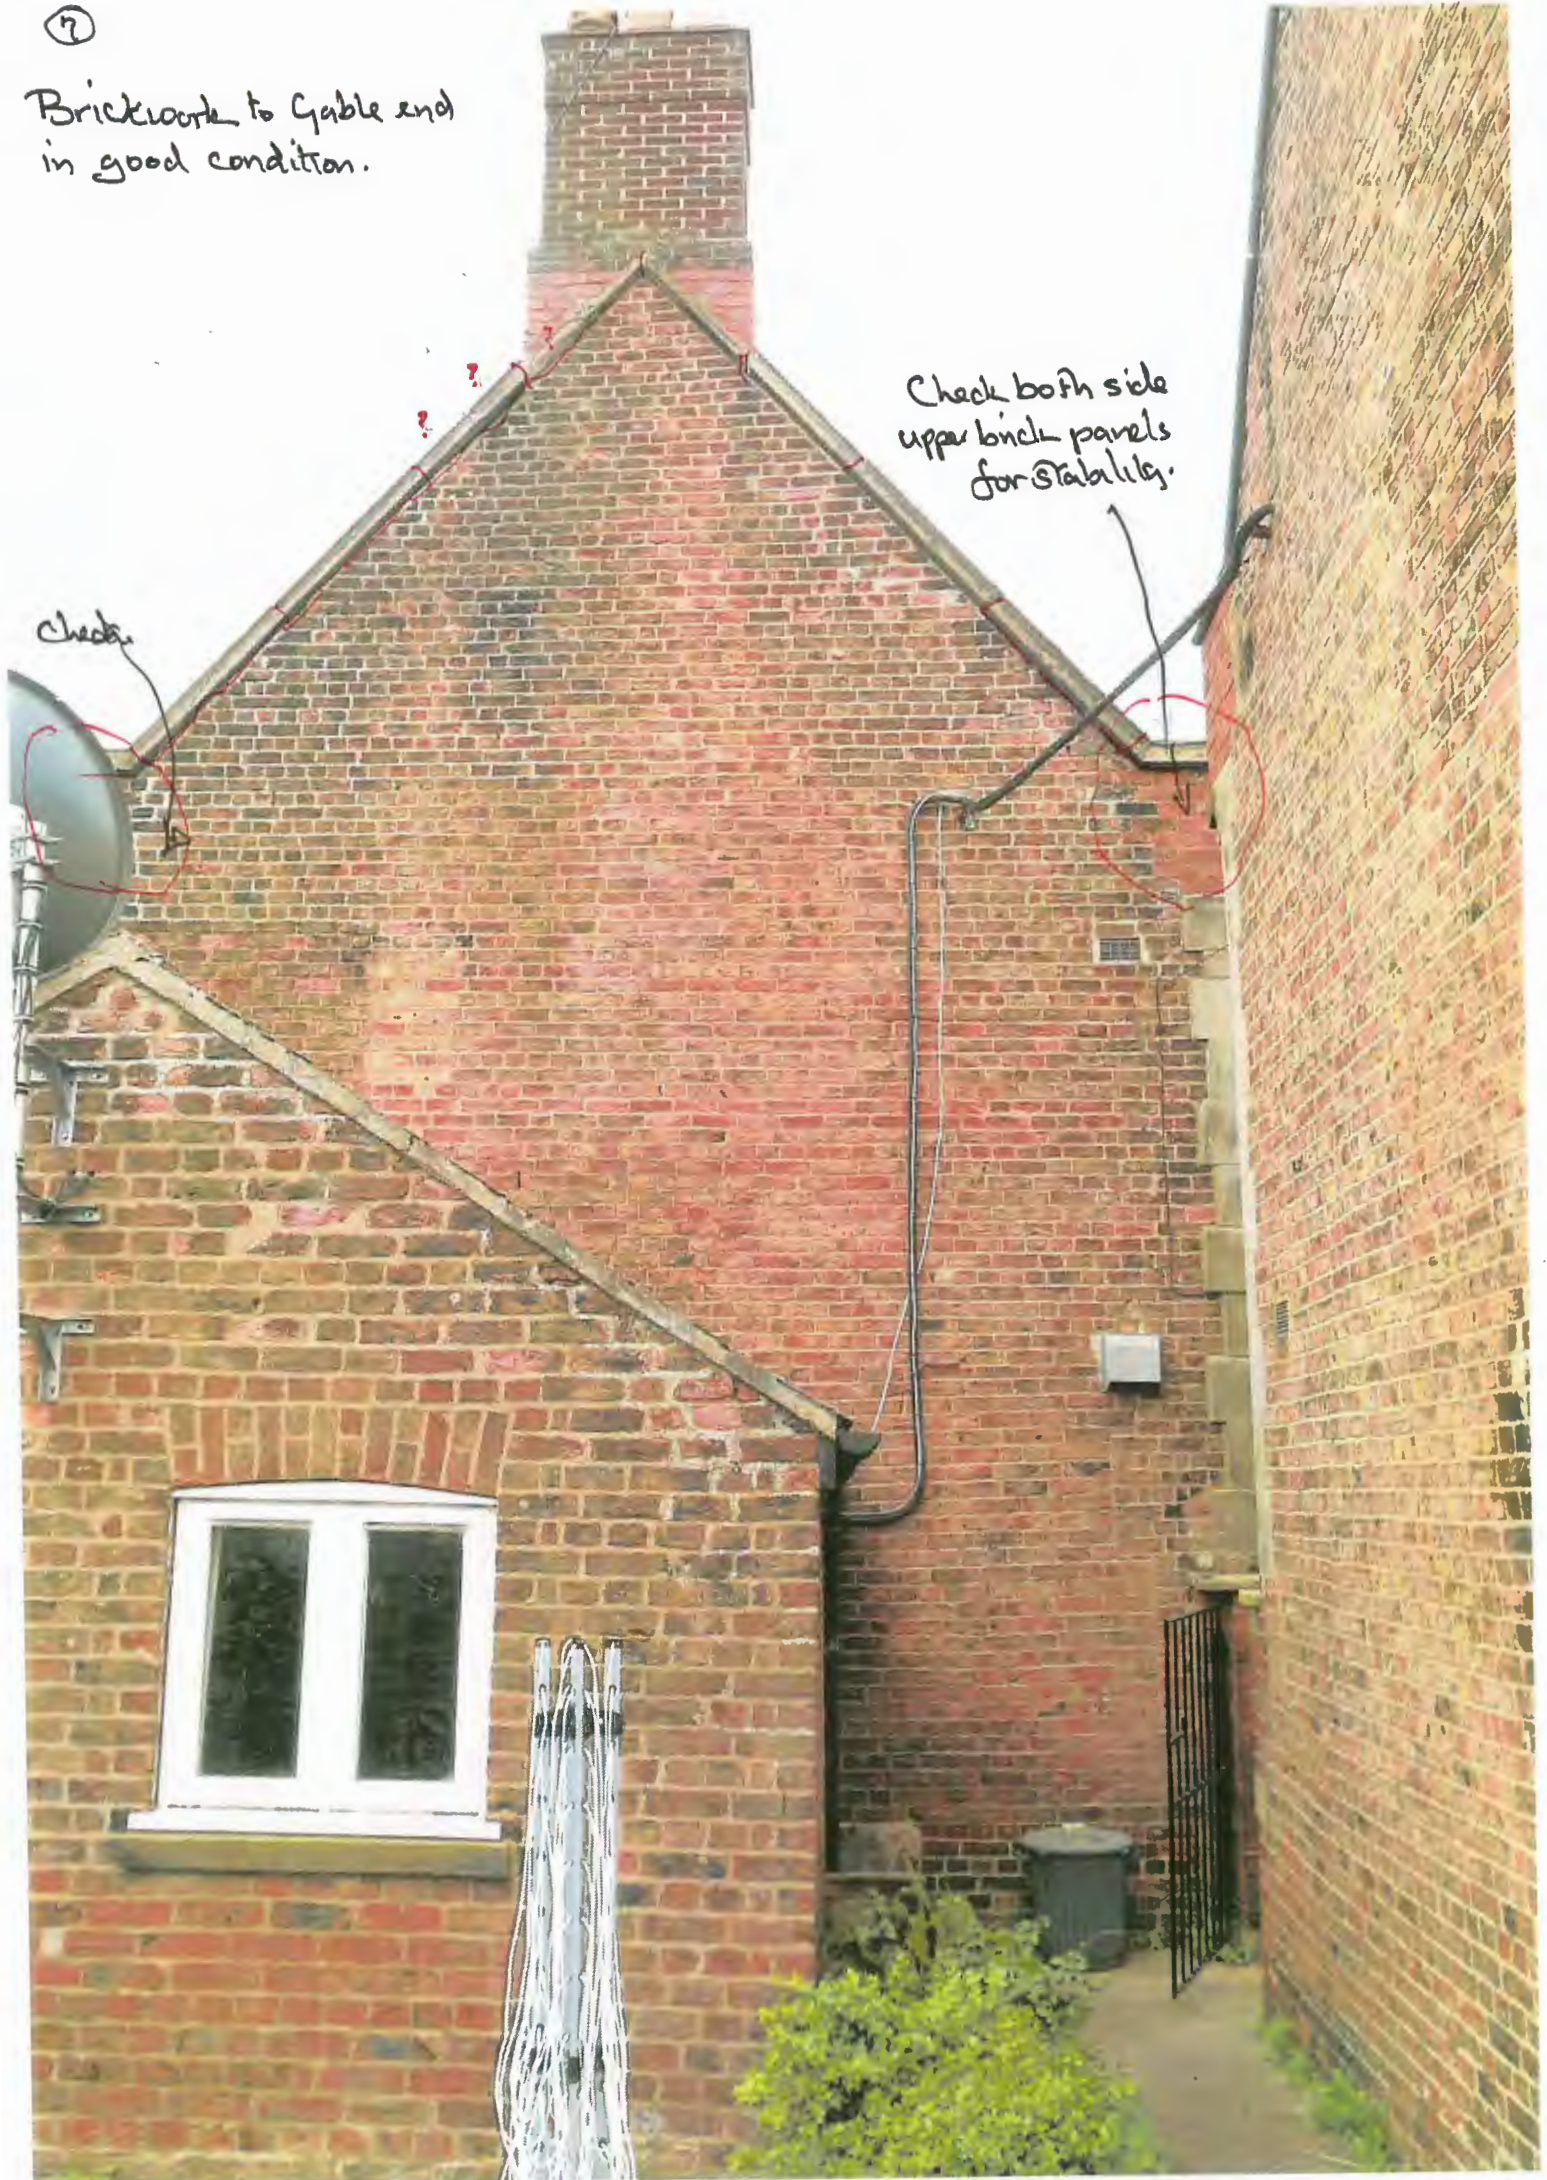
⑦

Brickwork to Gable end  
in good condition.

Check both side  
upper brick panels  
for stability.

check

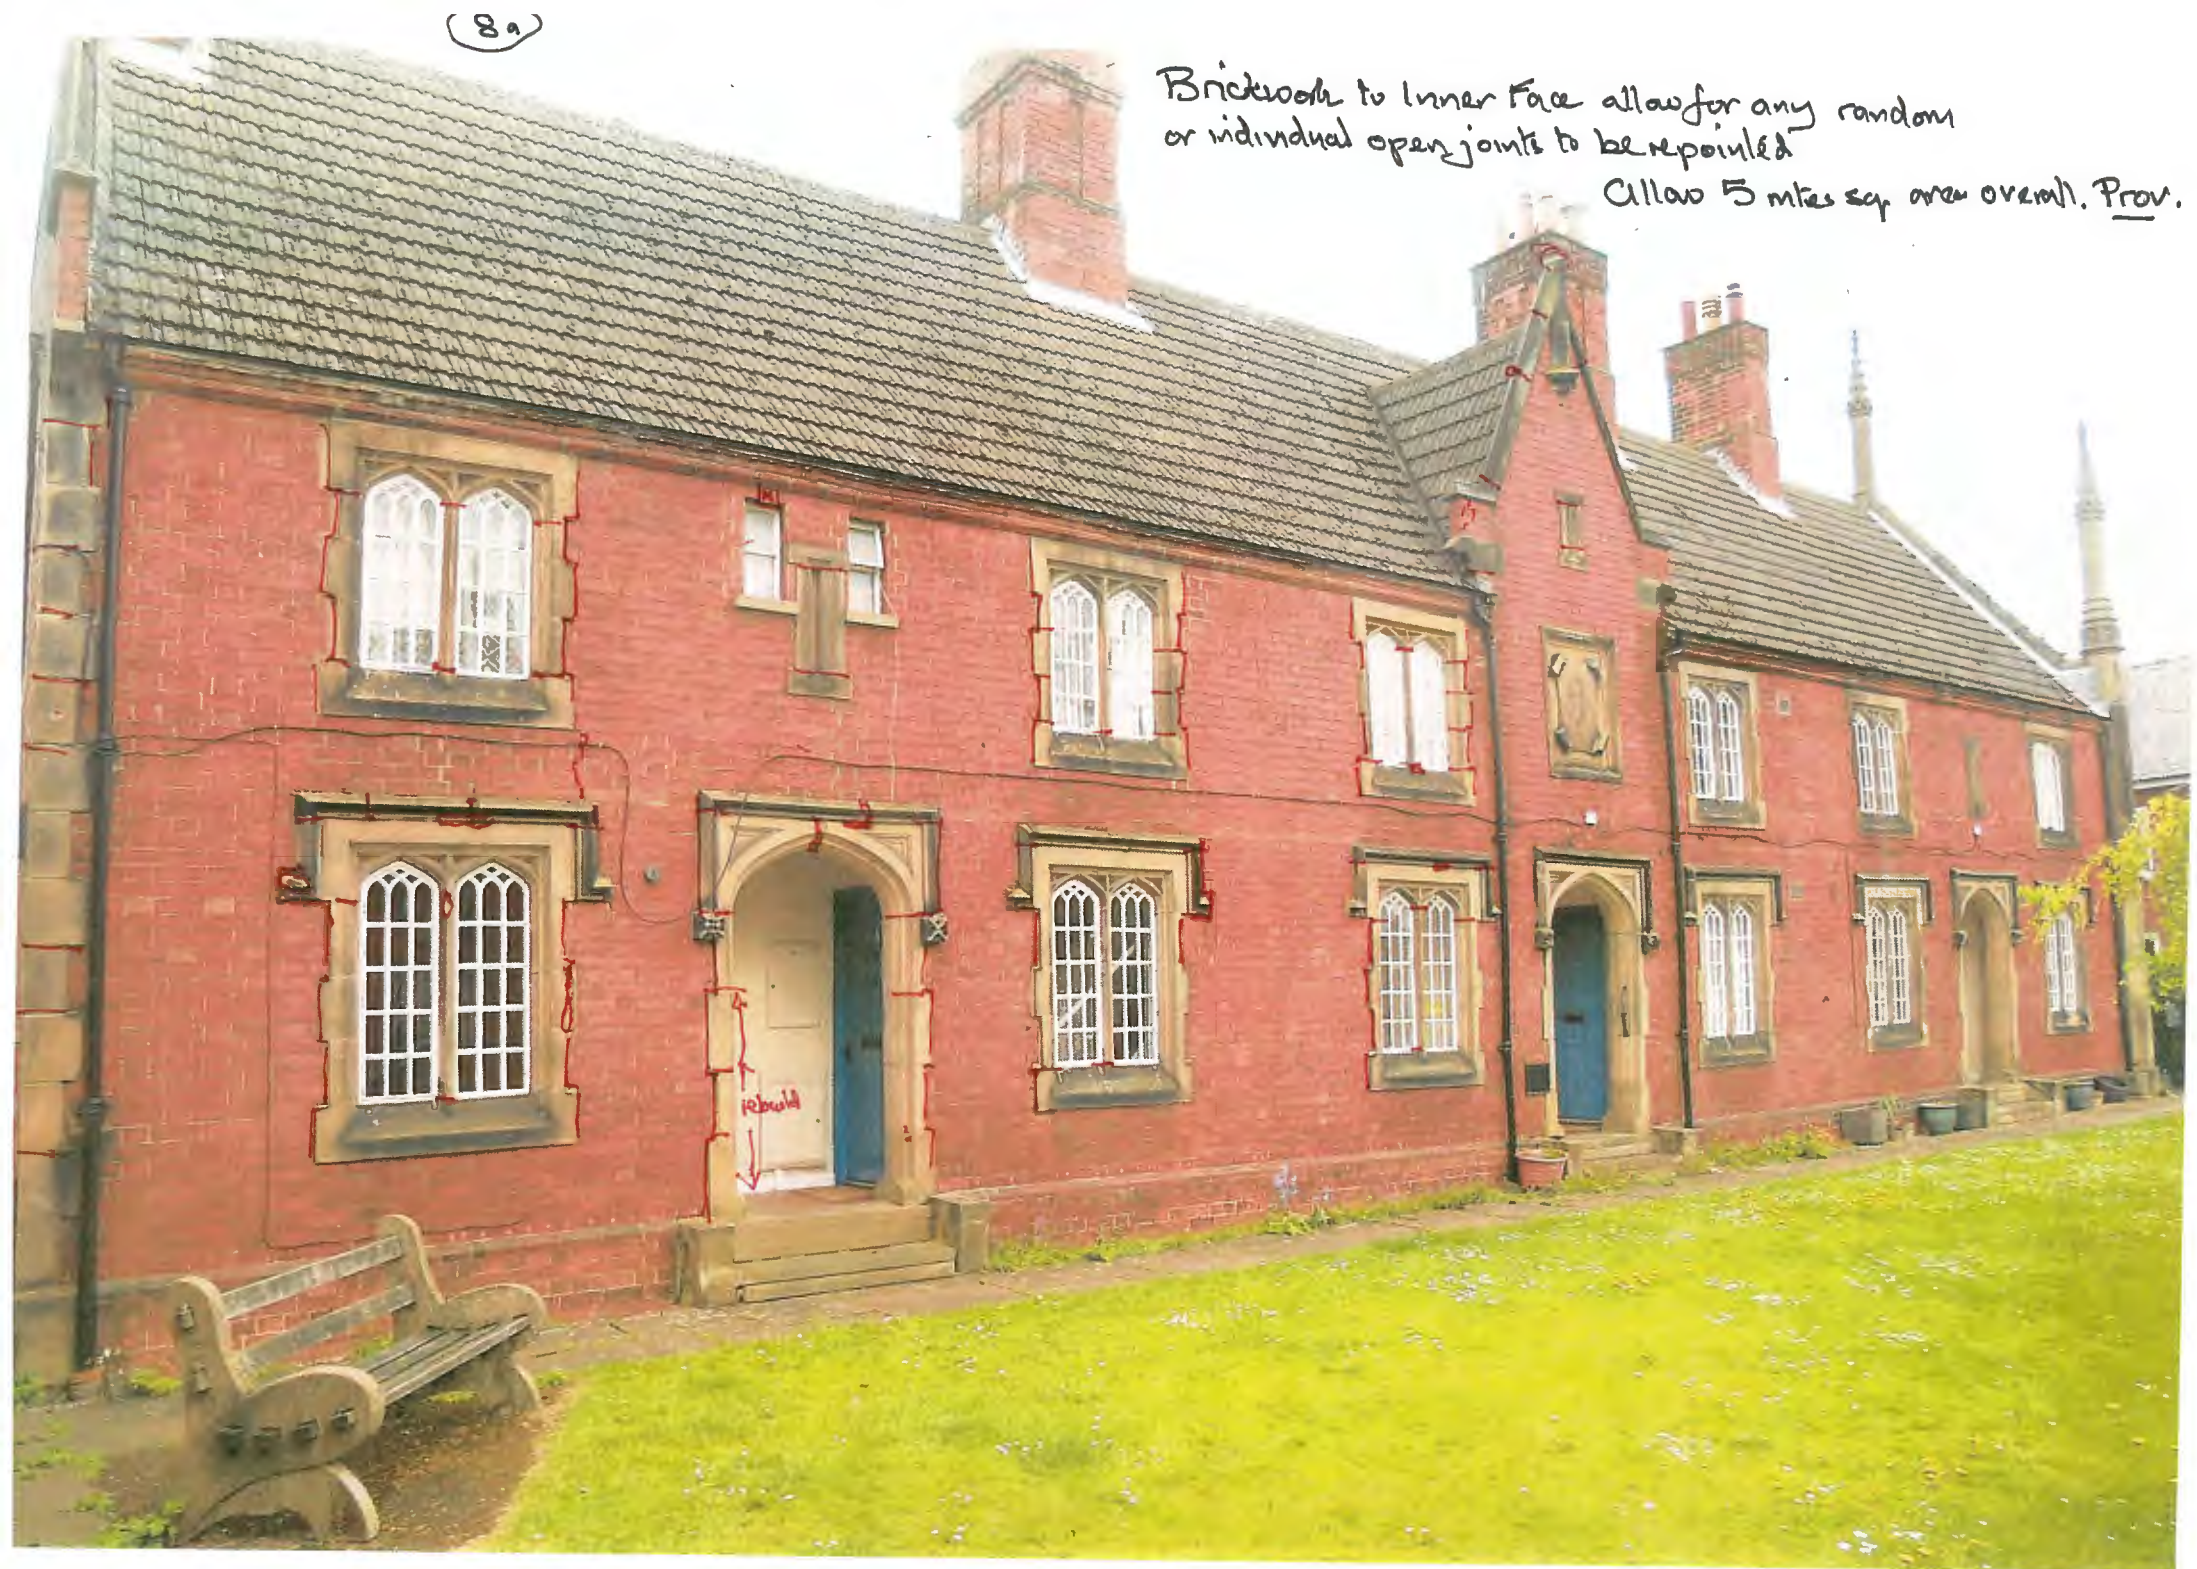
(8a)

Brickwork to inner face allow for any random  
or individual open joints to be repointed  
Allow 5 mts sq over overml. Prov.

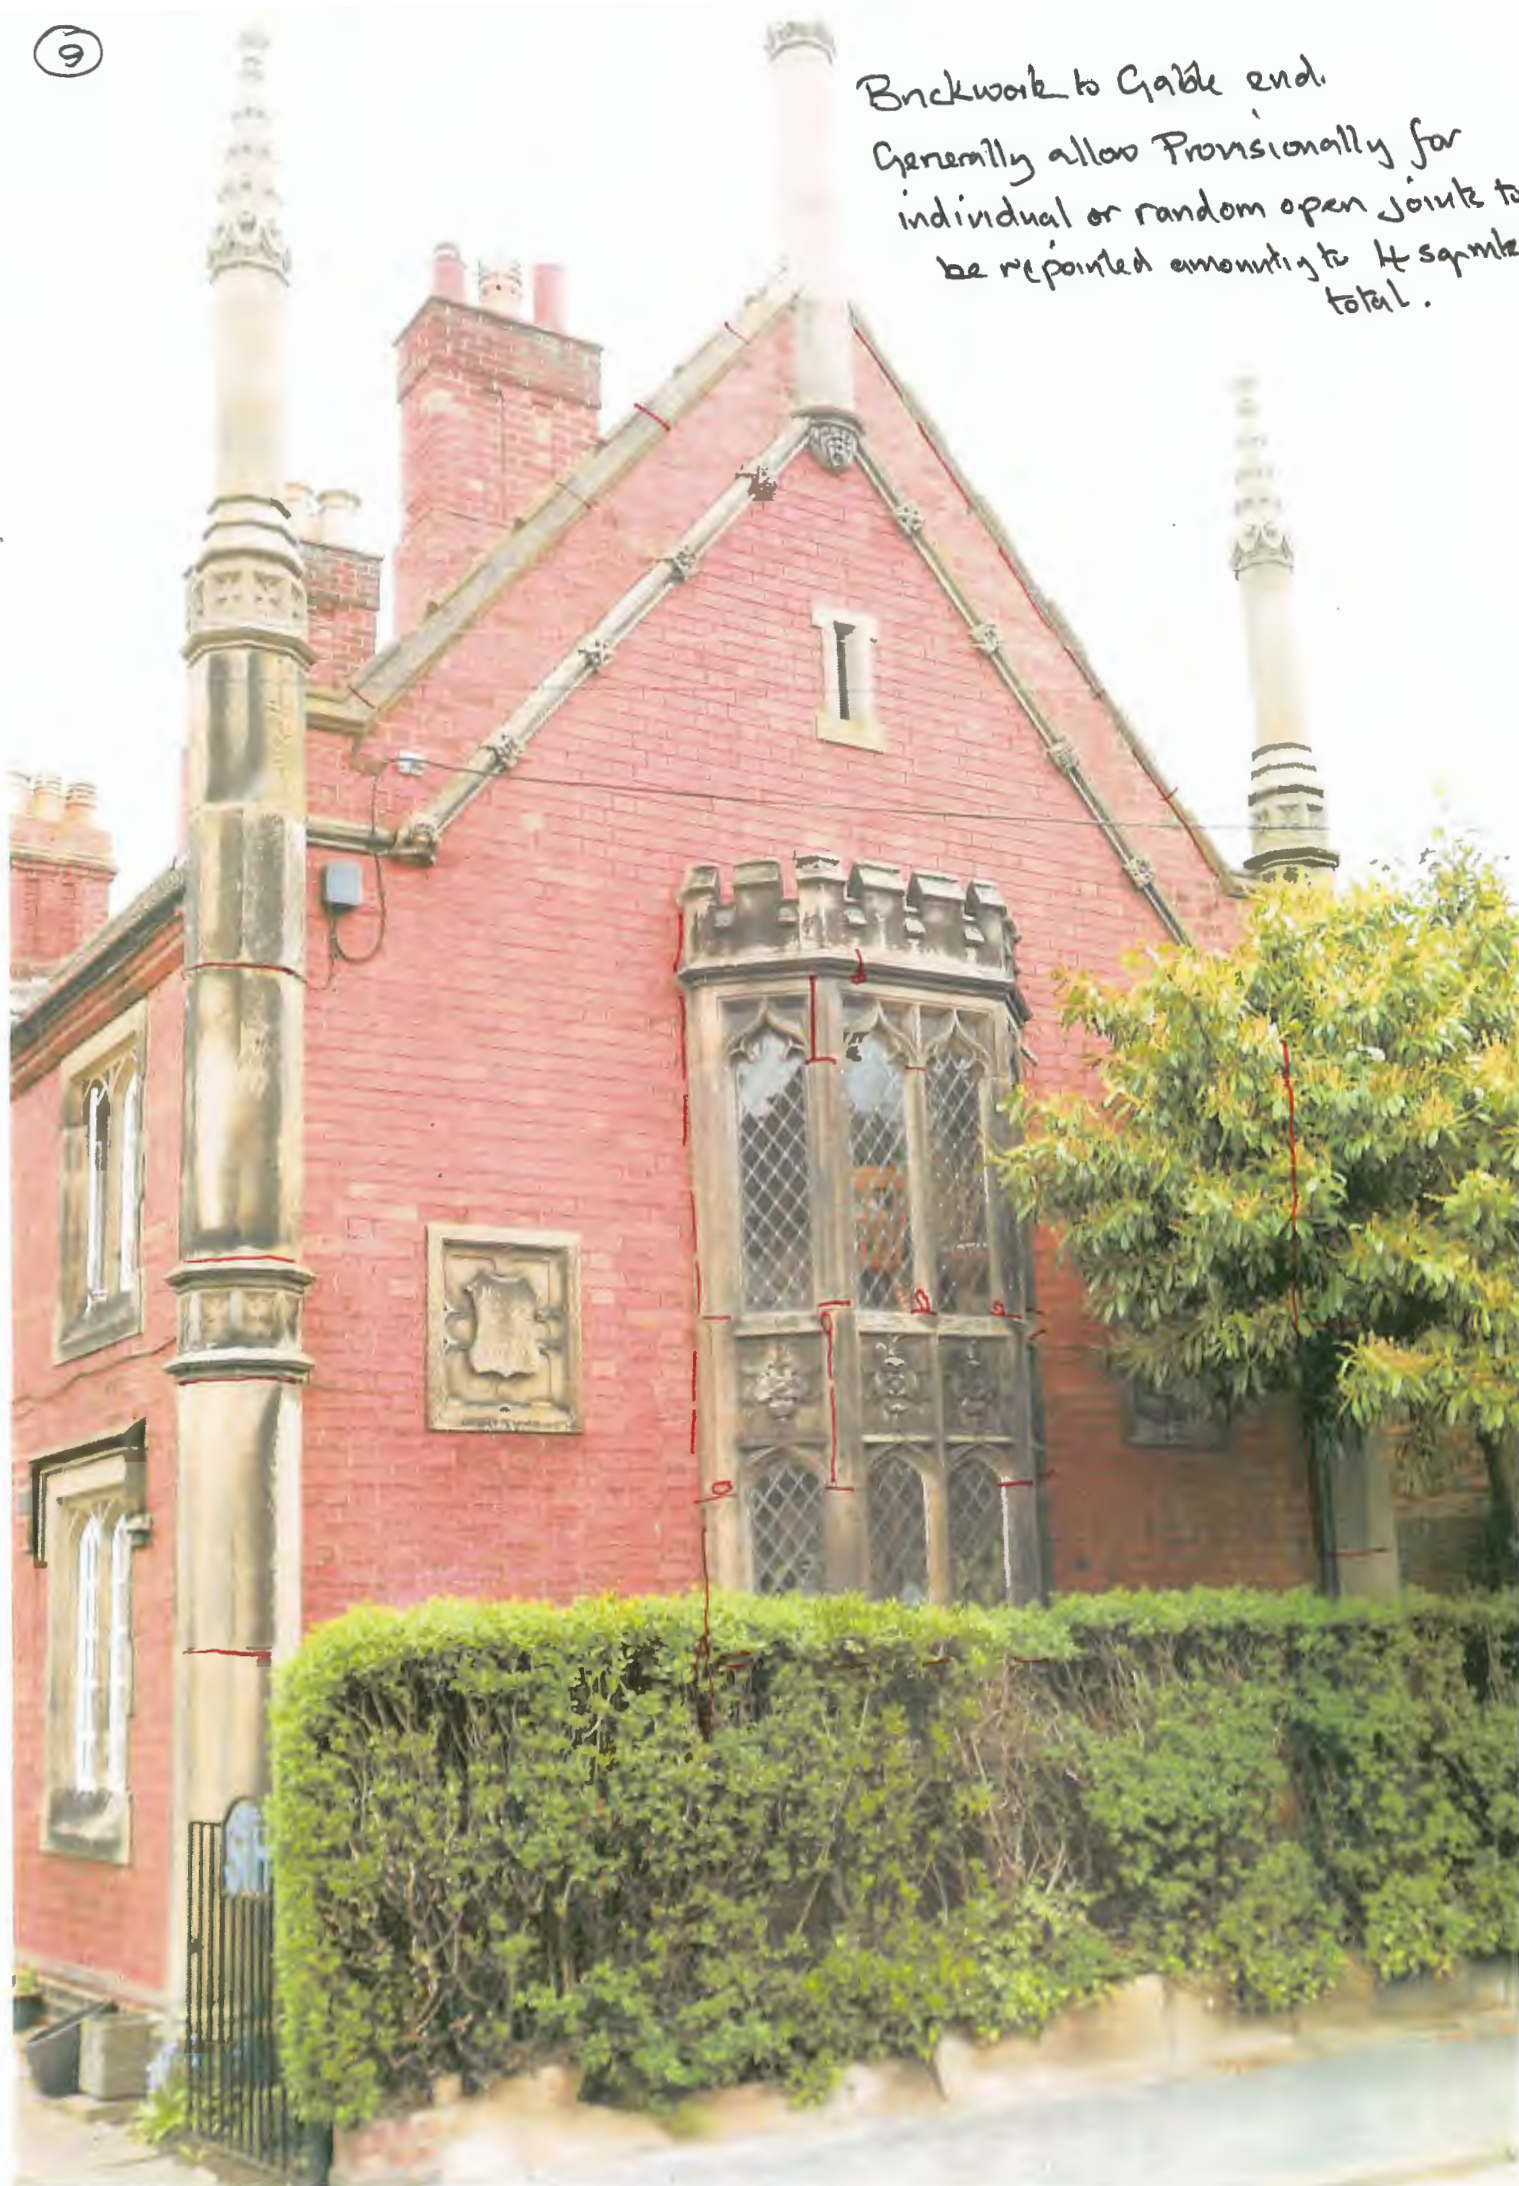
9

Brickwork to Gable end.  
Generally allow Provisionally for  
individual or random open joints to  
be repointed amounting to 4 sqmks  
total.
