Project:  
**Ayscoughfee Hall Museum & Gardens  
Church Gate, Spalding, PE11 2RA**

**Proposed rebuild of damaged gate  
pillar (north pillar of east gates - Love  
Lane).**

Drawing Title:  
**Plans and elevations as proposed**

| <b>A1572-61</b> | <b>P1</b> |

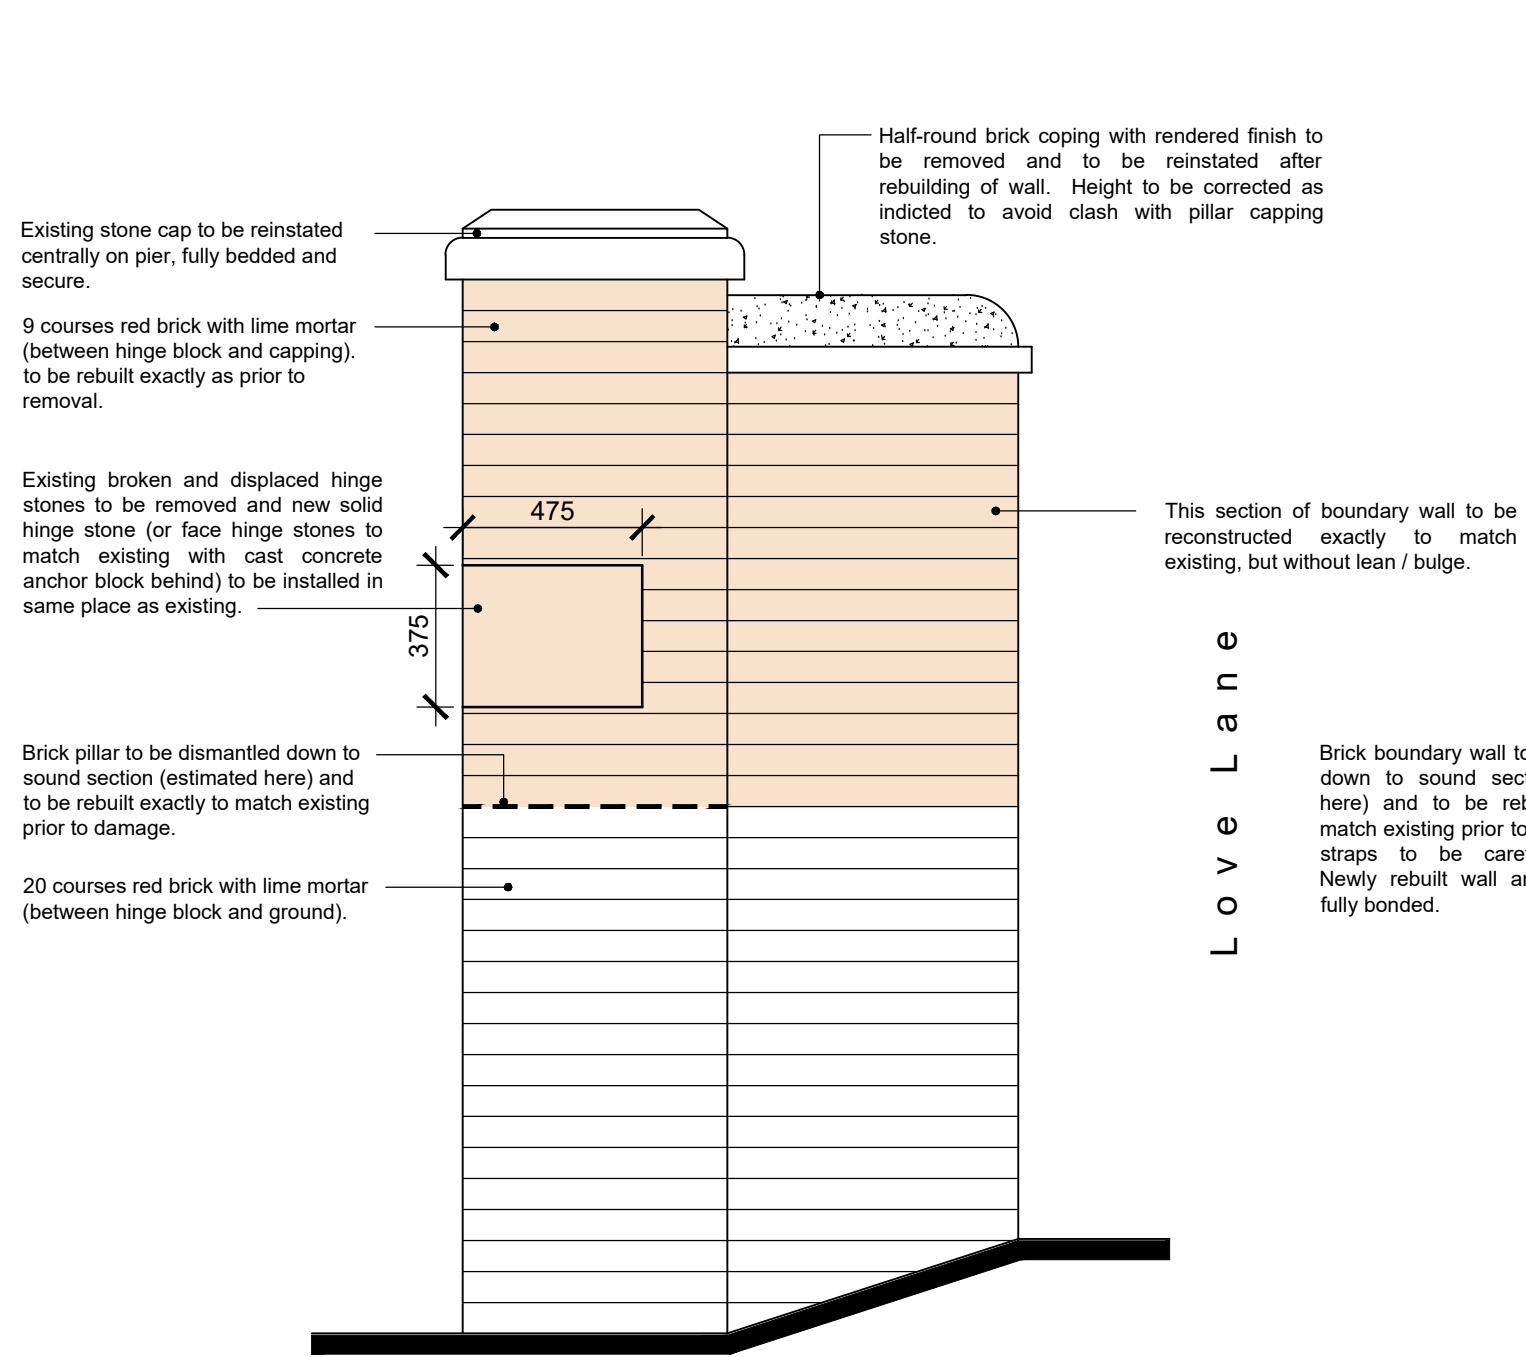
South elevation of north pillar and abutting wall  
Scale 1:20

The existing brick gate pillar to the north of the southern Love Lane opening, suffered impact damage in 2023 when stuck by a vehicle. The hinge stone on the west face of the pillar has cracked and parted vertically, through the line of the hinge plate. This stone has rotated anti-clockwise on plan such that it projects beyond the brickwork beneath by circa 50mm. The brickwork beneath the hinge stone has cracked vertically through at least 3 courses. The brickwork above the hinge stone (again on the west face) has been displaced to the north, such that it overhangs the north face of the pillar by circa 50mm, for a height of 9 courses. On the south face, the west section of the hinge stone has been shifted to the west, and a significant gap has opened up between the two components of the hinge stone, rising through 2 courses before reducing to a single crack. The impact also appears to have resulted in a number of smaller cracks throughout the pillar and into the adjoining boundary wall. In summary, the main elements of damage of the impact to the brickwork appear to be as follows:

1. Fracture and displacement of the west hinge stone.
2. Rotation of the upper section of the gate pillar.
3. General cracking throughout the pillar and into the abutting wall.

1. Careful removal of the stone pillar cap.
2. Careful removal of the rendered half-round brick capping and projecting brick course to the abutting boundary wall back to the line of where the batter commences.

3. Careful removal of the stone hinge blocks and steel hinge plate.
4. Careful dismantling of the brick pillar and the abutting boundary wall to the point at which the remaining brickwork is sound and plumb (estimated to be the levels indicated (shaded section)).

7. Cleaning and preparing of existing salvaged bricks for reuse.
8. Reconstruction of the brick pillar reusing salvaged bricks, and a suitable traditional lime mortar mix. The brickwork is to match the existing in all respects including bond, perp and bed joint width (critical), mortar colour, texture, finish and pointing profile etc. The brick pillar is to be rebuilt to its original height and the existing stone pillar cap is to be reset and fixed securely on top, centred on the pillar to achieve equal overhang to all faces.

9. Either a new solid stone hinge block is to be constructed into the pillar (i.e. full depth block, not face blocks as installed earlier in 2023), or new face blocks, securely fixed to a central block of in-situ concrete at the centre of the pillar. The block is to be secure in all respects. The visible faces of the stone hinge block are to match the existing in all respects to allow appropriate bonding in to the brickwork.

10. Reconstruction of the brick boundary wall reusing salvaged bricks, and a suitable traditional lime mortar mix. The brickwork is to match the existing in all respects including bond, perp and bed joint width (critical), mortar colour, texture, finish and pointing profile etc. The brick wall is to have the projecting brick course reinstated and the half-brick capping set securely on top. Note that the level of the capping abutting the pillar is to be reduced by 1 course to align with the existing capping on the remainder of the wall to the north. The half-round brick capping is to receive a render finish to match the existing. Note that the brickwork of the rebuilt wall and pillar is to be fully bonded at the changes of direction and intersections.

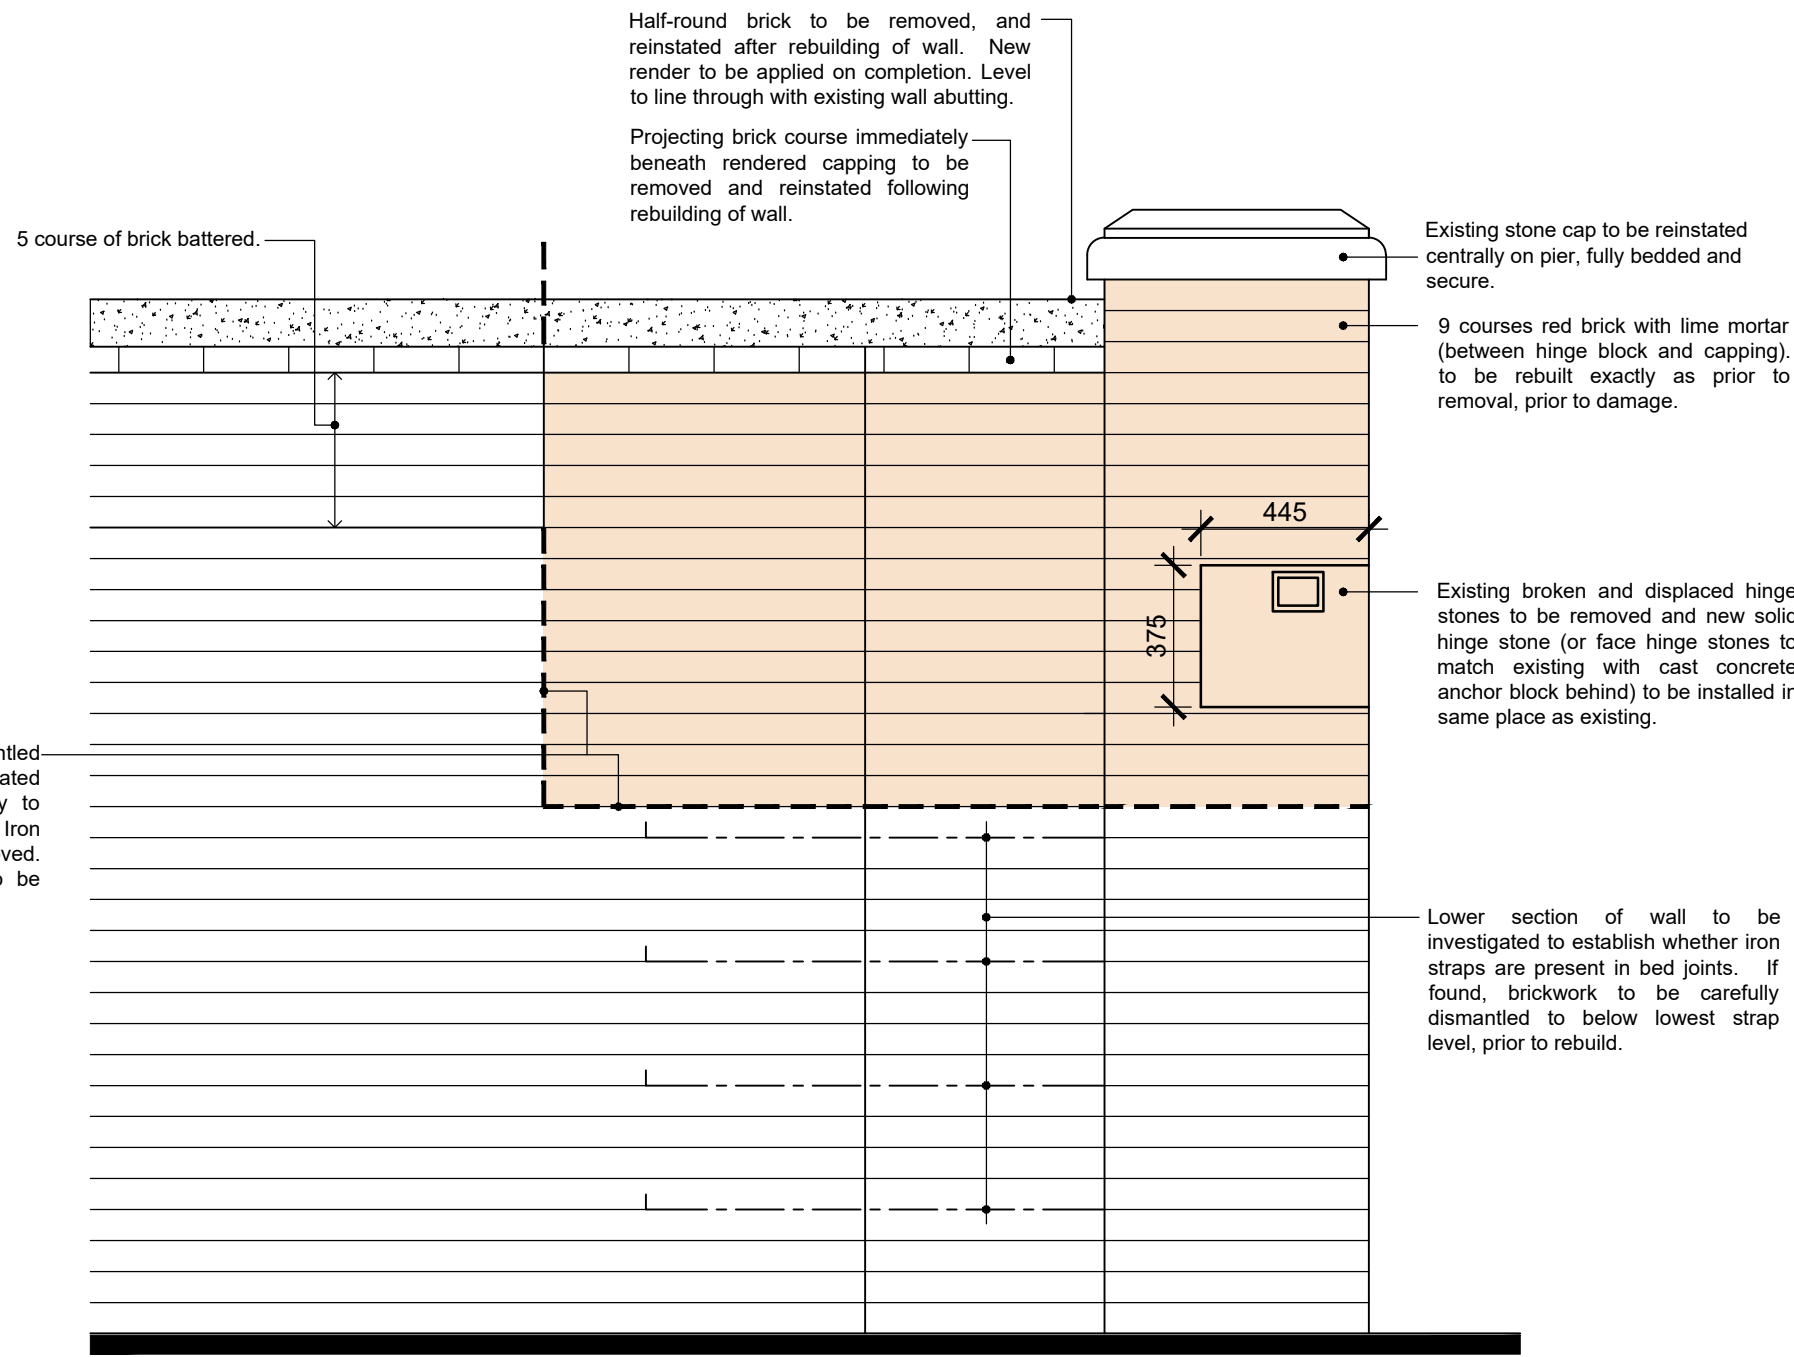
East elevation of north pillar and abutting wall  
Scale 1:20

Beyond this, immediately north of the pillar there are a number of iron straps set within the bed-joints of the brickwork, continuing around the wall splay on plan, and set at various heights. This mortar cover on the ironwork has eroded away on the upper 3 straps, exposing the iron to the elements. This has resulted in the iron corroding, expanding significantly in the process. Consequently, the brickwork above has been lifted. It is suspected that there may be a total of 7 iron straps, though only 3 are visible.

5. Careful removal and disposal of the 3 corroded iron straps.
6. Investigation of the wall at lower level to establish whether further iron straps exist. Should this be the case then the works are to include the dismantling of further brickwork and the removal of all iron straps.
