*Air raid shelter*

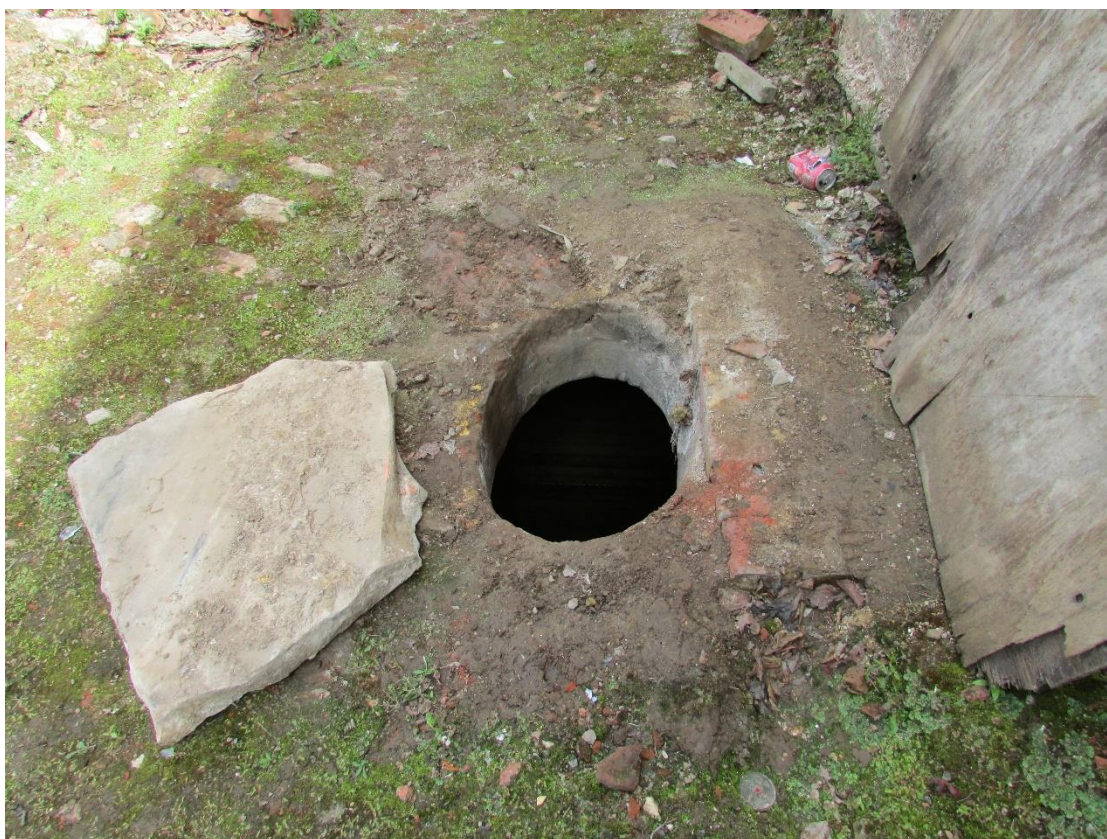
Plate 17 Manhole of Cistern on Victoria Street Site, looking east

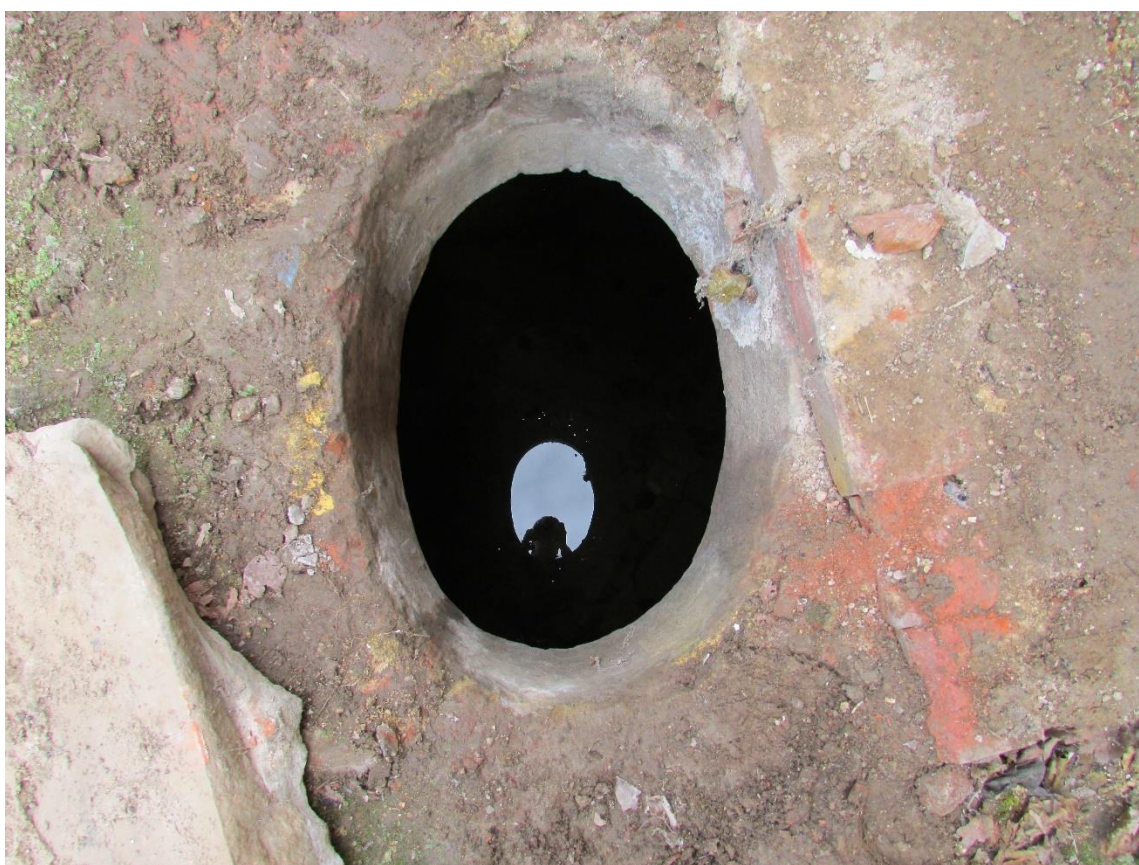
Plate 18 Manhole of Cistern on Victoria Street Site, looking down and east

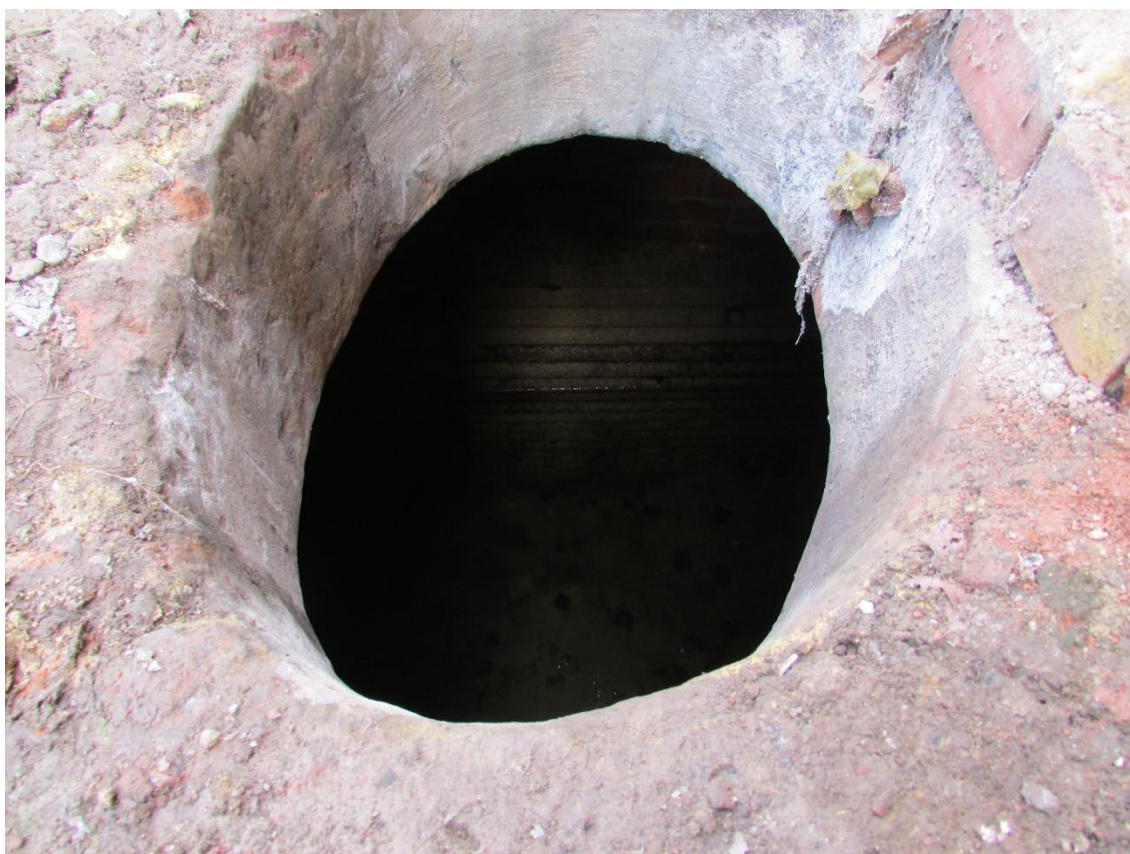
Plate 19 Manhole of Cistern on Victoria Street Site, looking down and east

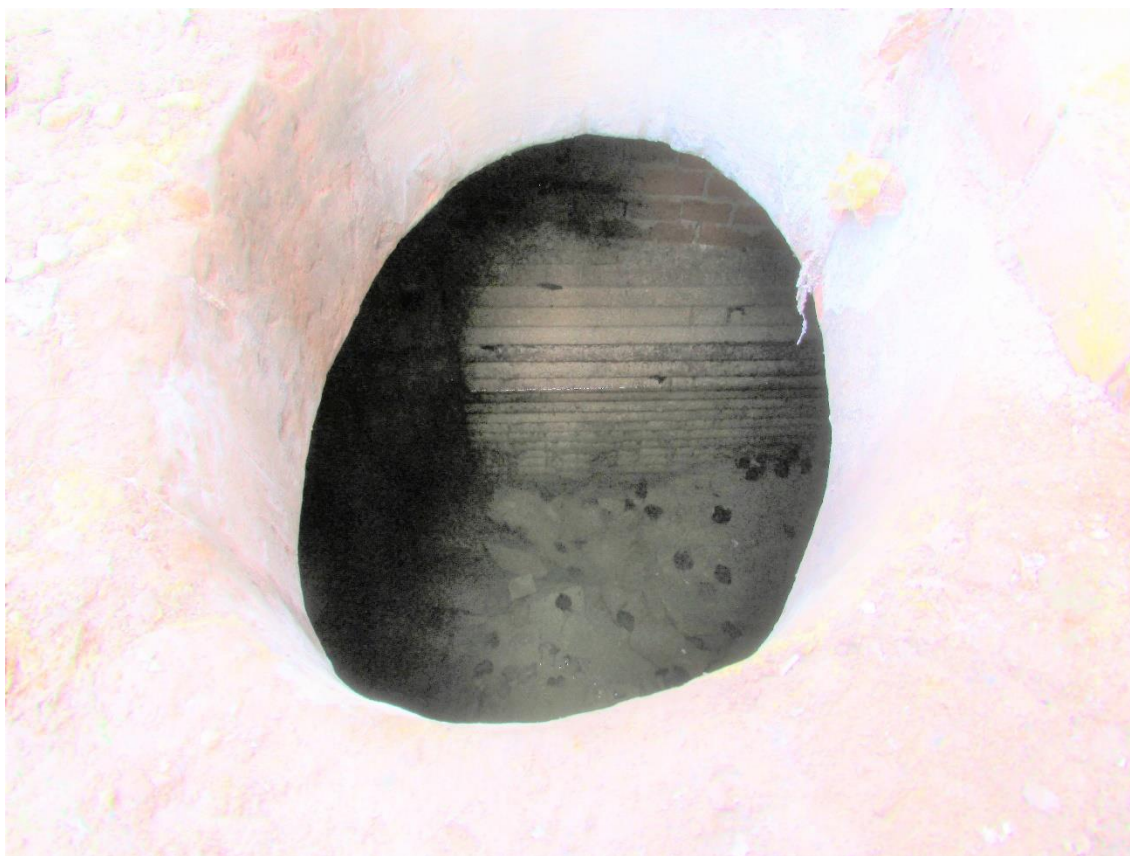
Plate 20 Plate 19 lightened: Manhole of Cistern on Victoria Street Site, looking down and east

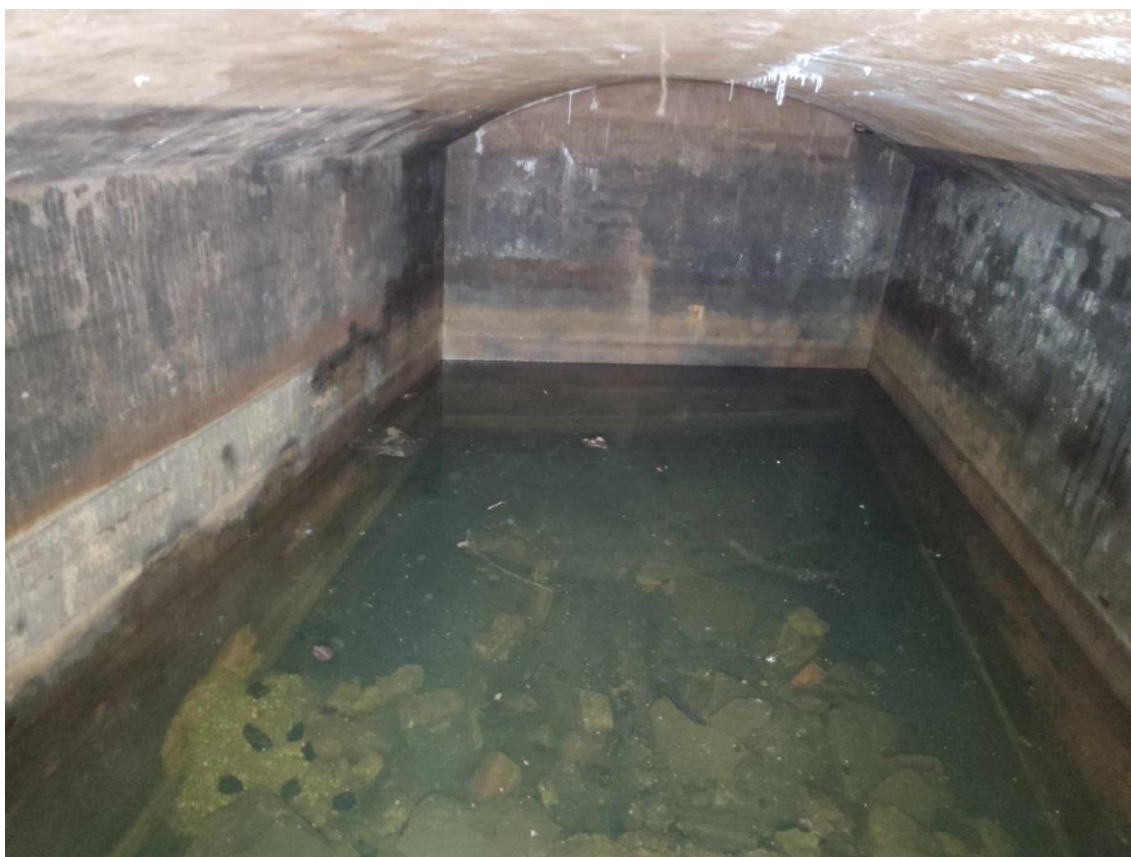
Plate 21 Cistern on Victoria Street Site, looking west from the manhole

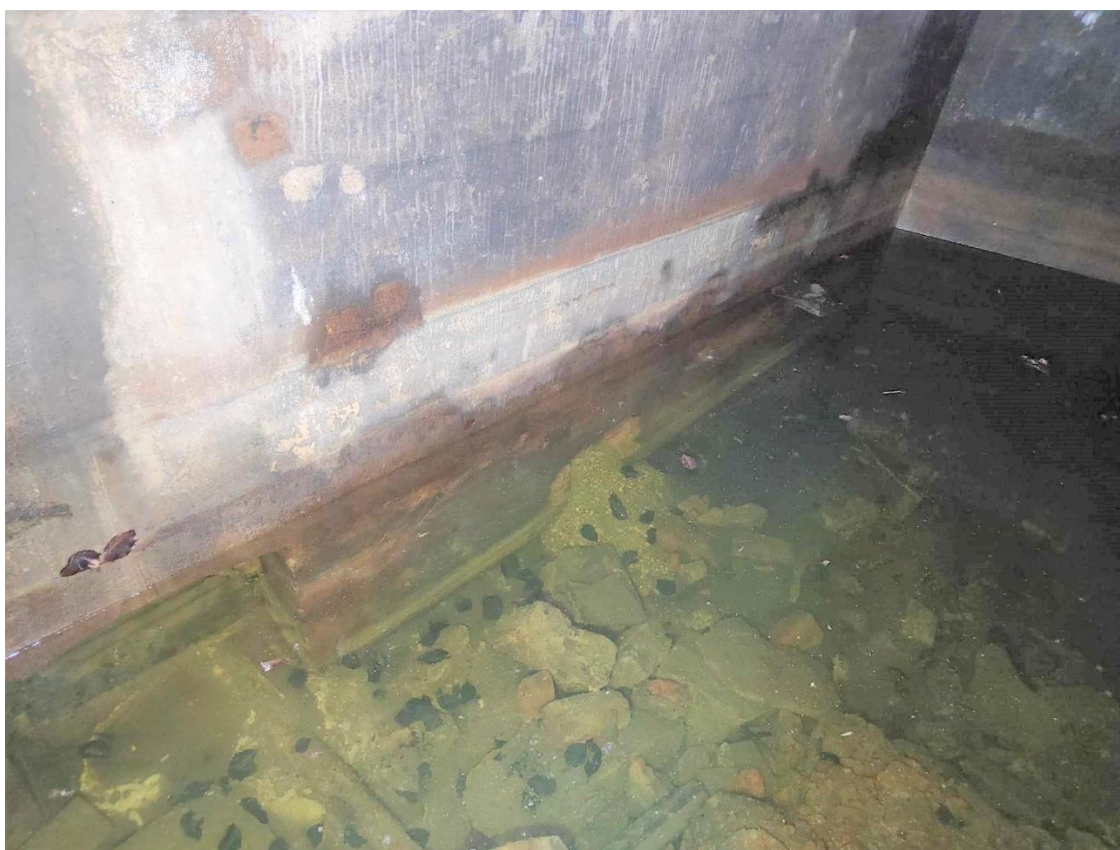
Plate 22 South wall & two drains in Cistern on Victoria Street Site, looking south-west from manhole

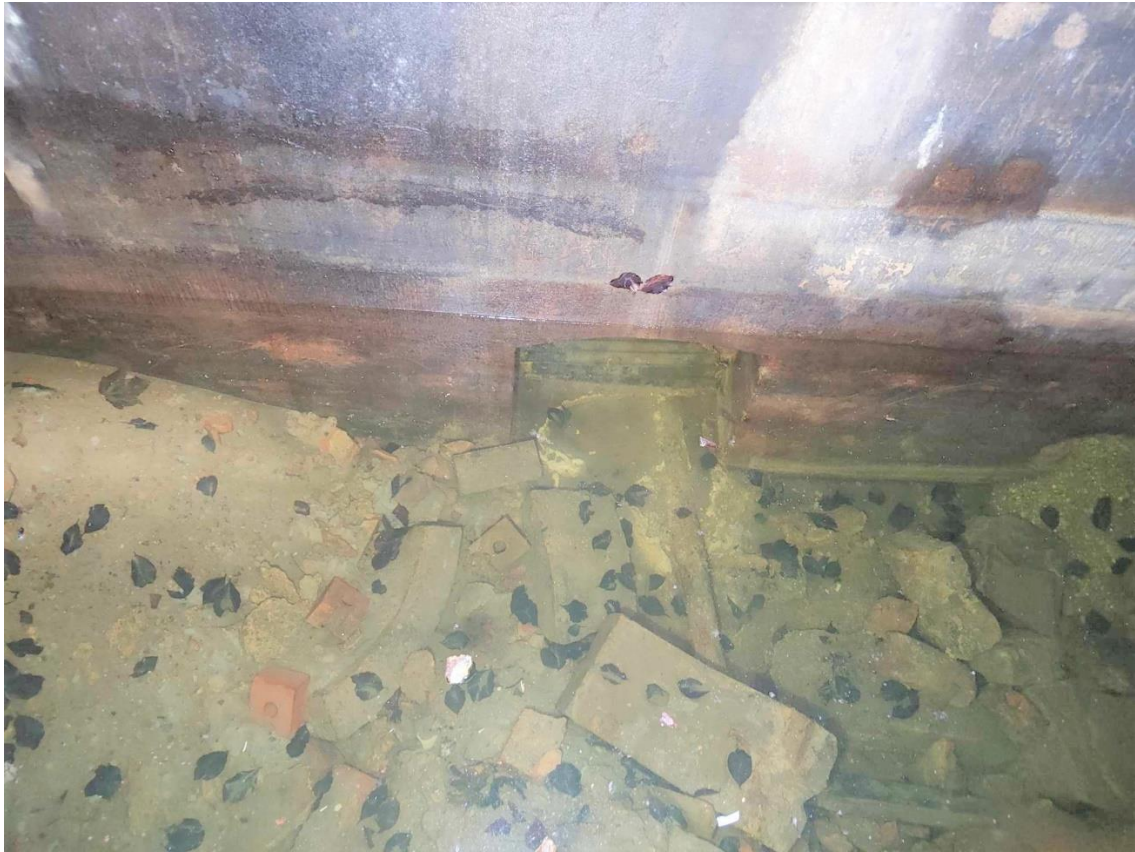
Plate 23 South wall & east drain in Cistern on Victoria Street Site, looking south from manhole

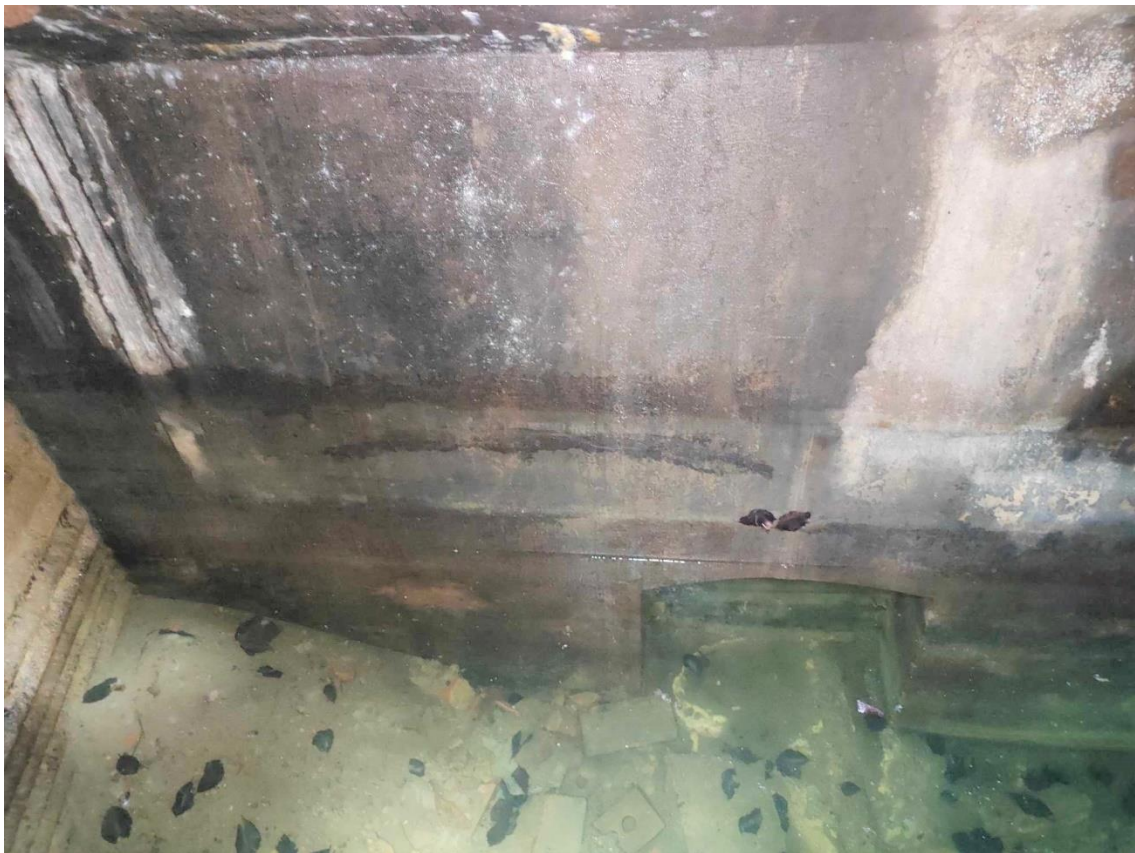
Plate 24 South wall & east drain in Cistern on Victoria Street Site, looking south from manhole

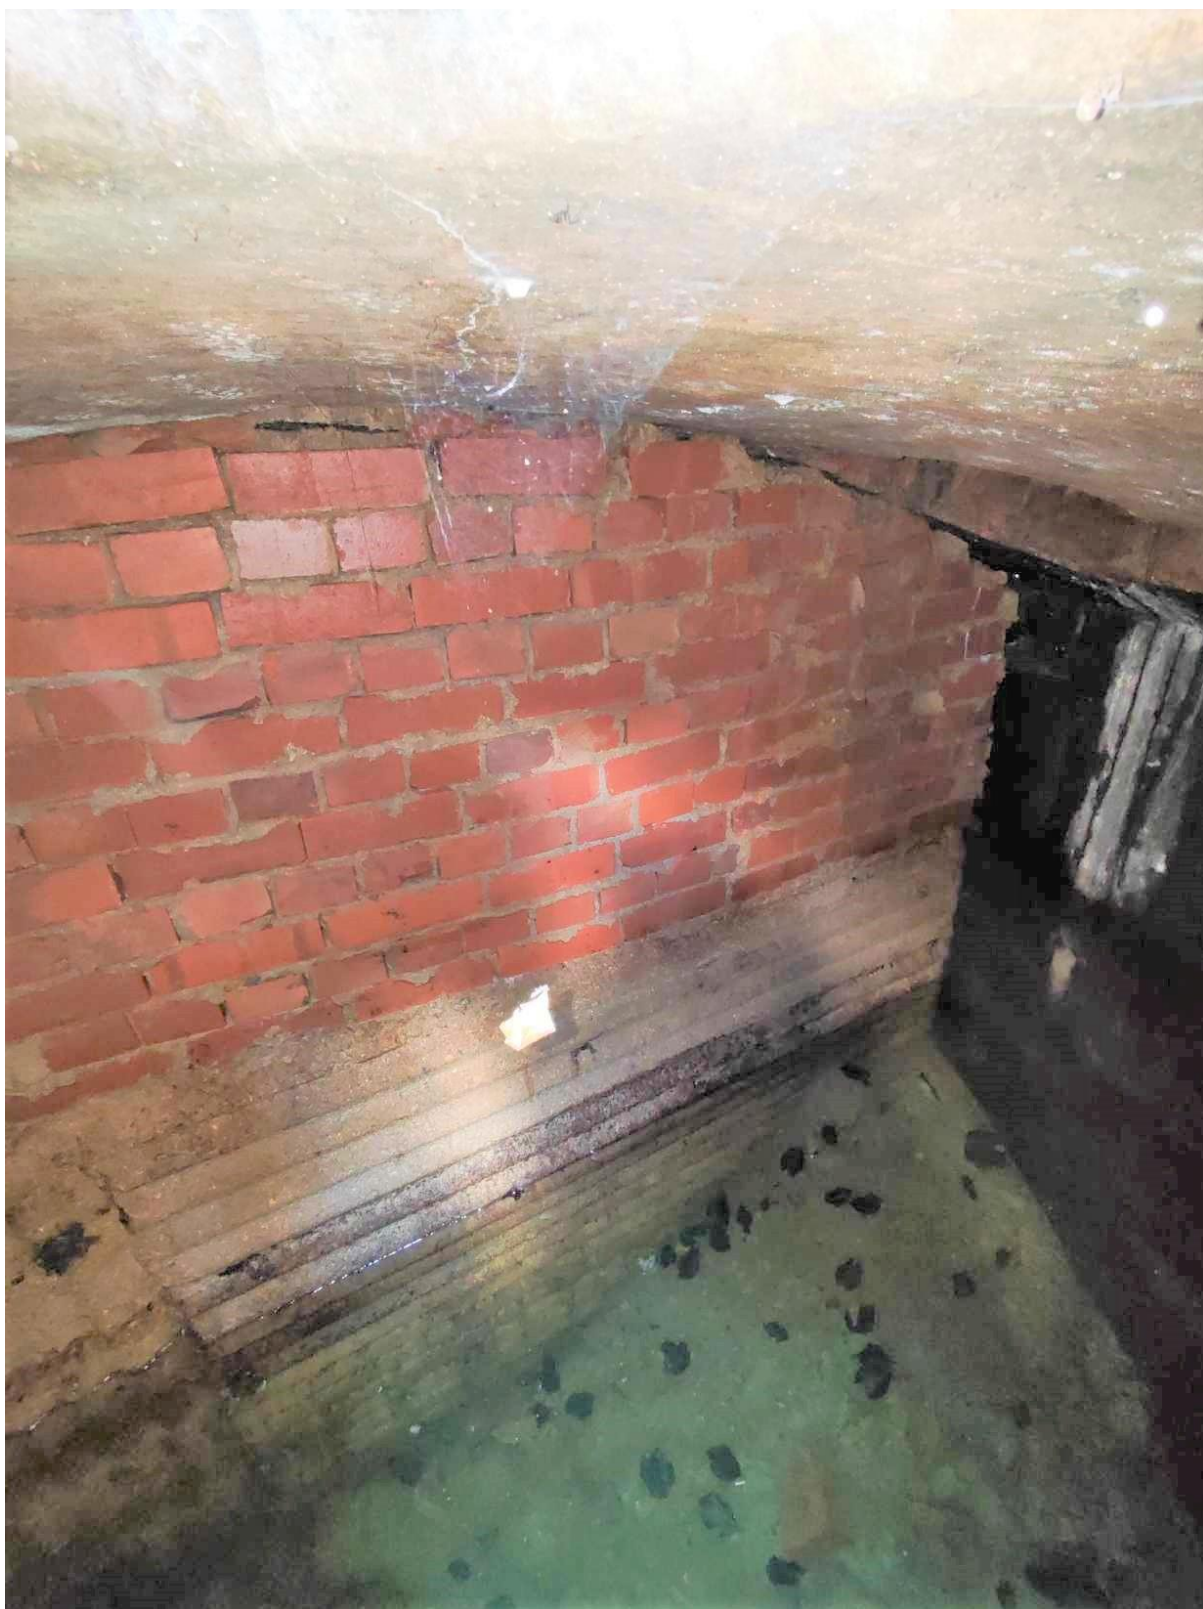
Plate 25 East blocking brick wall and south wall in Cistern on Victoria Street Site, looking south-east from manhole

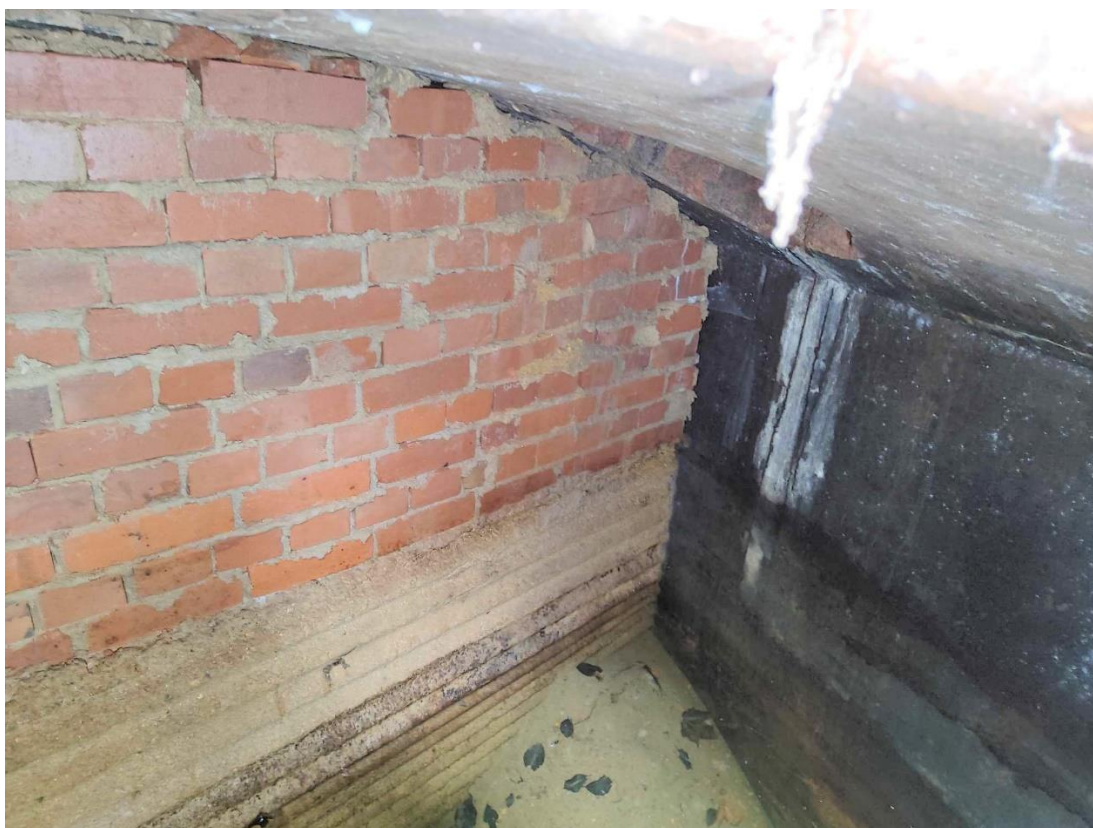
Plate 26 East blocking wall and south wall in Cistern on Victoria Street Site, looking south-east from manhole

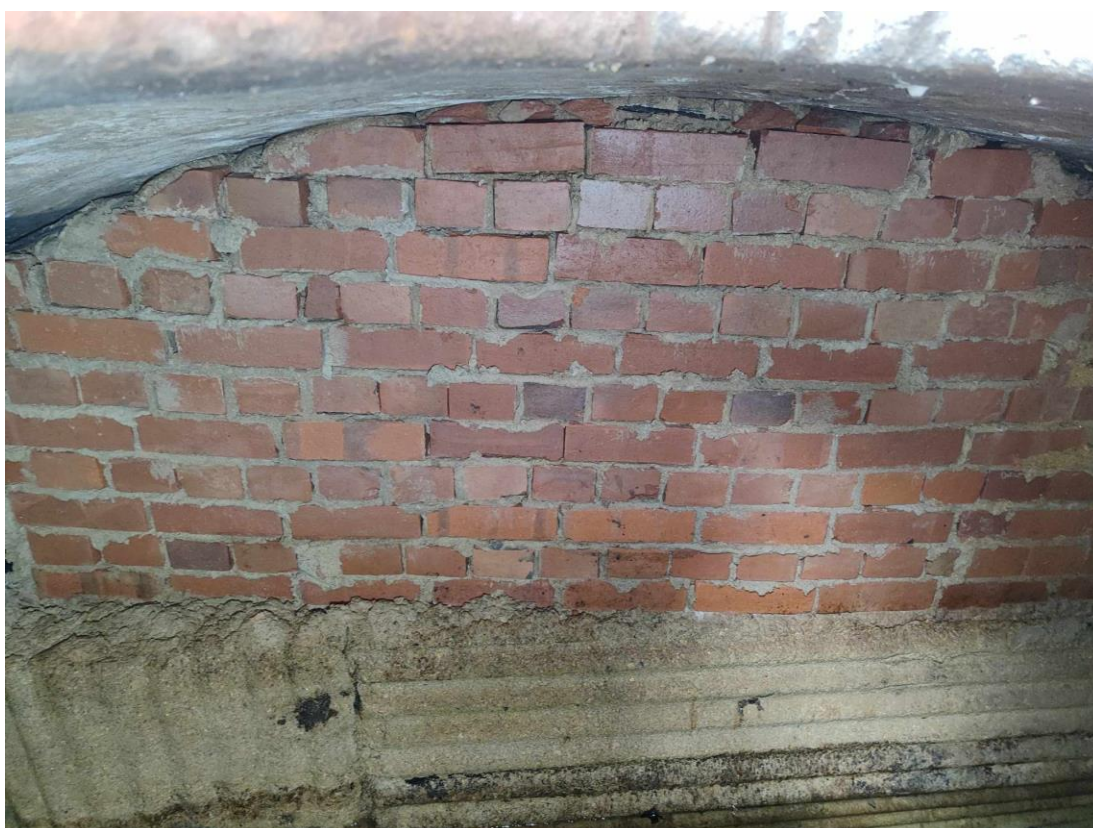
Plate 27 East blocking wall in Cistern on Victoria Street Site, looking east from manhole

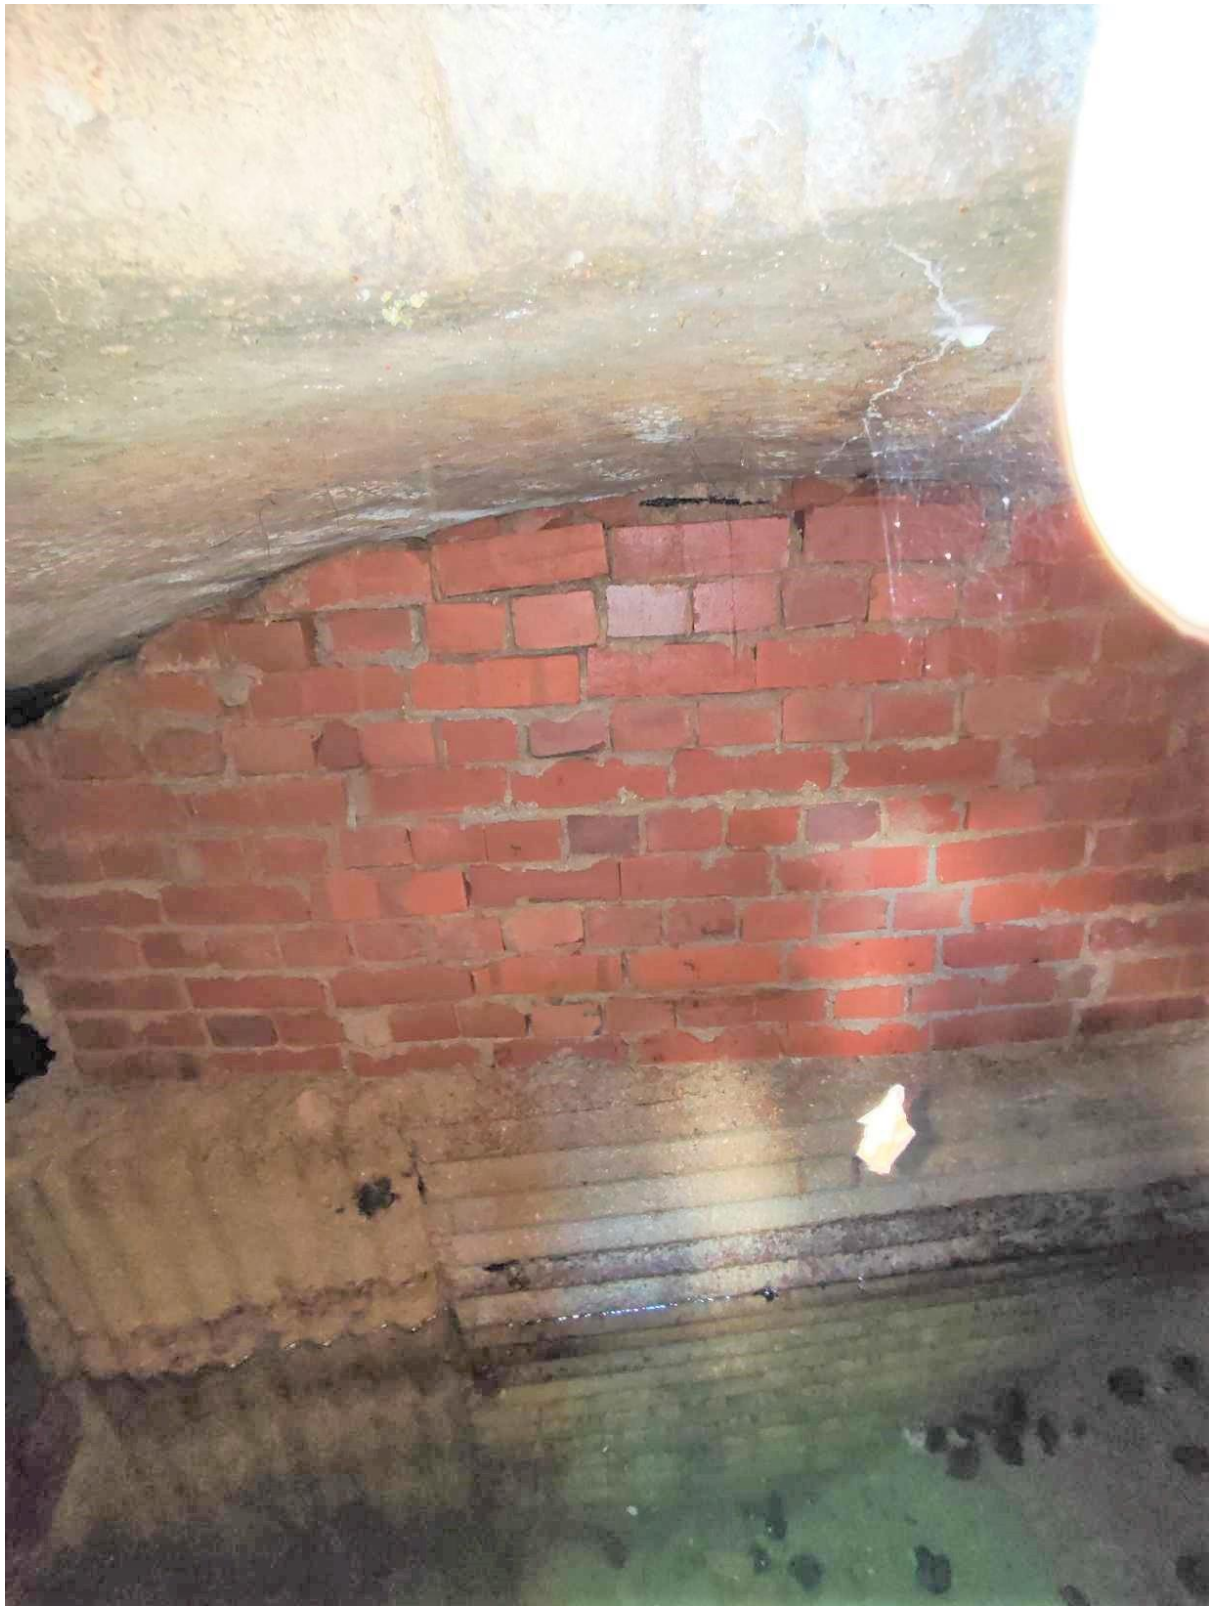
Plate 28 East blocking wall in Cistern on Victoria Street Site, looking east from manhole

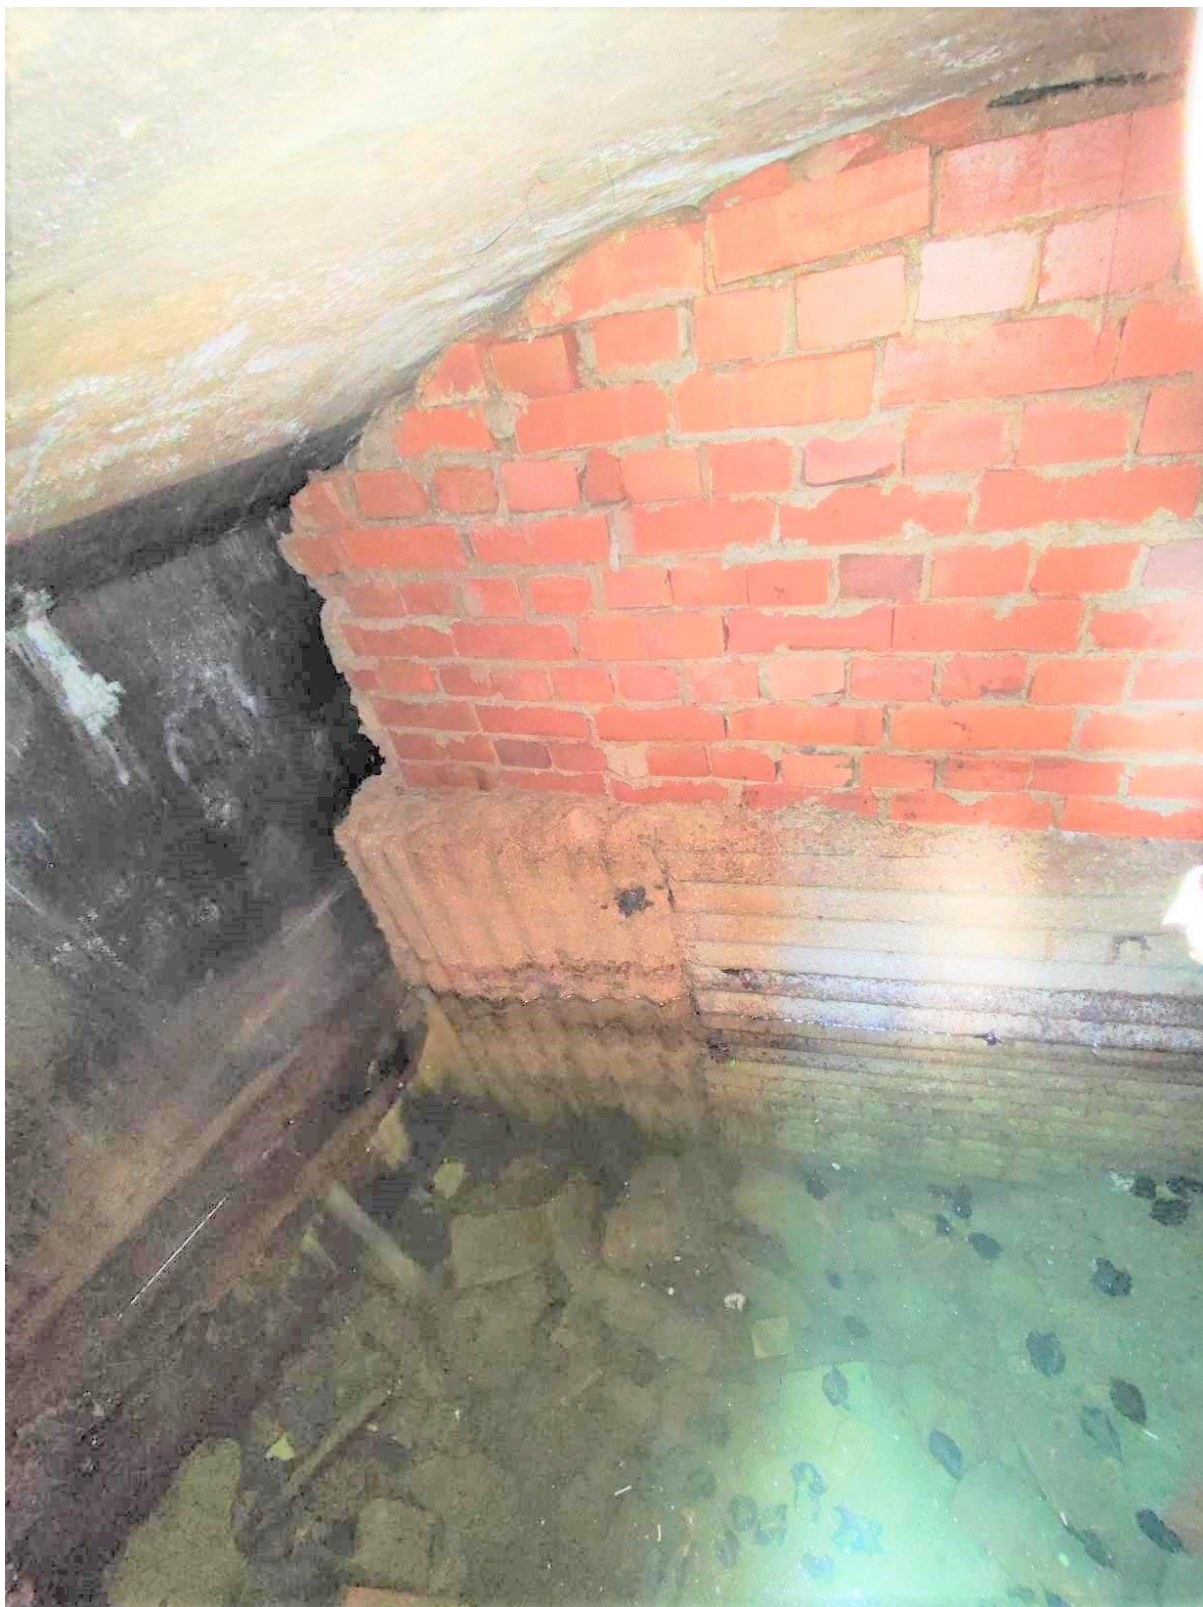
Plate 29 North wall and east blocking wall in Cistern on Victoria Street Site, looking north-east from manhole

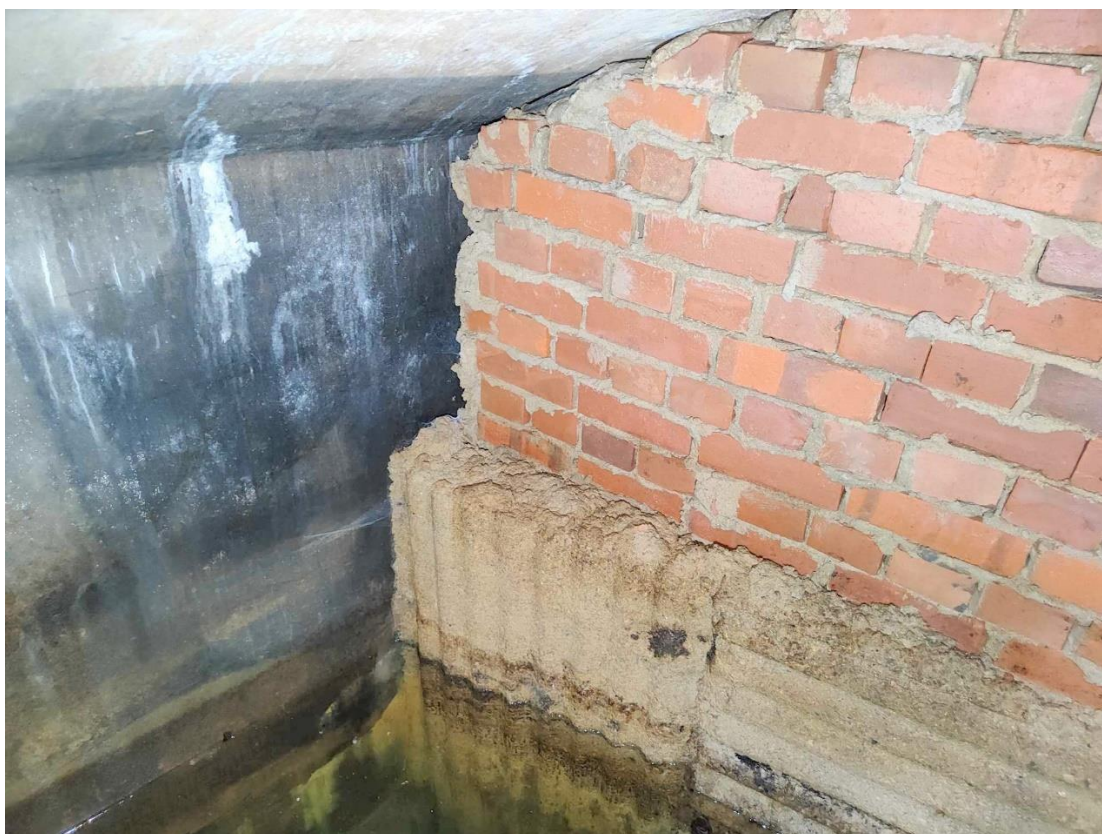
Plate 30 North wall and east blocking wall in Cistern on Victoria Street Site, looking north-east from manhole

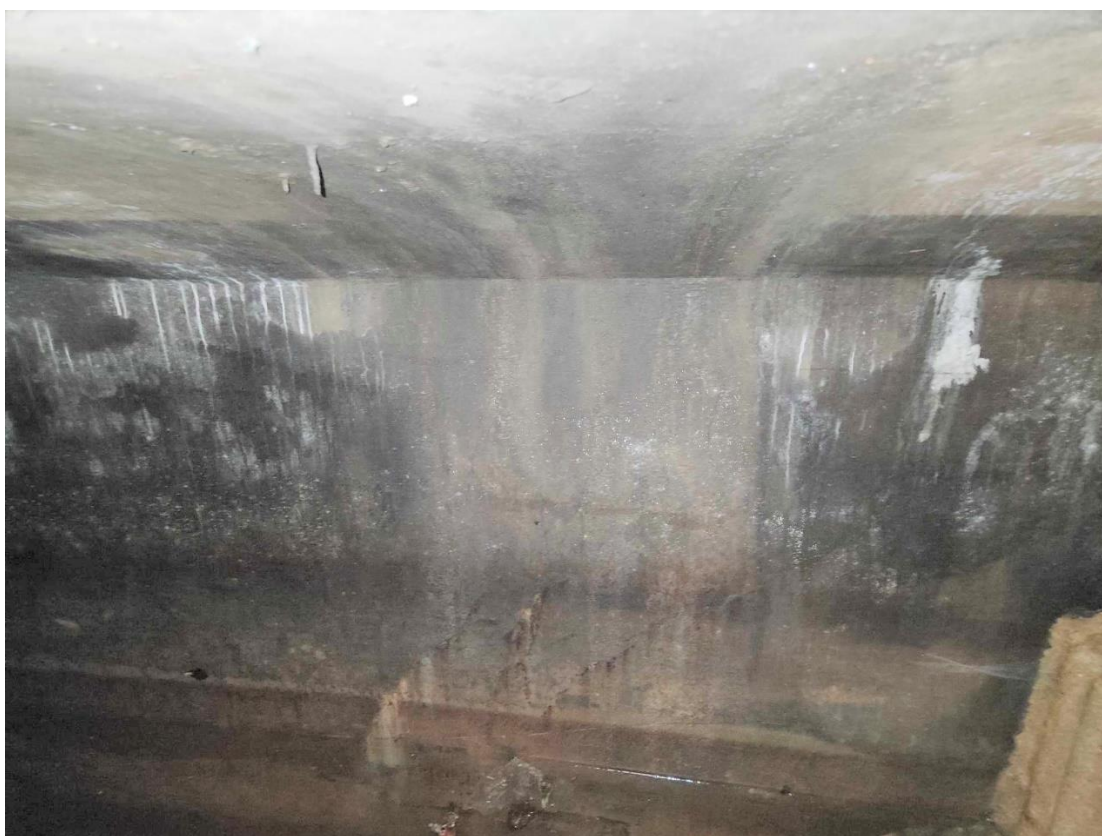
Plate 31 North wall in Cistern on Victoria Street Site, looking north from manhole

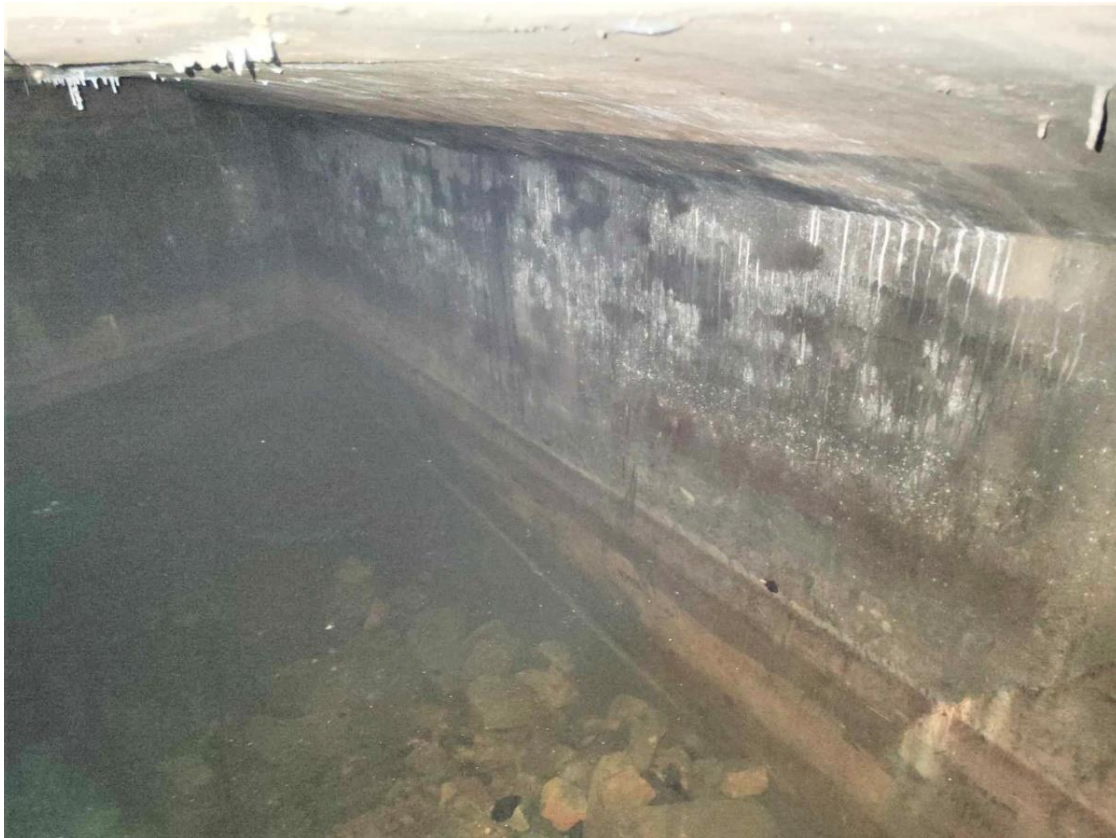
Plate 32 North wall in Cistern on Victoria Street Site, looking north-west from manhole

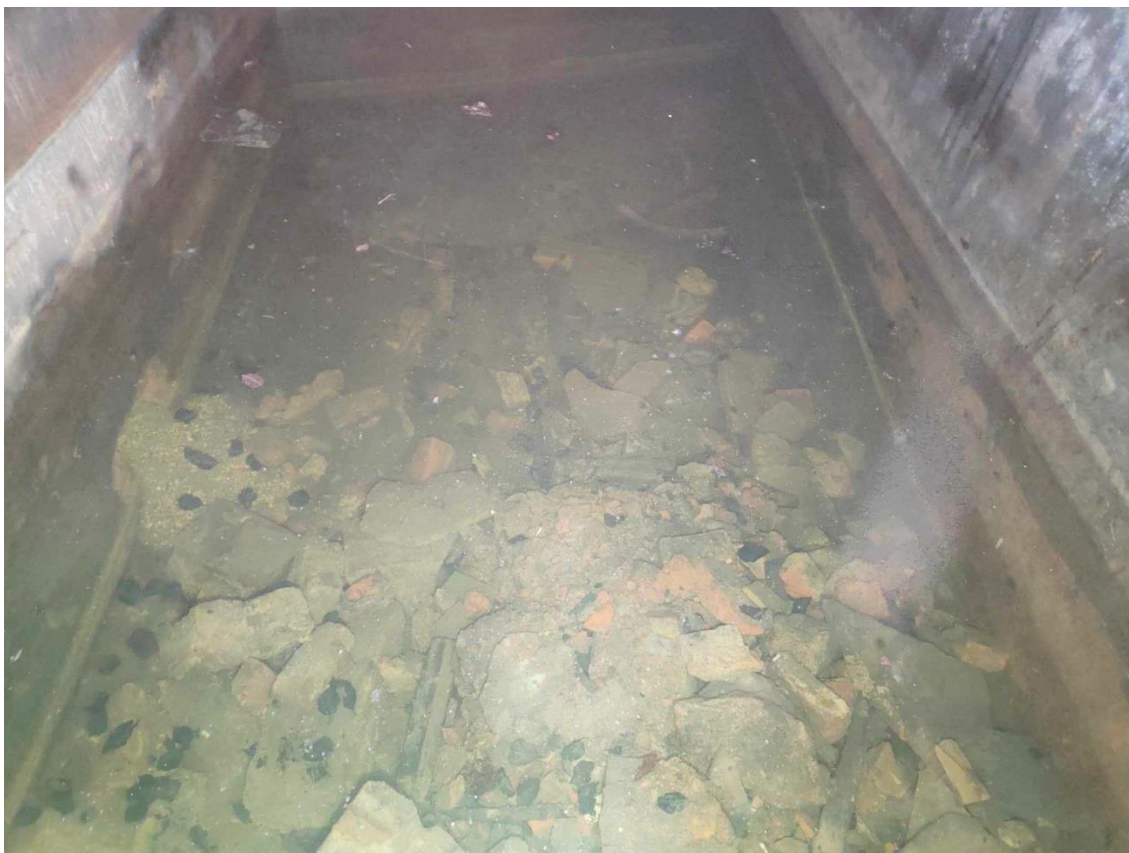
Plate 33 Rubble within the Cistern on Victoria Street Site, looking down and west from manhole

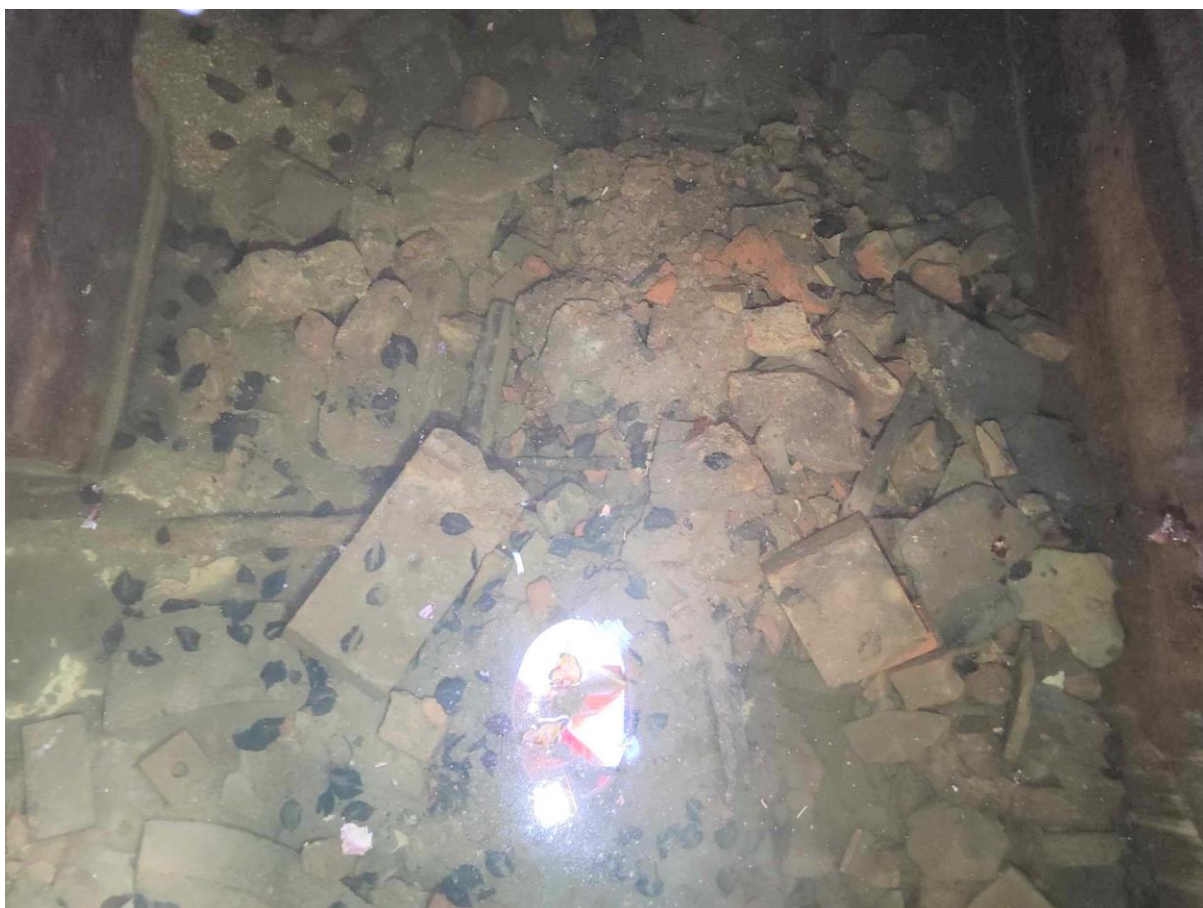
Plate 34 Rubble within the Cistern on Victoria Street Site, looking down and west from manhole

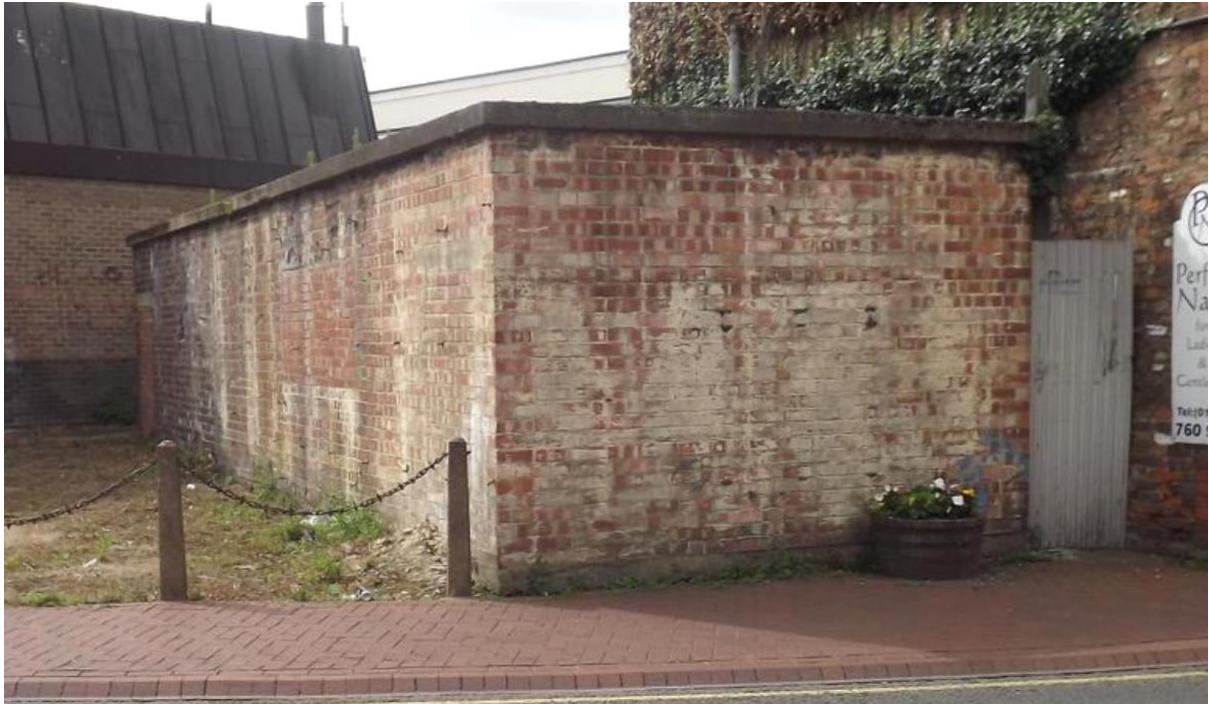
Plate 35: The air raid shelter prior to reopening, looking southwest © Stuart Banham (flickr)

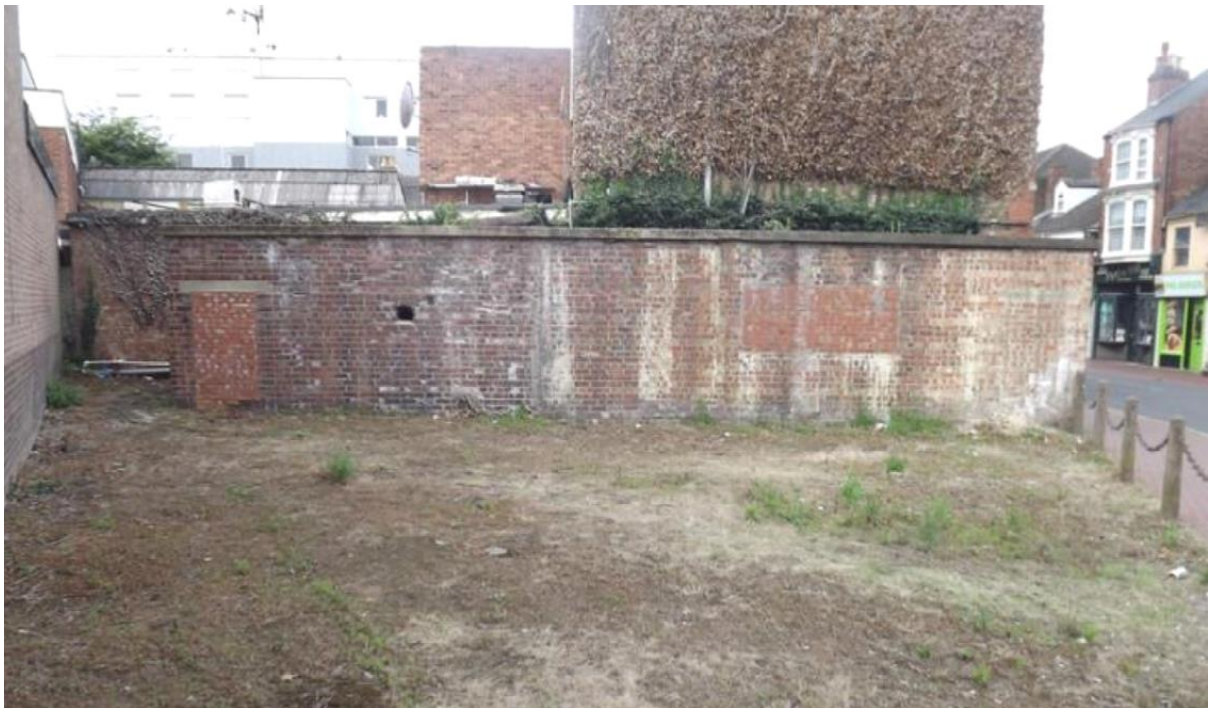
Plate 36: East elevation of the air raid shelter prior to reopening, looking west © Stuart Banham (flickr)
