*Air raid shelter*

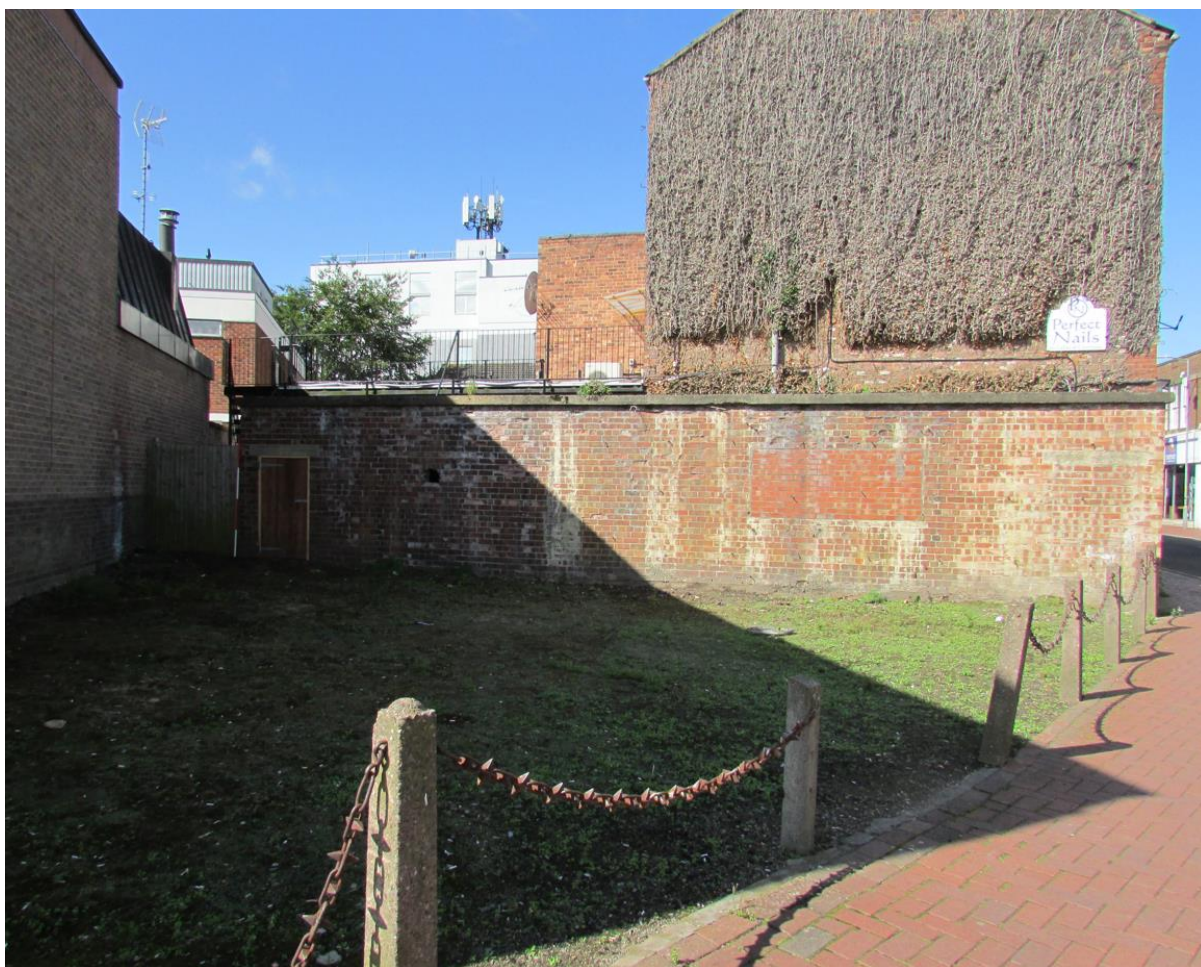
Plate 37: East elevation of the air raid shelter, looking southwest, showing northwest wall of former bank (left) and east wall of no. 19 Station Street (right). This photograph was taken in August 2023 after the southern entrance had been reopened IMG\_2300

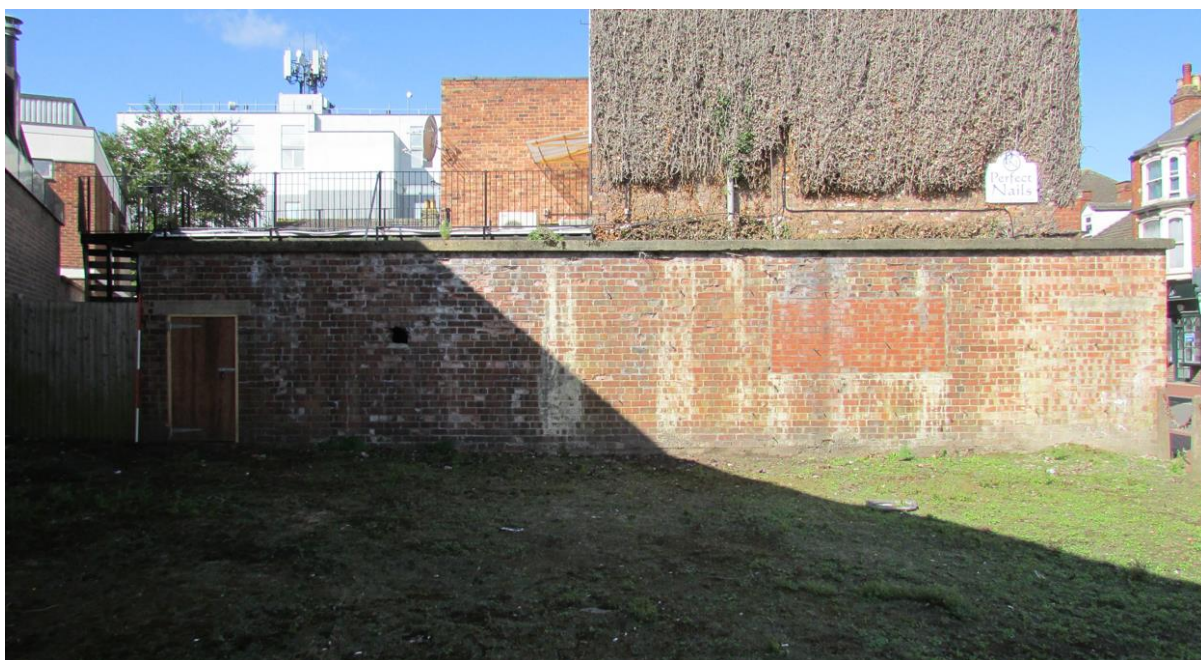
Plate 38: East elevation of the air raid shelter after reopening, looking west. IMG\_2299

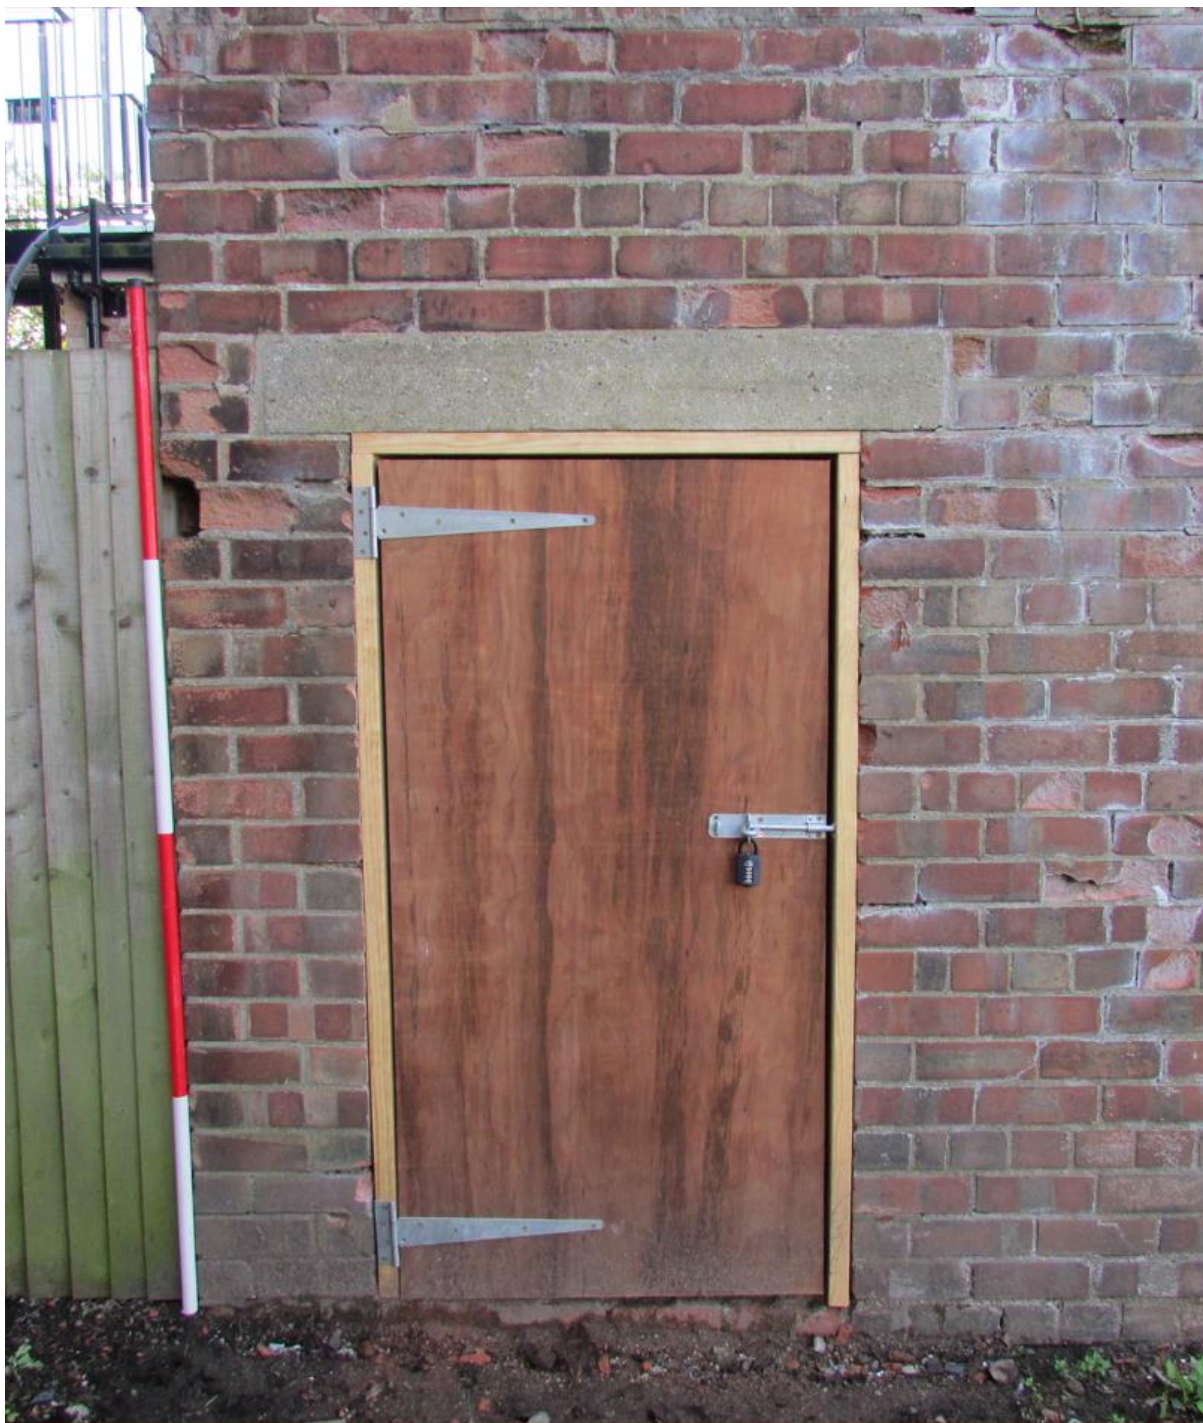
Plate 39: South entrance to air raid shelter, showing temporary door, looking west. IMG\_2301

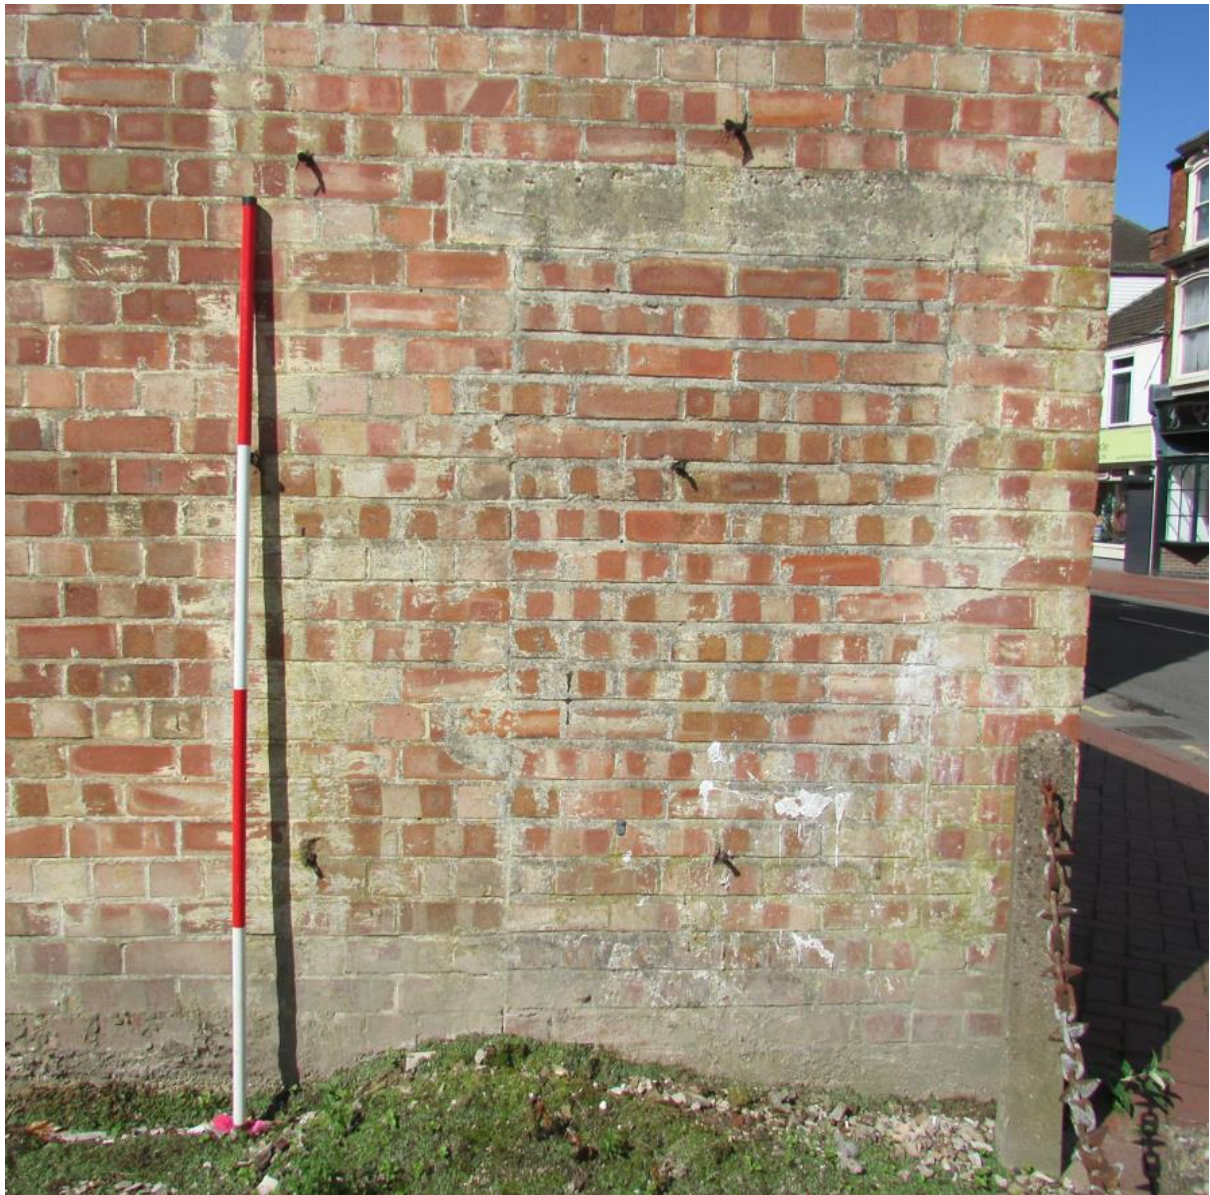
Plate 40: Bricked-in north entrance to air raid shelter, looking west IMG\_2304

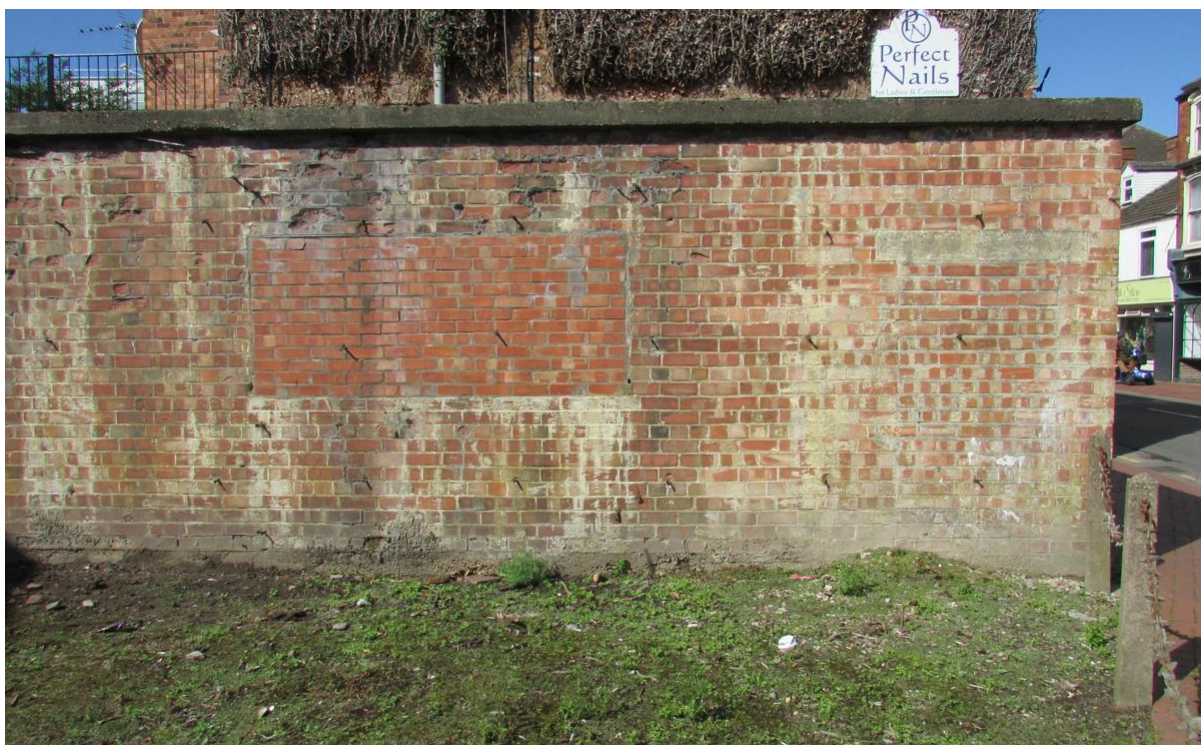
Plate 41: Aperture cut into brickwork of east elevation, infilled with post-war red brickwork, looking west IMG\_2311

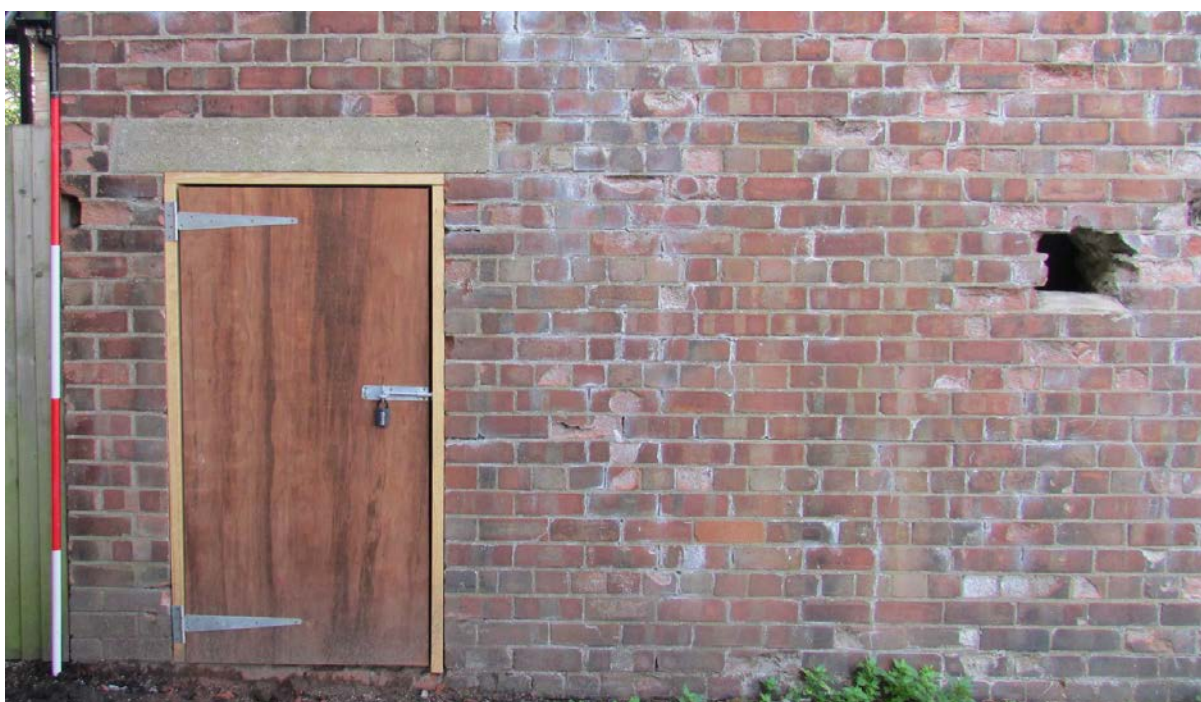
Plate 42: Opening in brickwork of east elevation close to the southern entrance, looking west IMG\_2306

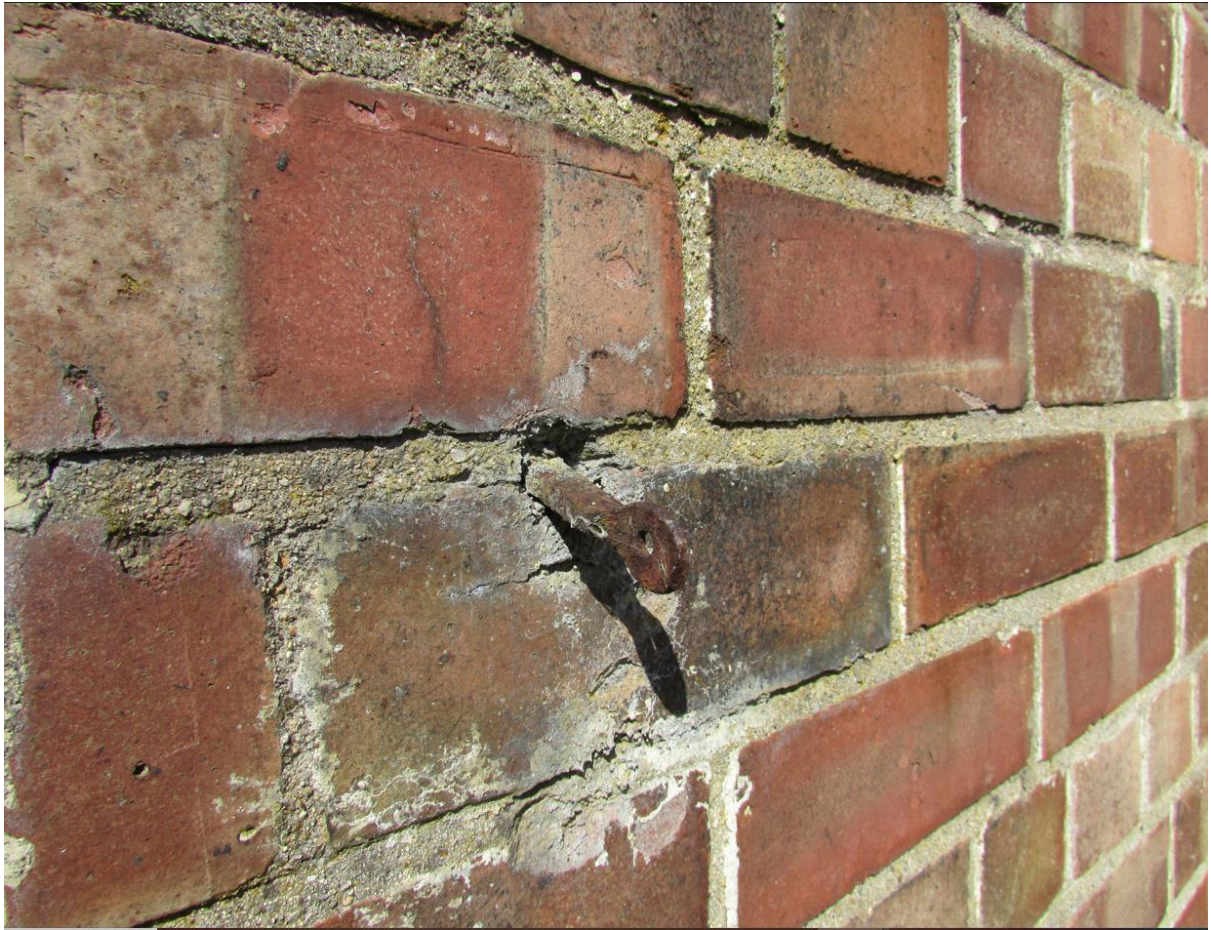
Plate 43: Metal bracket inserted into mortar in east elevation IMG\_2305

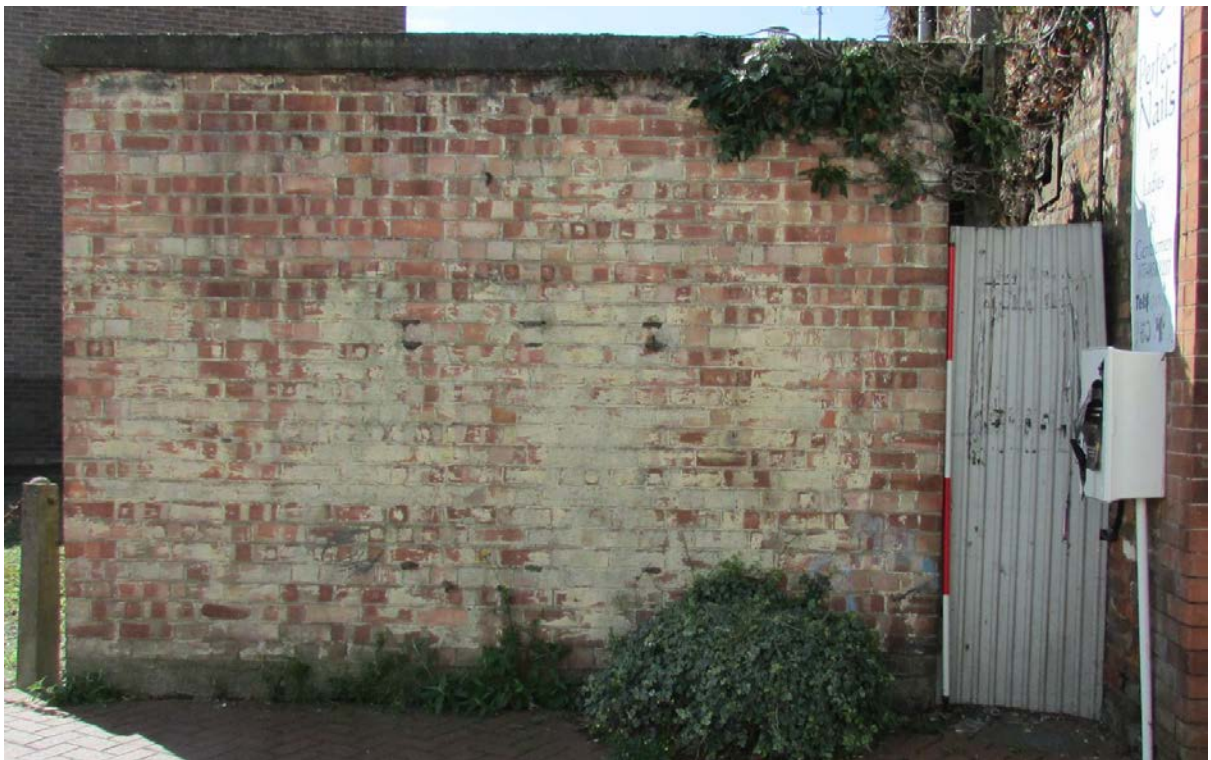
Plate 44: North elevation of the shelter, looking south IMG\_2312

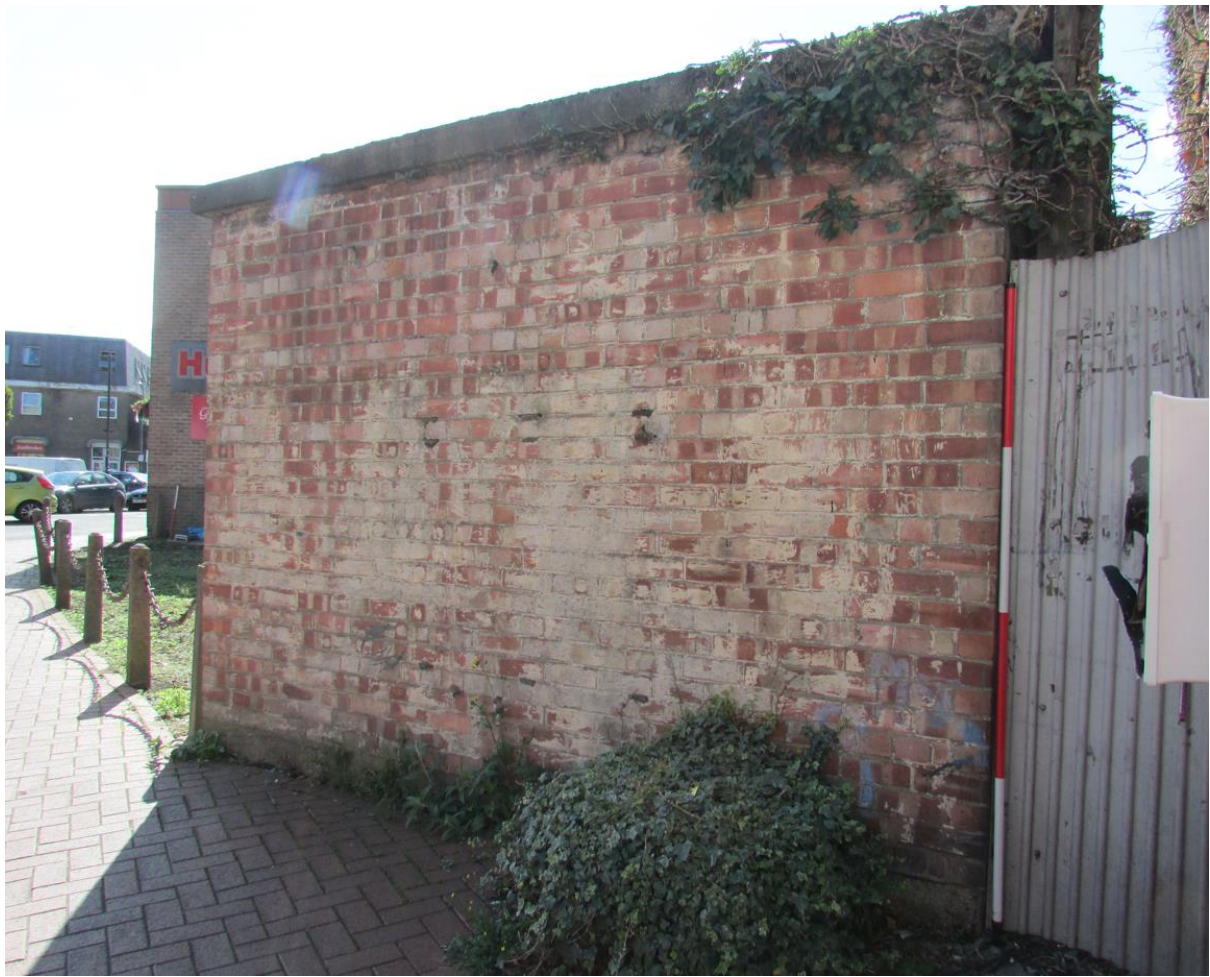
Plate 45: North elevation of the shelter, looking southeast, showing wooden pegs embedded in mortar  
IMG\_2313

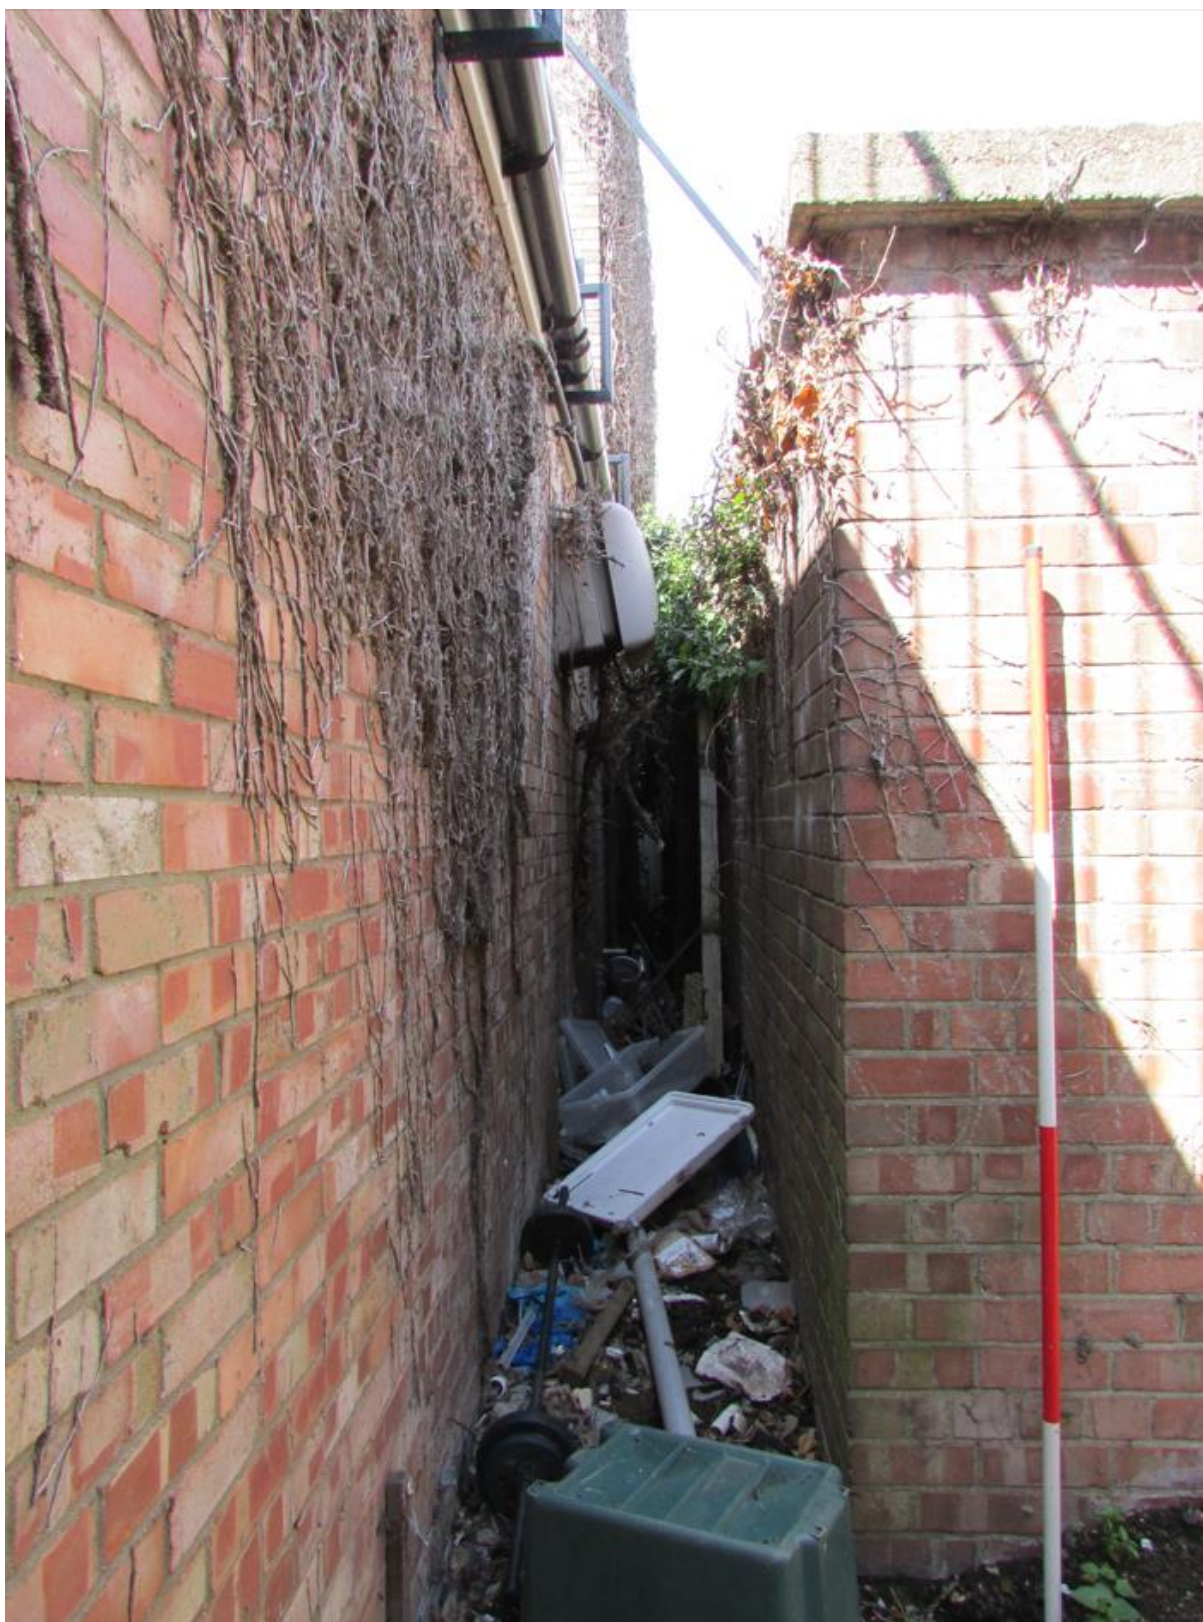
Plate 46: Narrow passage between no. 19 Station Street (left) and west elevation of air raid shelter, looking north IMG\_2375

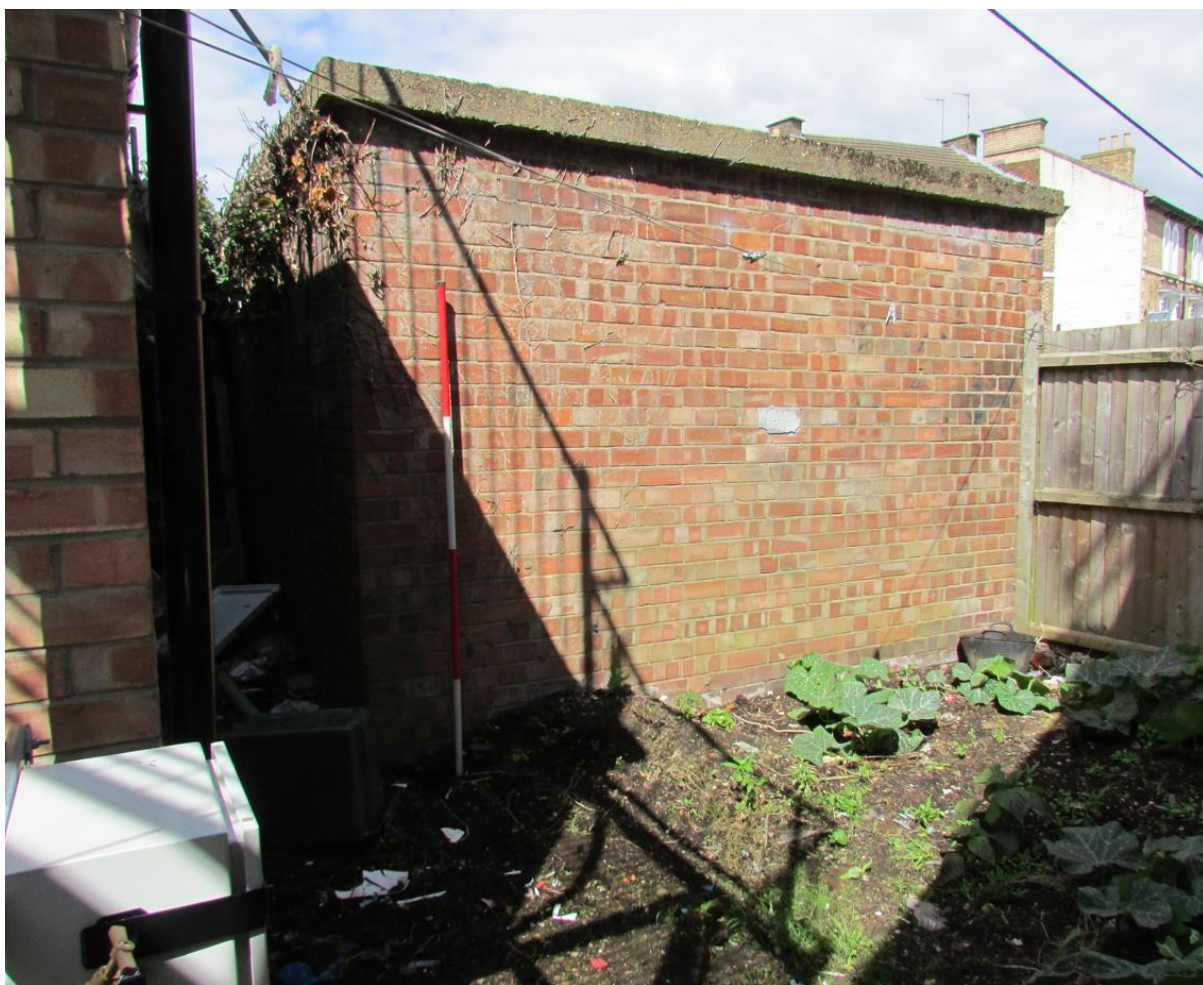
Plate 47: South elevation of the shelter, looking northeast IMG\_2374

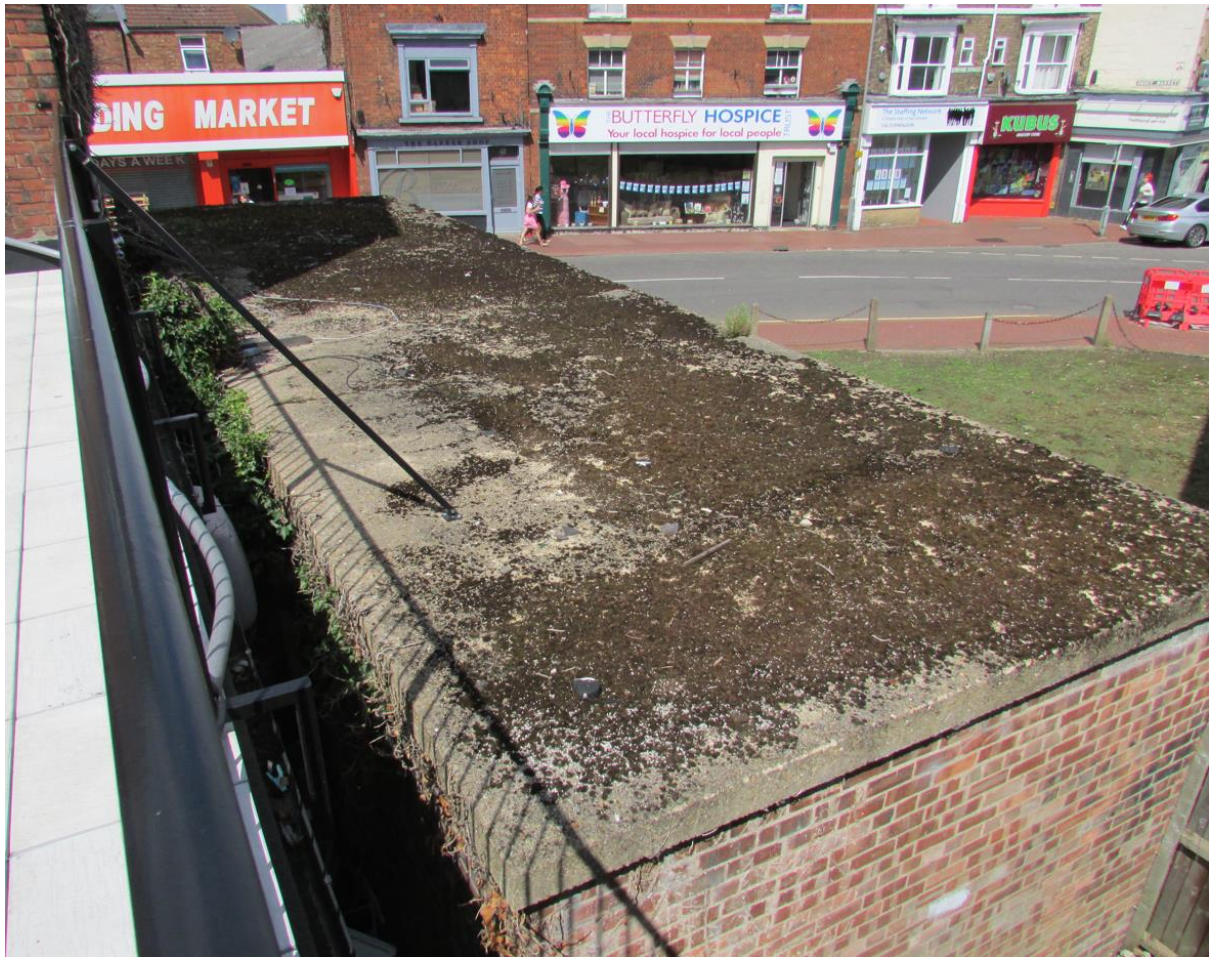
Plate 48: Concrete roof slab of the shelter, looking northeast from no. 19 Station Street flat IMG\_2377

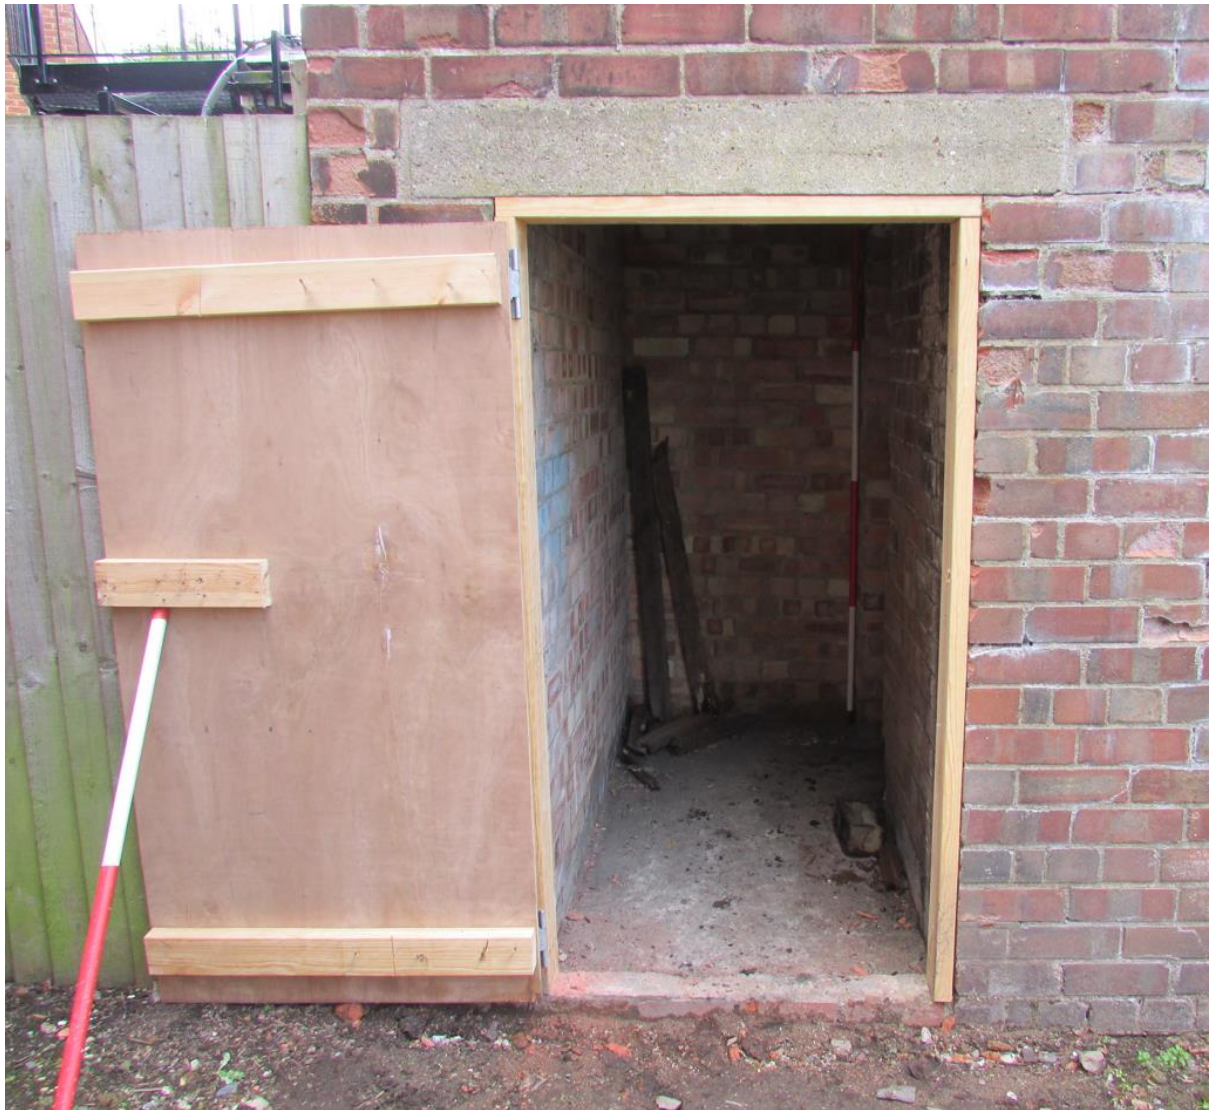
Plate 49: Outer south entrance to shelter showing interior of entrance lobby, looking west IMG\_2318

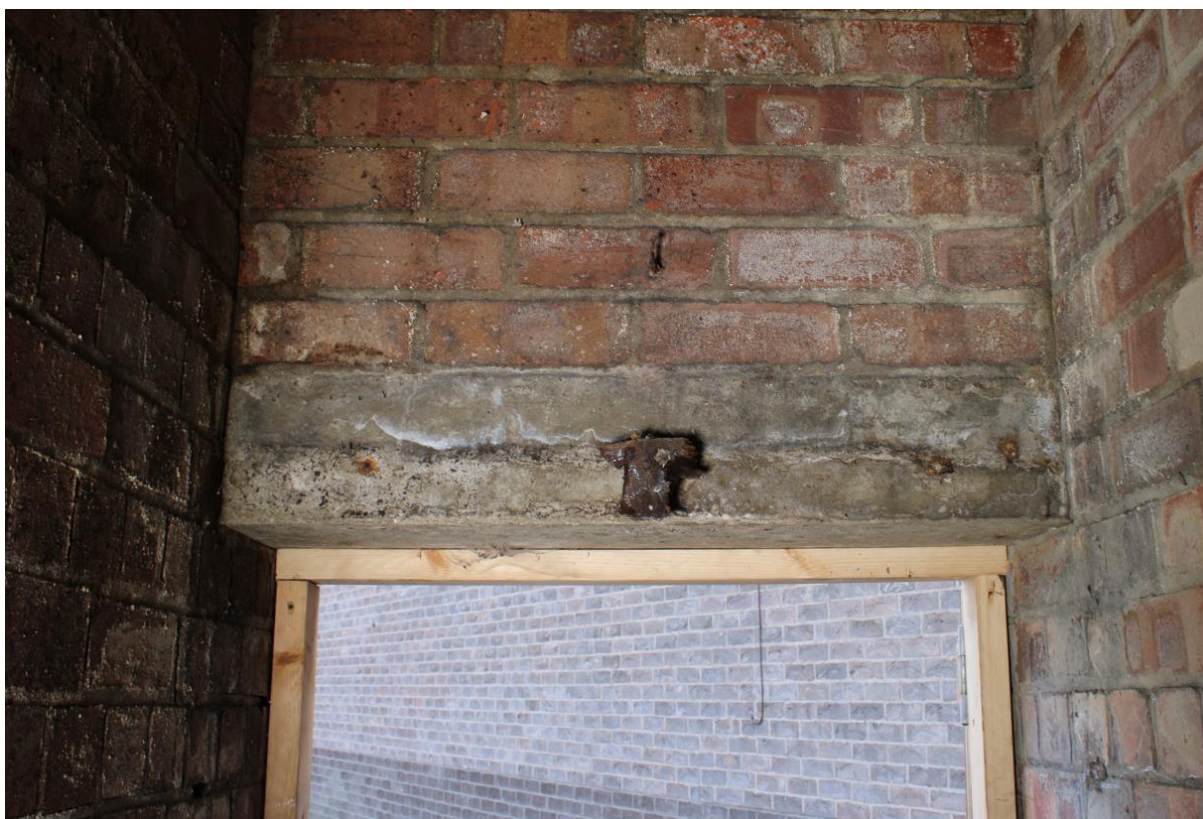
Plate 50: Rear face of concrete lintel over outer south entrance, showing wooden bracket and possible imprint of former timber doorframe attachment points in the brickwork below IMG\_1606

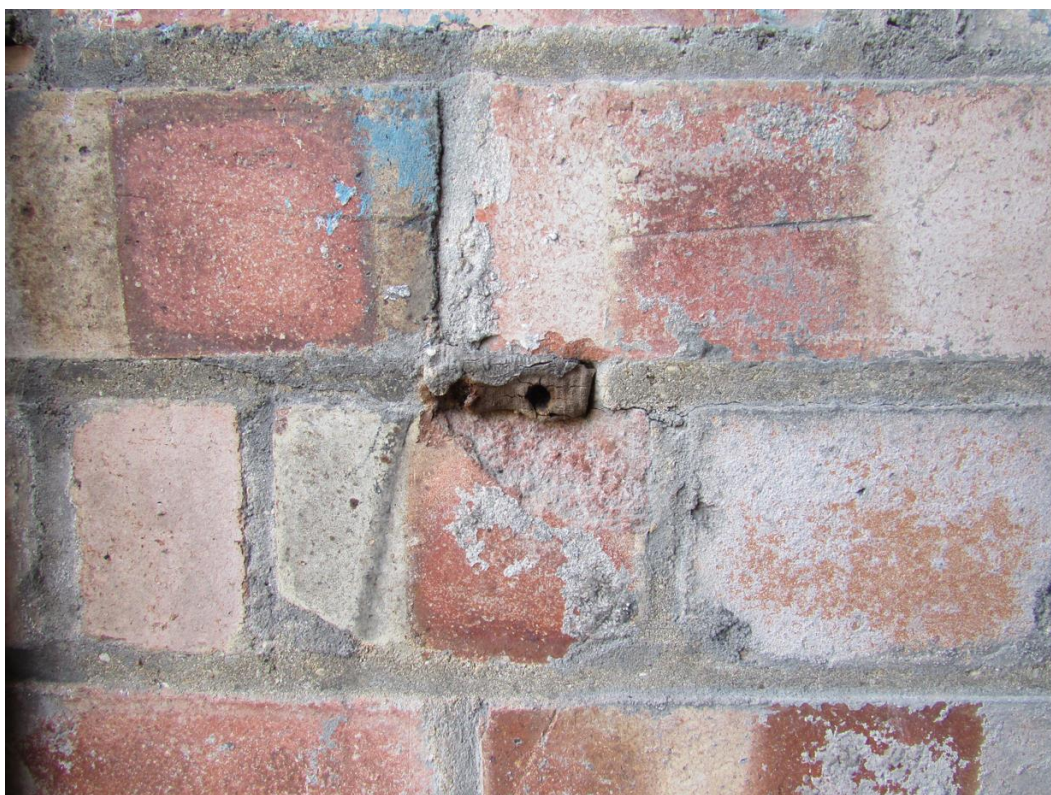
Plate 51: Close-up view of attachment point for possible doorframe in wall of outer south entrance IMG\_2323

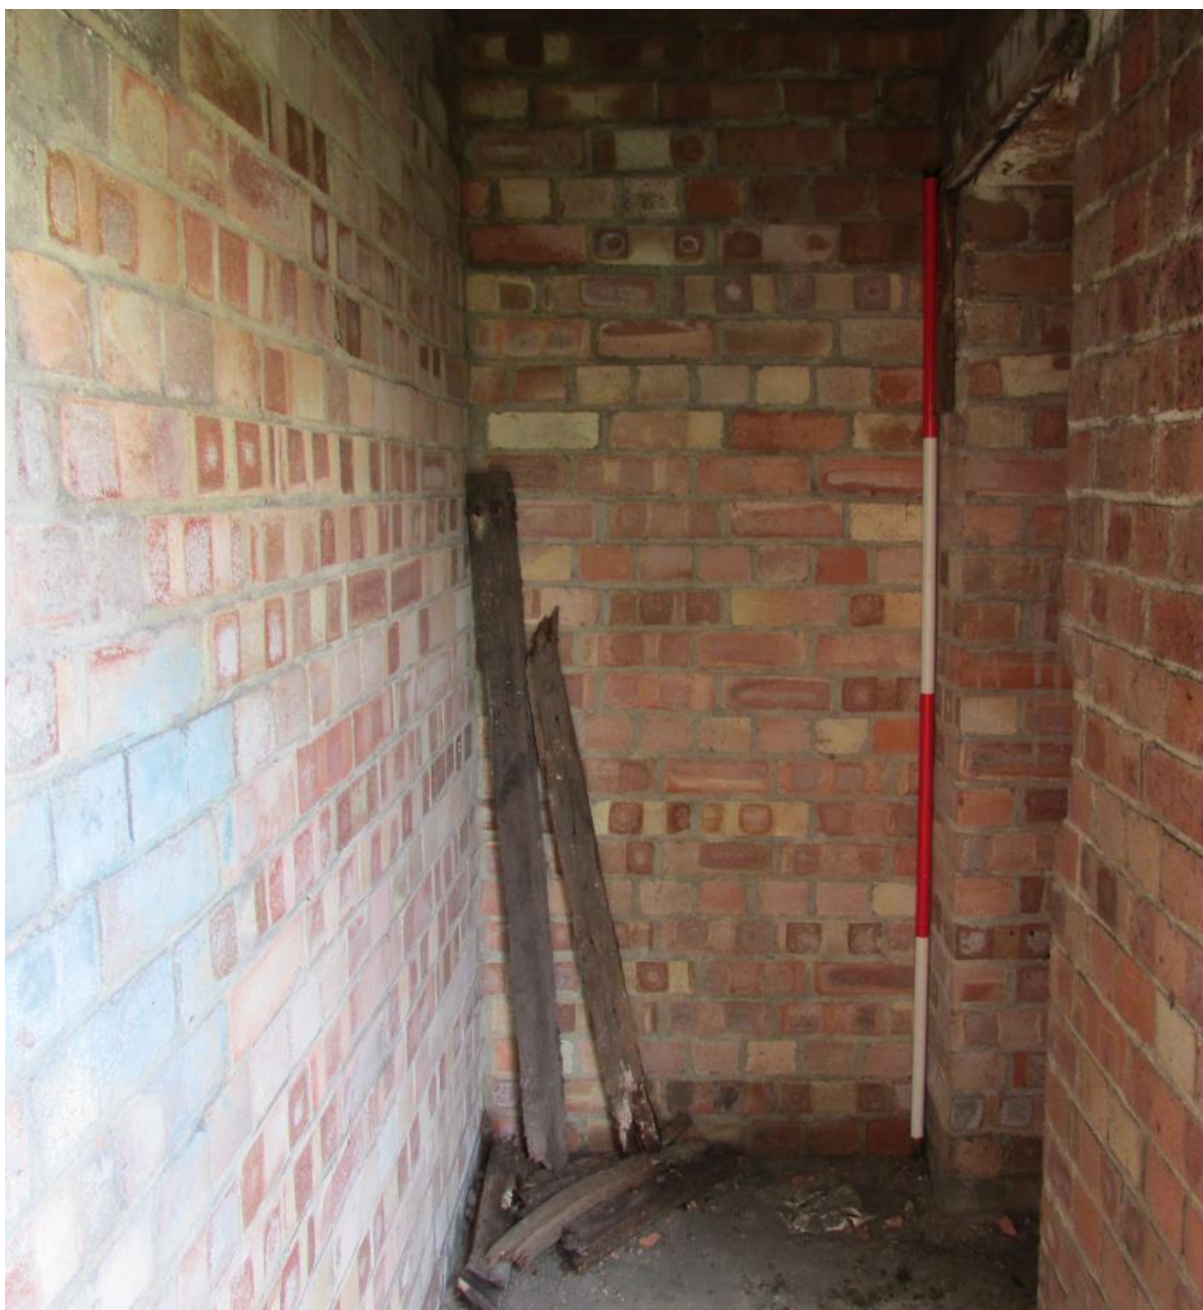
Plate 52: View of interior of south entrance lobby. The inner entrance to the shelter compartments is on the right IMG\_2319

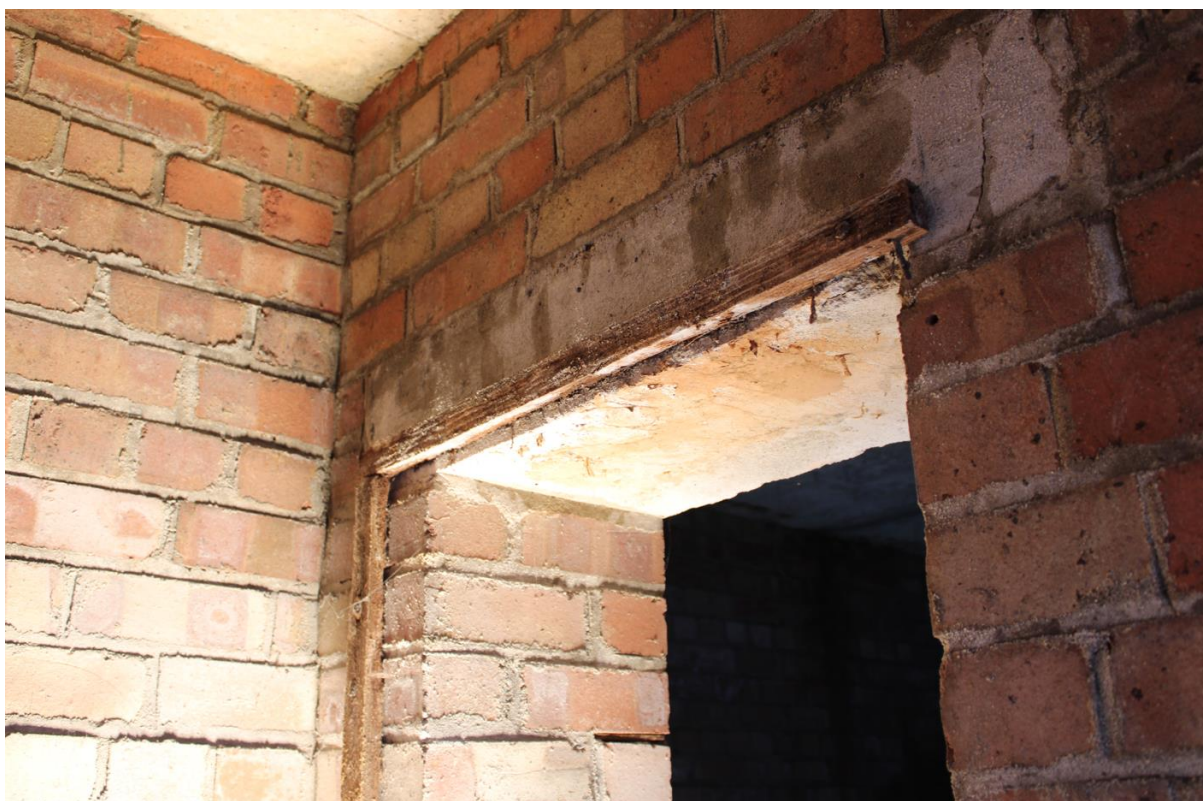
Plate 53: Close-up view of inner (south) entrance to shelter, showing incomplete simple timber frame and attachment point for probable gas curtain IMG\_1607

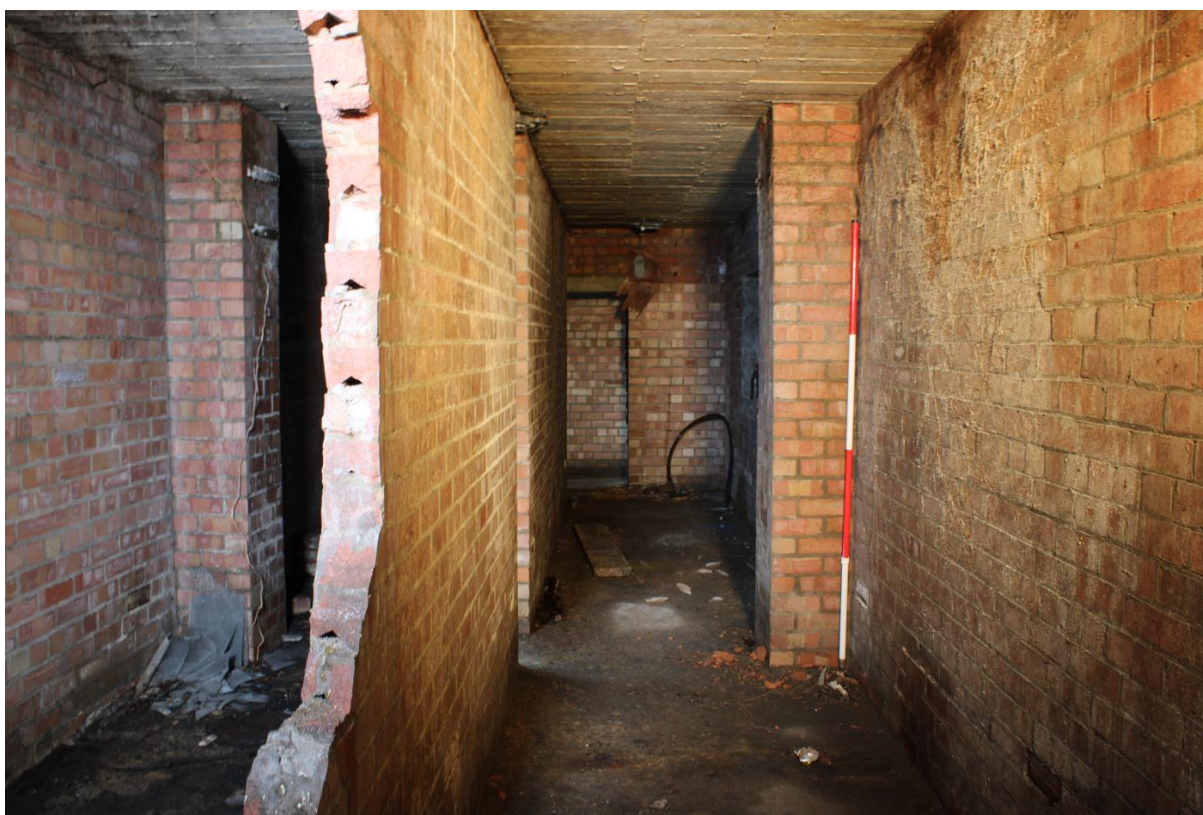
Plate 54: View of the interior of the shelter, showing central partition wall and compartments on either side, looking north towards the inner (north) entrance IMG\_1498)

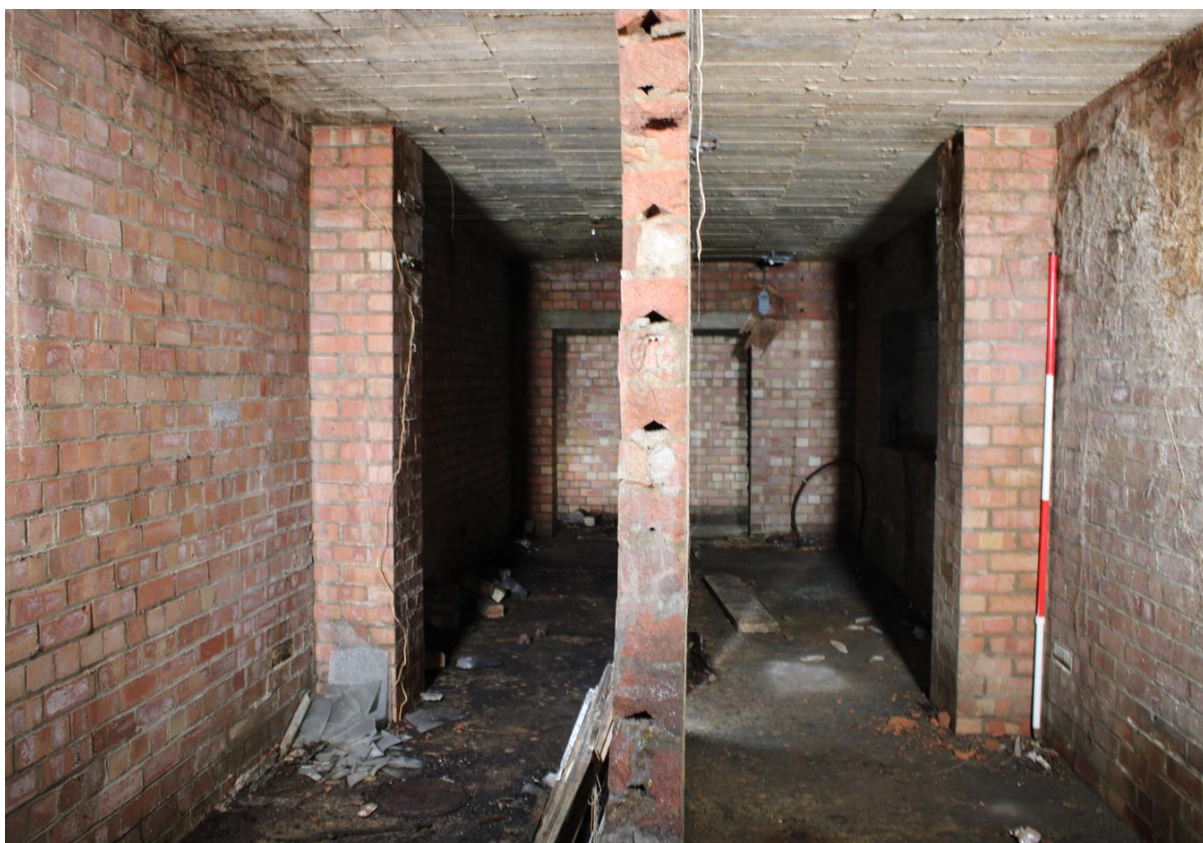
Plate 55: Another view of the interior, showing compartments on each side of central wall and north cubicle (left) inner (north) entrance (right) at the far end, looking north IMG\_1501
