*Air raid shelter*

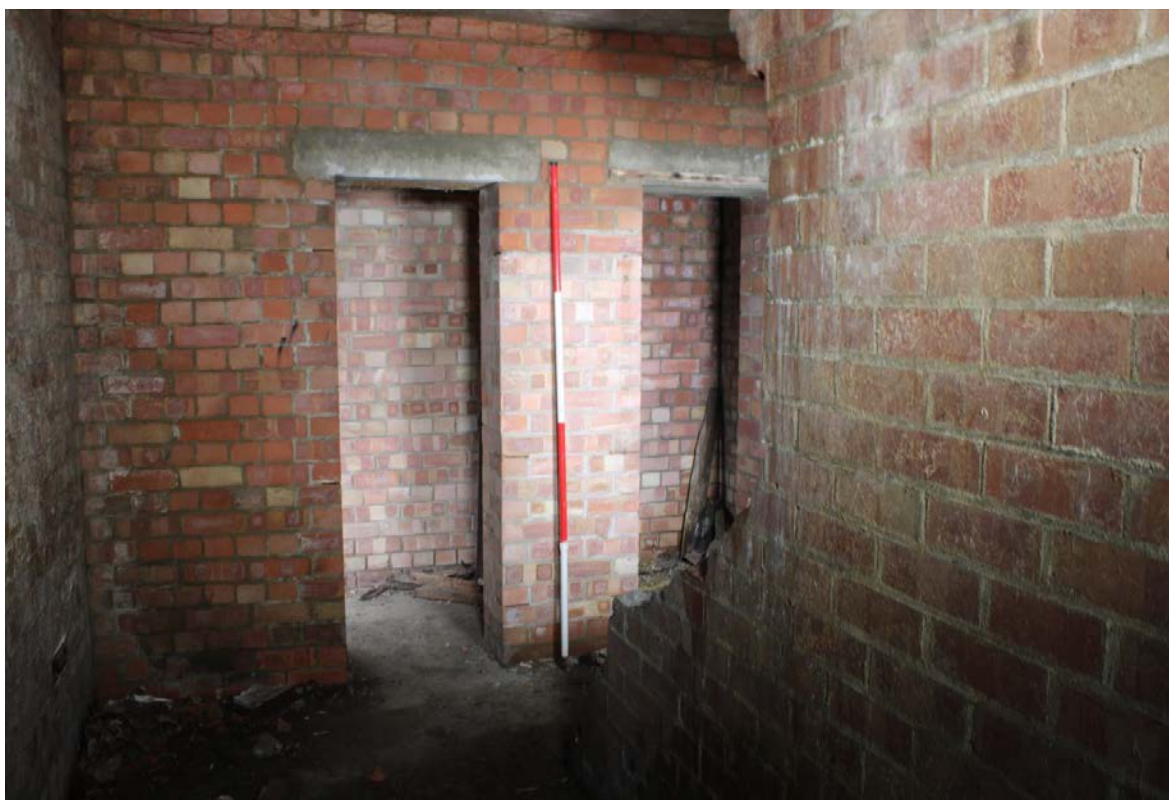
Plate 56: Interior view of inner (south) entrance (left), partially demolished central partition wall (nearest to camera) and south cubicle IMG\_1510

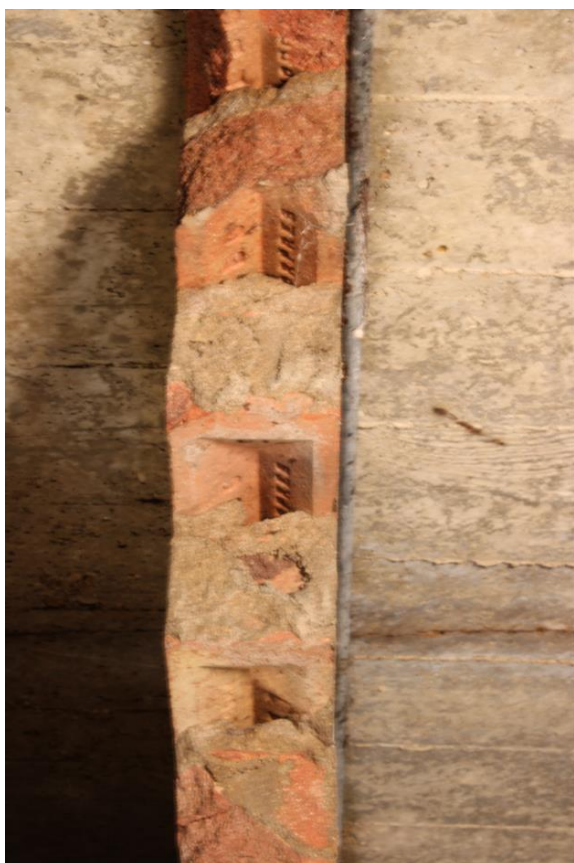
Plate 57: Detail view showing LBC 'PHORPRES' Fletton bricks used in the construction of the central partition wall IMG\_1592

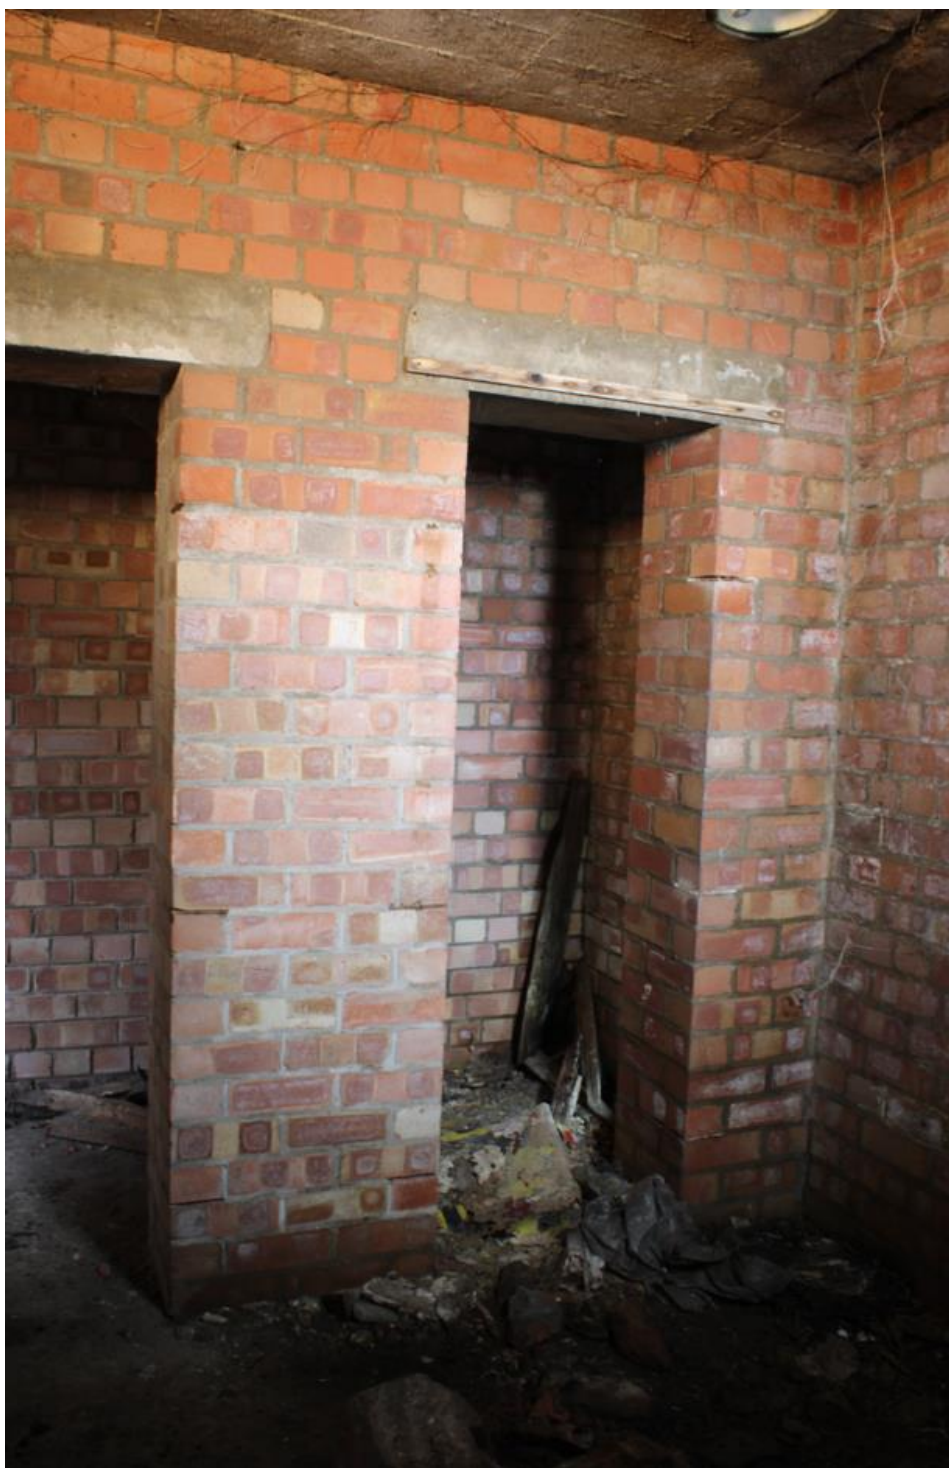
Plate 58: Inner (south) entrance (left) and entrance to south cubicle (right), looking southwest  
IMG\_1581

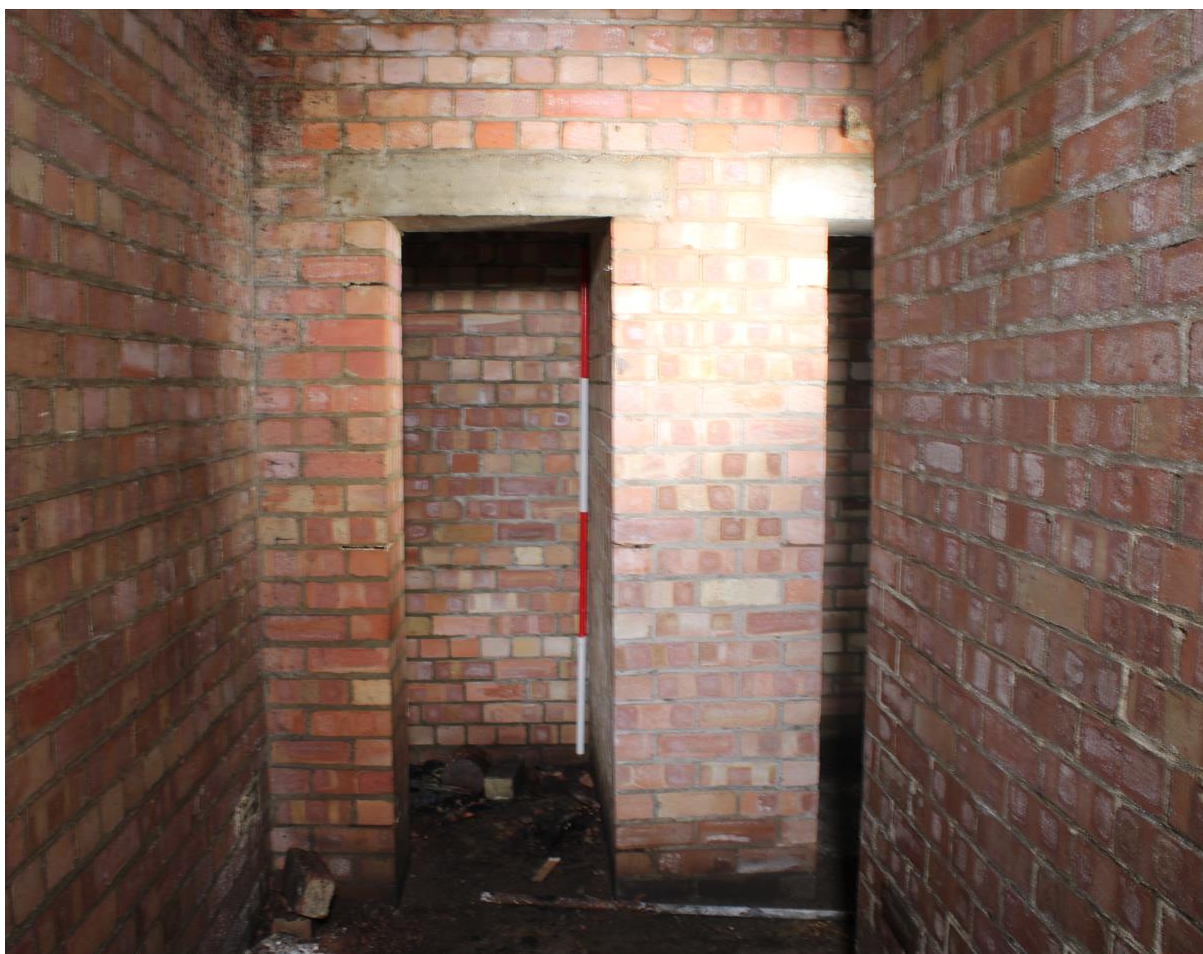
Plate 59: Entrance to north cubicle (left) and inner (north) entrance, looking northeast IMG\_1526

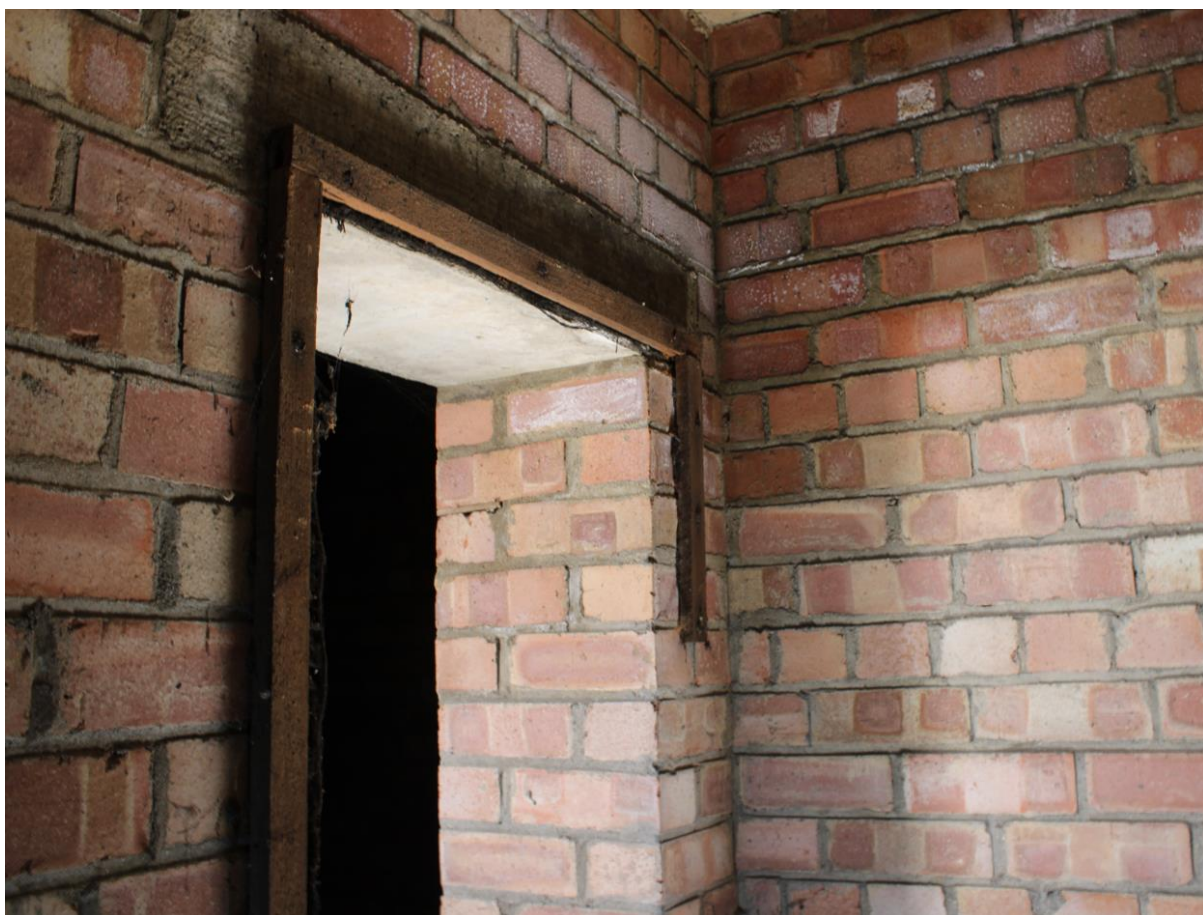
Plate 60: Timber frame attached to outer face of inner (north) entrance, looking southwest IMG\_1539

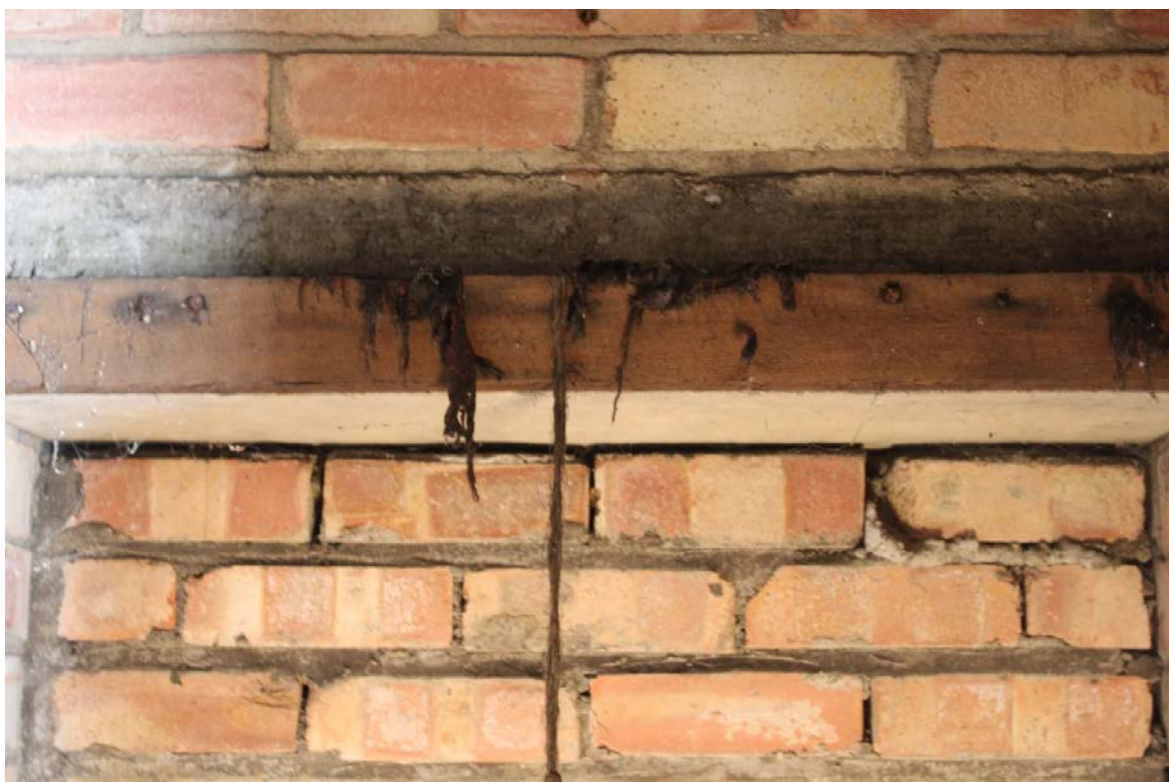
Plate 61: Remains of the gas curtain at the inner north entrance to the shelter IMG\_1533

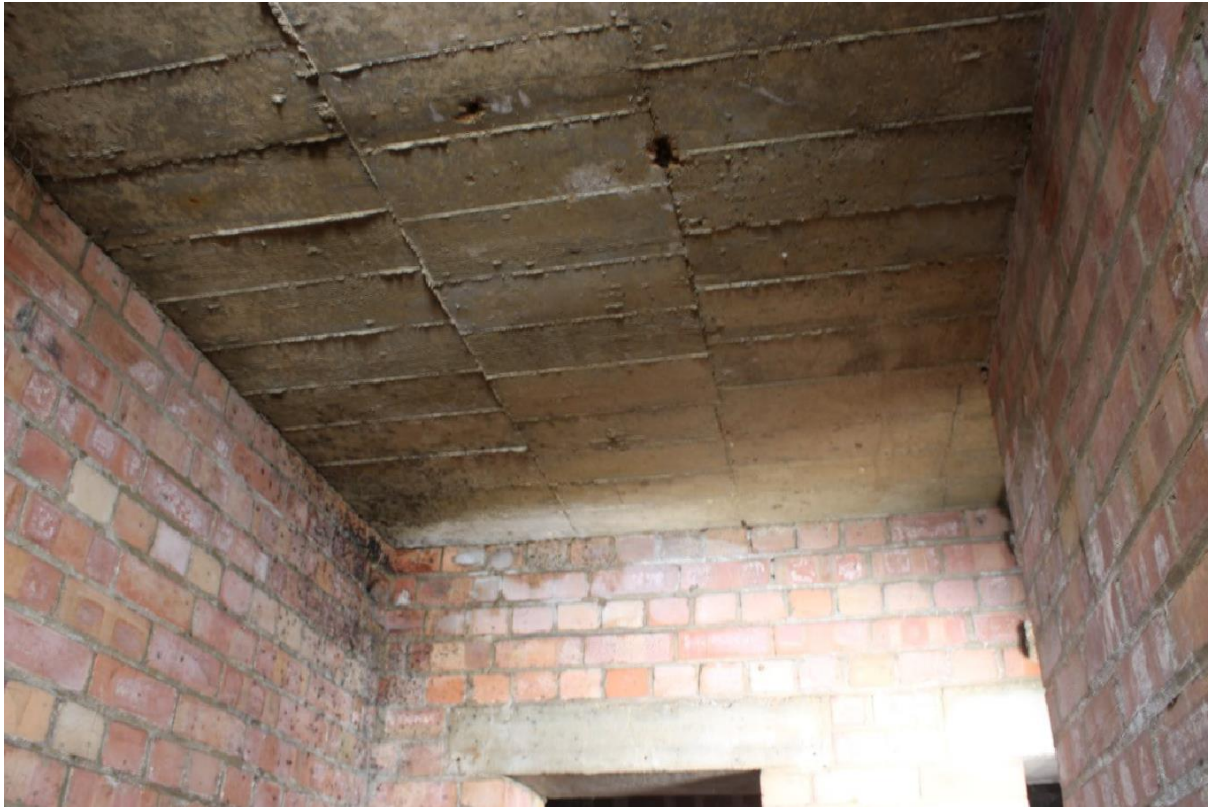
Plate 62: Imprints of timber shuttering in the concrete roof slab IMG\_1528

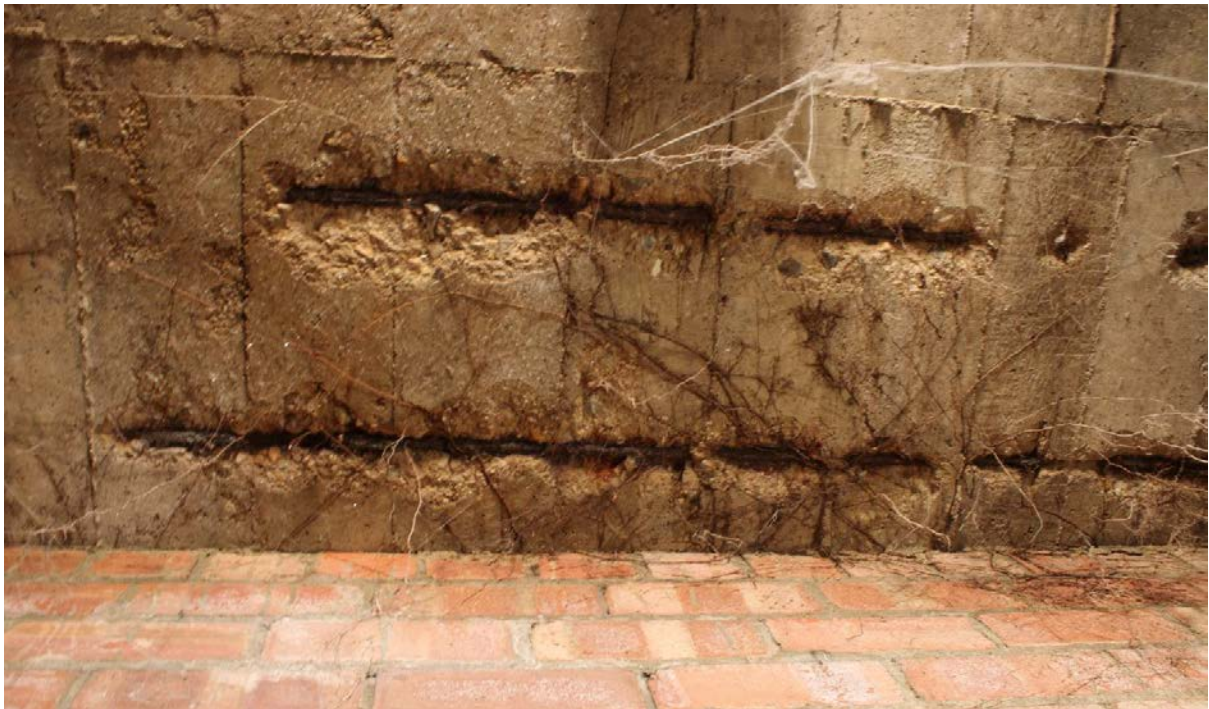
Plate 63: Exposed longitudinal metal reinforcing bars in the concrete roof slab IMG\_1586

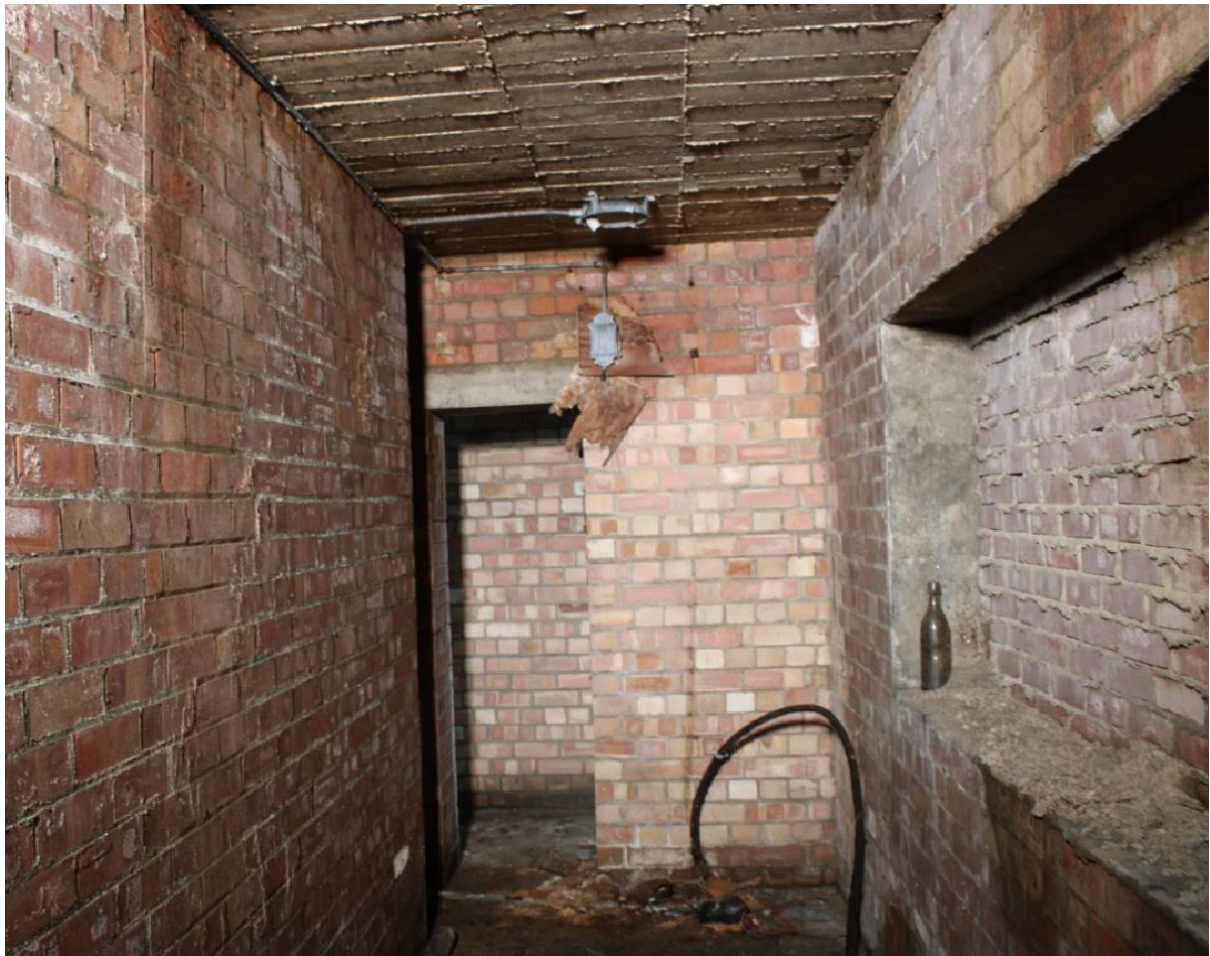
Plate 64: North end of the eastern compartment of the shelter, showing the mains electricity cable (bottom right). The high-level fuse board and a junction box can be seen above the lintel of the inner (north) entrance IMG\_1548

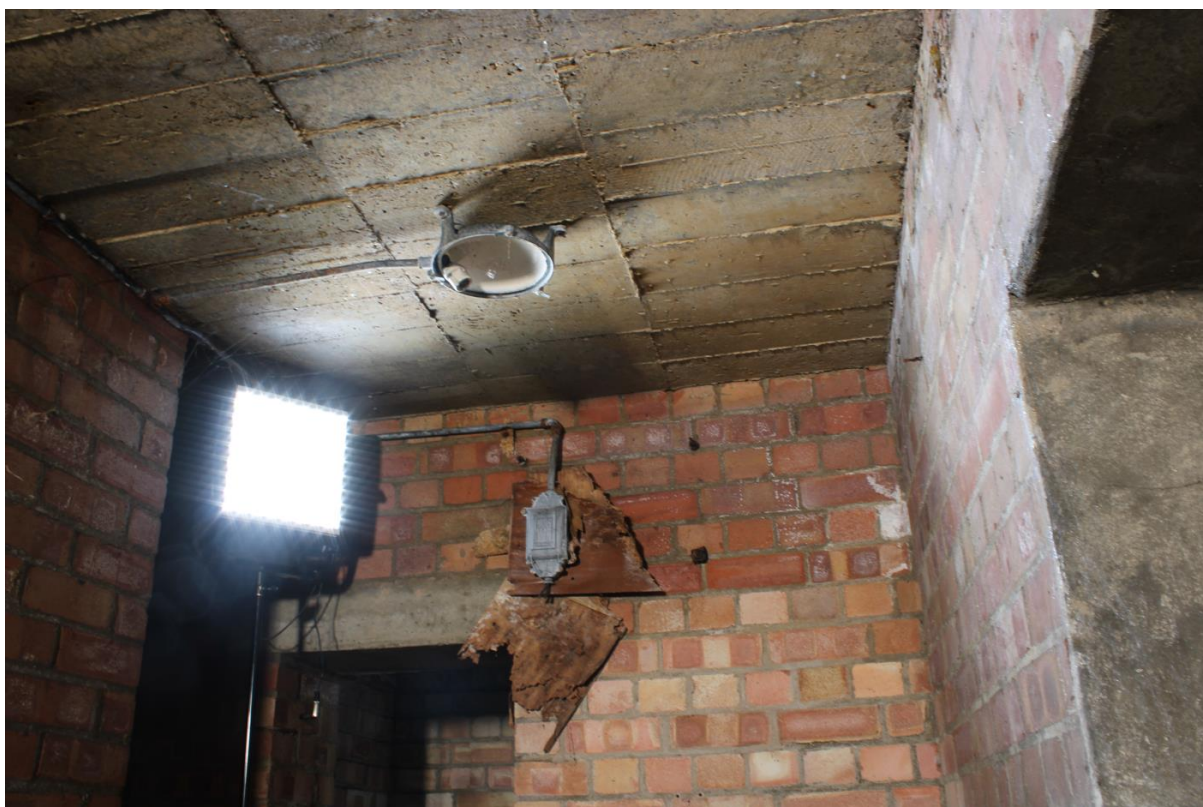
Plate 65: Junction box and board at northern end of east compartment, showing in-situ ceiling light fitting IMG\_1562

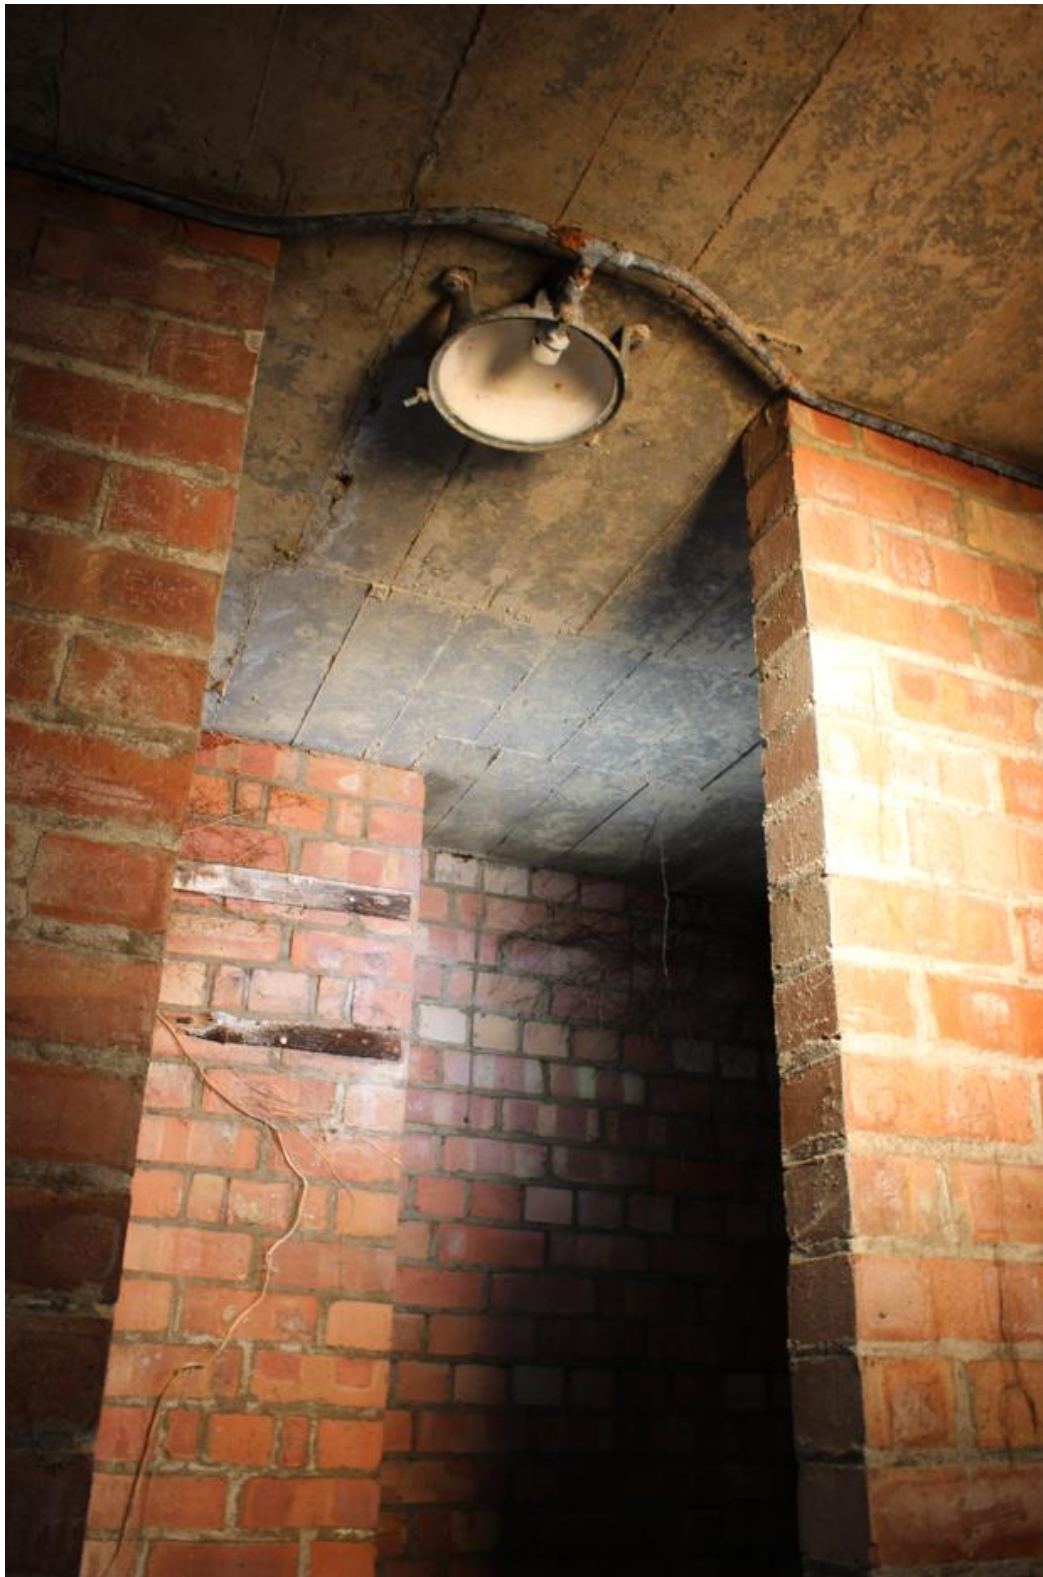
Plate 66: Ceiling light fitting in the centre of the shelter, illuminating both east and west shelter compartments IMG\_1570

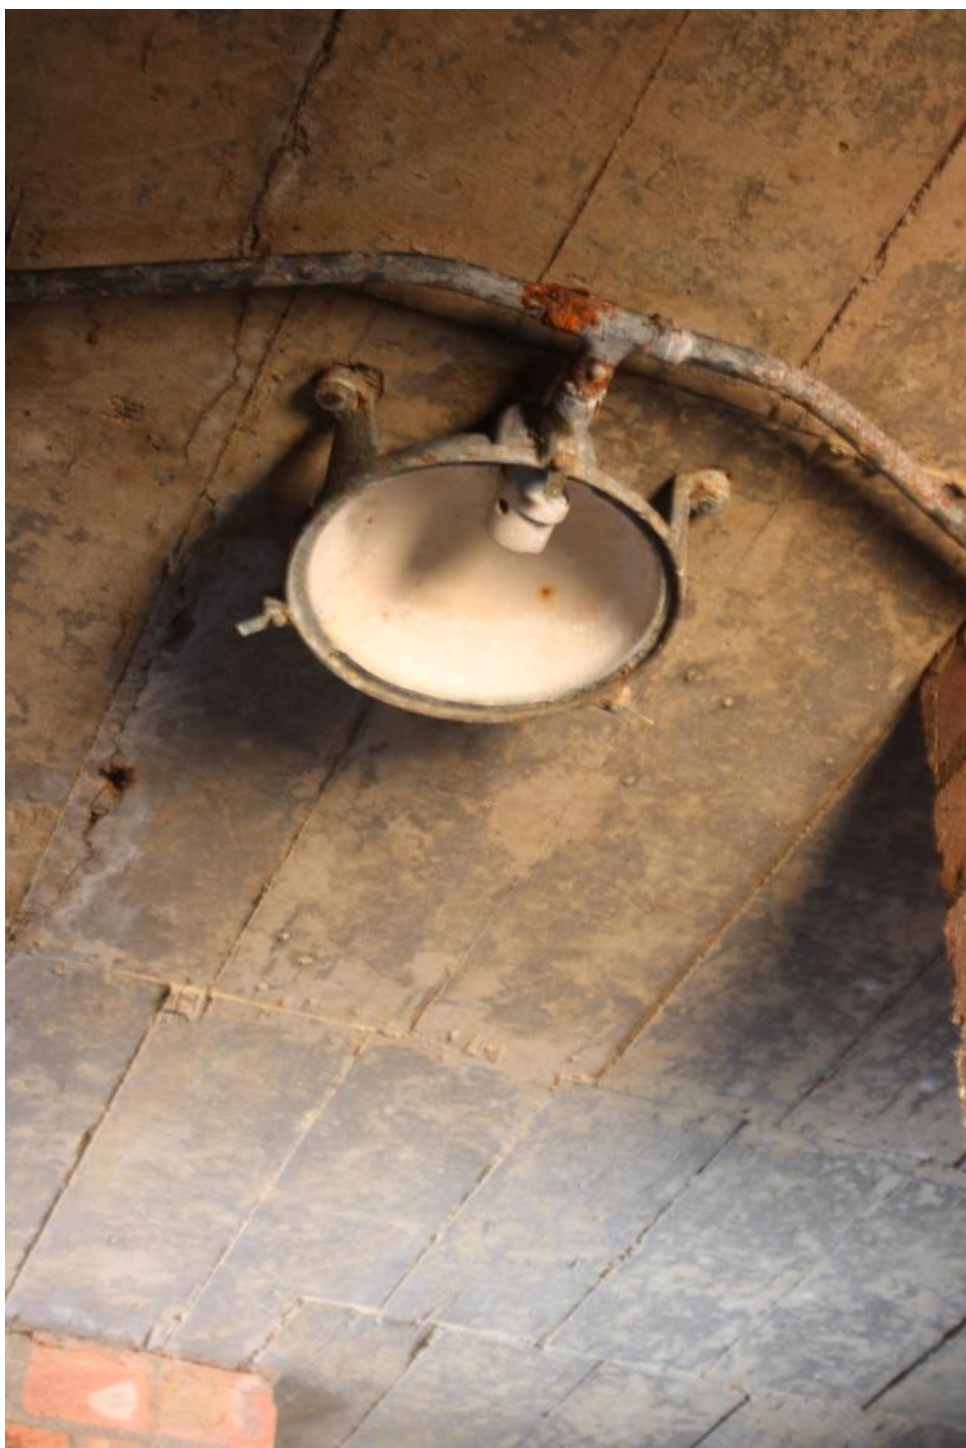
Plate 67: Detail view of central ceiling light fitting, showing method of attachment to roof slab  
IMG\_1571

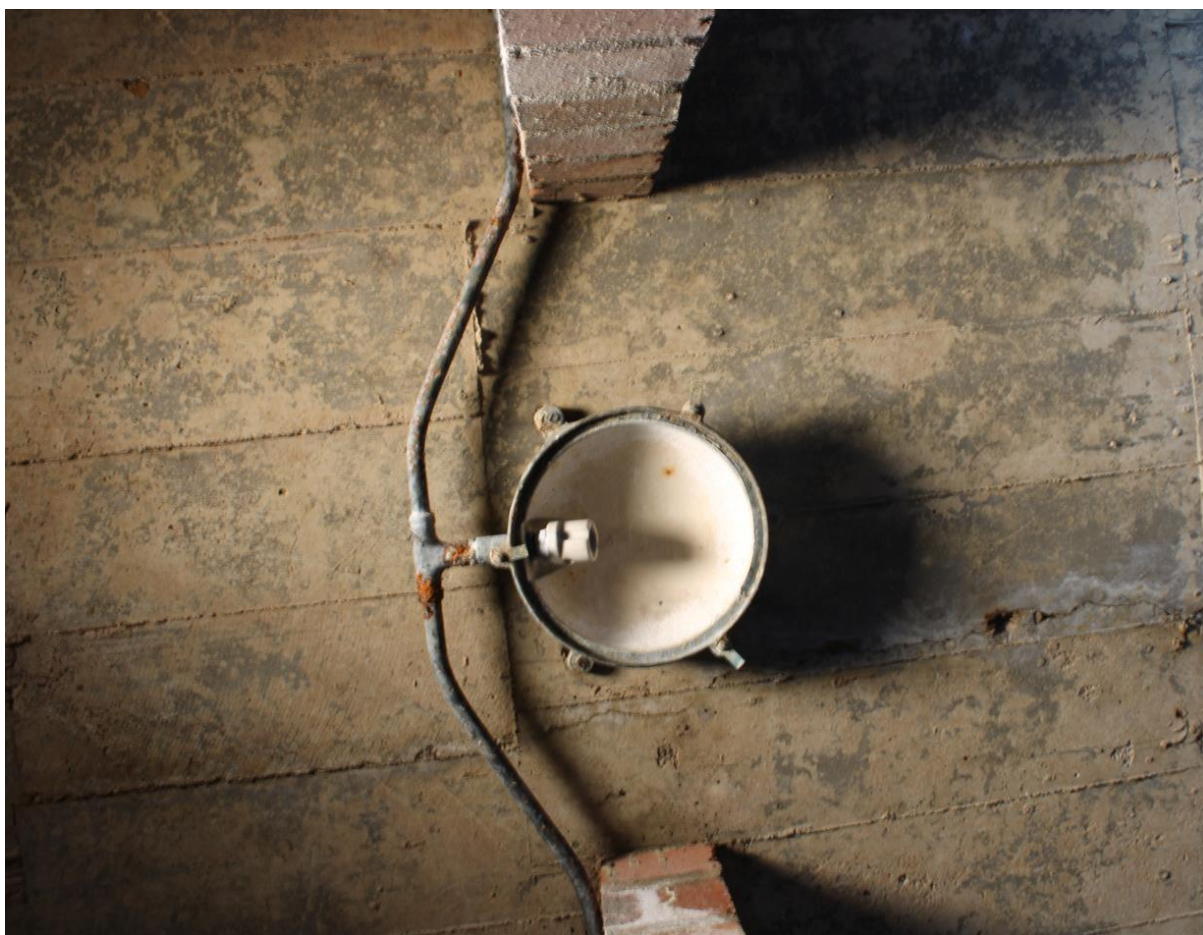
Plate 68: Detail view of central light fitting, showing method of attachment for bulb IMG\_1576

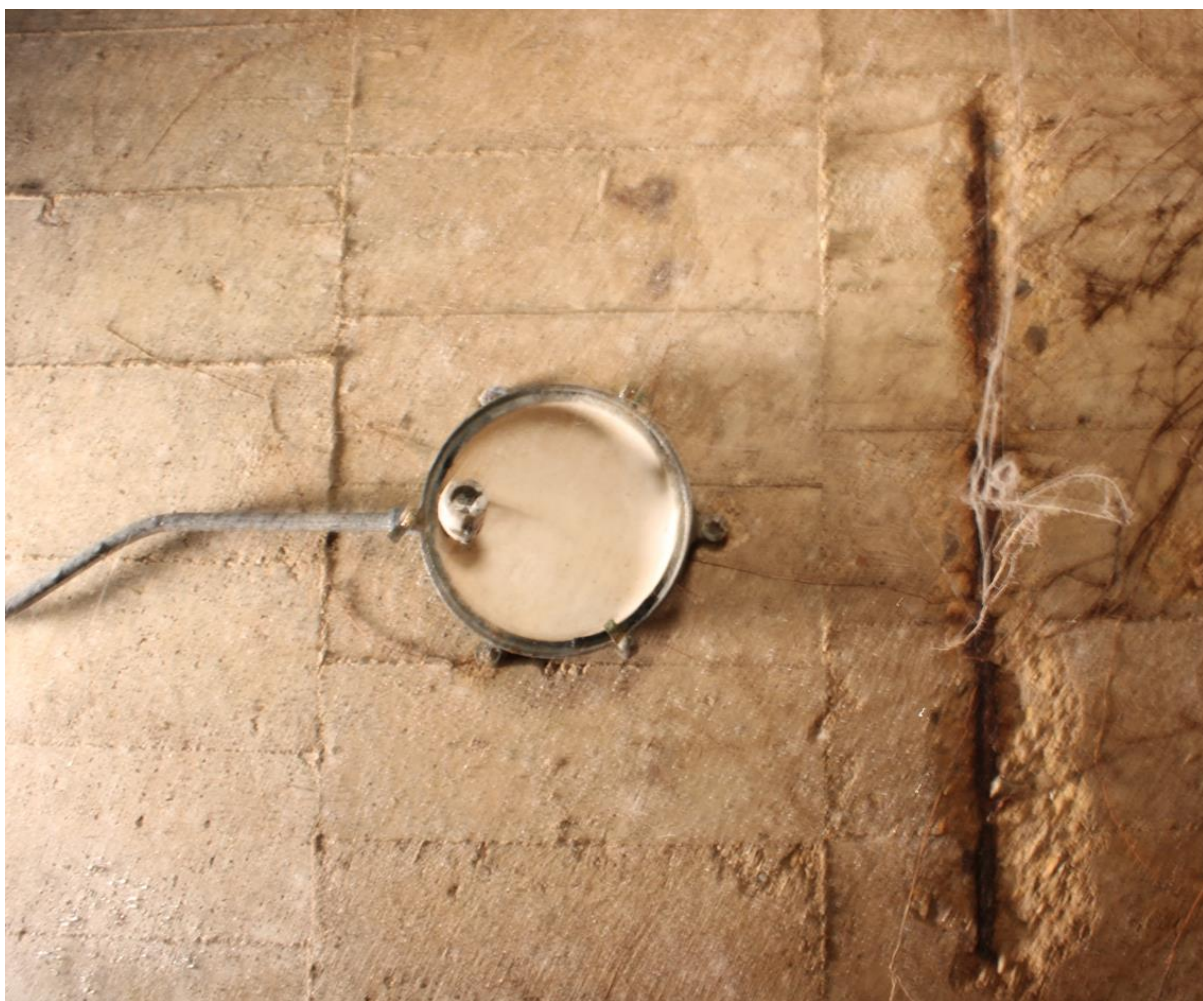
Plate 69: Ceiling light fitting at the south end of the shelter. This would have illuminated the area inside the south entrance to the building IMG\_1585

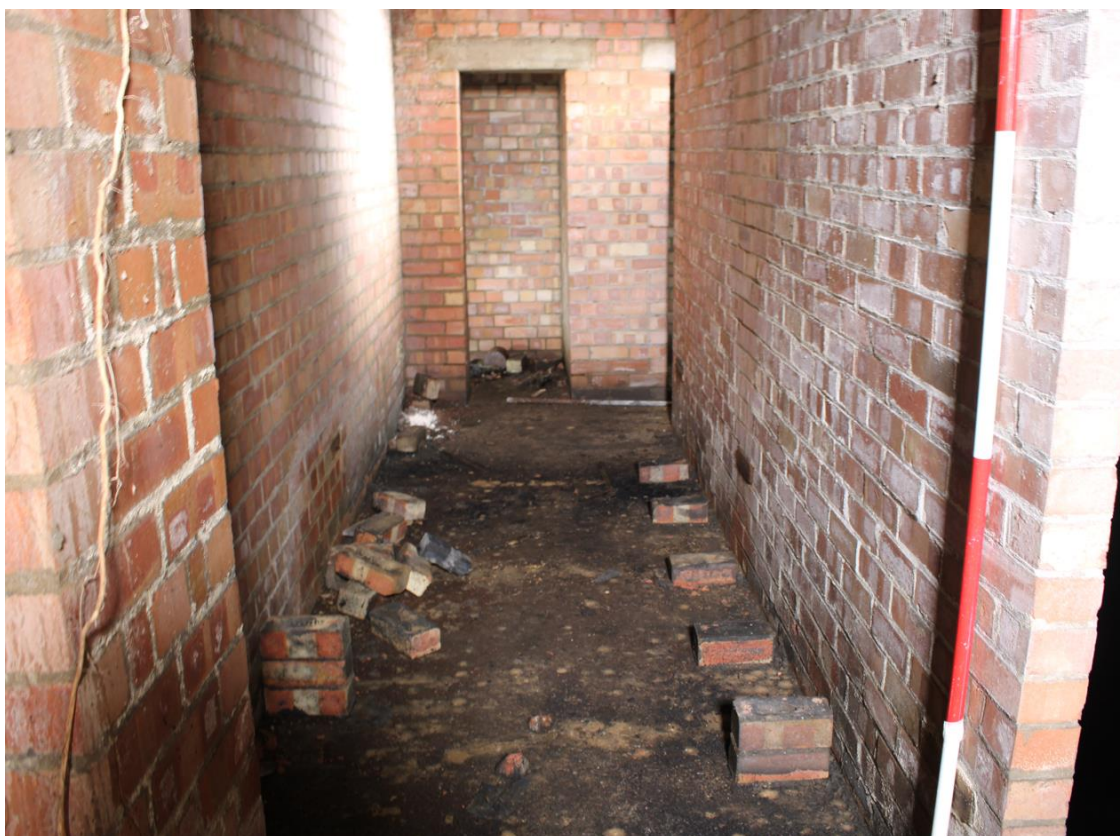
Plate 70: Brick supports for bench seating on the floor of west shelter compartment, north end  
IMG\_1520

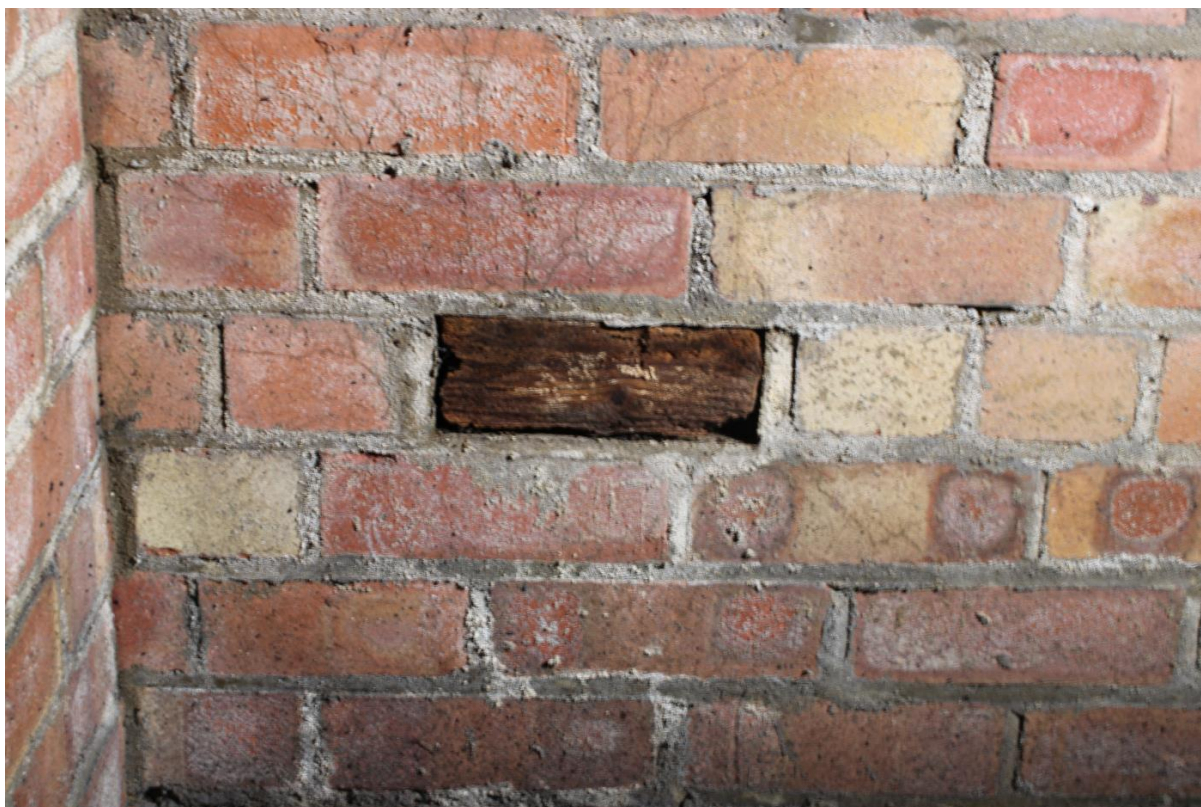
Plate 71: Timber anchor for probable bench seating in west [?] shelter compartment IMG\_1578

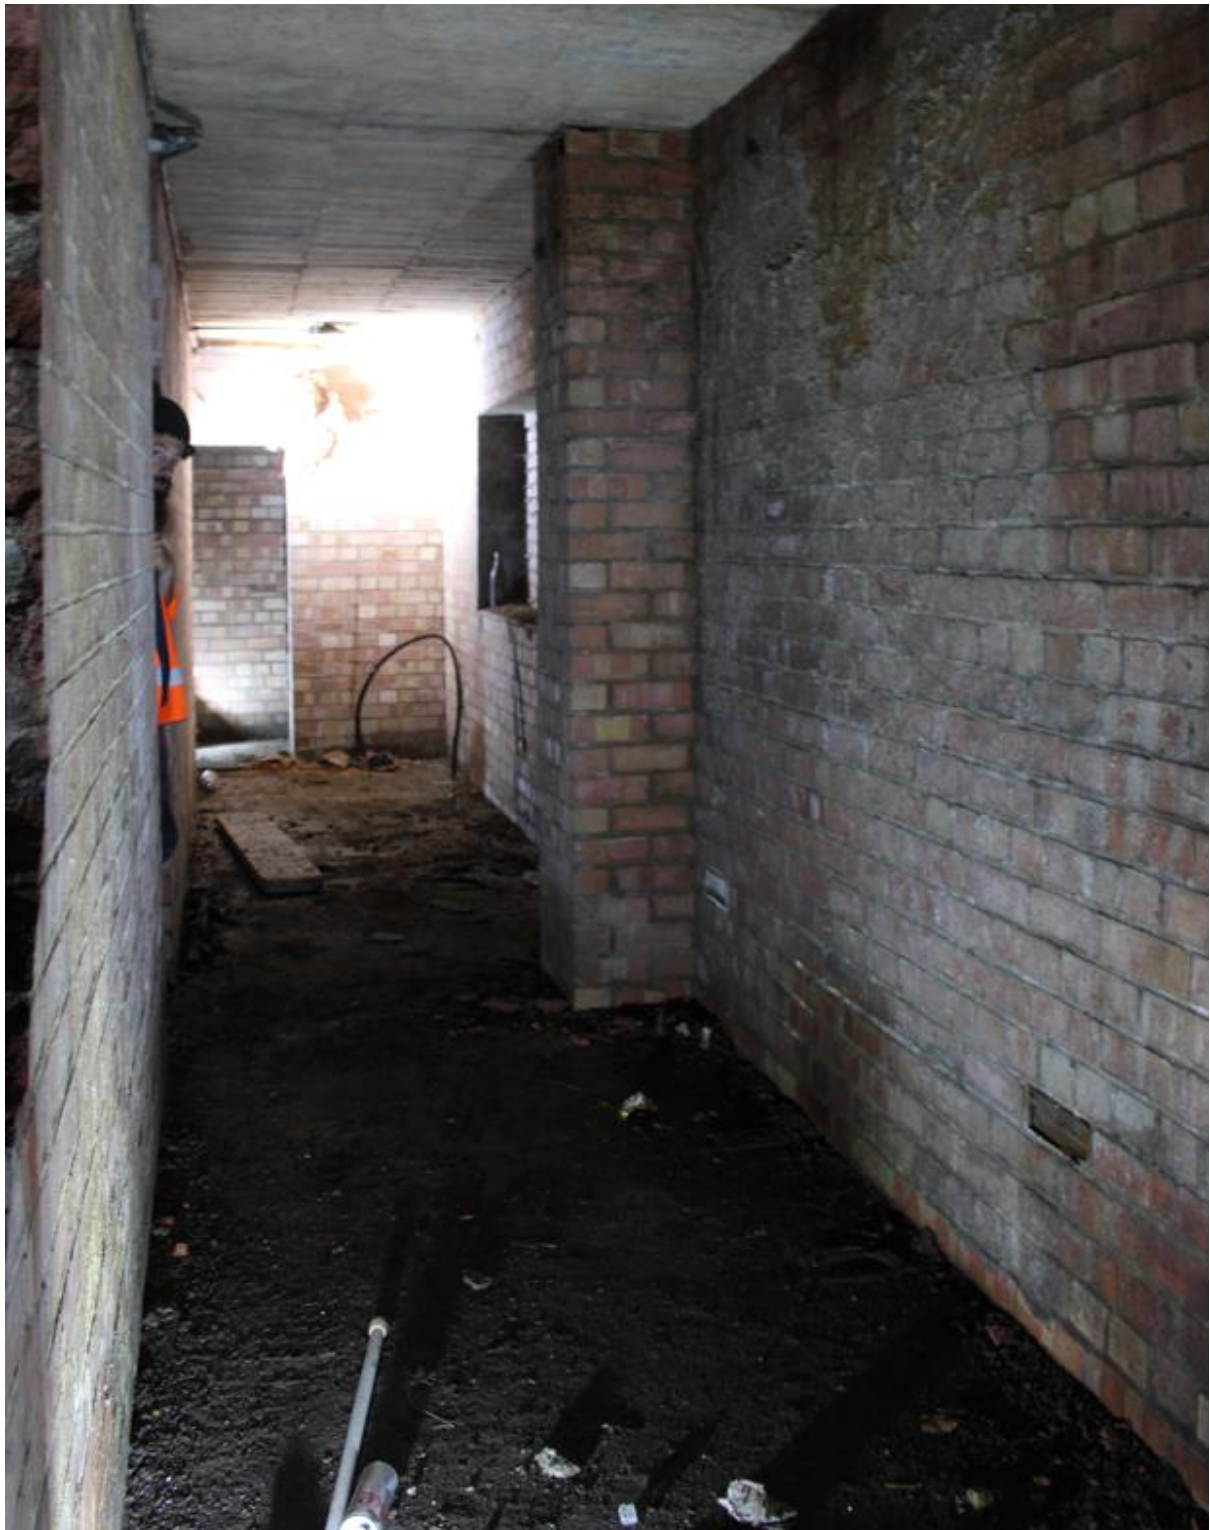
Plate 72: Timber anchor for probable bench seating in east shelter compartment; the block has been inserted in the inner face of the east elevation of the shelter IMG\_1595

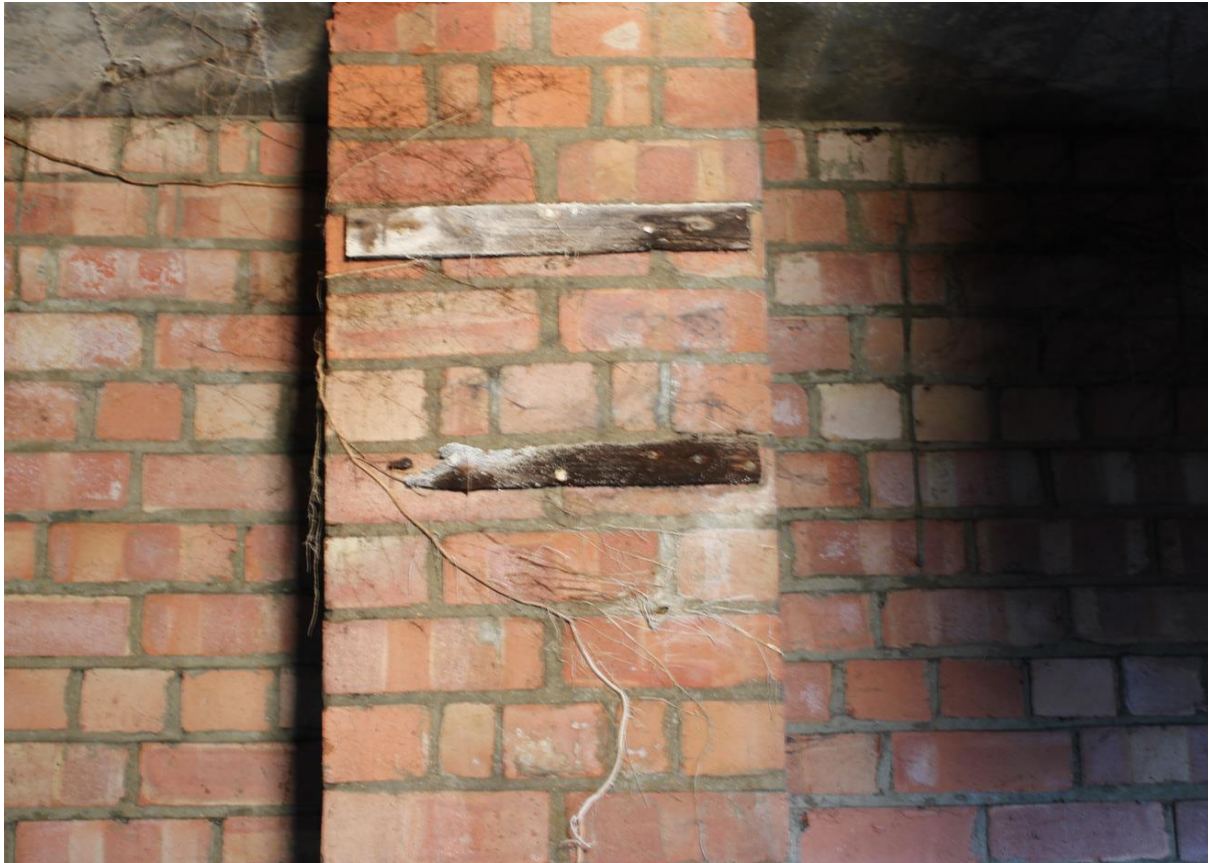
Plate 73: Timber battens attached to central brick pier in west shelter compartment IMG\_1577

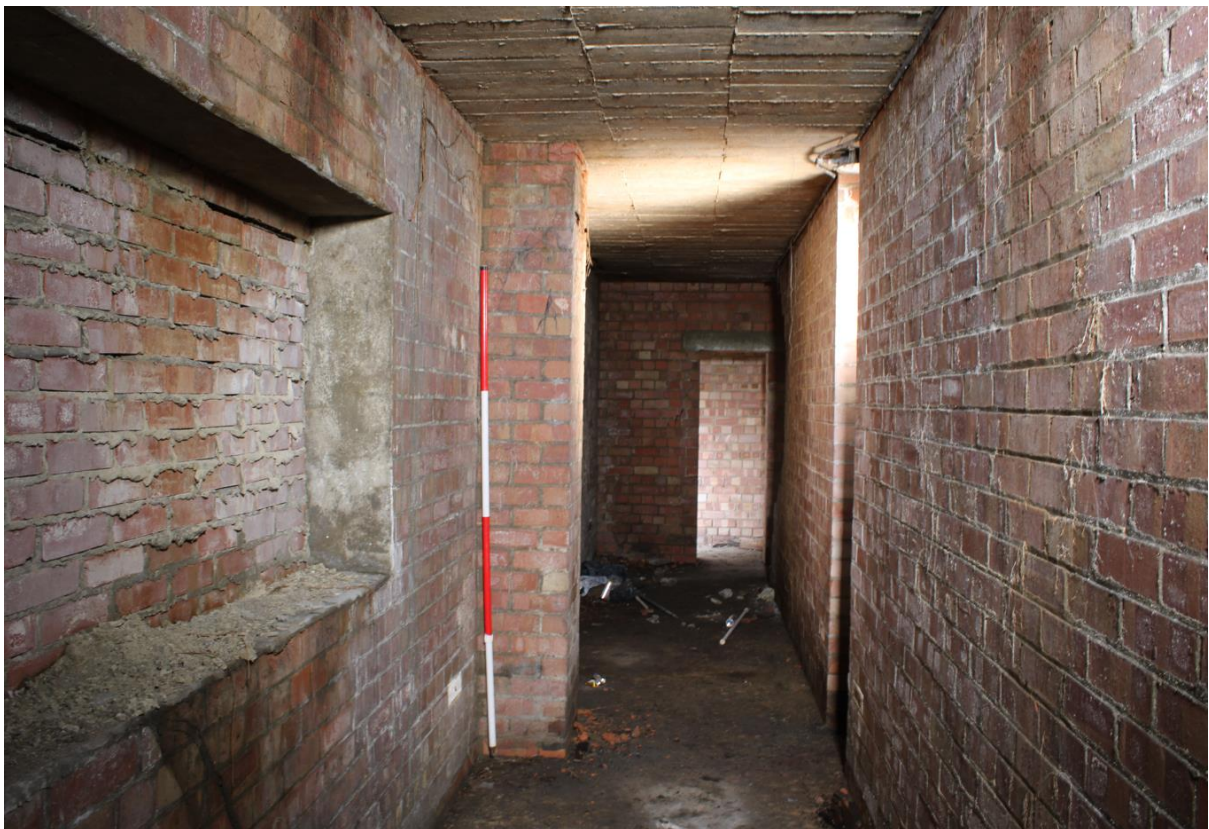
Plate 74: Infilled post-war window opening in east wall of the shelter, looking south IMG\_1558
