## Spalding Gentlemen's Society Structural Condition Report

**Ref:** 180615/D Hubbard

**Date:** 04 March 2021

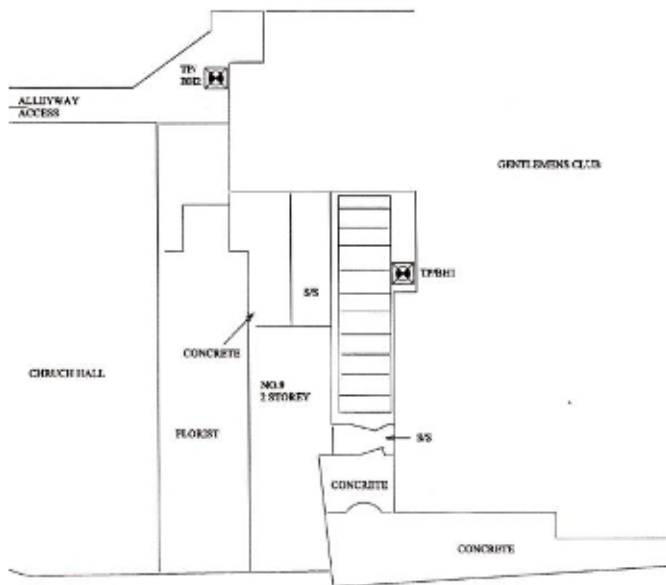
Figure 2 - CET Ground Investigation Locations

The ground investigation found that the existing foundations were founded on Made Ground at 0.7m below ground level. The foundations comprised of concrete strip footings and extended 200-250mm beyond the face of the wall.

Generally, the ground conditions comprised of Made Ground to a depth of 1.0m overlying a combination of clayey silt and sand. The laboratory testing results found the clayey, silty Made Ground to have a plasticity index of 21-23% which means that it would be categorised as having Medium Volume Change Potential.

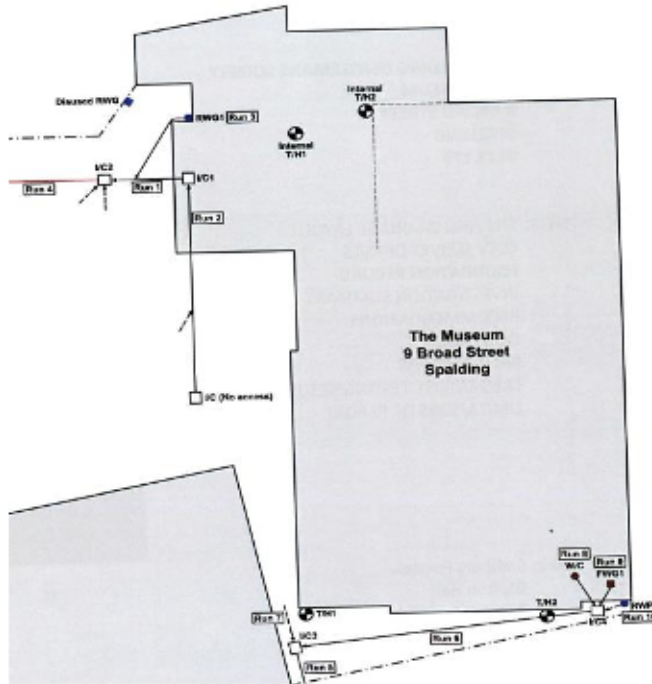
Figure 3 - DRC Ground Investigation Locations

The existing foundations to the front elevation were found to be formed of corbelled brickwork founded at 0.7m below ground level. The corbelled brick foundation to the Strong Room was founded at 0.55m below floor level.

The report categorised the ground as either silt or clay and all samples tested were found to have a Medium Volume Change Potential.

The ground floor slab within the Maples Room was found to be 150mm thick unreinforced concrete and is formed on 200mm of fill material.

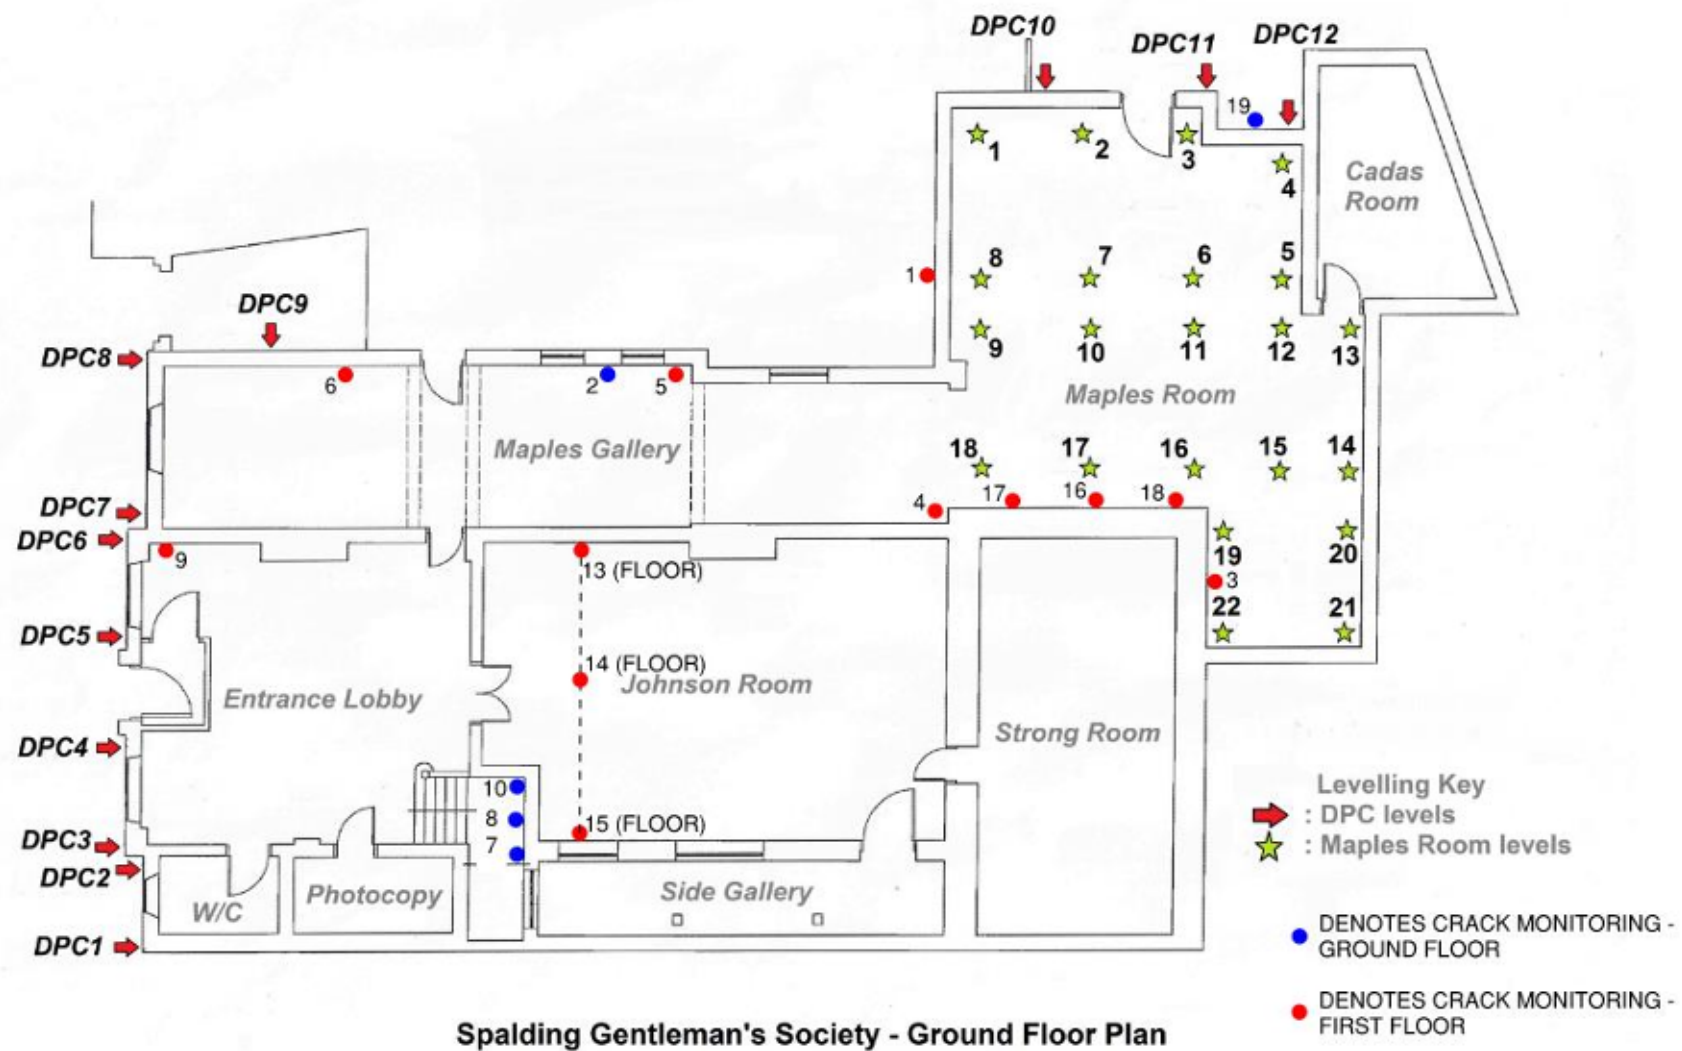
Figure 5 - Monitoring Key Plan

- 4.3 The movement of these cracks appears to be reasonably stable with the maximum change since November 2018 being 0.89mm (Location 2) and since October 2011 being 1.99mm in the same location.
- 4.4 The overall crack movements recorded since both October 2011 and the commencement of the latest monitoring in November 2018 are shown in Figure 6 below.

- 4.6 The cracks have widened slightly since the initial visit in November 2018 by a maximum of 0.73mm (Location 12). Again, there appears to be a degree of opening / closing of these cracks between readings as shown by the fluctuations on graphs 3 and 4 in Appendix B.
- 4.7 Several cracks have also reduced in width when compared to the initial set of readings in November 2018. This is shown in Figure 7 below with the negative values indicating readings where the crack widths have decreased.

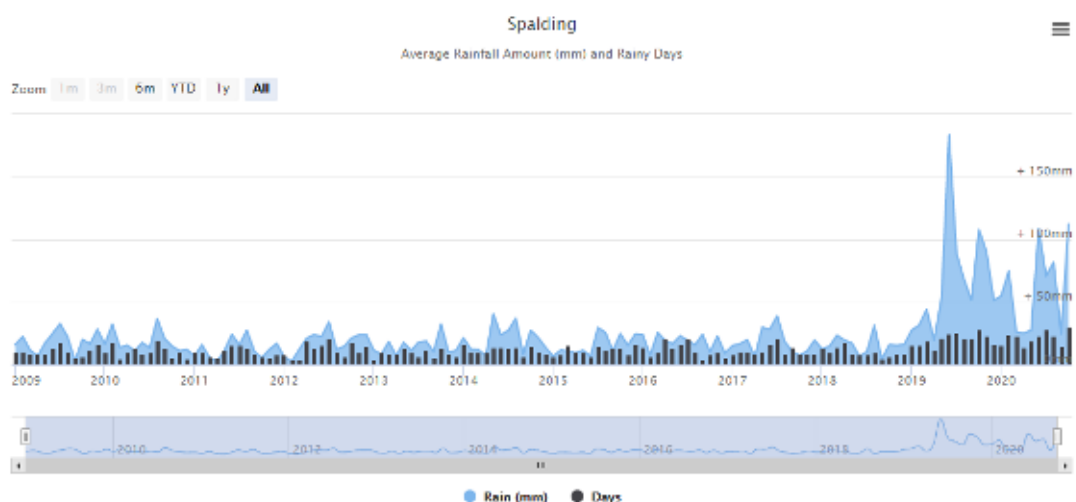
Figure 8 - Spalding Rainfall Data Chart

- 4.10 The DPC monitoring points at the front of the building have all moved upwards with the average movement being 9.4mm. With reference to graph 5 most of this movement appears to have taken place between November 2019 and February 2020.
- 4.11 The latest set of data (recorded in November 2020) shows some further upward movement, this corresponds with the November readings in 2018 and 2019 which also showed upward movement.
- 4.12 Despite the small amount of downward recovery generally observed during the summer months the general trend of the front elevation movement is upwards. This could be due to changes in the ground water regime. With reference to the rainfall graph in Figure 8 below there was a prolonged period of heavy rainfall during the second half of 2019 which preceded the occurrence the most significant upward movement at the end of 2019.

- 4.13 Similarly, further heavy rainfall was observed during the first half of 2020 which was followed by further upward movement of the front elevation between August and November 2020.
