## **MUSEUM BUILDING**

**SPALDING**

## **STRUCTURAL REMEDIAL WORKS STRATEGY**

**SPALDING GENTLEMEN'S SOCIETY**

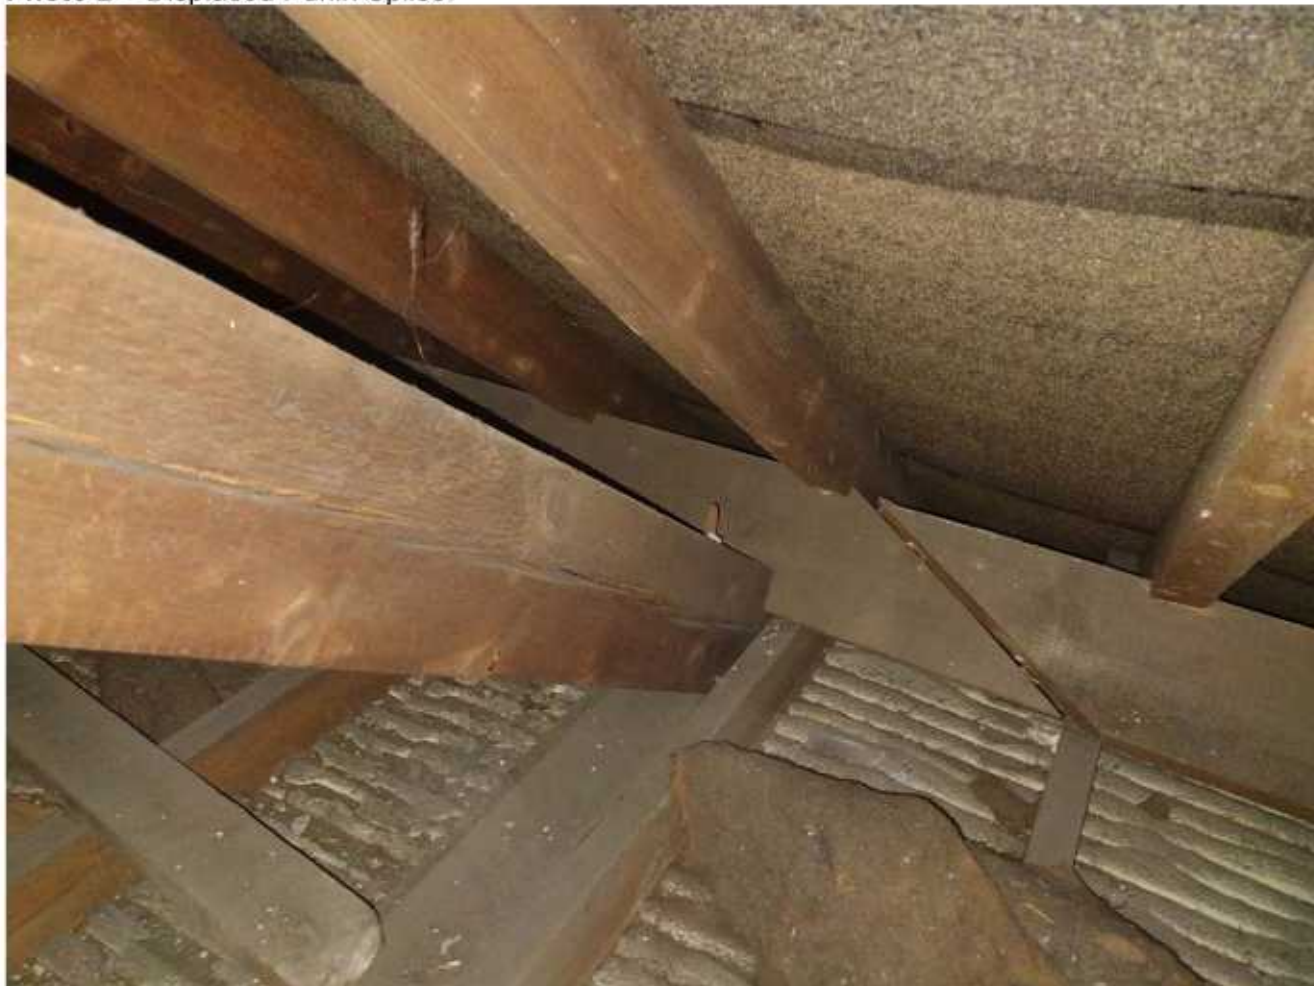
This movement has caused significant distortion to the roof and first floor structures along with masonry cracking, generally concentrated around openings (*Photo 1*). The purlin splices, located roughly at the high point of the movement, have been pulled open by 25mm by the roof movement to either side (*Photo 2*). The ridge board, which is not spliced at the same location, has remained largely undamaged. The difference between the purlin and ridge elongation has caused the roof trusses to twist on elevation, with the ridge effectively pulling the gable triangles inwards. This has caused significant cracking at the front gable eaves at the junction with the lower wall (*Photo 3*).

**Photo 2 – Displaced Purlin Splice:**

- Installation of diagonal roof bracing, straps and ties in three bays to stabilise the gable end masonry and to resolve the out-of-plane forces caused by the twisted roof structure. Steel plate repairs will be required where principal rafters have been split by the movement.

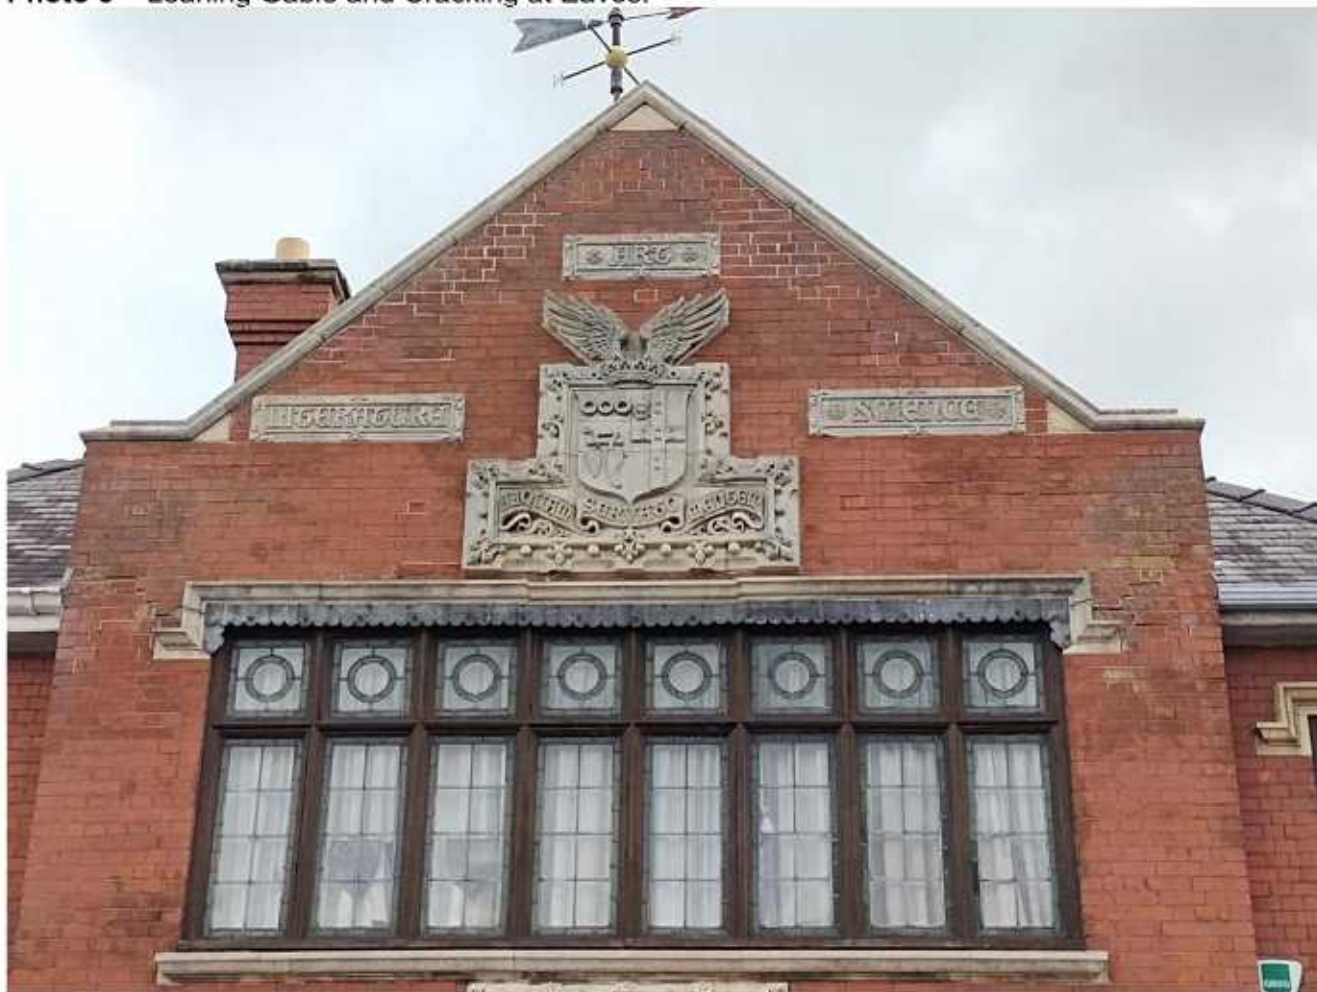
**Photo 3 – Leaning Gable and Cracking at Eaves:**

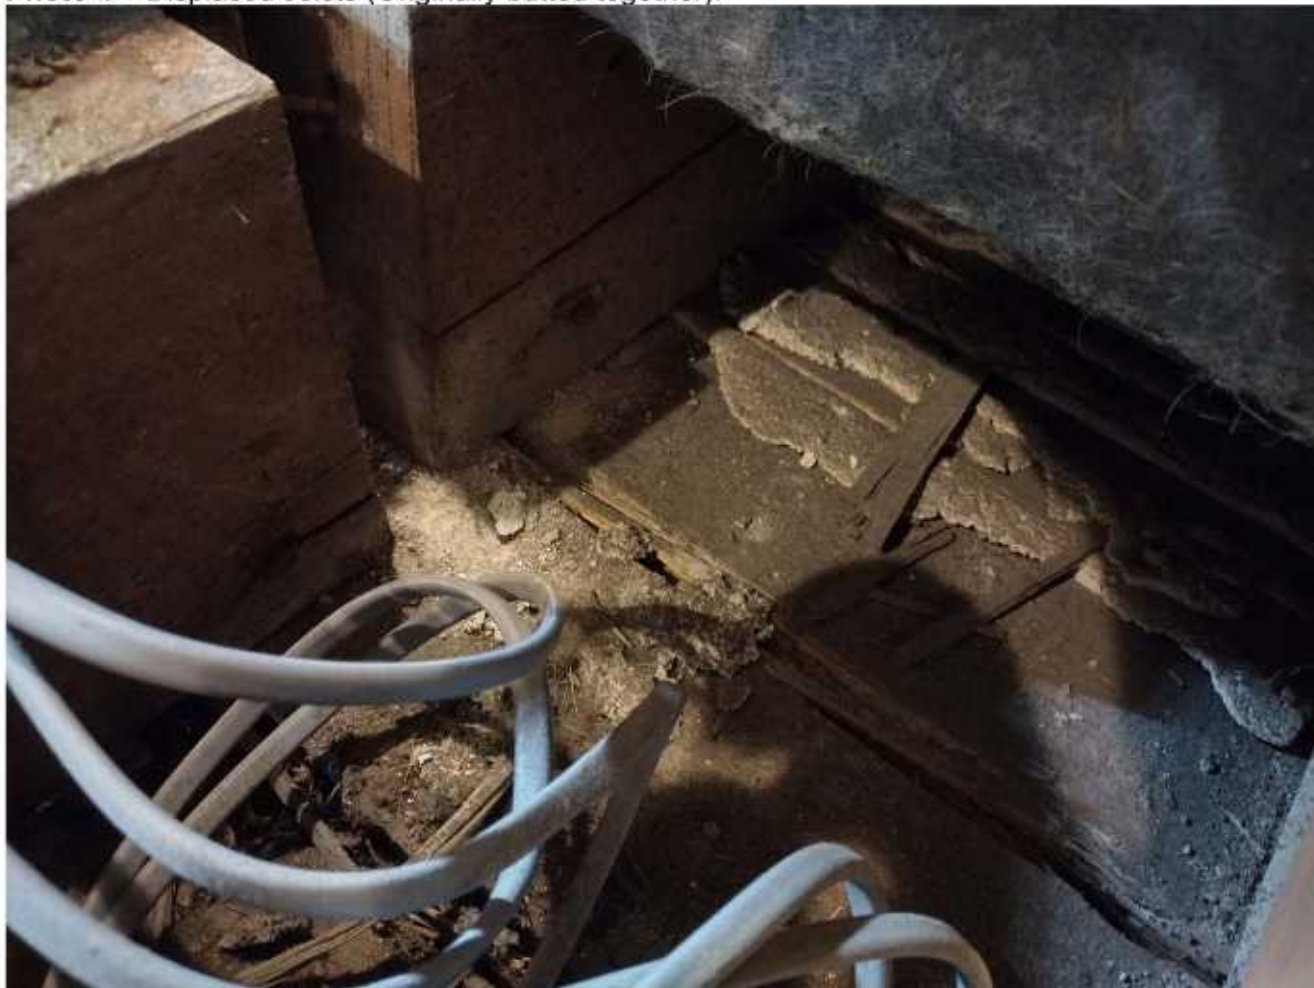
The first floor joists and beams have remained tied to their respective gable ends, causing all of the differential lateral movement to manifest at the internal wall support position. The floor joists have parted by 40mm at this position, with gaps in the floorboards having been previously infilled on at least one occasion historically (*Photo 4*).

**Photo 4** – Displaced Joists (Originally butted together):

- Provision of ties between the first floor joists and passageway wall to reinstate lateral restraint at first floor level. New steel channel sections fixed to the internal main building wall will reinstate adequate bearing to the joists and provide continuity of lateral restraint between the two areas. Tying will also be provided where the first floor joists have separated in the Turner Room.

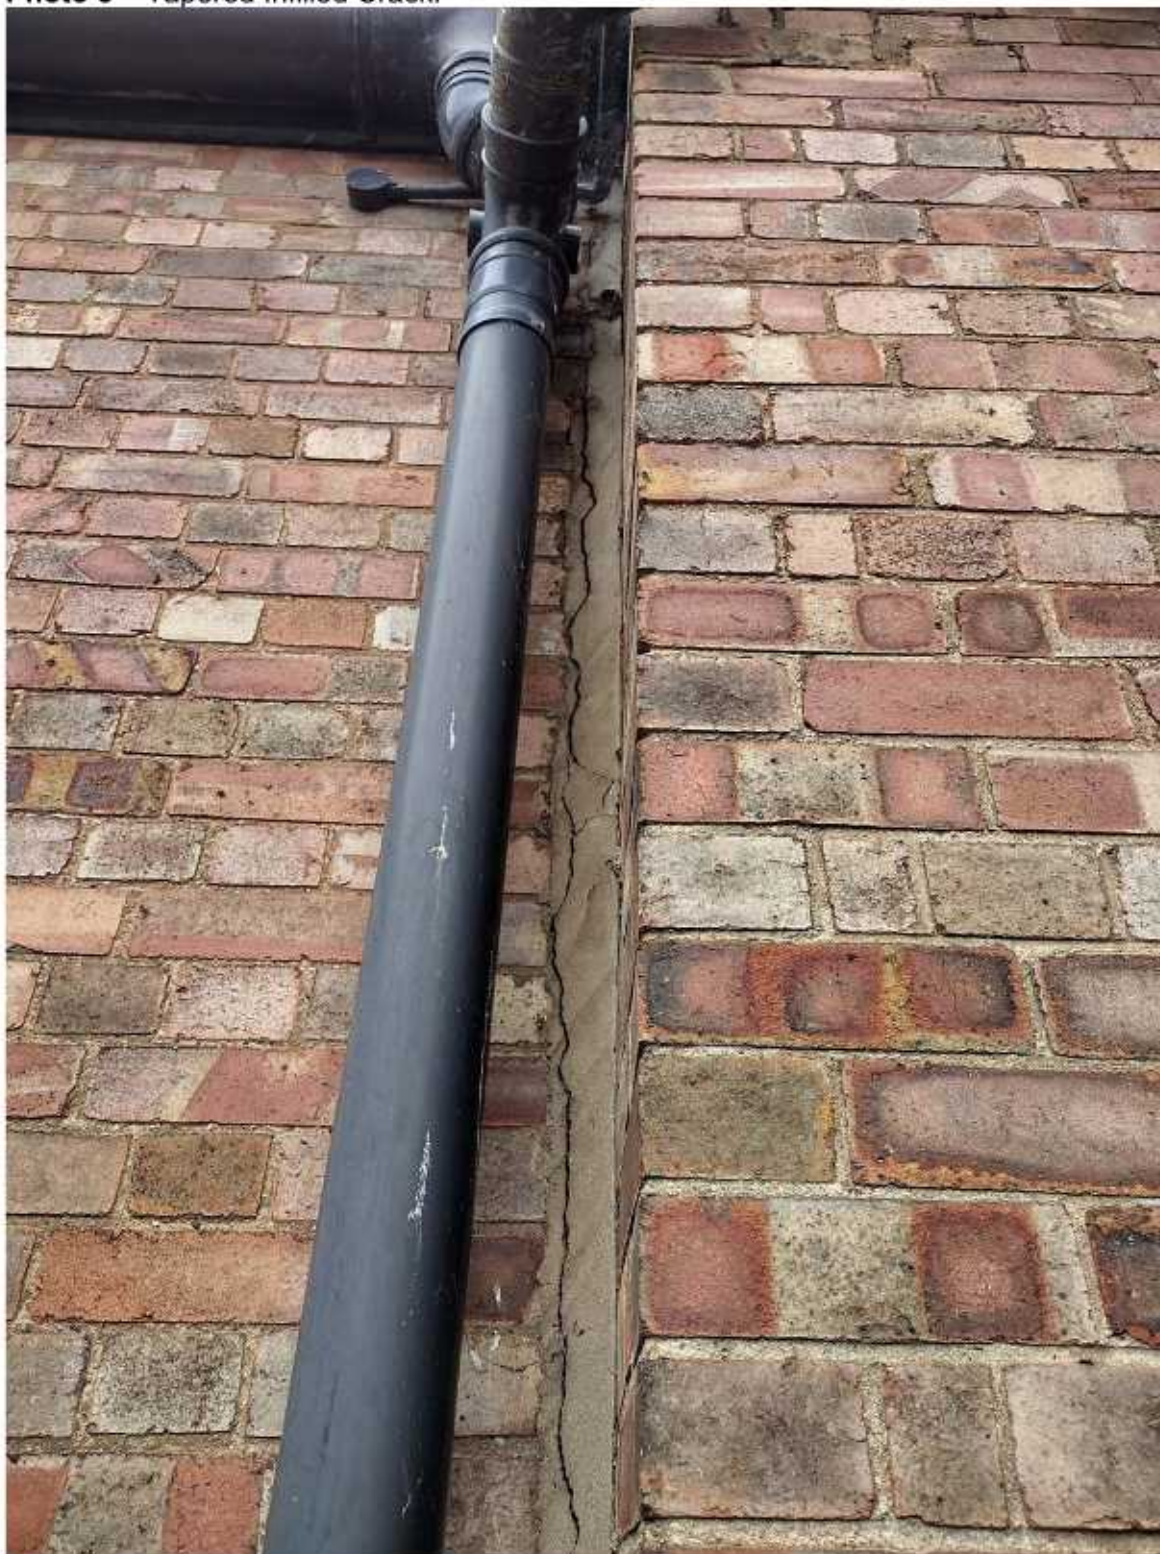
The 1955 addition of an additional storey above the, originally single storey, scullery area in the Caretaker's accommodation caused significant differential settlement between the two elements, with a mortar-filled tapering gap of over 25mm width having re-cracked by a further 5mm (*Photo 5*).

**Photo 5 – Tapered Infilled Crack:**

- Slate-packing and repointing of all masonry cracks together with installation of resin-bonded stainless tie bars to reinstate the integrity of the separated masonry panels.

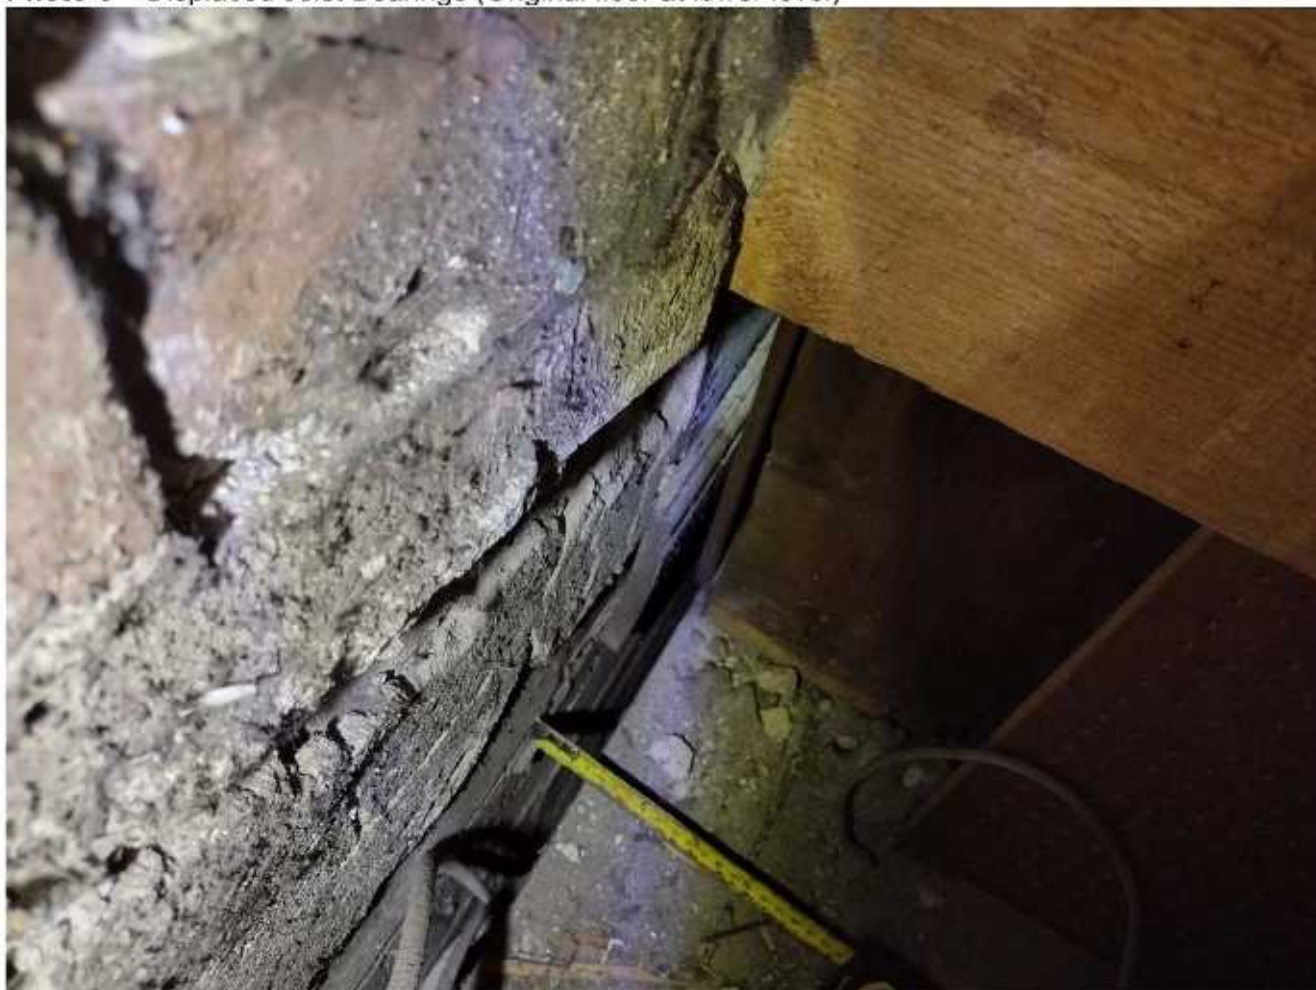
Work undertaken at the same time included the removal of the internal buttressing walls from the lean-to Caretaker's accommodation removed much of the lateral stability to the north wall. This allowed significant vertical and rotational displacement to occur when the adjacent passageway below-ground drainage failed, causing subsidence of the north wall and ground floor slab to this area and widespread masonry cracking, particularly around window openings. The vertical and lateral displacement of the north wall relative to the main building has caused the original first floor joists to pull out of the supporting wall by at least 40mm (*Photo 6*).

**Photo 6 – Displaced Joist Bearings (Original floor at lower level)**
