# **Phase 1 Land Contamination Risk Assessment**

## **Proposed Residential Development – Erection of 5 No. Dwellings**

## **River Bank / Cradge Bank, Spalding PE11 3AA**

**Date: August 2022**

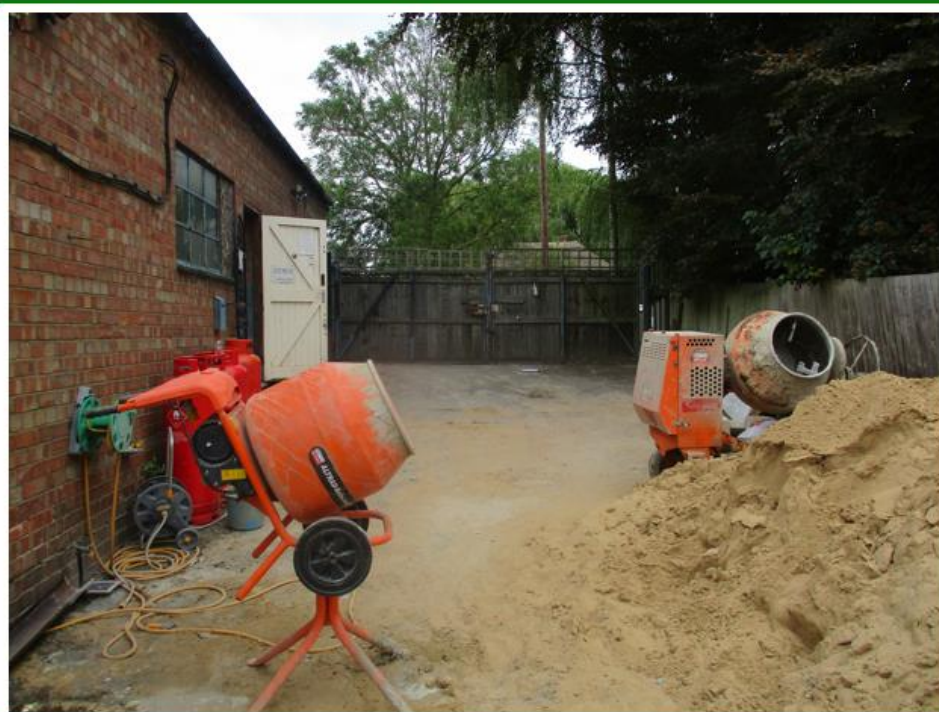
**Photo No.1: Facing east showing the eastern site access which leads off River Bank with workshop unit to left of photo**

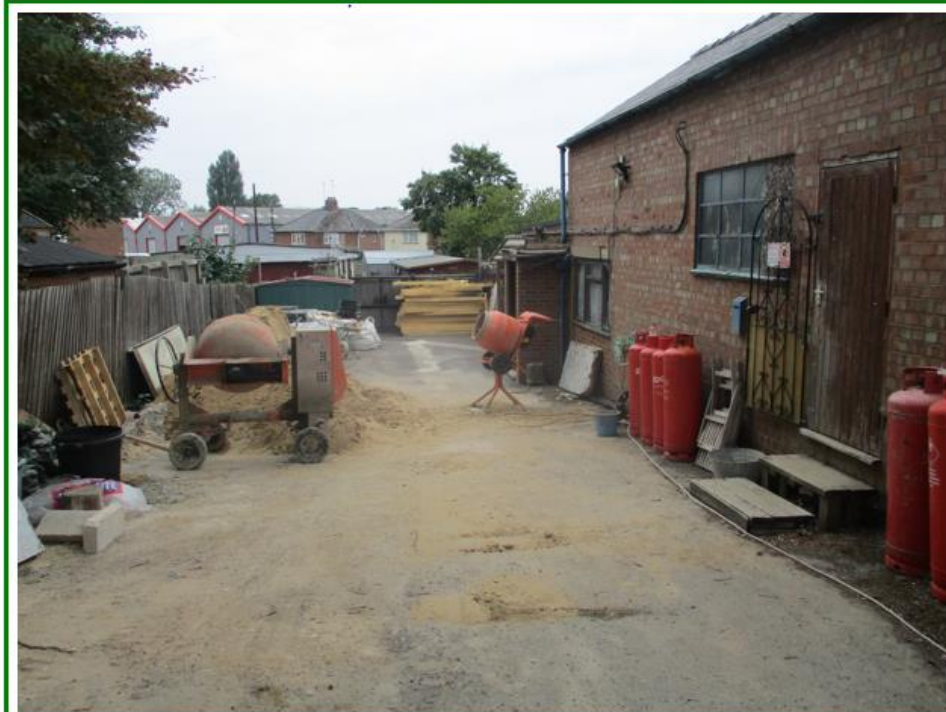
**Photo No.2: Facing west from the site access off River Bank showing construction materials storage and workshop (right)**

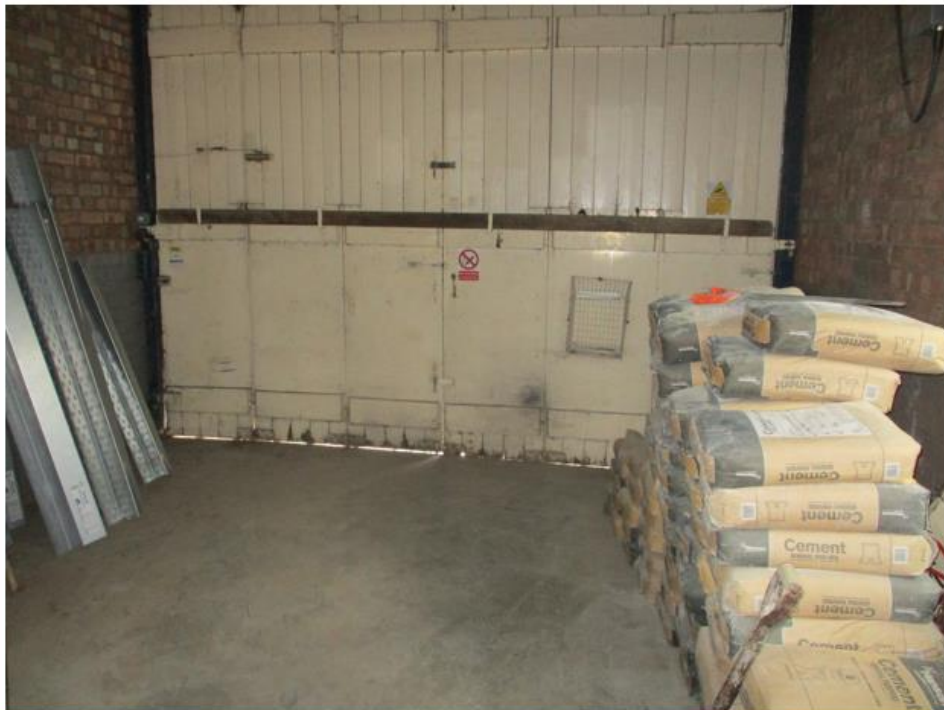
**Photo No.3: Facing east showing the large garage door of the workshop leading off River Bank east of site**

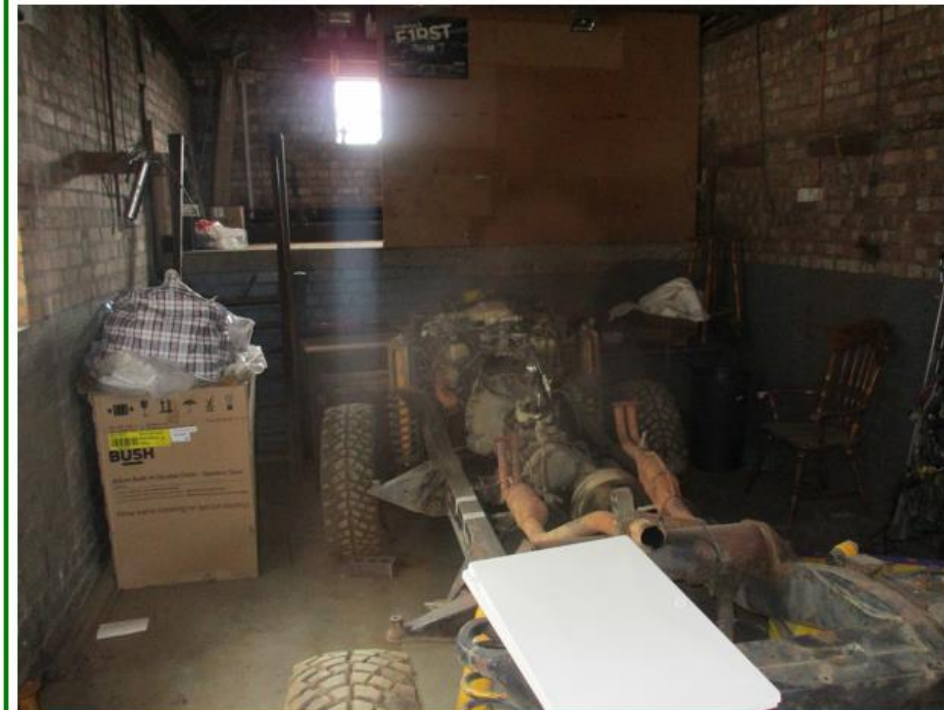
**Photo No.4: Facing west showing interior of the workshop, vehicle storage and miscellaneous tools and materials storage**

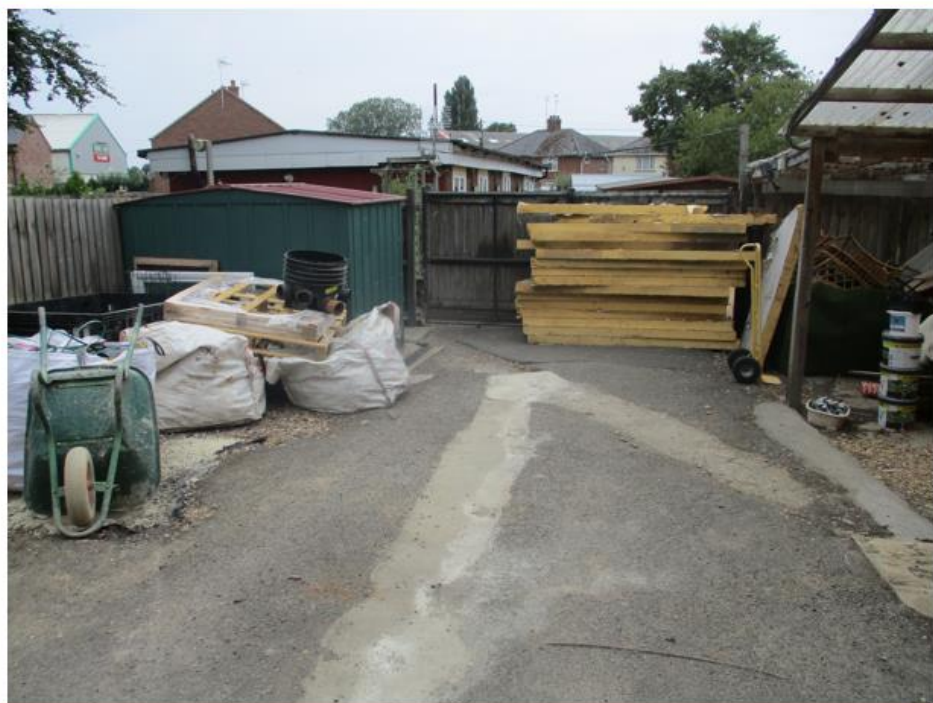
**Photo No.5: Facing west from just SW of the workshop showing further construction materials storage**

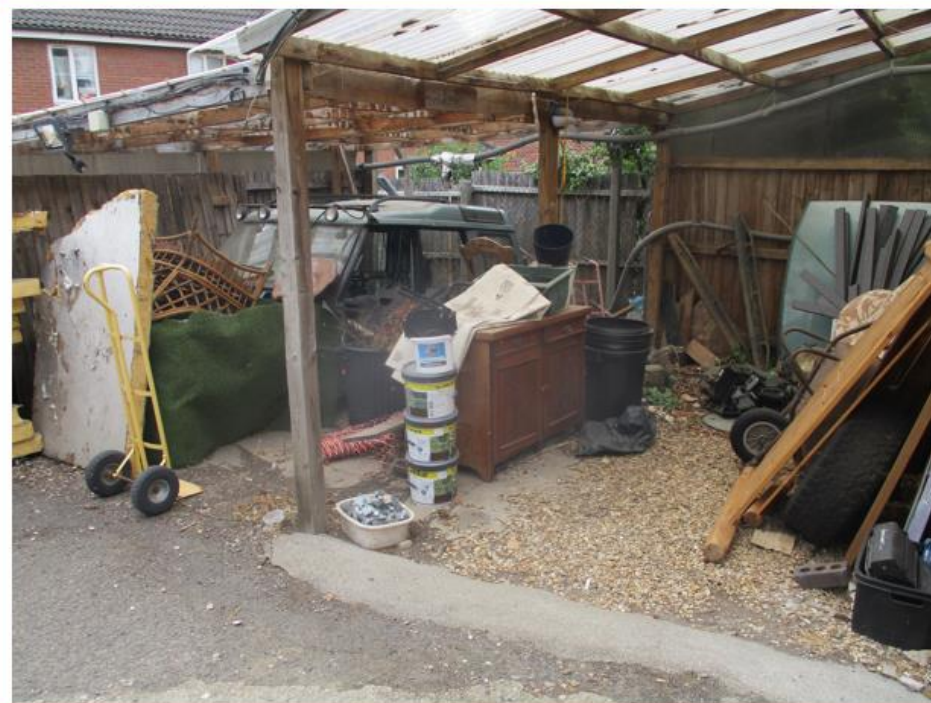
**Photo No.6: Facing NW showing a storage area on the western face of the workshop structure**

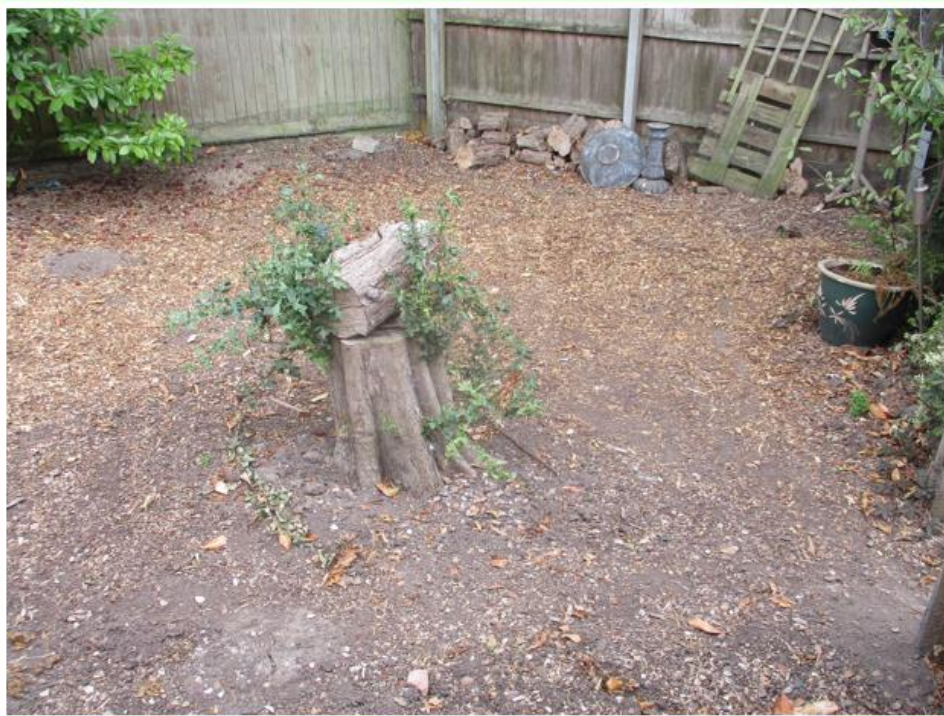
**Photo No.7: Small gardened area noted centrally on site, adj, to the southern boundary of stie**

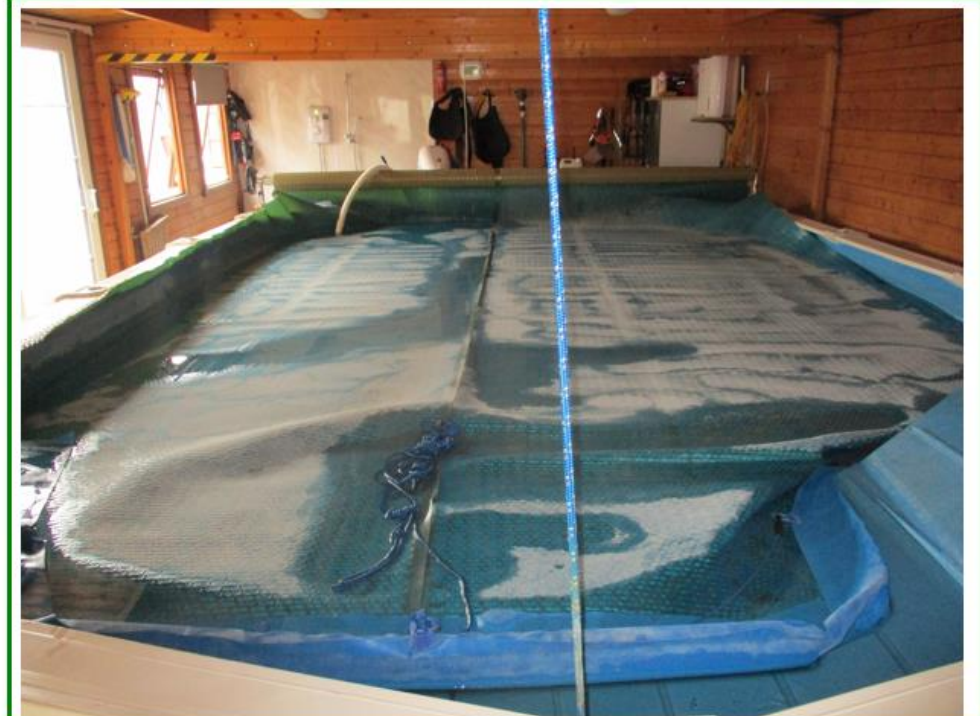
**Photo No.8: Facing west from the eastern extent of the hydrotherapy structure with pool noted within**

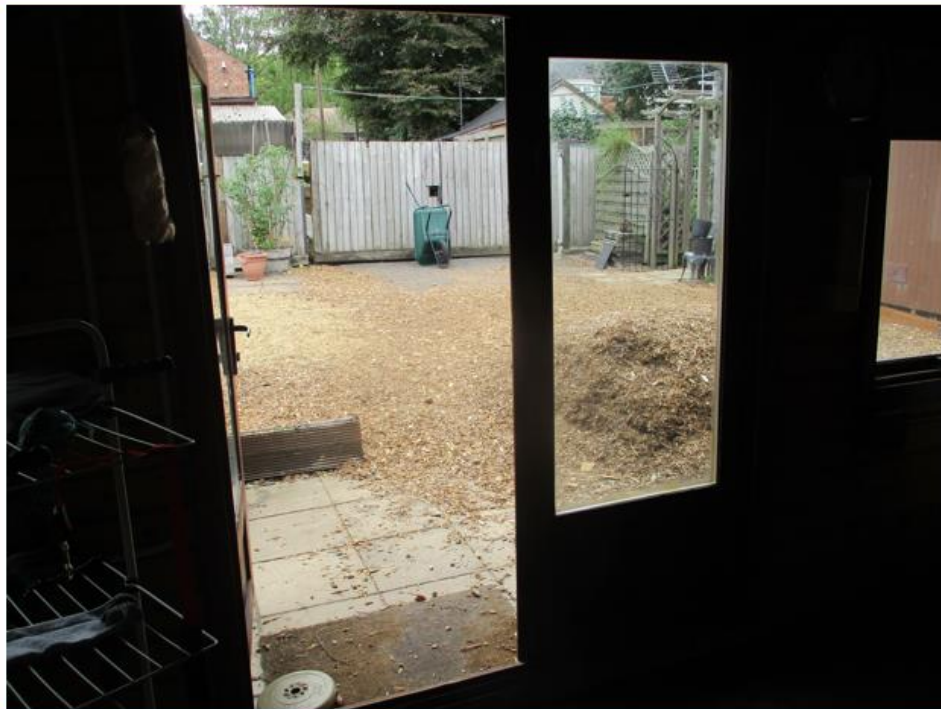
**Photo No.9: Facing east from inside the eastern extent of the pool structure showing small, centrally located open area**

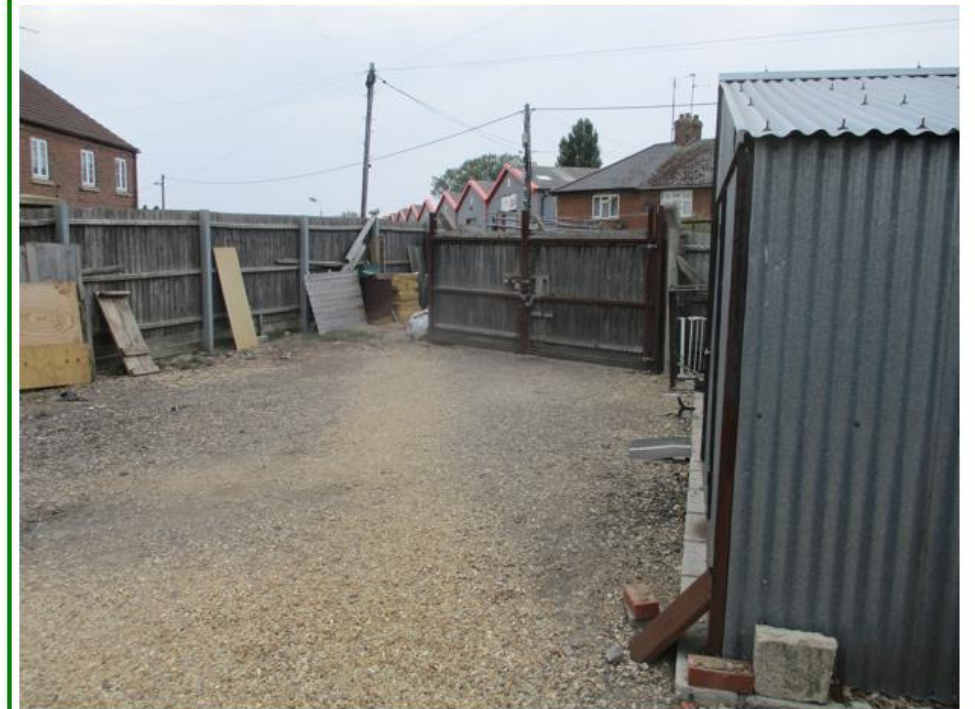
**Photo No.10: facing west in the western extent of site showing gated site access leading east off Cradge Bank**

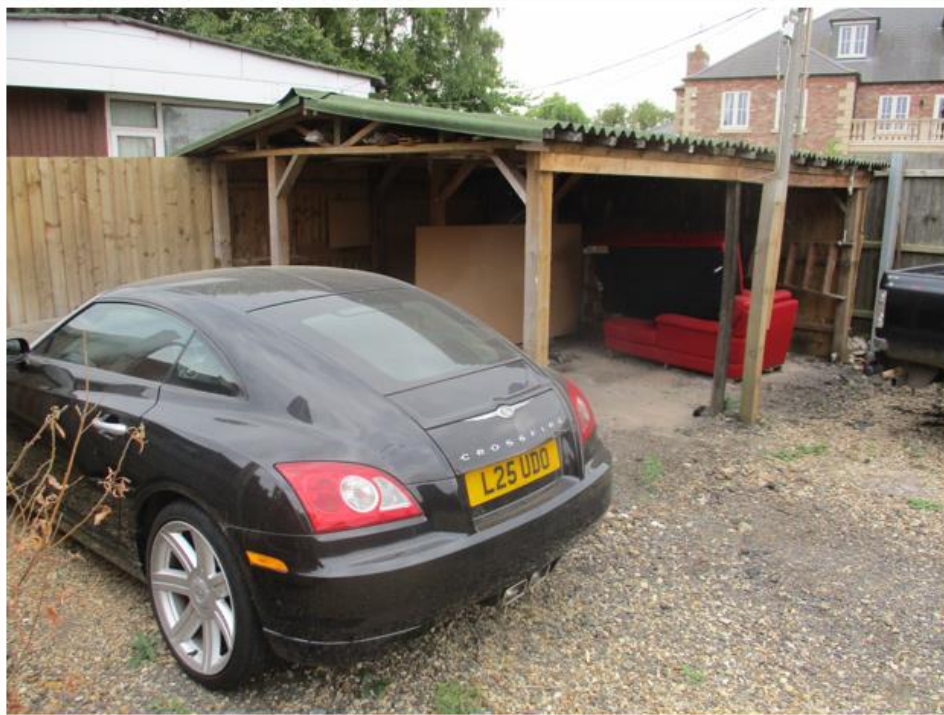
**Photo No.11: Facing slightly SE in the western extent of site showing lean-to and vehicle storage (dwelling to rear of photo)**

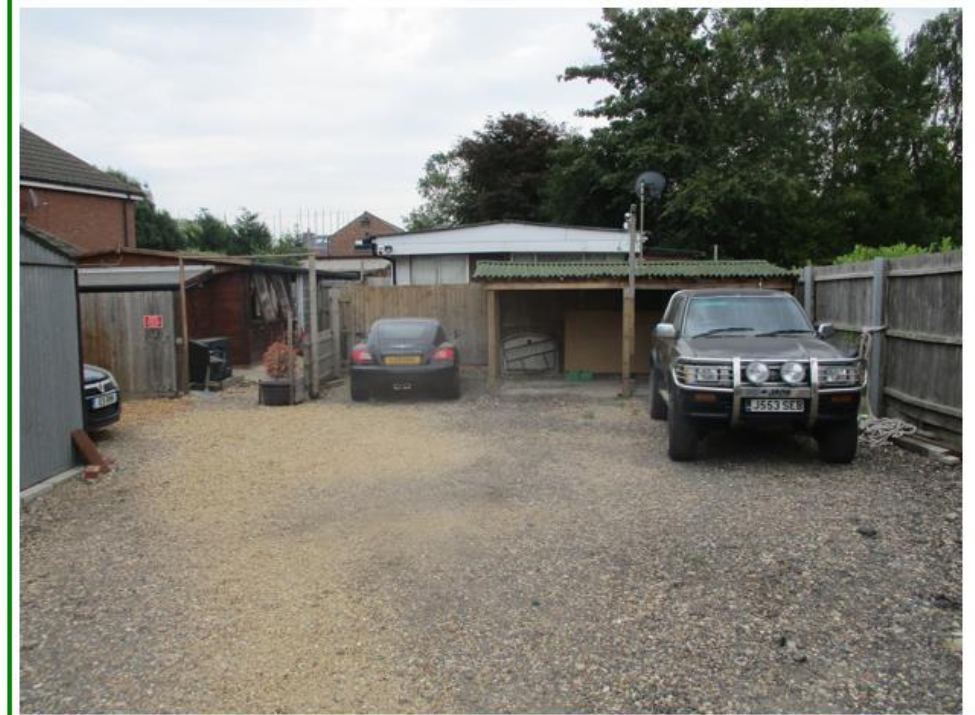
**Photo No.12: Facing east from the western site access showing parking area, dwelling to rear of parking area**

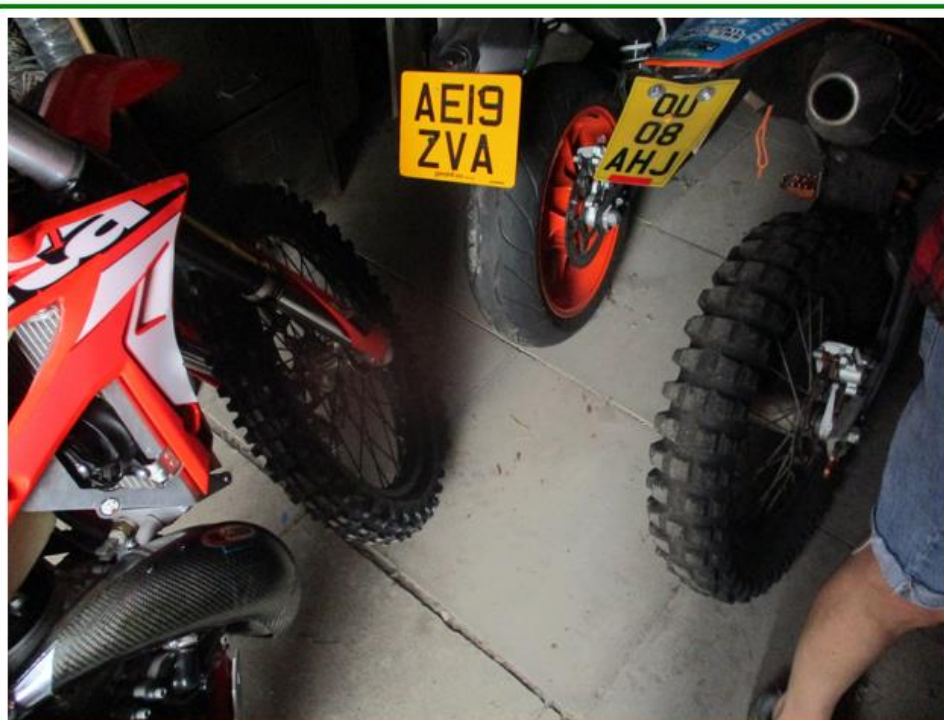
**Photo No.13: Example shot of the interior of a bike-storage shed located in the NW corner of site (paving flooring)**

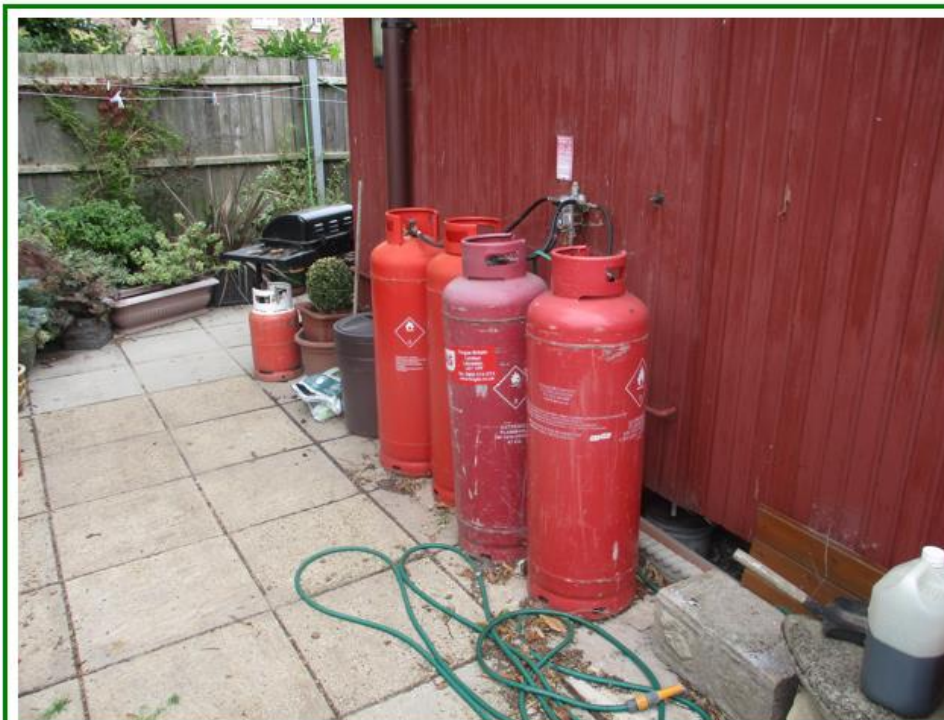
**Photo No.14: Gas bottle storage and small garden area noted on the eastern face of the dwelling on site**
