# Ground Gas Verification Report

## Public Open Space, Wygate Park, Spalding

**BRD241183-OR14-A**

**November 2020**

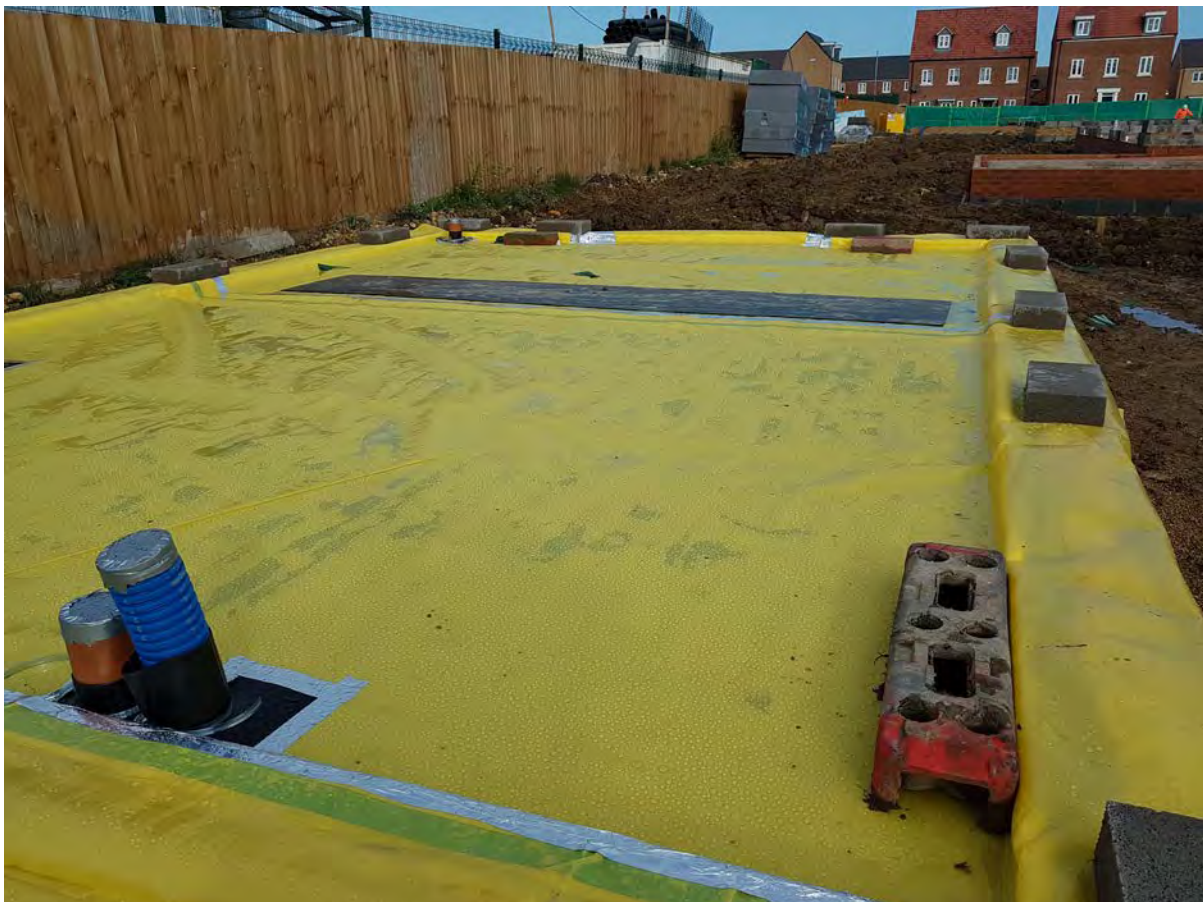
| <b>Membrane Condition:</b> | Plot 904: Good condition with minimal trafficking and evidence of use of crawl boards to protect membrane. |
| <b>Laps, Welds and joint seals:</b> | Plot 904: Generally good tape joints and recent rain ponding confirms good watertight joints. Three minor defects were identified. The defects were drawn to the attention of the groundworker. It was agreed that as the membrane was damp, repairs would be made once it had dried out. BRD would re-inspect these areas at the same time checking the placement of the steel mesh reinforcement has not caused any punctures. BRD also provided some tips and advice to the fitting of gas membranes. |

**Photo 3** – Plot 904, the first plot to have the membrane fitted. Note black crawl board used when fitting central joint left in place for the purpose of the verification inspection.

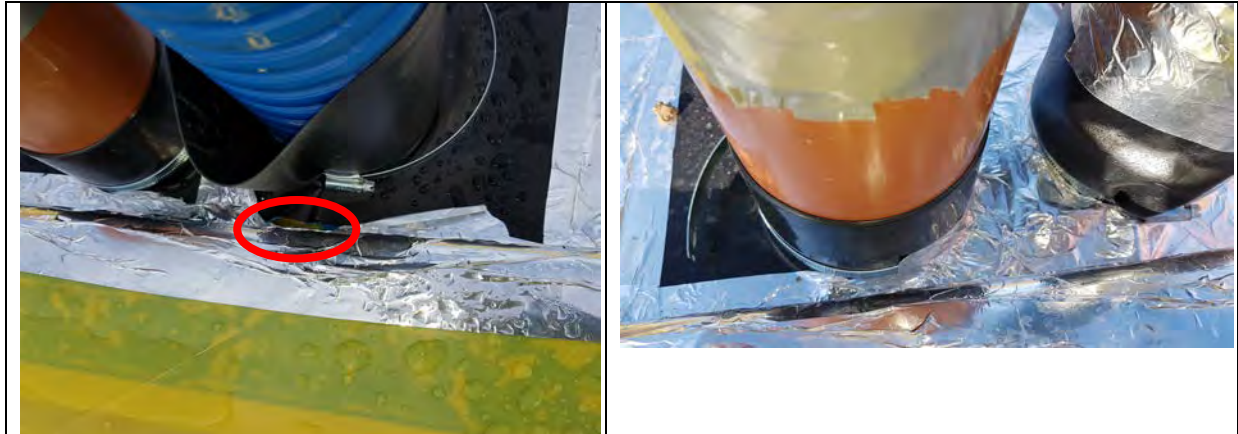
**Photos 1 and 2** – Gap in sealing around ‘top hat’ found on Plot 904 and remedied.

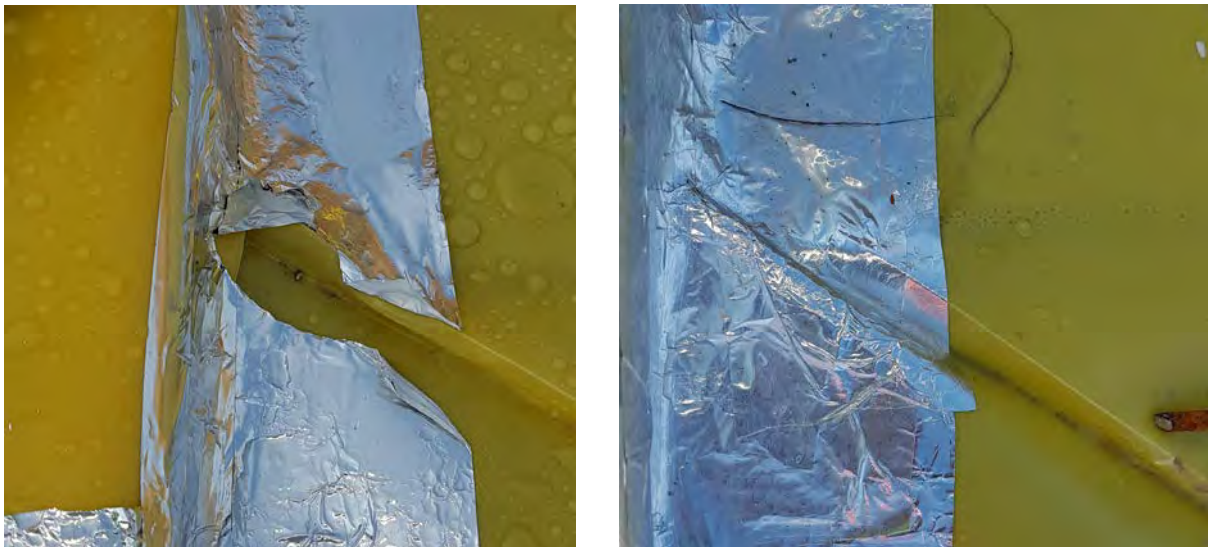
**Photo 3 and 4** – Tape seal ran over at fold in membrane creating air gap along fold and repaired defect. Note that Photo 3 (left) shows the defect after it had been opened up by the verifier to make it more obvious where repair was required.

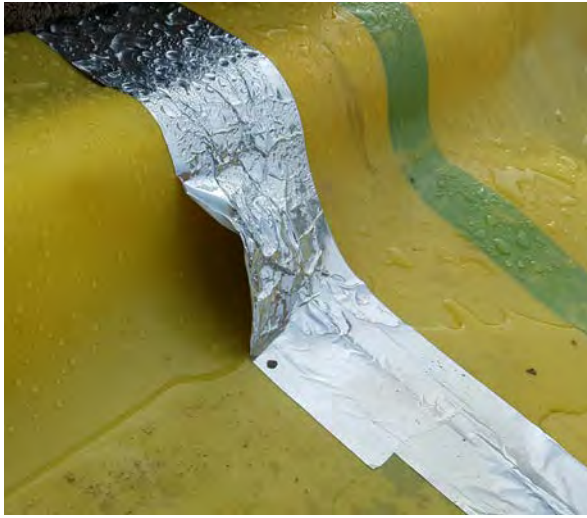
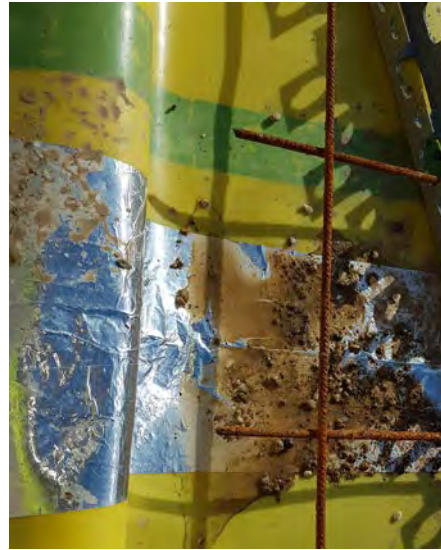
**Photo 5 & 6** – Inadequate sealing of tape against membrane. Note that Photo 5 (left) shows the defect after it had been opened up by the verifier to make it more obvious where repair was required. Photo 6 (right) shows repair and placement of mesh well away from the membrane.

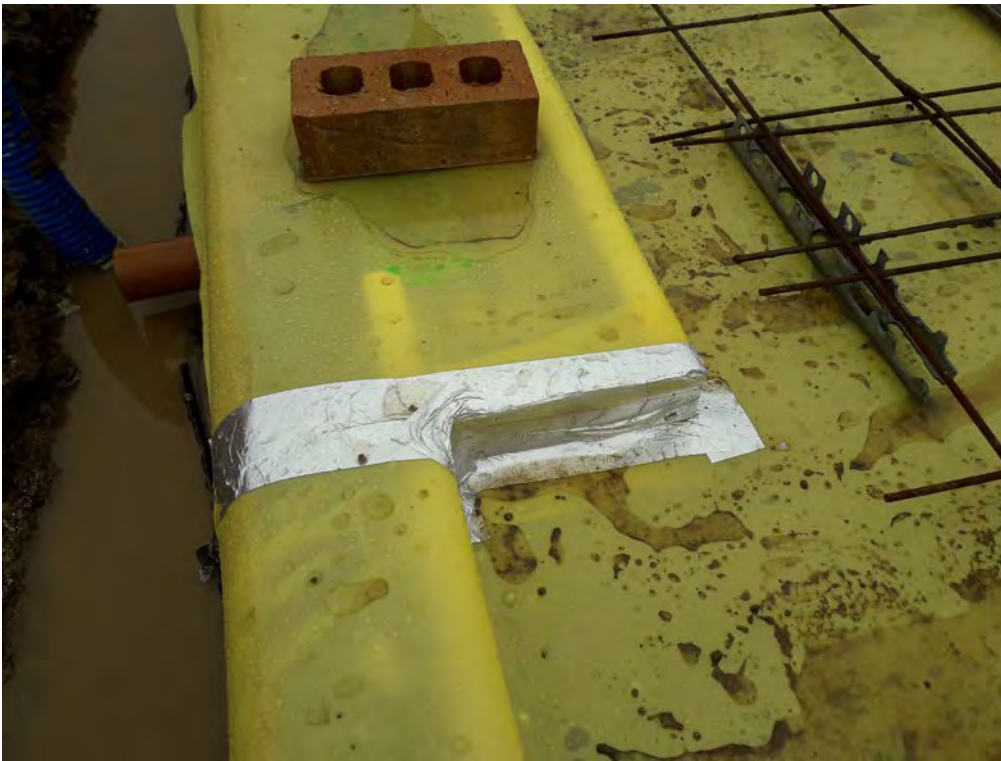
**Photo 2** – Corner detail. Note pooling of water on the membrane (bottom right of photo) indicating water tight seal.

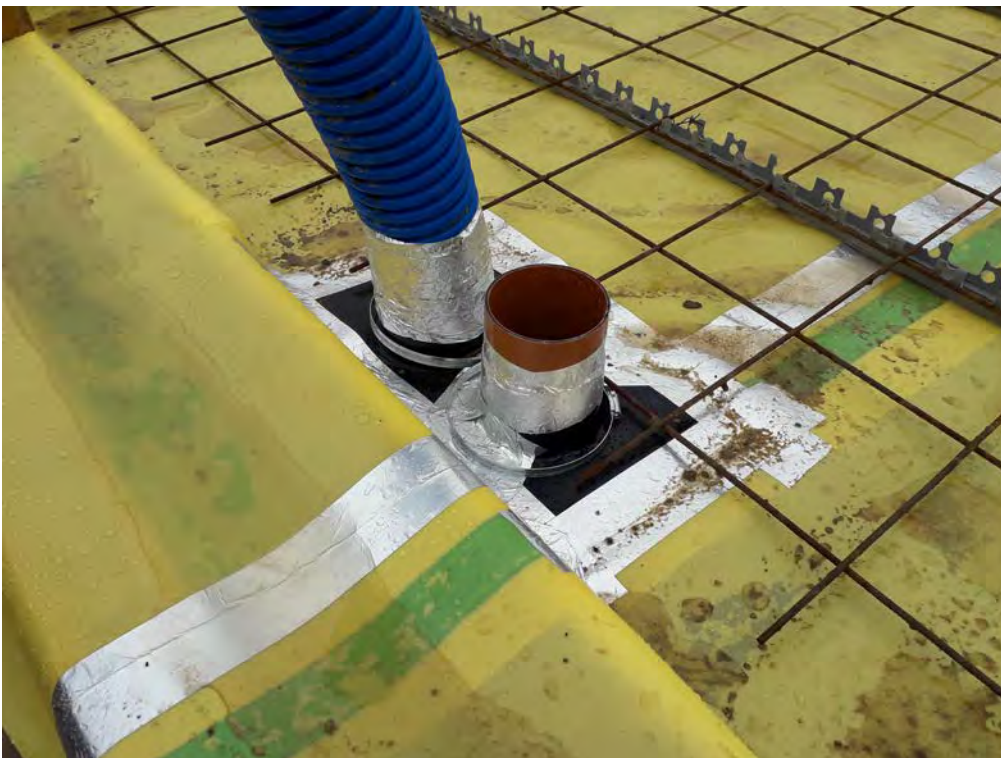
**Photo 3** – Detail of sealing around top hats which were all to a good standard. Note loose jubilee clip not tightened by the fitters due to concern clips might compromise the taped seal.

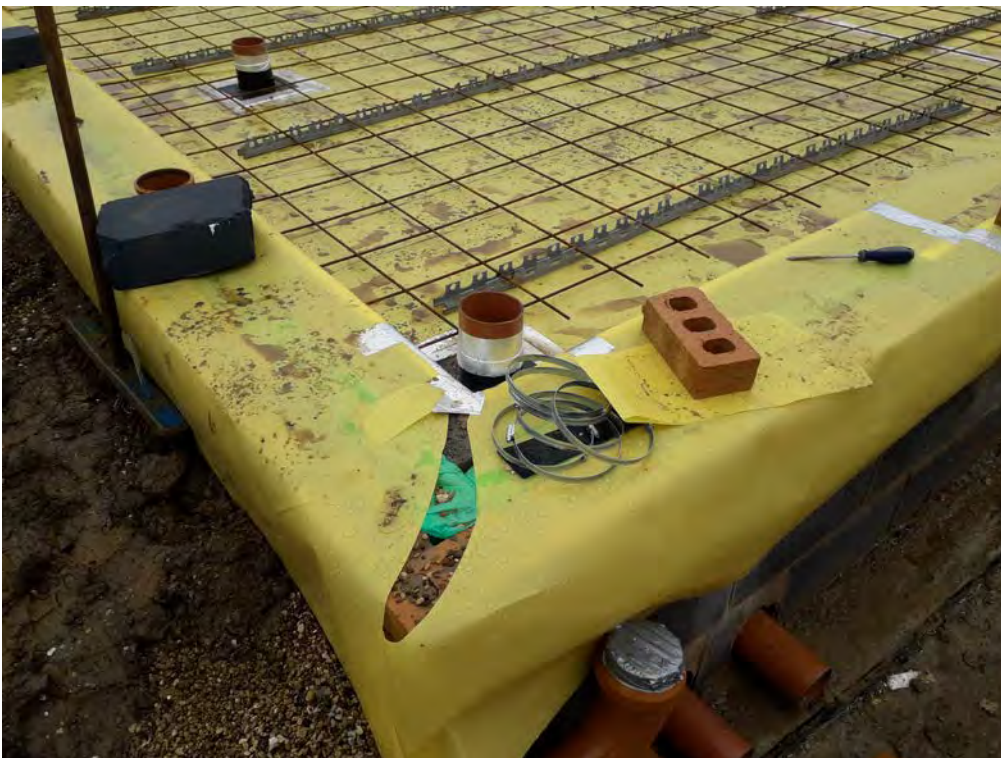
**Photo 5** – Tear in the corner of Plot 901. Note material nearby to enable a repair.

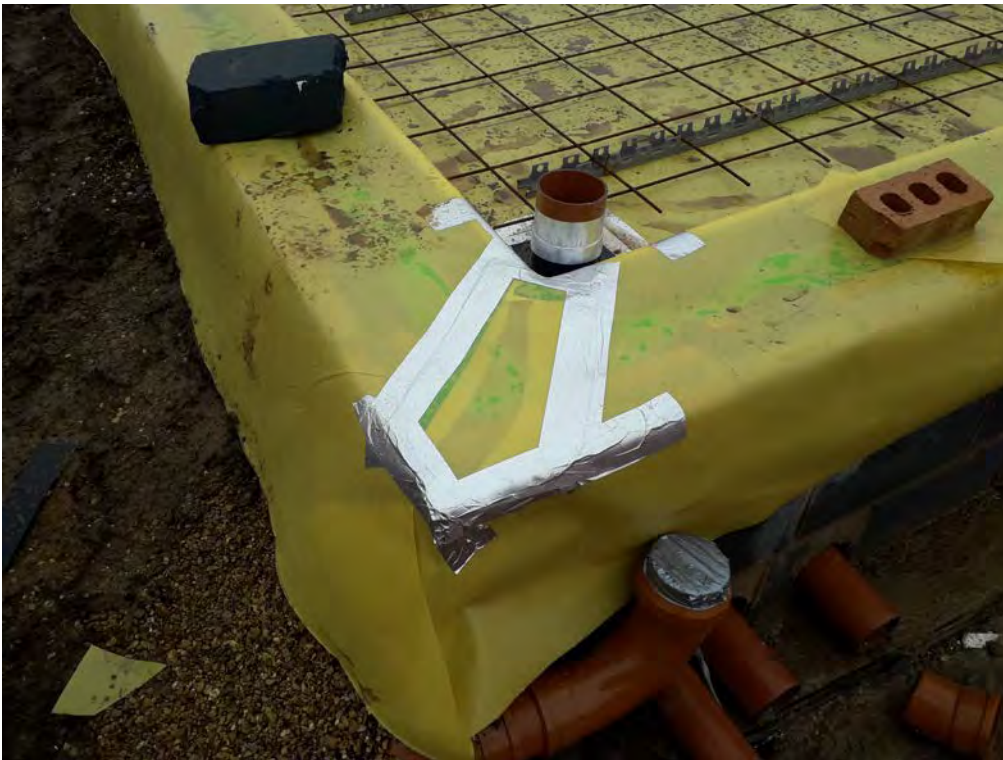
**Photo 6** – Corner of Plot 901 following repair.

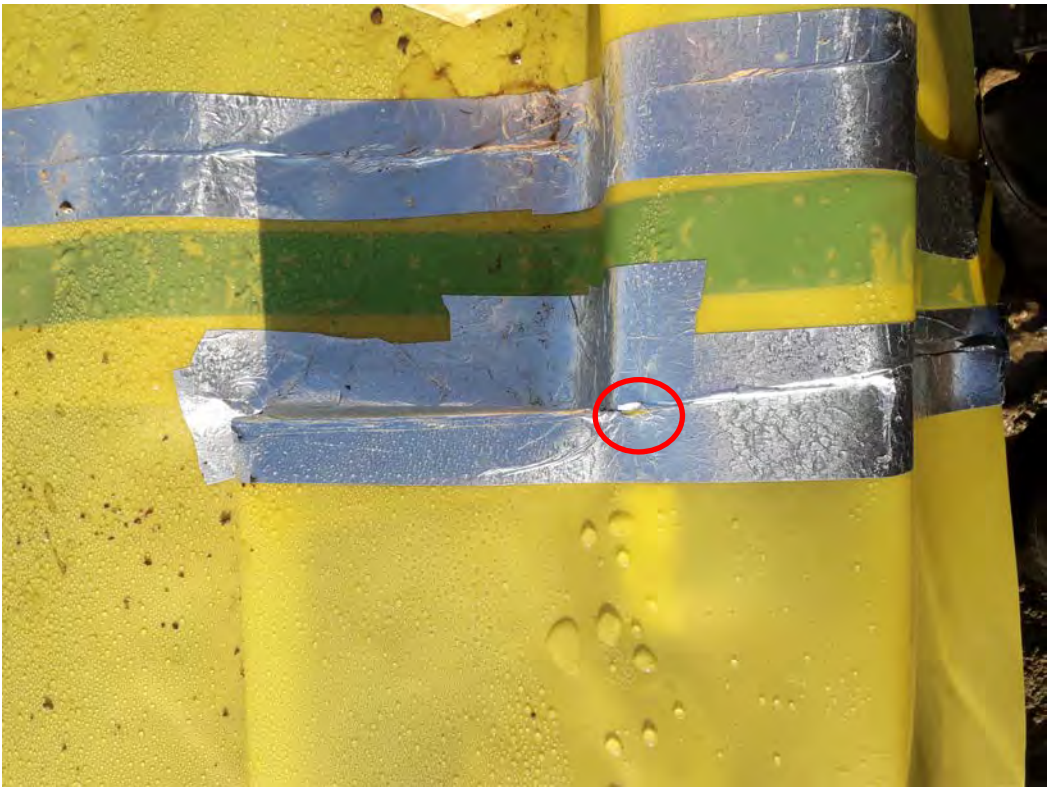
| <b>Laps, Welds and joint seals:</b> | Good condition with no significant defects. Minor tearing of tape in three corner seals where the membrane had been lifted by the breeze and put pressure on the corner seal tape. Tears immediately repaired by the fitters and discussed about ensuring sufficient weight is added to the edges of the membrane to prevent this happening in the future. |

**Photo 3** – Minor tear in corner of corner joint due to wind lifting membrane.

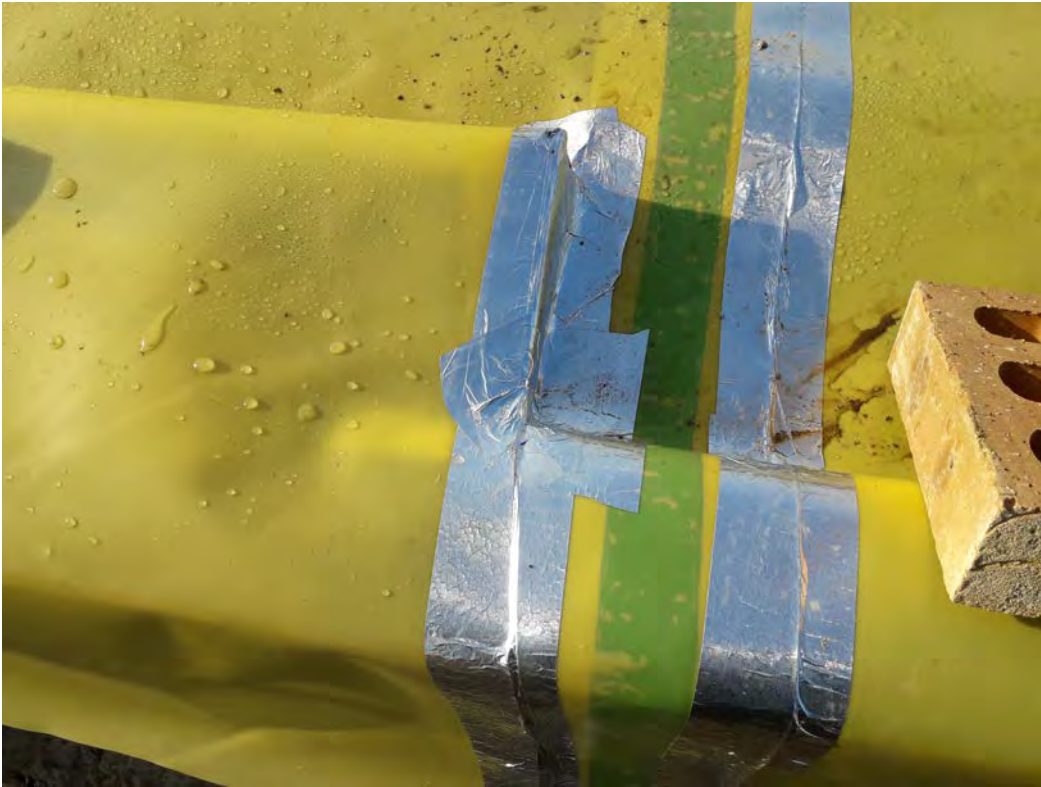
**Photo 4** – Minor tear repaired.

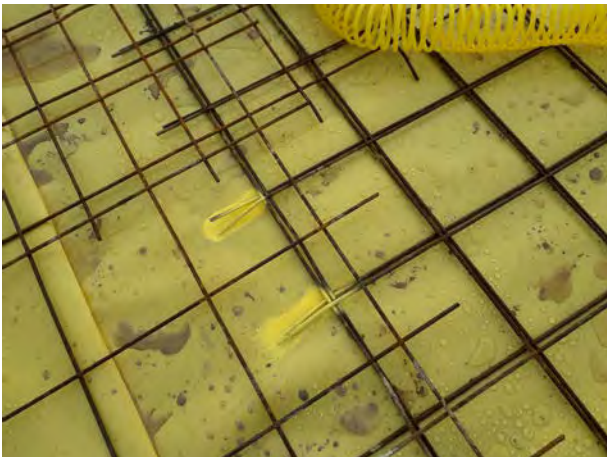
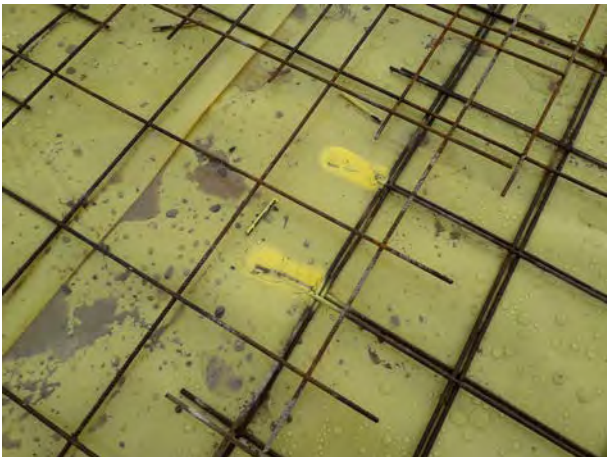
| <b>Membrane Condition:</b> | <p>Very good condition with no punctures or tears identified.</p> <p>Steel mesh was not placed on supporting brackets in this plot. Two areas identified where steel mesh was pressing on the membrane although had not punctured. BRD spoke to the fitter and advised that if brackets are not to be used than care needs to be taken when placing the steel mesh and any pressure points removed by snipping off individual metal prongs. Also advised that the mesh adjacent to the perimeter walls should be flush, i.e. any metal prongs should be removed from the edge of the mesh.</p> |

**Photo 2** – Mesh pressing into membrane and following removal of prongs.

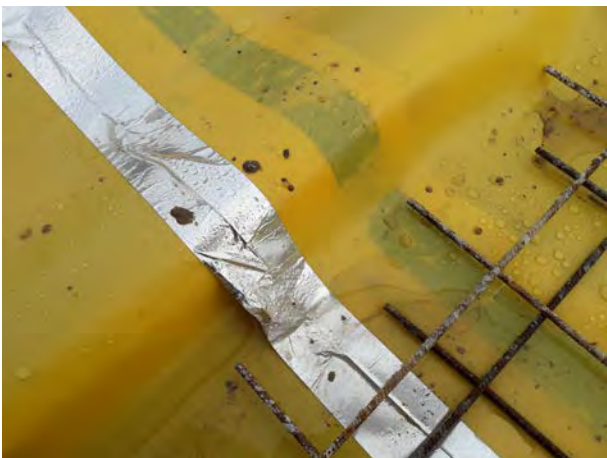
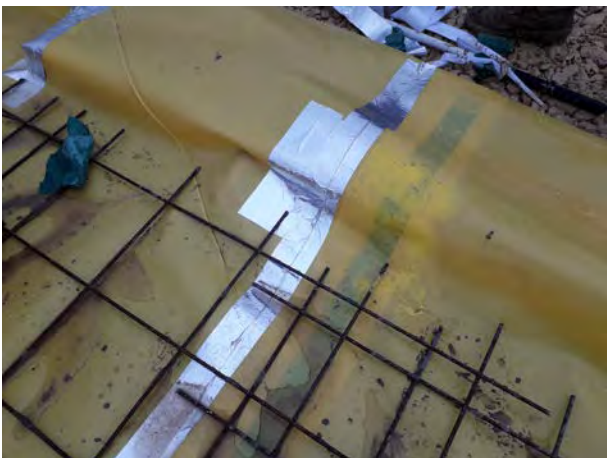
| <b>Laps, Welds and joint seals:</b> | <p>Seven defects were identified across the membrane of Plot 910/911 during this inspection.</p> <p>Most of the defects were breaks in the seal of the double sided and silver tape at the point where the membrane laps up and over the edge of the building. BRD marked up all of the defects and informed the fitter who made the necessary repairs whilst BRD were still present. A couple of defects were noted along the central seams where the silver or double sided tape had not been adequately applied or sealed.</p> |

**Photo 3** – Break in seal at lap up onto outer brick wall and following repair.

| | All seven defects repaired and verified. |

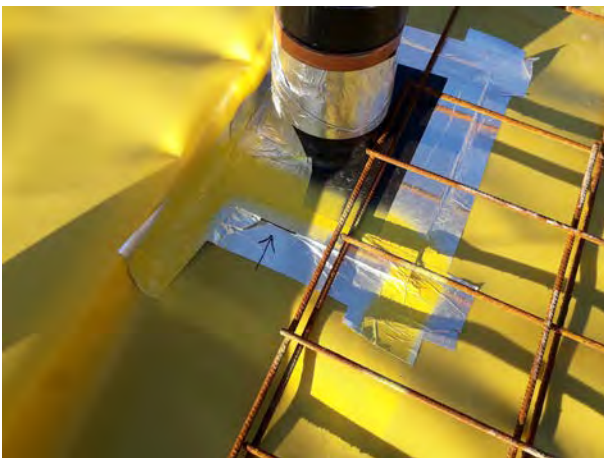
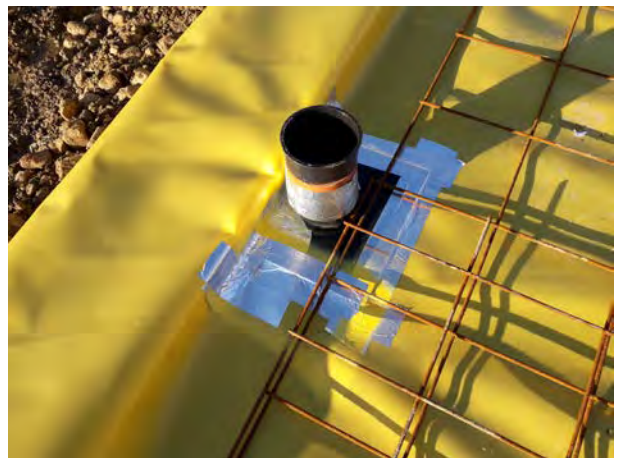
| <b>Laps, Welds and joint seals:</b> | <p>Plot 912/913/914: Good condition with no significant defects. Three minor defects noted across the membrane. Two defects were associated with the silver tape seal around two top hats. The silver tape had spilt, exposing the black top hat beneath. A replacement strip of silver tape was applied by the fitter. The third defect was a break in the seal in both the double sided and silver tape at the end of one seam. This was also repaired by the fitter.</p> <p>Steel mesh had been snipped around the edges as suggested by BRD during the previous inspection visit.</p> <p>Plot 920: Good condition with no defects at the time of installation. BRD observed the fitter placing the double sided tape across the entirety of the membrane and confirmed it had been adequately sealed.</p> |

**Photo 3** – Minor tear in silver tape around top hat before and after repair.

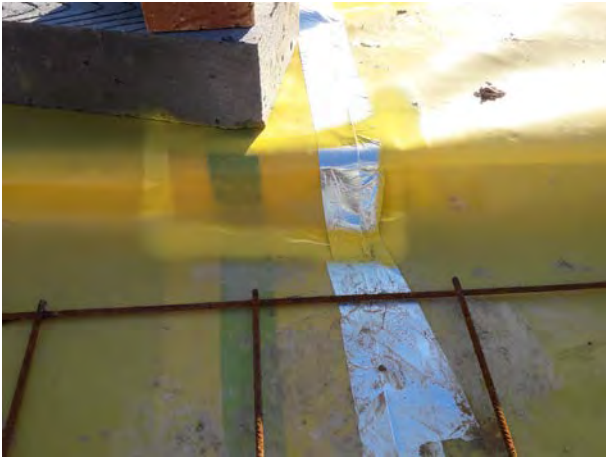
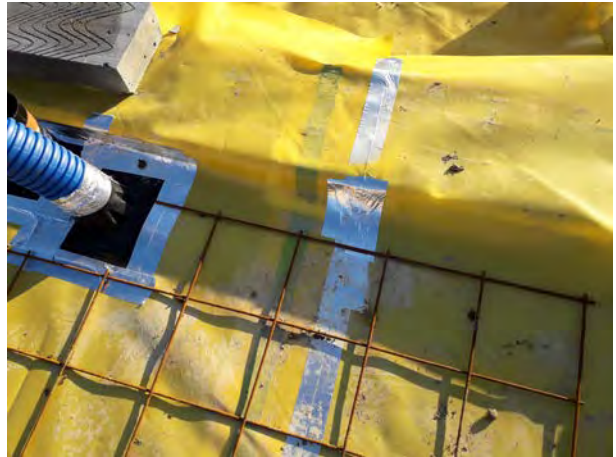
**Photo 4** – Break in seal at end of membrane seam before and after repair.

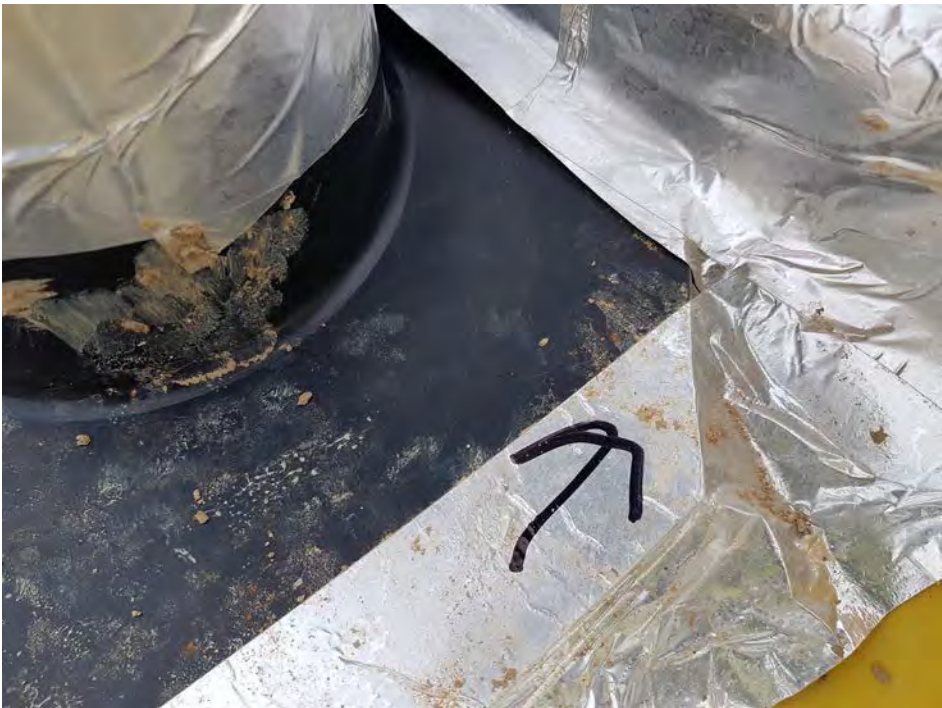
| <b>Laps, Welds and joint seals:</b> | Relatively good condition with 3No. minor defects around the corner joints. Additional silver tape was applied by the fitter and the seal confirmed by BRD. |

**Photo 4** - Defect around top hat before repair.

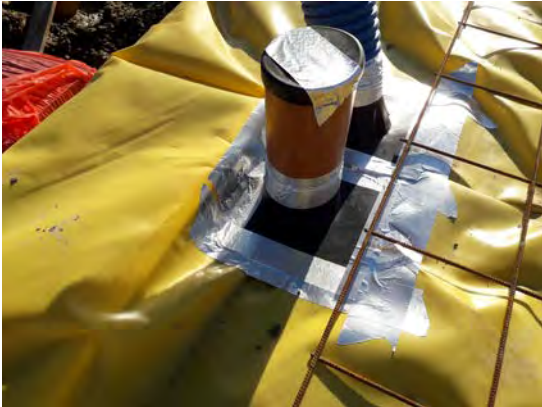
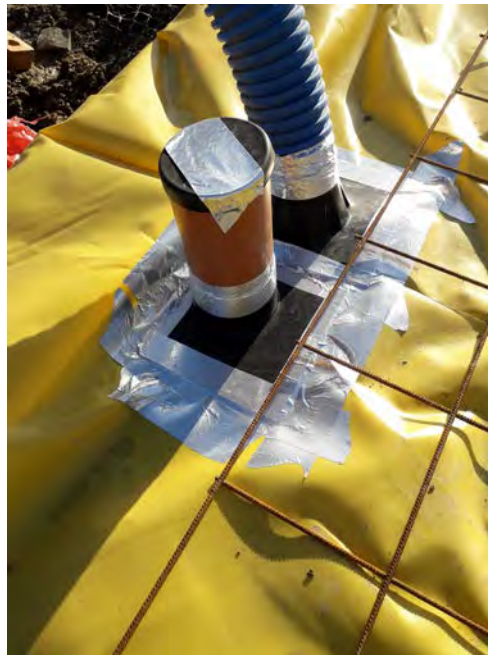
| <b>Laps, Welds and joint seals:</b> | Good condition with no significant defects. One minor defect noted where the silver tape had become loose around one edge of a top hat. Additional silver tape was applied by the fitter and the seal confirmed by BRD. Steel mesh had been snipped around the edges. |

**Photo 4** – Break in seal at top hat before and after repair.

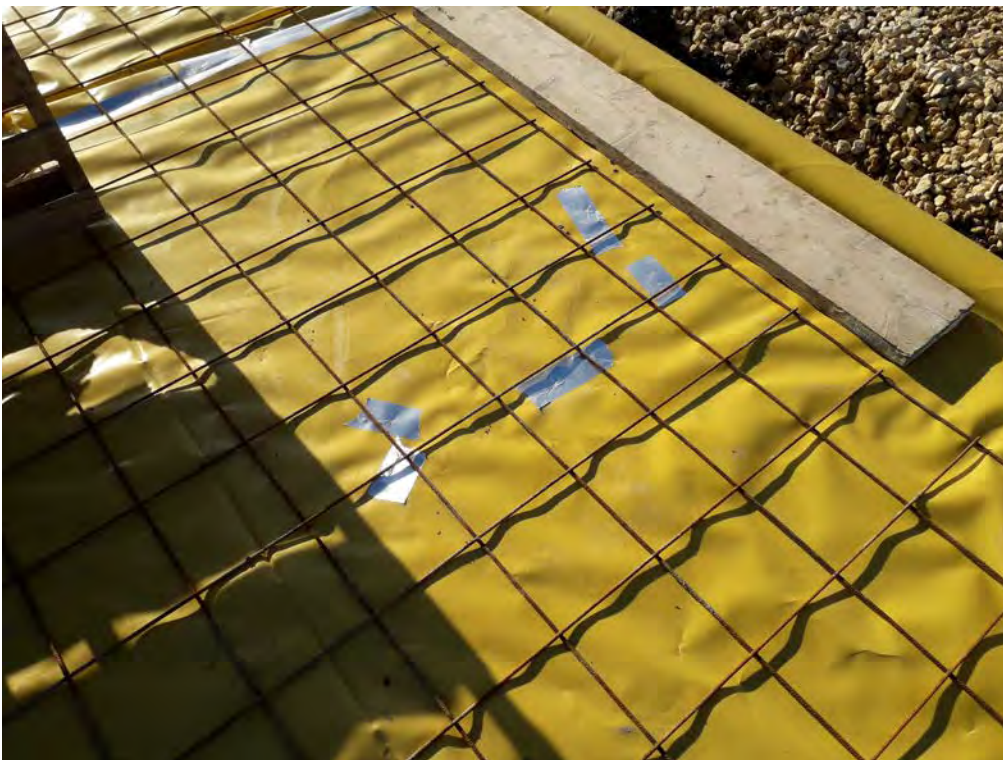
**Photo 5** – Patch repairs on the membrane placed prior to the inspection visit.

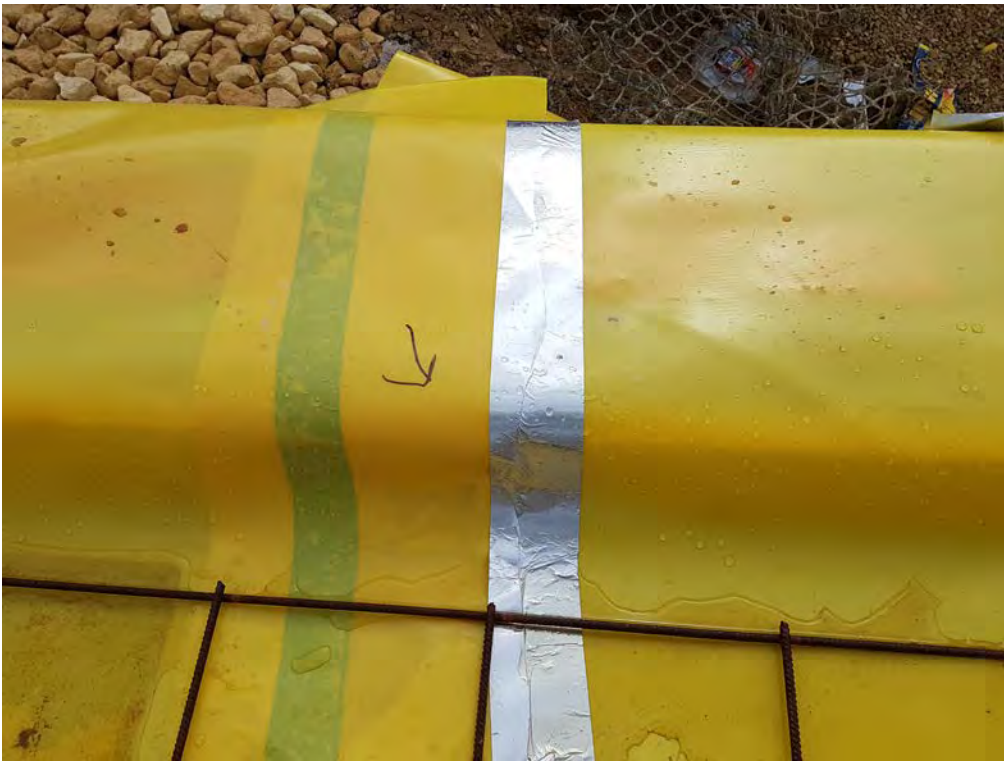
**Photo 2** – Minor defect in silver tape seal along fold of membrane to Plot 924/925.

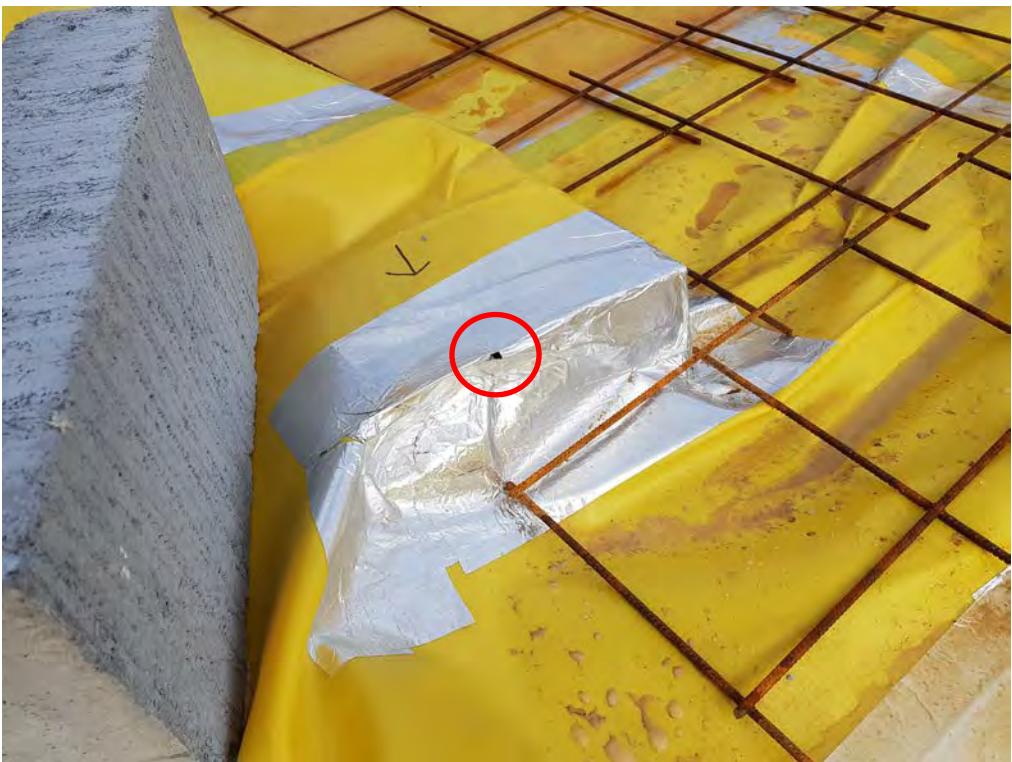
**Photo 5** – Minor defect on tape seal for Plot 923.

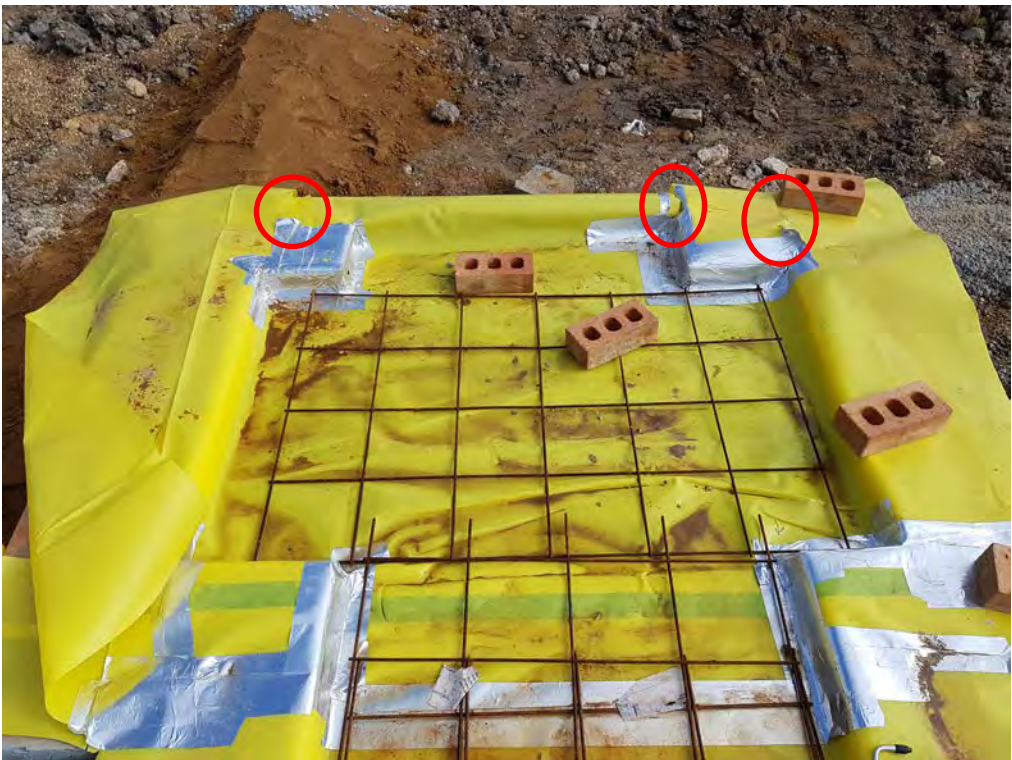
**Photo 7** – Corner detailing for Plot 926, note three identified defects within silver tape corner seal.

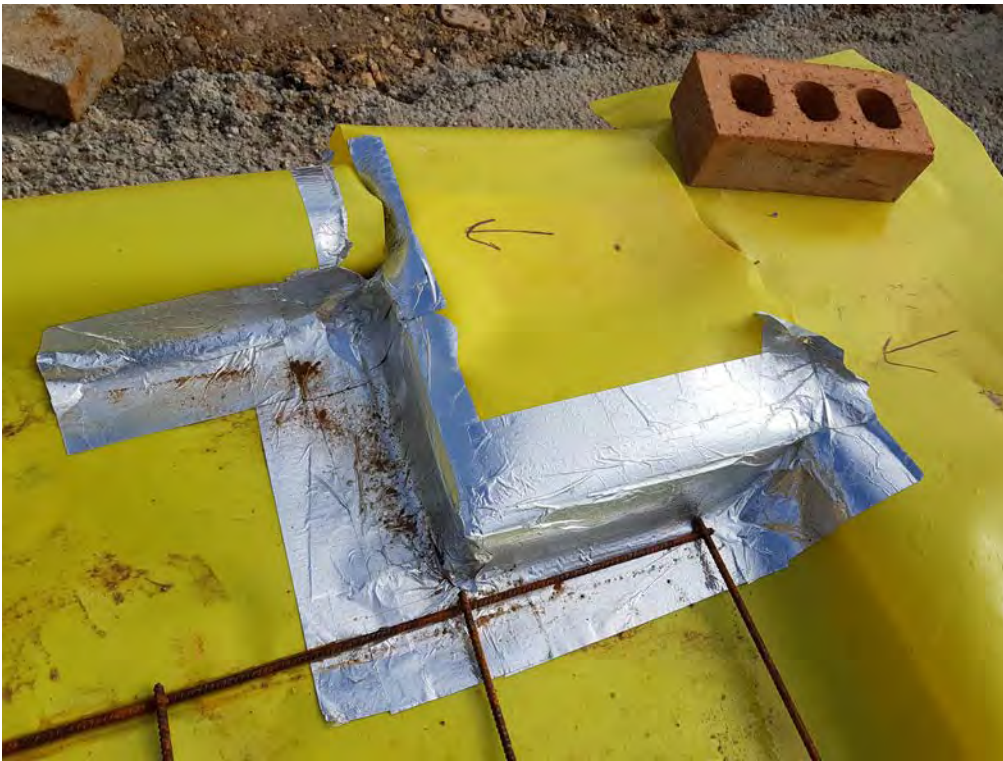
**Photo 8** – Detail of defects identified in seal for Plot 926.

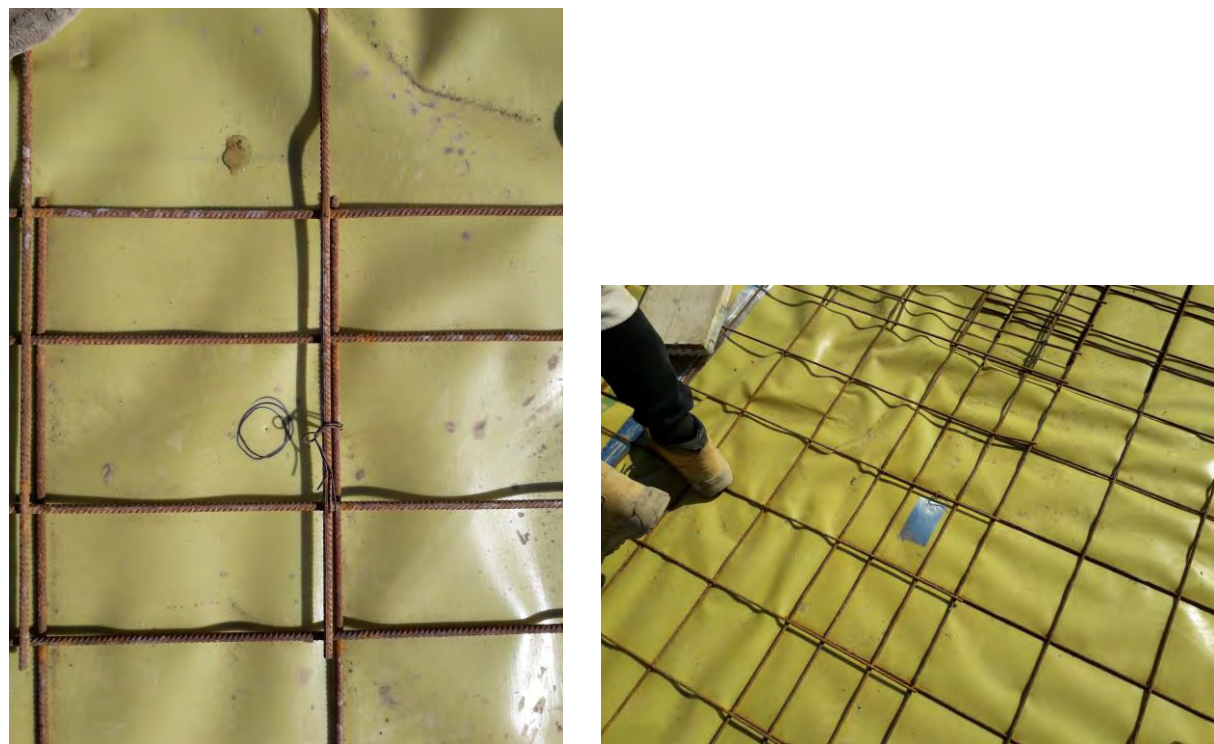
**Photo 4** - Example of minor puncture holes in the membrane of Plot 927/928/929, before and after repair.

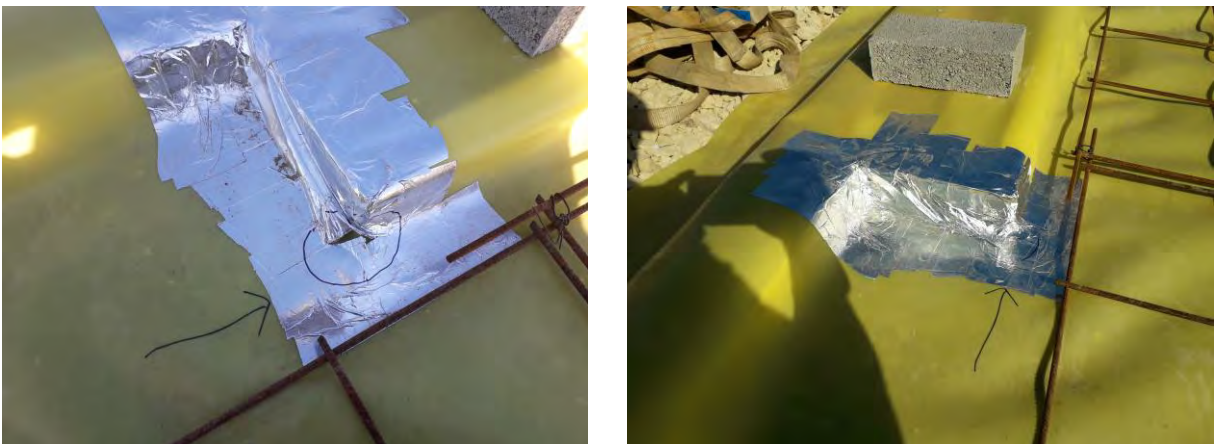
**Photo 5** - Tear in silver tape within a corner joint before and after repair.
